# Television Desk-Based Report

Great Jackson Street, Plot D

Renaker Build Ltd

March, 2023

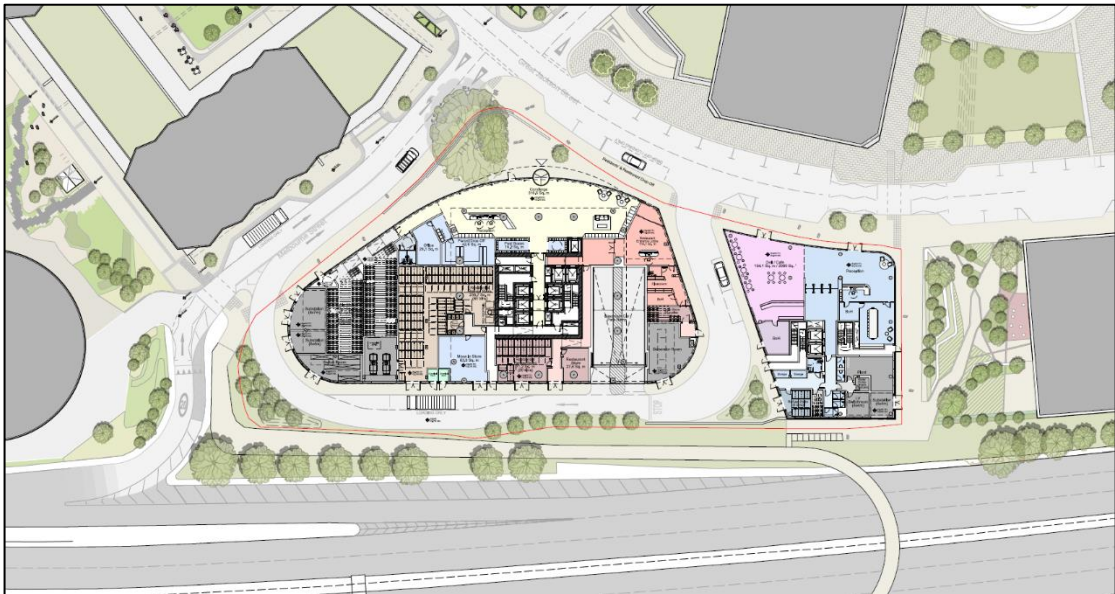
Figure 1 – Proposed development general arrangement plan

The general arrangement plan for the proposed development is shown in Figure 1<sup>2</sup> below. The residential tower is the building in the centre of the figure, and the building for office use is to the right.

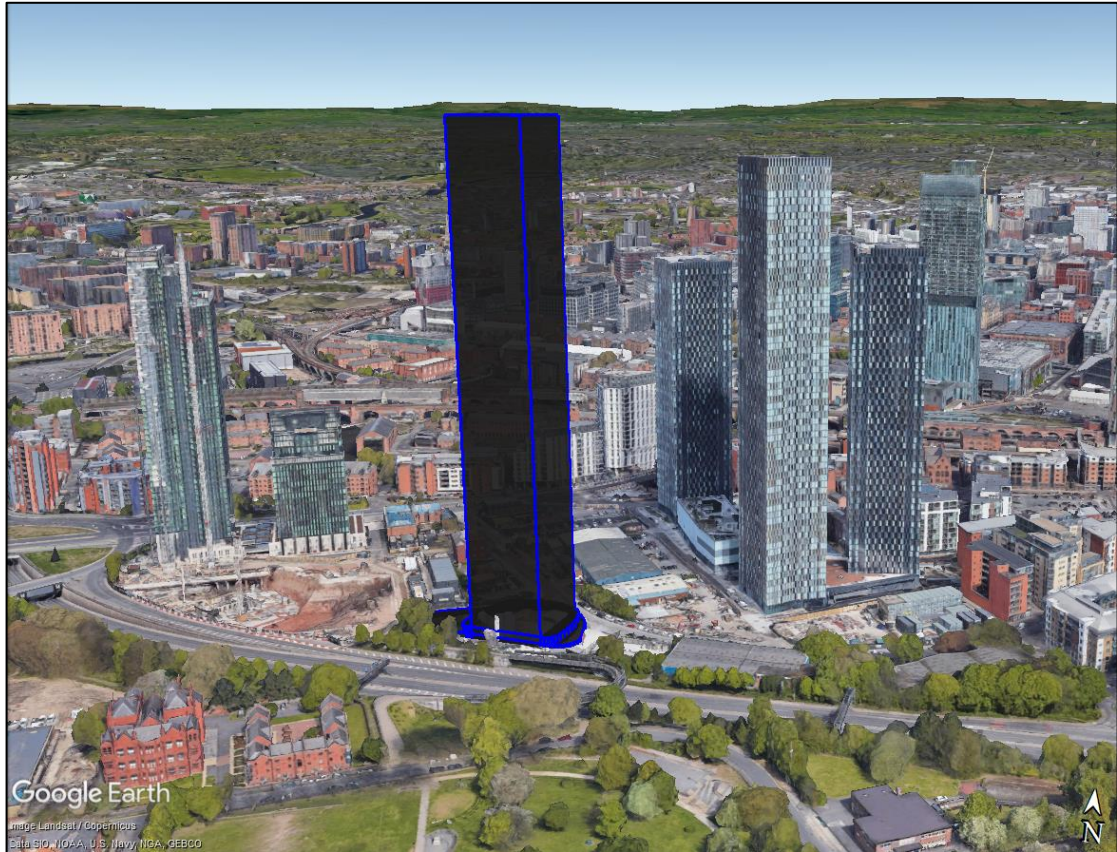
Figure 2 – 3D building representation

A representative 3D aerial image of the proposed development is shown in Figure 2 below.

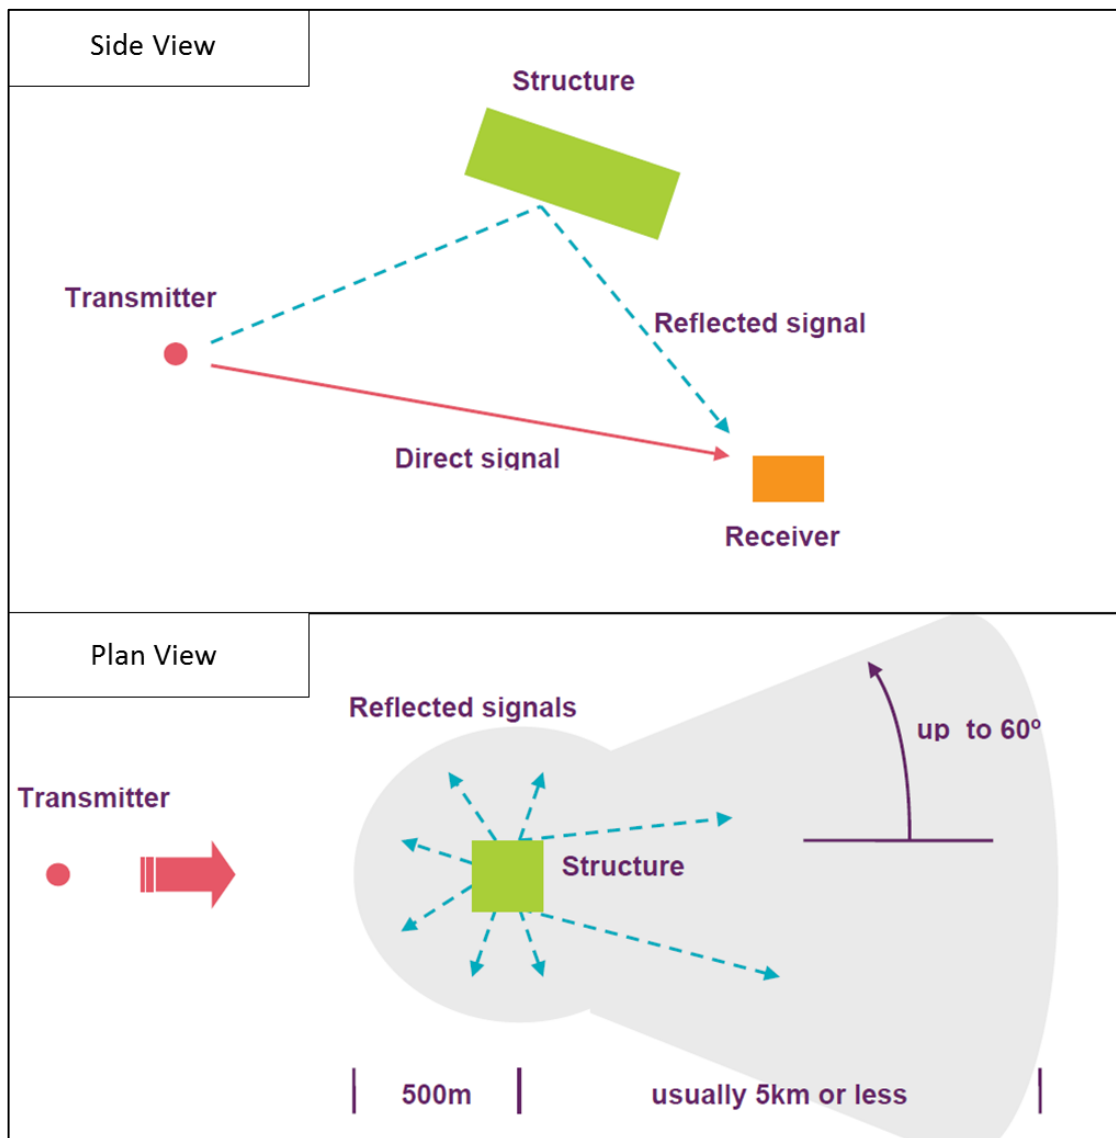
Figure 5 – Reflection Zones

For large developments with straight edges, the transmitted signal can be reflected by the building itself. This causes an effect known as ‘multipath interference’ whereby the signal is received twice by an aerial at different times. The direct signal arrives first because it has a shorter distance to travel.

Figure 5<sup>7</sup> below (taken from Section 3.3 of the Ofcom guidance referenced above) illustrates this effect.

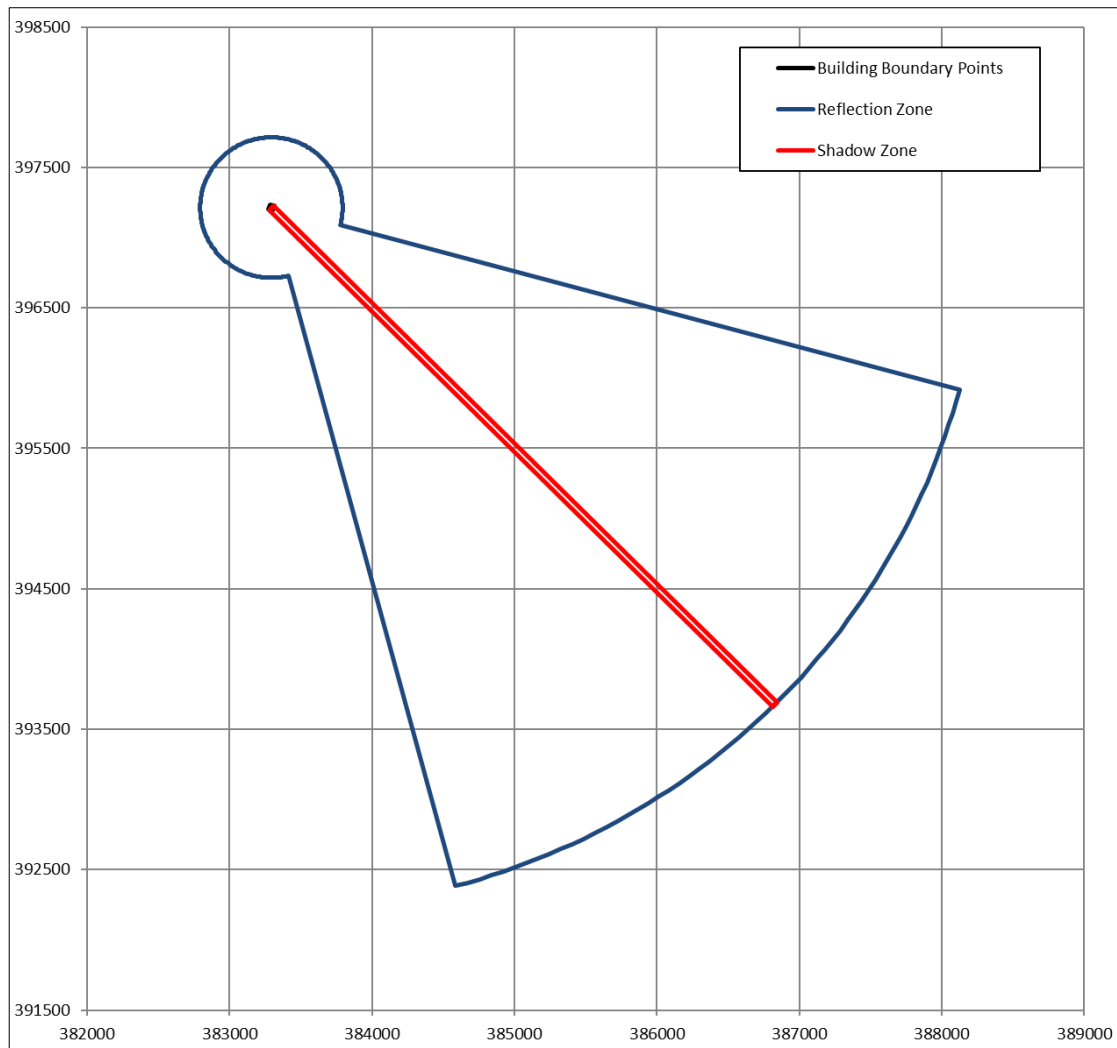
Figure 6 – Interference areas

These were defined based on the geometry of the potential interference zones as set out in the previous section. Both zones extend to a distance of 5km beyond the building in accordance with the Ofcom guidance.

In the case of the shadow zone, this has been modelled as having straight sides in order to be conservative. In actuality due to diffraction effects the zone would have a more triangular shape as shown in Figure 4 in the previous section.

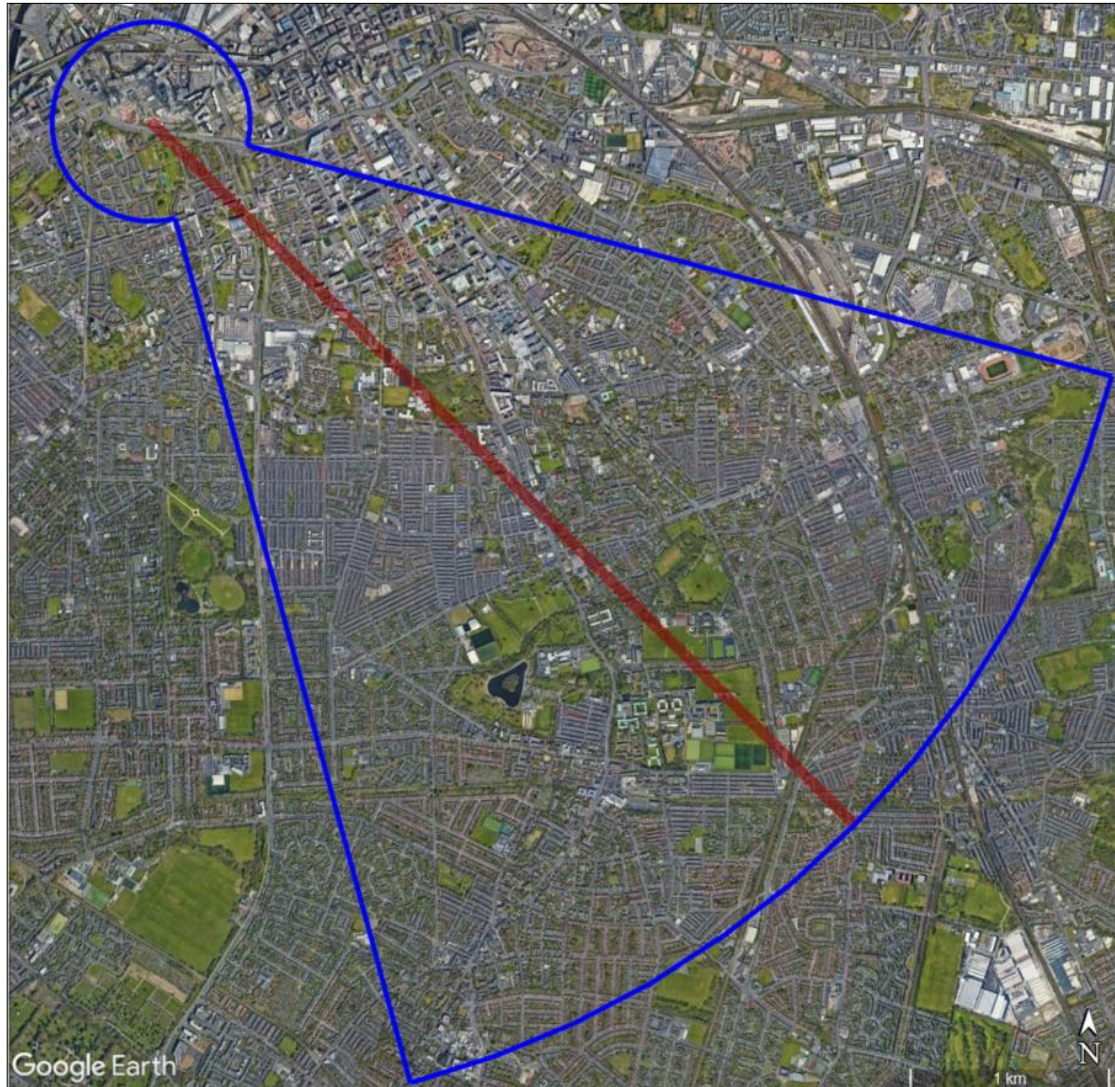
Figure 7 – Interference zones – aerial image

Figure 7 below shows the interference zones overlaid onto aerial photography of the area.

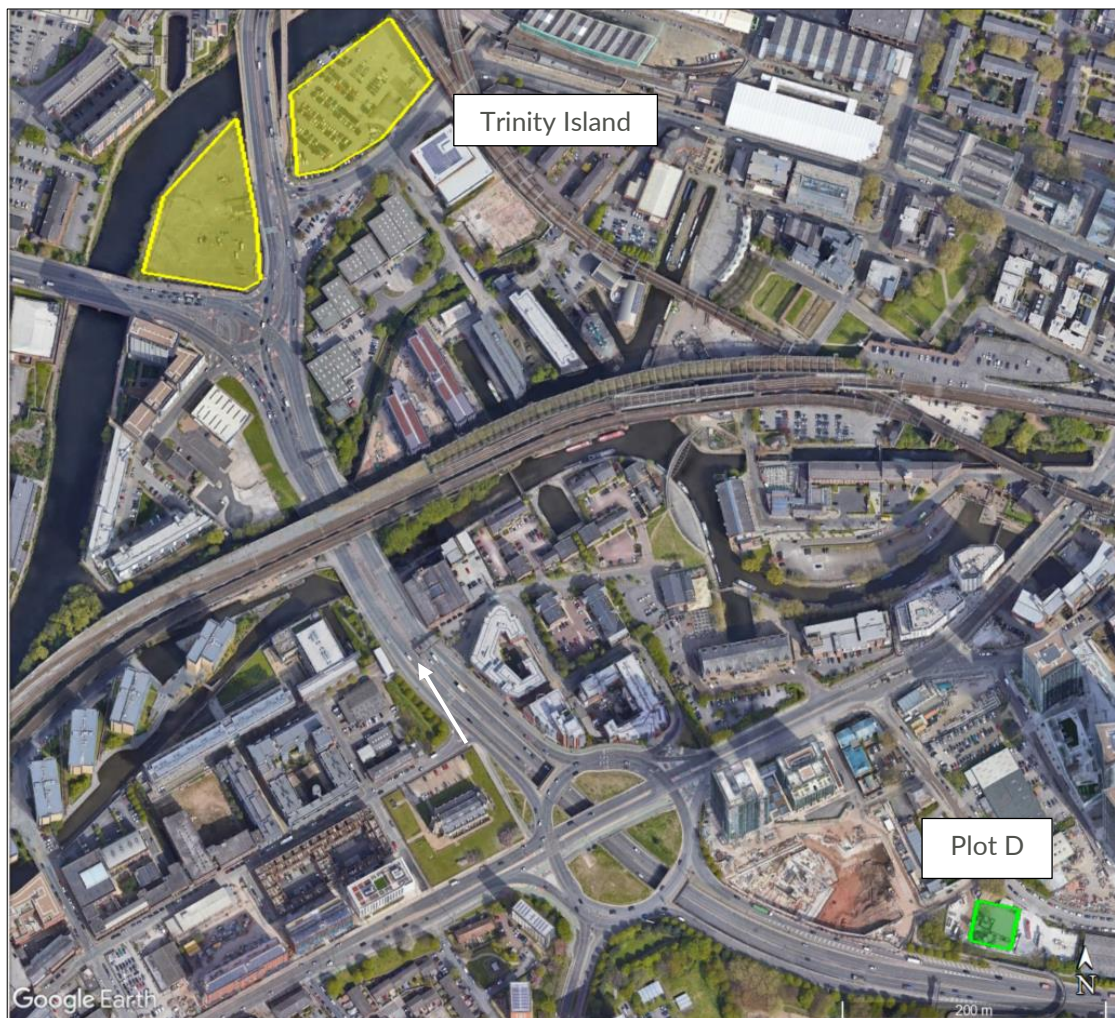
Figure 8 – Location of Trinity Island development (yellow) relative to the Plot D (green)

The Trinity Island development is composed of four towers located to the northwest of the proposed development. Figure 8 below Trinity Island's site boundary (yellow polygons) and its location relative to the proposed development Plot D (green polygon).

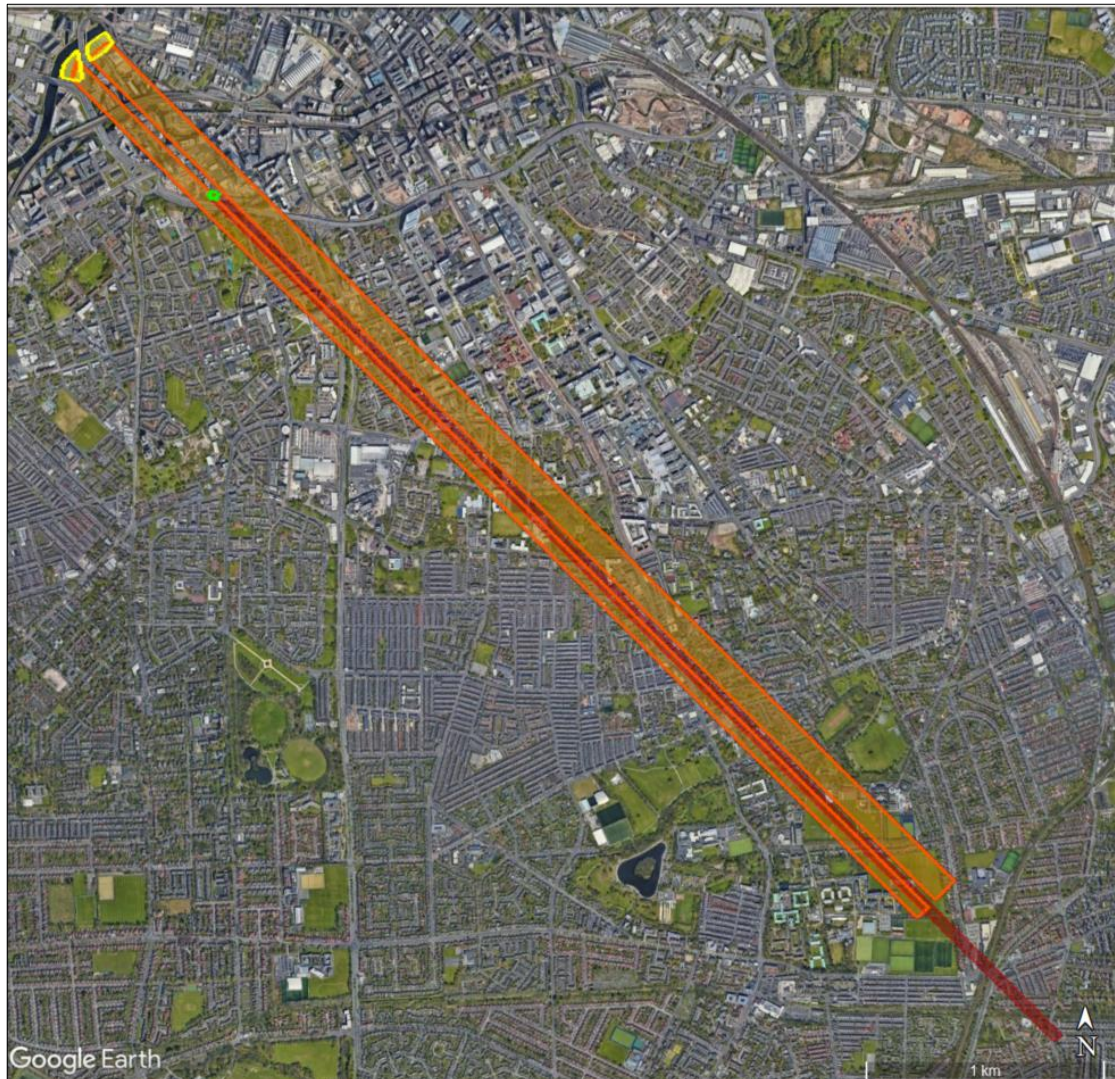
Figure 9 – Interference zones (Trinity Island and Plot D) – aerial image

Figure 9 below shows the potential interference areas that were modelled for the development Trinity Island (orange line) and the Plot D (red line). Since both developments are on the same bearing with Winter Hill and are close to each other both shadow areas overlap.

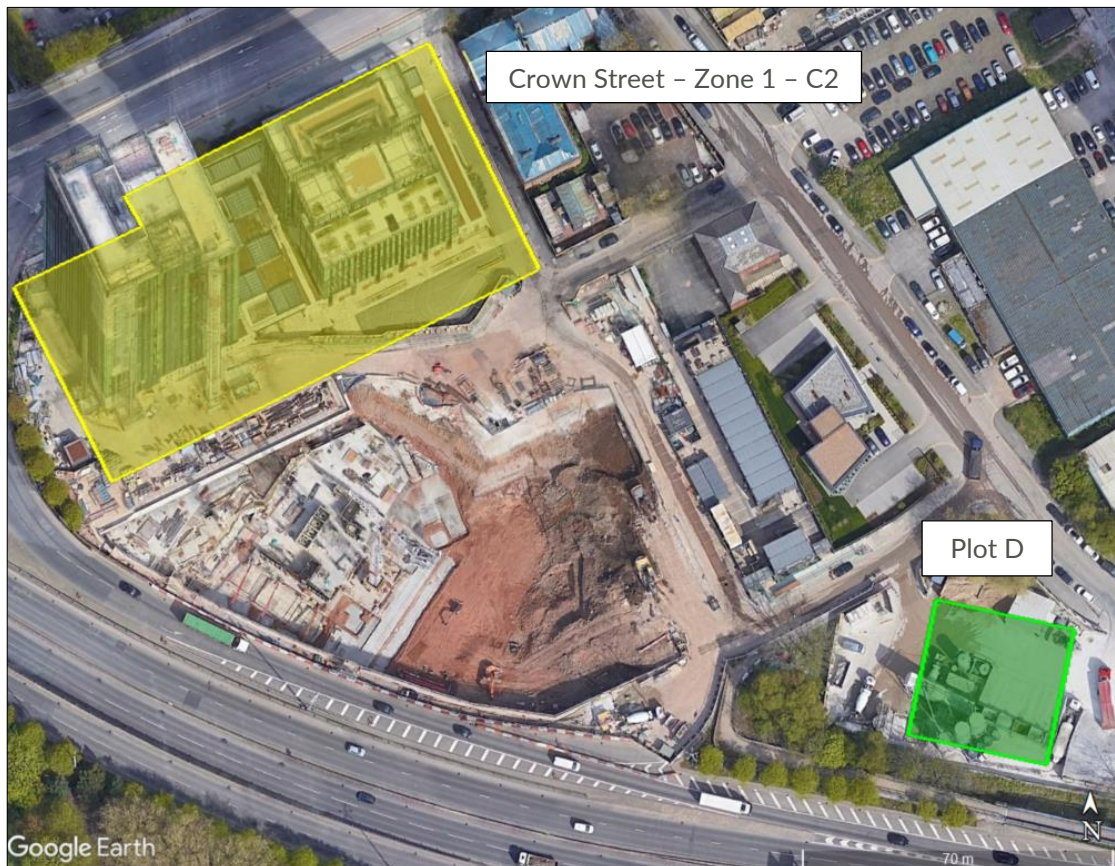
Figure 11 – Location of Crown Street – Zone 1 – C2 development (yellow) relative to the Plot D (green)

The Crown Street – Zone 1 – C2 development is composed of two towers located to the northwest of the proposed development. Figure 11 below Crown Street – Zone 1 – C2's site boundary (yellow polygons) and its location relative to the proposed development Plot D (green polygon).

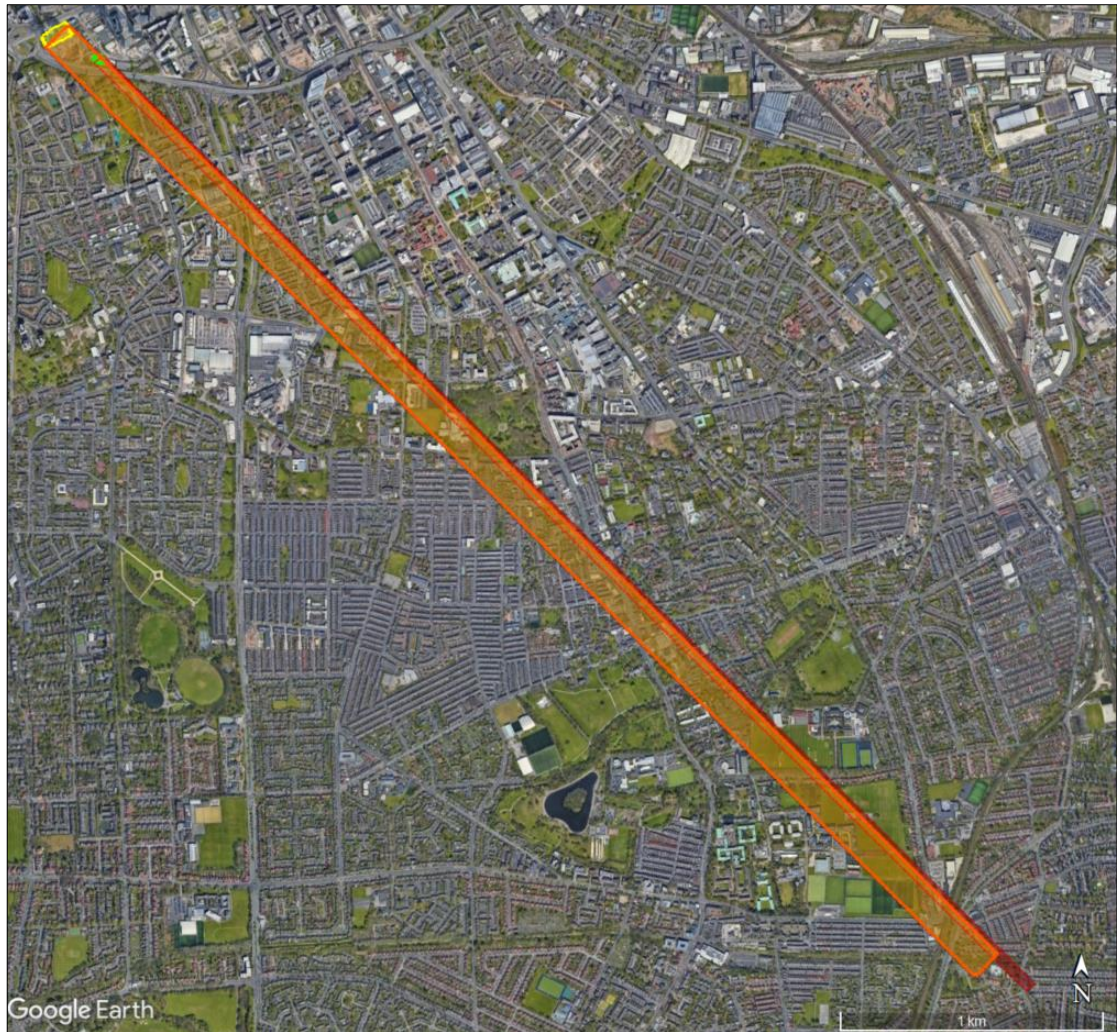
Figure 12 – Interference zones (Crown Street – Zone 1 – C2 and Plot D) – aerial image

Figure 12 below shows the potential interference areas that were modelled for the development Crown Street – Zone 1 – C2 (orange line) and the Plot D (red line). Since both developments are on the same bearing with Winter Hill and are close to each other both shadow areas almost fully overlap.
