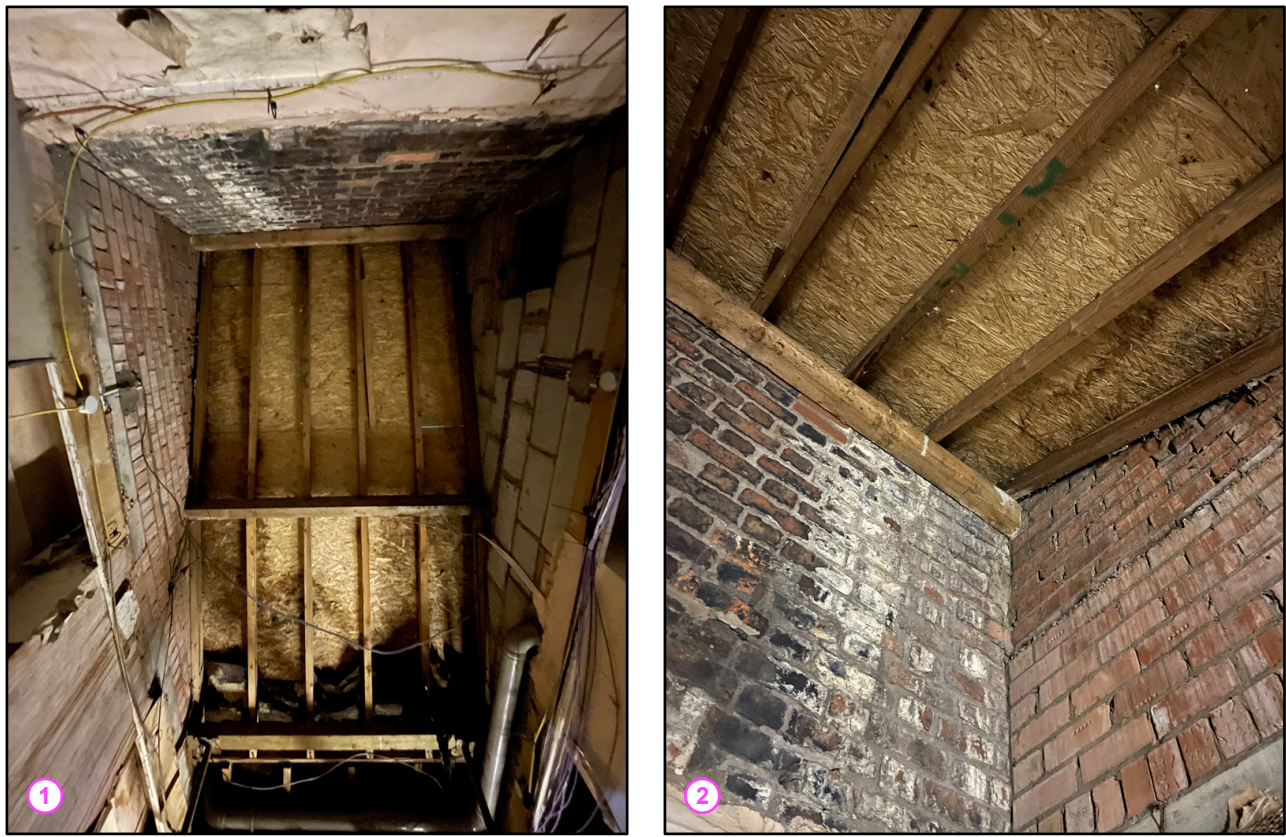
ROOM F.24

- No cornice
- Ceiling has collapsed completely leaving exposed the timber rafters above

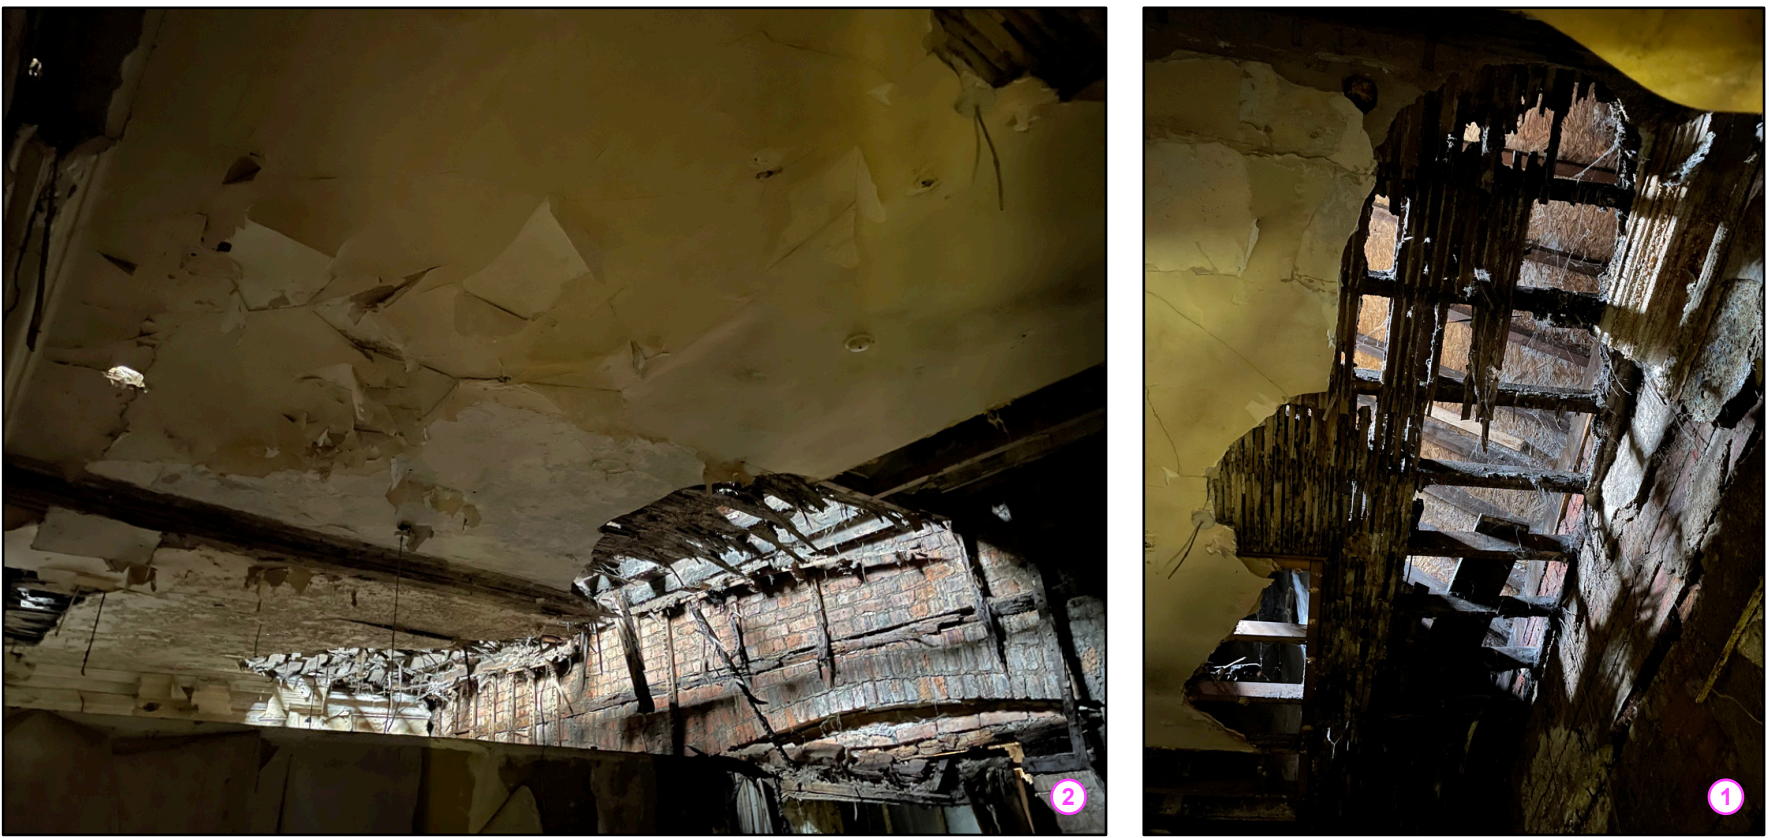
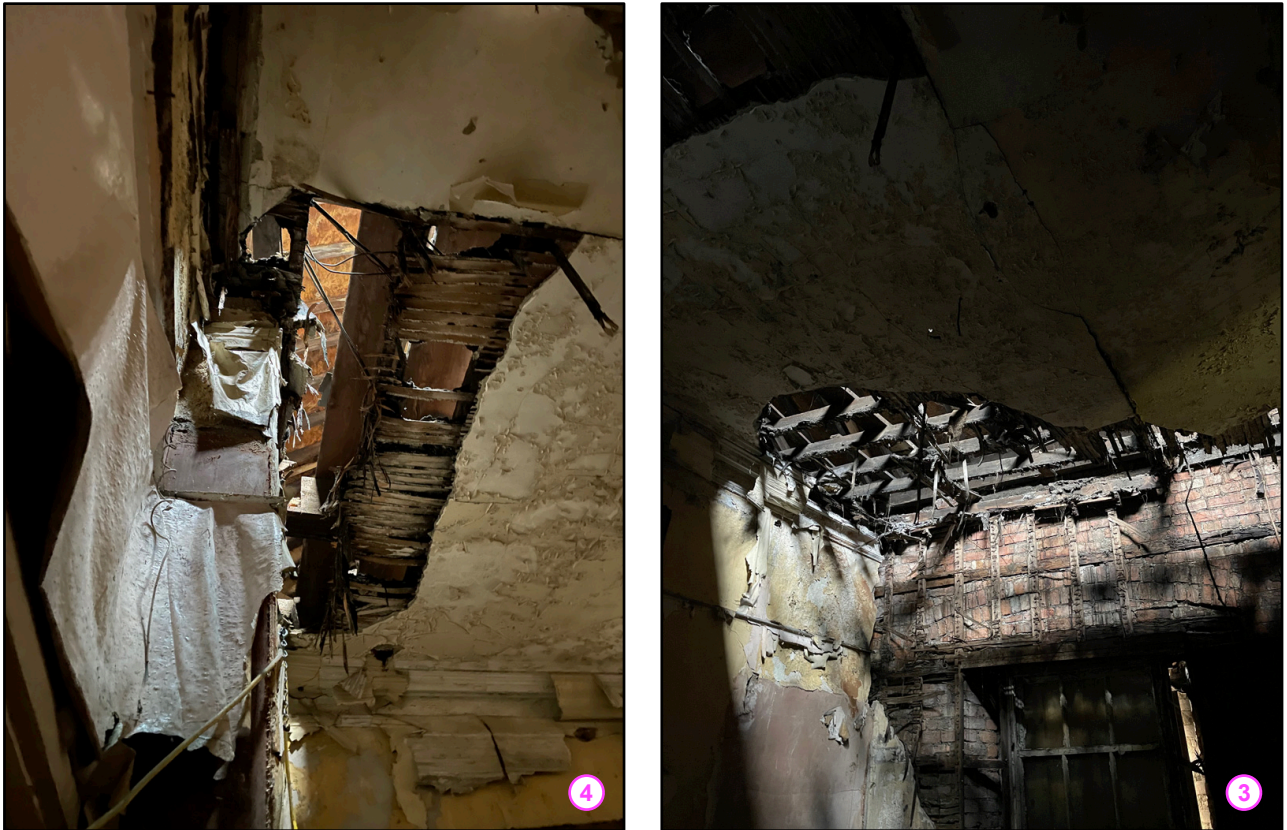
ROOMS F.26 / F.27 / F.28 / F.29

- Restricted access - Rooms are inaccessible due to collapsed ceiling and/or unsafe floor structure
- Limited cornice as noted on the plan
- Most of the ceiling has collapsed - the rest looks badly damaged

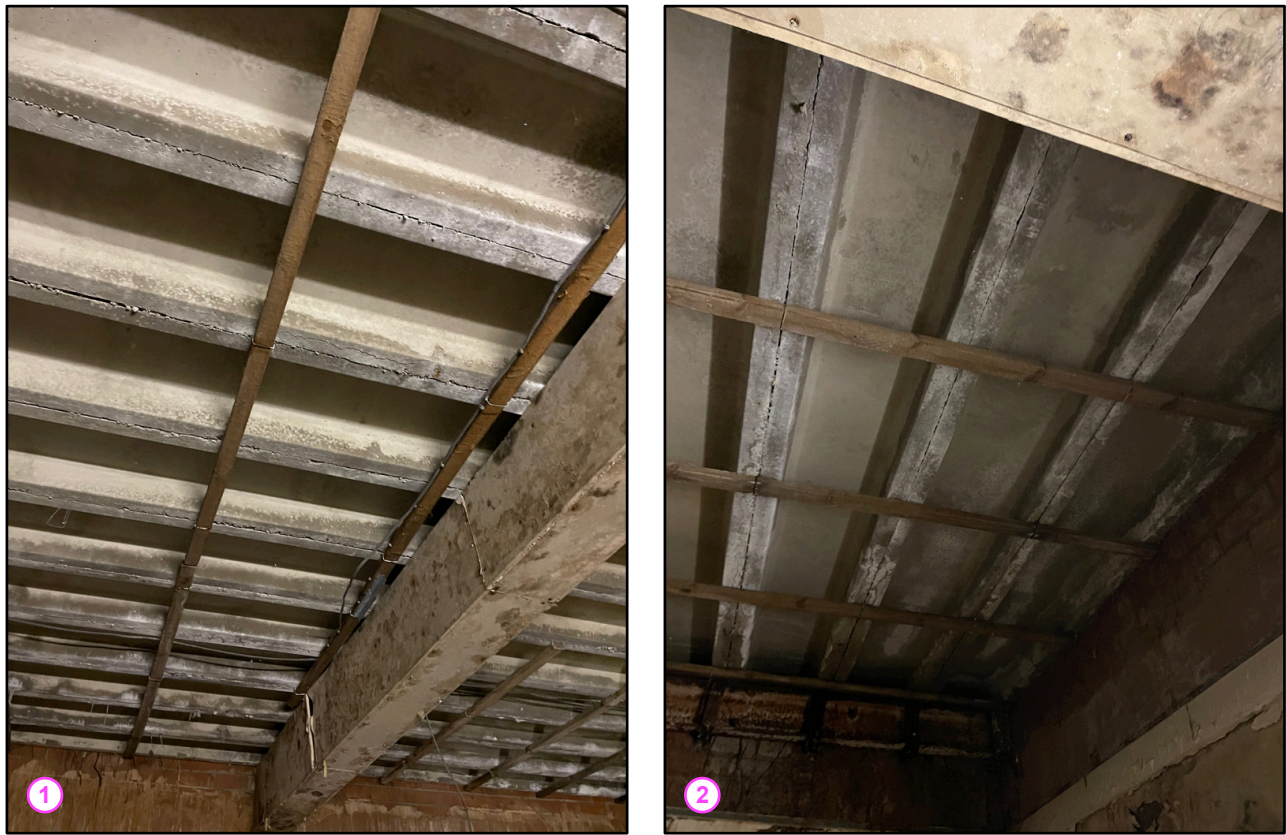
ROOM F.25

- Restricted access - Room is inaccessible due to collapsed ceiling and/or unsafe floor structure
- No cornice
- All ceiling has collapsed exposing a precast concrete floor above
