# Television Desk-Based Report

Crown Street, Phase 3

Renaker Build Ltd

Pager Power has been commissioned to investigate the potential impact of a proposed building development (Phase 3) located on Crown Street, Manchester city centre upon terrestrial television services.

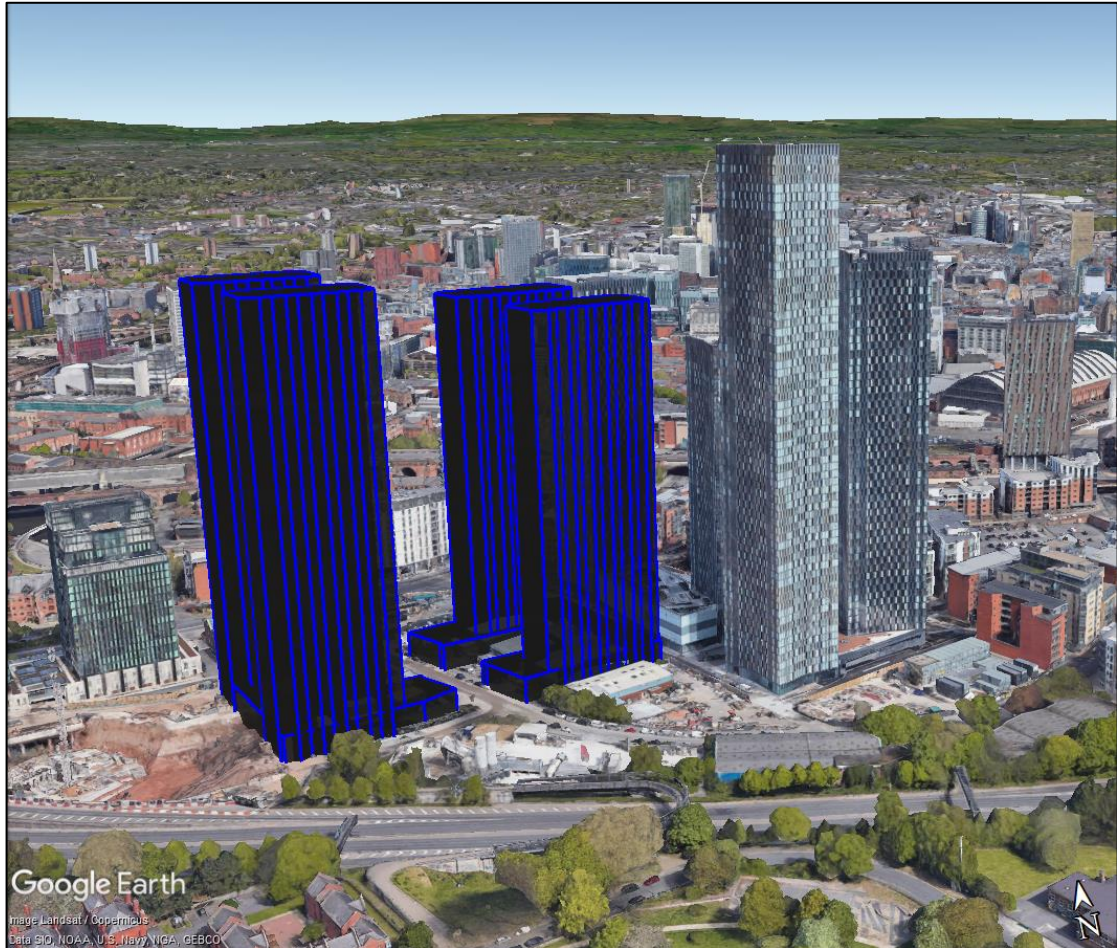
Figure 2 – 3D building representation

A representative 3D aerial image of the proposed development is shown in Figure 2 below.

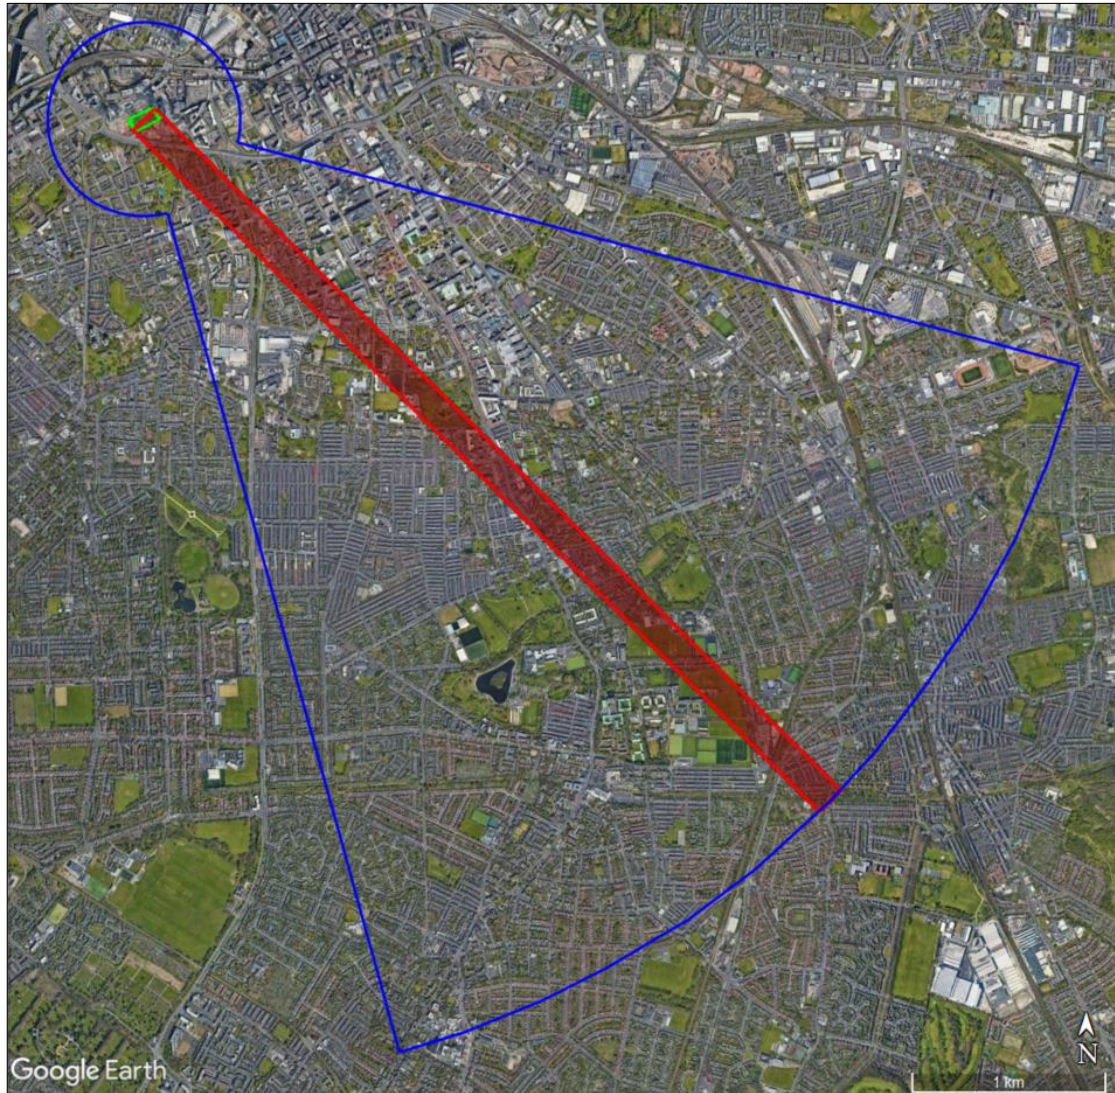
Figure 7 – Interference zones – aerial image

Figure 7 below shows the interference zones overlaid onto aerial photography of the area.

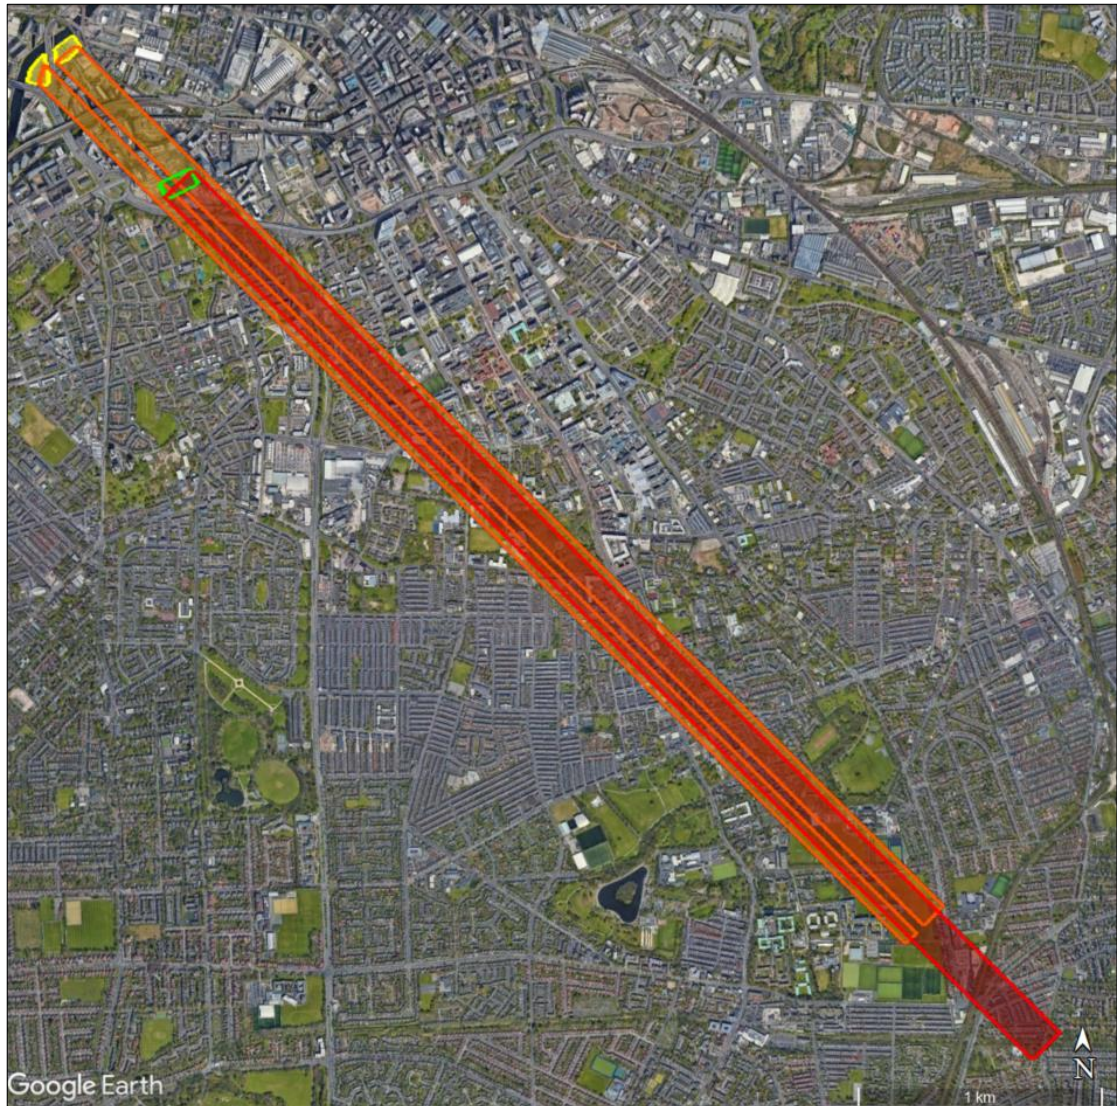
Figure 9 – Interference zones (Trinity Island and Phase 3) – aerial image

Figure 9 below shows the potential interference areas that were modelled for the development Trinity Island (orange line) and the Phase 3 (red line). Since both developments are on the same bearing with Winter Hill and are close to each other both shadow areas almost fully overlap.

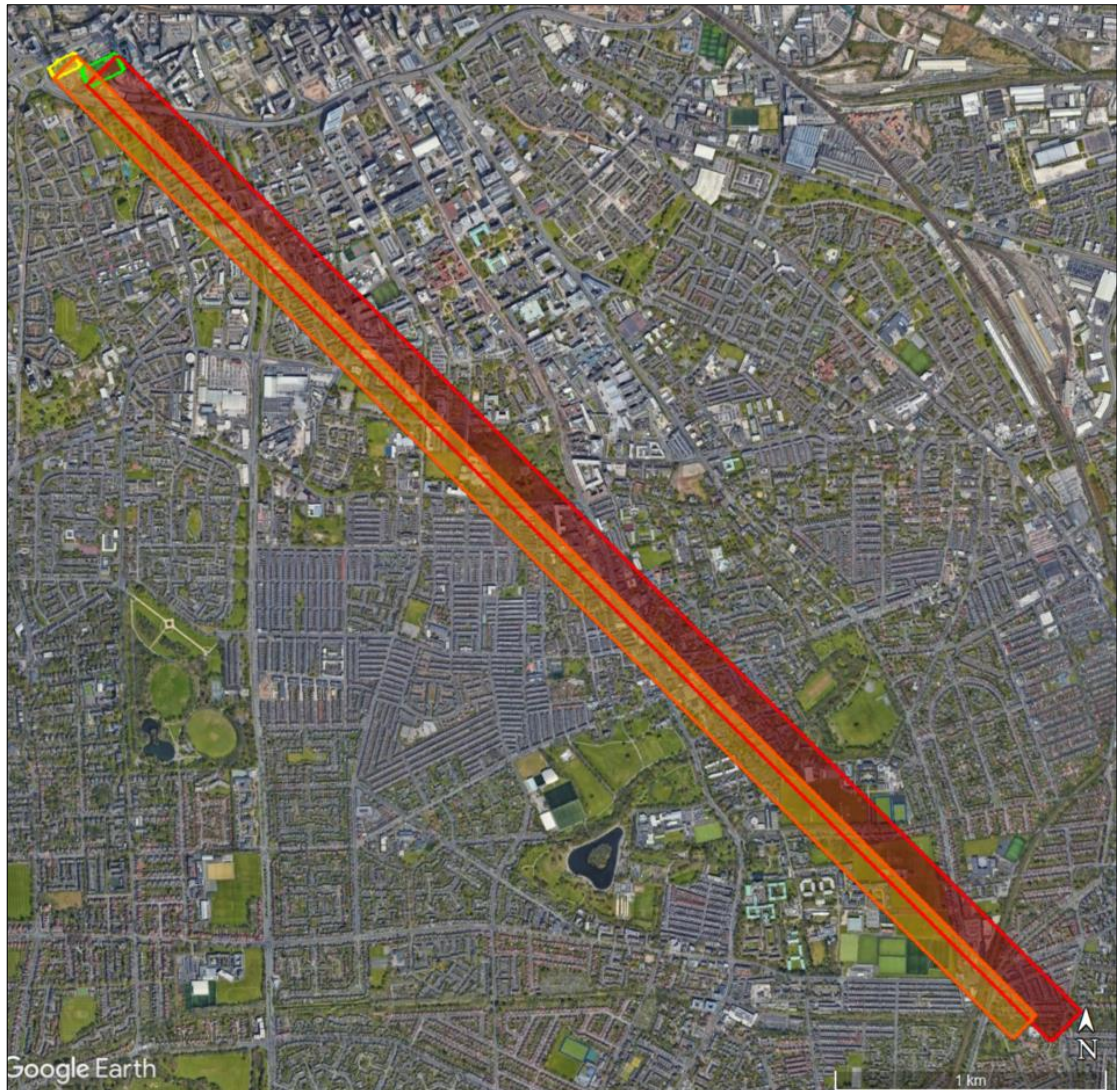
Figure 12 – Interference zones (Crown Street – Zone 1 – C2 and Phase 3) – aerial image

Figure 12 below shows the potential interference areas that were modelled for the development Crown Street – Zone 1 – C2 (orange line) and the Phase 3 (red line). Since both developments are on a similar bearing with Winter Hill and are close to each other both shadow areas partially overlap.
