Materials Analysis: Paint, Stucco & Window Joinery

### **Manchester Opera House**

3, Quay Street  
Manchester M3 3HP

September 2022

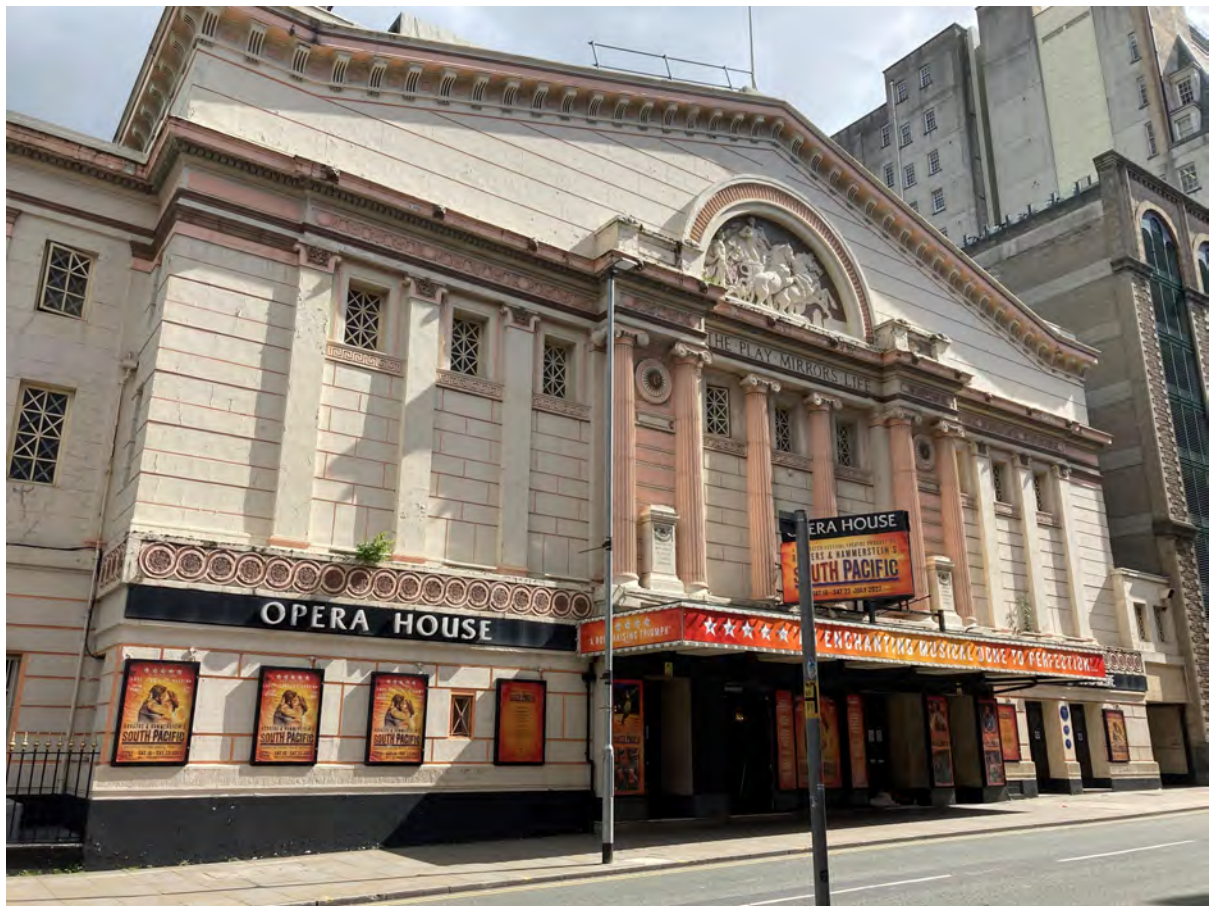
*Figure 1: The Opera House façade facing the road*

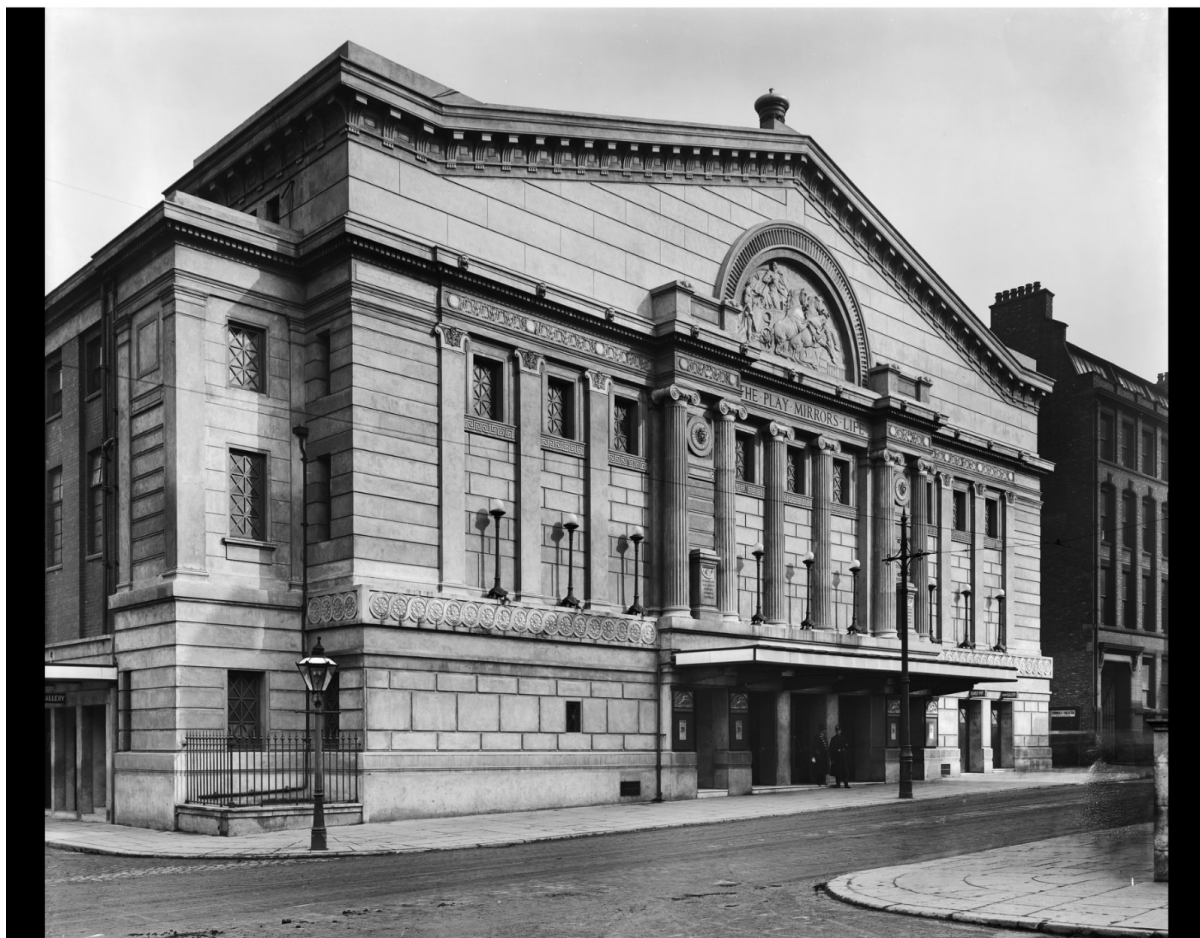
Figure 3: The Opera House in 1913 (source: Historic England)

coating, which appears to be the same as the early brown layer on Sample 6 from the fluted course above, with a pale yellowish-stone-coloured lead paint above it. These may relate to the decorative treatments of the façade up to the 1960s, as archival photographs (see Figure 3) and programme covers (see Figure 4) show this element painted in light colours up to 1968, and painted in dark colours from the 1970s onwards. The disturbed surface of the brown layer, however, may indicate that the surface has been scraped back before the application of the yellowish-stone lead paint, so any intervening layers may have been lost. The later layers are mainly black paints with primers: the zinc-based paints are likely to date from the mid-late 20<sup>th</sup> century, while the black alkyd paints are likely to be late 20<sup>th</sup>- 21<sup>st</sup> century.

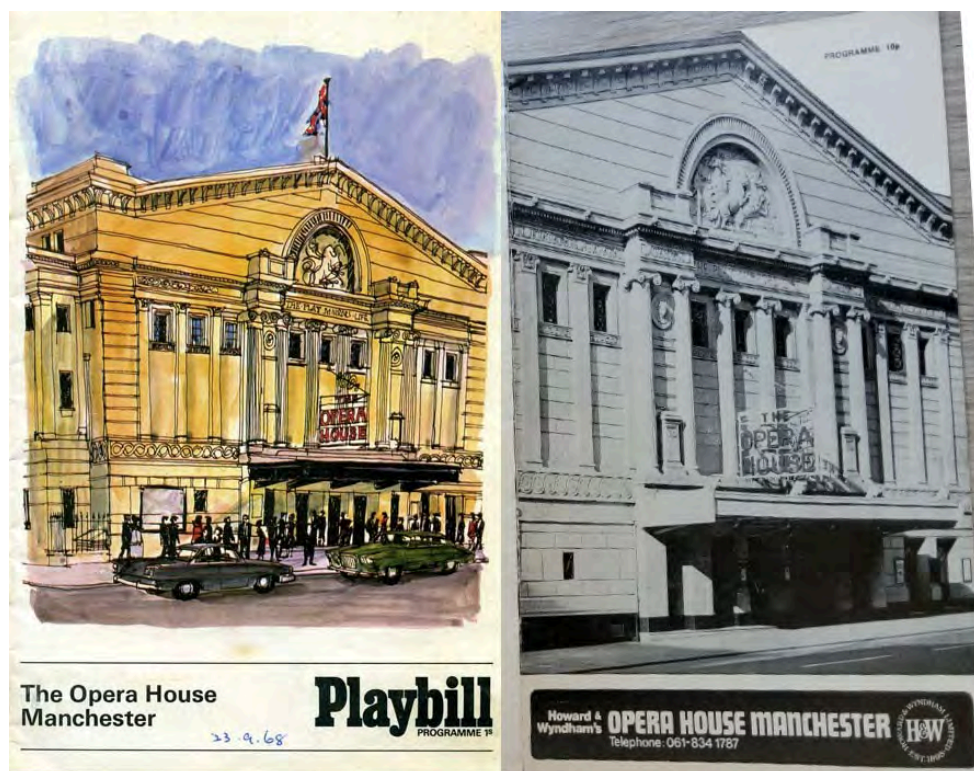
Figure 4:  
Details from  
1968 (left) and  
1977 (right)  
Opera House  
theatre  
programmes  
(source:  
manchesterhis  
tory.net)

The later schemes begin with a bright red alkyd paint, followed by several schemes of black, and finally by mainly white, off-white and cream alkyd and zinc paints. The single scheme of yellow alkyd paint may date from the 1960s, when programme covers show that the Opera House may have been given a predominantly yellow decorative treatment (see Figure 4).

The sample shows that the earliest visible layers are pale stone-coloured zinc paints, which may date from the period just before or just after the Second World War. The yellow alkyd paints that follow may date to the 1960s, when theatre programmes from the Opera House show the exterior of the building to be predominantly yellow (see Figure 4), although as this is an artist's interpretation, it may not be entirely accurate. The rest of the layers are mainly off-white and pale stone-coloured alkyd paints.

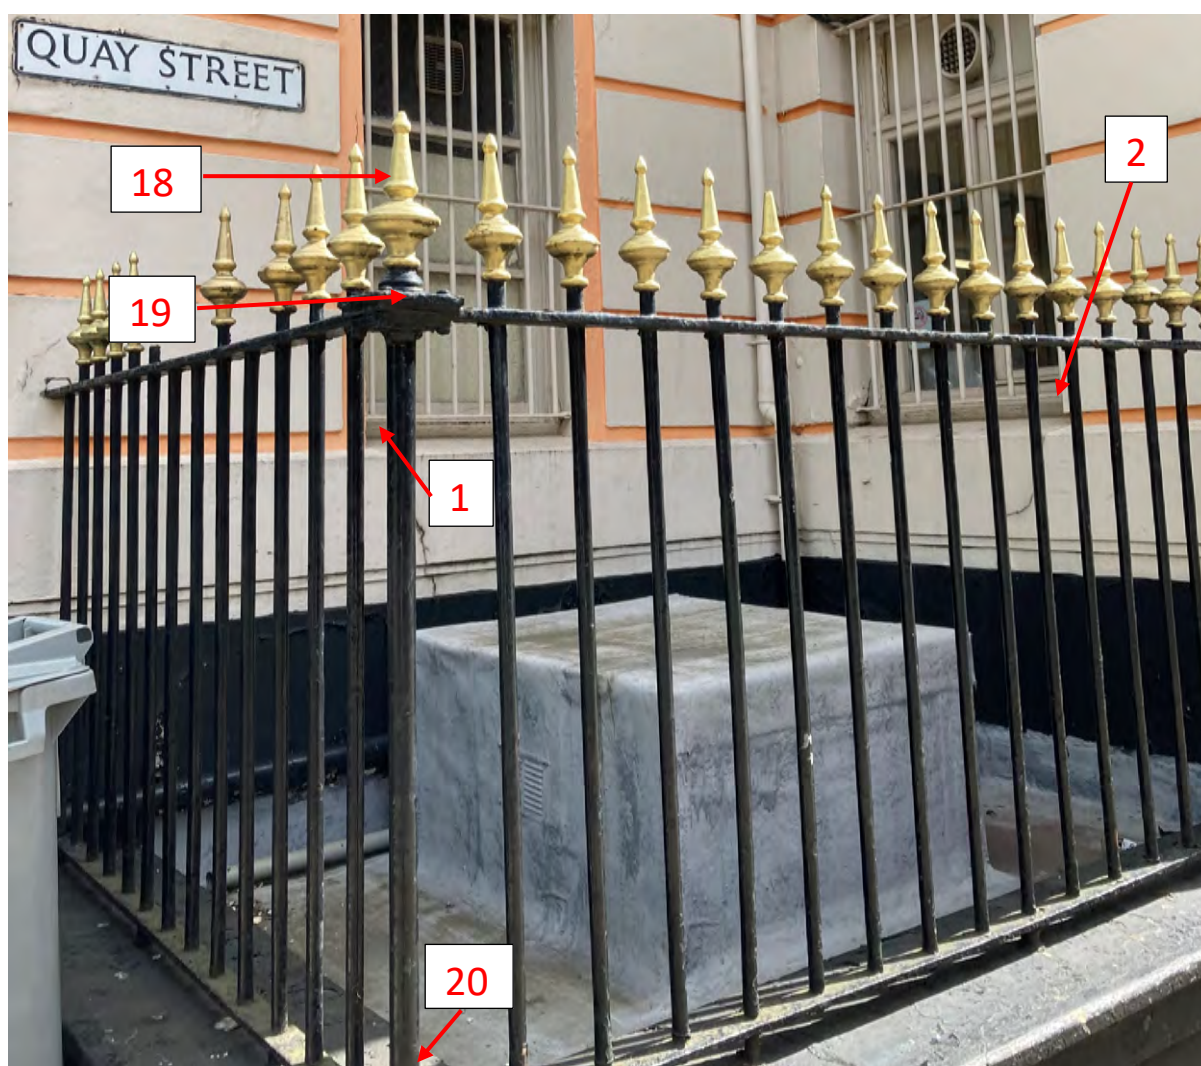
Figure 5: sample locations 1, 2 (windows W2-F and W3-F) & 18 – 20 (railings)

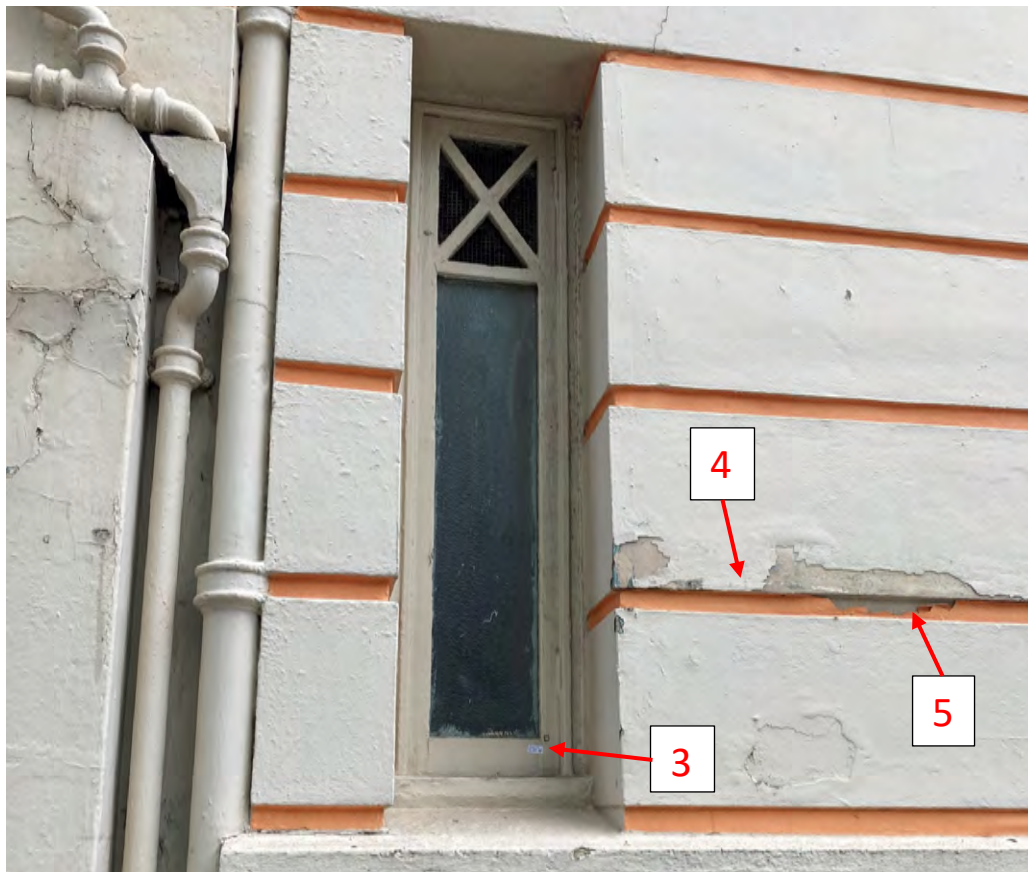
Figure 6: sample locations 3-5 (window W1-F and faux-ashlar blockwork of façade)

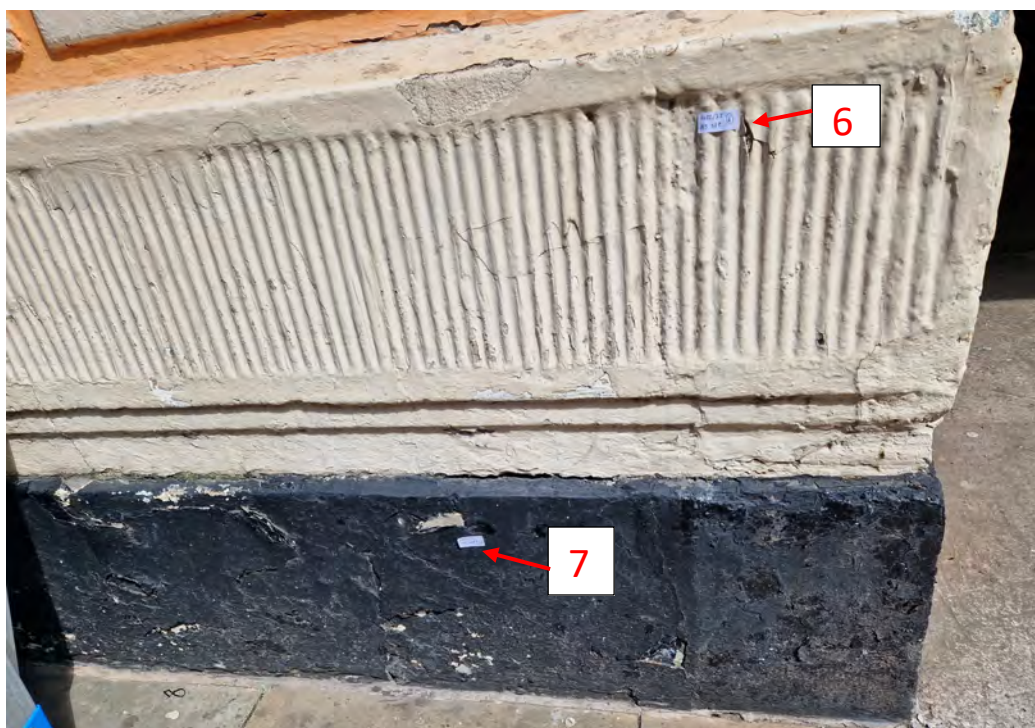
Figure 7: sample locations 6 & 7 (fluted course and flat plinth of lower façade)

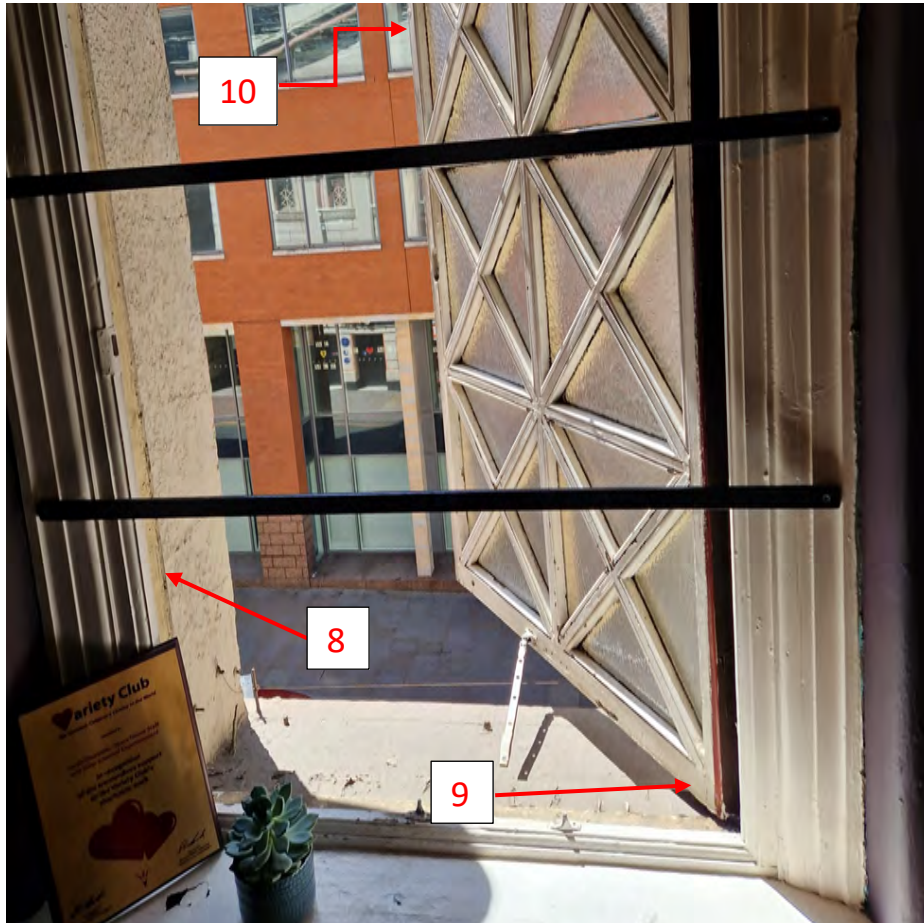
Figure 8: sample locations 8-10 (upper window W13-LG)

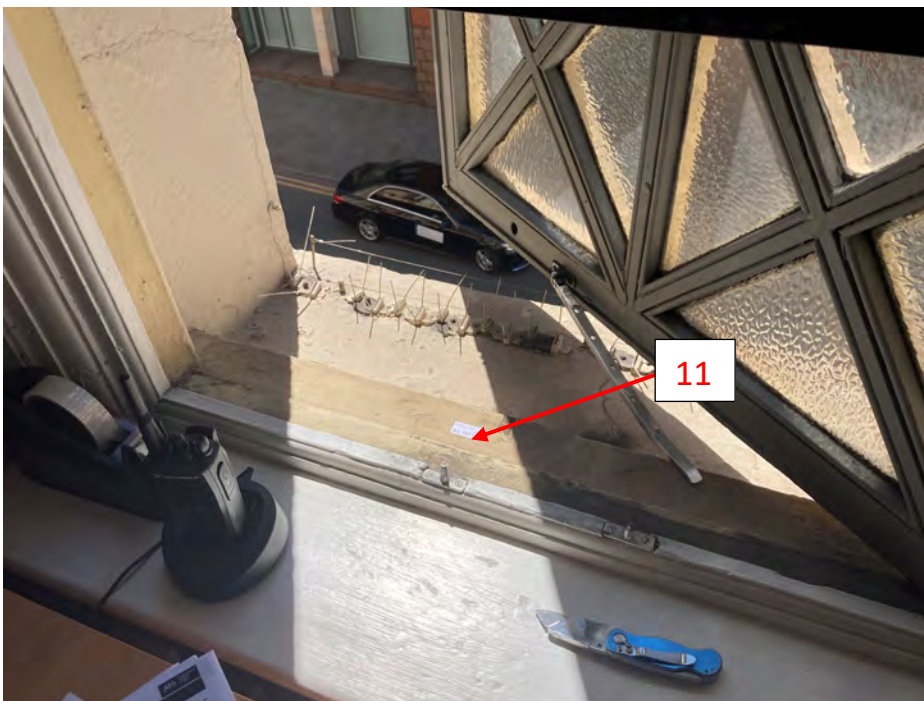
Figure 9: sample location 11 (upper window W11-LG)

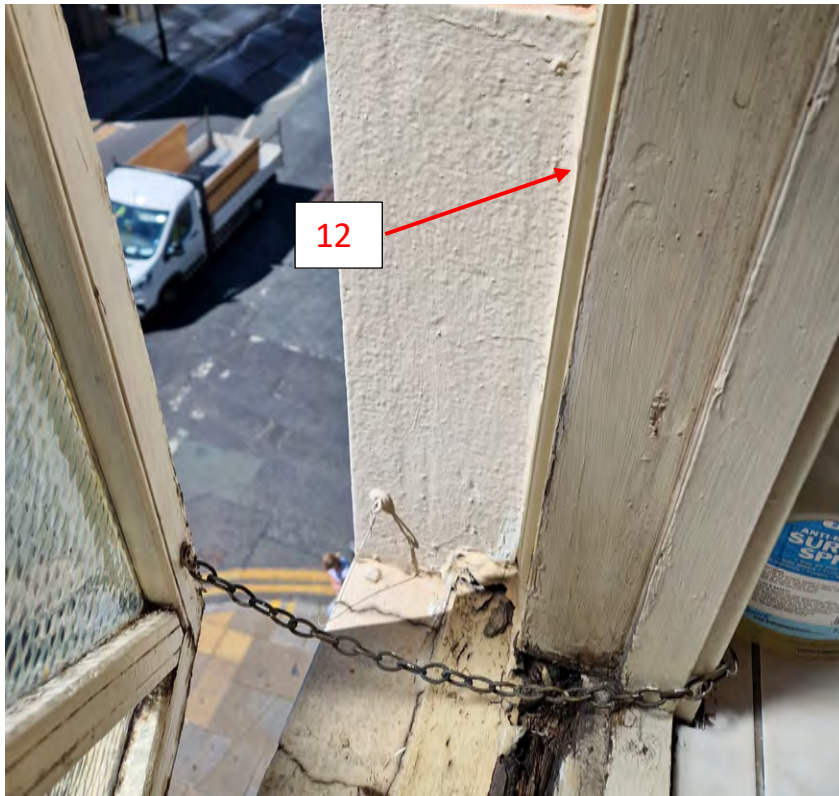
Figure 10: sample location 12 (upper window W8-LG)

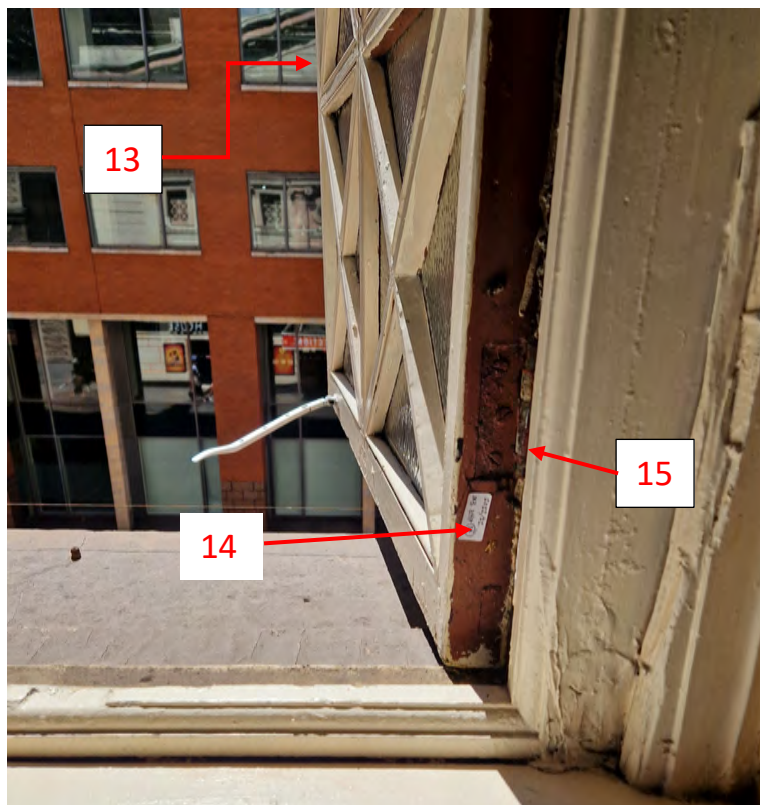
Figure 11: sample locations 13-15 (upper window W15-LG)

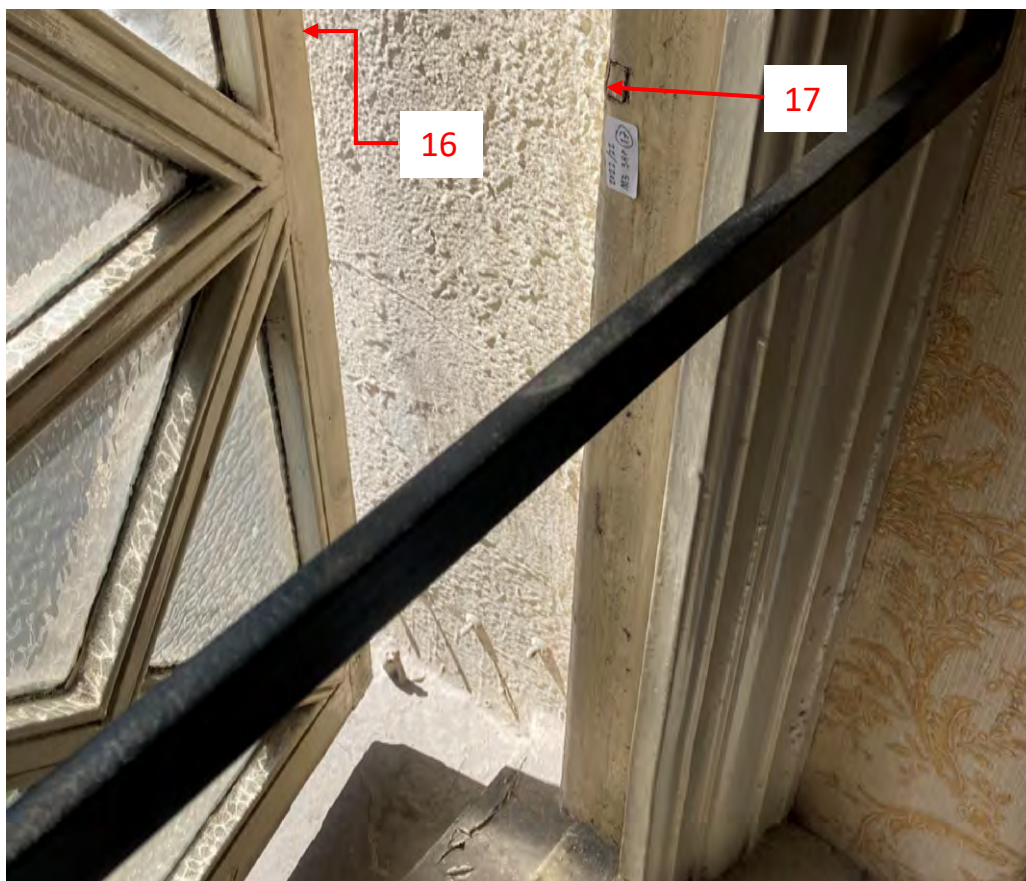
*Figure 12: sample locations 16 & 17 (upper window W16-LG)*

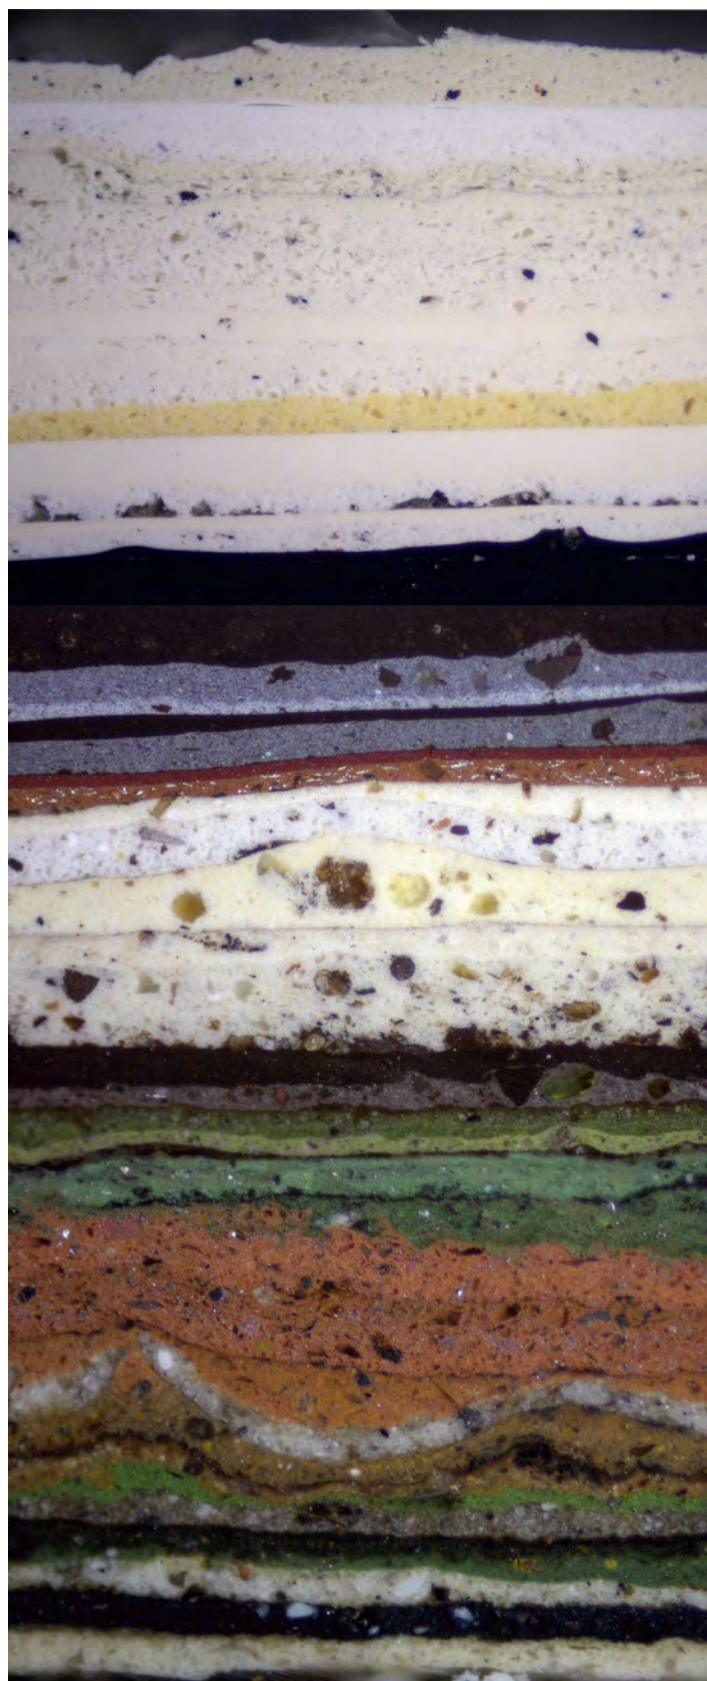
The earliest layers are lead oil paints in strong colours: initially blue/black, then mid-green, tan brown and red. These were often refreshed once or twice between colour changes. These are followed by off-white and cream zinc paints, which may date to the 1930s or 1940s.

Figure 13: **Sample 3**, exterior window casement W1-F

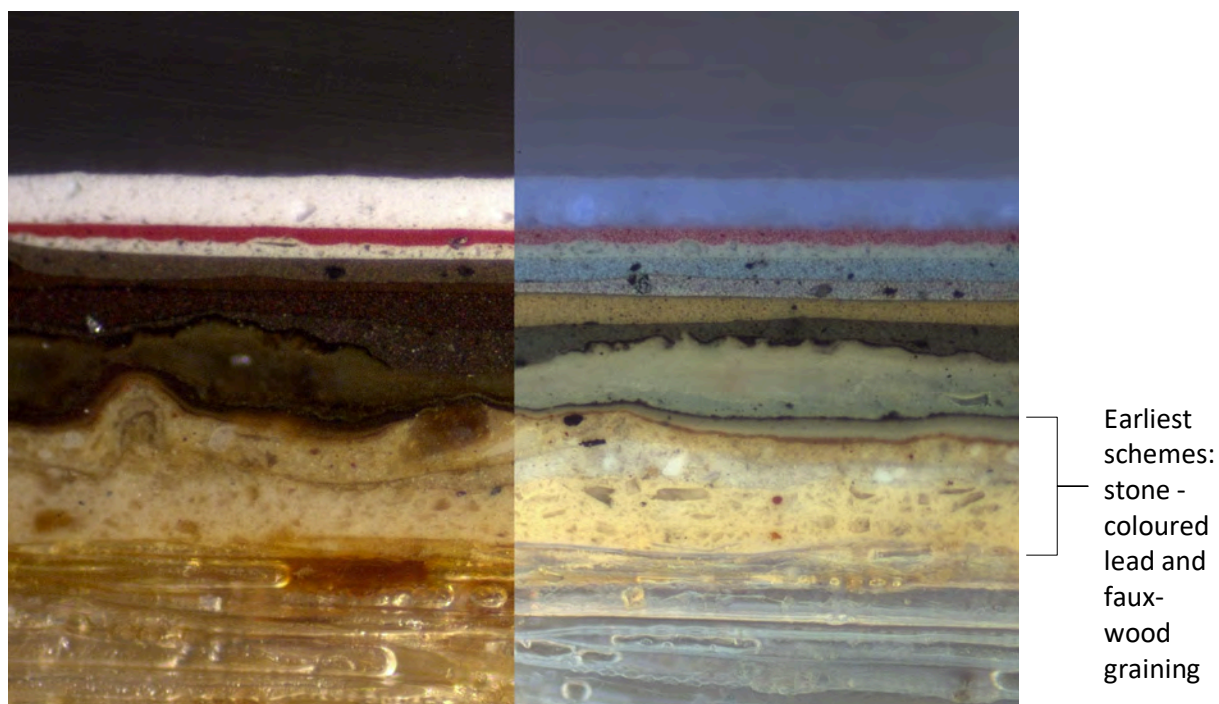
Figure 15: **Sample 9**, interior casement of W13-LG (right is under UV light)

The samples taken from the interiors of the upper windows show that the earliest decorative scheme was a stone-coloured lead paint, followed by a faux-wood-grained finish (which is common in late 19<sup>th</sup> and early 20<sup>th</sup> century interior decoration), and later covered by several layers of varnish. This was followed by several different shades of brown zinc paints, and lastly by a layer of red zinc paint, before the current layer of modern white paint was applied.

This indicates that the interiors of the windows were treated differently from the exteriors, and that the decorative schemes used on the insides of the windows were more likely related to the interior decoration of the Opera House.

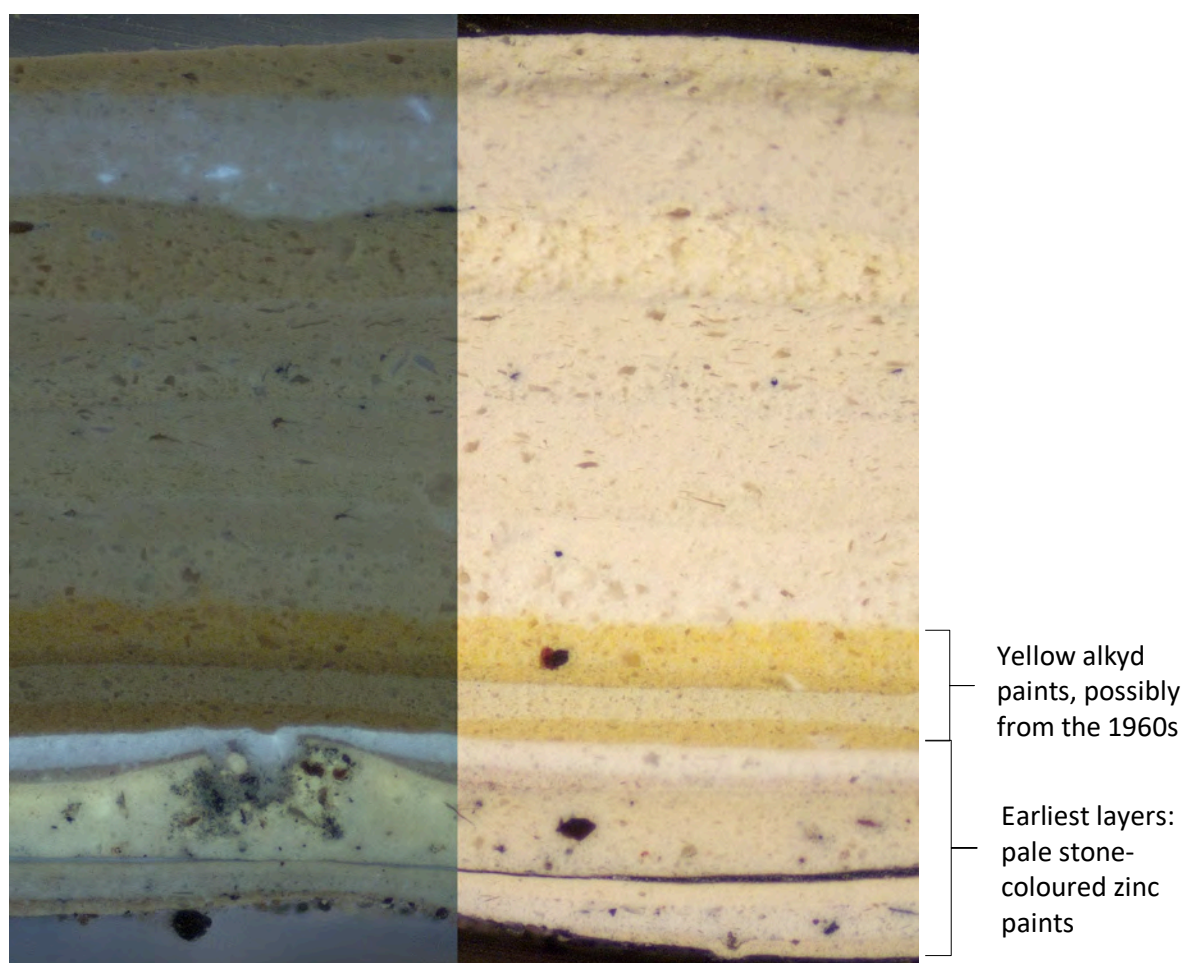
Figure 16: **Sample 4**, façade stucco (left is under UV light)

The sample taken from the façade stucco shows only more recent zinc and alkyd paints, suggesting that either the façade has been cleaned of paint in the past, or that that it was initially unpainted only to be painted in a pale stone colour later, when surfaces appeared weathered and deemed unsightly. It is worth noting that residues of blue paint were seen in some areas of the façade on site, but these do not appear in the sample taken.

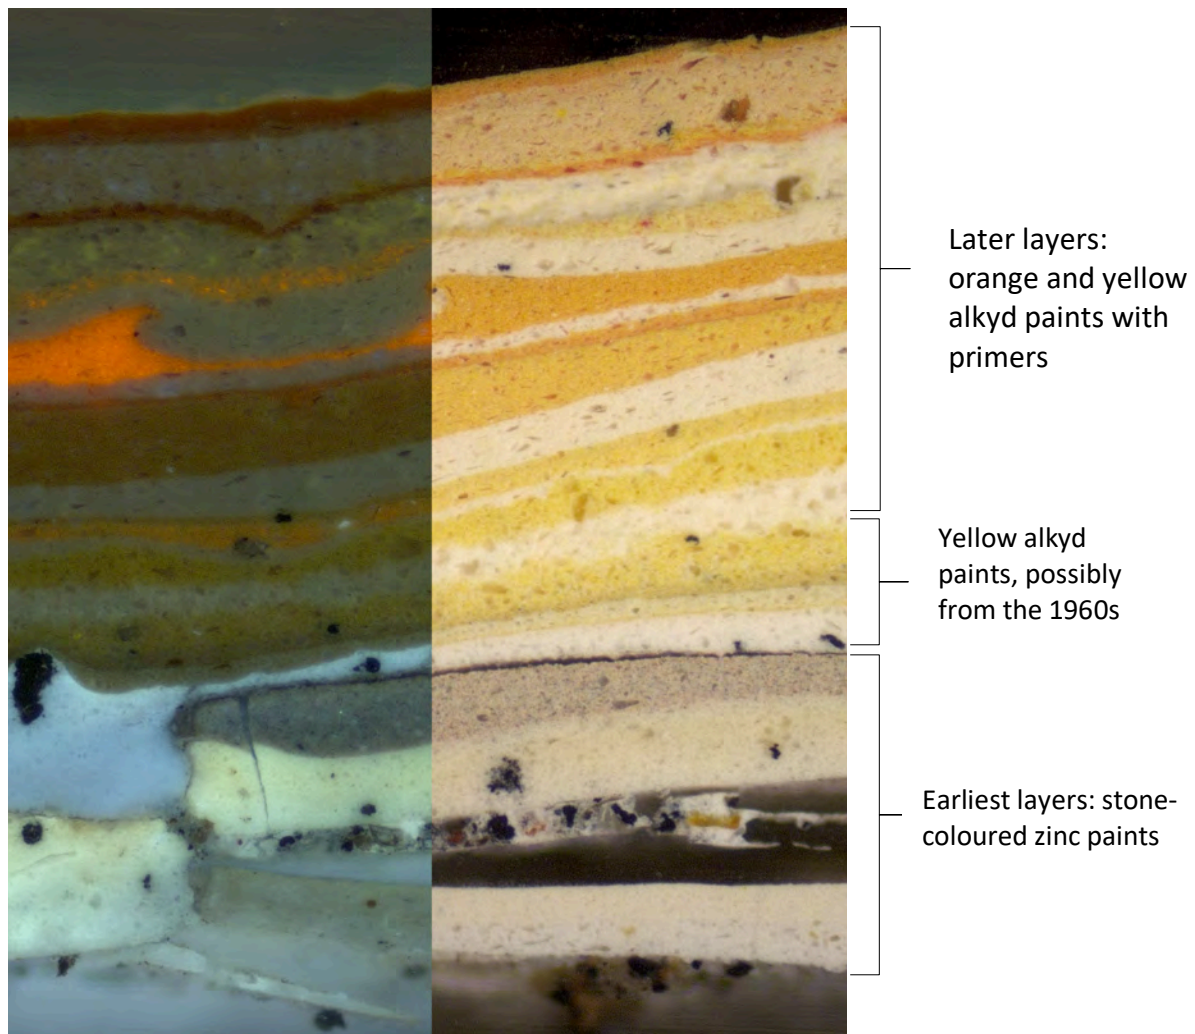
Figure 17: **Sample 5**, joints between faux-ashlar blocks on façade (left is under UV light)

The sample taken from the joints between the faux-ashlar blocks of the façade shows a similar early stratigraphy to the sample from the blocks themselves: the earliest layers are stone-coloured zinc paints, followed by the same yellow alkyd layers as on the blocks, which may date to the 1960s. Above these yellow layers, however, the sample shows that the yellow alkyds continued for two more schemes, and then were changed to orange or yellow-orange alkyd paints.

This suggests that the joints have often been picked out in yellow or orange (with the blocks themselves being painted in lighter off-white or cream colours) since the ‘yellow scheme’ of the 1960s. Before this period, however, it is uncertain whether the joints were painted differently from the blocks, although the presence of a slightly darker stone colour in the earliest layers may support this for the period of the stone-coloured zinc schemes.

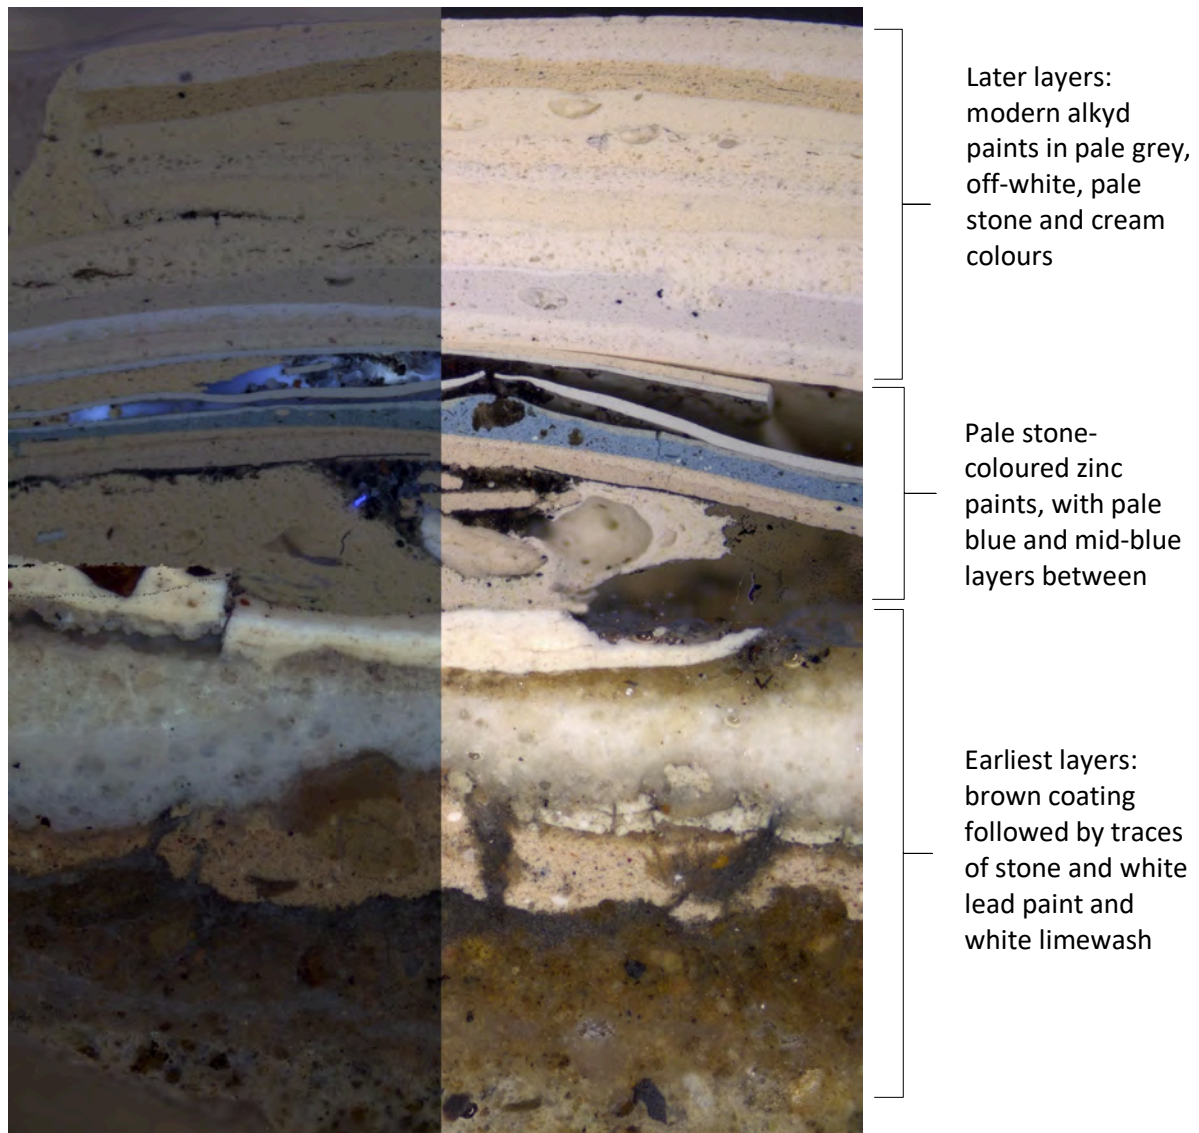
Figure 18: **Sample 6**, fluted course, lower façade (left is under UV light)

The sample from the fluted course below the faux-ashlar blockwork shows an early layer of mid-brown just above the substrate; this layer may be the original render colour, or it may be a coating added later in the building's history, but the heavy dirt layer on it suggests that it was in place for some time. This is followed by traces of white and stone-coloured paint, which appear similar to later layers, and may have seeped down to this level through cracks in the layers above. These are followed by two layers of white limewash, and then by several layers of white lead oil paints. The next schemes are a series of stone-coloured zinc paints, which appear similar to the earliest layers on Samples 4 and 5, and may date to the

same period in the mid-20<sup>th</sup> century. Within these stone-coloured layers, however, are layers of pale blue and mid-blue, indicating that this element of the façade may have been picked out in blue tones at some point in the mid-20<sup>th</sup> century. These layers may also relate to the blue paint residues seen elsewhere on the façade during the sampling visit. The final layers are all modern alkyd paints in pale colours: pale grey, off-white, pale stone and cream.

This suggests that the fluted course has been painted in pale colours throughout much of its history, but it was painted to match the blocks in the façade above in some schemes, and picked out in toning colours (such as blue or grey) in other schemes.

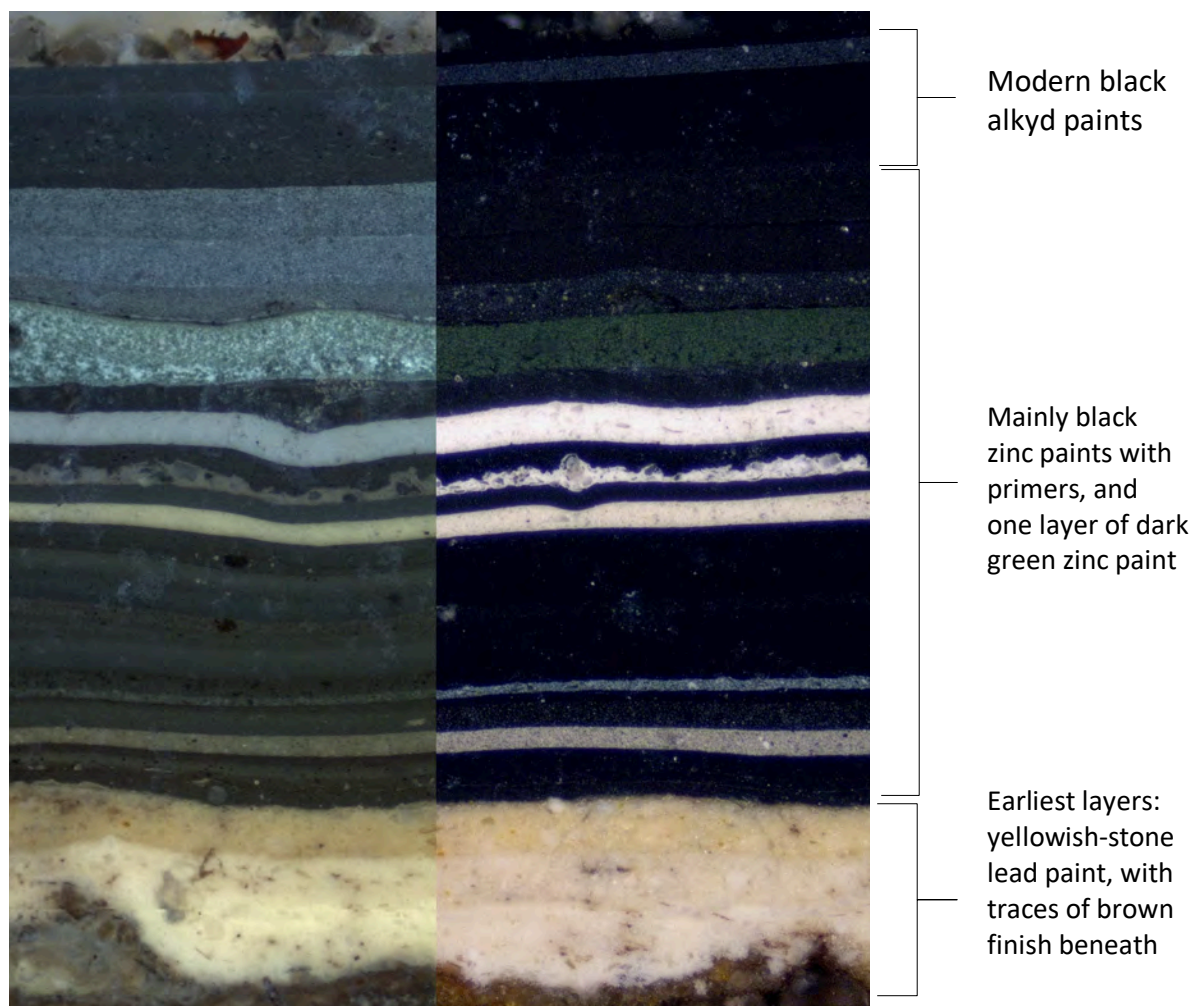
Figure 19: **Sample 7**, flat plinth at base of façade (left is under UV light)

The sample removed from the flat plinth at the base of the façade shows a somewhat different stratigraphy to the elements above it. The earliest layers are traces of a brown

The resemblance of the early brown finish to the earliest layer in Sample 6 above suggests that the lowest two elements on the façade may have been treated similarly in early decorative schemes.

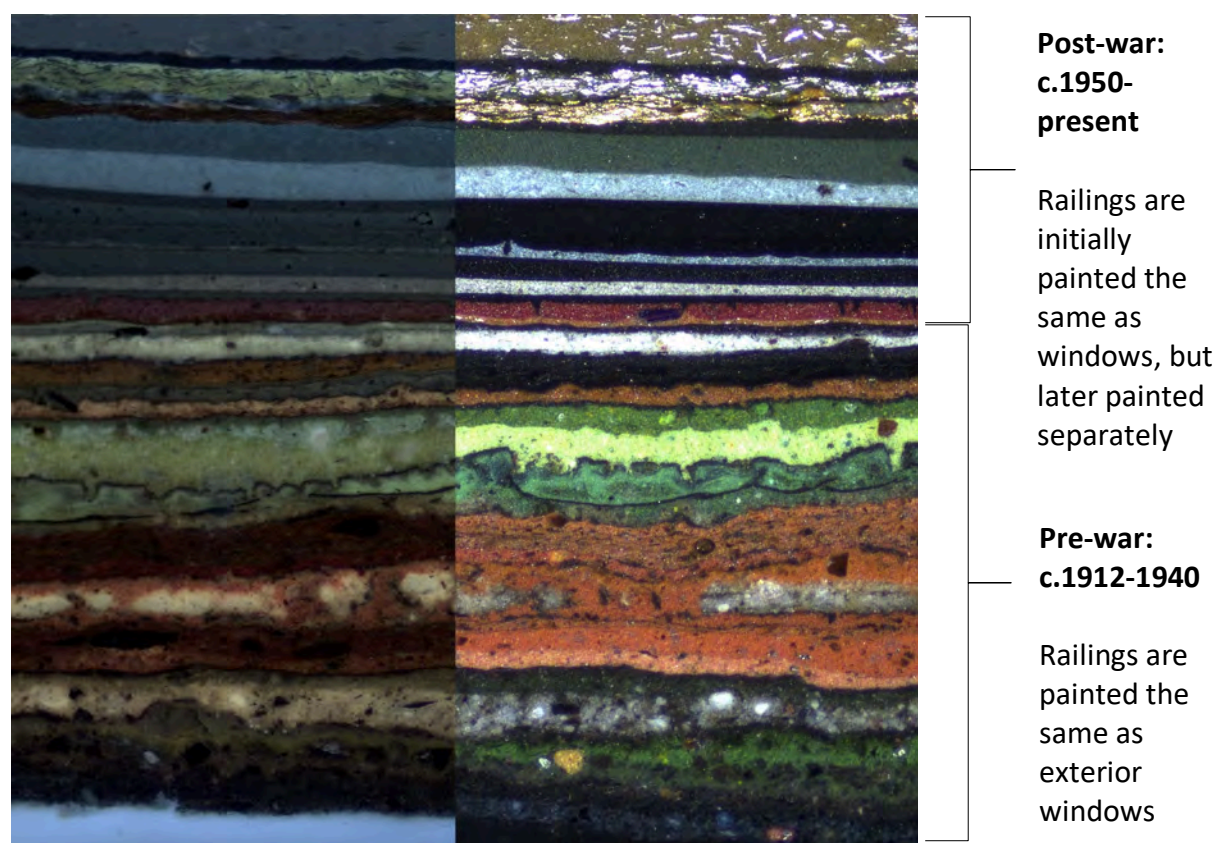
Figure 20: **Sample 18**, finial of railings (left is under UV light)

The samples removed from the railings show almost the same early stratigraphy as the samples removed from the exterior windows, with the same early colours of blue-black, mid-green and red lead paints (only the tan brown is missing). This similarity continues into the early post-war period, with the same bright red followed by several layers of black, before diverging from the window schemes around the 1960s, when the railings were painted a dark green (possibly during the yellow façade period), and then the finials were picked out (for the first time) in metallic paints.

This indicates that the railings have historically been painted the same colour as the exterior window frames, and that for the majority of their history, the finials were painted the same as the rest of the railings.

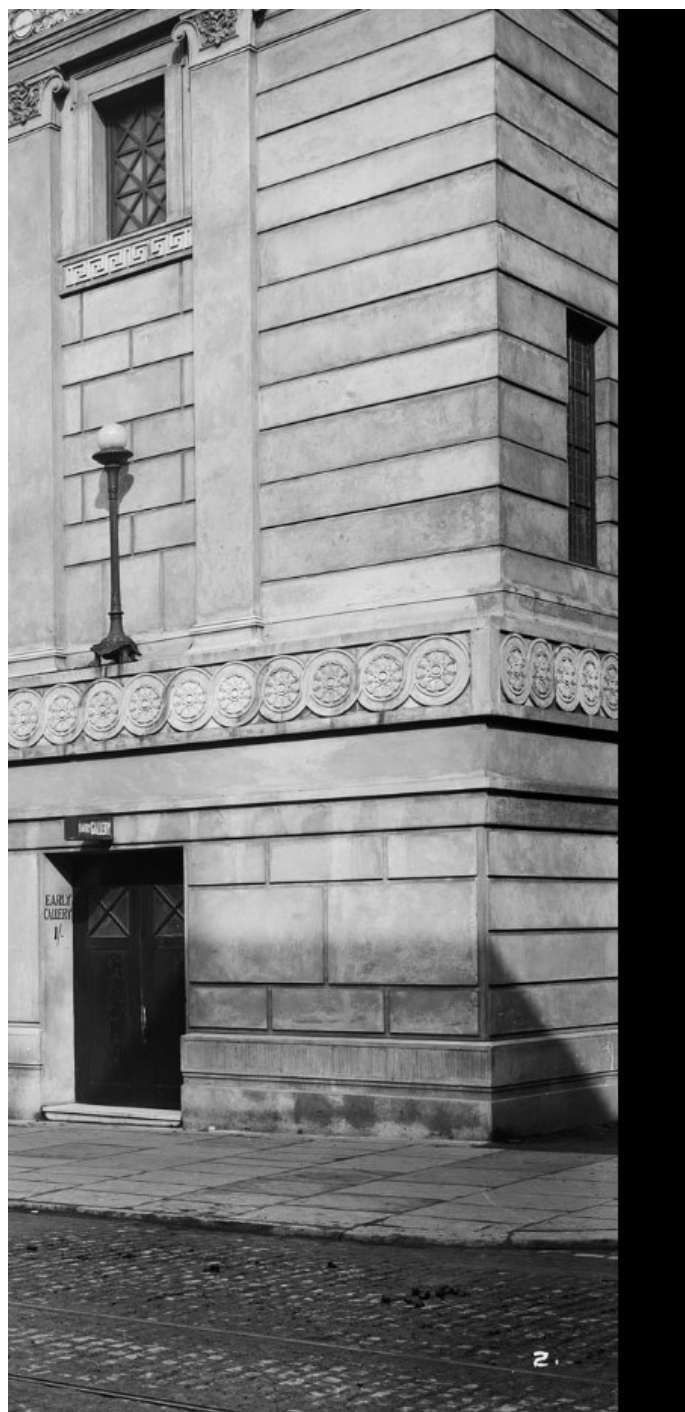
*Figure 21: Detail of the Opera House in 1913, showing window & facade treatments (source: Historic England)*

The external elements of the windows were originally painted in strong colours, firstly blue-black, then mid-green, tan brown and red. This can be seen in Figure 21, where the window frame and casement are clearly considerably darker than the surrounding façade. These colours were a practical choice, given the high levels of sulphurous air pollution in Manchester in the early 20<sup>th</sup> century. Both window frame and casement were painted in the same colours during this early period.

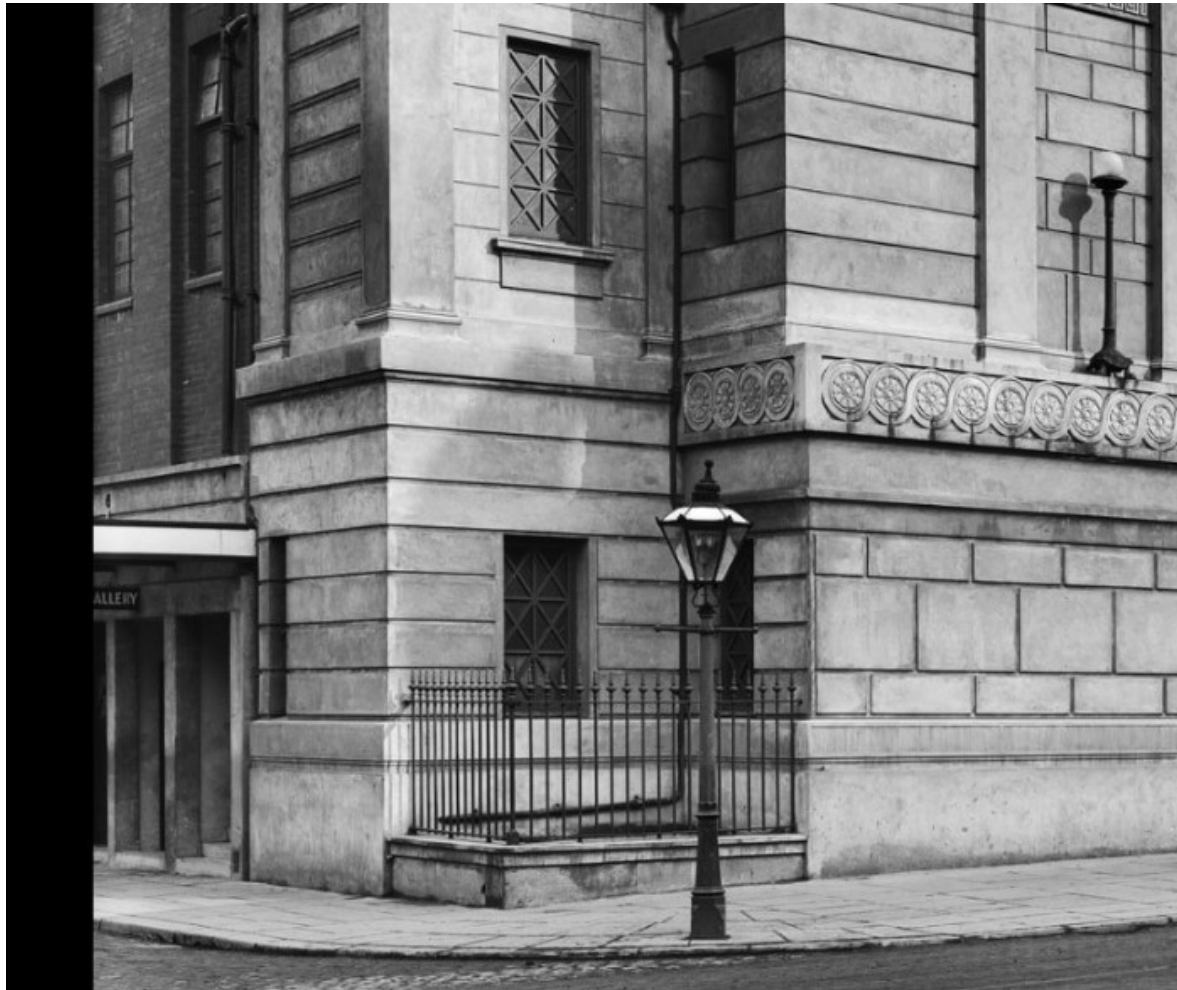
The absence of early paint evidence on the façade stucco, coupled with early images of the exterior, strongly suggests it was originally left unpainted. The first paint scheme in pale stone was applied just before or after World War II, probably because the building's appearance had become stained and blackened due to atmospheric pollutants. The surfaces of the façade in the 1913 photographs below (fig.22) appear to be entirely unpainted.

*Figure 22: detail of the Opera House in 1913, showing railings (source: Historic England)*

The railings on the corner of the façade were originally painted the same as the exterior windows, in a single colour. Photographs from 1913 appear to show much of the exterior metalwork painted the same dark colour as the windows (see Figure 22), so it is likely that the railings were included in this comprehensive exterior decorative scheme.
