Materials Analysis: Paint, Stucco & Window Joinery

### **Manchester Opera House**

3, Quay Street  
Manchester M3 3HP

September 2022

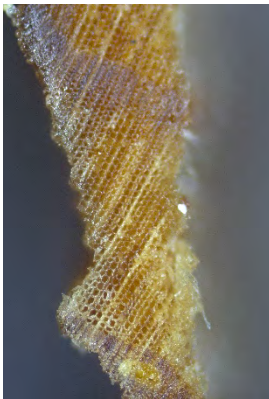
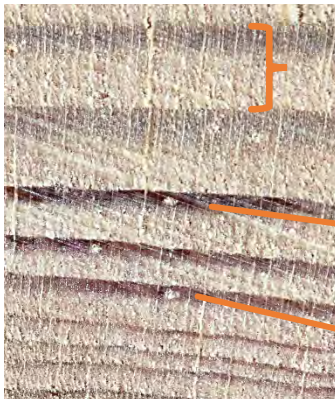
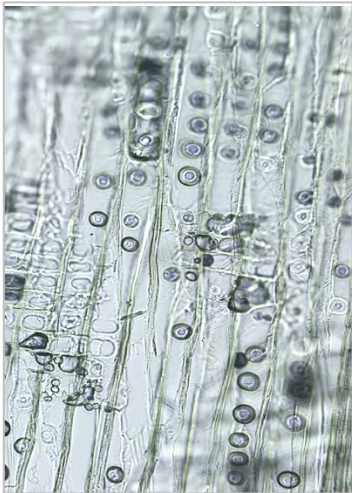
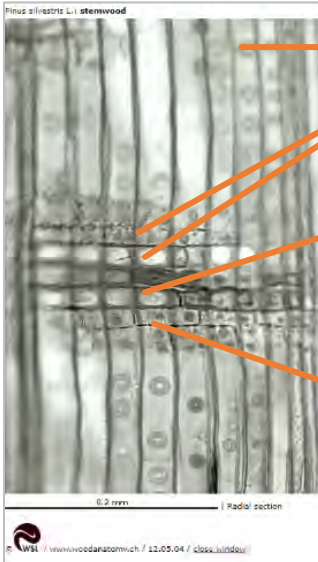
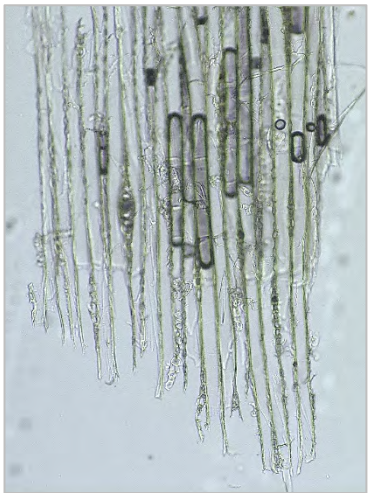
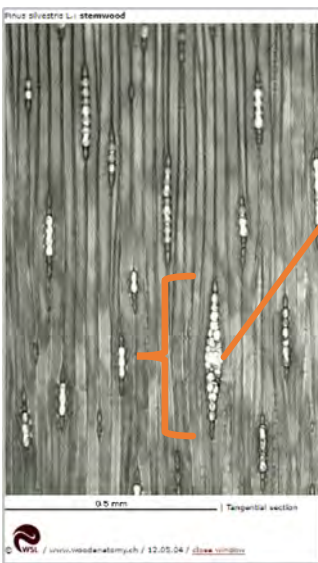
**The species identified for this sample is Scots Pine (*Pinus sylvestris*).**

| Sample W 16 LG | Reference images | Features |
|---|---|---|
| | <p><i>Cross section 10 x magnification</i></p> | <ul style="list-style-type: none"> <li>• Pores/vessels absent</li> <li>• Growth ring boundaries distinct</li> <li>• Transition early to late wood abrupt</li> <li>• Resin canals sparse but present in mostly in late wood, large</li> </ul> |
| <p><i>Radial section 100 x magnification</i></p> | <p><i>Pinus sylvestris L. stemwood</i><br/>0.2 mm Radial section<br/>© WSL / www.woodanatomych / 12.05.04 / close window</p> | <ul style="list-style-type: none"> <li>• Tracheid pits uniseriate</li> <li>• Rays heterocellular</li> <li>• Cross-fields from parenchyma cells to tracheids with single fenestriform pits</li> <li>• Ray tracheids distinctly dentated walls</li> </ul> |
| <p><i>Tangential section 50 x magnification</i></p> | <p><i>Pinus sylvestris L. stemwood</i><br/>0.5 mm Tangential section<br/>© WSL / www.woodanatomych / 12.05.04 / close window</p> | <ul style="list-style-type: none"> <li>• Rays up to 15 cells high</li> <li>• Resin canals in rays with thin-walled epithelial cells</li> </ul> |

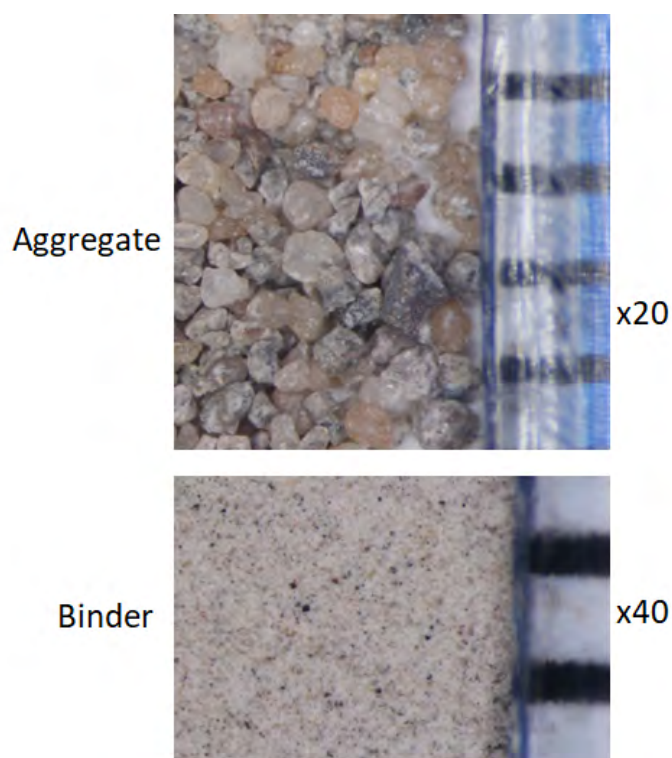
Visual inspection of the aggregate showed that the material was of fairly consistent grain size, typically around 0.5mm in diameter with occasional larger grains, up to 1mm in size (Figure 1). The binder fraction was an off-white. beige powder with darker/ black specks apparent throughout.

**Figure 1.** Micrographs (x20/40) of the ground mortar samples. Ruler on each image shows a millimetre scale.
