Our reference: 077879-CUR-00-XX-RP-GE-003-P02

**Re: Phase 2 Geo-Environmental and Geotechnical Summary Letter Report for Jersey Wharf, Manchester**

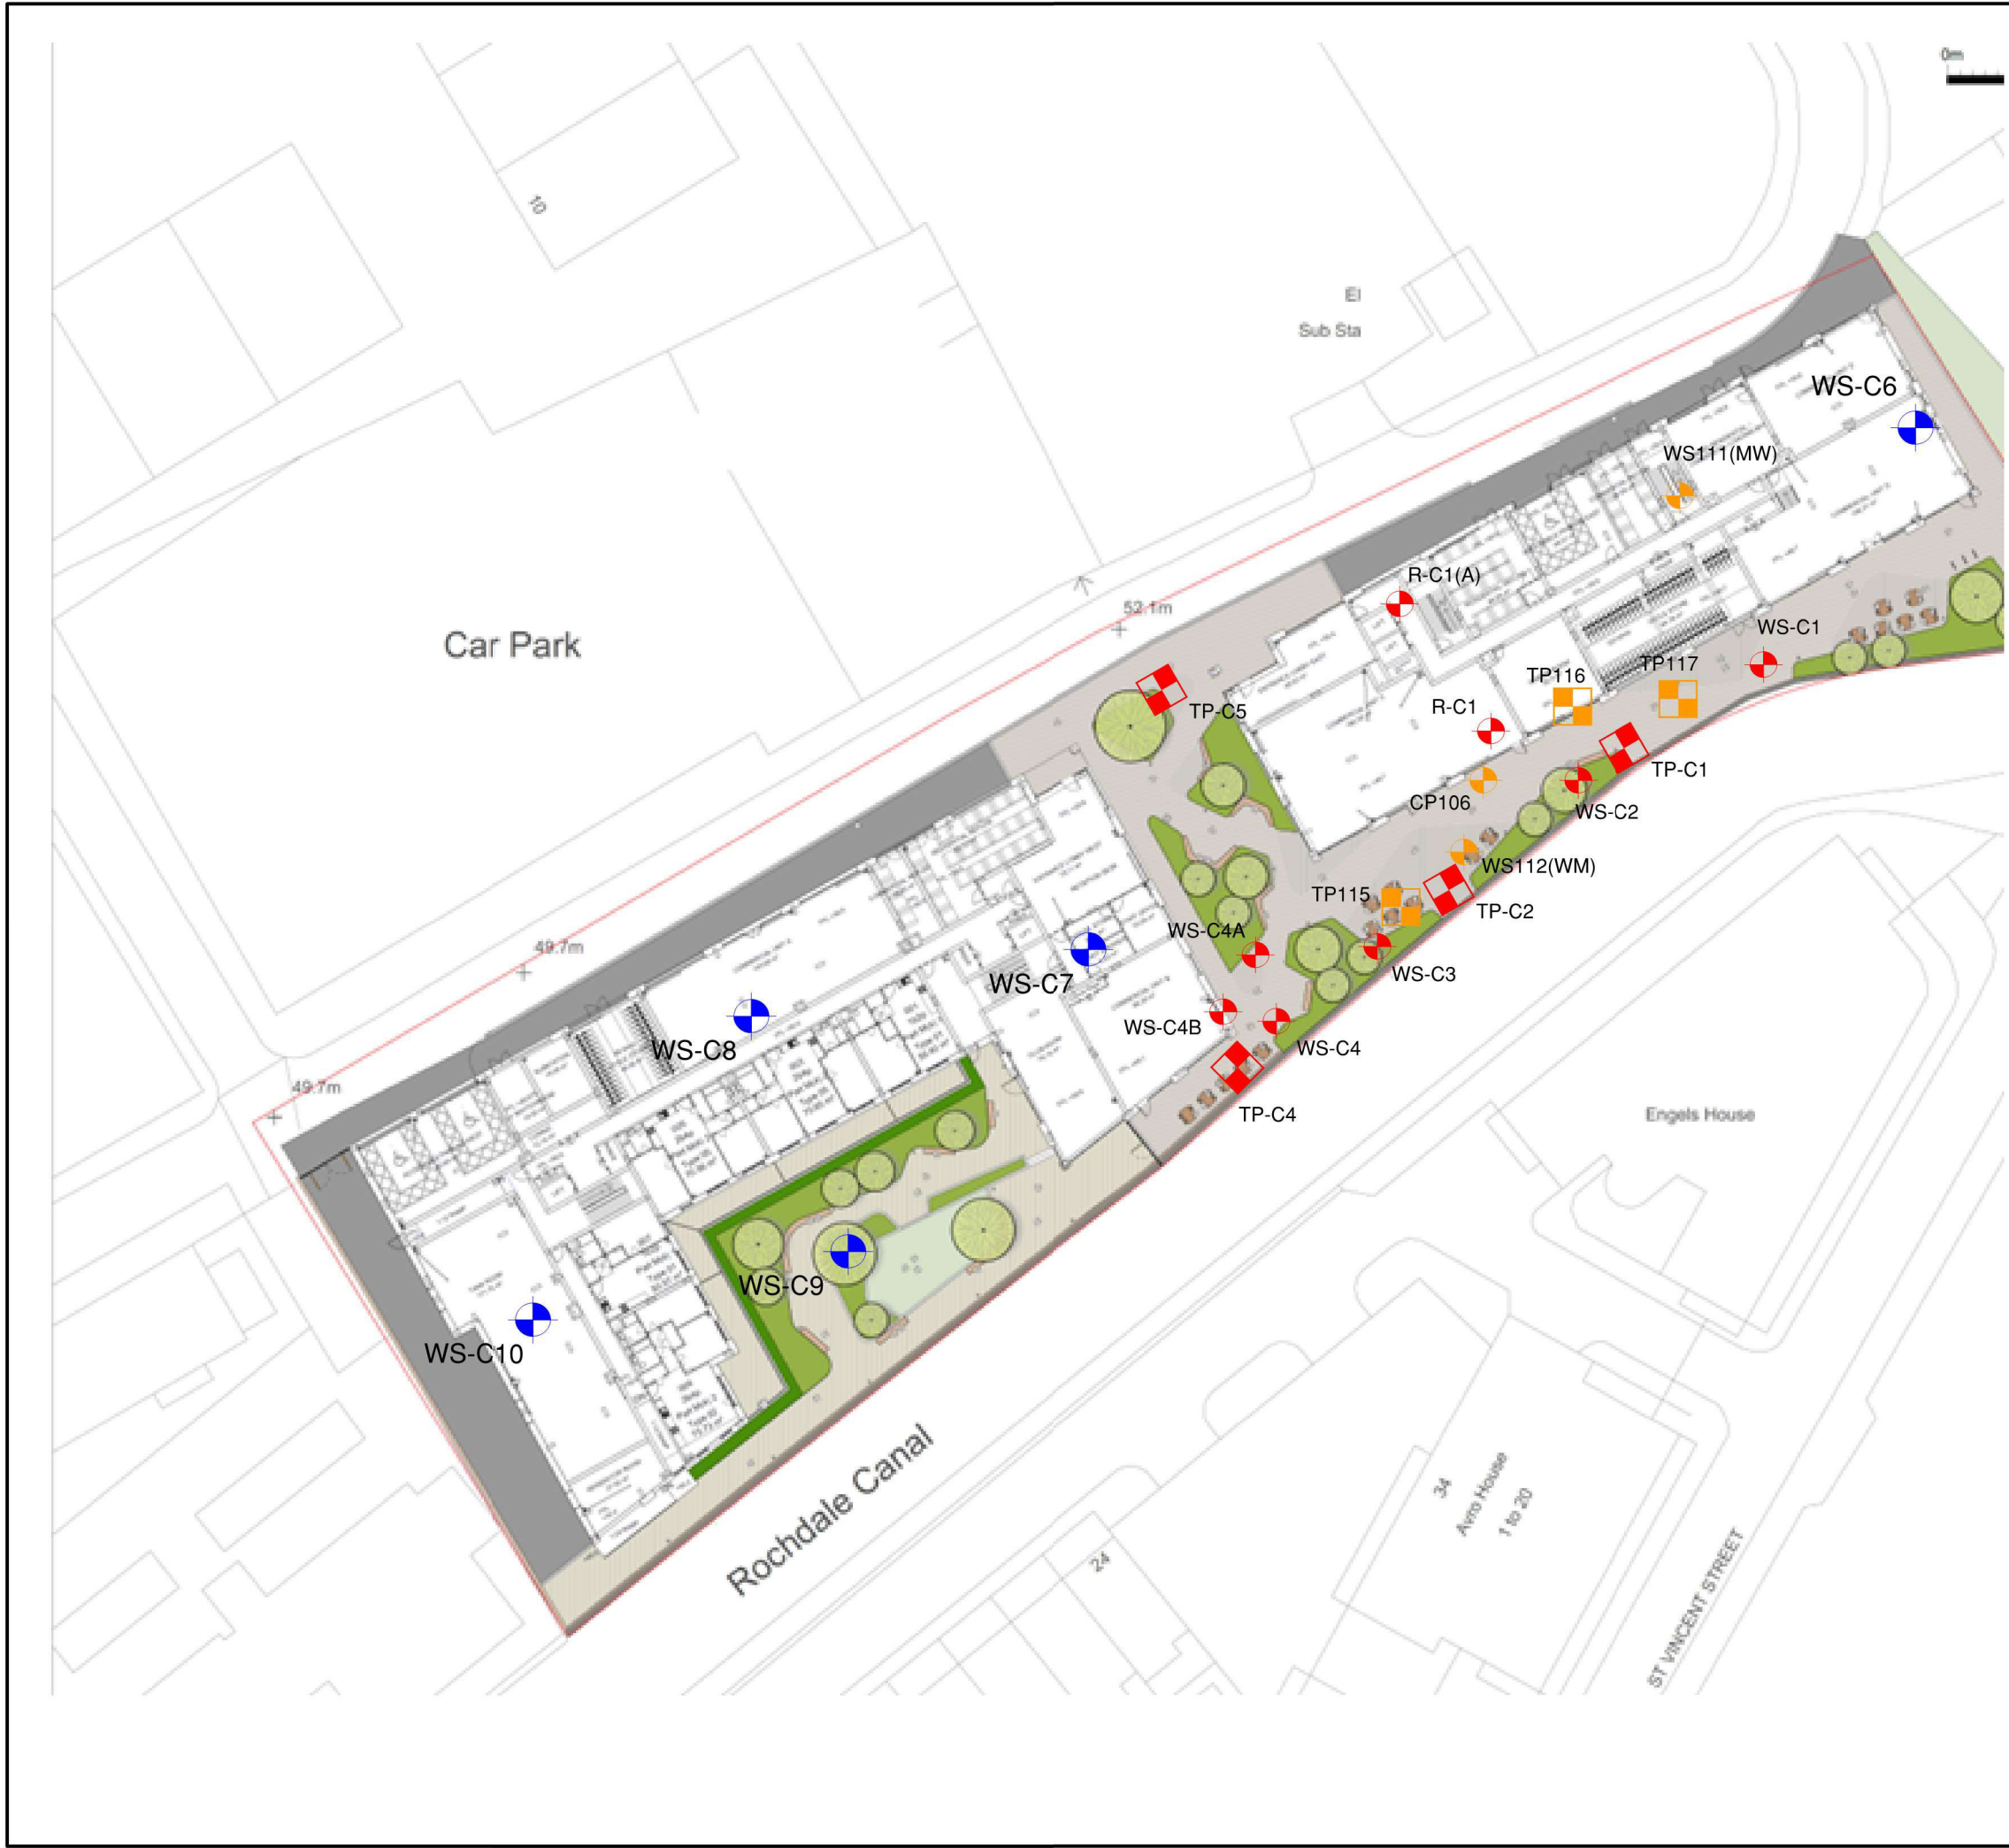
**EXISTING BOREHOLES**

An exploratory hole plan is included at the end of this report in Appendix A1, Ref. 077879-CUR-00-XX-DR-GE-80002-P01.
