# Upper Brook Street Masterplan (McLaren / Kadans)

**Arboricultural Survey to BS5837:2012**

**53-57 Upper Brook Street,  
Manchester,  
Greater Manchester,  
M13 9TD**

**20 April 2023**

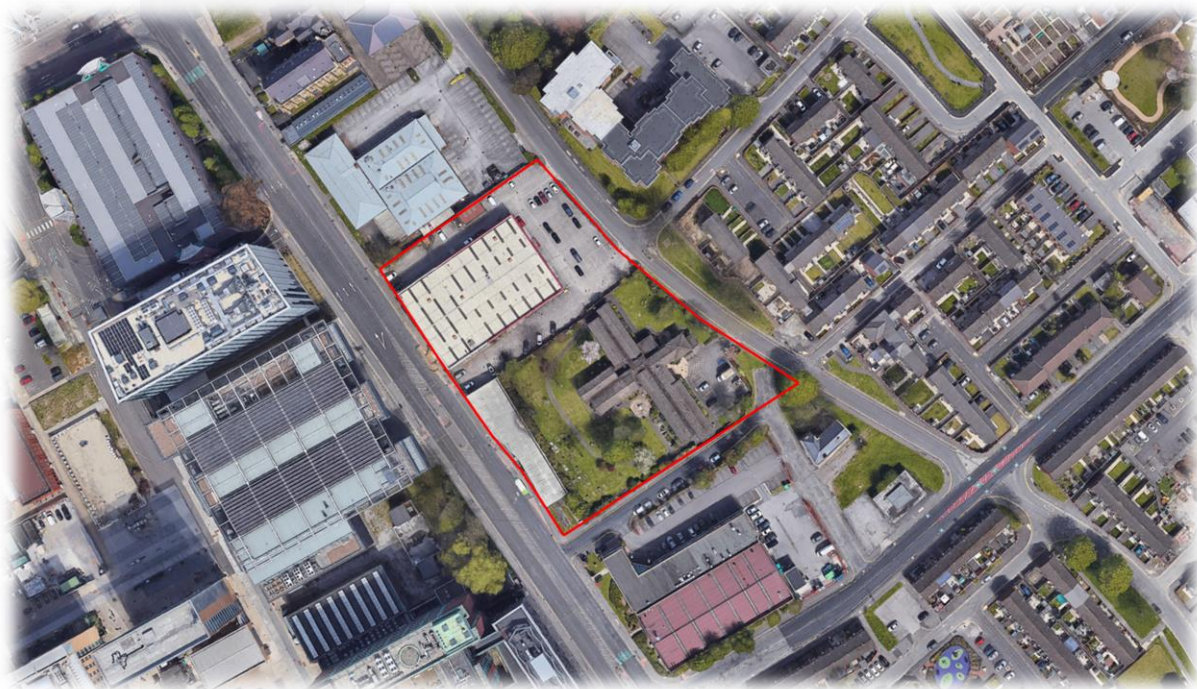
**Figure 2:** Aerial Image of site with approximate red line boundary denoting area surveyed (Google Earth)

The Site extends to 1.084 hectares (ha) and is partially in use as a temporary paid car park. The paid car park is located on a section of the Site which was formerly in use as a Citroën car dealership and is accessed from both Upper Brook Street (UBS) to the west and Kincardine Road to the east. The remainder of the Site comprises the former Elizabeth Yarwood Court residential complex, which is accessed from Kincardine Road to the east of the Site.

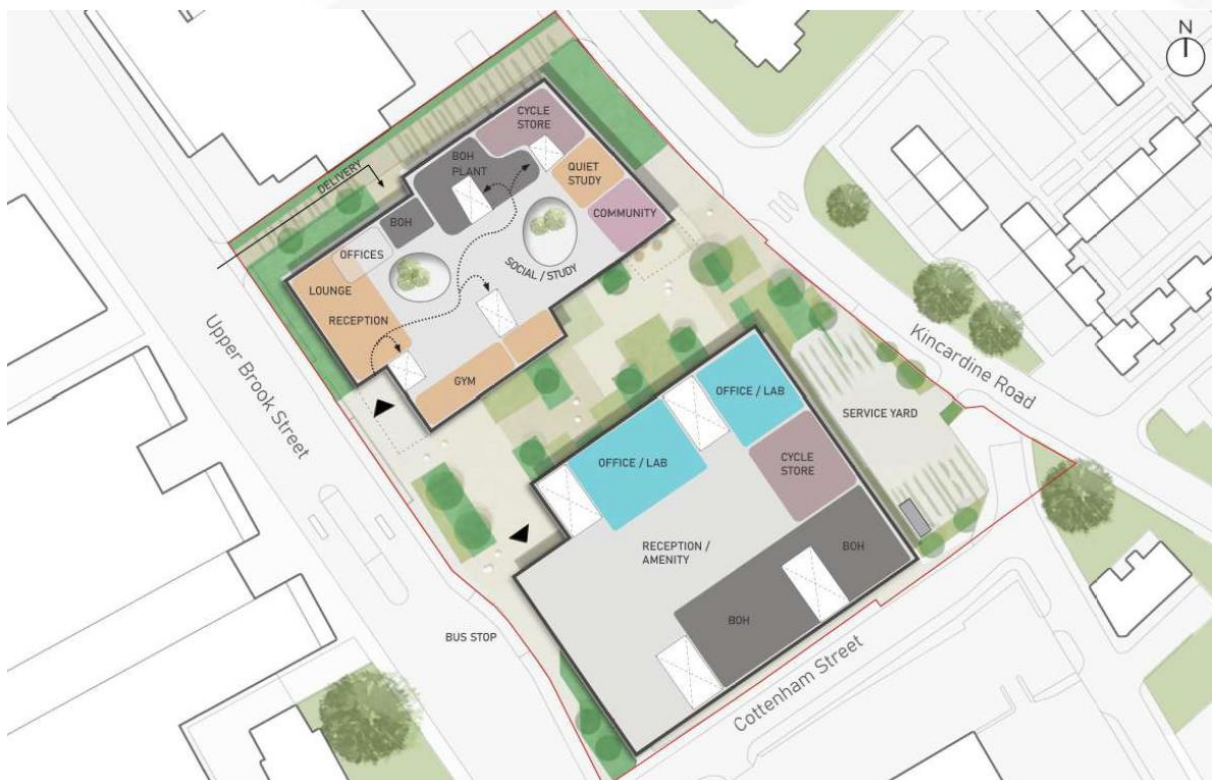
**Figure 3:** Proposed scheme. (Sheppard Robson)

Full planning permission for the demolition of existing buildings and erection of a single 6 to 9 storey block for Sci-Tech use (Use Class E (g)(ii) and 267sqm of a café/bar (Use Class E (b), and a single 9 to 23 storey block to be used for Purpose Built Student Accommodation (Use Sui Generis), comprising 737 bedrooms in total and 293sqm of community use (Use Class F2 (b) and 80sqm of commercial floorspace (Use Class E) on Phase one of the Upper Brook Street Masterplan.

It is likely that arboricultural impacts can be addressed with arboricultural methodology or minor amendments to the proposal.
