**PROSPERITY CAPITAL PARTNERS LTD**

**THE OLD BREWERY GARDENS, MANCHESTER**

**PHASE 1 DESK STUDY – CONTAMINATED LAND ASSESSMENT**

**DATE ISSUED:** 11 JANUARY 2018  
**JOB NUMBER:** LO10517  
**REPORT NUMBER:** R006.01  
**STATUS:** FINAL

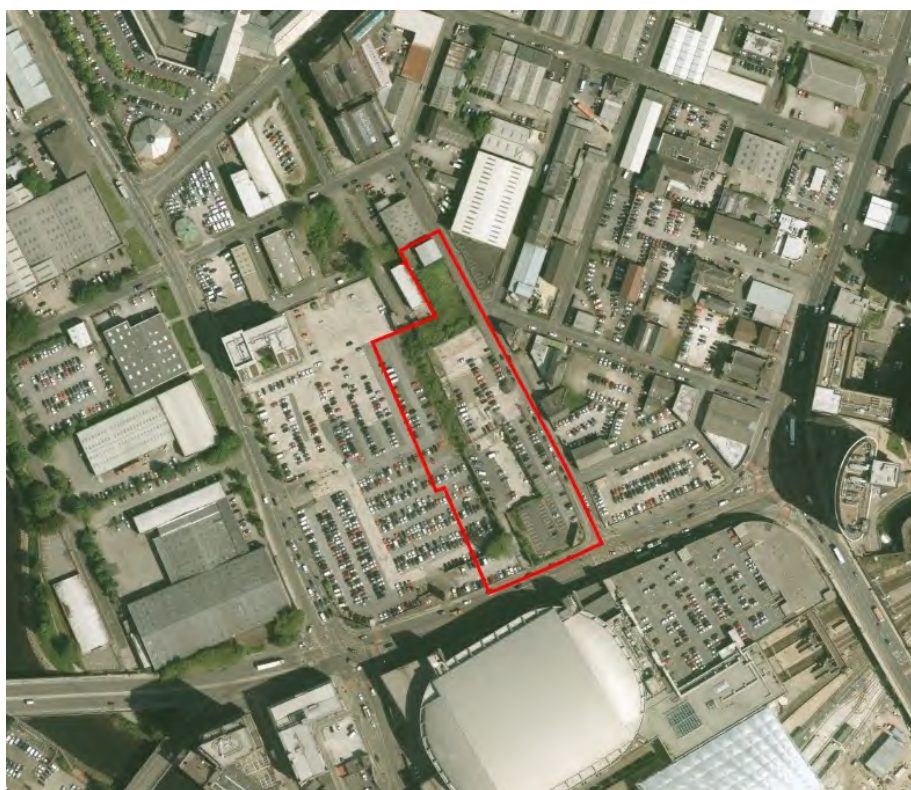
**Figure 1: Aerial Image Showing the Approximate Site Boundary**

- 2.2 The site is identified as The Old Brewery Gardens, Manchester and is located north of Manchester Victoria Station and Manchester Arena and wholly located in the administrative area of Manchester City Council (MCC). The site is approximately rectangular in shape and comprises two car parks, some scrubland areas, a ticket booth in the east of the site and an office building in the north of the site. The site levels vary greatly across the site with the higher levels in the east. The site is located as shown on Figure 1.
