# Design and Access Statement

## Science and Industry Museum

### Station Building

Client: The Board of Trustees of the Science Museum  
Date: April 2023  
Revision: B

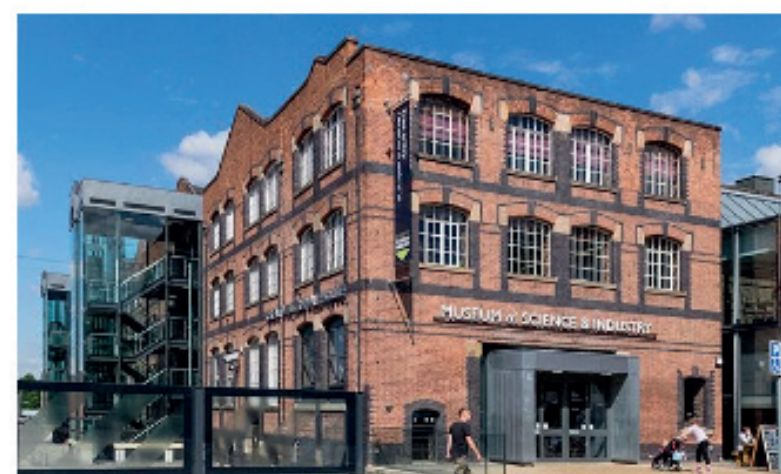
Museum of Science & Industry  
Fire Compartmentation Survey Report

Atelier MB Ltd have been appointed by The Trustees of the Science Museum to prepare applications for Listed Building Consent in relation to a series of fire related remediation works. These urgent works have been identified by a Fire Door and Compartmentation Surveys carried out by Neo.

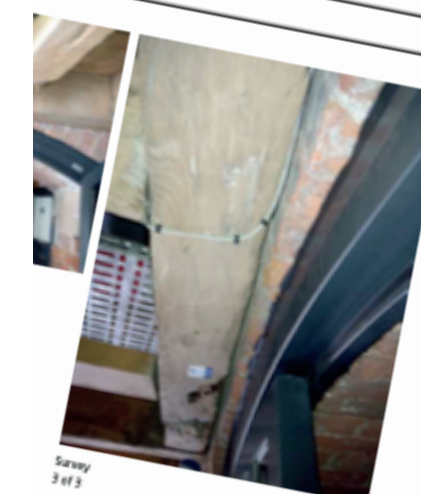
**0015:38 - History 2 of 2 (ates Zone(s) - Ground Floor**

ap where the metal conduit penetrates the blockwork. Use RWA-45 to pack out the gap and mastic.

istic seal is needed to close the gap. Push up rwa45 as high as can so mastic seal is not on show as much.

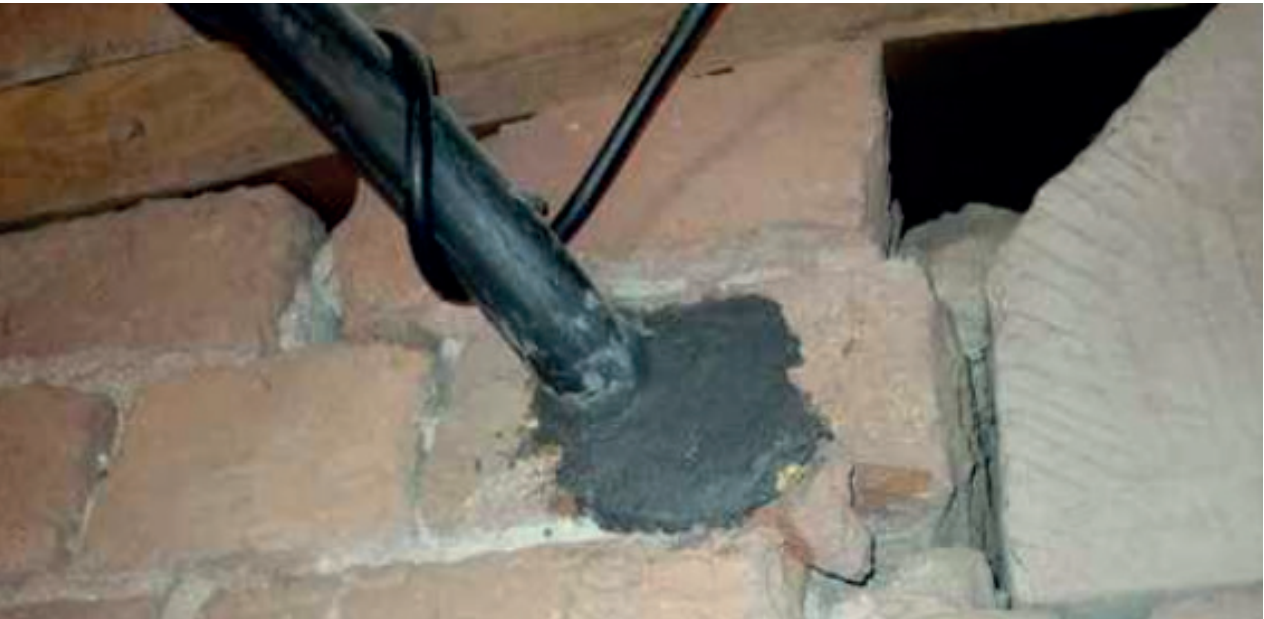
Example photo of localised cleaning of brickwork to remove mastic

Localised repointing where the pointing is missing or has eroded to more than twice the width of the joint.  
Localised cleaning of brickwork to remove either mastic sealant and/or cement based mortar. This is to be done by hand tools only, and if this is unsuccessful then the CA will review on site and consider leaving the deposits rather than risk damaging the underlying brickwork.

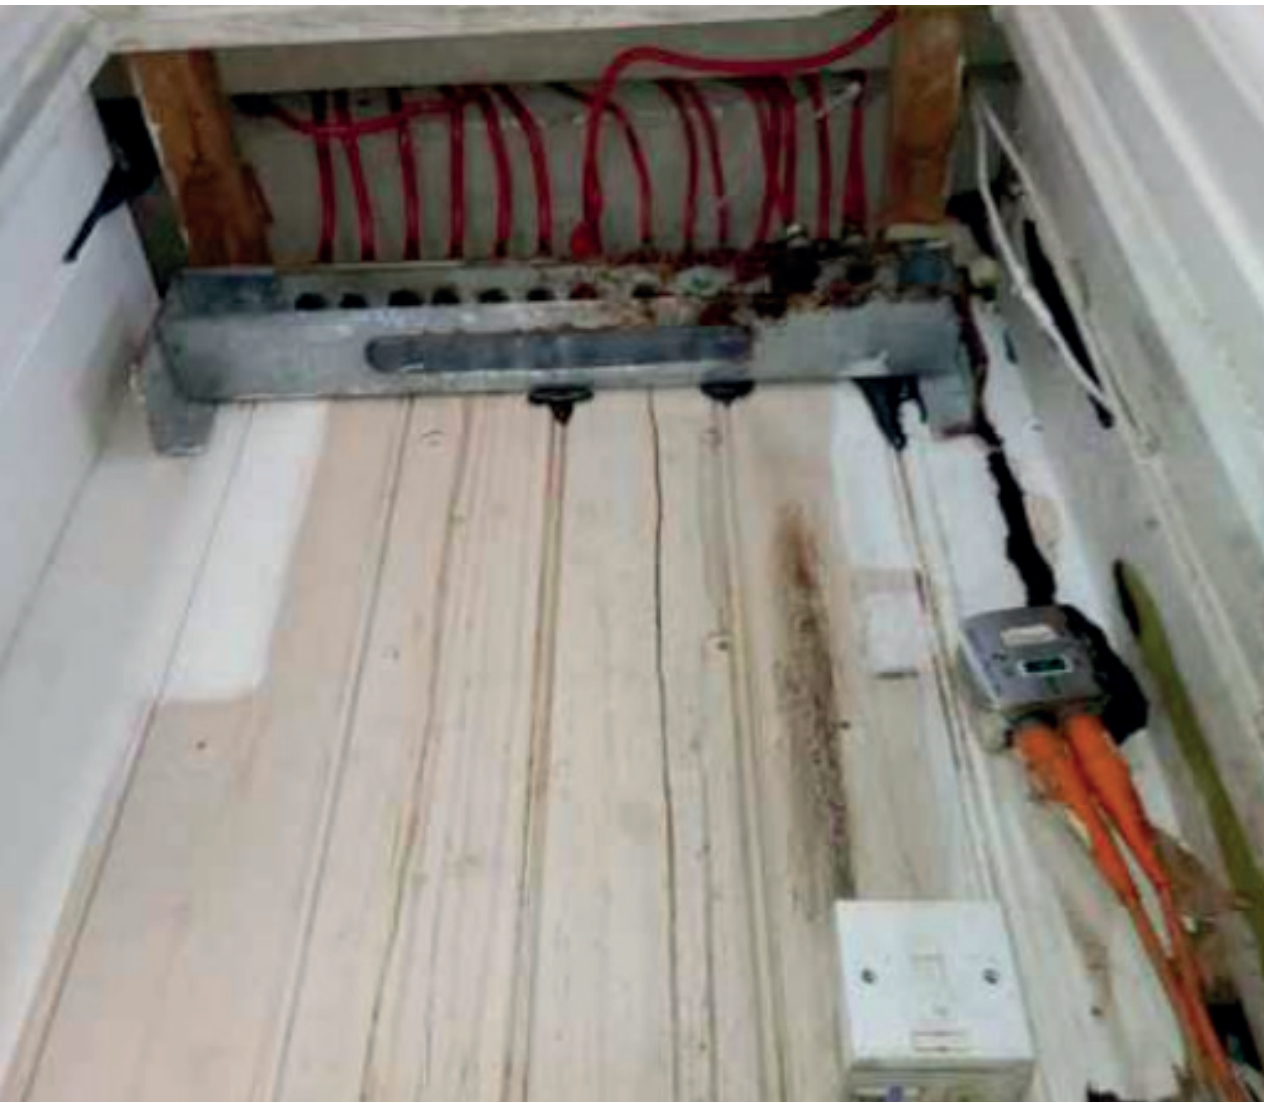
Example photo of existing wall recessed cupboard to be lined

Lining of existing wall recessed cupboard with fire rated board. This ensures the wall within which the cupboard sits is fully fire rated.

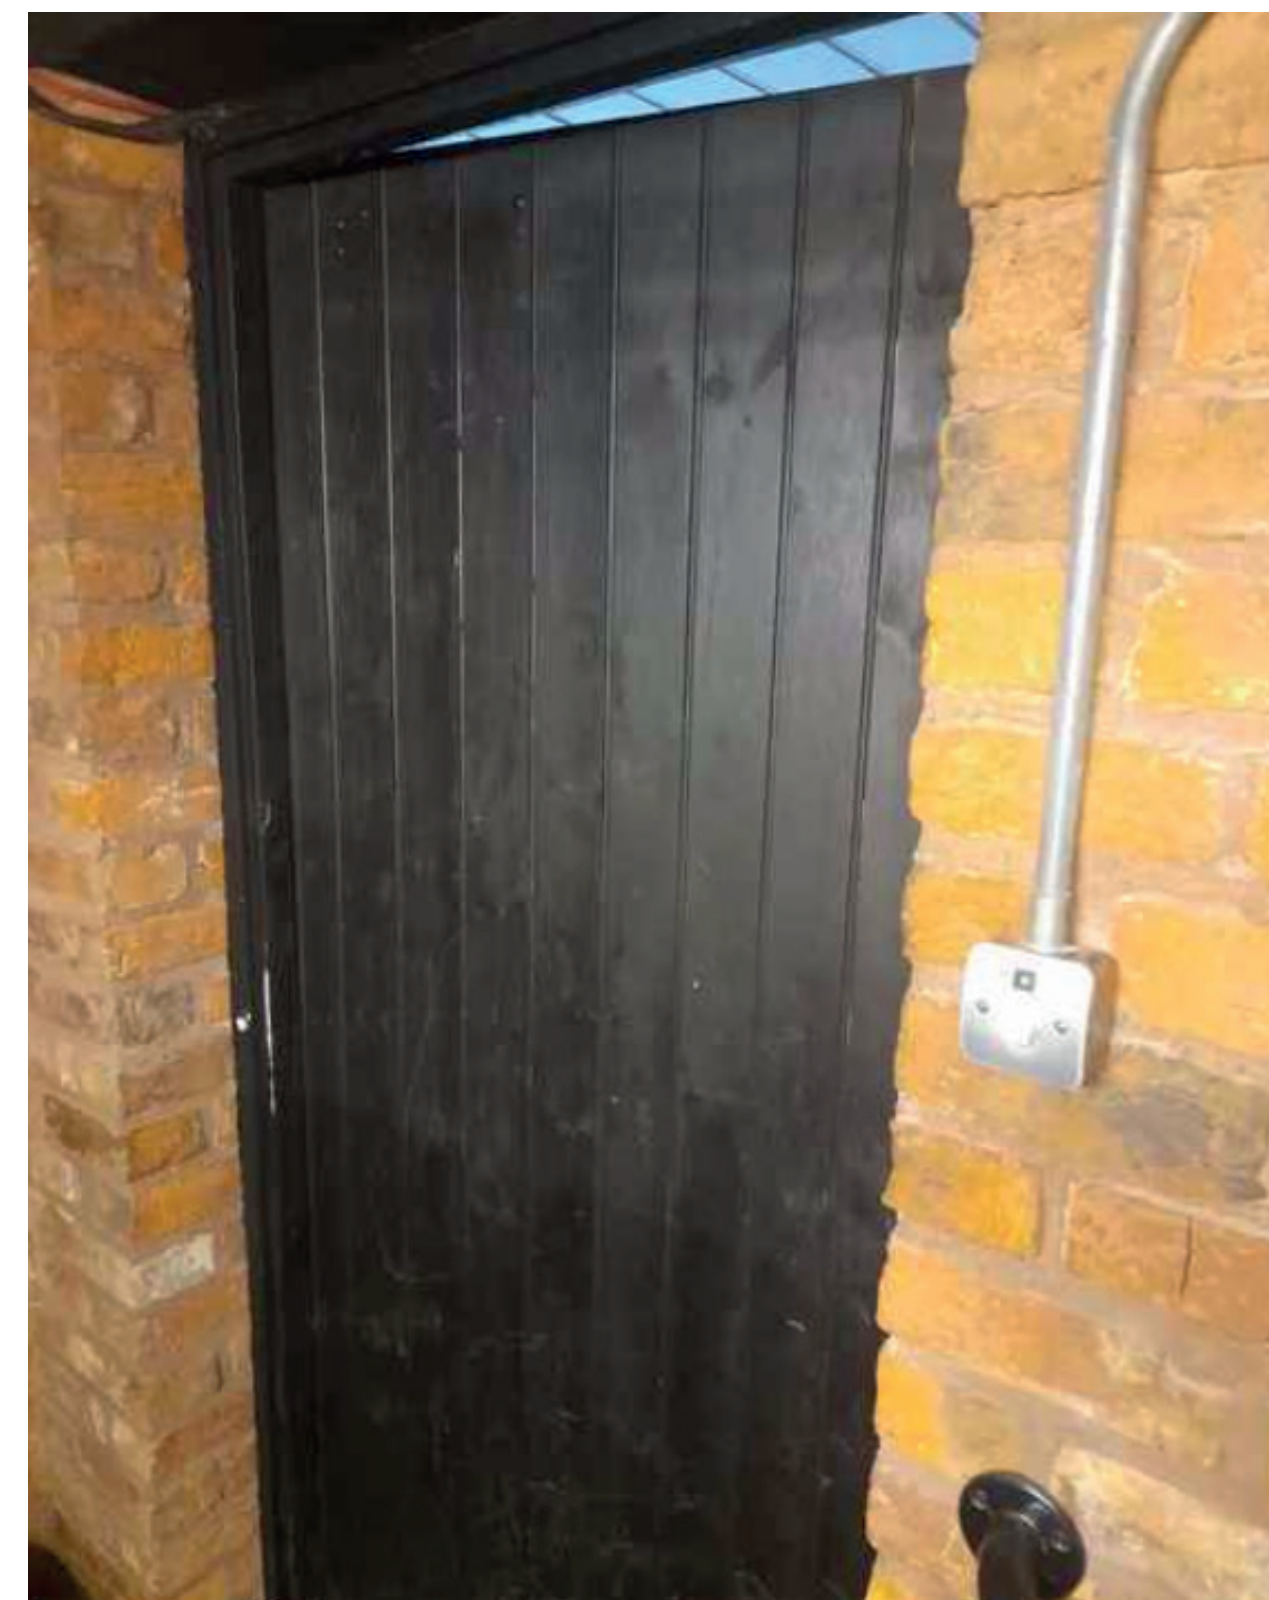
Typical existing vertical boarded timber door

2 no. doors are being replaced with compliant fire doors that will visually match the existing doors (vertical timber boarded and painted black).

In one instance the door is missing. This separates SB\_LG04 and the adjacent space. The Fire Surgery report has determined that this whole wall needs to have 30mins fire resistance. Therefore, a new fire door needs to be inserted in this location. The new door will be vertical timber boarded and painted black to match the nearest existing doors. The new doorset will be screw fixed into existing mortar joints in the brickwork. Hand tools only.

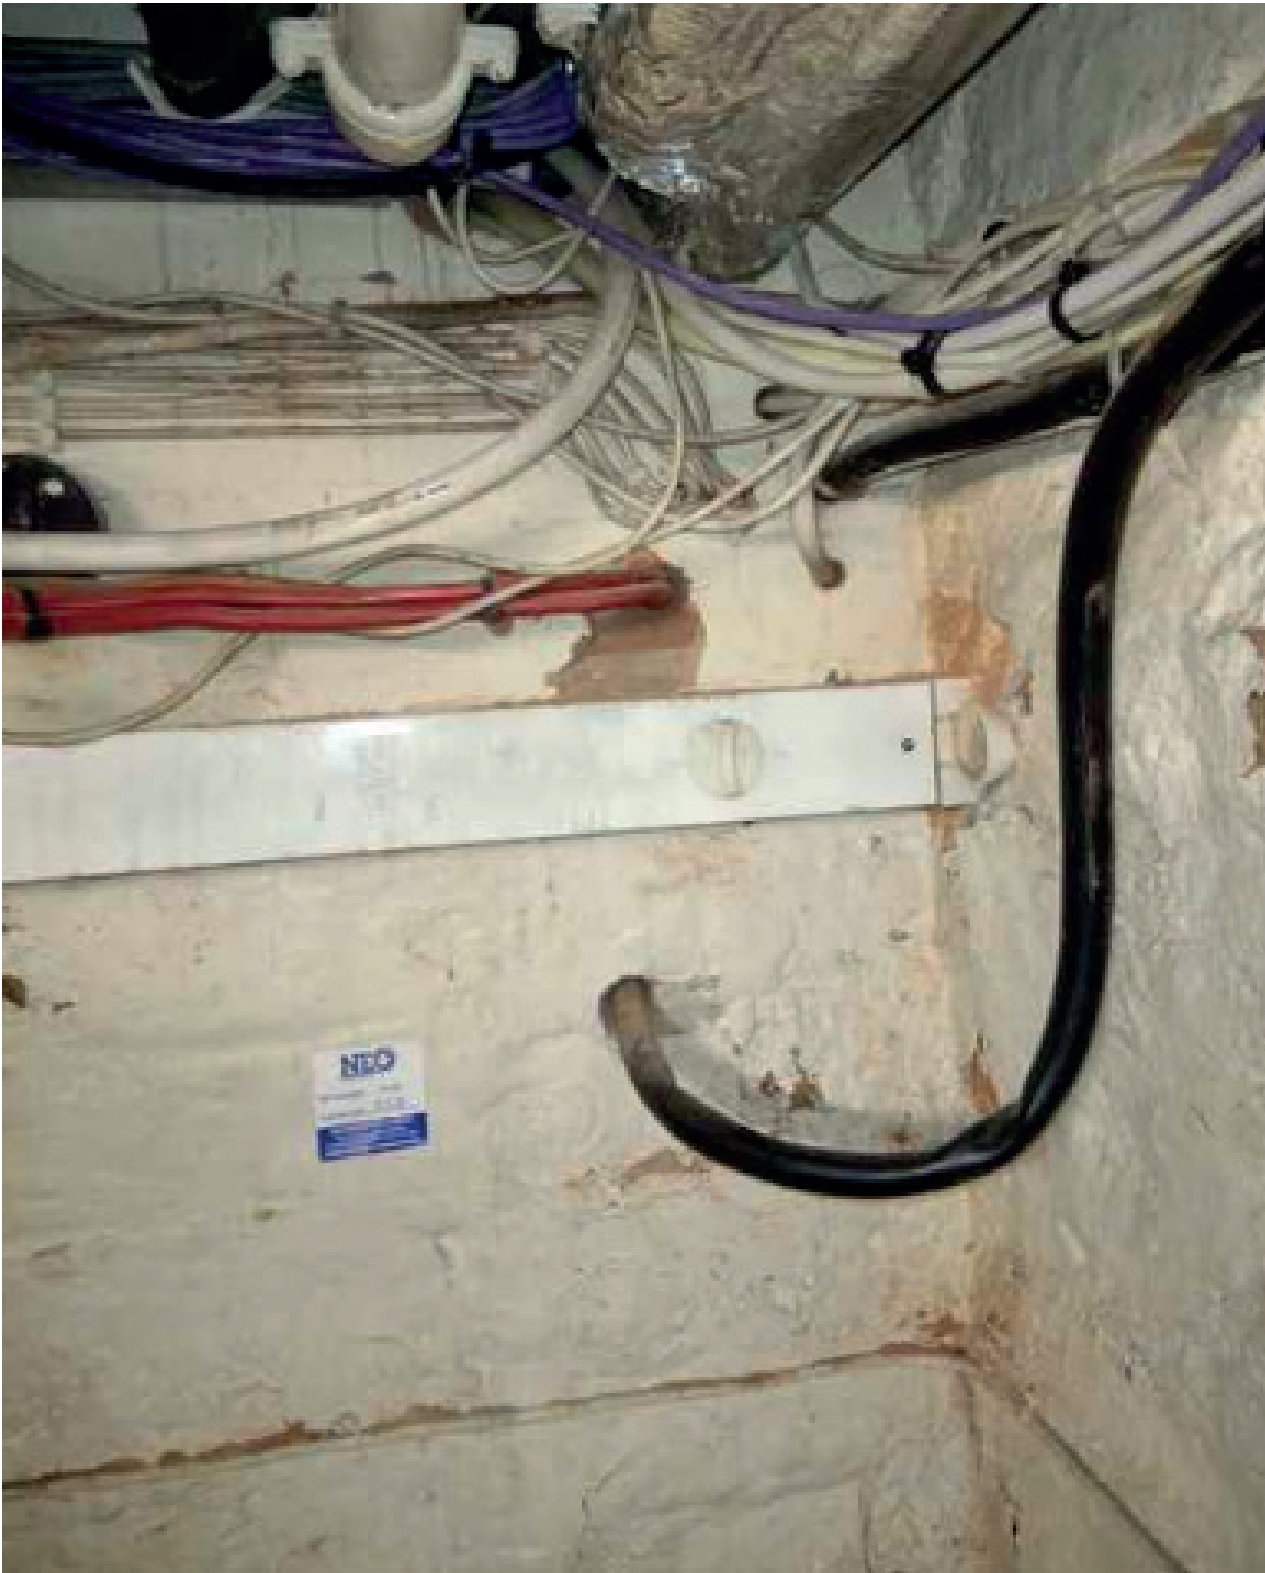
Location of localised cleaning of brickwork to enable standard fire stopping detail to be installed.

*Clean paint from brickwork, repoint, standard fire stopping detail.  
Locally clean off loose and friable non breathable paint finish to brickwork surface using a poultice.  
Carry out trials to determine shortest period of time in which the poultice needs to remain in place.  
Take mortar samples and agree matching mortar mix via samples with the CA.  
Localised repointing as required with matching mortar.*

*ROCKWOOL FIREPRO® Acoustic Intumescent Sealant around services penetrations with Rockwool RWA insulation backing, both sides*

Methodology for brickwork cleaning - extract from Methodologies document.
