Original: 24<sup>th</sup> April 2023  
Rev A: 24<sup>th</sup> July 2023

## **Ginnel Basement, Ormond Building, Manchester – Heritage Statement and Design and Access Statement**

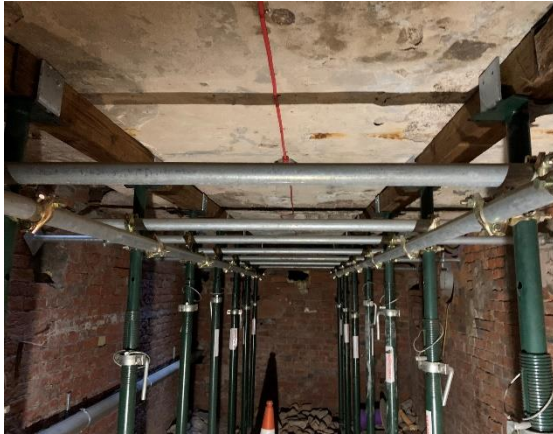
*Figure 1: Temporary props supporting soffit.*

The existing steel beams are showing significant signs of corrosion and the basement slab level has experienced varying degrees of localised, minor degradation which, through on-site investigations, has been identified as primarily having been caused by water ingress. There are currently temporary props in place to support the ceiling/floor above which, it is understood, have been in place for 1-2 years. Photographs of the rooms in their existing condition are provided below (**Figures 1-6**).

The proposals comprise the construction of a blockwork wall to be built directly off the basement ground level bearing slab to provide immediate support to the historic beams within the concrete soffit across the identified areas of the Ginnel Basement. The blockwork wall will be built up to the underside of the existing beams, packed and shimmed as required to provide the necessary support. Lintels will be provided at the base of the blockwork walls to bridge over the existing manhole and gulleys as required. The beams themselves will be sanded to remove loose steelwork and painted as required. All spalled and loose concrete will be removed to the ground bearing slab and will be repaired in a sensitive manner.

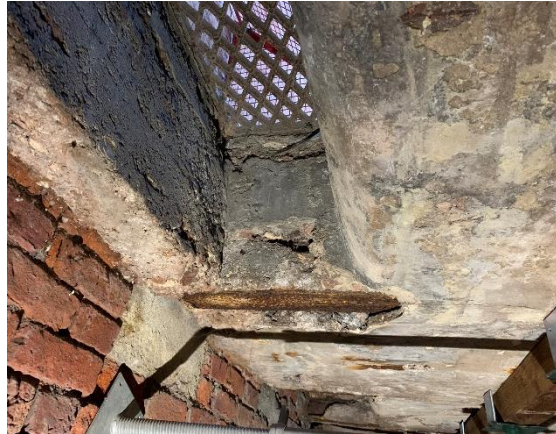
*Figure 2: Corroded steel beams, deteriorated concrete soffit, and original ceiling light.*

As identified above, the existing historic steel beams in the identified areas of the Ginnel Basement are significantly corroded. Site investigations have identified that the basement slab level has also experienced varying degrees of localised minor degradation which is primarily due to water ingress. Subsequently, there are areas of the concrete slab that have spalled or generally deteriorated.

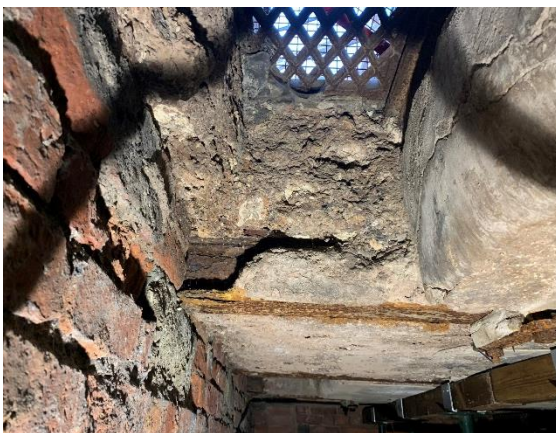
*Figure 3: Corroded steel beams, deteriorated concrete soffit, and original ceiling light.*

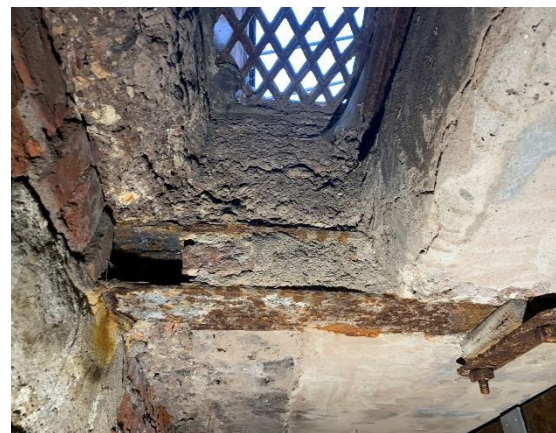
*Figure 4: Corroded steel beams, deteriorated concrete soffit, and original ceiling light.*

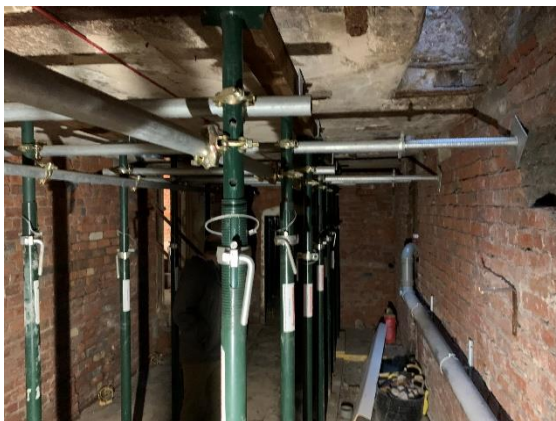
*Figure 5: Temporary props supporting soffit.*

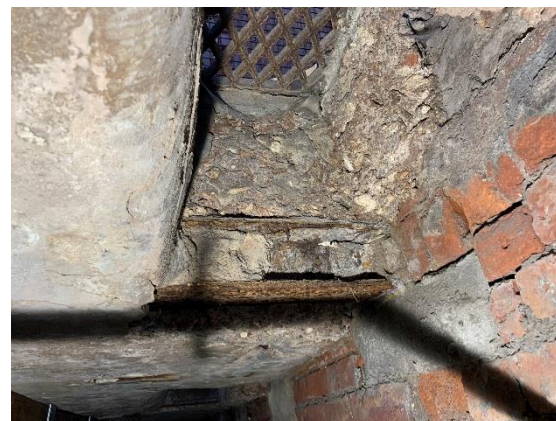
*Figure 6: Corroded steel beams, deteriorated concrete soffit, and original ceiling light.*

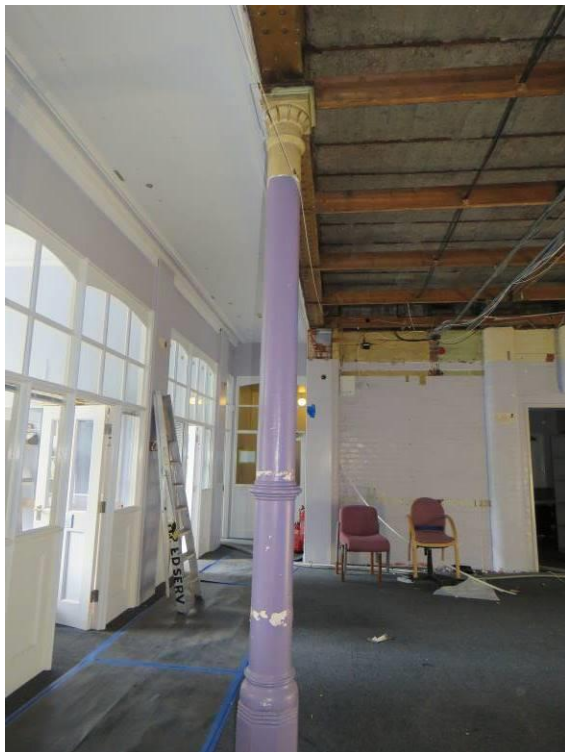
**Figure 48:** Looking south along the join between the original waiting room corridor (left) which is supported by a decorative cast iron column, and the altered c1920s inserted ceiling to the right, which was originally an open area.

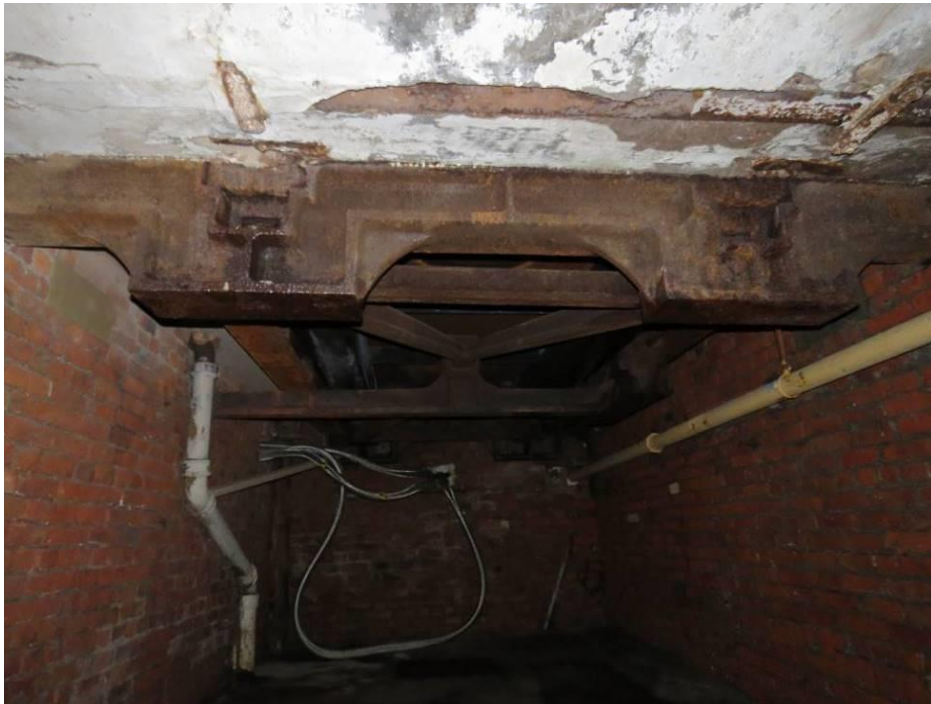
**Figure 55:** The underside of the original cast iron weighbridge as seen above in the ground floor cart way.
