GeoEnvironmental  
Investigation

Liberty Northern Moor

Wythenshawe

**Report Ref: A4701/22/SI/V2**

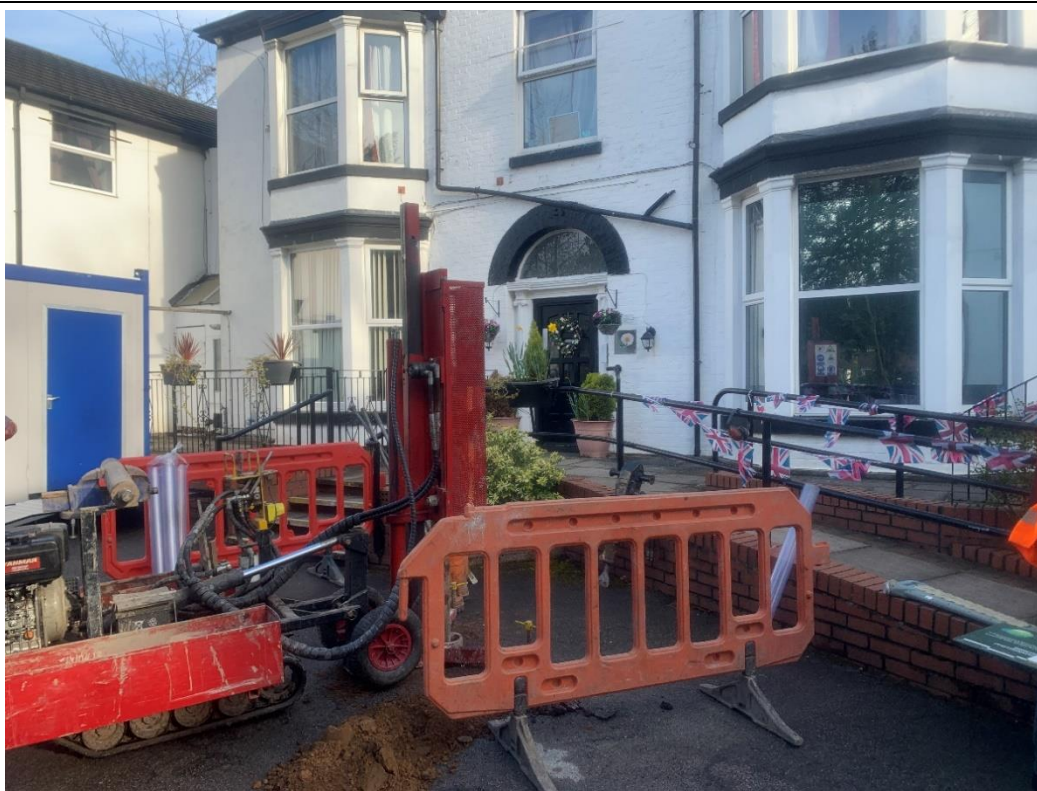
View of the windowless sampling rig at the front entrance, facing northwest

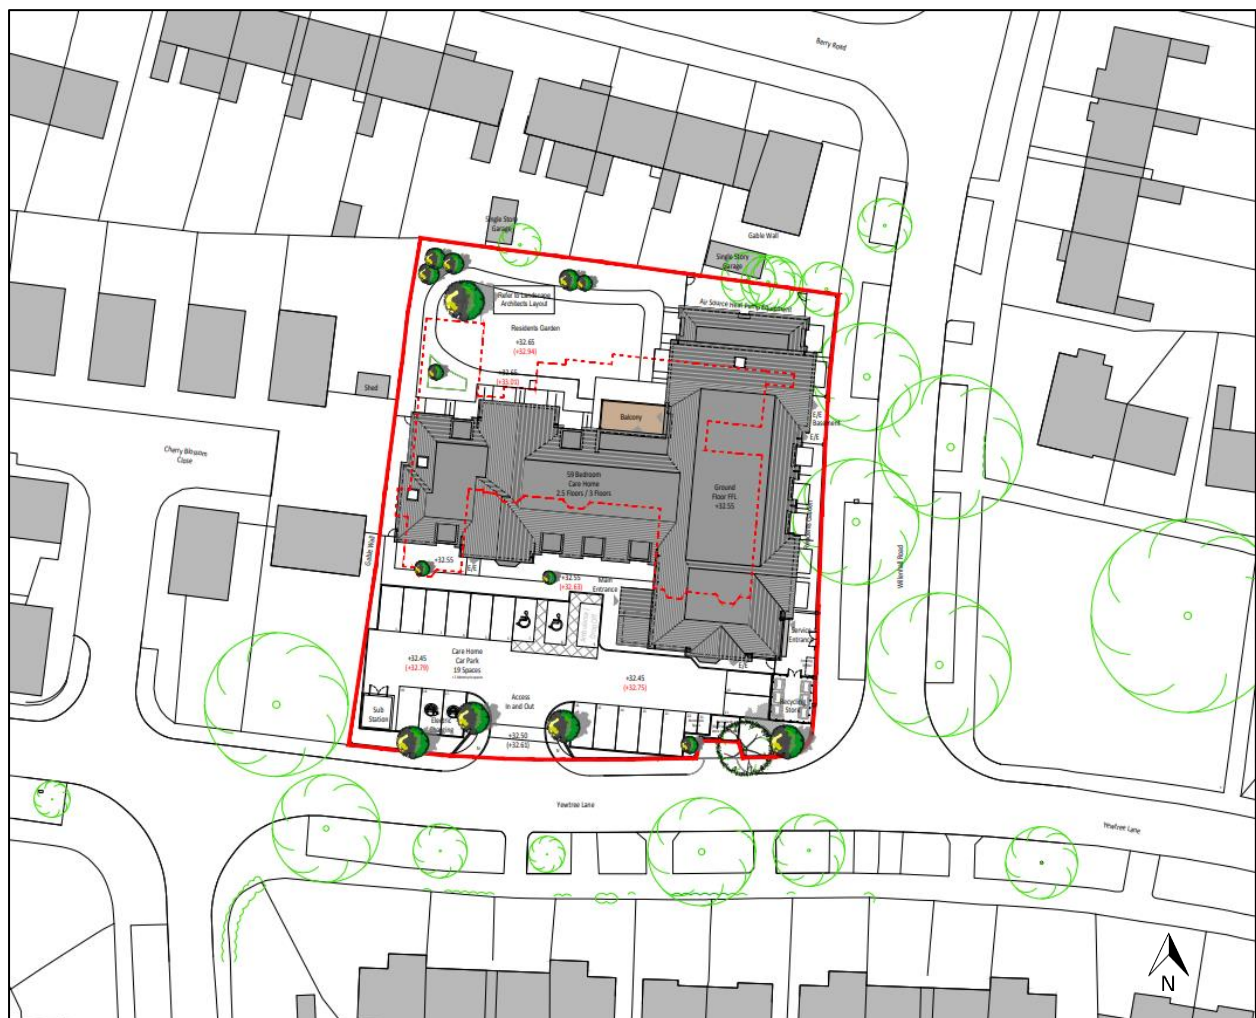
**Figure 3: Proposed Development Plan**

It is understood that the client wishes to demolish Yew Tree Manor Care Home to construct a new Care Home with a larger building footprint. The existing access route from Yew Tree Lane will be retained but utilised as a vehicle exit only. Another access route will be developed along Yew Tree Lane to be utilised as a vehicle entrance.

The proposed development layout details are shown in Figure 3, below.
