**Land at Dalton Avenue, Rusholme, Manchester,  
M14 7NR**

**Ecological Appraisal**

**Ref: SE/TADWQ031/02**

**January 2023**

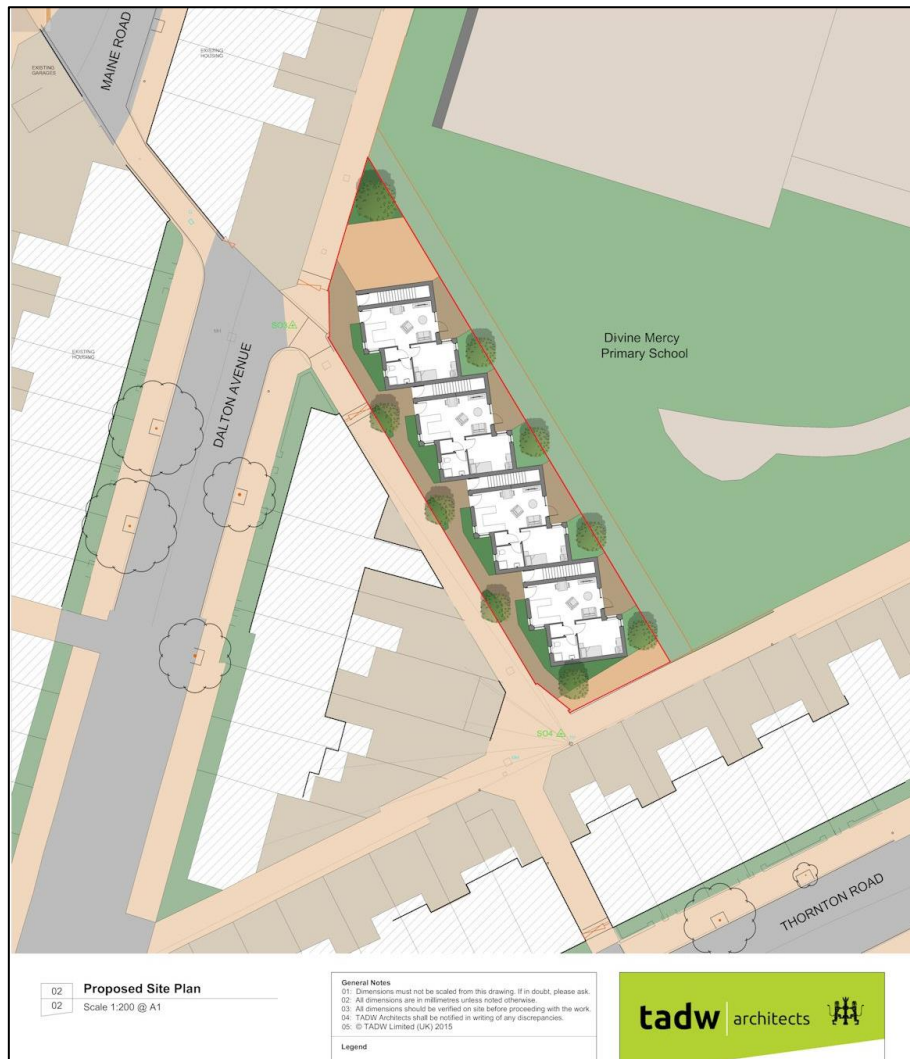
Plan 3: Proposed Site Plans.

1.3.2 The surveys described in this report were commissioned to inform an application by TADW Architects. The proposed work comprises demolition of the existing building and construction of 8 dwellings. The dwellings are single storey flats, each with their own private entrances (see Plan 3: Proposed Site Plans.). The planning process requires up-to-date survey data in order

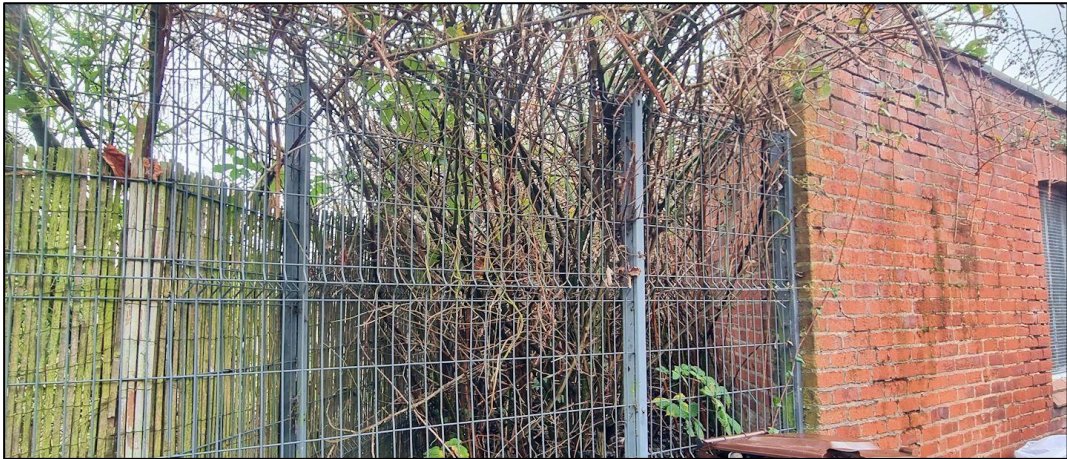
- 4.2.2 Between the disused building and the school grounds to the east was a narrow band (~2m) of scrub dominated by bramble (*Rubus fruticosus*) with some buddleia (*Buddleja davidii*) throughout and whips of self-seeded willow (*Salix* sp.). Here the ground flora was limited by leaf litter to infrequent herb Robert (*Geranium robertianum*) and nettle (*Urtica dioica*).

*Plate 2: There was a small parcel of scrub to the rear of the building that was largely inaccessible due to presence of fence and razor wire.*

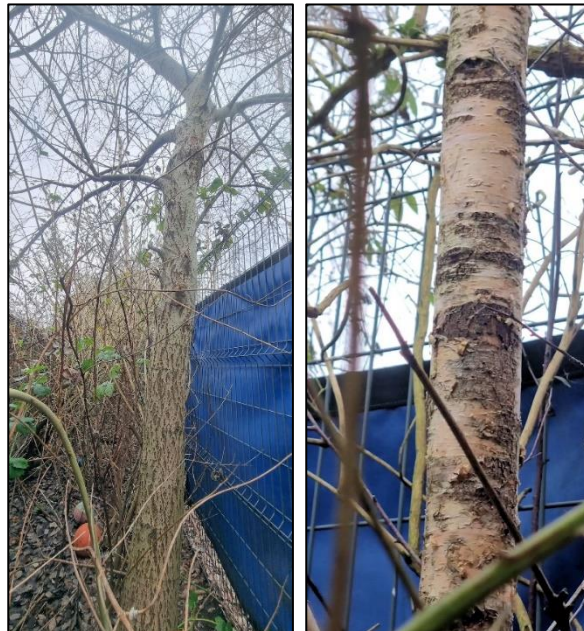
- 4.2.3 Within the scrub was a single, semi-mature willow and an immature birch (*Betula* sp.) (see Plate 3) along with numerous willow whips.

*Plate 3: There were a small number of semi-mature and immature trees within the scrub.*

- 4.5.1 The trees on site were semi-mature, self-seeded specimens that had not been subject to any form of management. A search for any knot holes, wounds or splits suitable for bat roosting failed to find any. All trees were classified as having 'Negligible' suitability for bats as there was no roosting potential (see Plate 3).

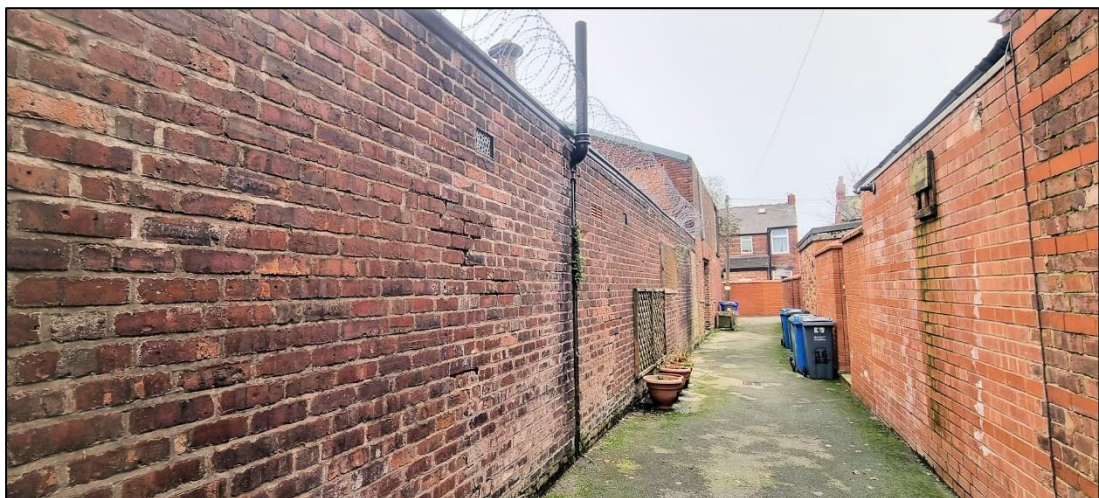
- 4.2.4 Surrounding the building was a small parcel of hardstanding (see Plate 4); here the flora was limited to pioneer species including common bent grass (*Agrostis capillaris*), nettle, willowherb (*Epilobium* sp.), broad leaved dock (*Rumex obtusifolius*) and dandelion (*Taraxacum officinale* agg.).

- 4.2.5 The buildings on site held no significant botanical interest (see Plate 4).

*Plate 4: The building and the hardstanding had little floristic value.*

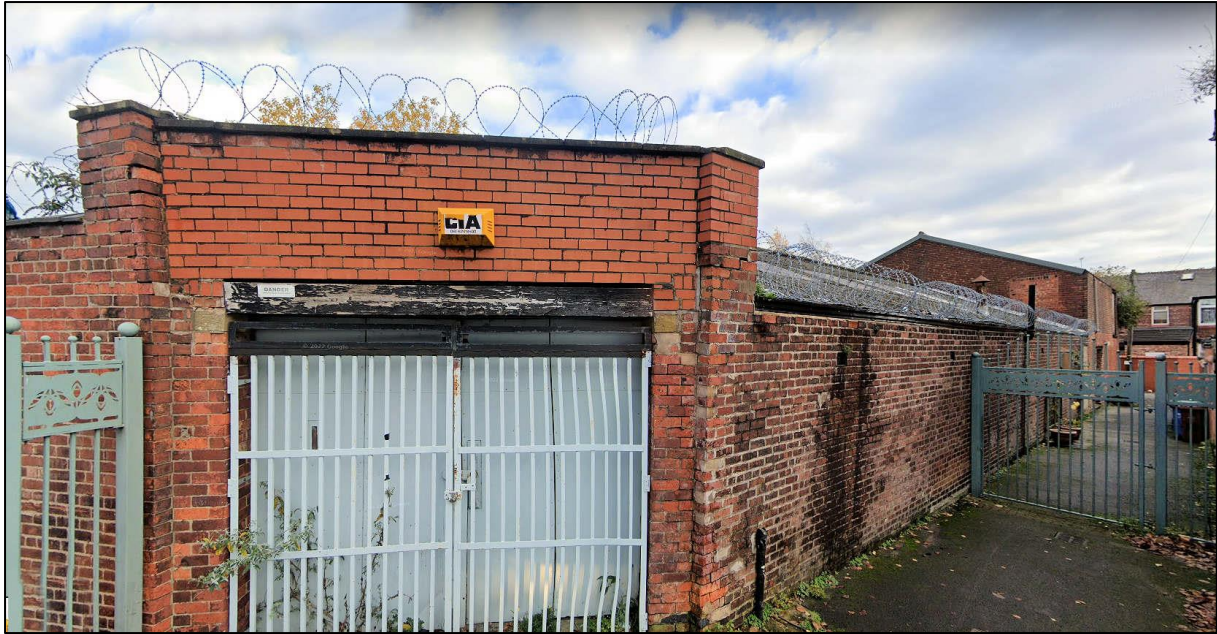
- 4.4.1 The target building consisted of disused commercial buildings (see Plate 5) set within an urban residential landscape. The building was in poor condition and was unoccupied at the time of survey.

*Plate 5: General View of the buildings from Dalton Avenue.*

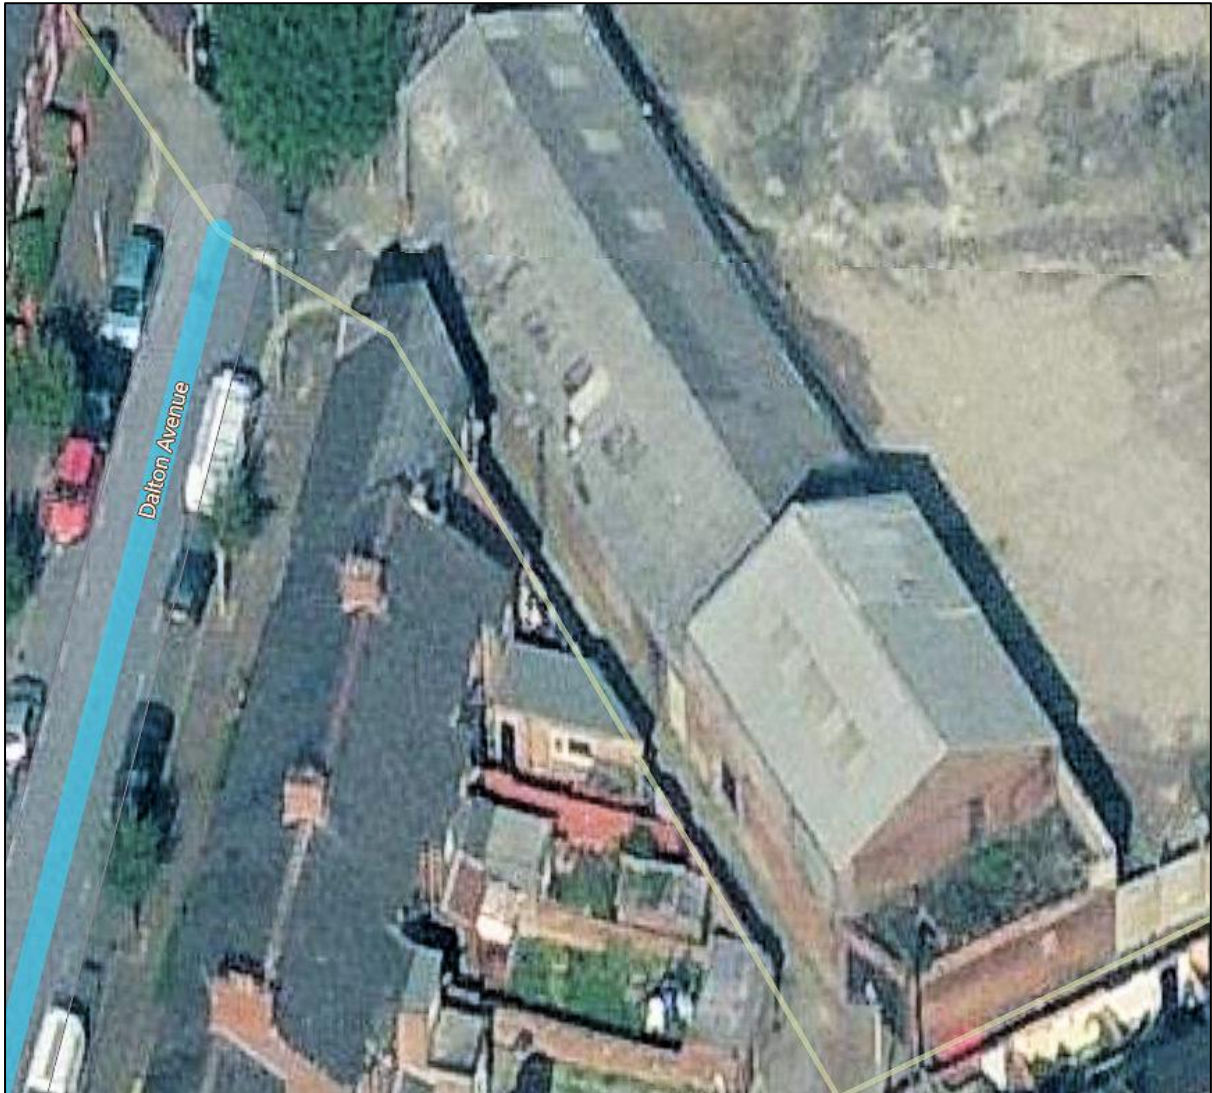
- 4.4.2 The building comprised two long and narrow former commercial units built of red brick with pitched roofs of corrugated cement board sheeting. The Northern half of the building was single storey and the Southern half was two storeys in height (see Plate 6).

*Plate 6: The two roof areas of the former light-industrial building were inspected.*

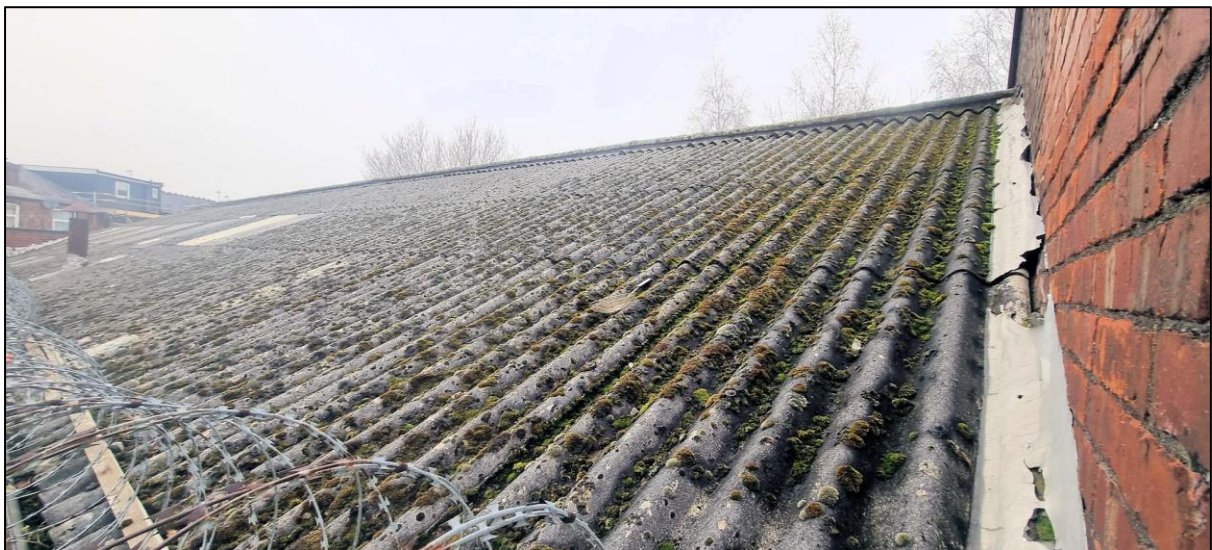
- 4.4.3 The roof was generally intact although gaps were apparent, particularly on the double height building to the south which had some broken and slipped sheeting which allowed the elements into the building. All intact corrugated sheets were tightly interlocking and no gaps were present between them where they overlapped. The corrugated sheets had a light moss covering (see Plate 7). It was concluded that there were no PRFs and no roosting opportunities within either the single storey roof on the Northern section of the building or the double height roof of the Southern section of building.

*Plate 7: The roofs were generally intact with no roosting potential.*

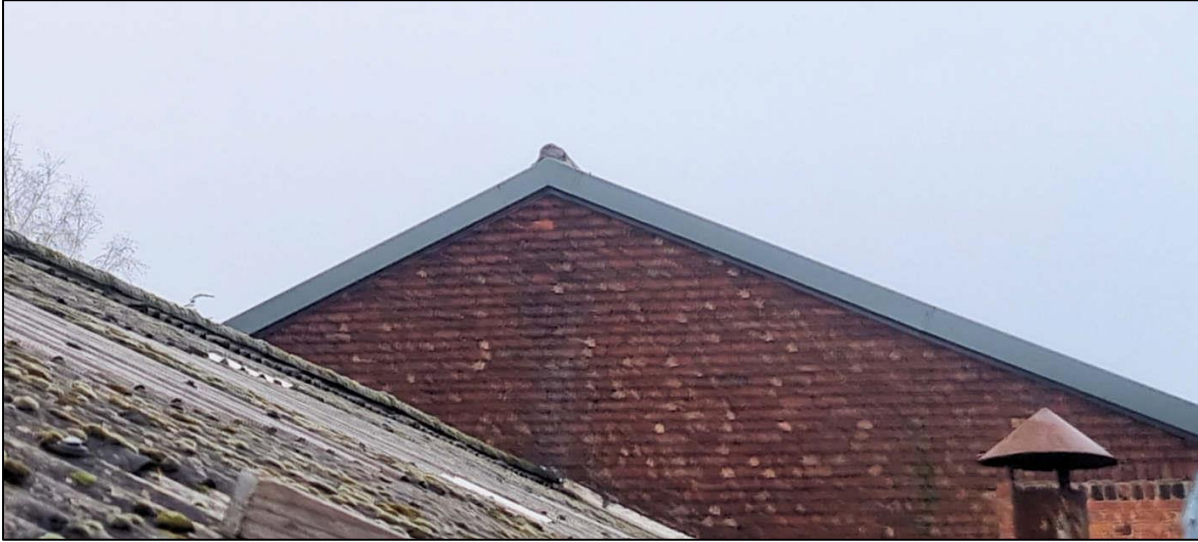
- 4.4.4 The dry verge boarding on the north facing gable end of the two storey building was carefully inspected from the ground. End capping of this type can have gaps behind which roosting is possible. However, the close binocular inspection showed that the verge was tight to the red brick walls. No gaps suitable for roosting were present (see Plate 8). The verges of the south facing gable were similarly intact with no PRFs (see Plate 9).

*Plate 8: The dry verge boards of the two storey building were afforded close attention as these can harbour roosting bats, but the survey found no gaps and no roosting potential.*

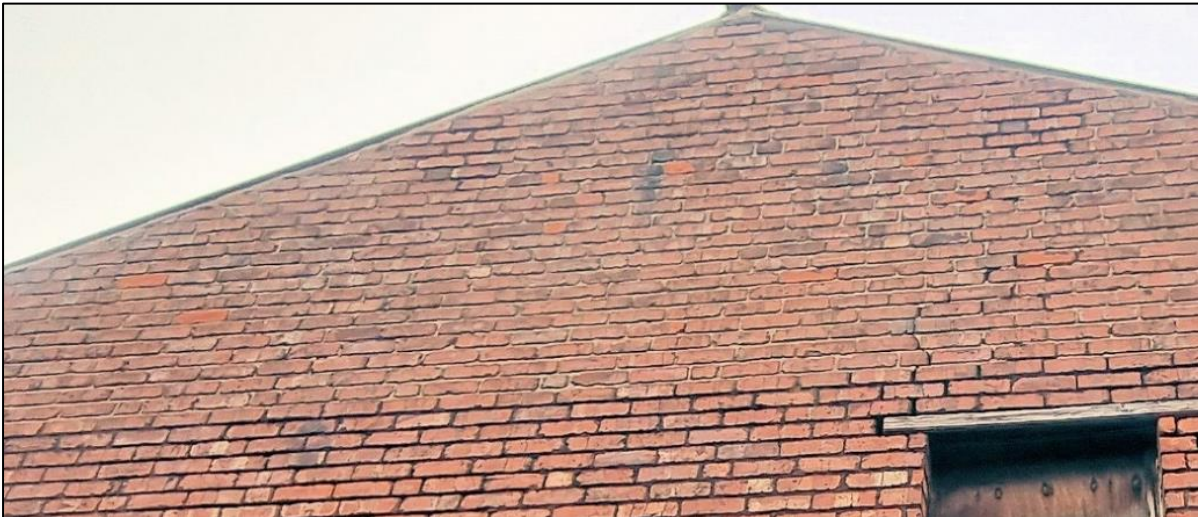
*Plate 9: The verges of the southern facing gable were well mortared with no PRFs. Areas of darker missing mortar around the lintels did not provide crevices sufficiently deep for roosting.*

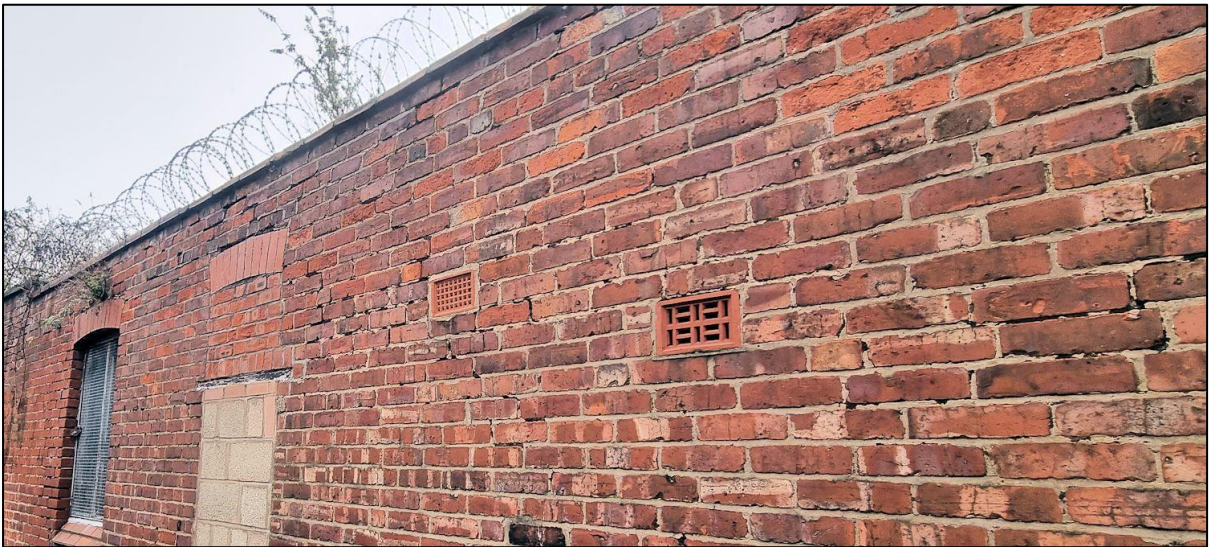
- 4.4.5 The gable end of the Northern building was also assessed. This only had a low gable as it adjoined a flat roof. The elevations to the gable was considered too low for bats to be able to effectively access as a flight line into and out of the gable would not have been possible. In the main, the gable end was also well rendered, so no suitable gaps were present anyway (see Plate 10). Further inspection of the roof edges with integral guttering or coping stones were intact with no apparent gaps and offered no roosting potential (see Plate 11).

*Plate 11: The coping stones on the wall tops were intact with no roosting potential.*

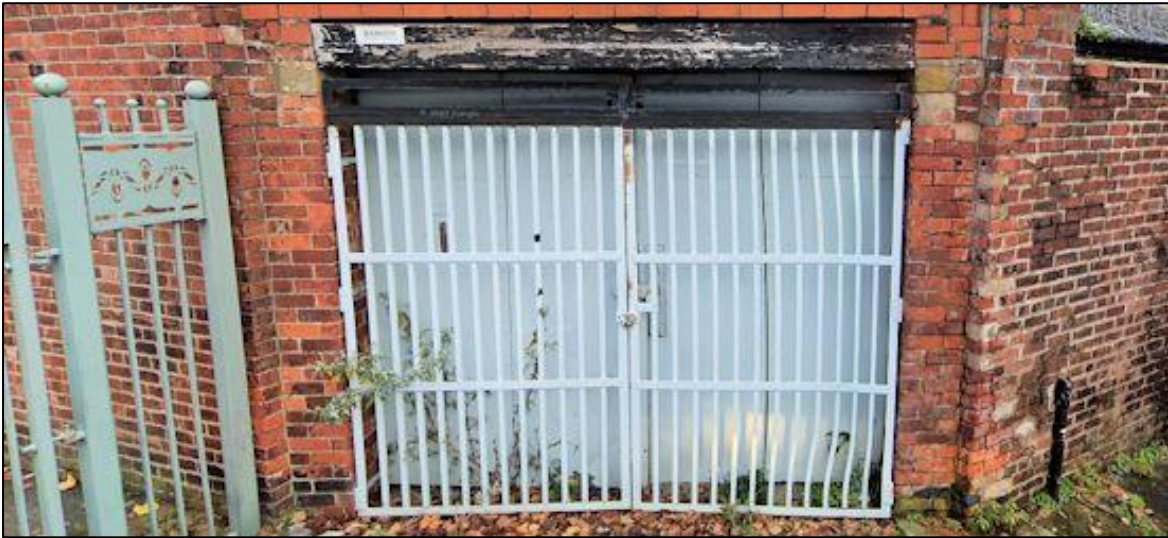
- 4.4.6 The frames of the windows and doors were intact with no PRFs so bats could not have roosted in the frames or lintels (see Plate 12). Nonetheless, there were gaps around boarded up doors and windows which would have permitted bats to fly into the interior of the building through the missing glass (see Plate 13).

*Plate 12: The door and window frames were generally intact so their frames did not confer any roosting possibilities.*

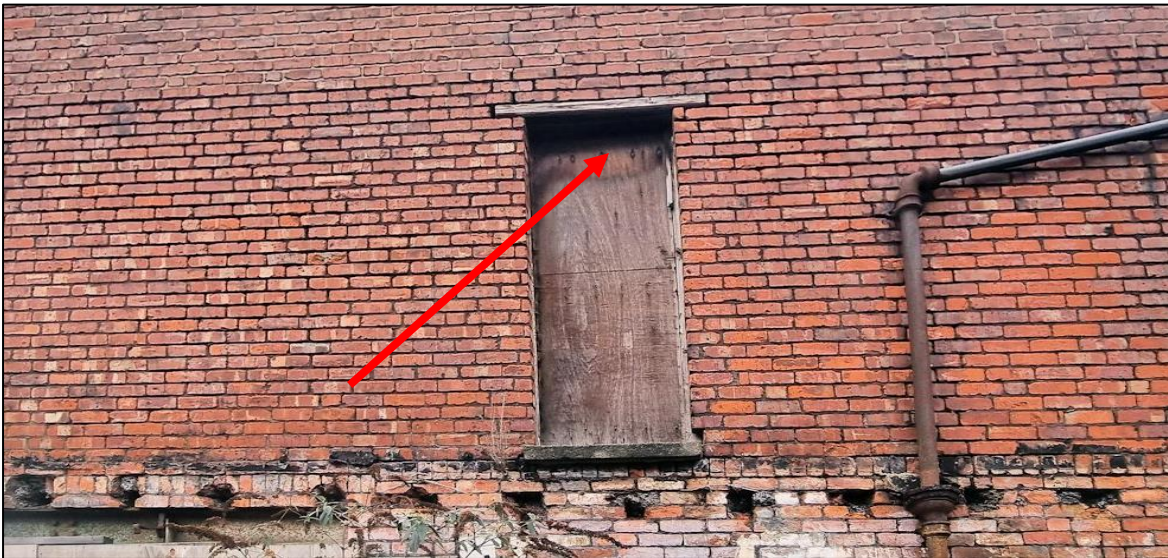
*Plate 13: Gaps around previously boarded up doors and windows allowed potential access to the internal space.*

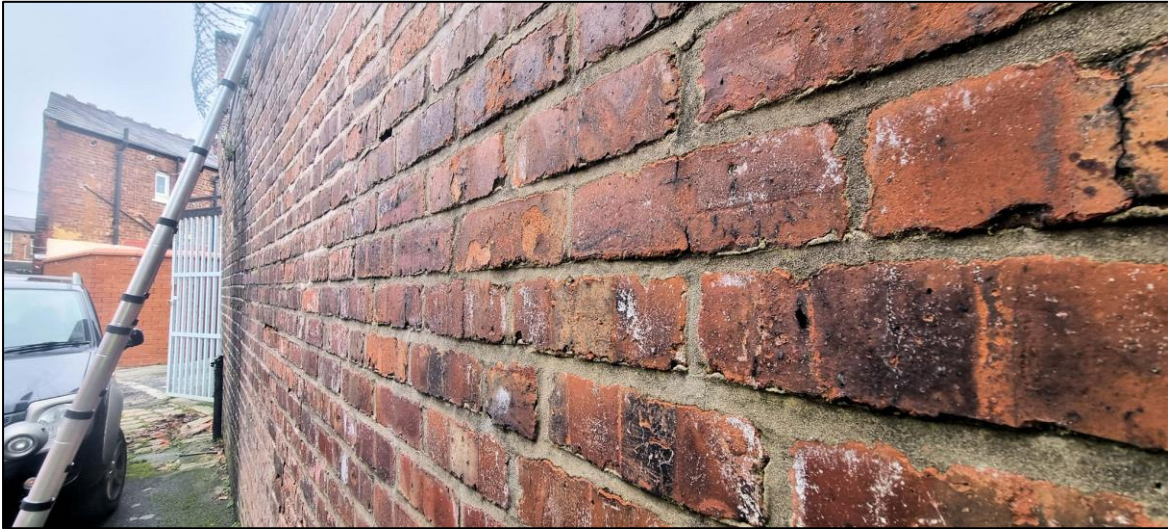
- 4.4.7 The brick walls were generally intact (see Plate 14) although there with cracks in the mortar but these did not lead to internal crevices or offer any roosting potential (see Plate 15). A large hole was noted on the rear wall of the building.

*Plate 14: The brickwork was generally intact with no bat roosting potential.*

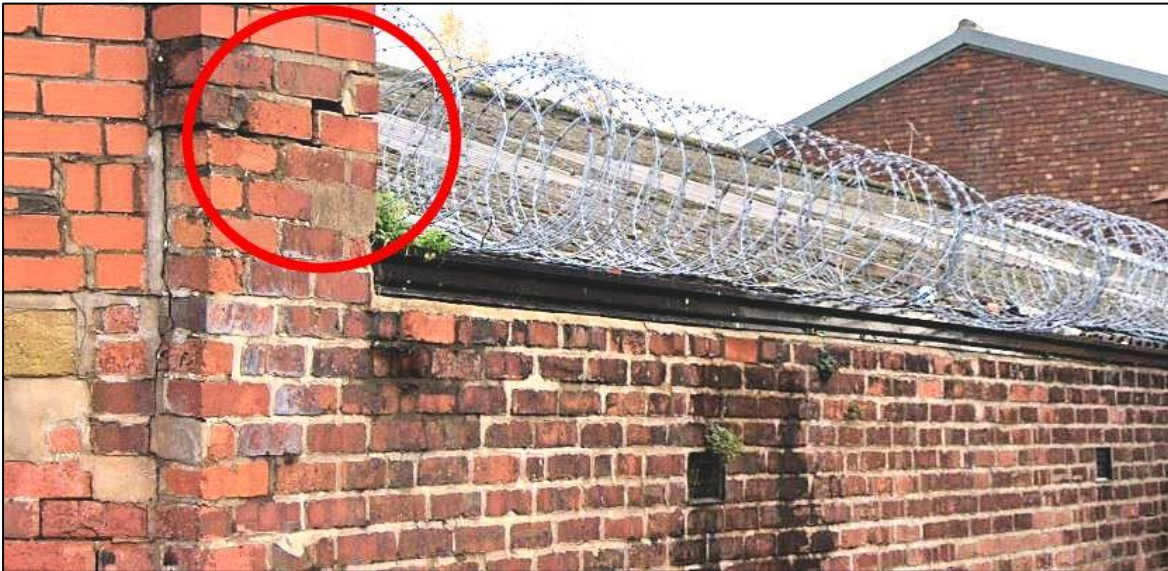
*Plate 15: Shallow area of missing mortar in the brickwork was present but were found not to lead to internal crevices or considered to have any roosting potential.*

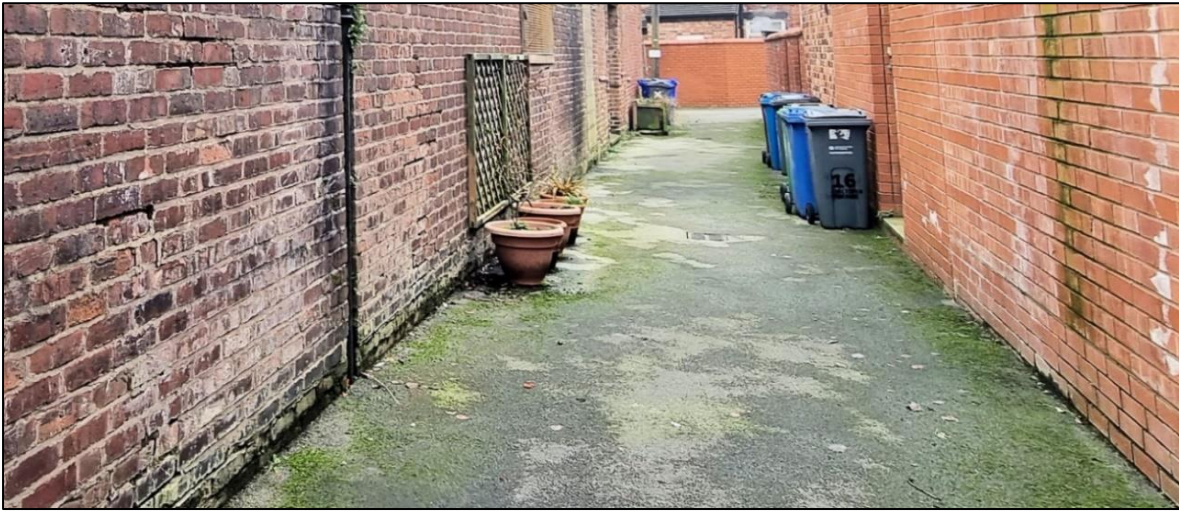
- 4.4.8 The walls and flat surfaces around the building were thoroughly and comprehensively searched for evidence of bat activity but none was found (see Plate 16). The rough surface of the brick work provided an ideal substrate for droppings to adhere to and these would have easily been observed; however, no signs of bats were discovered.

*Plate 16: There was no evidence of bat activity on the walls of flat surfaces around the buildings.*

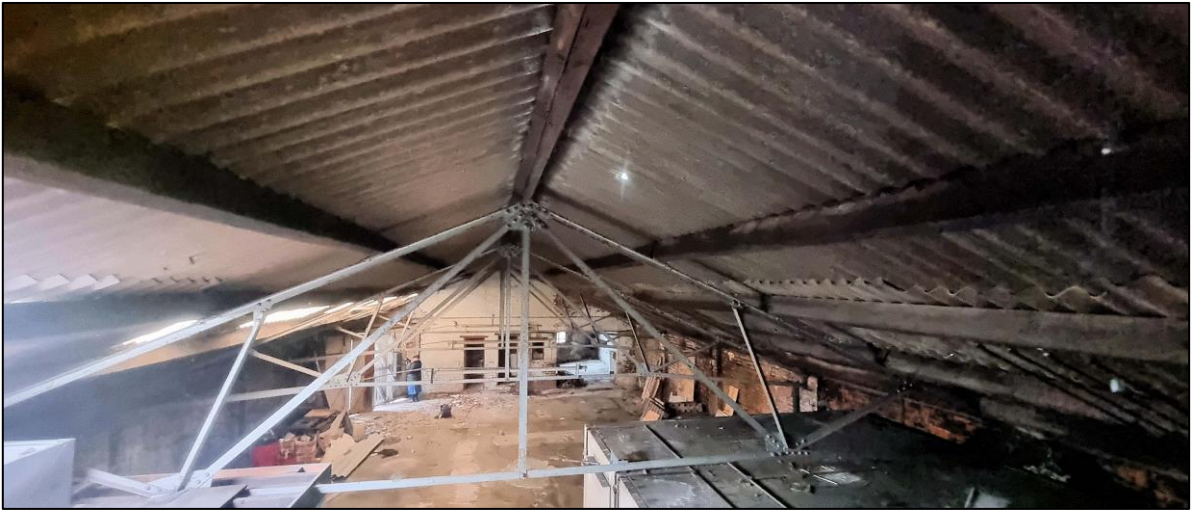
- 4.4.10 The entire survey area was divided into the two interconnected buildings divided by external walls with no doorway or other connection between the two. The interior of both buildings were single voids that were open along their entire length and from floor to ceiling. Partition walls sub-divided the working area, but these were free-standing and were only a couple of metres high (see Plate 17 and Plate 18). The underside of all roof areas were visible as there was no enclosed loft space. This absence of a loft significantly reduced potential for bat roosting.

*Plate 17: Internal view of the single storey building with exposed roofing sheets and trusses.*

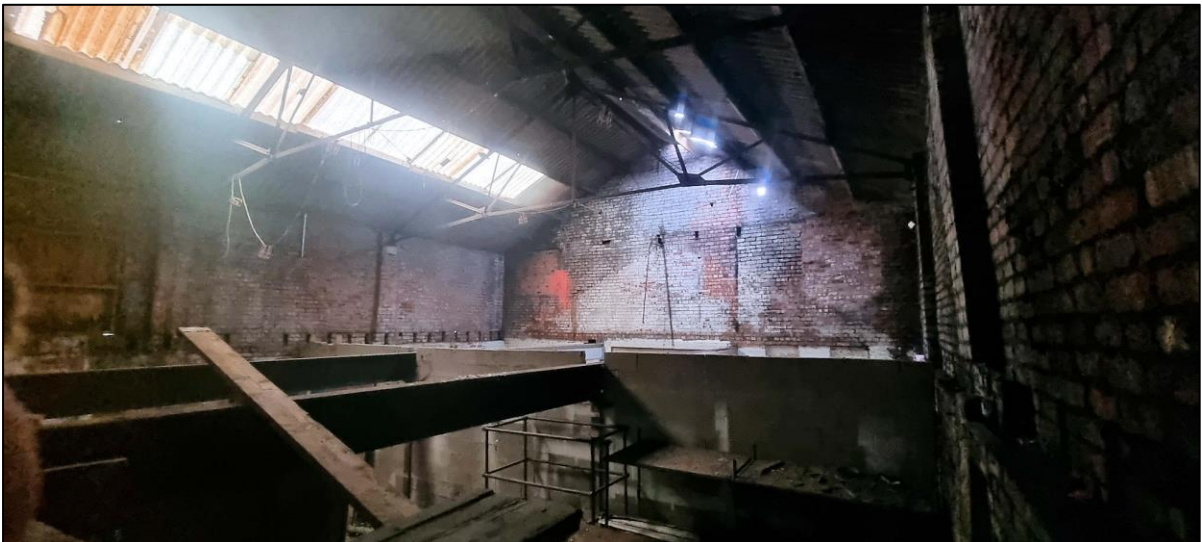
- 4.4.11 All of the underside of the corrugated roofing sheets and the joists were exposed and could readily be assessed for any bat roosting possibilities. Despite a thorough check being completed, neither of the roofs had any voids or crevices within the structures that could be used by bats for roosting.

*Plate 18: The two-storey building was also a void open from the floor to the roofing sheets and trusses. This offered no roosting potential.*

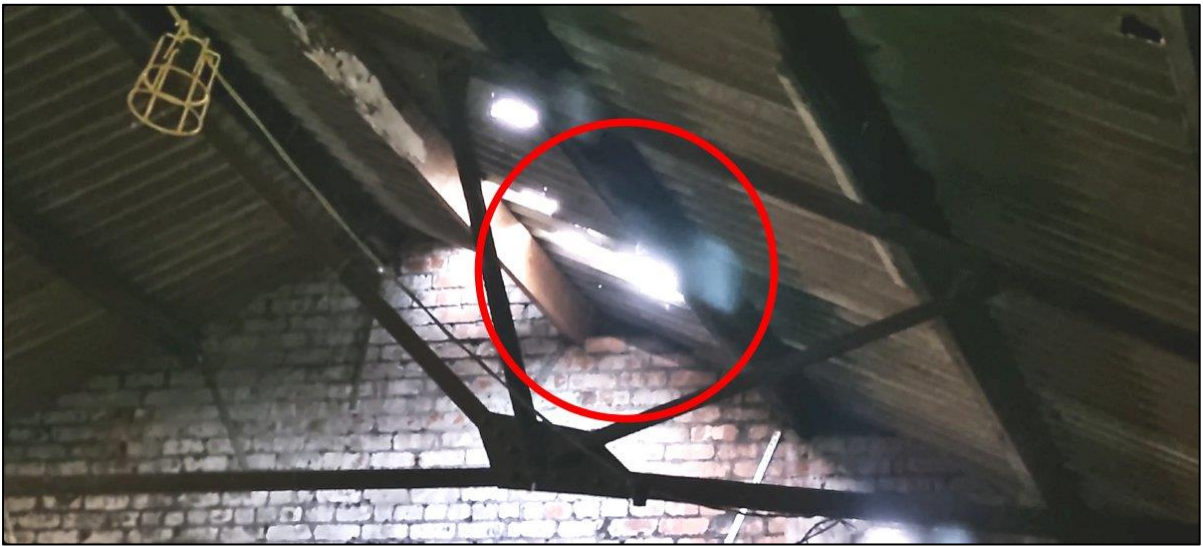
- 4.4.12 The roof of the single storey building was intact and watertight. sheets were generally intact although there was a portion of missing sheeting on east facing pitch of the two-storey building (see Plate 19) which would have allowed bats direct access to the internal void.

*Plate 19: Damaged roofing sheets left a hole in the east facing pitch allowed access to the internal space.*

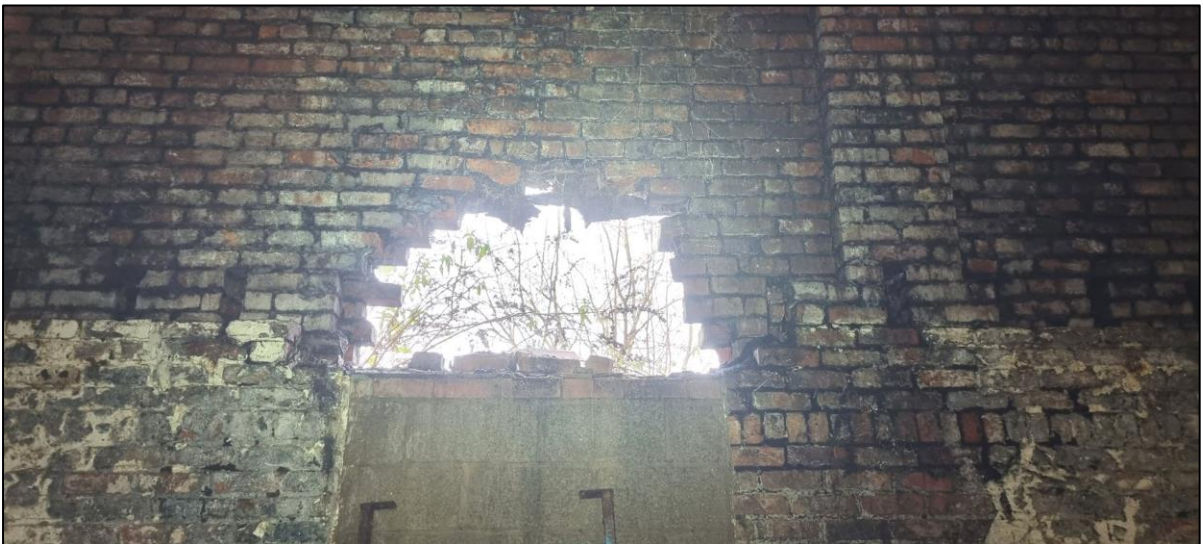
- 4.4.13 In addition, the red brick walls were generally intact although a large hole was noted in the Southern building (see Plate 20) which allowed access directly through into the internal void. However, a check of the walls found them to be well mortared and tightly abutting. All internal faces of the walls had no PRFs and offered no roosting potential.

*Plate 20: A large hole in the rear wall provided unfettered potential access to the internal space.*

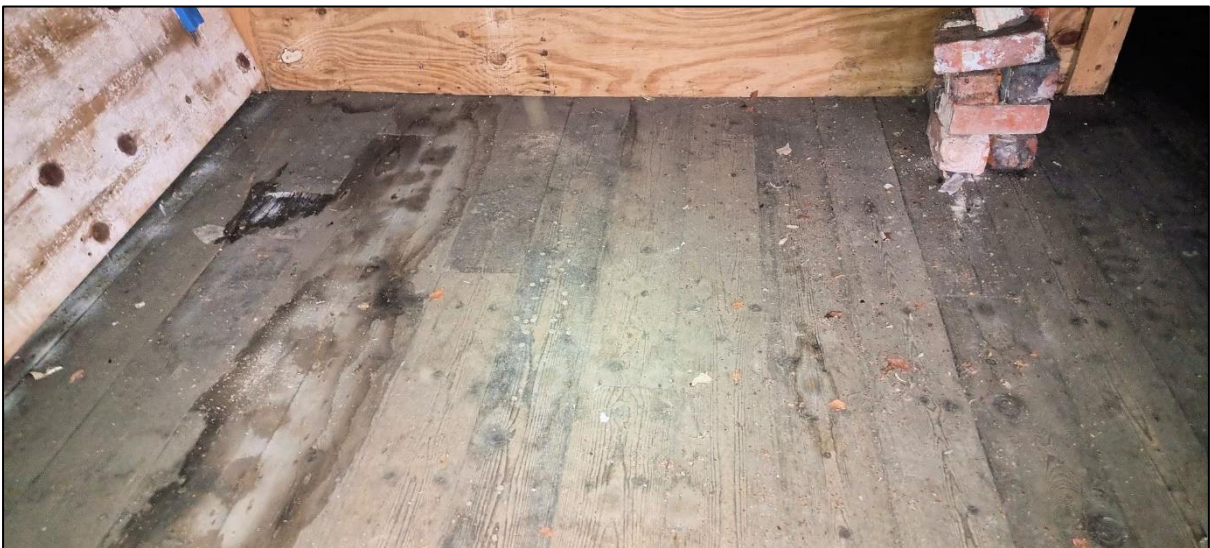
- 4.4.14 Finally a comprehensive search of the floors and all flat surfaces was conducted. This found no evidence of bats or bat activity (such as droppings or prey items within the either building (see Plate 21 and Plate 22)

*Plate 22: The flat surfaces had no evidence of bat activity.*
