**REMEDIATION STRATEGY**

**Miles Platting Area 7.5, Manchester**

**REPORT No: 22LPL087/RS**

| Document: | Remediation Strategy |

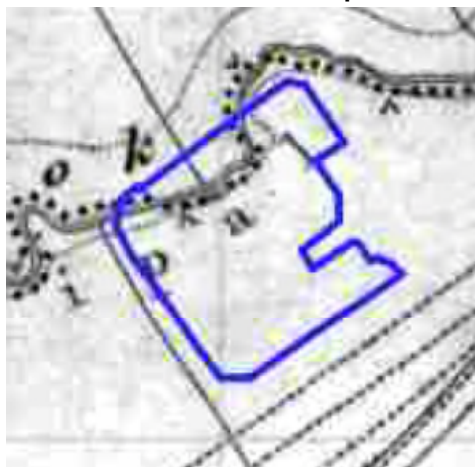
**1848 1:10,560 Map**

The earliest available map of site is the 1848 1:10,560 map which shows site as vacant ground with Shooters Brook running through it from east to west. An extract of this map is shown overleaf:

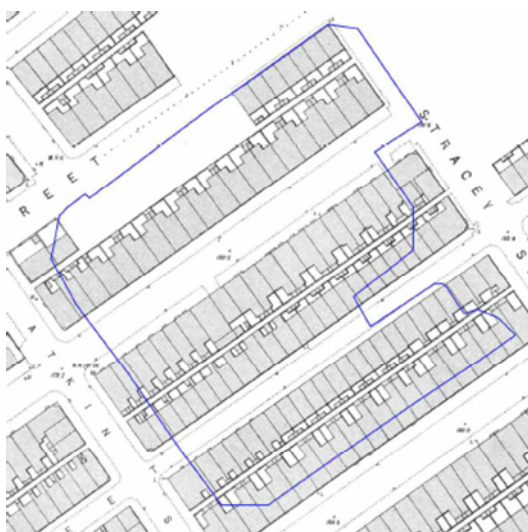
**1891 1:500 Map**

No further major changes occur onsite until the 1891 1:500 map when the site is mainly covered by terrace housing and two roads. An extract of this map is shown below;

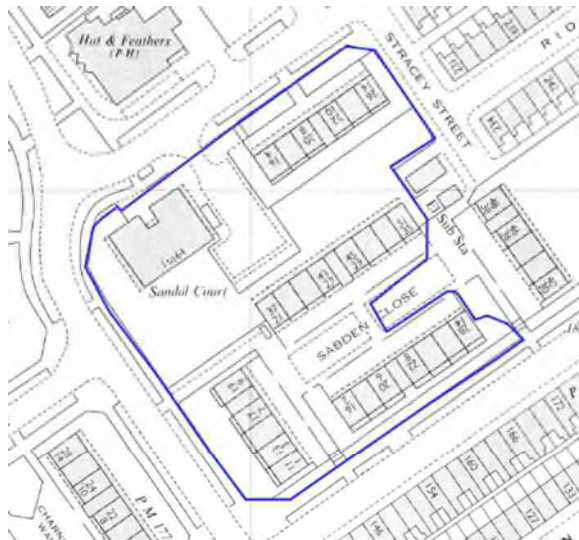
**1963-1968 1:1,250 Map**

No further major changes occur onsite until the 1963-1968 1:1,250 map when there are less terrace houses on site and there is a building called Sandal Court in the northwest of site. An extract of this map is shown overleaf:

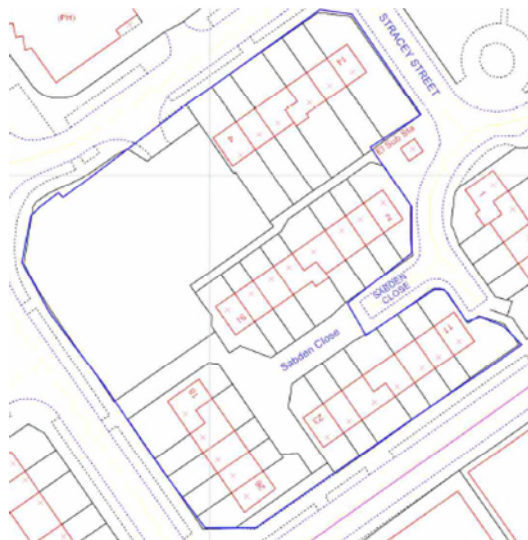
**2003 1:1,250 Map**

No further major changes occur onsite until the 2003 1:1,250 map when Sandal Court is no longer present. An extract of this map is shown below;

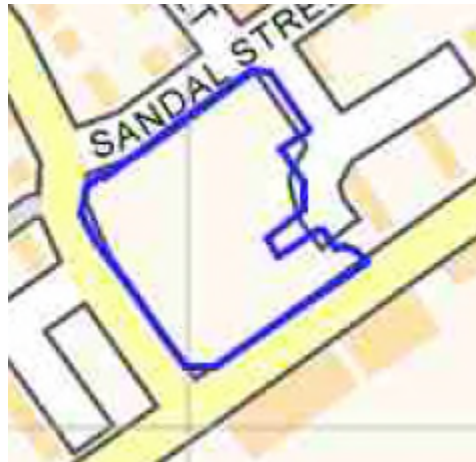
## 2022:10,000 Map

No further major changes occur onsite until the 2022 1:10,000 map when all of site is shown as vacant. An extract of this map is shown overleaf:

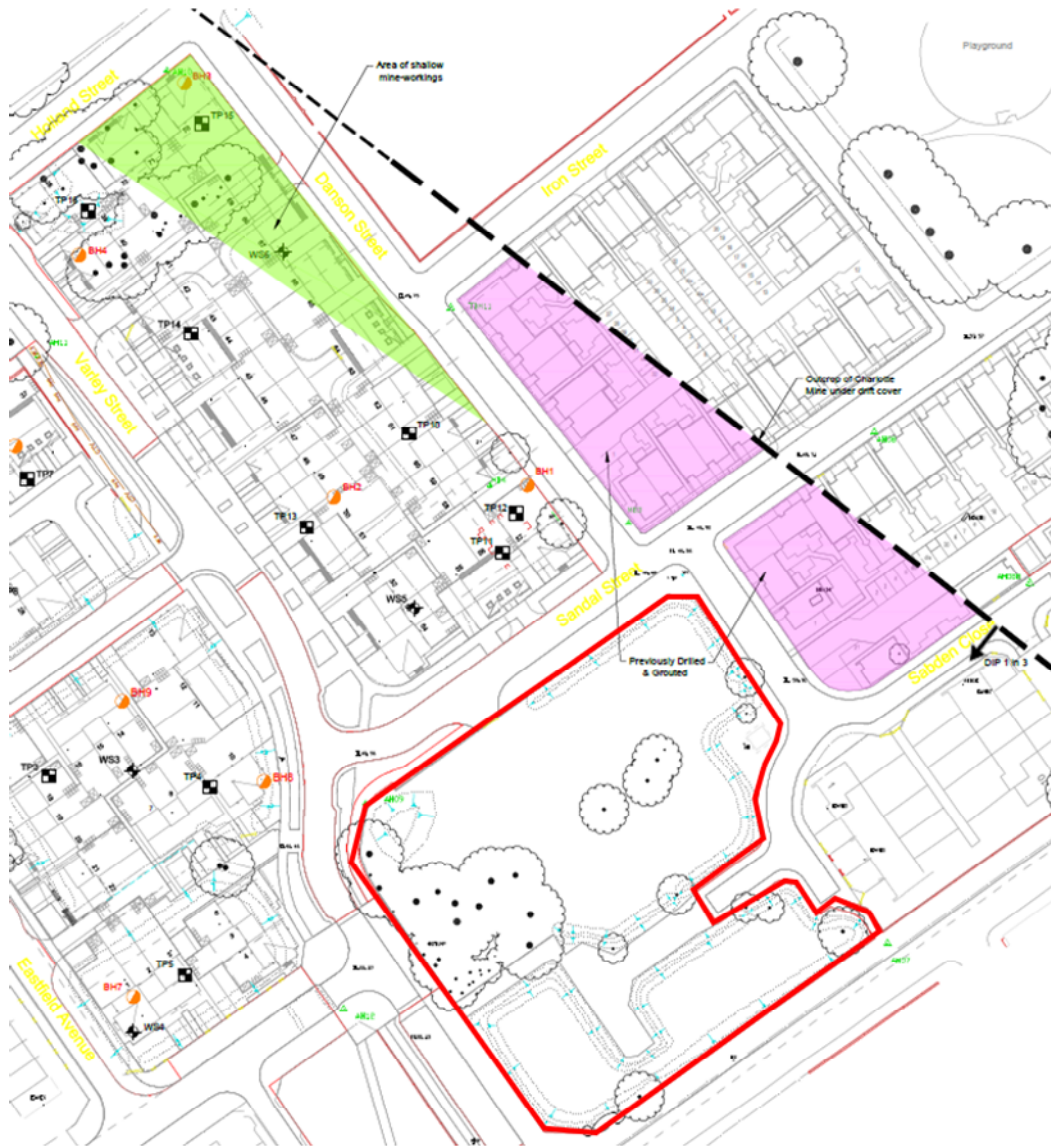
An extract of the exploratory hole location plan has been provided below. The drawing shows details of the areas previously drilled and grouted as per the Capita reports above. The Miles Platting Area 7.5B is outlined on the drawing extract.
