| <b>Project Name</b><br><b>Project Number</b><br><b>Title</b><br><b>Site</b><br><b>Client</b><br><b>Date</b> | Abraham Moss Leisure Centre<br>1620005164-001<br>Watching Brief Photographic Record<br>Abraham Moss Leisure Centre, Crescent Road, Manchester, M8 5UF<br>Laing O'Rourke<br>December 2021 |

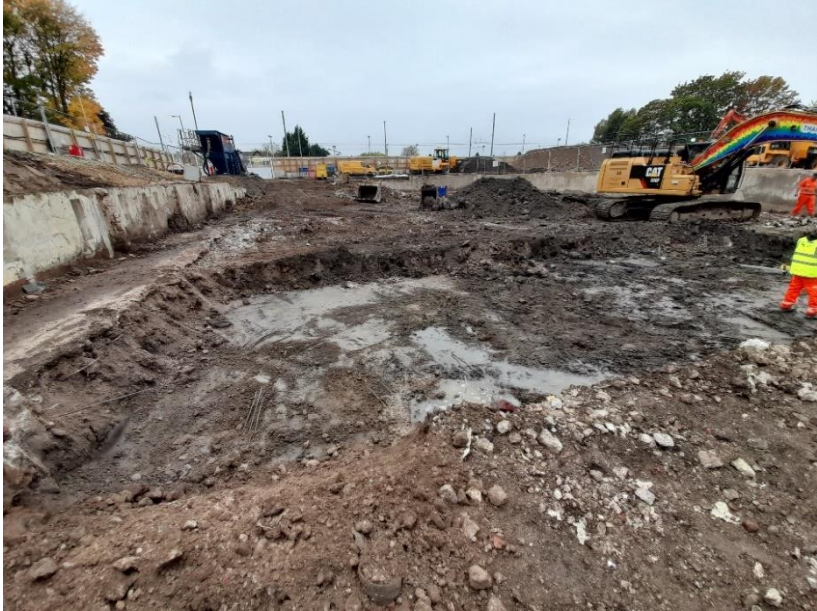
| | <p><b>Photo 1:</b> Excavating works in the north of the Basement Area. Photograph taken facing the south / south-west on 18/10/2021</p> |

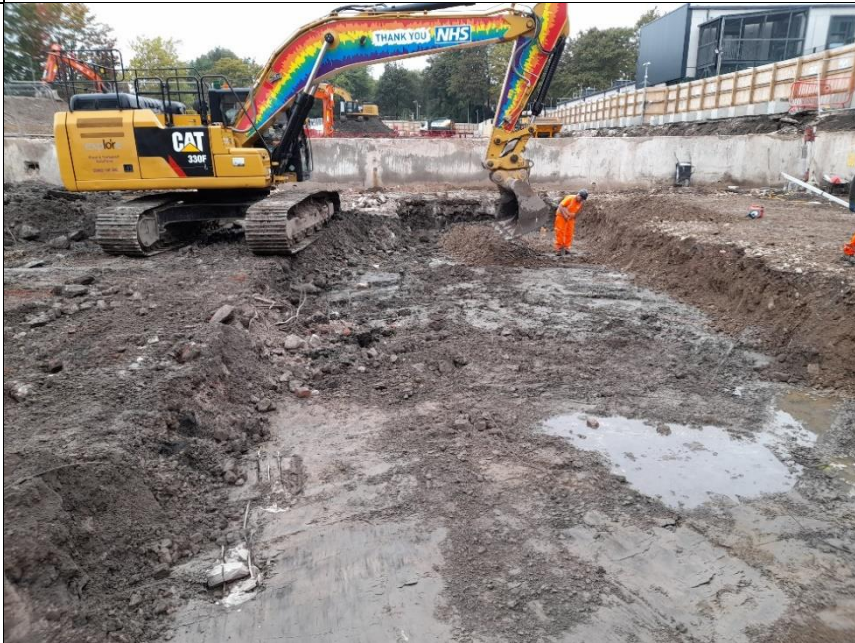
| | <p><b>Photo 2:</b> Excavated, lined and backfilled area (right), and the next strip of land undergoing excavation works. Photograph taken facing the west / north-west on 18/10/2021</p> |

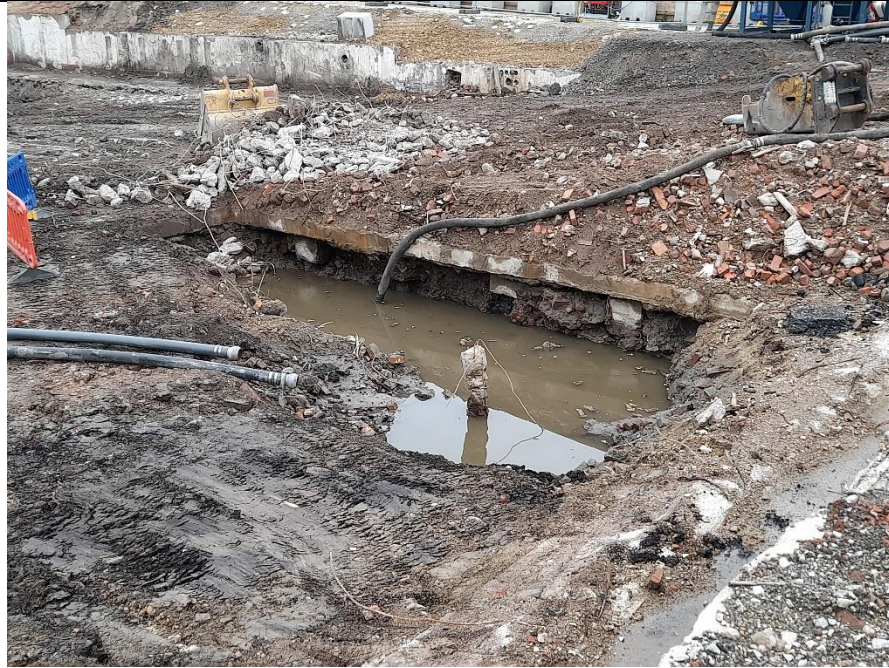
**Photo 3:** View of the groundwater within the Basement Area (the area where unexpected contamination was previous encountered. The water was pumped out of the pit and treated before discharge. Photograph taken facing the east / north-east on 18/10/2021.

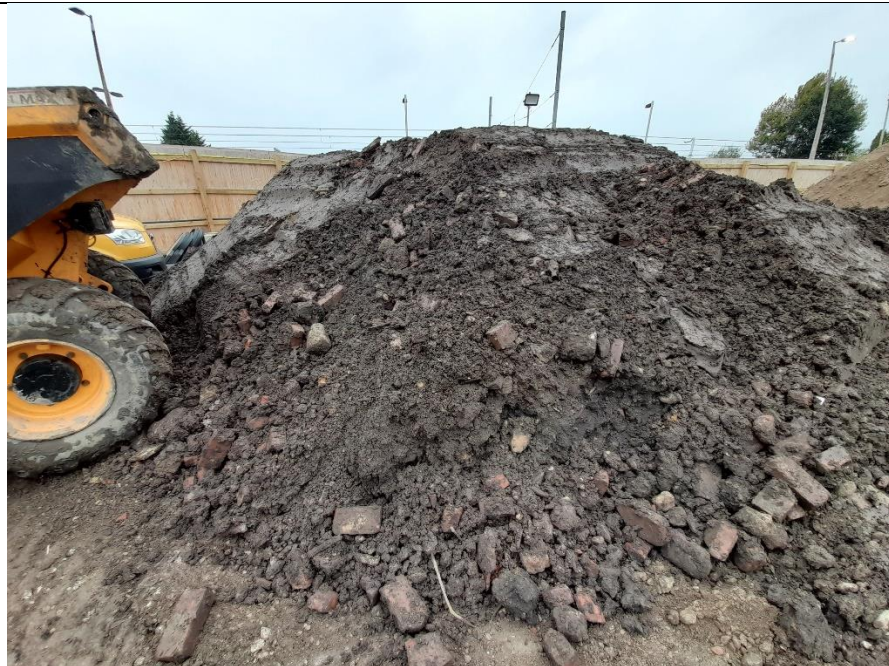
**Photo 4:** 'Hazardous' stockpile which was located to south-west of the Basement Area.

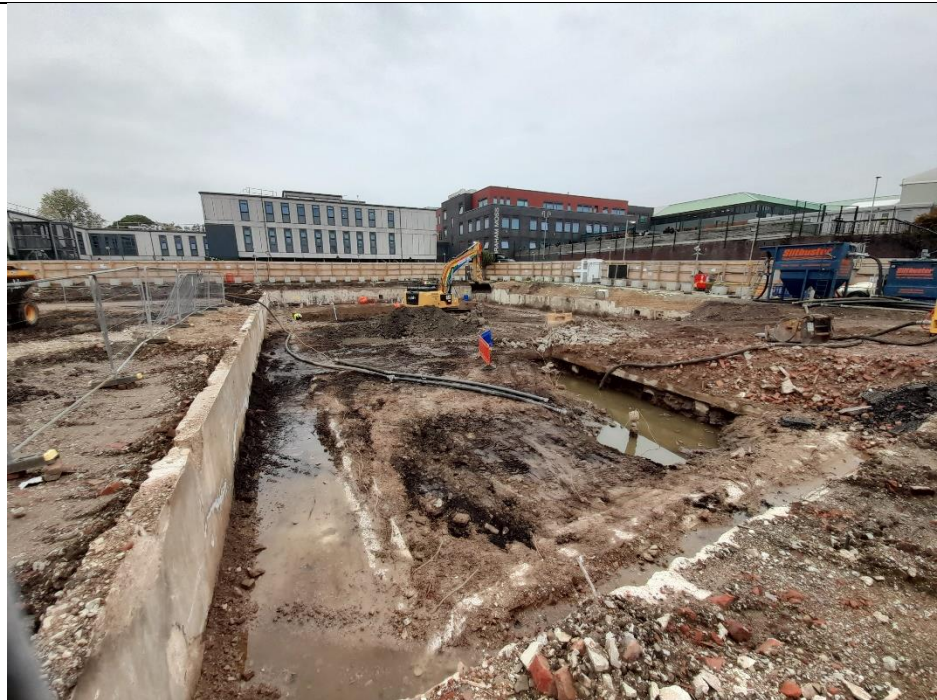
**Photo 5:** View of the Basement Area facing the north / north-east on the 18<sup>th</sup> October 2021.

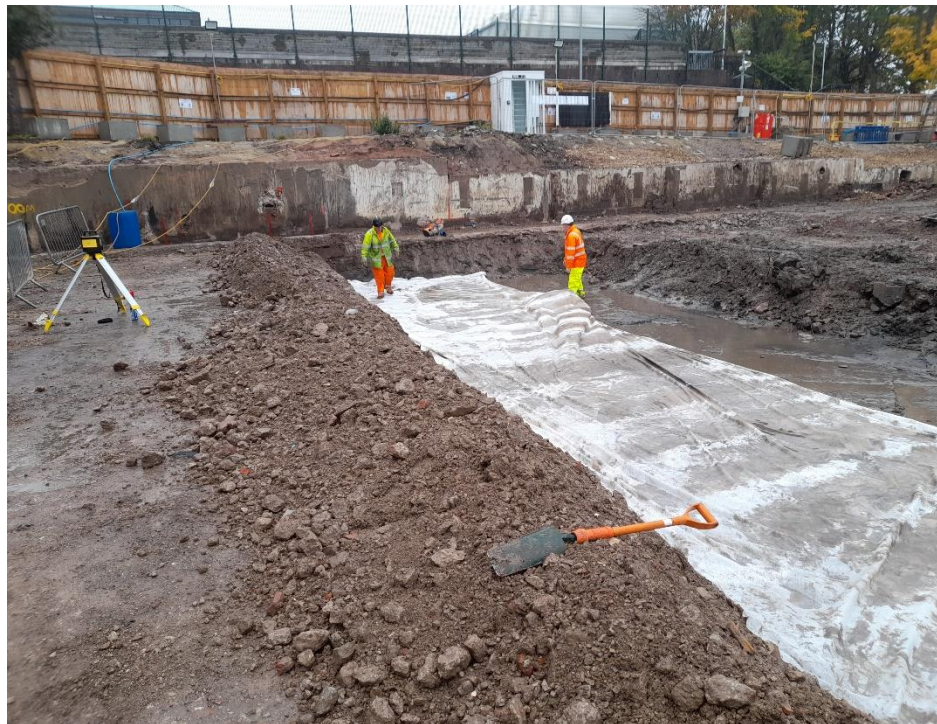
**Photo 6:** Contractor laying geotextile at the base of the excavation prior to backfilling with material. Photograph taken facing the east on 18/10/2021.

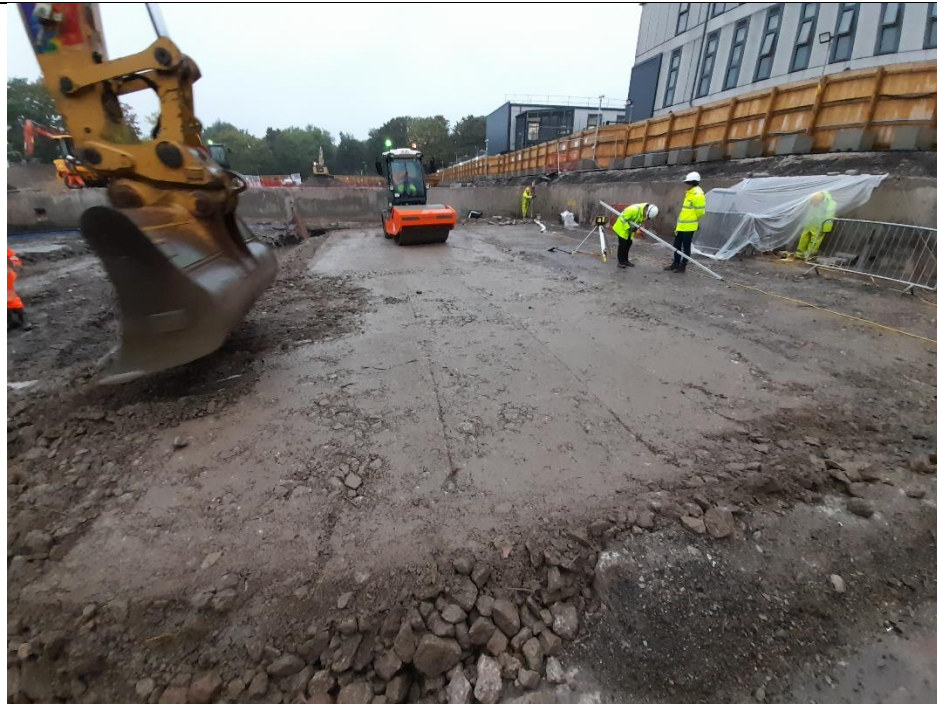
**Photo 7:** Roller compacting the backfill to form new foundation levels. Photograph taken facing the north-west on 19/10/2021.

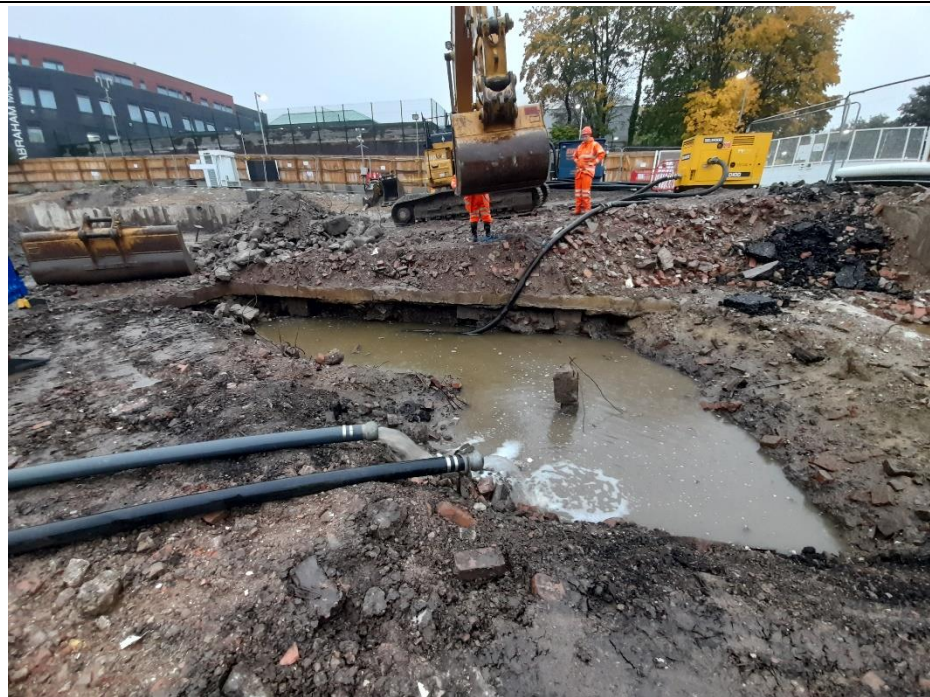
**Photo 8:** Groundwater / rainwater pumped out from an excavation north of the basement into the pit towards the south of the basement to be pumped out and treated via SiltBuster and pH regulating system prior to discharge. Photograph taken facing the east / south-east on 19/10/2021.

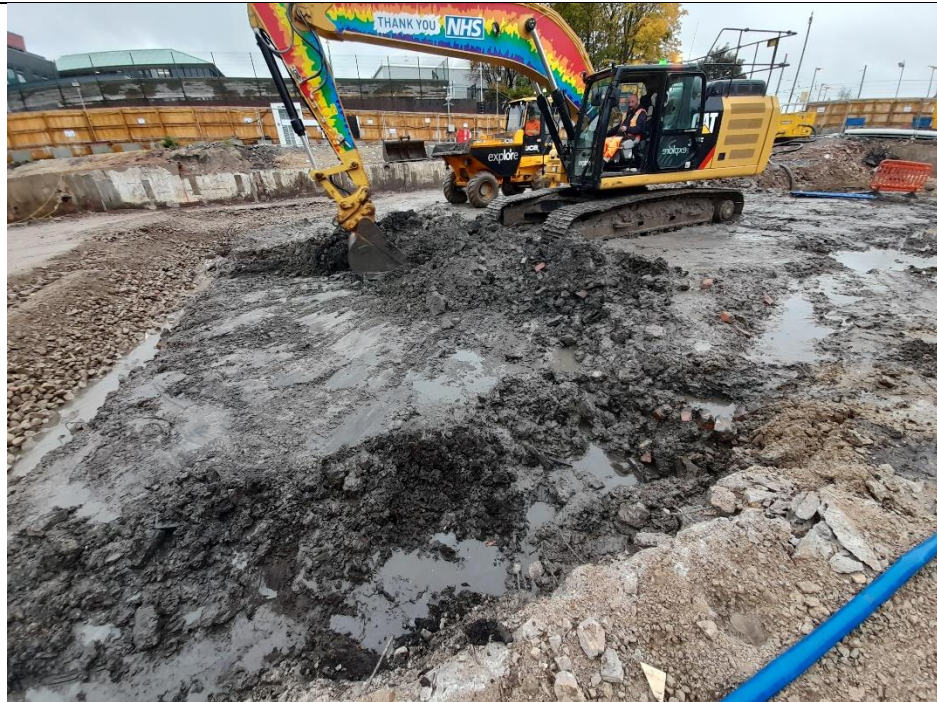
**Photo 9:** Ground conditions towards the north of the basement area following the pumping out of the groundwater. Photograph taken facing the south-east on 19/10/2021.

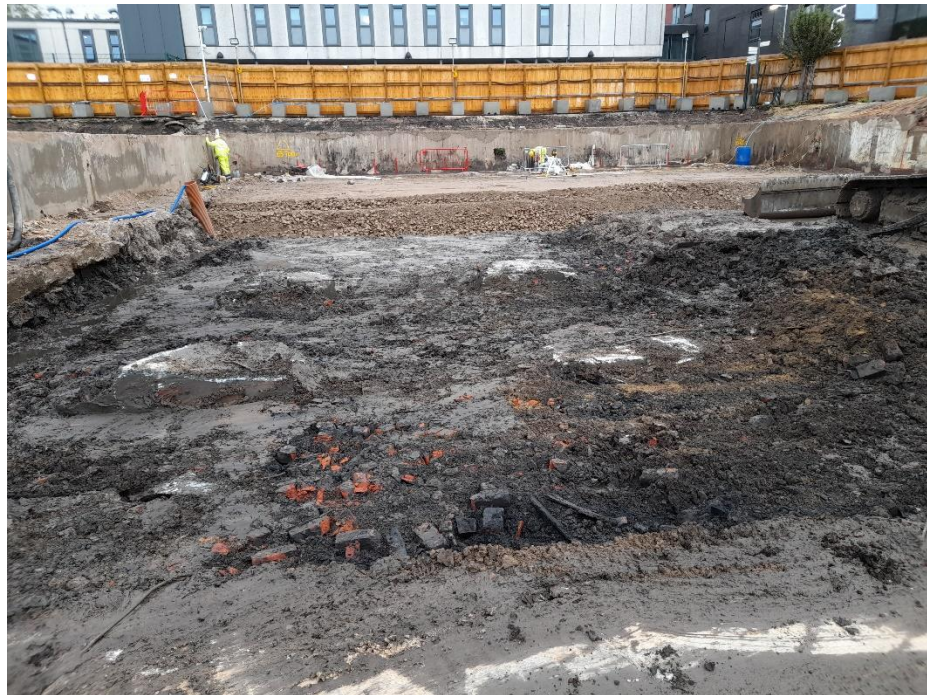
**Photo 10:** Ground conditions towards the centre towards the centre of the basement comprising of brick fill made ground. Photograph taken facing the north / north-east on 19/10/2021.

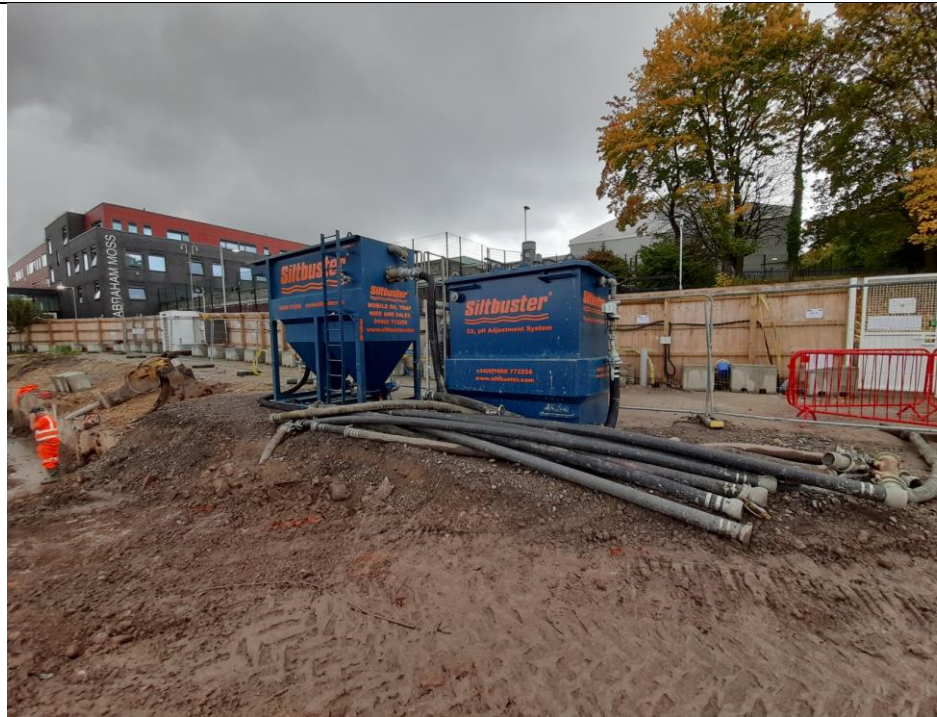
**Photo 11:** On-site water treatment system, located to south-east of the basement area. Photograph taken facing the north-east on 20/10/2021.

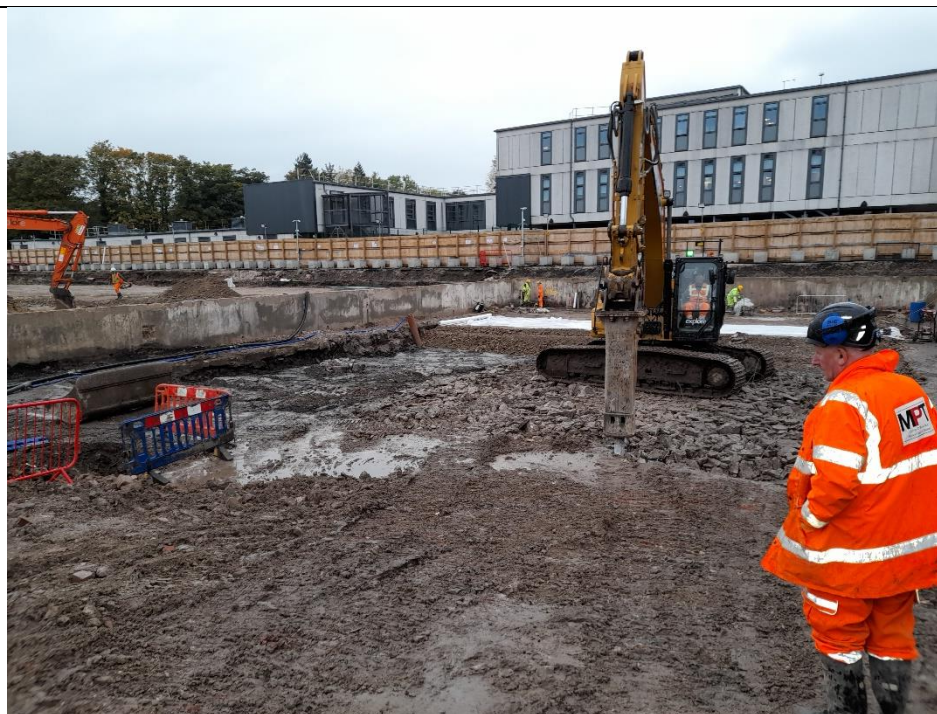
**Photograph 12:** Concrete breaking out towards the south of the basement area. Photograph taken facing the north on the 20/10/2021.

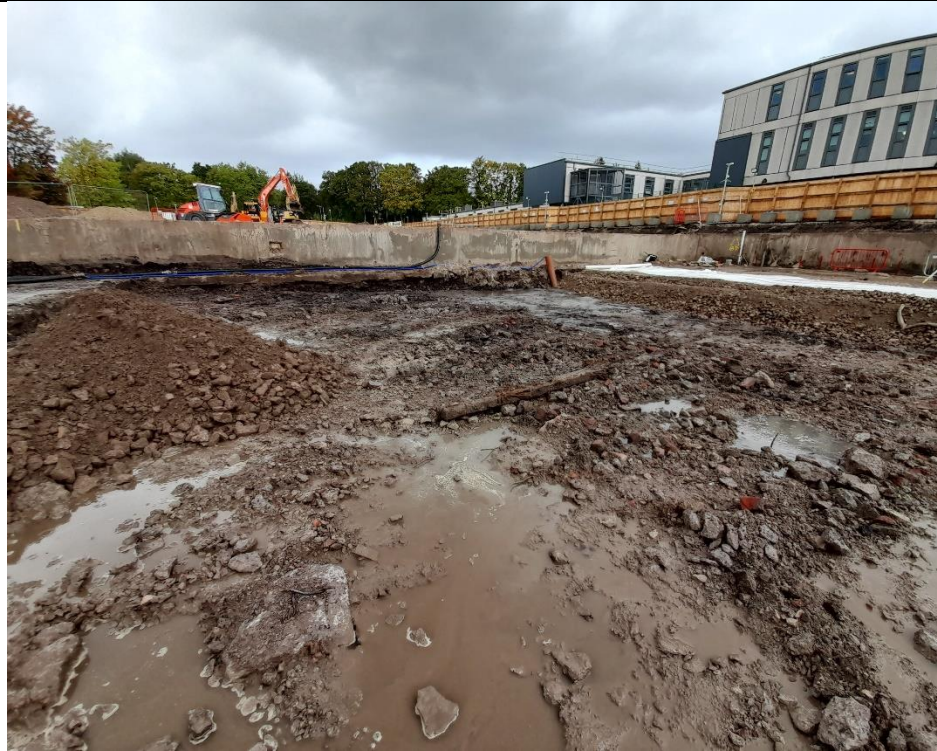
**Photo 13:** Excavated area in the centre of the basement area. Photograph taken facing the north-west on 20/10/2021.

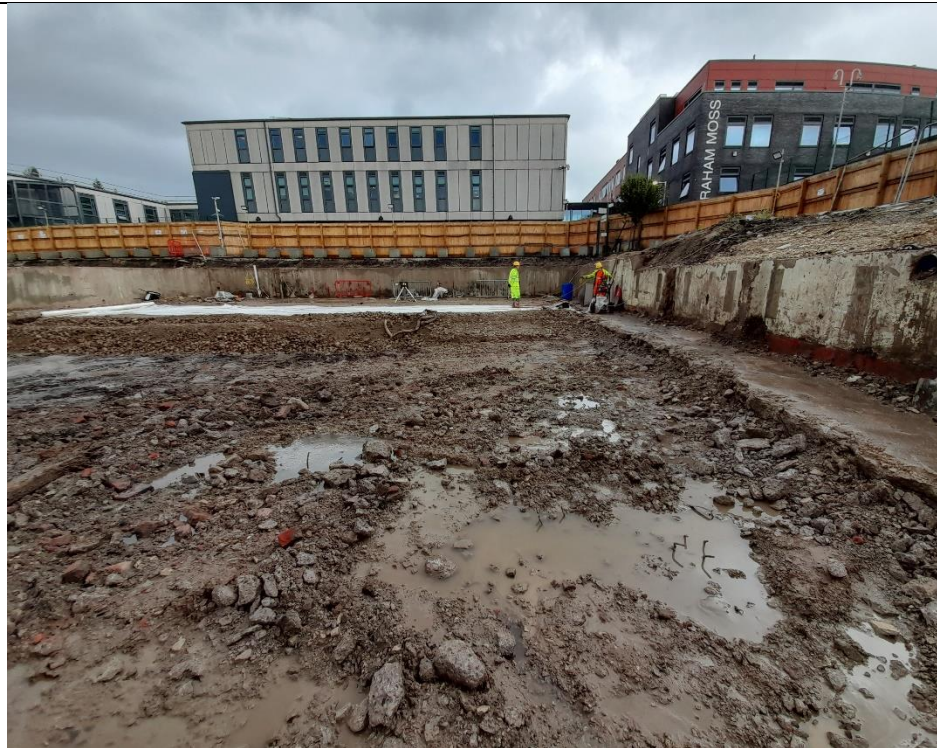
**Photo 14:** Excavation within the centre of the basement area with visible walls around the basement perimeter. Photograph taken facing the north / north-east on 20/10/2021.

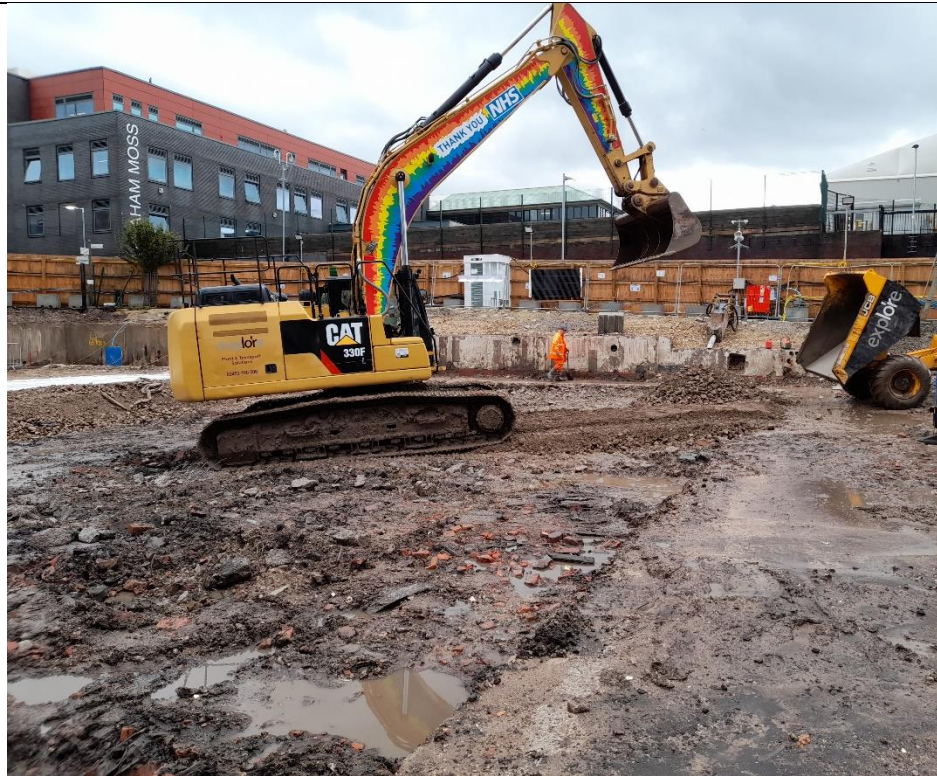
**Photo 15:** Excavation taken to the slab where VS17 was collected. LR01/LR02 was collected from the area underneath the slab (right of the photograph). Photograph taken facing the east on 20/10/2021.

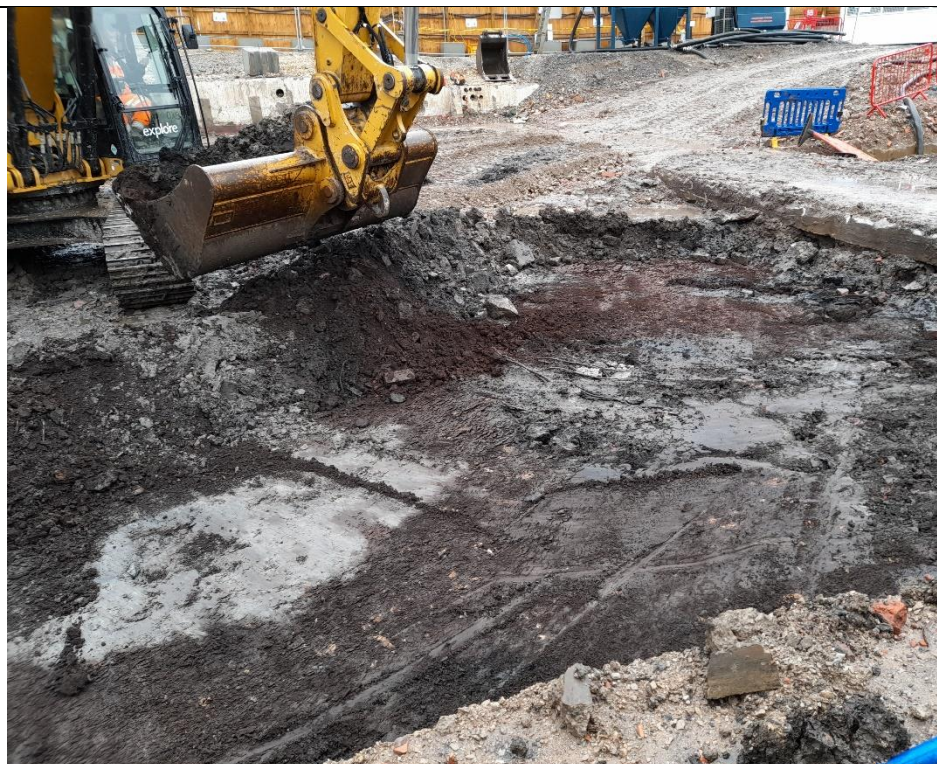
**Photo 16:** Ground conditions north and north-west of the previously encountered (August 2021) ground contamination. Photograph taken facing the south-east on 20/10/2021.

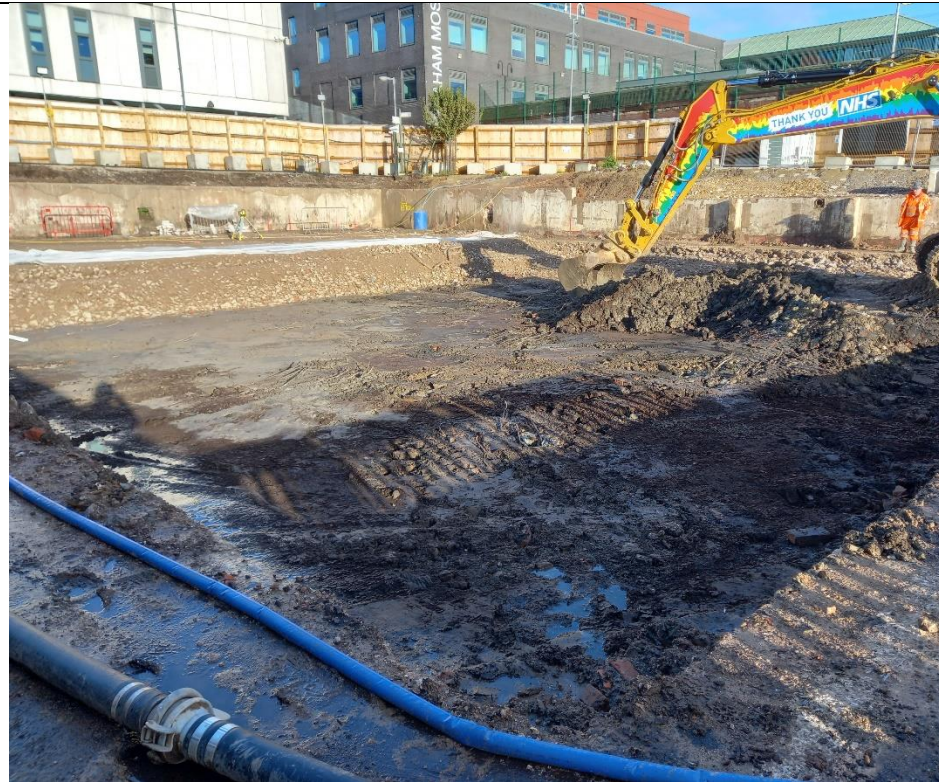
**Photo 17:** Excavation in the centre of the basement area (Zone D). Photograph taken facing the north-east on 20/10/2021.

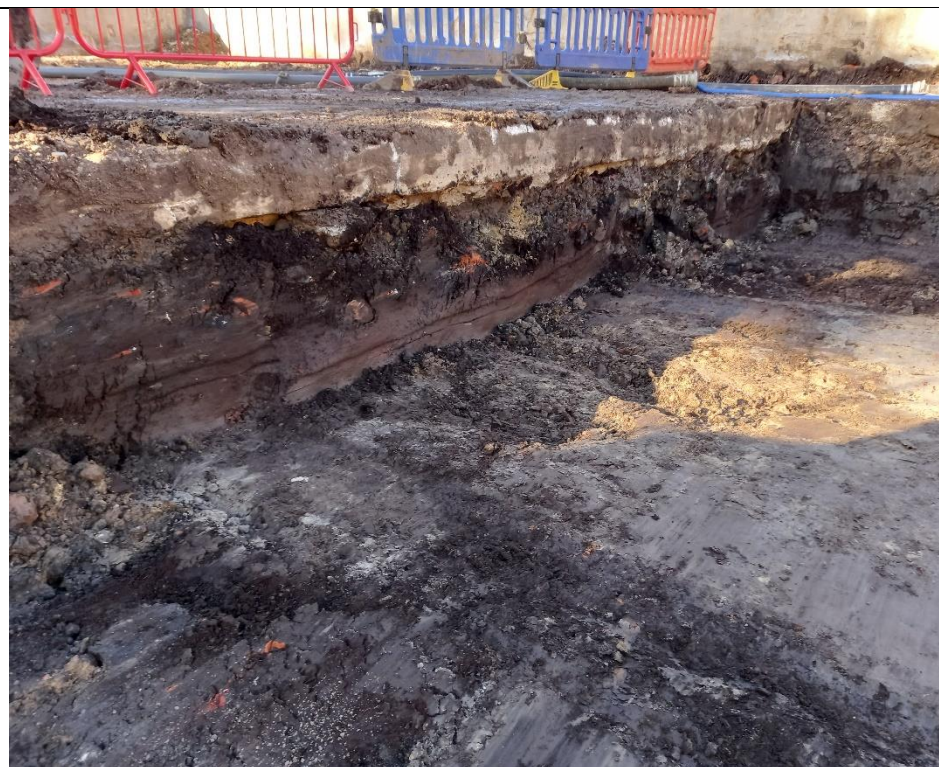
**Photo 18:** Zone D - Ground conditions approximately 1m north of the prior encountered contamination (August 2021). Ground prior to being lined and backfilled. Photograph taken facing the west on 21/10/2021.

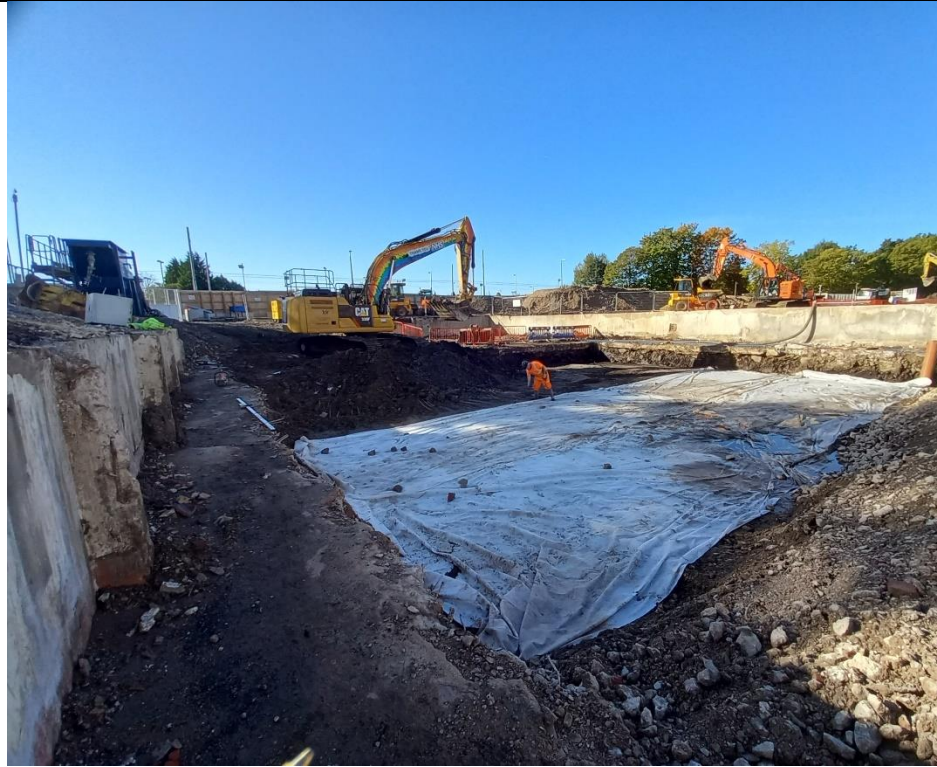
**Photo 19:** Centre of the basement area excavation lined with a geotextile. Photograph taken facing the south / south-west on 21/10/2021.

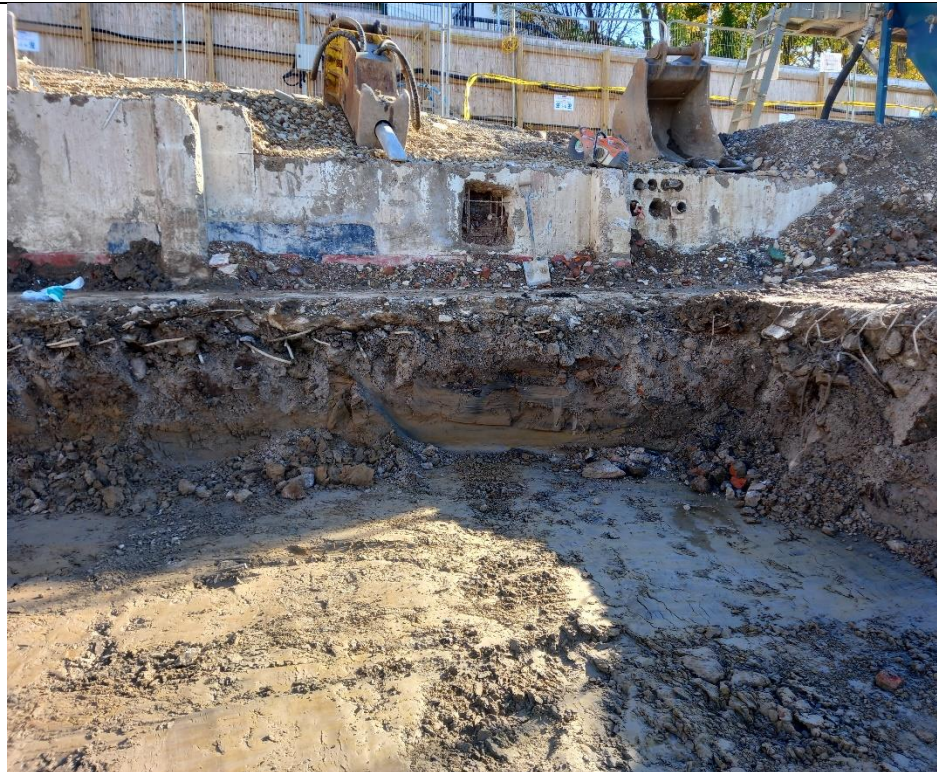
**Photo 20:** View of the ground conditions towards the east of the basement area. Photograph taken facing the east on 21/10/2021.

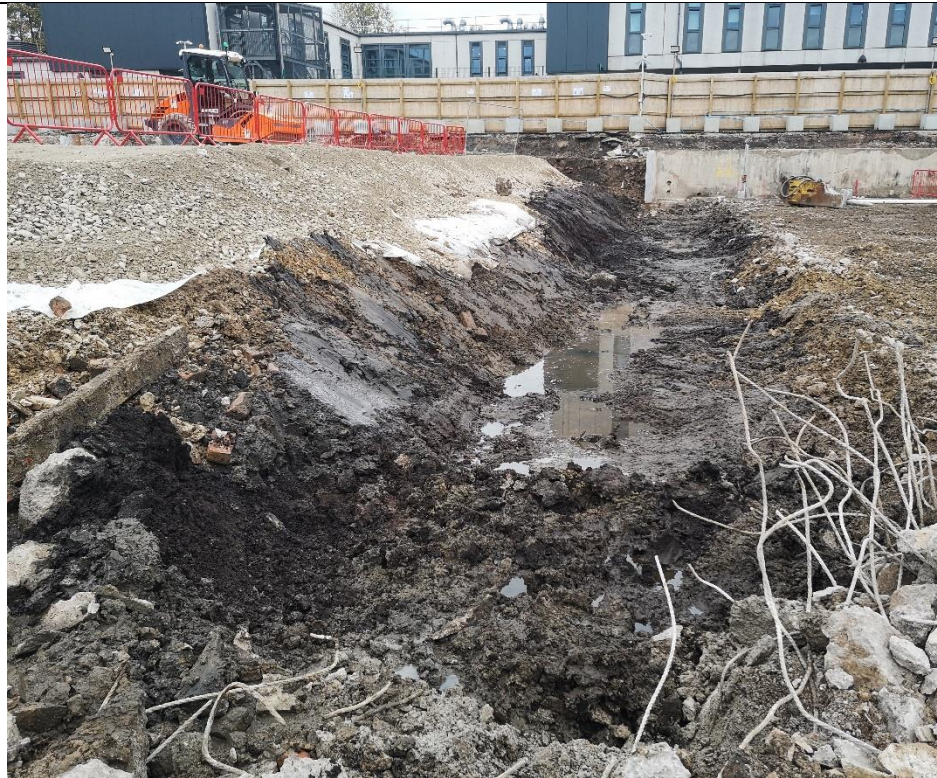
**Photo 21:** View of the ground conditions beneath the removed western basement wall. Photograph taken facing the north on 26/10/2021.

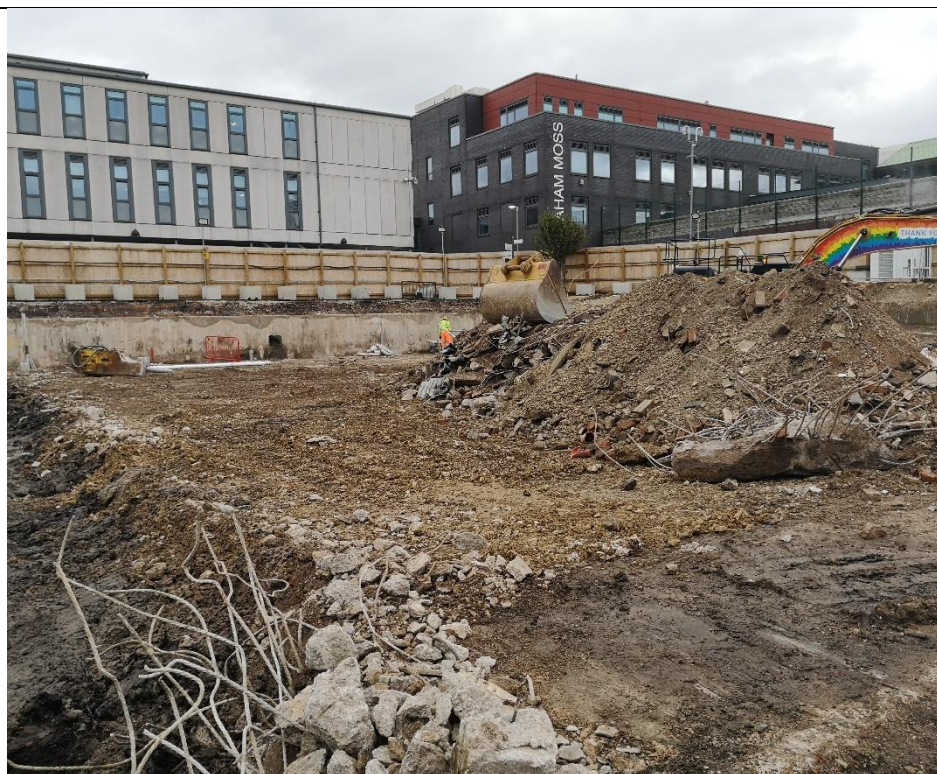
**Photo 22:** Temporarily stockpiled basement arising at the centre of the basement area. Photograph taken facing the north-east on 26/10/2021.

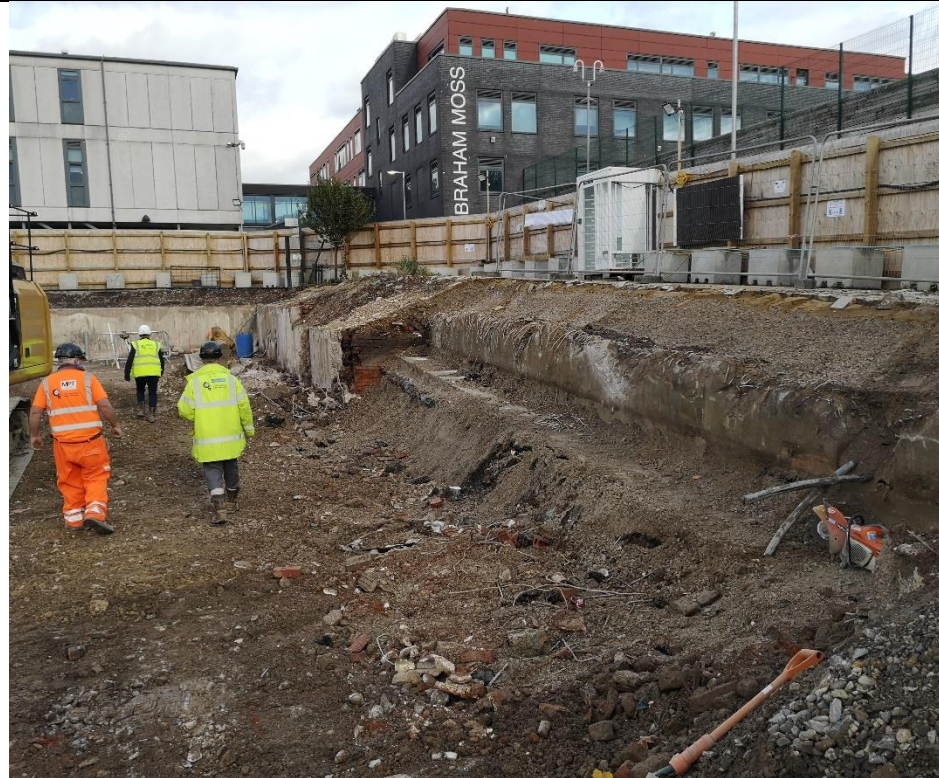
**Photo 23:** View of the removed eastern basement walls within the basement area. Photograph taken facing the north-east on 26/10/2021.

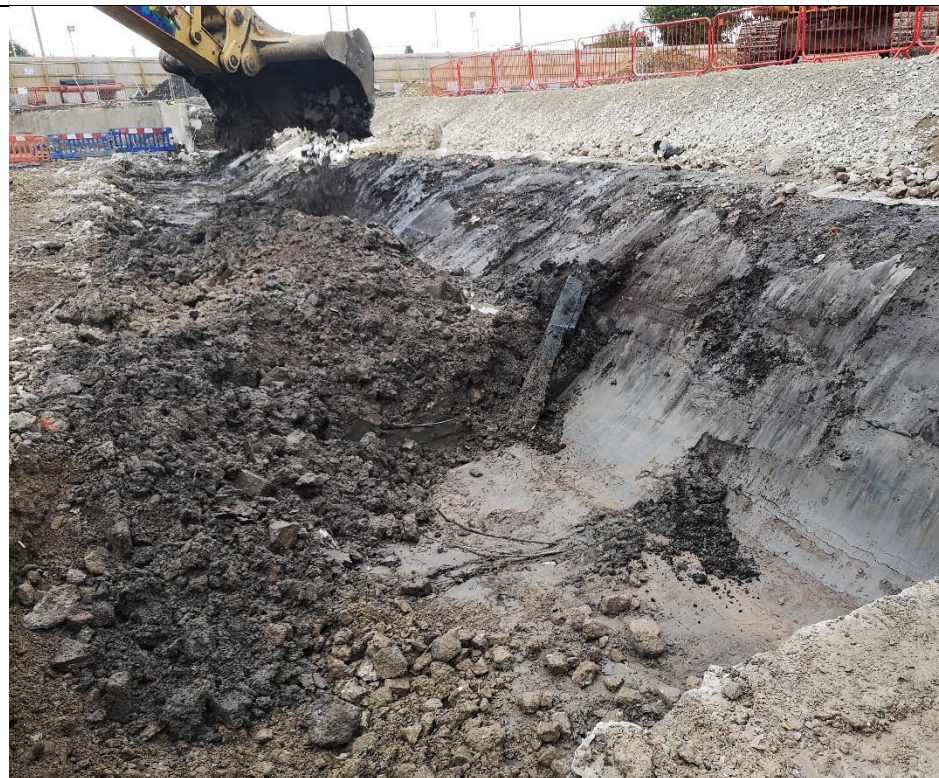
**Photo 24:** Excavation in the north-west of the basement area to allow for a new access ramp to the basement. Photograph taken facing the south / south-west on 26/10/2021.

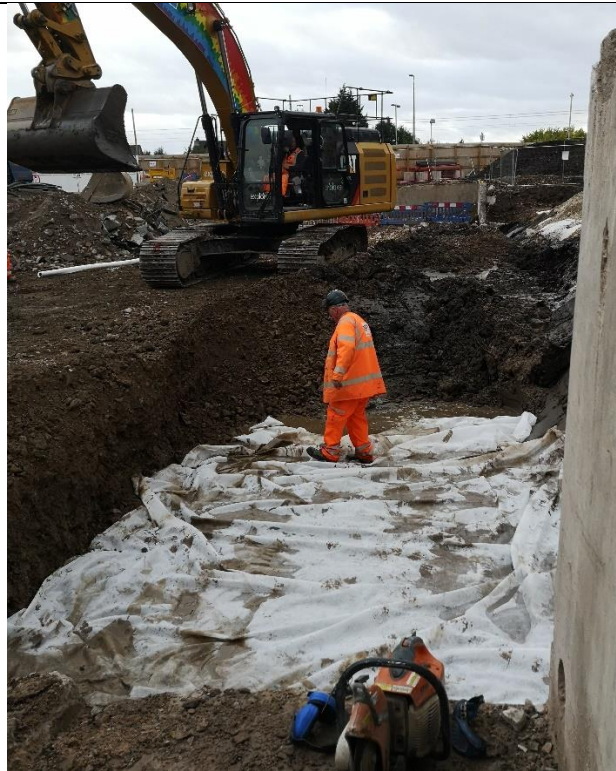
**Photo 25:** The new ramp excavation was lined with a geotextile on the 26/10/2021. Photograph taken facing the south.

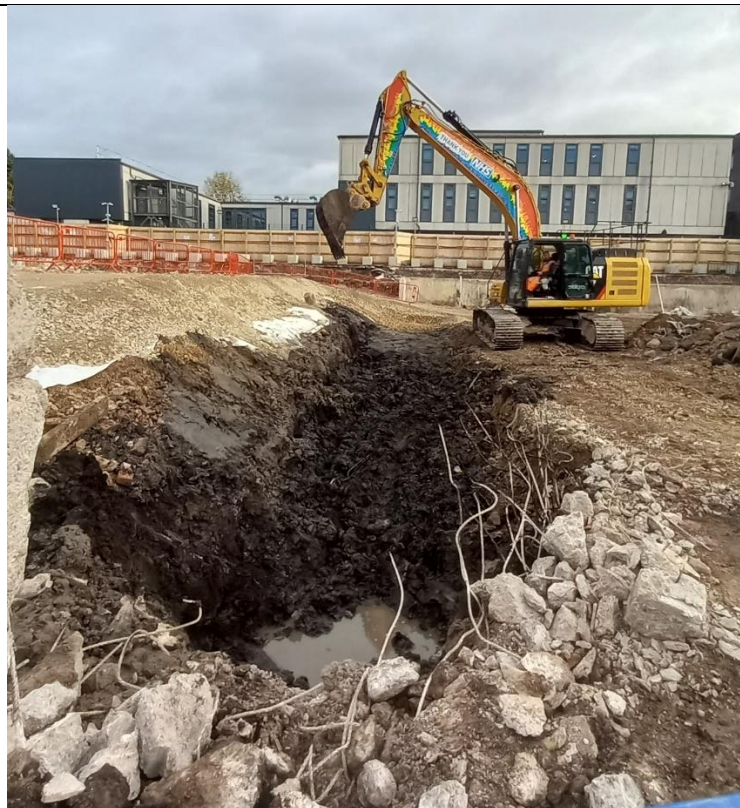
**Photo 26:** Ground conditions beneath and in proximity to the western basement wall following removal. Photograph taken facing the north / north-east on 27/10/2021.

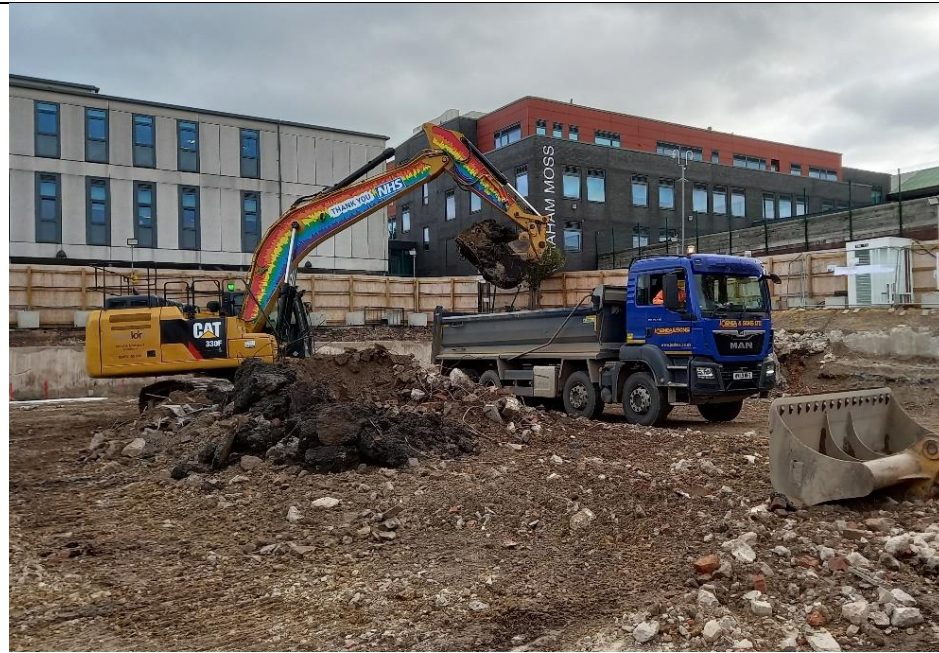
**Photo 27:** Soil arisings loaded for off-site disposal straight from the basement area (by J O'Shea & Sons Ltd). Photograph taken facing the north-east on 27/10/2021.

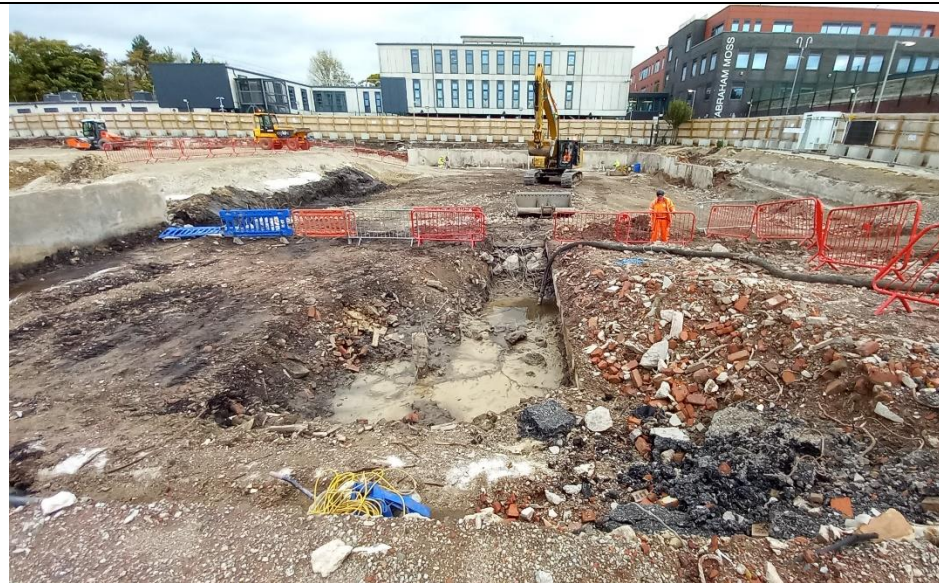
**Photo 28:** Water had been pumped out of the pit towards the south of the basement to allow for works within this area. Photograph taken facing the north / north-east on 27/10/2021.

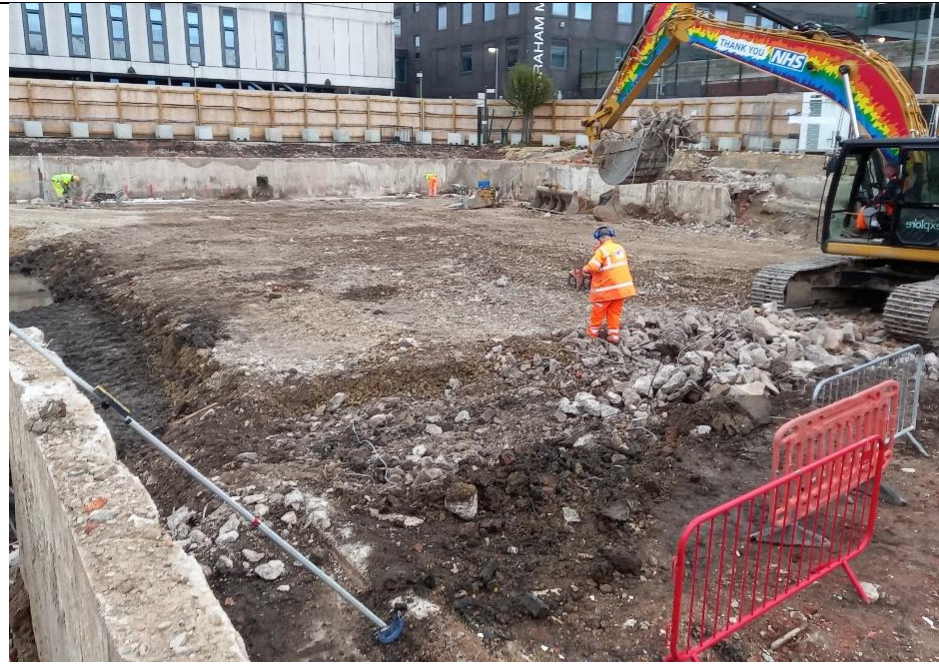
**Photo 29:** Breaking out of concrete strip towards the south-west of the basement. Photograph taken facing the north-east on 27/10/2021.

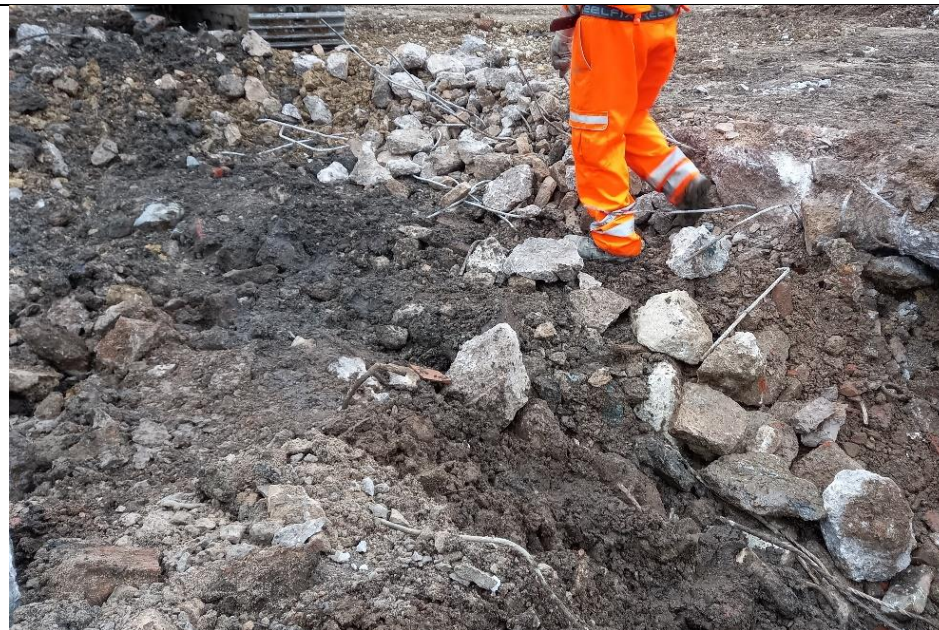
**Photo 30:** View of the ground conditions beneath the concrete slab following the removal towards the south-west of the basement. Photograph taken facing the north-east on 27/10/2021.

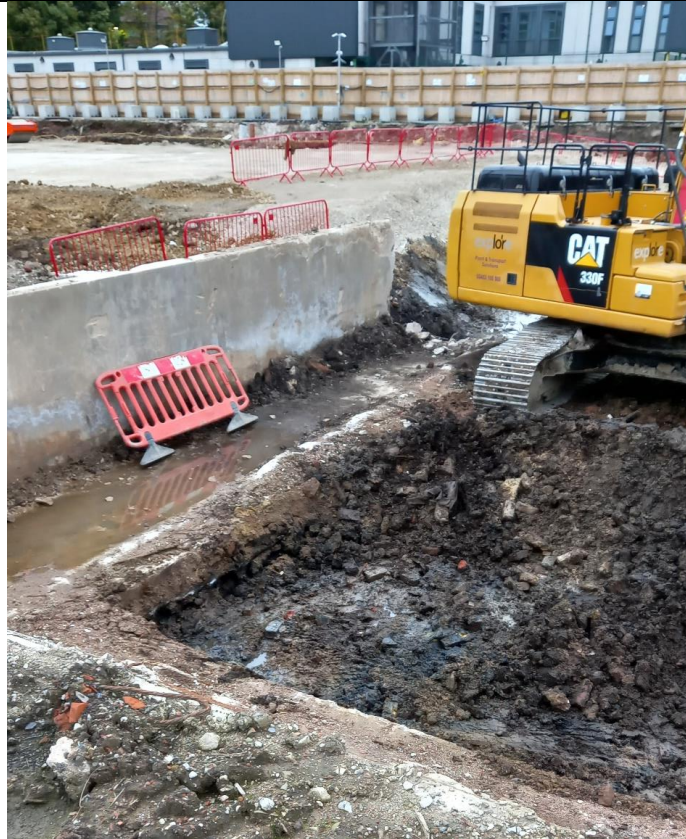
**Photo 31:** Ground conditions in the south-western corner (Zone E) of the Basement Area; with notable organic / foul odours. Photograph taken facing the north on 27/10/2021.

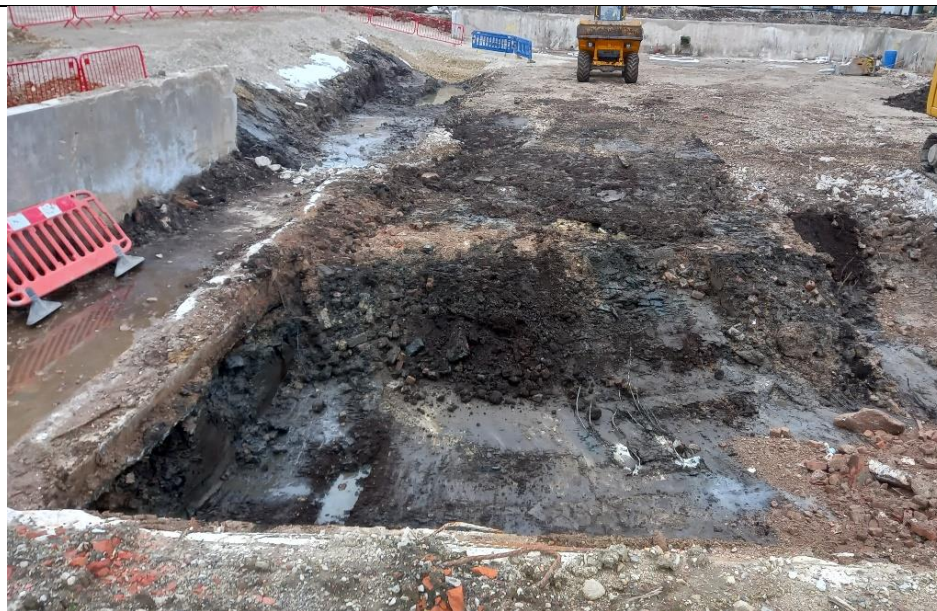
**Photo 32:** : View of excavated Zone E (in the south-west of the Basement Area). Photograph taken facing the north-east on 27/10/2021.

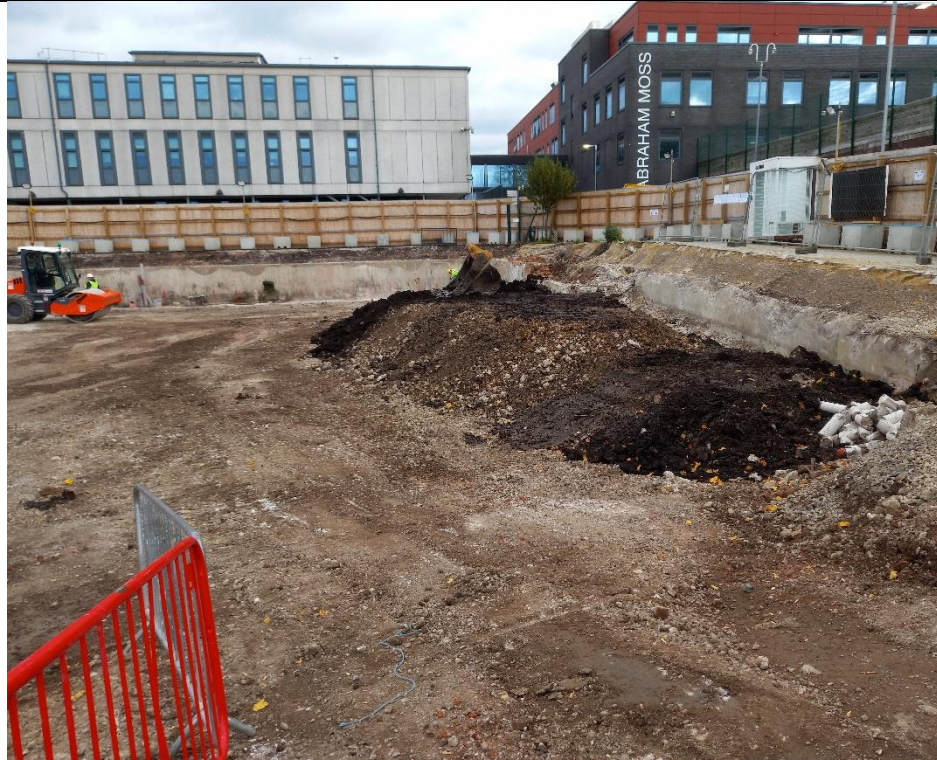
**Photo 33:** Arisings from Zone E temporarily stockpiled towards the east basement boundary. Photograph taken on 28/10/2021.
