| <b>Project Name</b><br><b>Project Number</b><br><b>Title</b><br><b>Site</b><br><b>Client</b><br><b>Date</b> | Abraham Moss Leisure Centre<br>1620005164-001<br>Watching Brief Photographic Record<br>Abraham Moss Leisure Centre, Crescent Road, Manchester, M8 5UF<br>Laing O'Rourke<br>December 2021 |

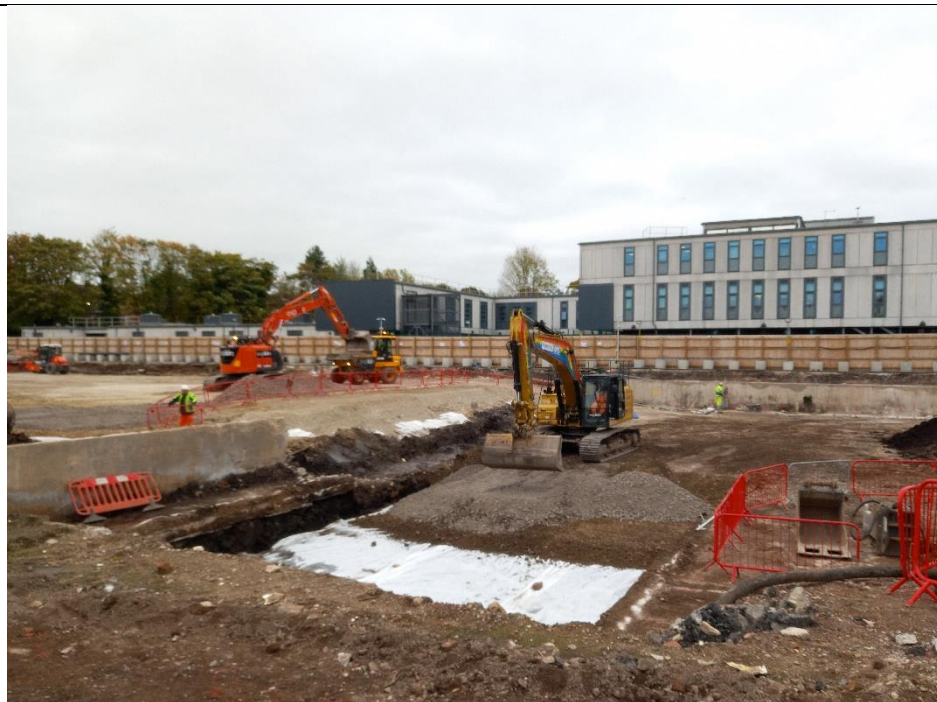
**Photo 34:** The excavation in Zone E lined and backfilled with imported arisings. Photograph taken facing the north on 28/10/2021.

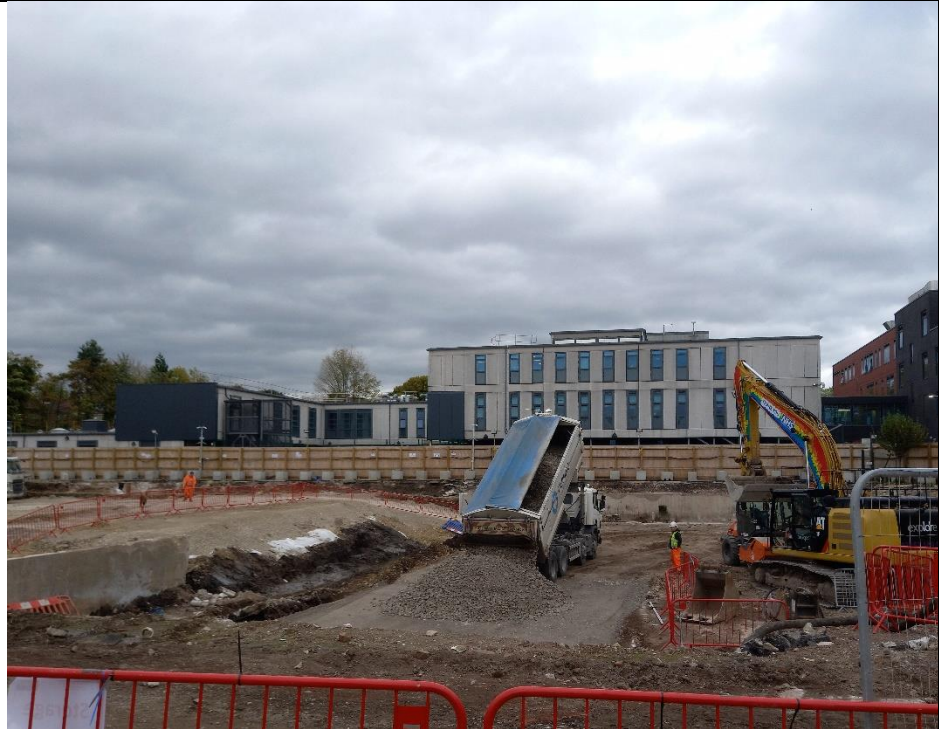
**Photo 35:** Imported aggregates used for backfill in the southern area of the basement. Photograph taken facing north / north-east on 28/10/2021.

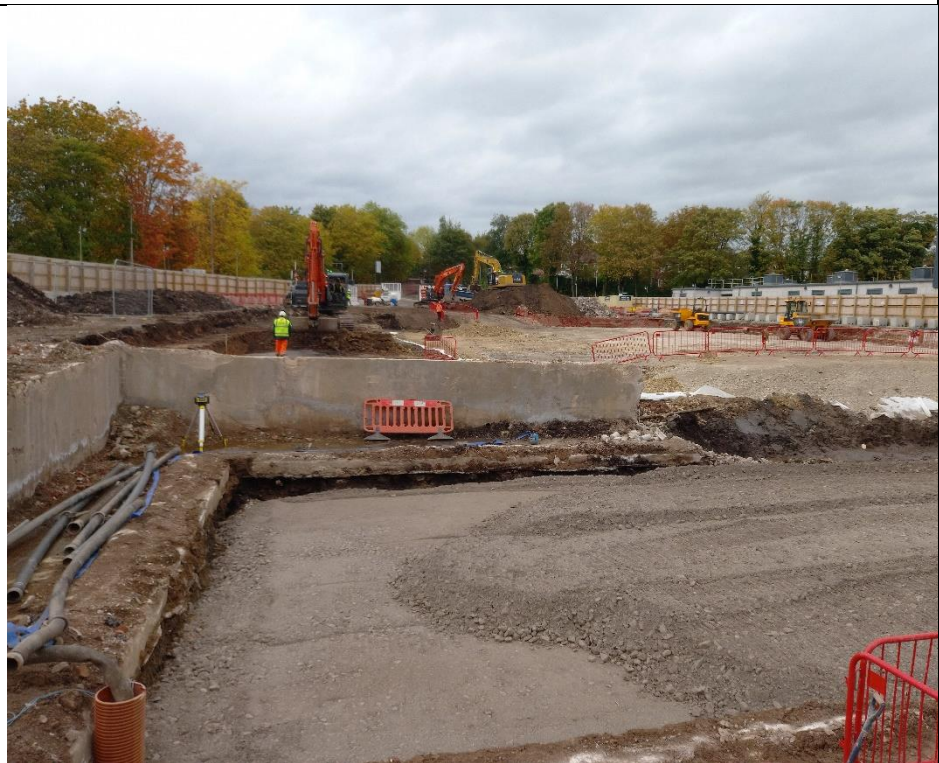
**Photo 36:** Backfill spread across Zone E in layers. Photograph taken facing the west on 28/10/2021.

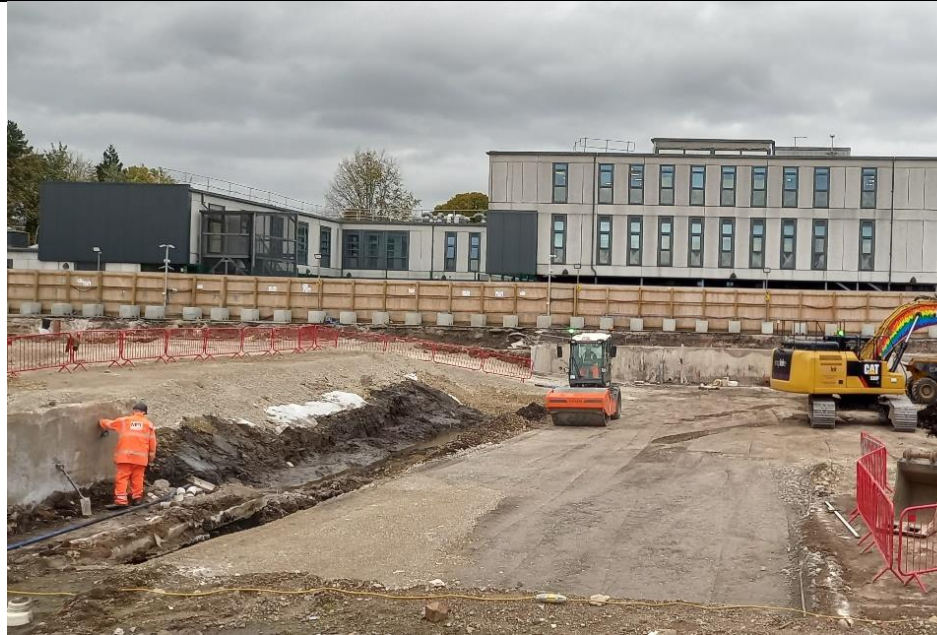
**Photo 37:** View of the basement area facing the north / north-east 28/10/2021.

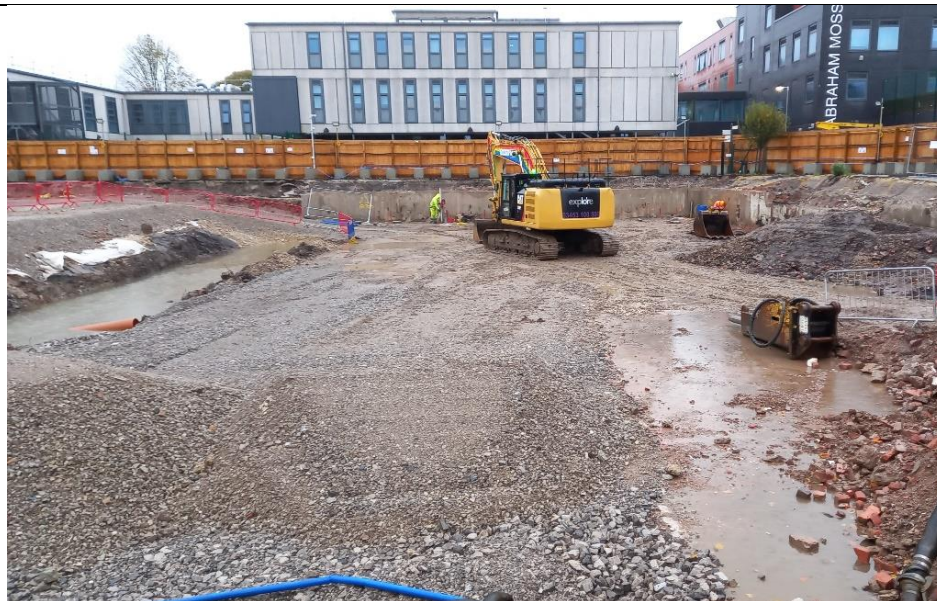
**Photo 38:** View of the basement area facing the north-east on 01/11/2021.

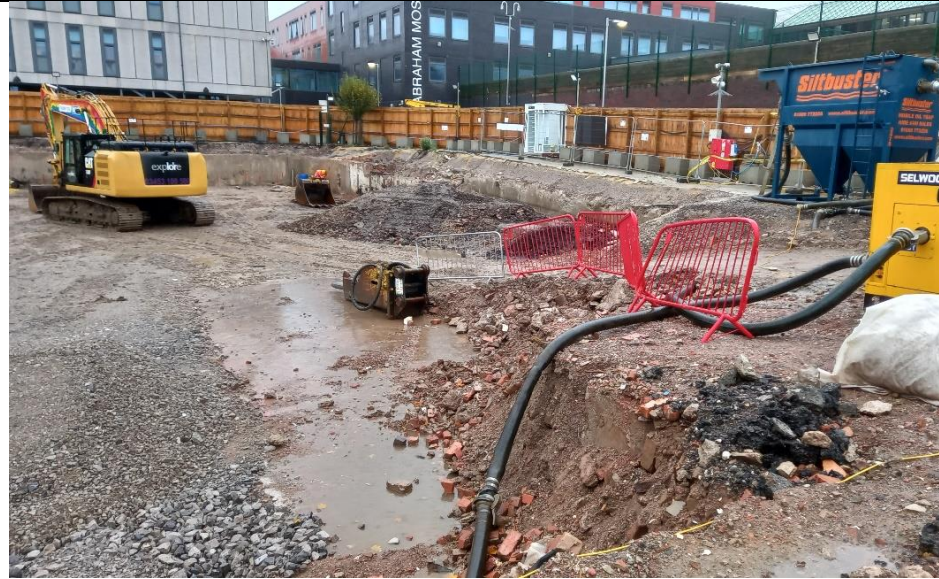
**Photo 39:** View of the basement area facing the north-east and east on 01/11/2021.

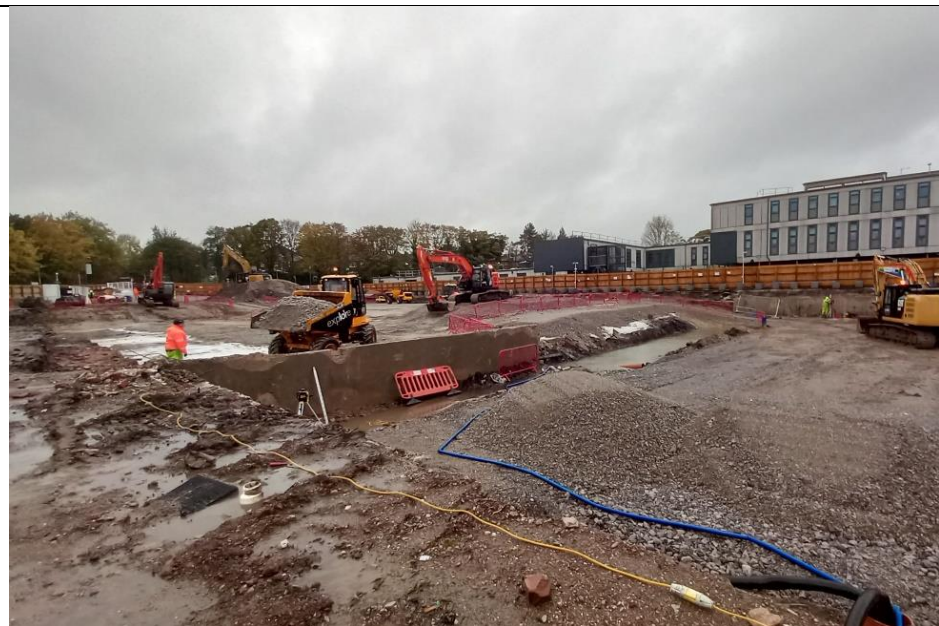
**Photo 40:** View of the basement area facing north and north-west on 01/11/2021.

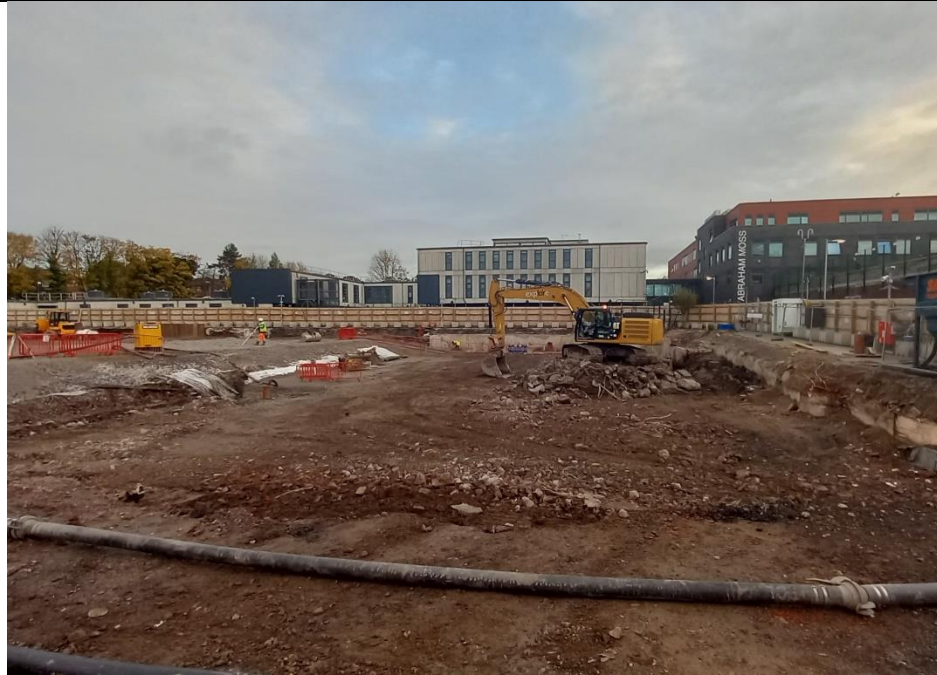
**Photo 41:** View of the basement area (beneath the concrete slab). Photograph taken facing the north and north-east on 09/11/2021.

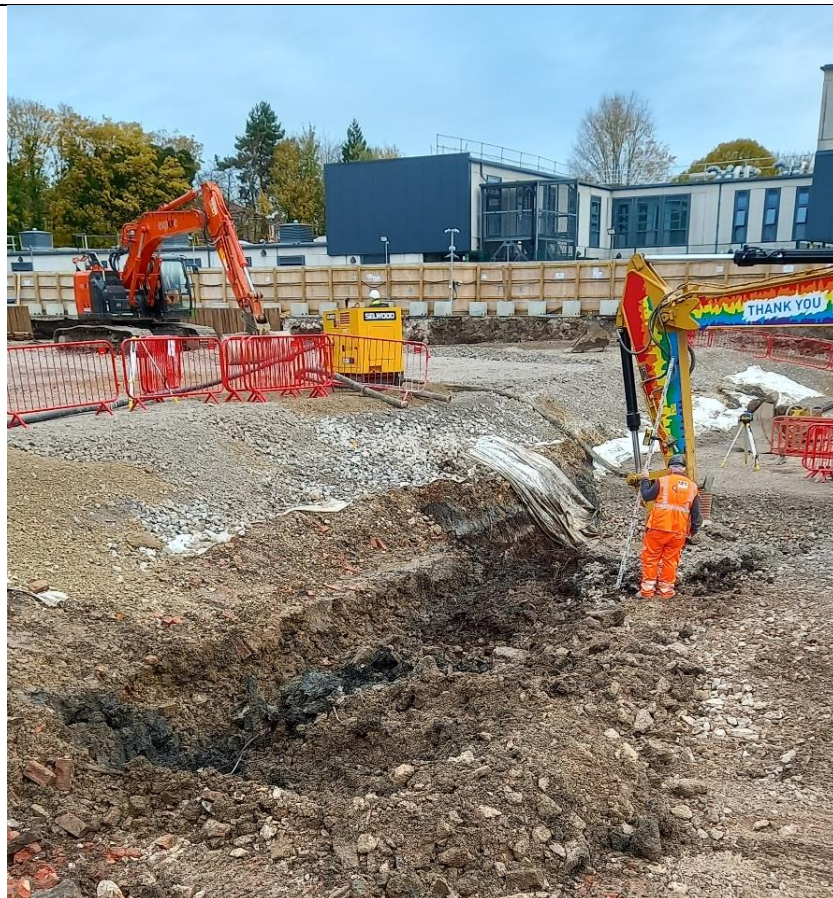
**Photo 42:** Ground conditions beneath the former concrete slab in the west / south-west of the basement. Photograph taken facing north on 09/11/2021.
