# Television Post-Construction Survey Report

Crown Street Phase 2

Renaker Build Limited

May 2023

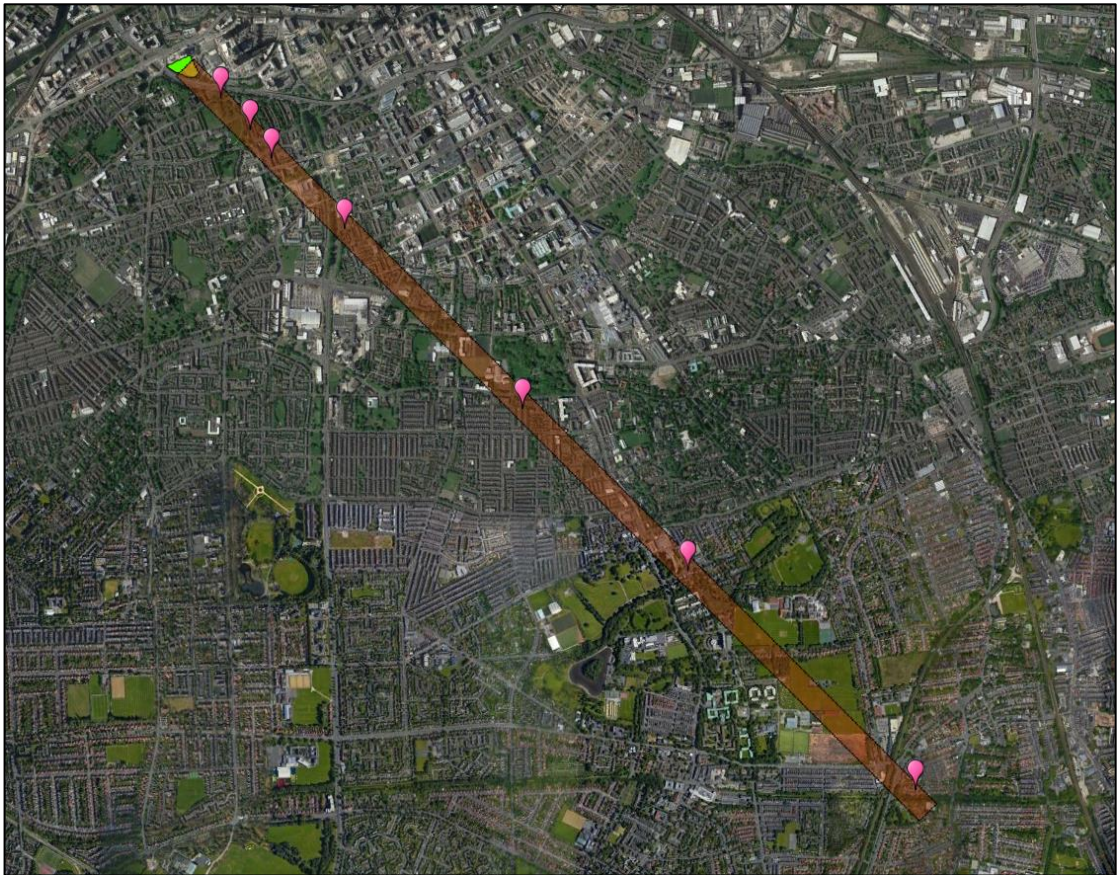
Figure 5 Survey locations

Figure 5 on the following page shows the survey locations overlaid onto aerial photography with the icons showing where television measurements were taken. The shadow and reflection zones are also shown. Survey locations were chosen pre-survey (within the shadow zone) however safe and available access influenced the specific position on the day. The locations on the following page show the actual survey locations. The coordinates of these points can be found in Appendix A.

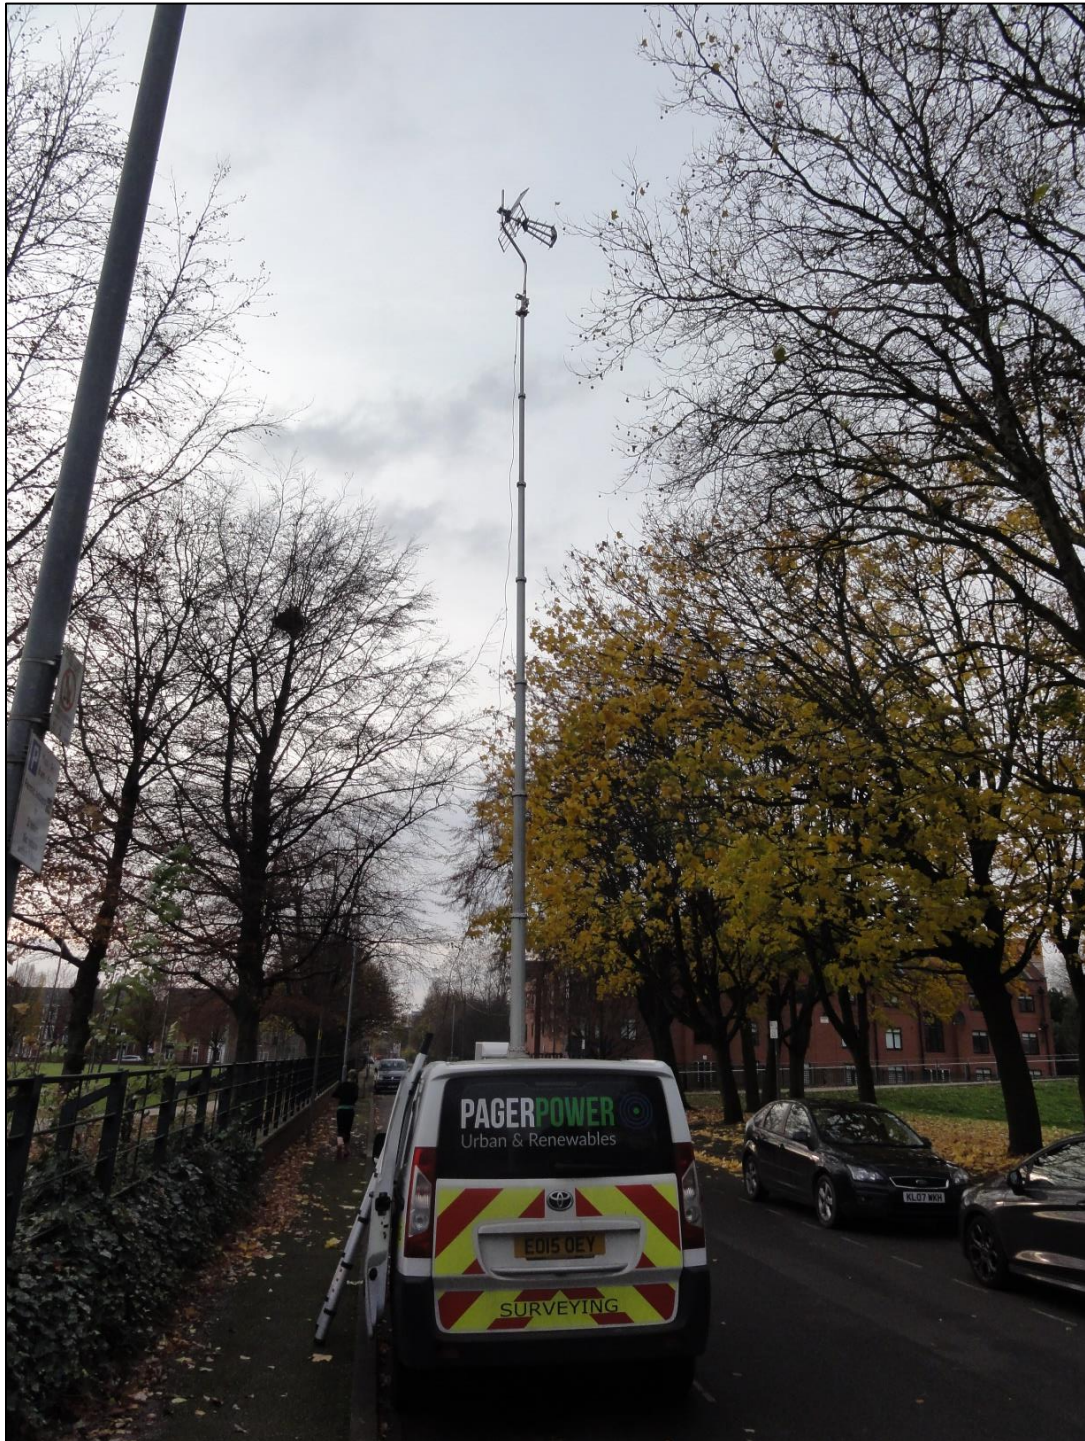
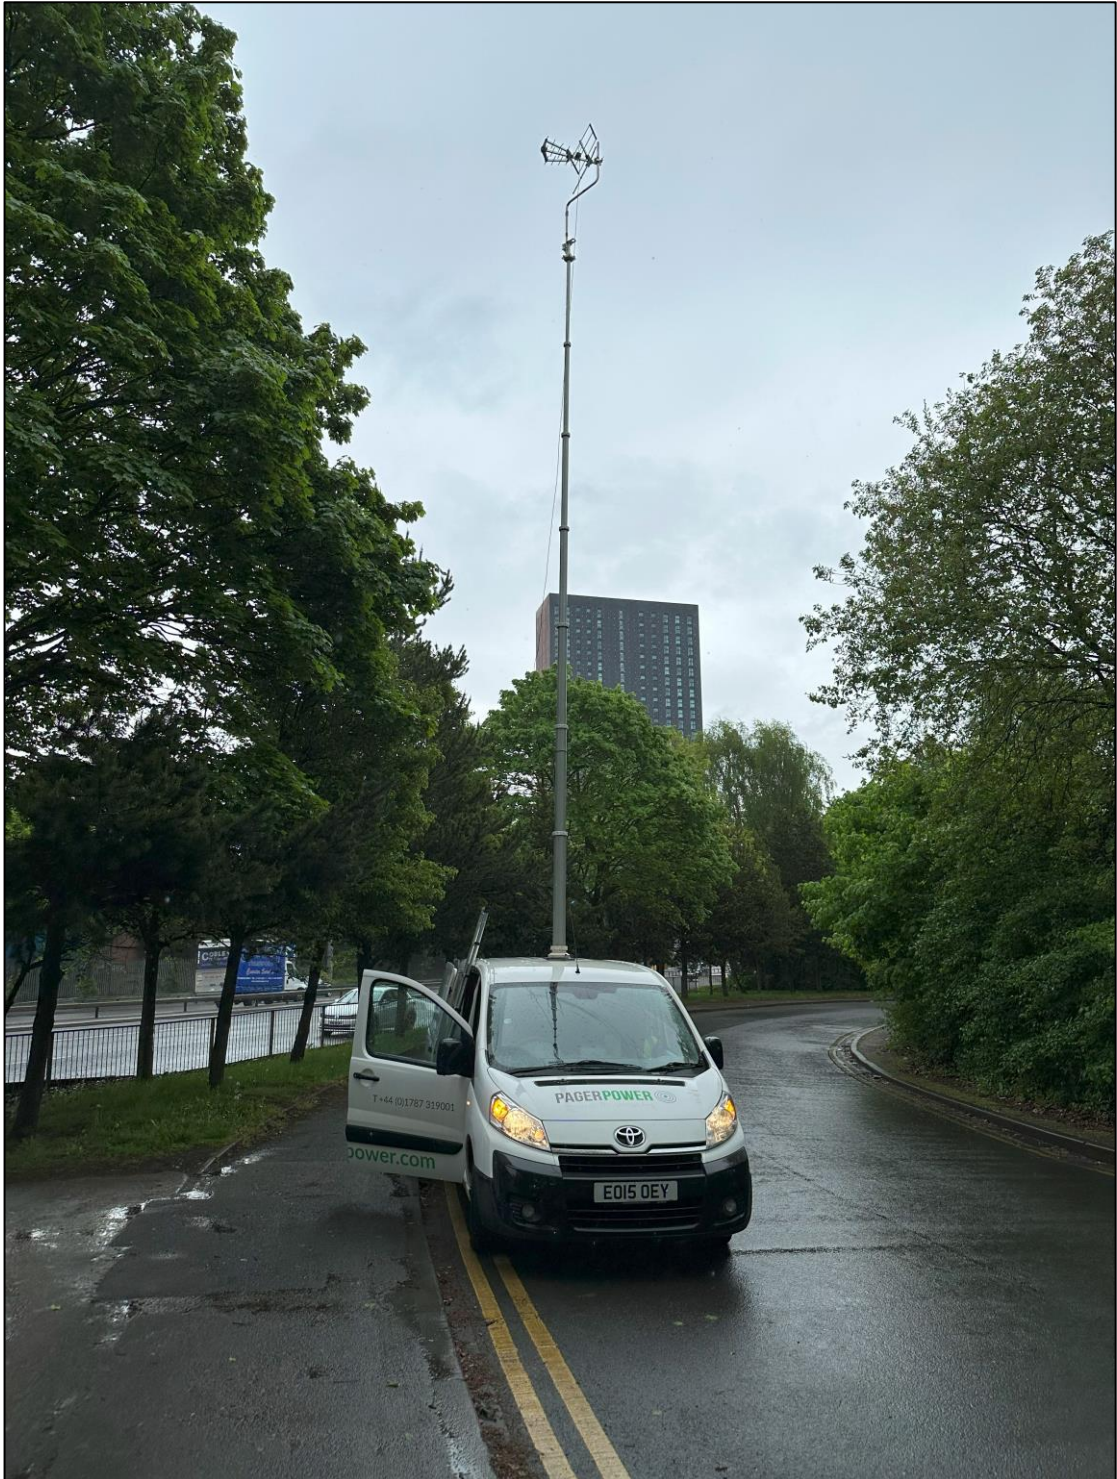
| Location | Average Measured Signal Strength (dB) | Remarks | High Level Conclusion |
|---|---|---|---|
| 1 | <p><b><u>Baseline:</u></b></p> <p>Main TV MUX: 45<br/>(Moderate)</p> <p>Local TV MUX: 37<br/>(Moderate)</p> <p><b><u>Post-Construction:</u></b></p> <p>Main TV MUX: 54.8<br/>(Good)</p> <p>Local TV MUX: 19.3<br/>(Low)</p> | <p>Aerials were not observed at this survey location.</p> <p>No satellite dishes observed.</p> <p><b><u>Baseline:</u></b> One main and two local multiplexes were not received at this location. Another local multiplex showed intermittent interference. The remaining multiplexes displayed fine picture and audio quality, with signal fluctuations of less than 1dB and no signs of interference.</p> <p><b><u>Post-Construction:</u></b> One local multiplex was not received at this location. The remaining local multiplex and all main multiplexes displayed fine picture and audio quality, with signal fluctuations of less than 0.6dB and no signs of interference.</p> | <p>The survey location is within 200m of the closest of the Proposed Development and in front of the site relative to the Winter Hill transmitter. This location has therefore been undertaken as a reference location for baseline conditions with respect to the other survey locations within the shadow zone.</p> <p><b><u>The TV signal strength at this location has mostly improved. There is no change in picture or audio quality and the signal strength of the main multiplexes is good.</u></b></p> |

Location 1 (baseline survey)

*Location 1 (post-construction survey)*

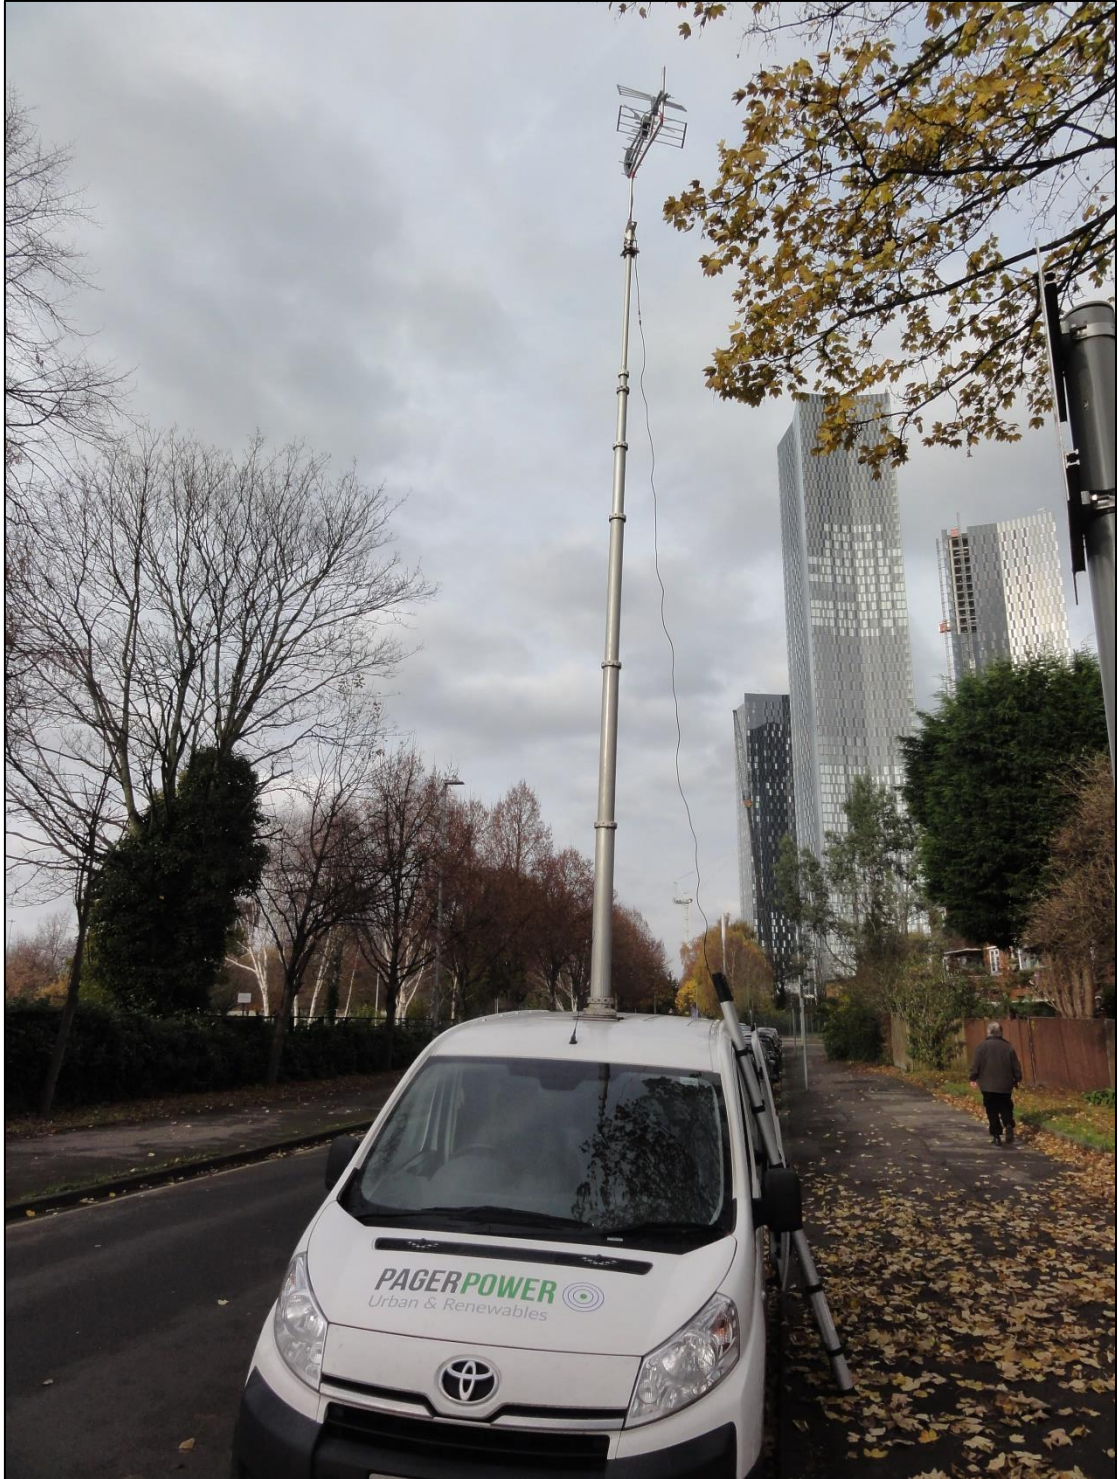
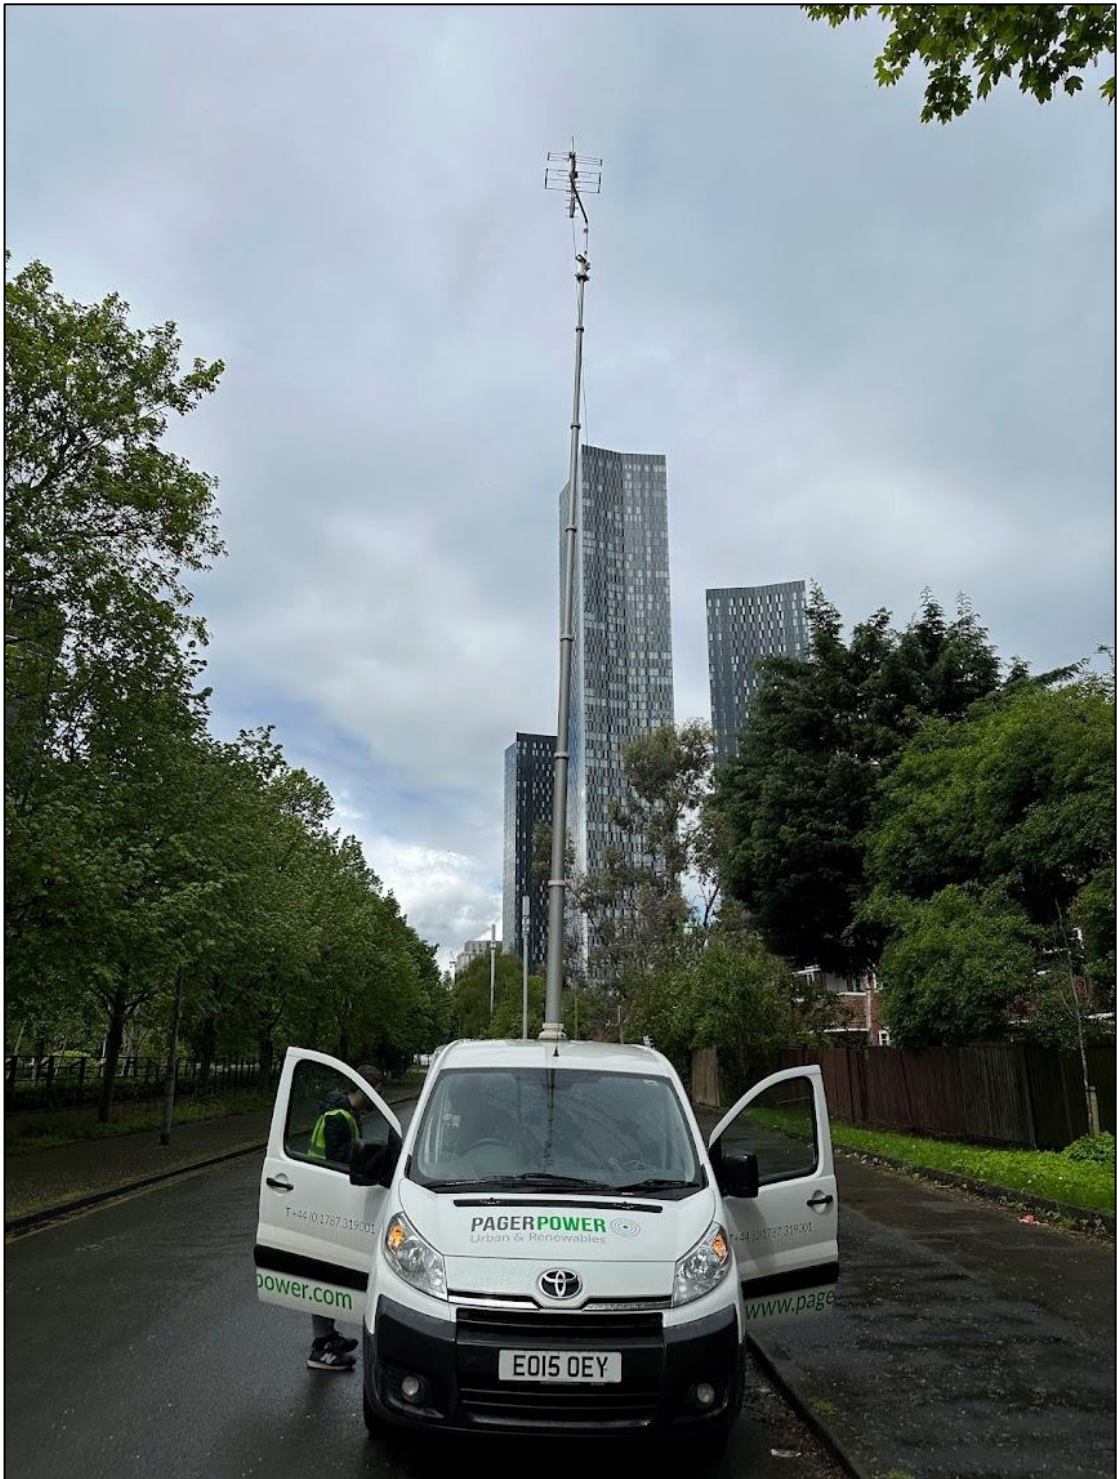
| Location | Average Measured Signal Strength (dB) | Remarks | High Level Conclusion |
|---|---|---|---|
| 2 | <p><b><u>Baseline:</u></b></p> <p>Main TV MUX: 60 (Very Good)</p> <p>Local TV MUX: 44 (Moderate)</p> <p><b><u>Post-Construction:</u></b></p> <p>Main TV MUX: 51.45 (Good)</p> <p>Local TV MUX: 36.9 (Moderate)</p> | <p>Horizontally polarised aerials directed towards the Winter Hill transmitter and satellite dishes were observed.</p> <p><b><u>Baseline:</u></b> All main multiplexes displayed fine picture and audio quality, with signal fluctuations of less than 1dB and no signs of interference.</p> <p>One local multiplex was not decoded at this location.</p> <p><b><u>Post-Construction:</u></b> All main multiplexes displayed fine picture and audio quality, with signal fluctuations of less than 0.6dB and no signs of interference.</p> <p>One local multiplex was not decoded at this location.</p> | <p>The survey location is within 400m of the closest of the Proposed Development and within its shadow zone.</p> <p><b><u>At this location, there has been a slight decrease in TV signal strength, however there is no change in picture or audio quality, and the signal strength of the main multiplexes is good.</u></b></p> |

Location 2 (baseline survey)

Location 2 (post-construction survey)

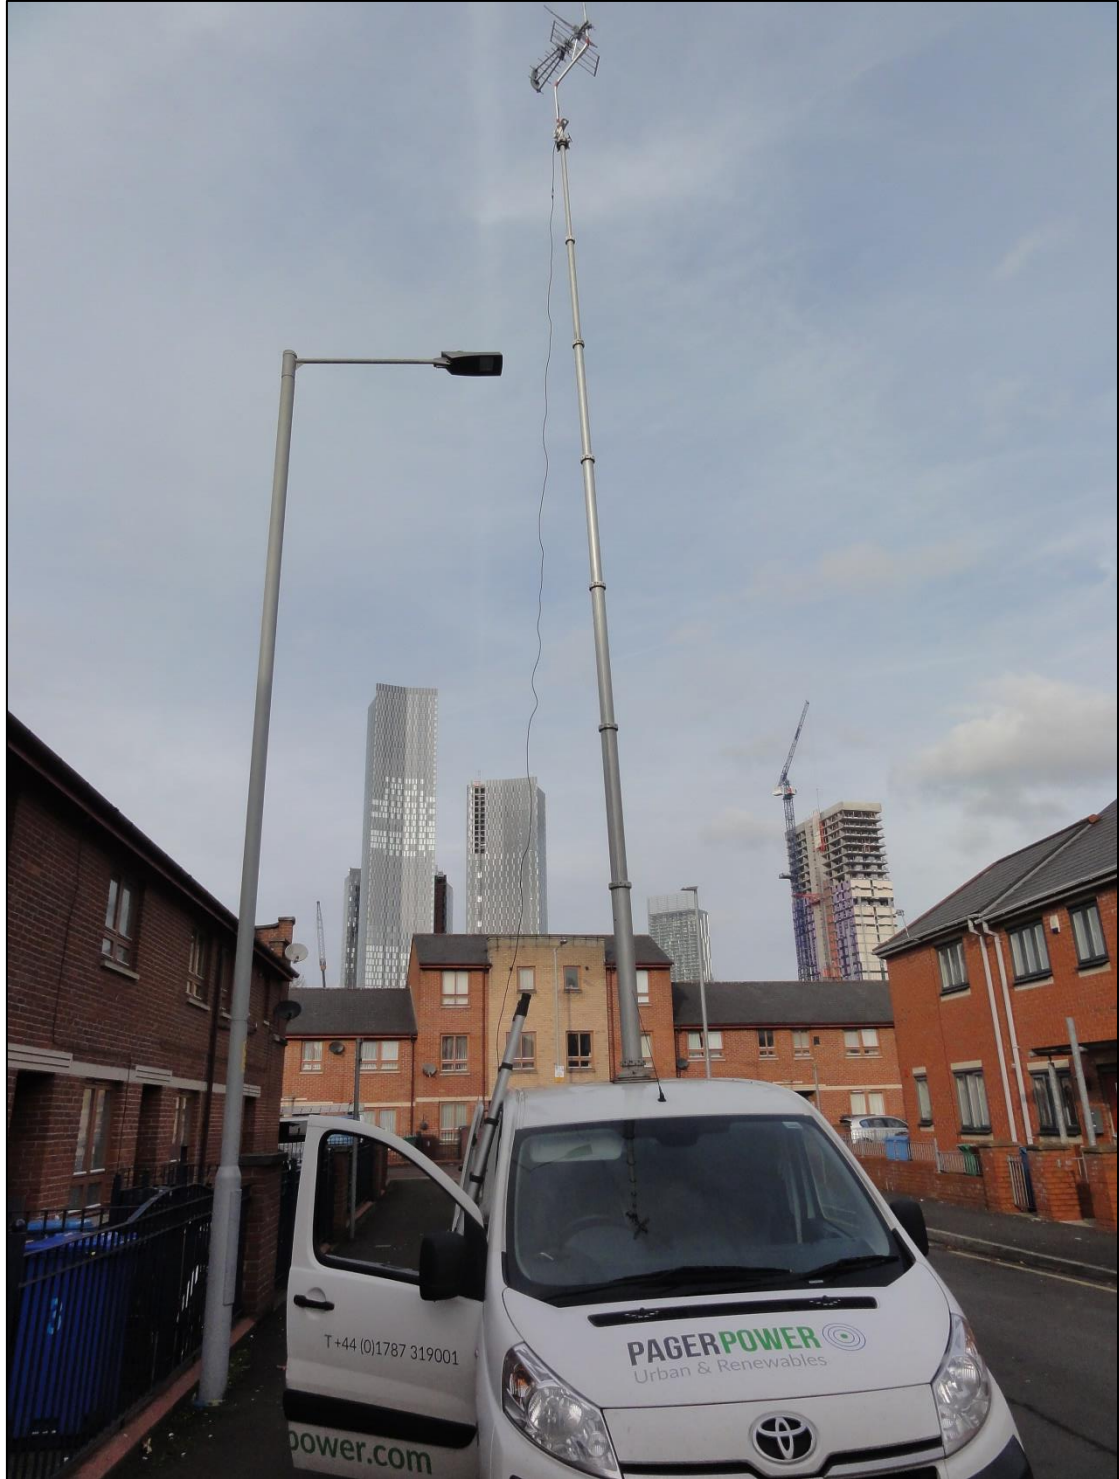
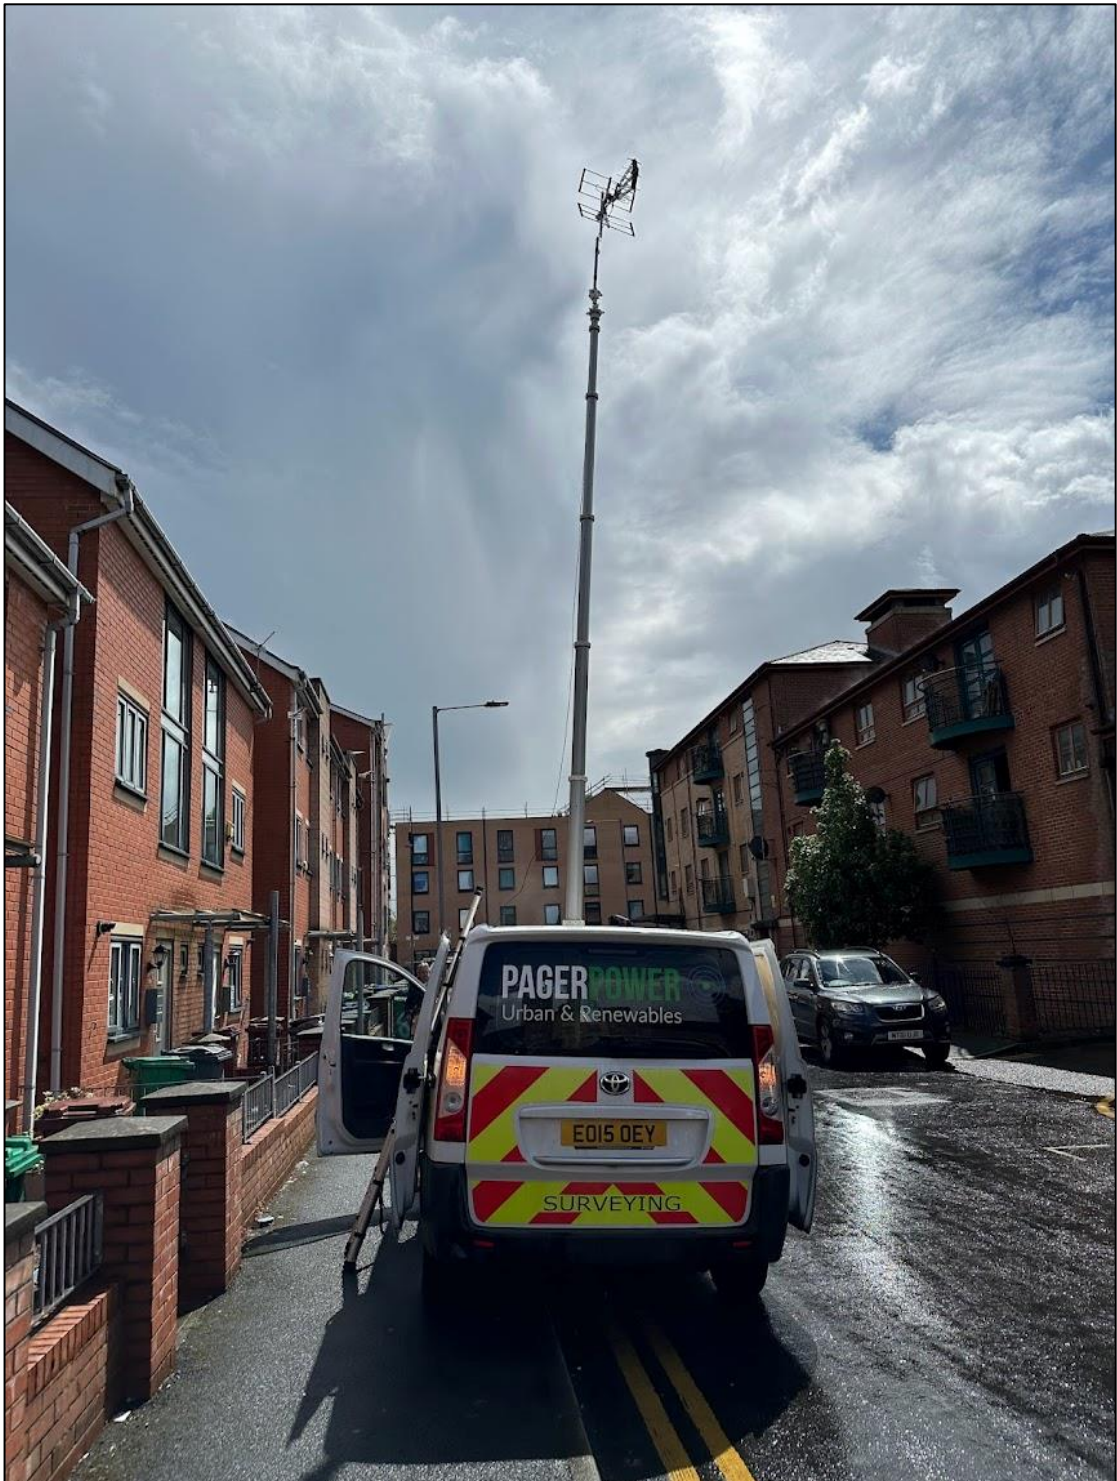
| Location | Average Measured Signal Strength (dB) | Remarks | High Level Conclusion |
|---|---|---|---|
| 3 | <p><b><u>Baseline:</u></b></p> <p>Main TV MUX: 51 (Good)</p> <p>Local TV MUX: 41 (Moderate)</p> <p><b><u>Post-Construction:</u></b></p> <p>Main TV MUX: 52.1 (Good)</p> <p>Local TV MUX: 33.7 (Low)</p> | <p>Horizontally polarised aerials directed towards the Winter Hill transmitter and many satellite dishes were observed.</p> <p><b><u>Baseline:</u></b> All main multiplexes displayed fine picture and audio quality, with signal fluctuations of less than 1dB and no signs of interference.</p> <p>Two local multiplexes were not decoded at this location.</p> <p><b><u>Post-Construction:</u></b> All main multiplexes displayed fine picture and audio quality, with signal fluctuations of less than 0.6dB and no signs of interference.</p> <p>One local multiplex was not decoded at this location.</p> | <p>The survey location is approximately 500 m of the closest of the Proposed Development.</p> <p><b><u>There is no significant change in TV signal strength at this location. There is no change in picture or audio quality and the signal strength of the main multiplexes is good.</u></b></p> |

Location 3 (baseline survey)

*Location 3 (post-construction survey)*

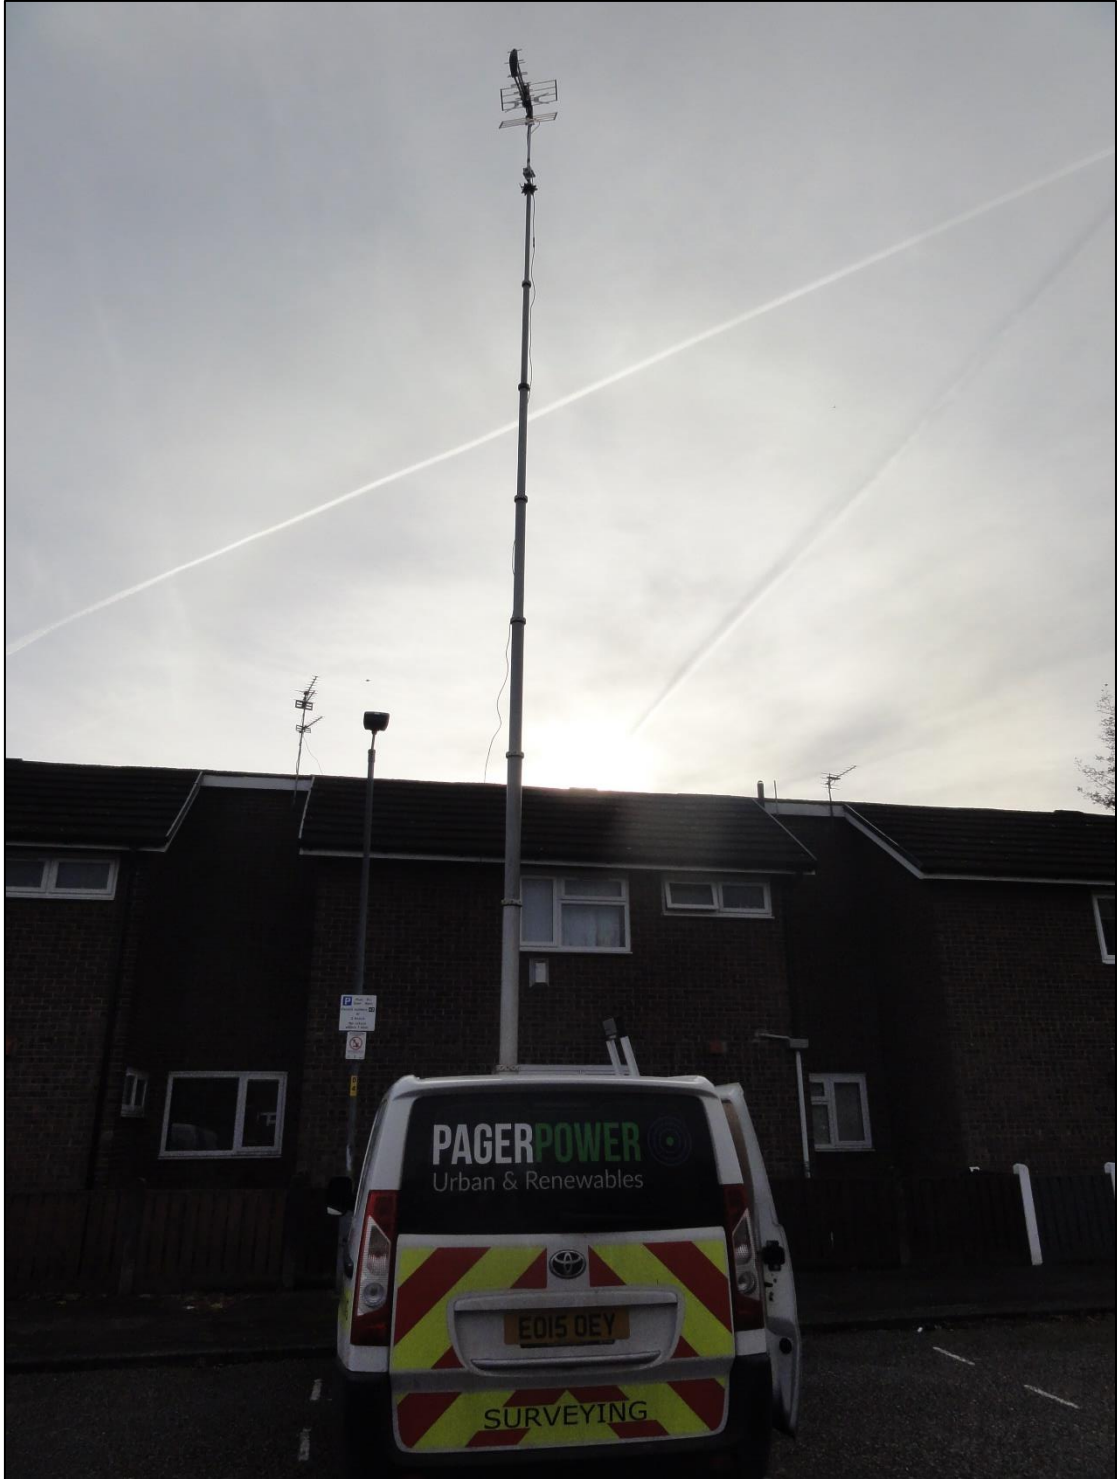
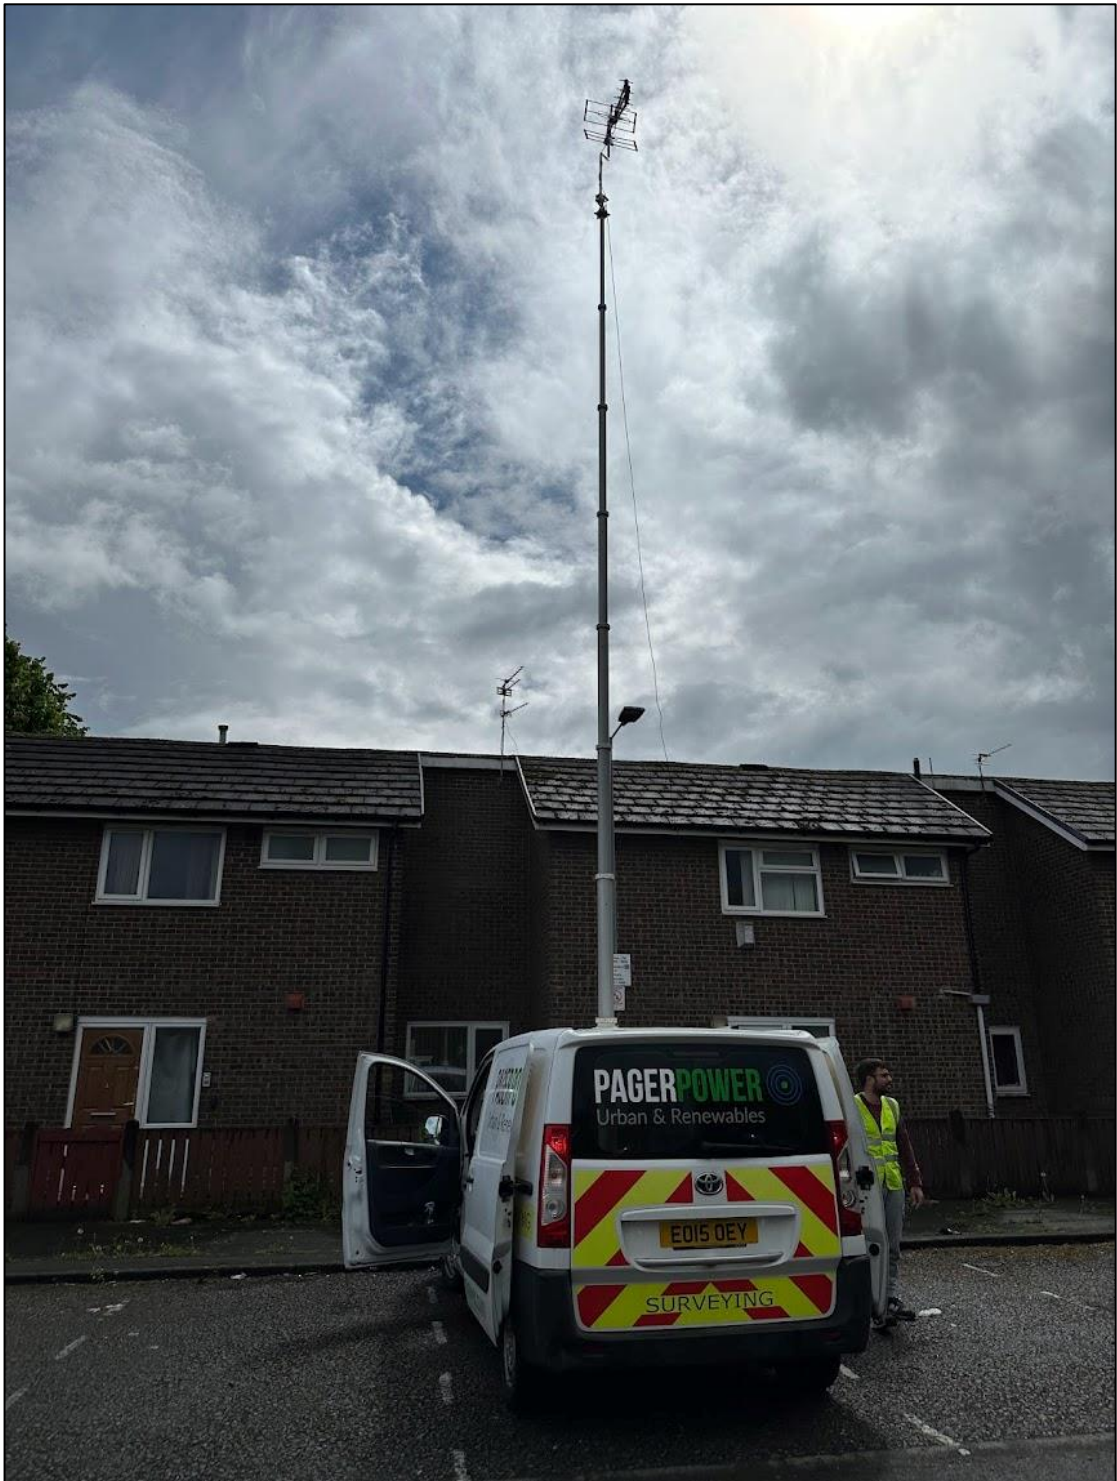
| Location | Average Measured Signal Strength (dB) | Remarks | High Level Conclusion |
|---|---|---|---|
| 4 | <p><b><u>Baseline:</u></b></p> <p>Main TV MUX: 47 (Good)</p> <p>Local TV MUX: 39 (Moderate)</p> <p><b><u>Post-Construction:</u></b></p> <p>Main TV MUX: 50.8 (Good)</p> <p>Local TV MUX: 32.3 (Low)</p> | <p>Horizontally polarised aerials directed towards the Winter Hill transmitter and satellite dishes were observed.</p> <p><b><u>Baseline:</u></b> All main multiplexes displayed fine picture and audio quality, with signal fluctuations of less than 1dB and no signs of interference.</p> <p>Two local multiplexes were not decoded at this location.</p> <p><b><u>Post-Construction:</u></b> All main multiplexes displayed fine picture and audio quality, with signal fluctuations of less than 0.4dB and no signs of interference.</p> <p>One local multiplex was not decoded at this location.</p> | <p>The survey location is more than 1 km from the Proposed Development and within its shadow zone.</p> <p><b><u>There is no significant change in TV signal strength at this location. There is no change in picture or audio quality and the signal strength of the main multiplexes is good.</u></b></p> |

Location 4 (baseline survey)

*Location 4 (post-construction survey)*

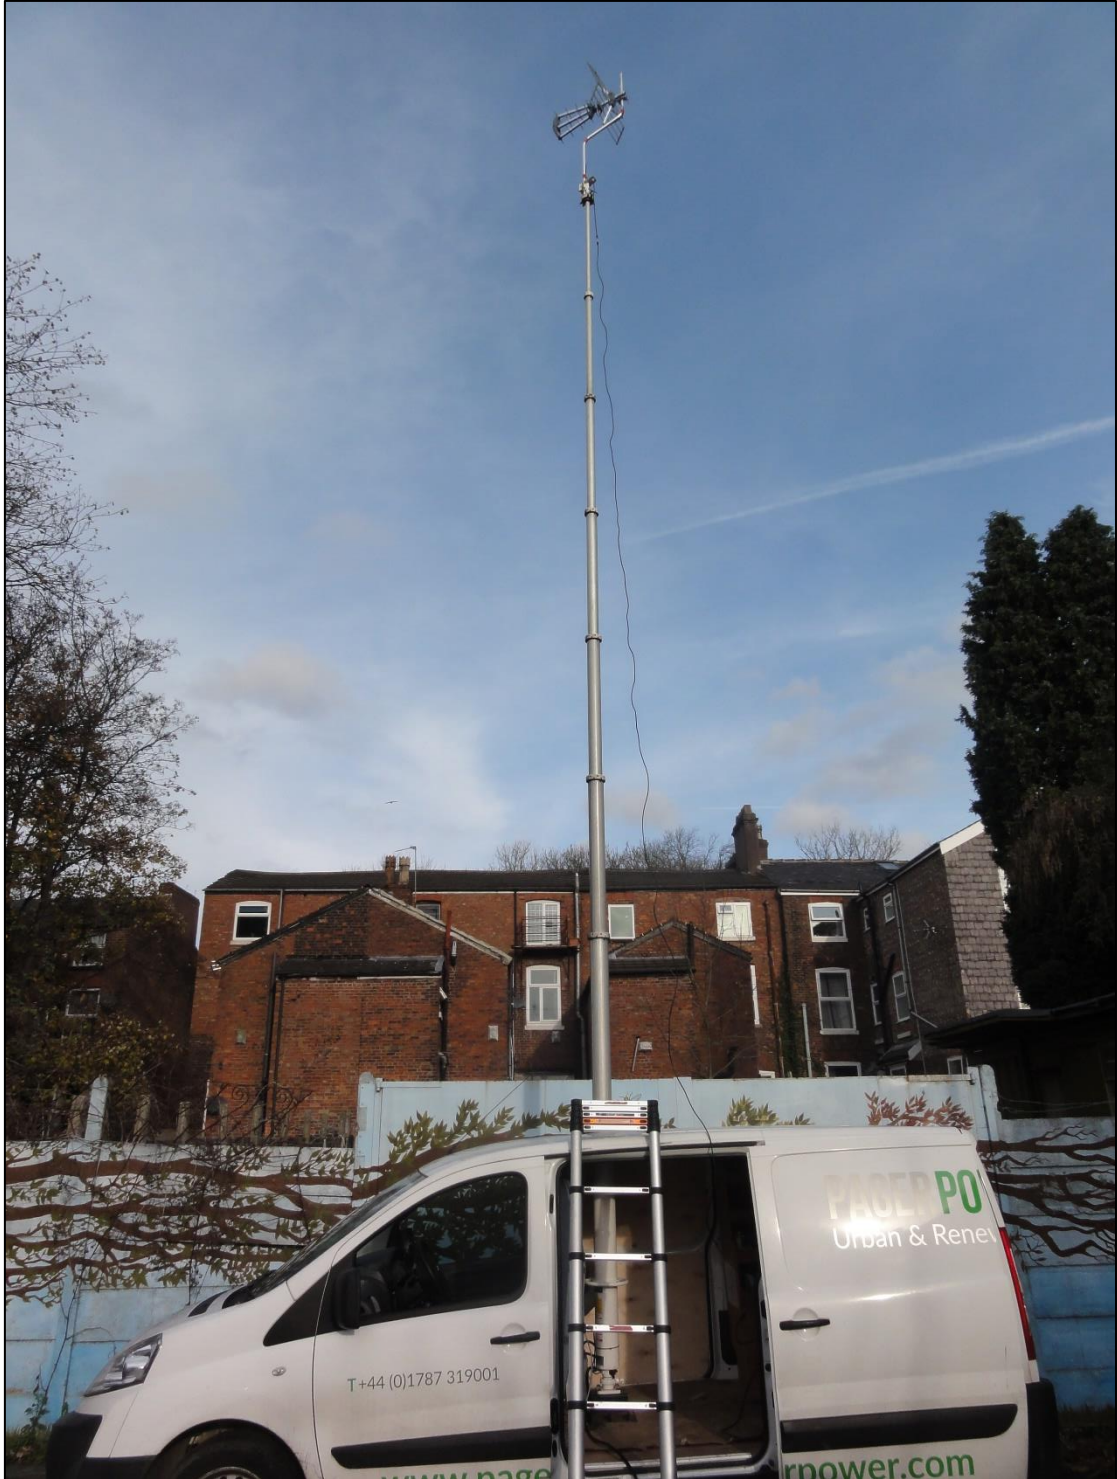
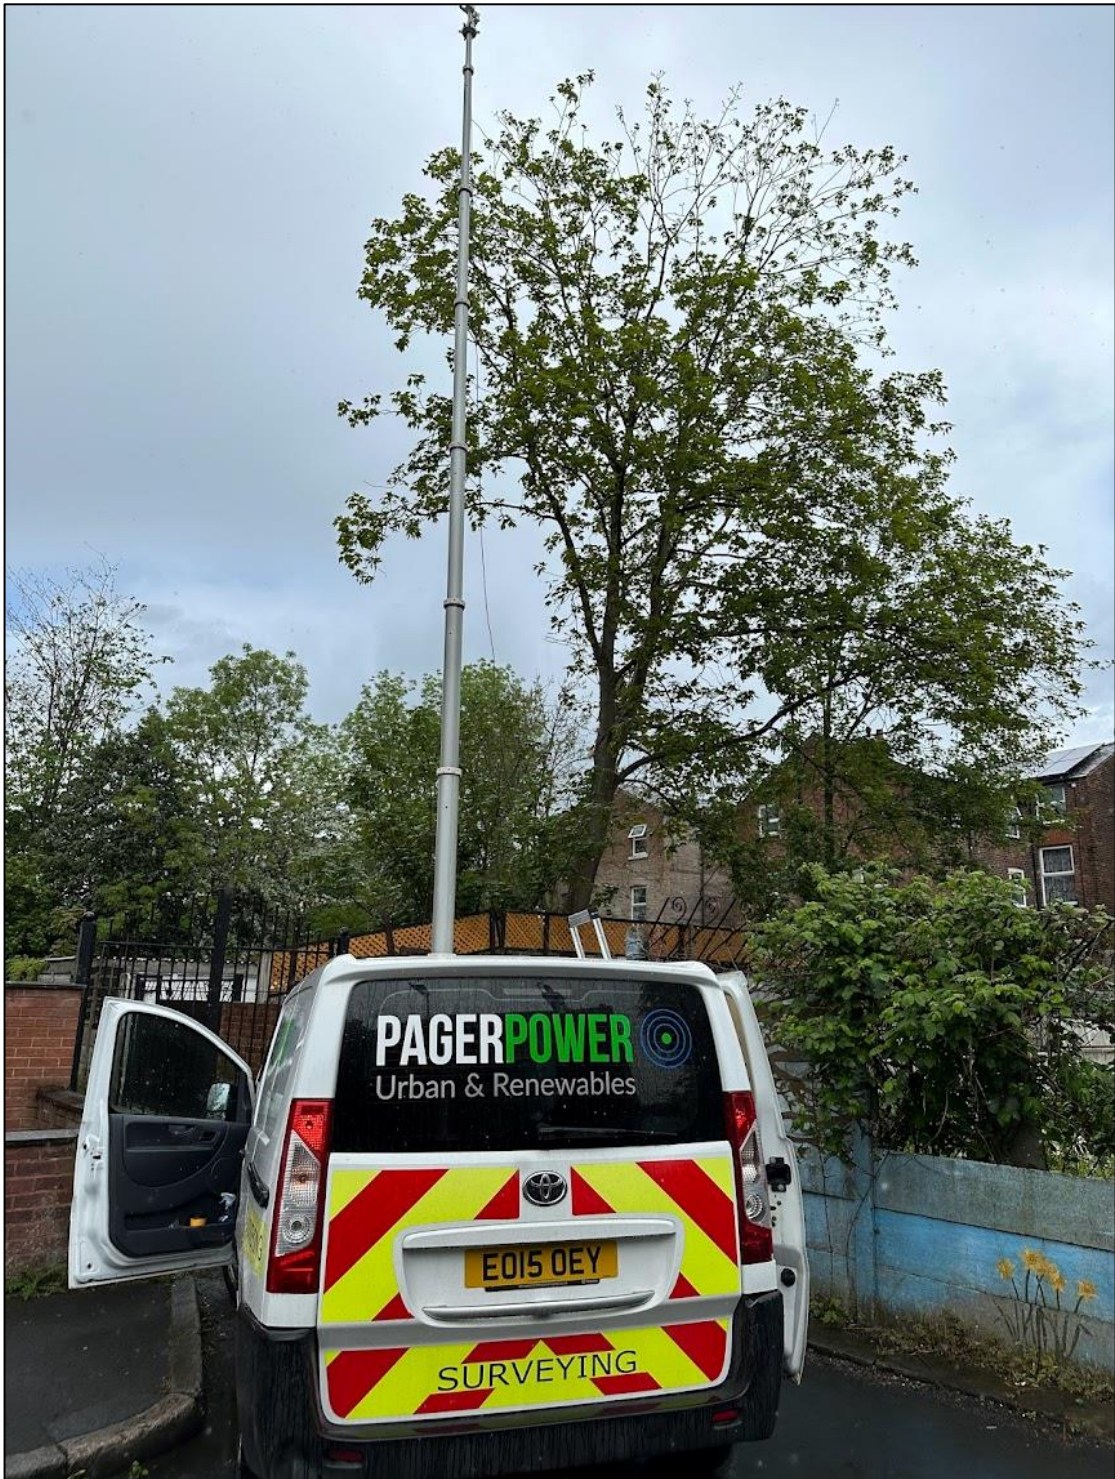
| Location | Average Measured Signal Strength (dB) | Remarks | High Level Conclusion |
|---|---|---|---|
| 5 | <p><b><u>Baseline:</u></b></p> <p>Main TV MUX: 58 (Very Good)</p> <p>Local TV MUX: 38 (Moderate)</p> <p><b><u>Post-Construction:</u></b></p> <p>Main TV MUX: 52.6 (Good)</p> <p>Local TV MUX: 33.95 (Low)</p> | <p>Horizontally polarised aerials directed towards the Winter Hill transmitter and many satellite dishes were observed.</p> <p><b><u>Baseline:</u></b> All main multiplexes displayed fine picture and audio quality, with signal fluctuations of less than 1dB and no signs of interference.</p> <p>One local multiplex was not decoded at this location.</p> <p><b><u>Post-Construction:</u></b> All main multiplexes displayed fine picture and audio quality, with signal fluctuations of less than 0.6dB and no signs of interference.</p> <p>One local multiplex was intermittent at this location.</p> | <p>The survey location is more than 2 km from the Proposed Development and within its shadow zone.</p> <p><b><u>At this location, there has been a slight decrease in TV signal strength, however there is no change in picture or audio quality, and the signal strength of the main multiplexes is good. Given the distance from the built development (more than 1km), any change in signal strength or quality is not likely to be attributable to the development.</u></b></p> |

Location 5 (baseline survey)

Location 5 (post-construction survey)

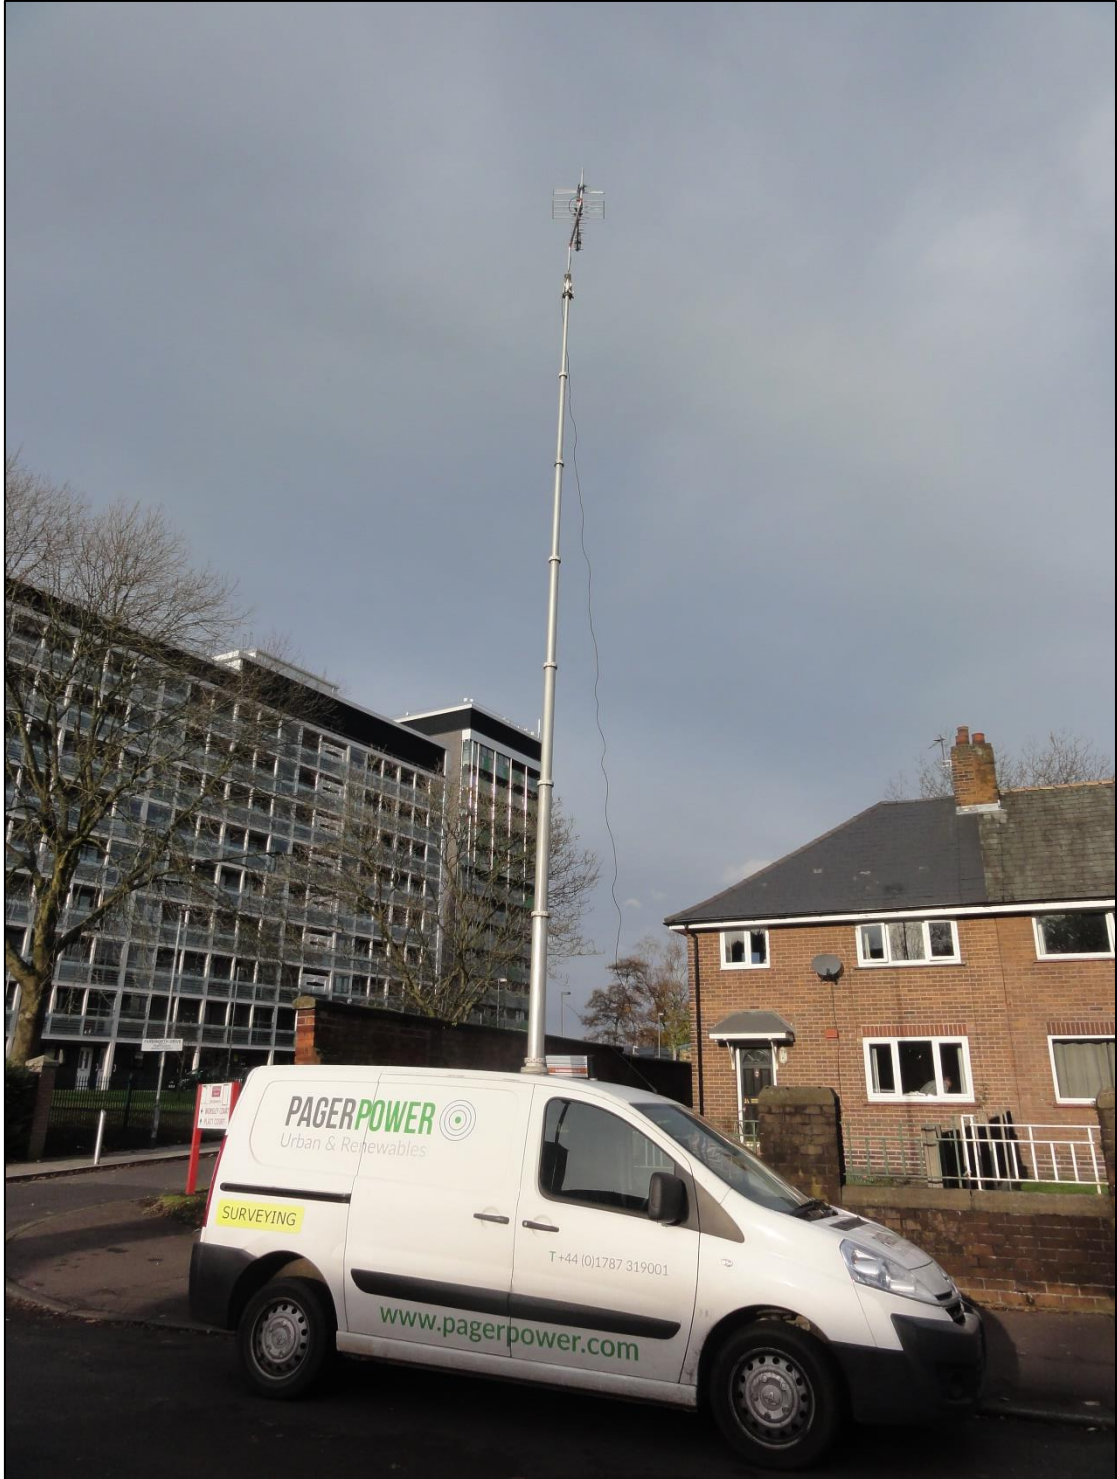
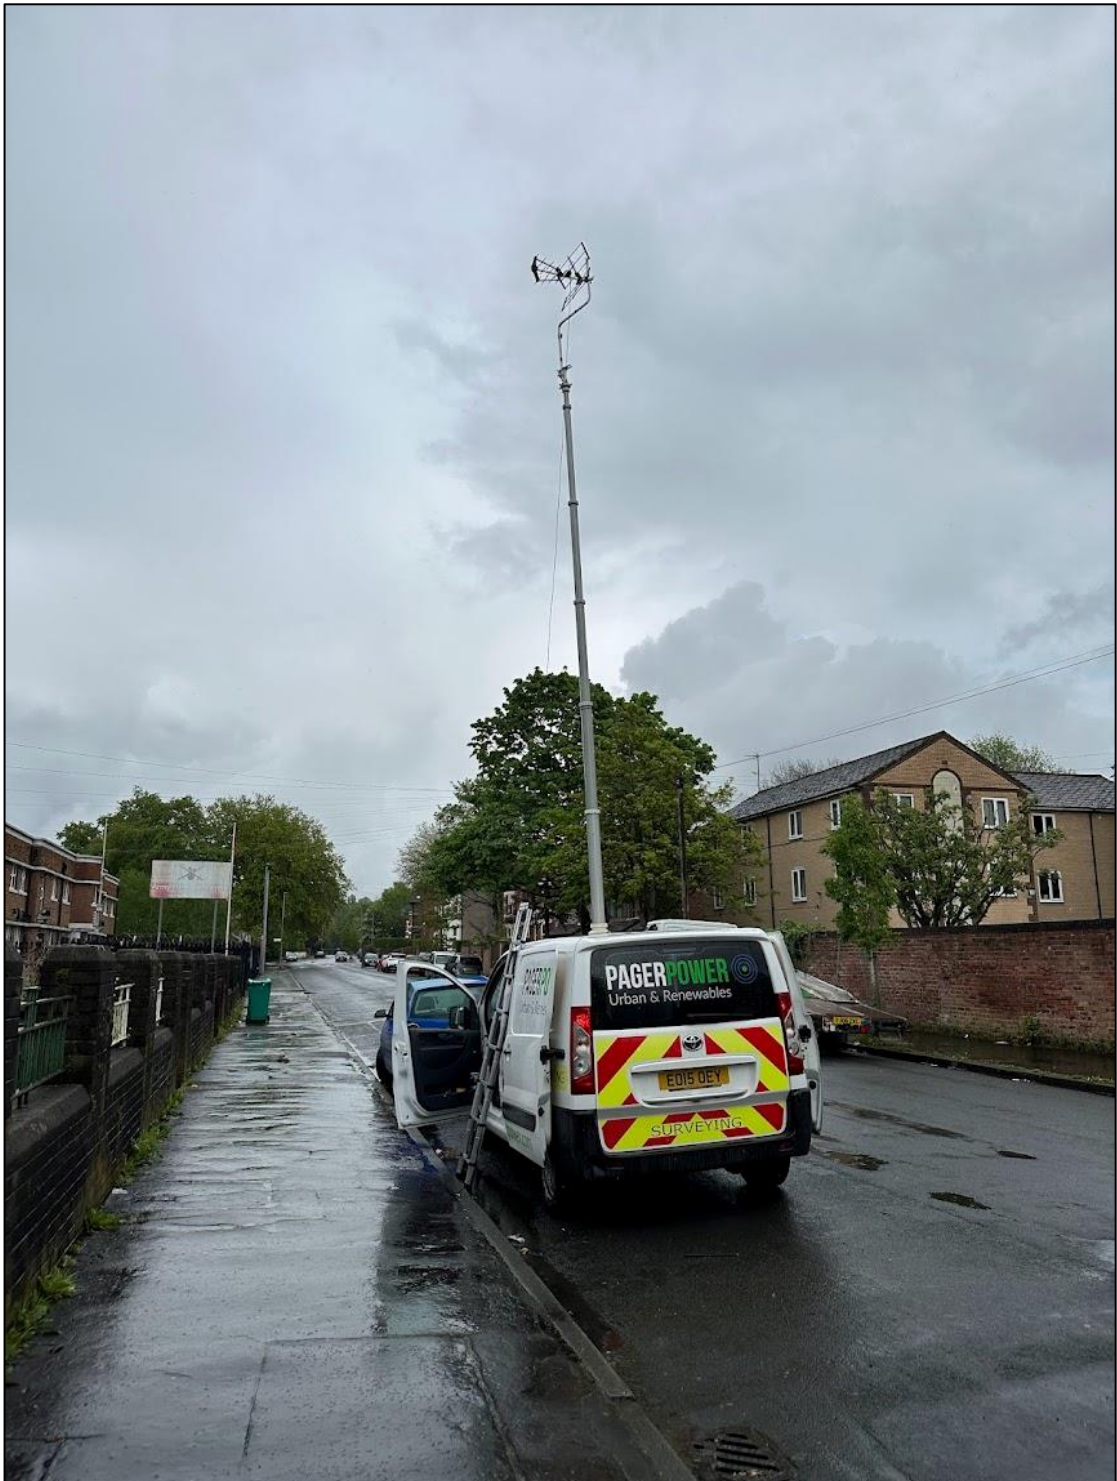
| Location | Average Measured Signal Strength (dB) | Remarks | High Level Conclusion |
|---|---|---|---|
| 6 | <p><b><u>Baseline:</u></b></p> <p>Main TV MUX: 70 (Very Good)</p> <p>Local TV MUX: 52 (Good)</p> <p><b><u>Post-Construction:</u></b></p> <p>Main TV MUX: 63.15 (Very Good)</p> <p>Local TV MUX: 43.4 (Moderate)</p> | <p>Horizontally polarised aerials directed towards the Winter Hill transmitter and satellite dishes were observed.</p> <p><b><u>Baseline:</u></b> All main multiplexes displayed fine picture and audio quality, with signal fluctuations of less than 1dB and no signs of interference.</p> <p>One local multiplex was not decoded at this location.</p> <p><b><u>Post-Construction:</u></b> All main and local multiplexes displayed fine picture and audio quality, with signal fluctuations of less than 0.3dB and no signs of interference.</p> | <p>The survey location is more than 3 km from the Proposed Development and within its shadow zone.</p> <p><b><u>At this location, there has been a slight decrease in TV signal strength, however there is no change in picture or audio quality, and the signal strength of the main multiplexes is good. Given the distance from the built development (more than 1km), any change in signal strength or quality is not likely to be attributable to the development.</u></b></p> |

Location 6 (baseline survey)

*Location 6 (post-construction survey)*
