# Television Post-Construction Survey Report

Crown Street Phase 2

Renaker Build Limited

May 2023

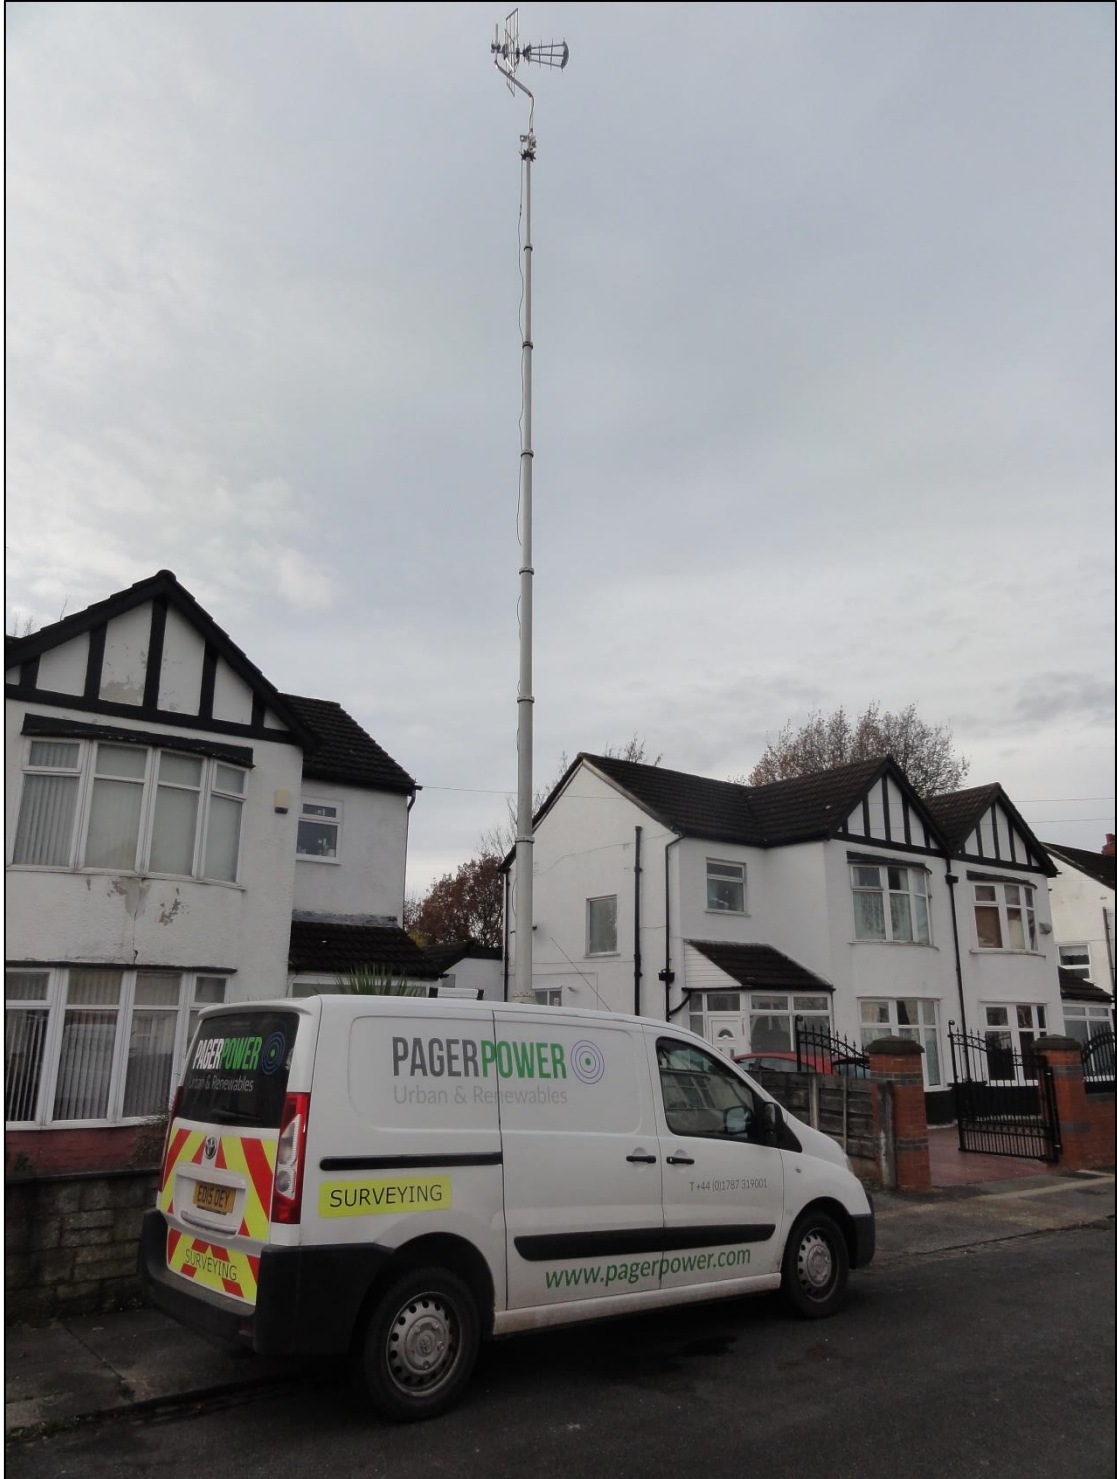
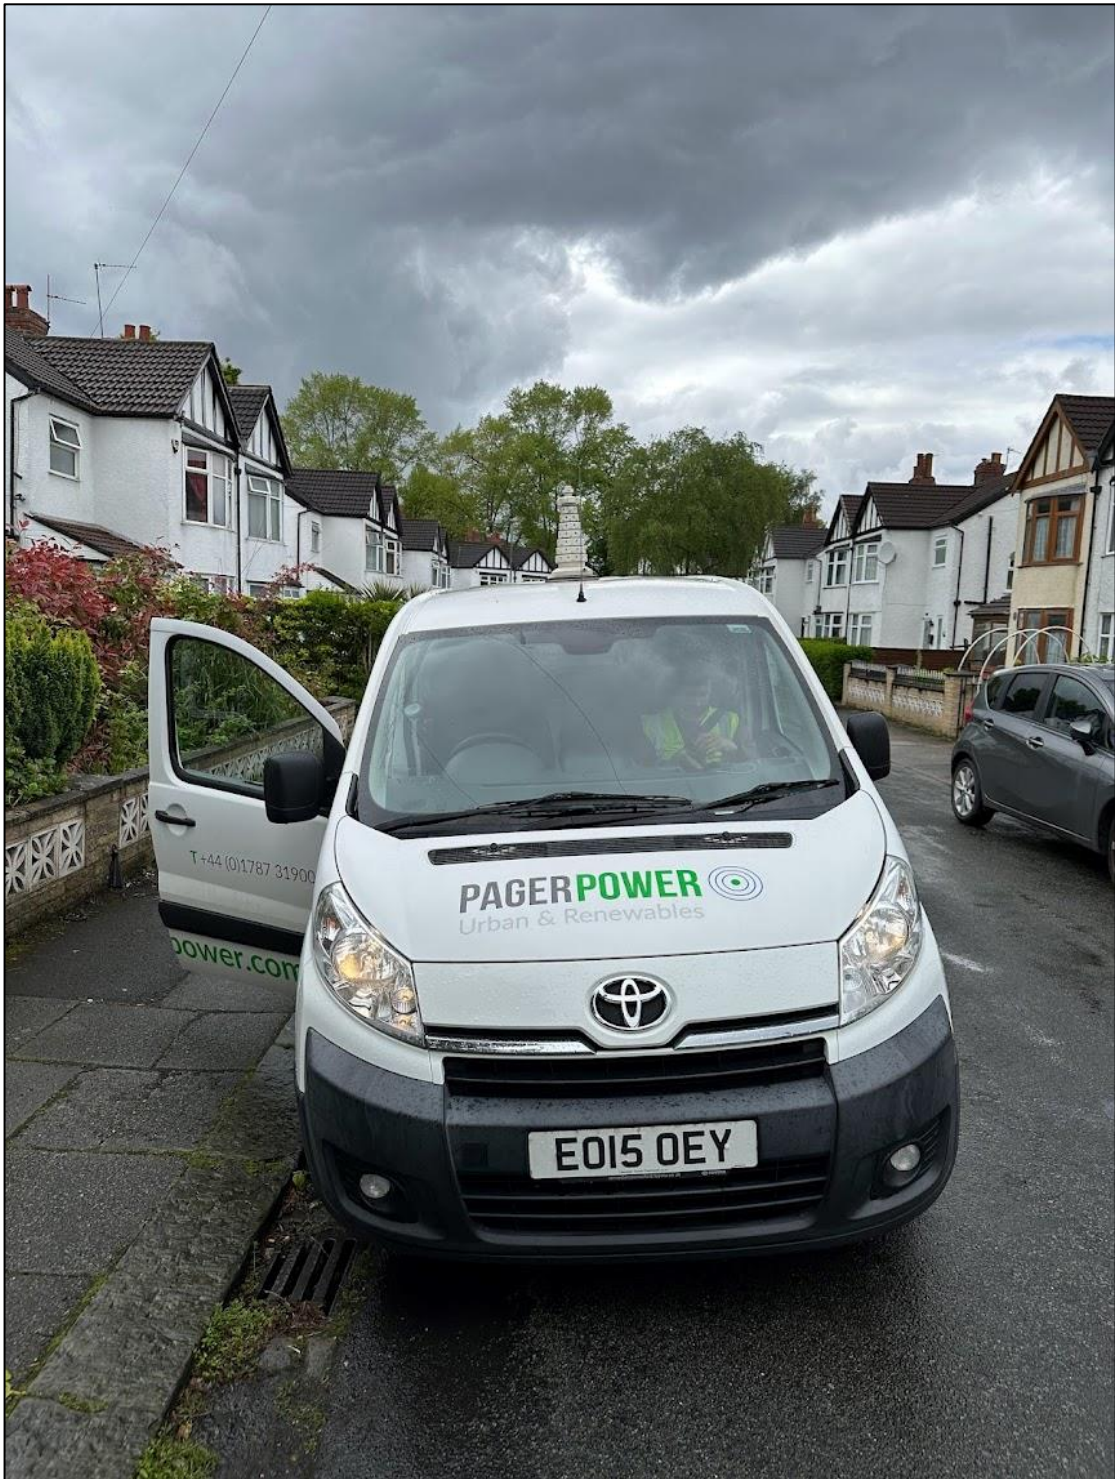
| Location | Average Measured Signal Strength (dB) | Remarks | High Level Conclusion |
|---|---|---|---|
| 7 | <p><b><u>Baseline:</u></b></p> <p>Main TV MUX: 68 (Very Good)</p> <p>Local TV MUX: 50 (Good)</p> <p><b><u>Post-Construction:</u></b></p> <p>Main TV MUX: 63.2 (Very Good)</p> | <p>Horizontally polarised aerials directed towards the Winter Hill transmitter and some satellite dishes were observed.</p> <p><b><u>Baseline:</u></b> All main multiplexes displayed fine picture and audio quality, with signal fluctuations of less than 1dB and no signs of interference.</p> <p>One local multiplex was not decoded at this location.</p> <p><b><u>Post-Construction:</u></b> All main and local multiplexes displayed fine picture and audio quality, with signal fluctuations of less than 1dB and no signs of interference.</p> | <p>The survey location is more than 4 km from the Proposed Development and within its shadow zone.</p> <p><b><u>At this location, there has been a slight decrease in TV signal strength, however there is no change in picture or audio quality, and the signal strength of the main multiplexes is good. Given the distance from the built development (more than 1km), any change in signal strength</u></b></p> |

Location 7 (baseline survey)

Location 7 (post-construction survey)
