# DESIGN STATEMENT

Project: Emergency Structural Reinstatement Works  
Liverpool Road Hotel, Manchester

Project No: 2205-02

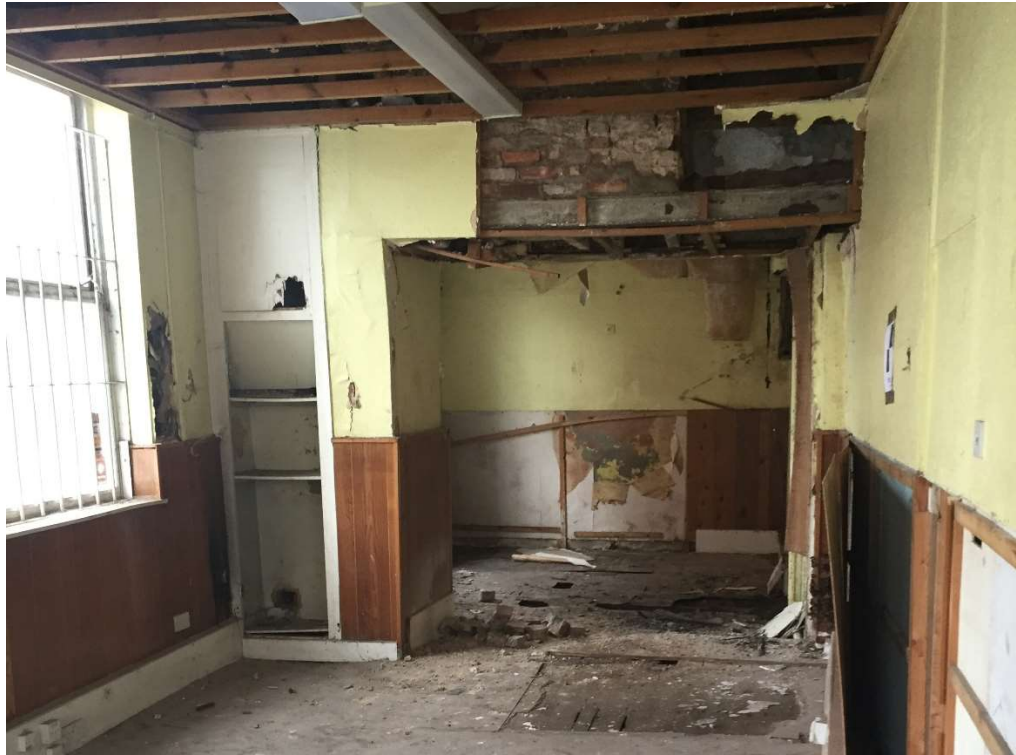
This arrangement is also evident at basement level. However, as can be seen in the following photo, the load-bearing wall and chimney breast had been partially removed at ground floor by 2017.

There are no details available for the transfer structure that was introduced as part of these alterations, and it is not clear from the photographs how the remaining section of masonry above was supported.

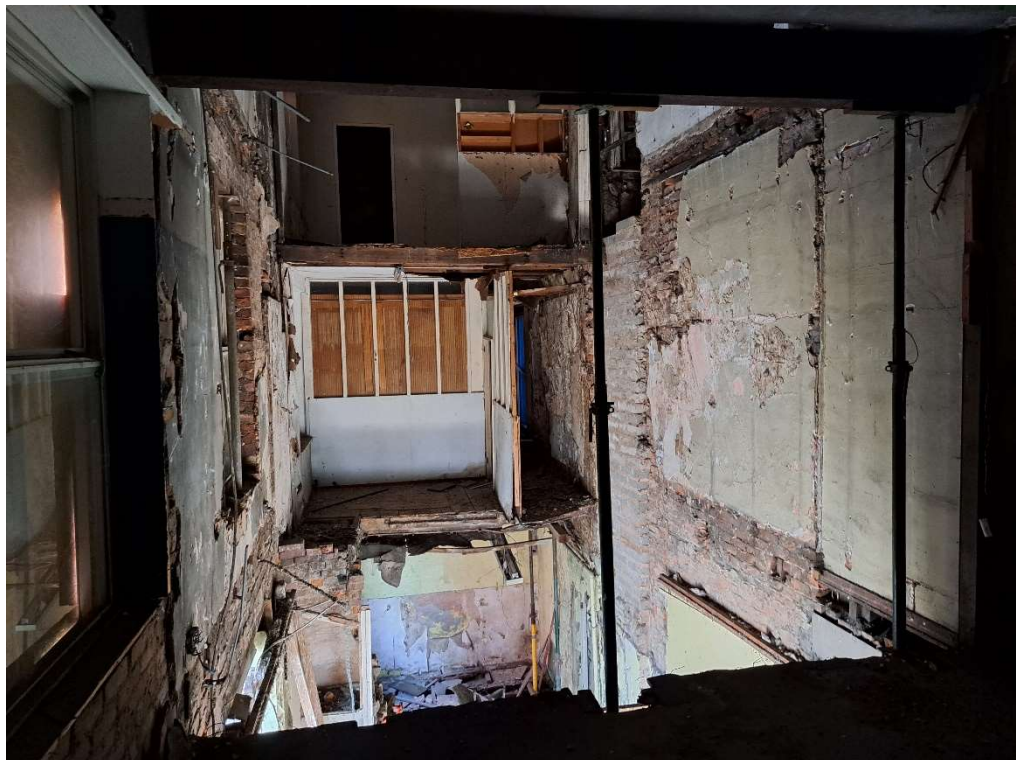
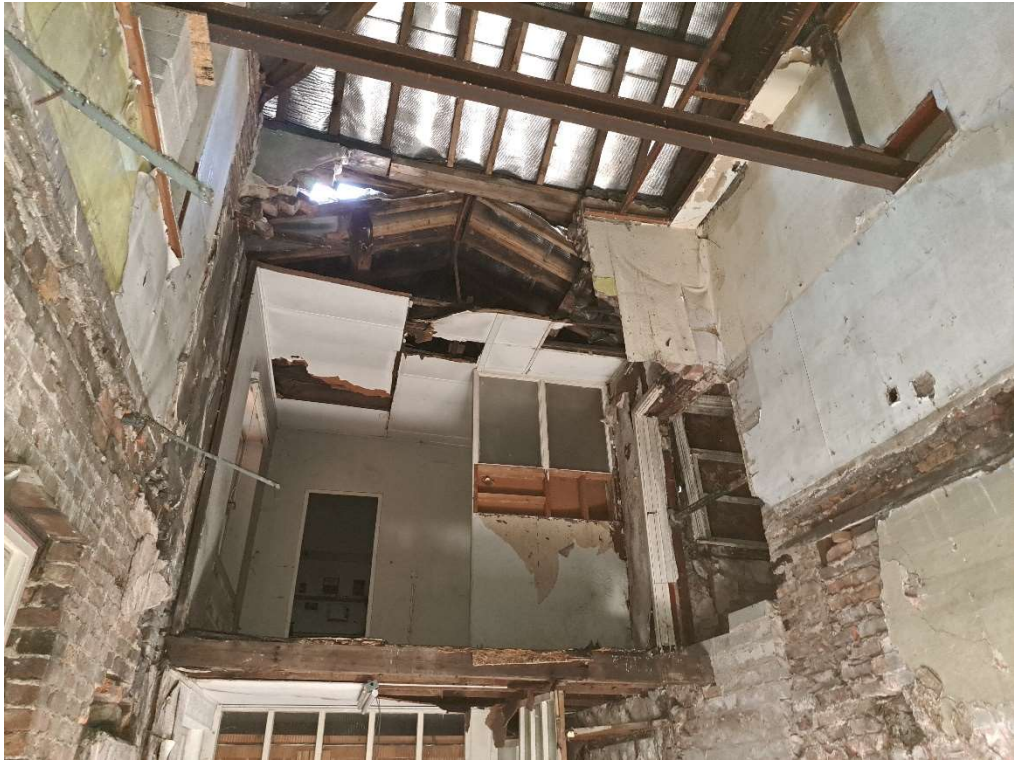
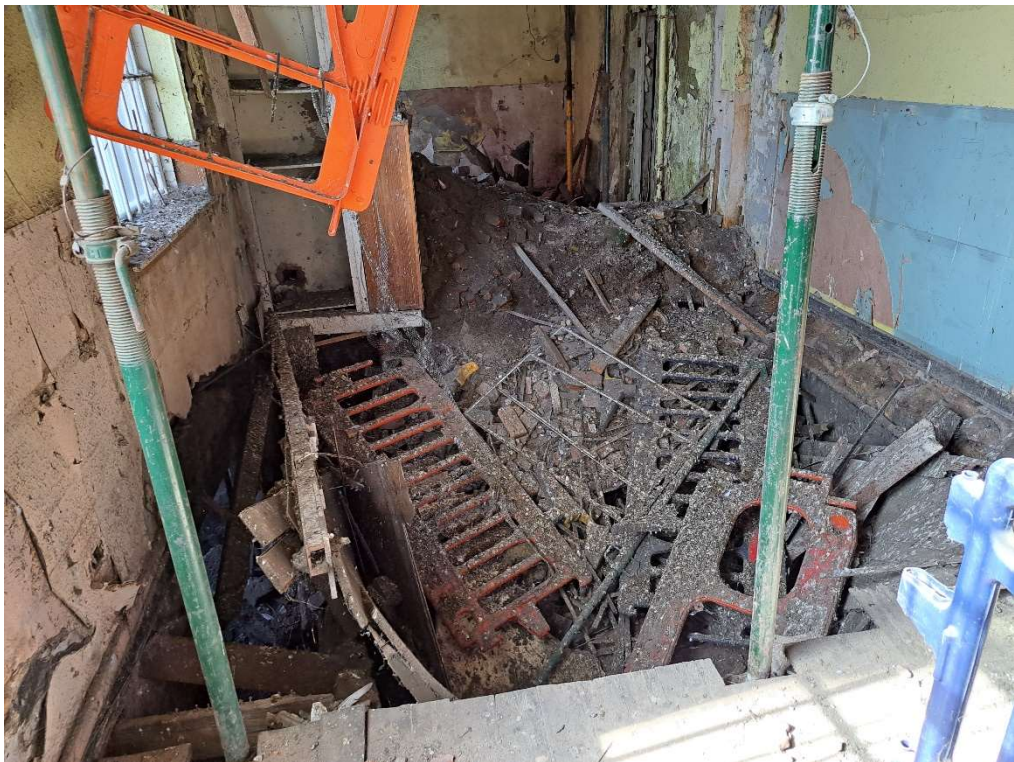
Since 2017, the load-bearing masonry wall, chimney breast and transfer structure identified in Section 2 have collapsed from roof to ground floor. This has also caused the timber floor supported by the load-bearing wall and transfer structure from ground to 2<sup>nd</sup> floor in the front part of 123 Liverpool Road to collapse as well. The following photos show the condition of the remaining structure during the first inspection carried out by Renaissance in June 2022.

A section of roof had been left unsupported and the end of a primary roof truss was only supported by a section of corbelled masonry left from the collapsed load-bearing wall as well as rudimentary temporary propping installed prior to Renaissance's involvement.

To protect the building from further progressive collapse as a matter of urgency and to allow the debris from the initial partial collapse to be cleared below, Renaissance designed a temporary support system for the roof structure and corbelled masonry shown on drawing LRH-REN-XX-ZZ-DR-S-90001 and installed in August 2022.

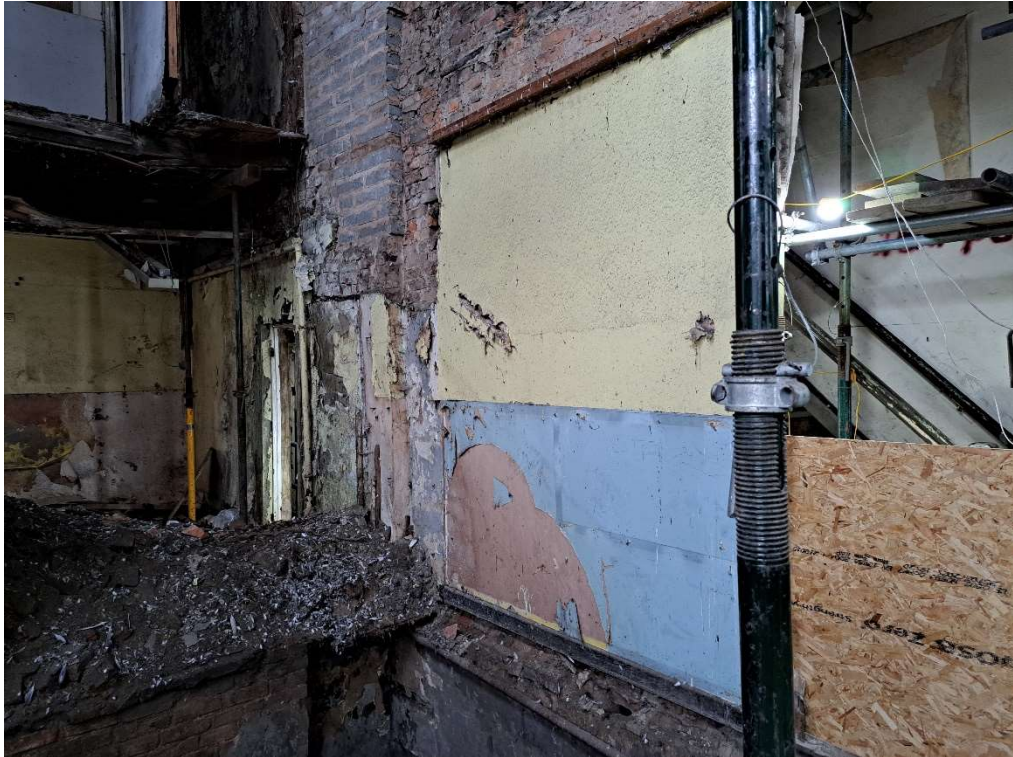
Following the installation of the temporary support system and the subsequent clearing of debris from the basement of 123 Liverpool Road, a further inspection by Renaissance has revealed that the internal load-bearing wall adjacent to the collapse is visibly bowing and at risk of collapse due to it being unrestrained from basement to roof level. The section of external wall adjacent to the collapse has also been left unrestrained. The unstable internal load-bearing wall is shown in the photo below.

Furthermore, a section of timber joists and internal partitions at 1<sup>st</sup> floor are also partially unsupported to the rear of the collapse zone preventing access at ground floor below.

An initial assessment was made by Renaissance to determine the feasibility of introducing temporary restraint to the walls either side of the collapse zone. However, the lack of access to the rear due to the unstable 1<sup>st</sup> floor joists above means that there is no area to support a temporary restraint system without putting workers directly underneath the unstable internal wall. As a result, the only feasible approach to the next stage of making safe works is to take down the unstable internal wall to create a safe access point to the rear of 123 Liverpool Road and allow the unstable elements at 1<sup>st</sup> floor to be cleared or propped preventing further progressive collapse of the building. The design for the additional temporary works and an indicative construction methodology for this next stage of making safe works is shown on drawings LRH-REN-XX-ZZ-DR-S-90002 to LRH-REN-XX-ZZ-DR-S-90005.

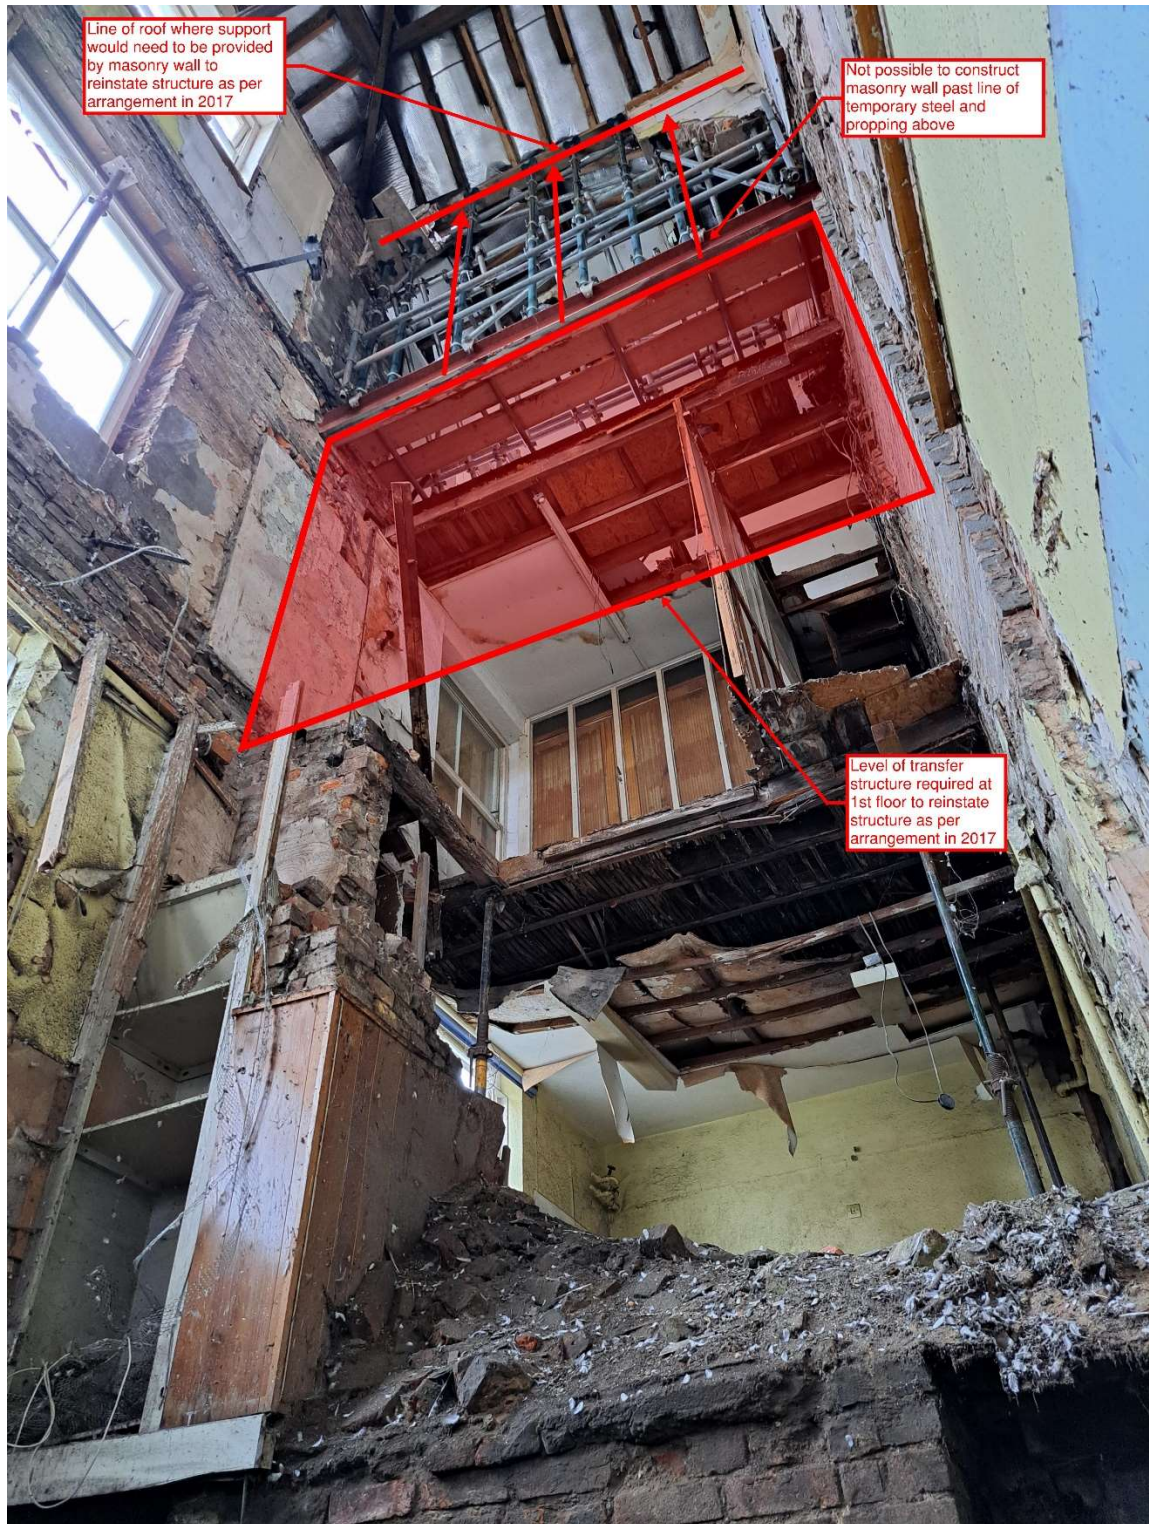
A design review has been carried out by Renaissance focused on whether the permanent structure could be reinstated as per the arrangement that was apparent in 2017 which would involve installing a new transfer frame at ground floor and re-constructing the load-bearing wall and chimney breast from 1<sup>st</sup> floor to roof level. However, this has been deemed not

possible due to the presence of the temporary propping currently installed at 2<sup>nd</sup> floor to support the roof. Furthermore, the works involved with making amendments to the propping to allow for the wall to be re-constructed at 2<sup>nd</sup> floor would have a high risk of causing further progressive collapse and loss of building fabric. The photo below gives an idea of what is currently installed at 2<sup>nd</sup> floor and indicates the reasons for reinstating the structure in its original form being unfeasible.

As a result of this, the solution proposed for reinstating the timber floor from ground to 2<sup>nd</sup> floor and re-supporting the roof is to install a new steel frame from basement to roof level with columns offset to pass by the temporary propping at 2<sup>nd</sup> floor. The new timber floors can be supported by the steel frame at each level and tie into the external wall to ensure that it is suitably restrained in the permanent condition. The preliminary design for the emergency reinstatement works is shown on drawings LRH-REN-XX-ZZ-DR-S-90006 and LRH-REN-XX-ZZ-DR-S-90007.
