Eagle House, Manchester  
Partition Investigations  
June 2023

Investigations have been carried out to partitions on third and second floors to investigate the build up of these.

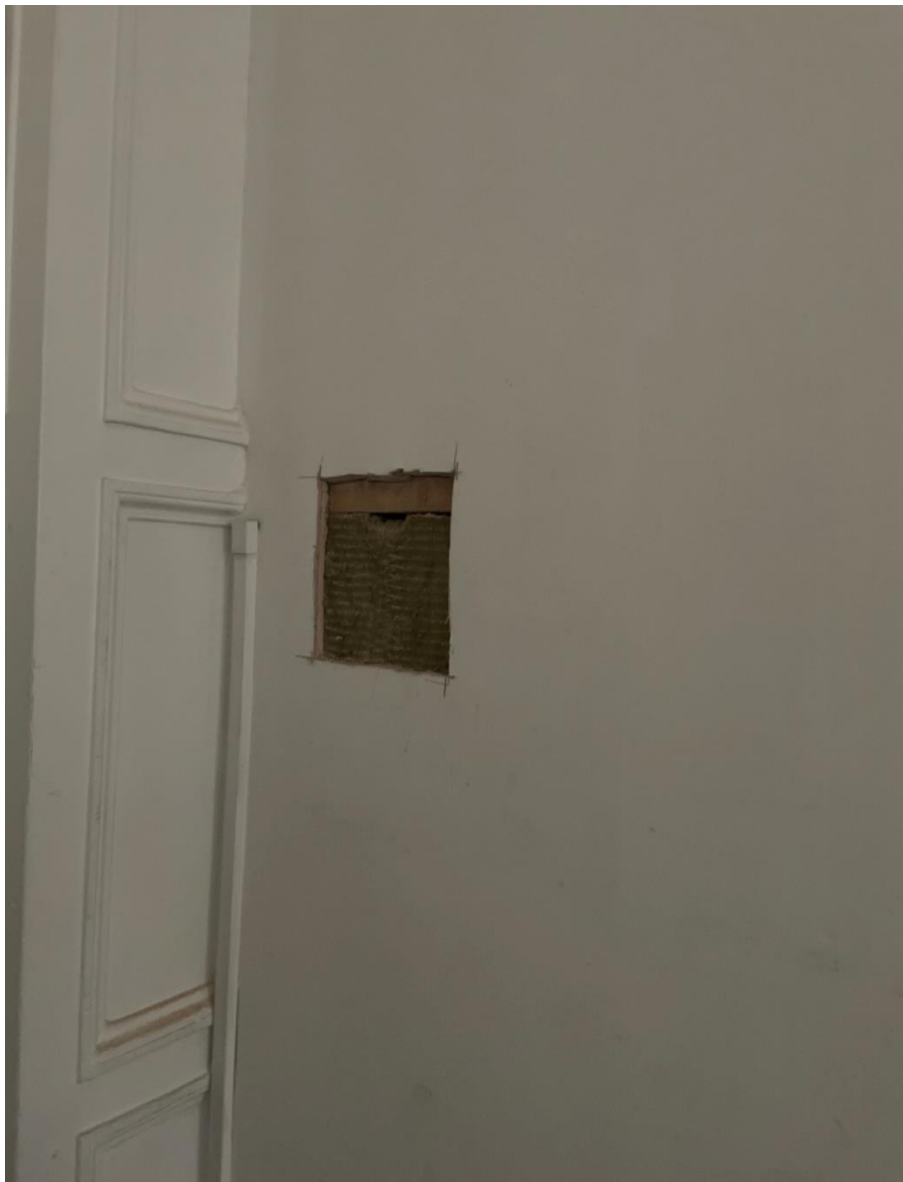
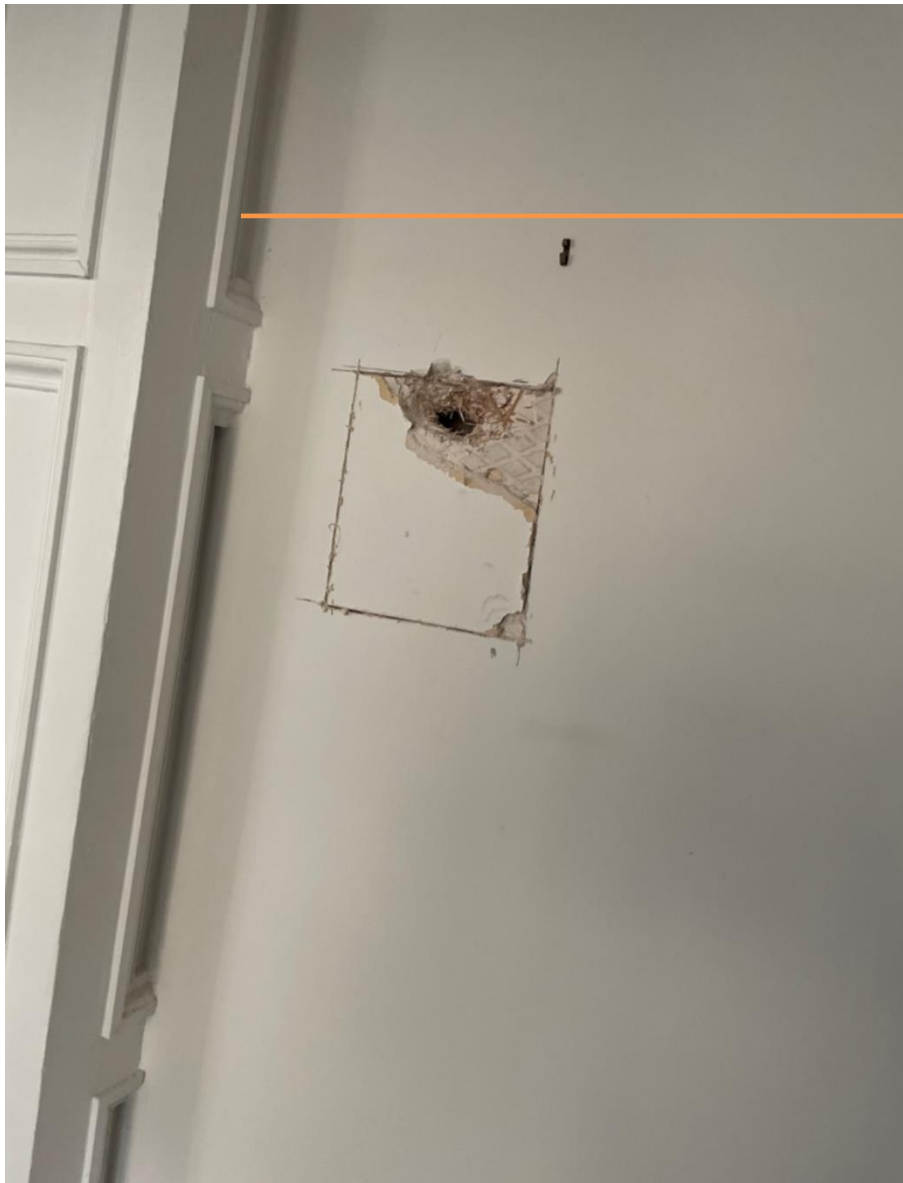
Comparison of abutment details with columns

Agreed with planning that this partition should remain in place

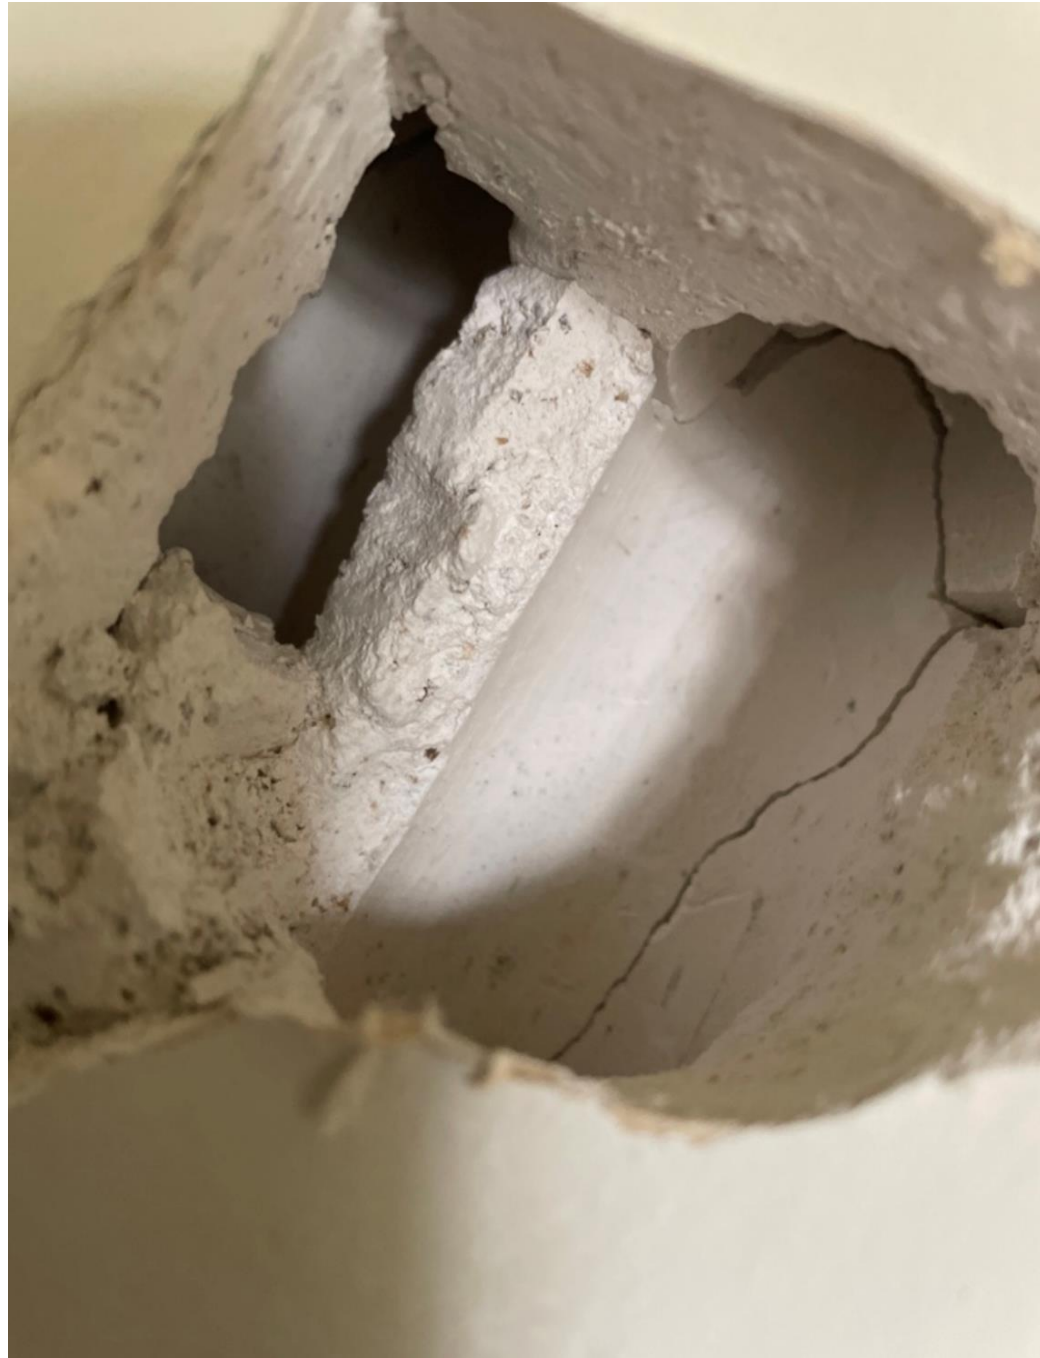
Opening up of partition to the third floor demonstrated that there is no encased glazing detail in this location.

The original design intent was that this partition was glazed. It remains the applicants desire that this solid partition be replaced with glazing.

Agreed with planning that original skirtings should be retained
