# Heritage Statement

Science and Industry Museum  
1830s Warehouse

Client: Trustees of the Science Museum  
Date: July 2023  
Revision: B

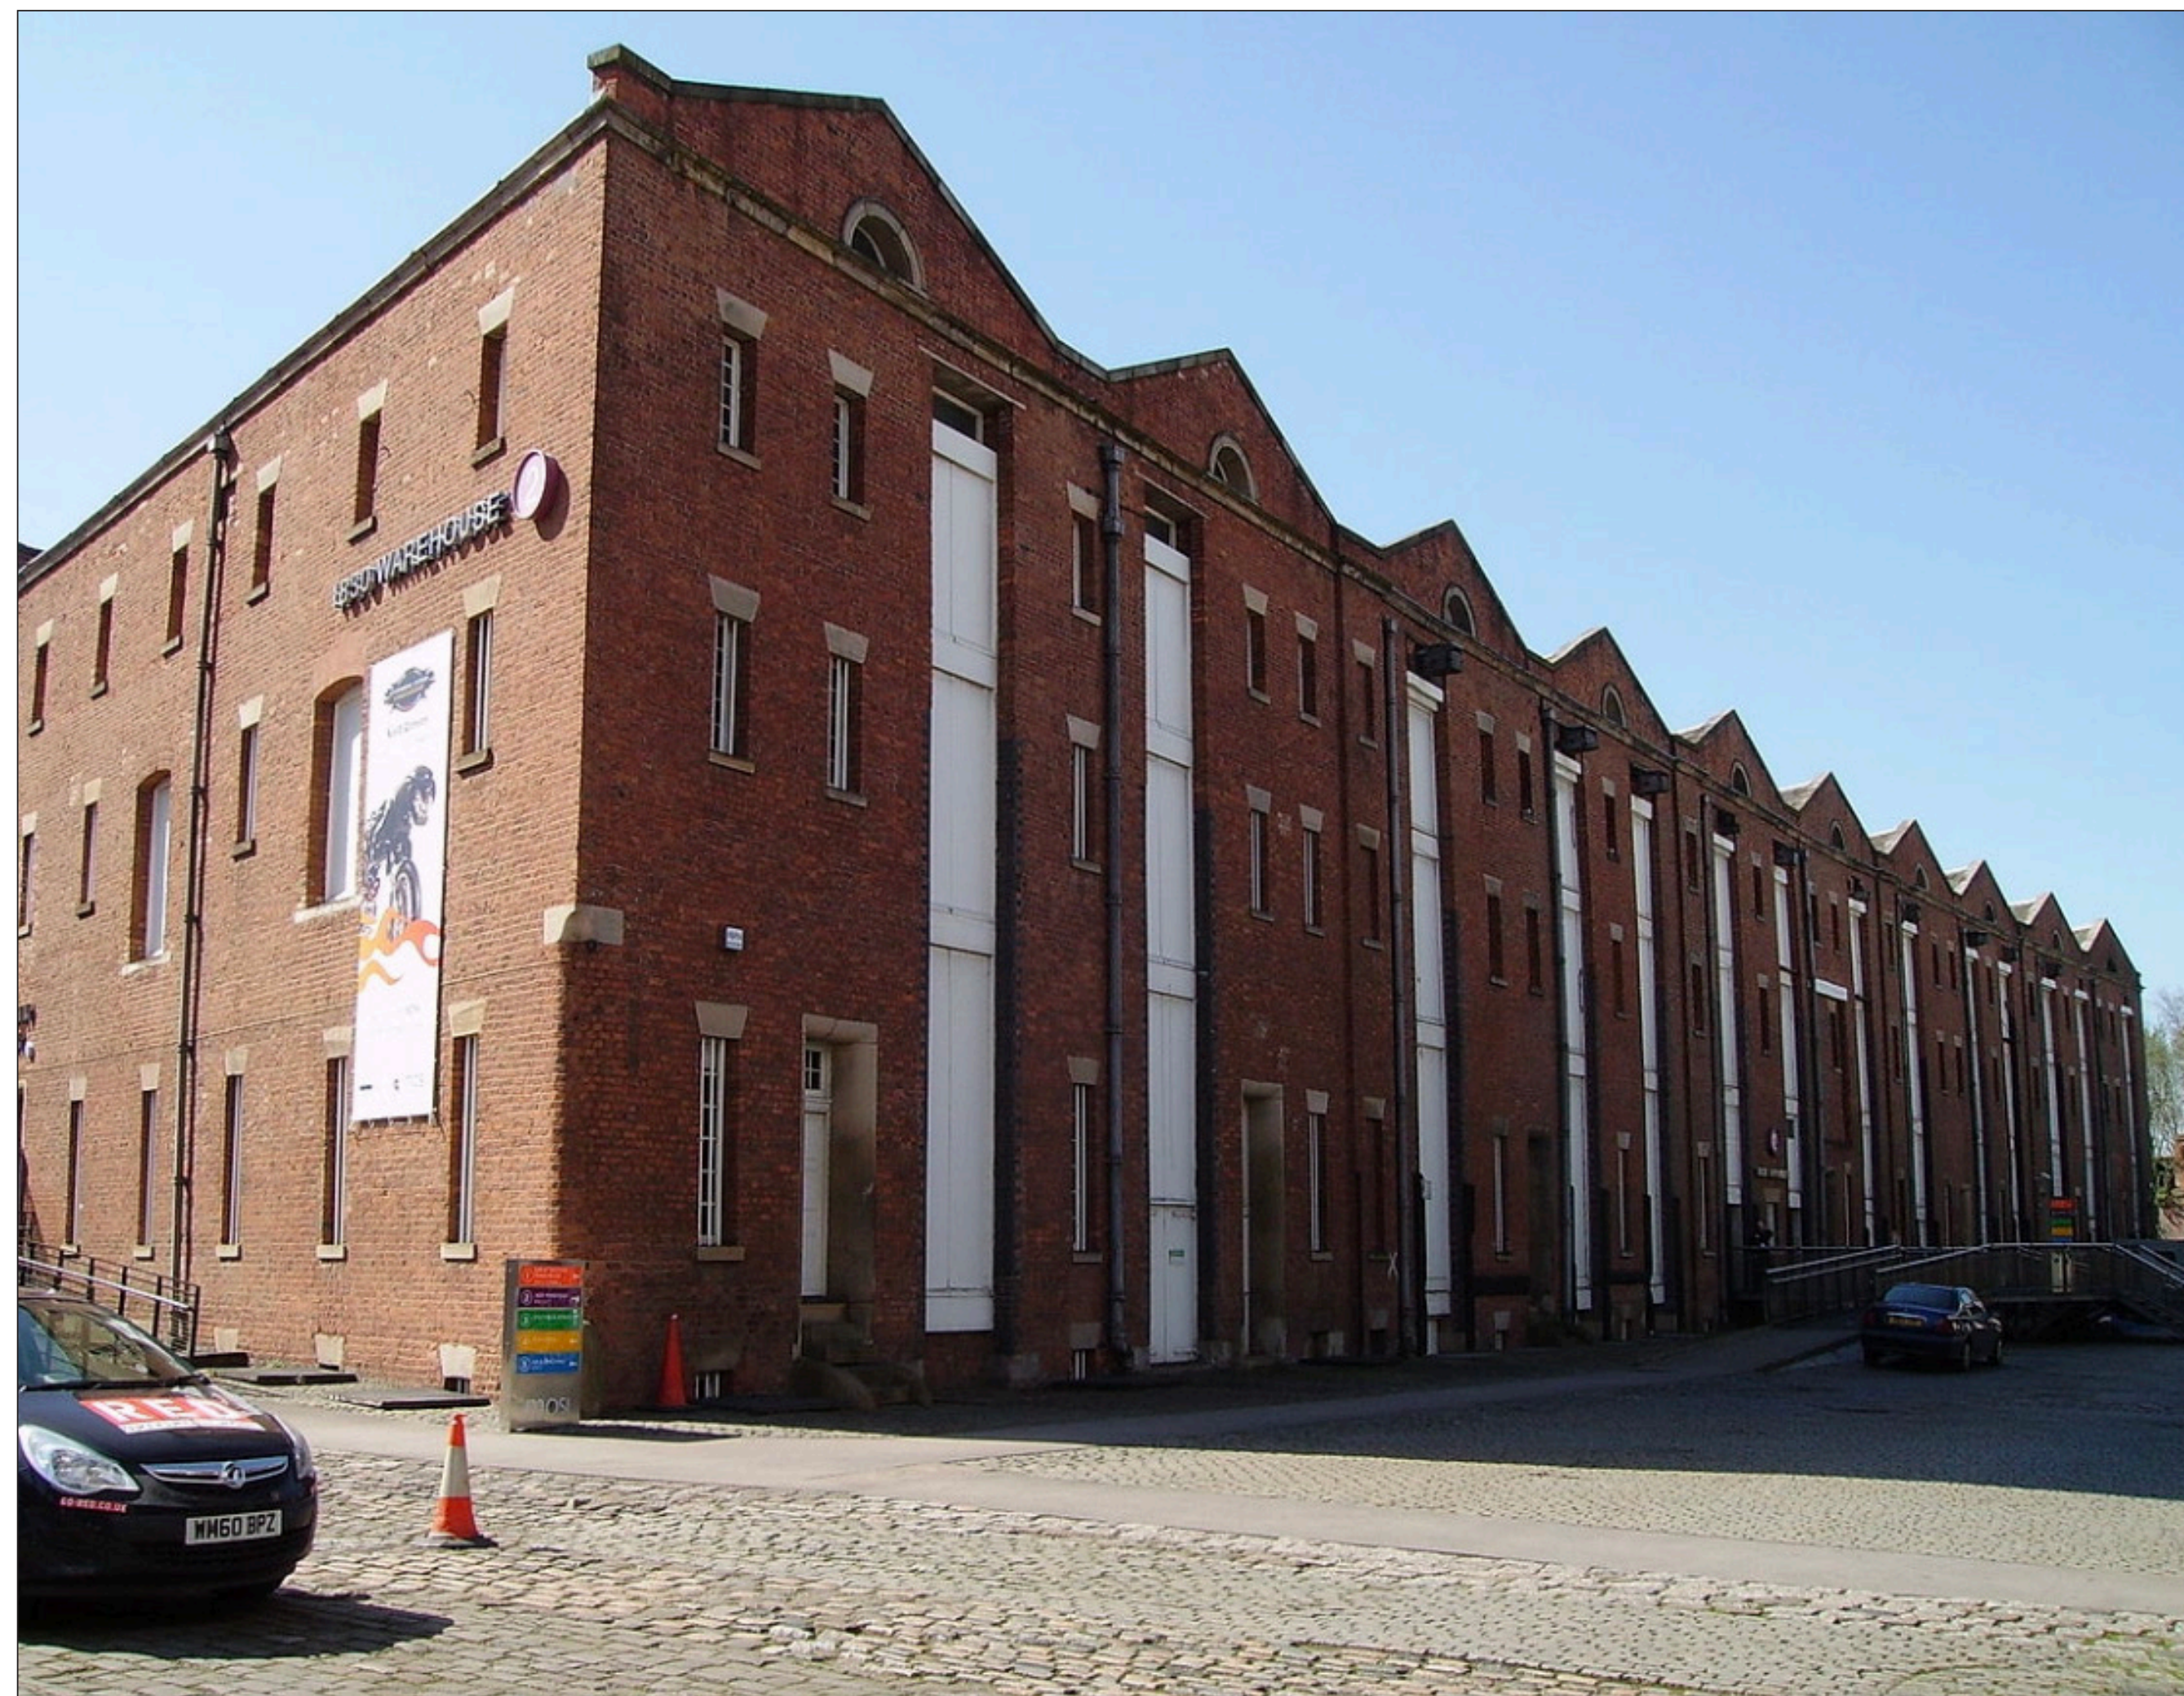
The building is of timber framed construction with walls of red brick and stone detailing, with a slate roof covering. The form curves slightly to run alongside the railway line. Divided into a series of five bays, it has a regular arrangement of windows and large loading bays (with doors) to the yard side, which serve vertical circulation. The warehouse stands at four stories plus basement to the yard side, though extends only two stories above the railway tracks due to raised level of platform. Internally there are exposed brick walls, and the timber frame is visible. Various modern alterations are present which have been added to service the museum use.

Image 4: Photograph of 1830s Warehouse from the yard side.

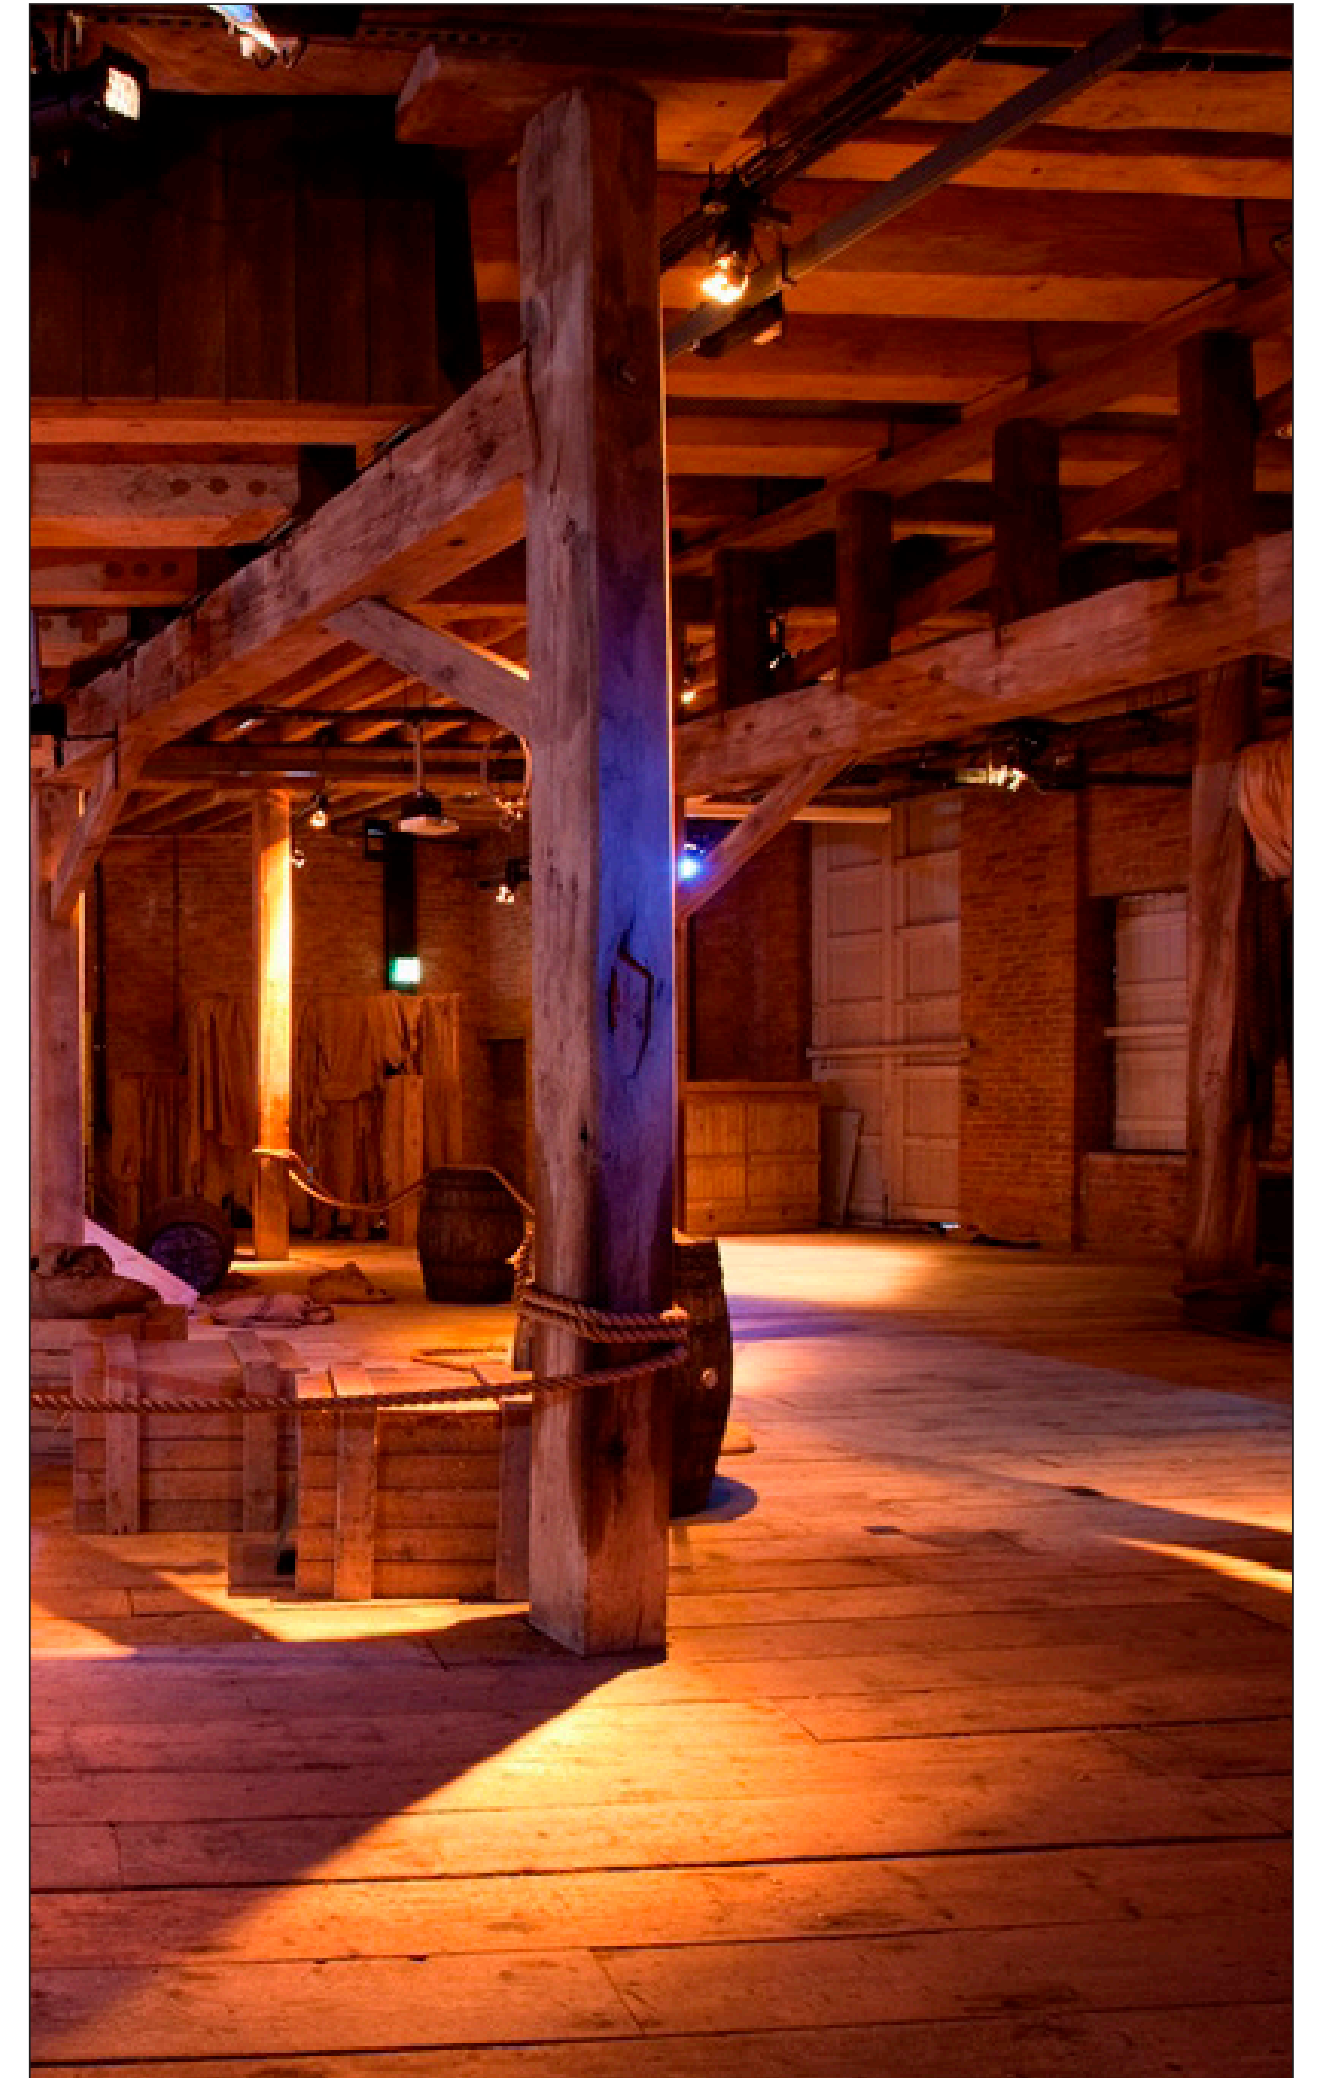
Image 6: Ground floor of 1830s Warehouse following conversion to museum.

The eastern bay features more substantial modern intervention to serve museum purposes with a steel and concrete frame which were added to form the Electricity Gallery. The remaining areas of the interior have been adapted through the insertion of lifts and staircases to serve the various spaces.

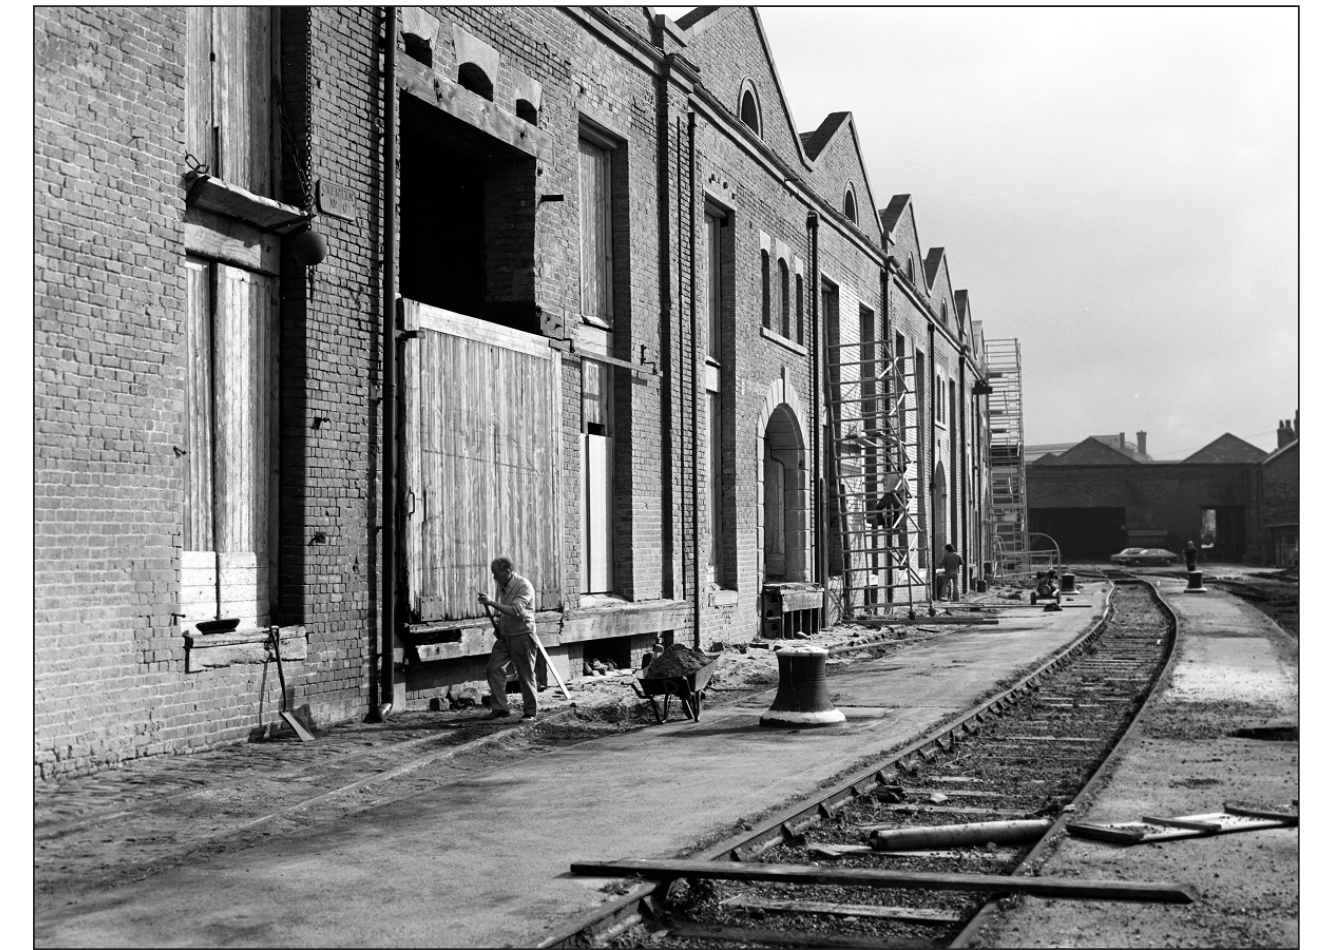
By the early 1980s, the 1830s building was in a poor state of repair and fully derelict. In 1982, the arches to the western end were converted to form a link between the 1830s Warehouse and the Station Building. Two arches were fitted with new concrete floors to form part of the Gas Gallery in 1990. A series of further phased works were undertaken and completed in 1997.

Image 7 : Photograph showing 1830S Warehouse works underway for museum conversion, 1980s, Manchester Archive.

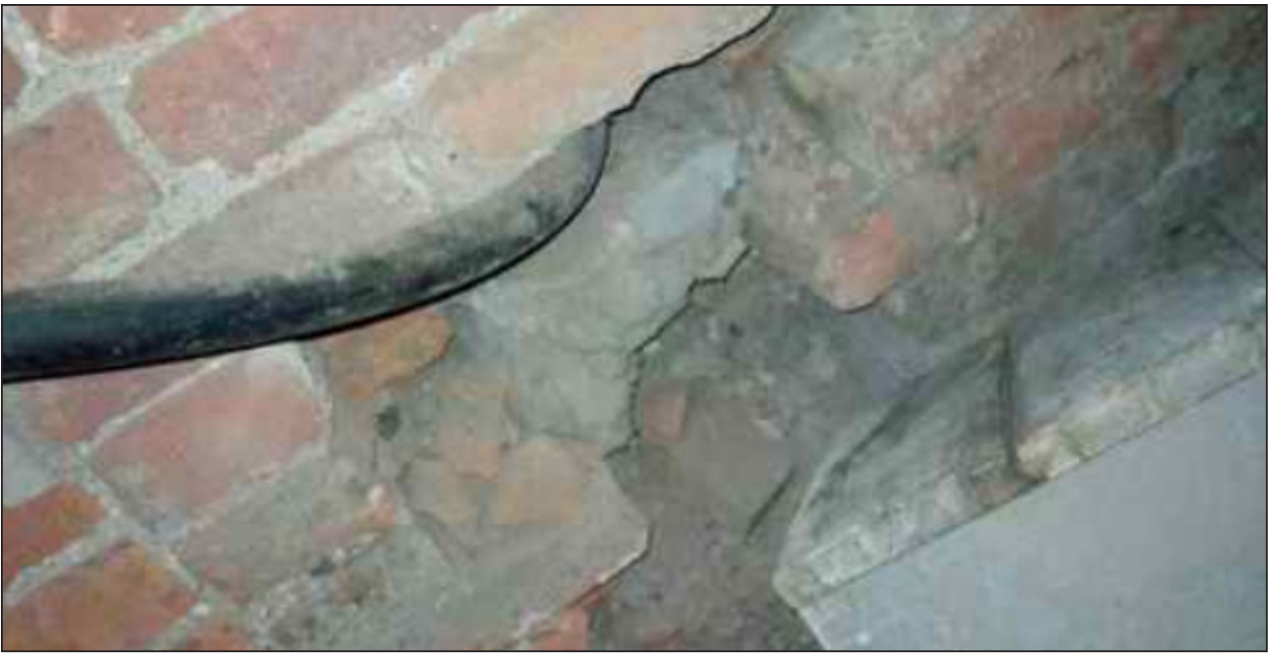
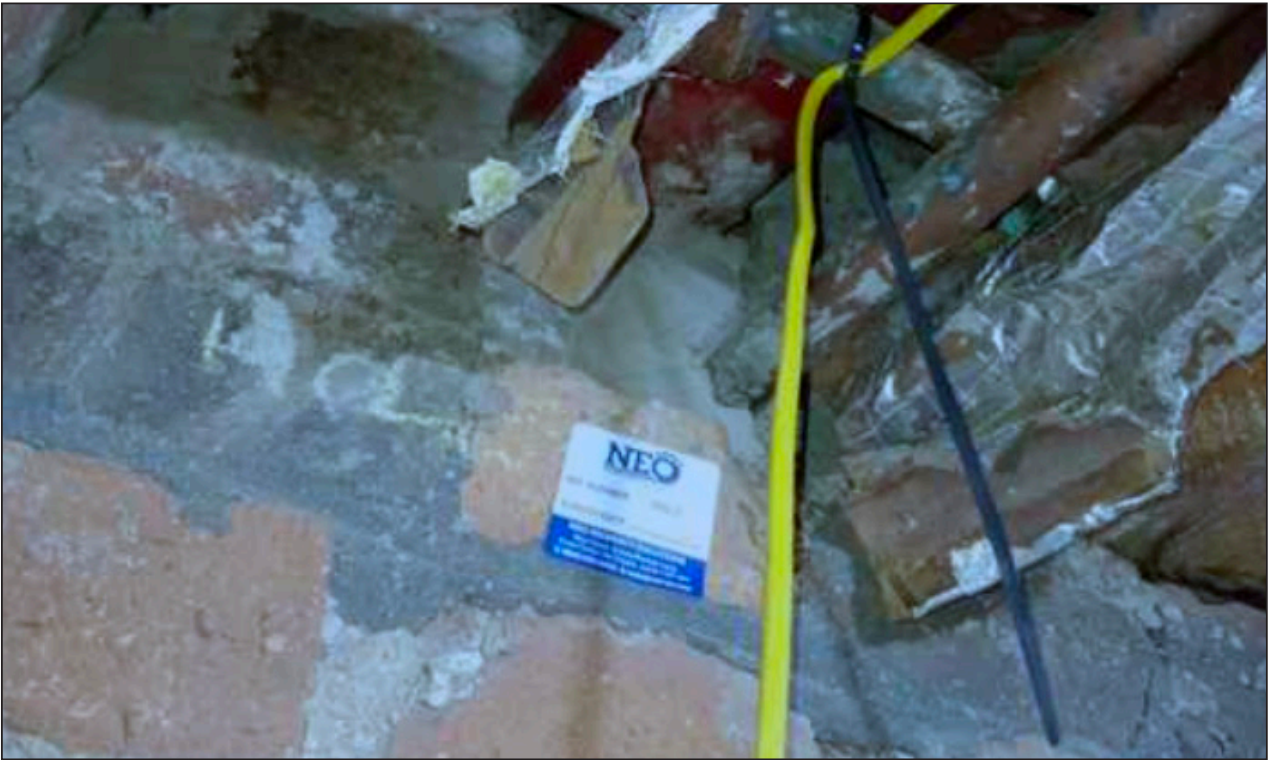
Images 15, 16, 17, showing examples of repair locations at PIN locations 0020:38, 60:38 and 53:38

PIN Location: 0001:38, 0020:38, 00086:38  
 Methodology: COMP\_MET\_501  
 Change: Non-compliant glazing to be replaced with new fire rated version.  
 Impact: Neutral, there will be negligible visual change.

PIN Location: 00060:38, 0006:38 0007:38, 0008:38, 0161:38  
 Methodology: COMP\_MET\_503 COMP\_MET\_502  
 Change: Brickwork repair where required with like for like handmade red bricks pointed in agreed lime mortar mix. Fire-batting and intumescent seals to be applied to voids and around pipes, cables, and cable trays.  
 Impact: Enhancement through careful repair of brickwork, fire batting and sealant will have a minimal impact on historic fabric and aesthetics, which will have a negligible adverse impact. This is considered to be greatly outweighed by the advantages of fire protection to the building.

PIN Location: 0012:38, 0053:38, 0158:38, 0165:38, 0166:38 009:38 00013:38 0107:38  
 Methodology: COMP\_MET\_506 COMP\_MET\_505 COMP\_MET\_519  
 Change: Sealing around gaps to cable, tray, conduit, pipes, trunking, and holes in existing penetrations. Cleaning of brickwork and careful removal of graphite coloured material where present to brick surface using hand tools/poultice. Remove damaged brick pieces where present, using hand tools only. New mortar to mix to be agreed. New hand-made bricks (to match existing) to be added, where required, leaving smallest opening necessary to feed cables/pipes. Bedded and pointed with lime-based mortar. Use of ablative batt where needed and sealing of gaps with intumescent sealant and backing.  
 Impact: Enhancement, through removal of non-original inappropriate material. These changes are to existing penetrations, which will be filled with like for like bricks and minimal amount of intumescent material to protect from potential fire spread risk. This approach involves no/very minimal harm to historical fabric.

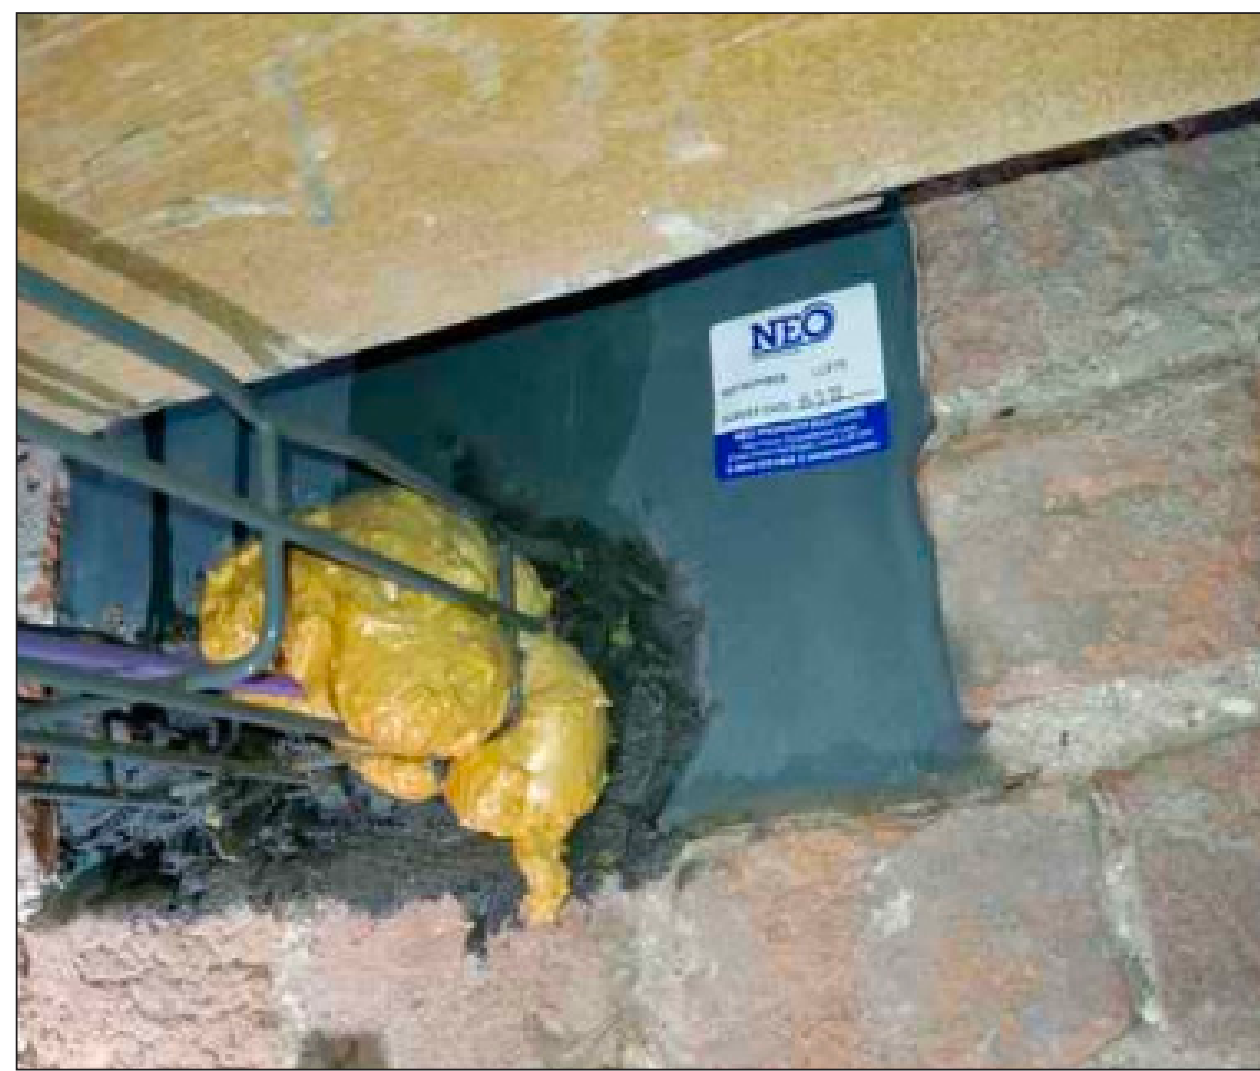
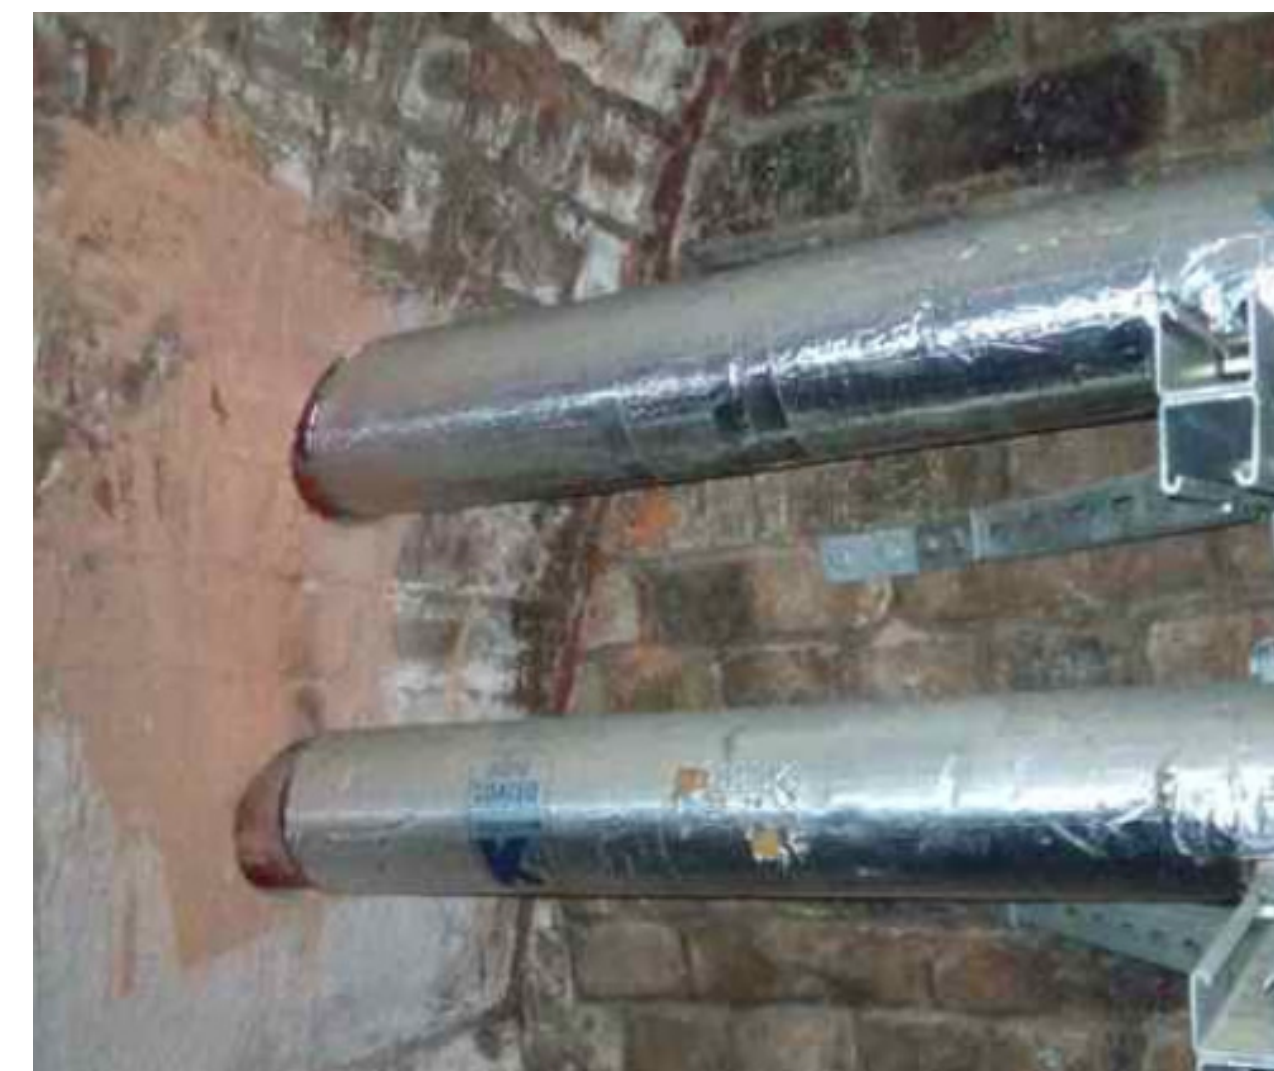
Images 18 and 19 showing typical repair location at 013:38 and 0025:38

Change: Sealing gaps around cable, cable trays, conduit, pipes, trunking, and holes in existing penetrations. Cleaning of brickwork and careful removal of foam and mastic to holes using hand tools/poultice. New mortar to mix agreed. New hand-made bricks to be added where required, leaving smallest opening necessary to feed cables/pipes. Bedded and pointed with lime-based mortar. Sealing of gaps with intumescent sealant and backing.

Change: Sealing around gaps to cable, tray, conduit, pipes, trunking, and holes in existing penetrations. Cleaning of brickwork involves removal of existing mortar around cable and face of masonry. Removal with hand tools or to be left in-situ if cannot be removed without damage to brickwork faces. Mortar mix to be agreed. Intumescent sealant and backing to seal holes.

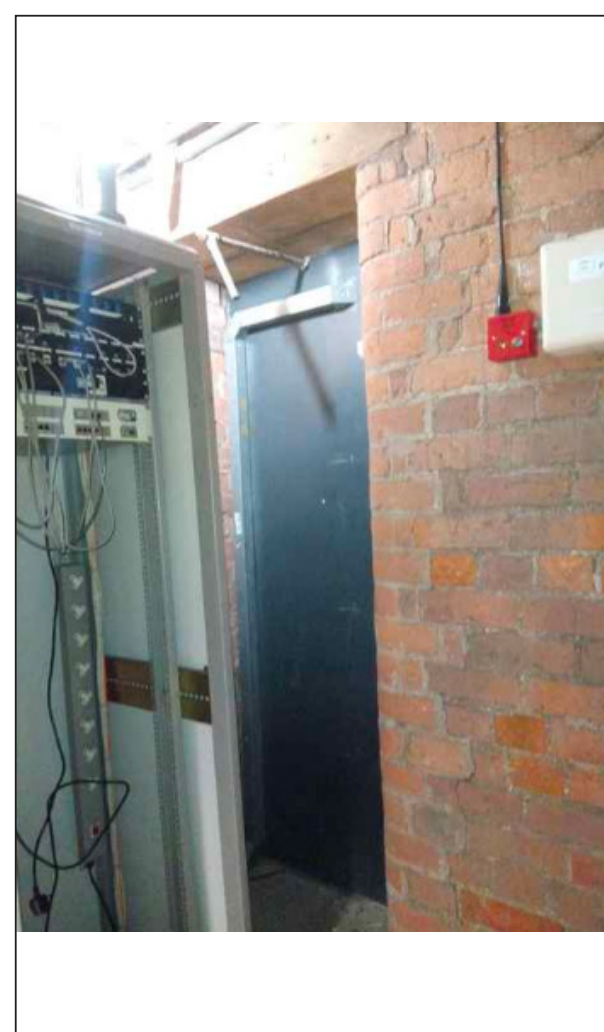
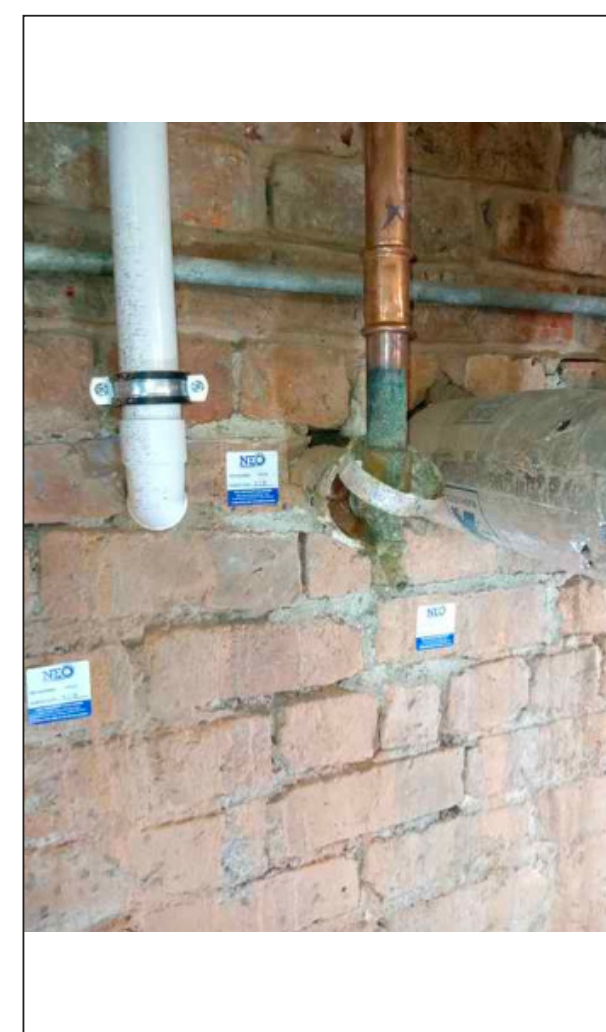
Images 24 and 25: Locations 0058:38 and 0074:38

Images 26 and 27: Locations 0078:38 and 0120:38

Change: Removal of non-compliant existing partition. Removal of redundant conduit. Installation of new fire rated partition, sealed with intumescent sealant and Rockwool. All metal studs to be fixed in mortar joints only. New timber skirtings to match existing and redecoration to match existing. Work to historical fabric to be carried out with hand tools such as plasterers' small tools, half hacksaw blades, pointing keys, and specially made steel hooks. Power tools will not be permitted. Impact: Replacement of existing partition with new has neutral impact. Providing fire protection is an enhancement, lowering risk of potential fire spread.

Change: Seal around cables, trays, conduit, pipes, trunking, and holes. Lagging to be pulled back and brickwork to be repointed in appropriate lime mortar mix to be agreed. Insulation backing and intumescent sealant to be applied to existing service penetrations. Impact: Enhancement of historic fabric with appropriate pointing. Fire protection seals to existing holes is an enhancement, lowering risk of potential fire spread.

Change: New fire partition required. Repoint brickwork, fixing of new partition into mortar joints only, lime mortar mix to be agreed. Intumescent sealant to be applied to perimeter of new partition. Work to historical fabric to be carried out with hand tools such as plasterers' small tools, half hacksaw blades, pointing keys, and specially made steel hooks. Power tools will not be permitted. Paint new plaster to new partition. Impact: Minor adverse with addition of non-original partition. Considered justified on the basis that the fire report has

Change: Fire stopping to be added to head of wall by installation of ablative coated batt to face of timber- installed vertically, intumescent seal to perimeter.
