# PHASE 2 SITE INVESTIGATION

Plots O + N, Mayfield

Mayfield Partnership Ltd

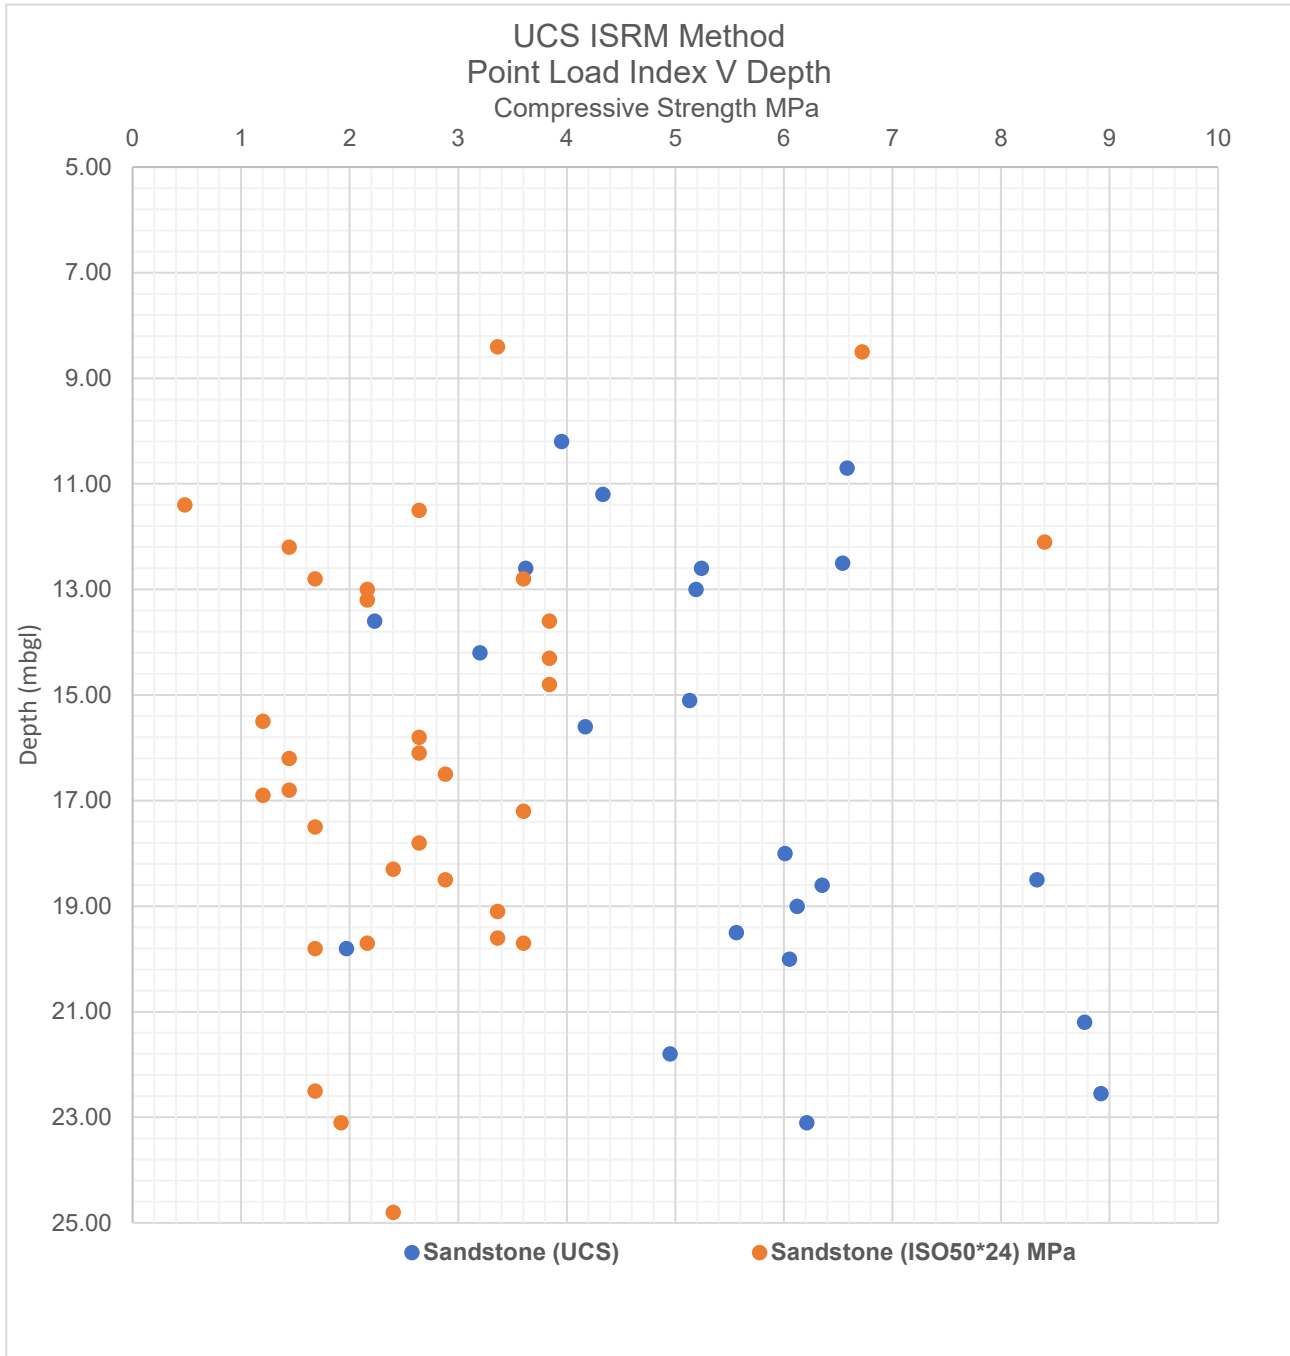
**FIGURE 7.1: Uniaxial Compressive Strength and Interpreted UCS**

- 10.0.10 As discussed in Section 7.0, laboratory testing, Uniaxial Compressive Strength and Point Load Index ( $Is_{50}$ ) testing was undertaken on suitable rock core samples. The results of the UCS and the estimated UCS from Point Load Index ( $UCS = Is_{50} \times 24$ ) are present in Figure 7.1

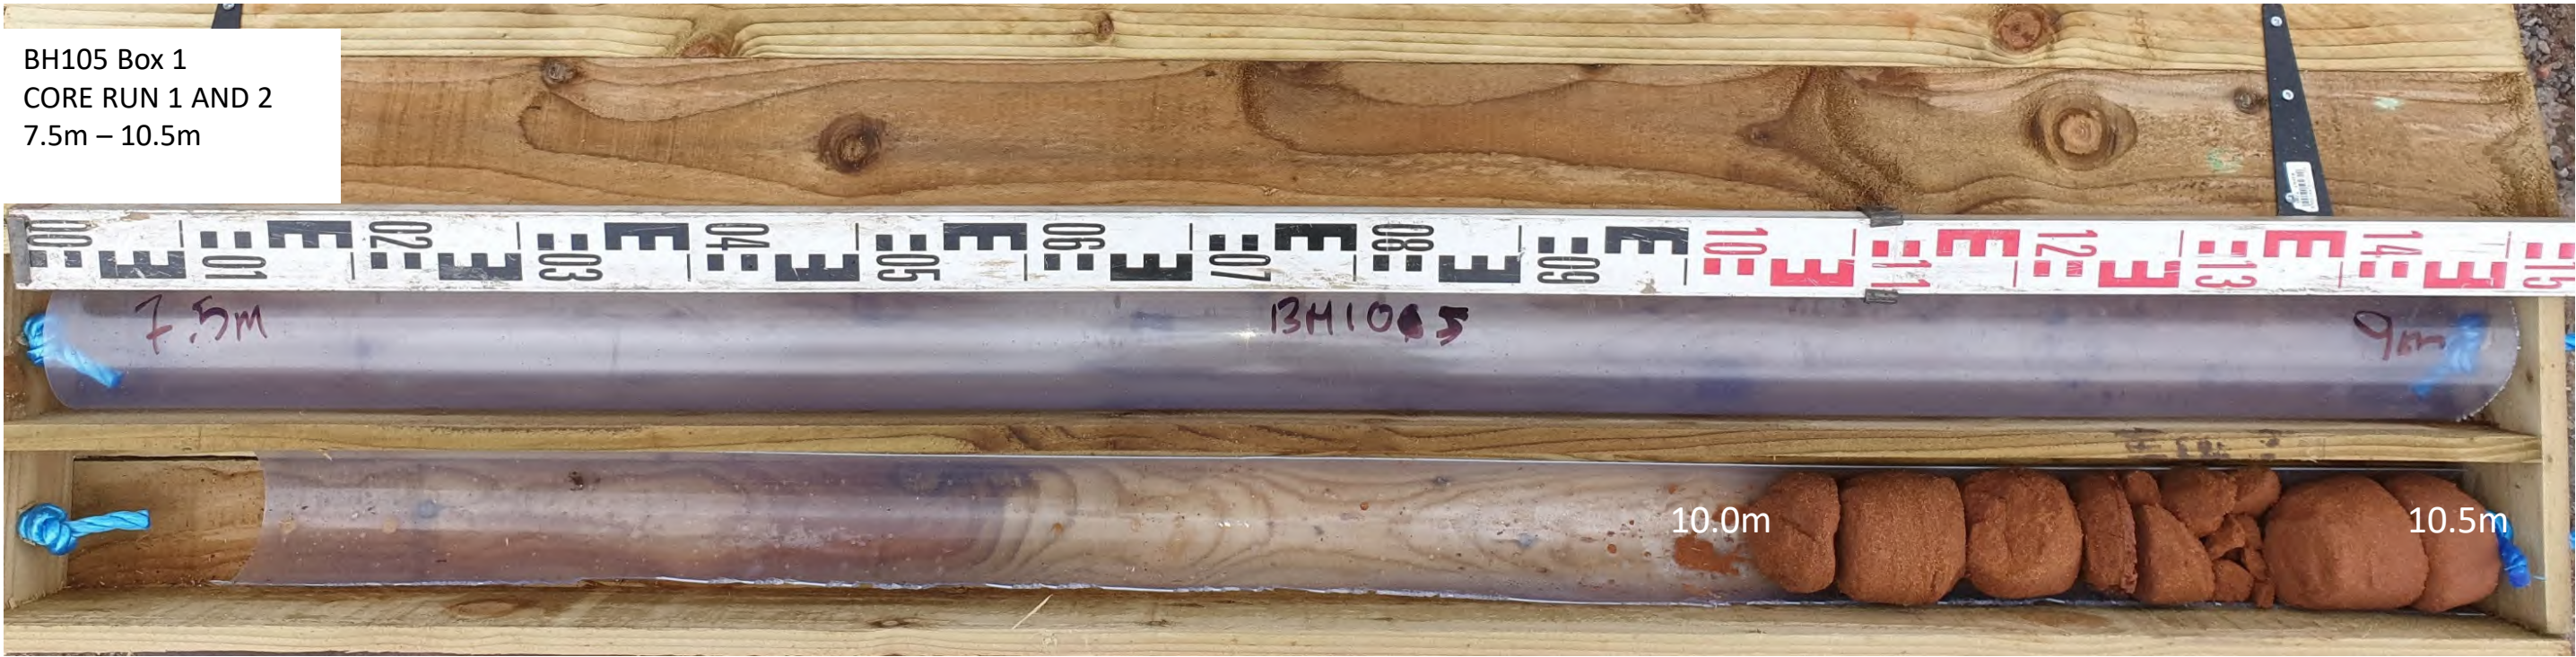
BH105 Box 1  
CORE RUN 1 AND 2  
7.5m – 10.5m

- 10.0.8 The rock core (photographic evidence of which is provided within Appendix B) included frequent zones of non-intact, weathered or total core loss with depth with strengths reported as extremely weak to very weak to weak (refer to UCS and Point Load testing results on core specimens provided within Appendix D. The broken nature of bedrock beneath the site could potentially be related to historic ground movement associated with a nearby geological fault line.

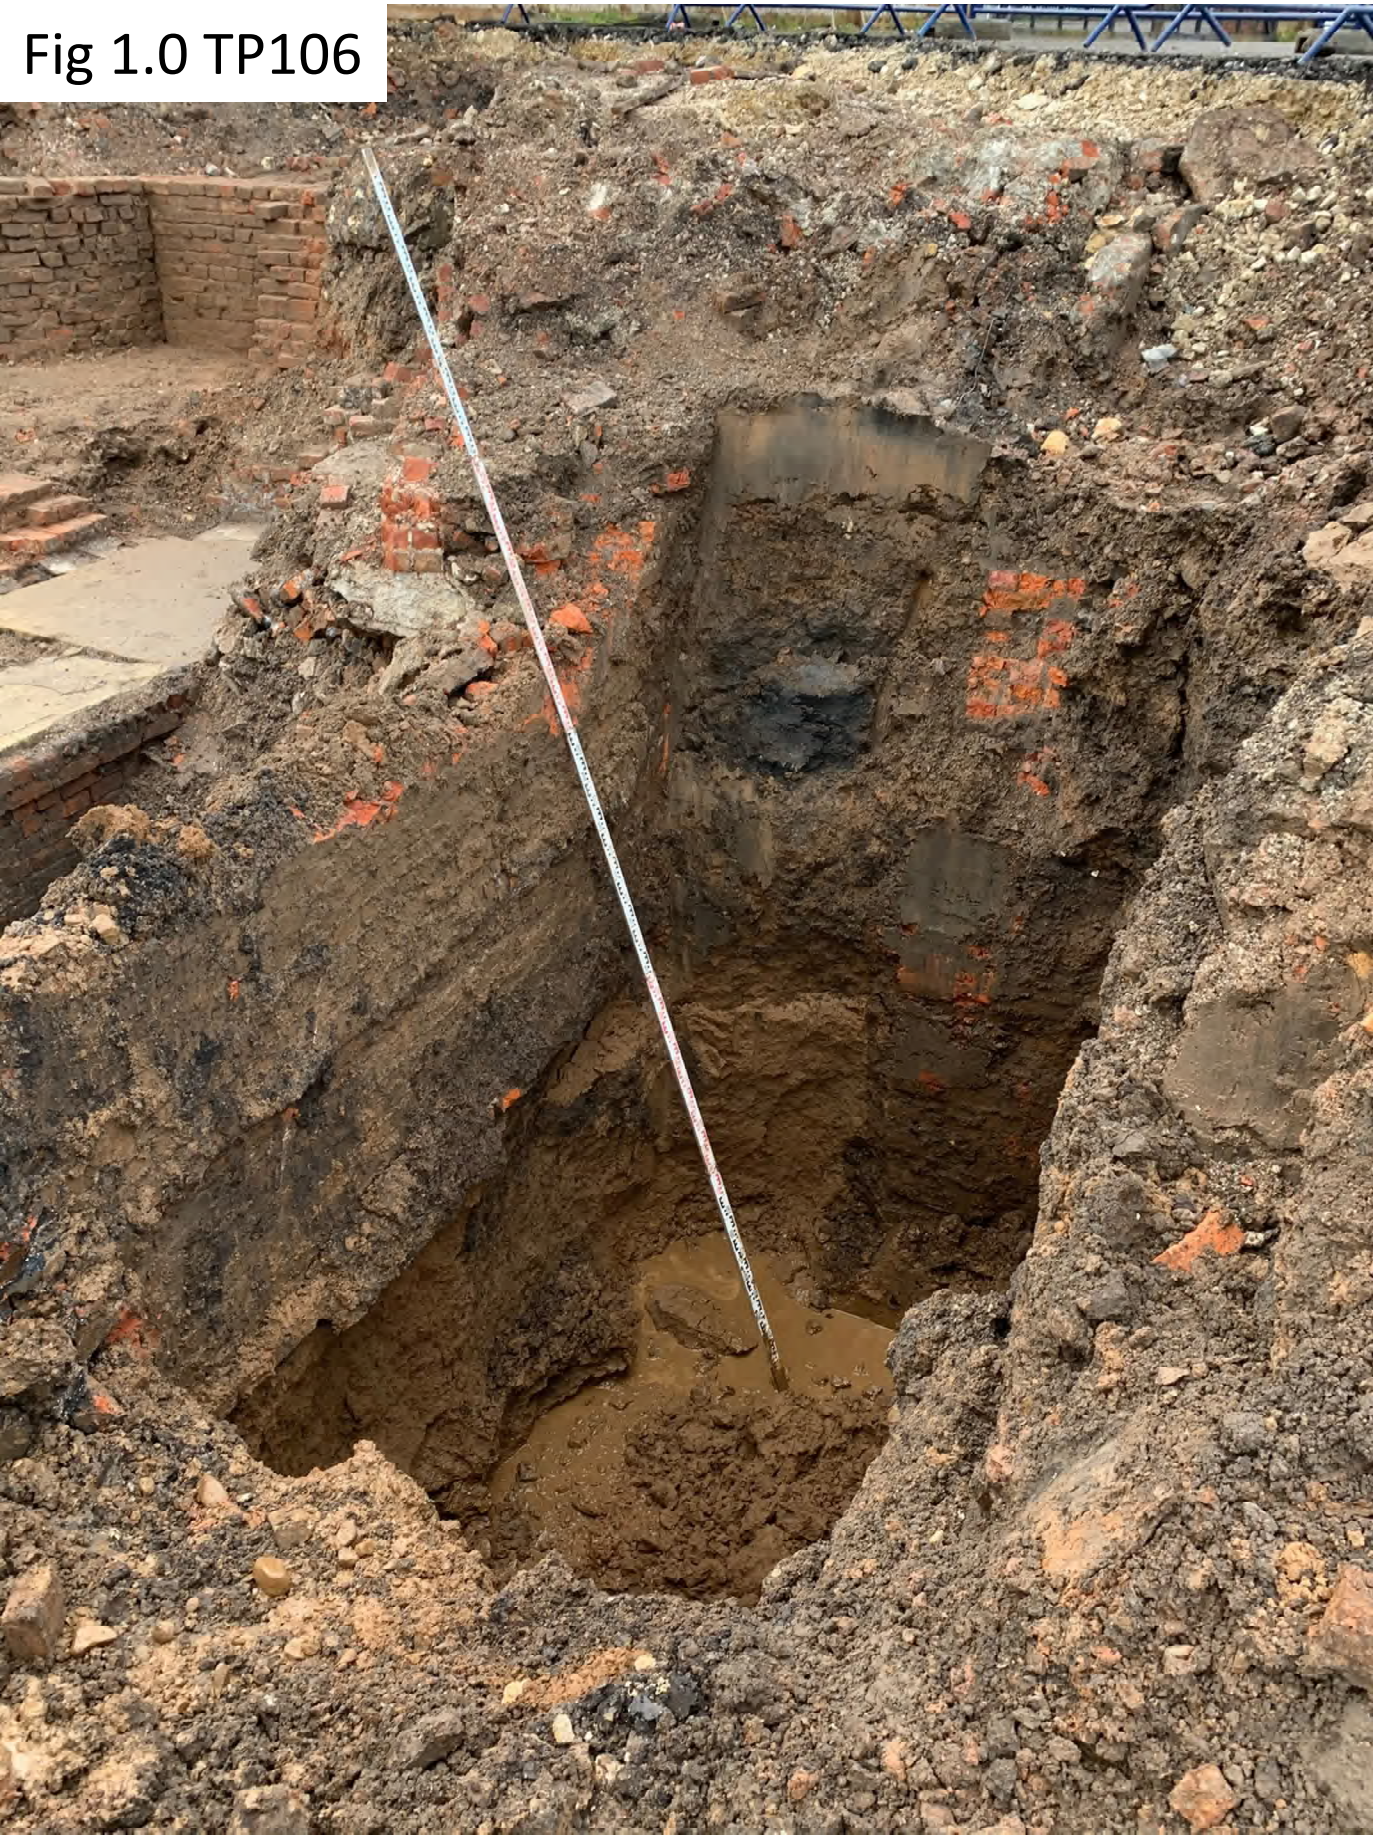
Fig 1.0 TP106

- 6.1.7 As previously discussed, a program of additional ground investigation works was completed across the Mayfield Baths site (within the former Poulton Office footprint) to further assess ground conditions in this area. The works comprised the formation of x5 trial pits (TP106 to 110) within and around the baths to confirm ground conditions.

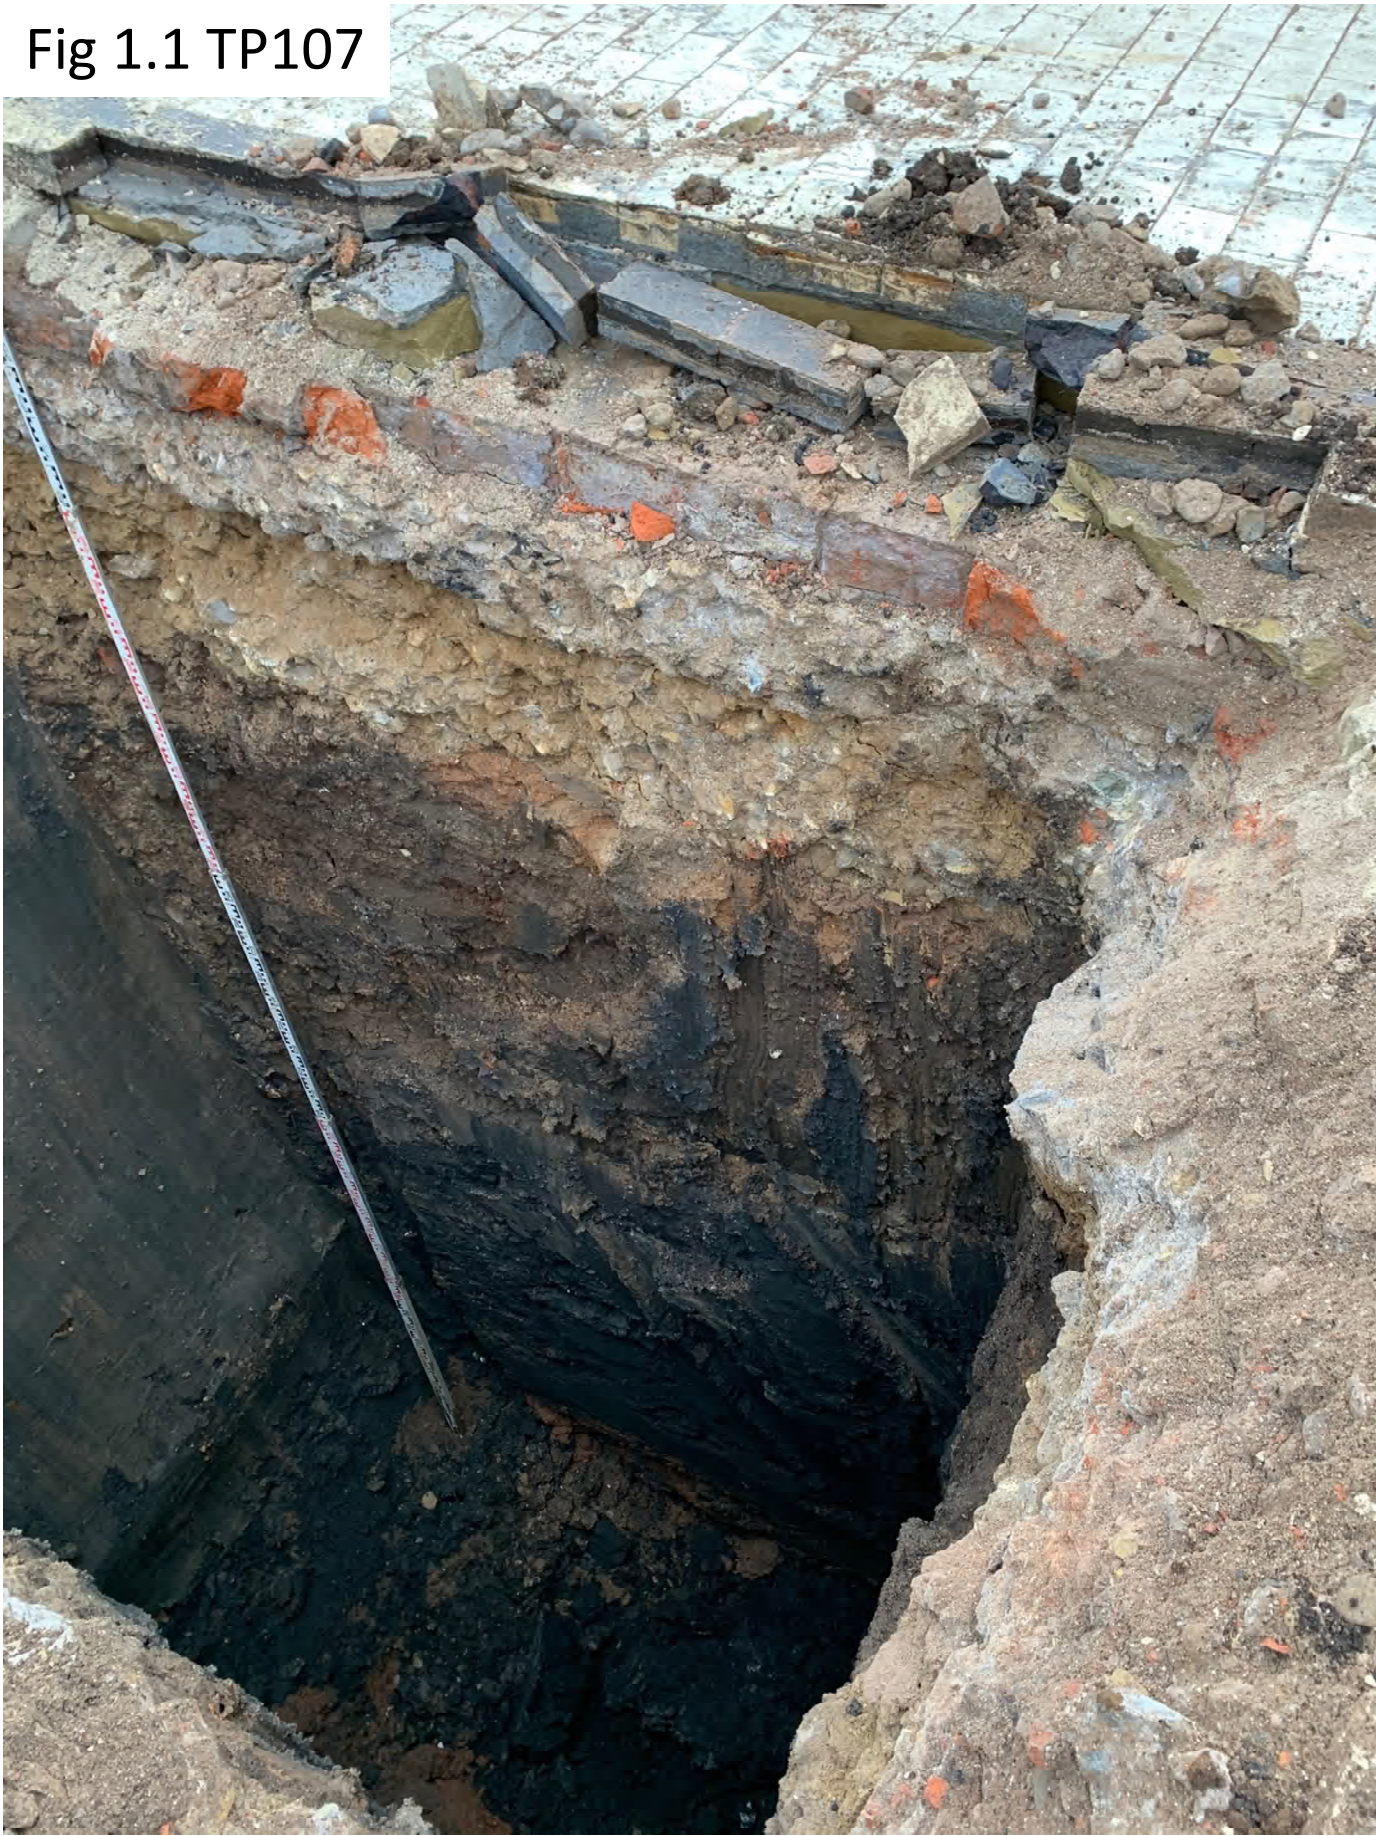
Fig 1.1 TP107

- 6.1.8 Made ground was reported at all exploratory locations comprising a mixture of demolition type fill material and the Victorian construction build up of the swimming pools (a detailed description of which is provided on TP107 log and accompanying photographs within Appendix B). The depth of made ground varied around the baths to depths between 30.0 and 32.9mAOD with some brick walls and structures found to extend to significant depths beneath the site (possible relating to old drainage infrastructure) e.g. brick wall noted in TP108 that extended to a depth circa 28.8mAOD.

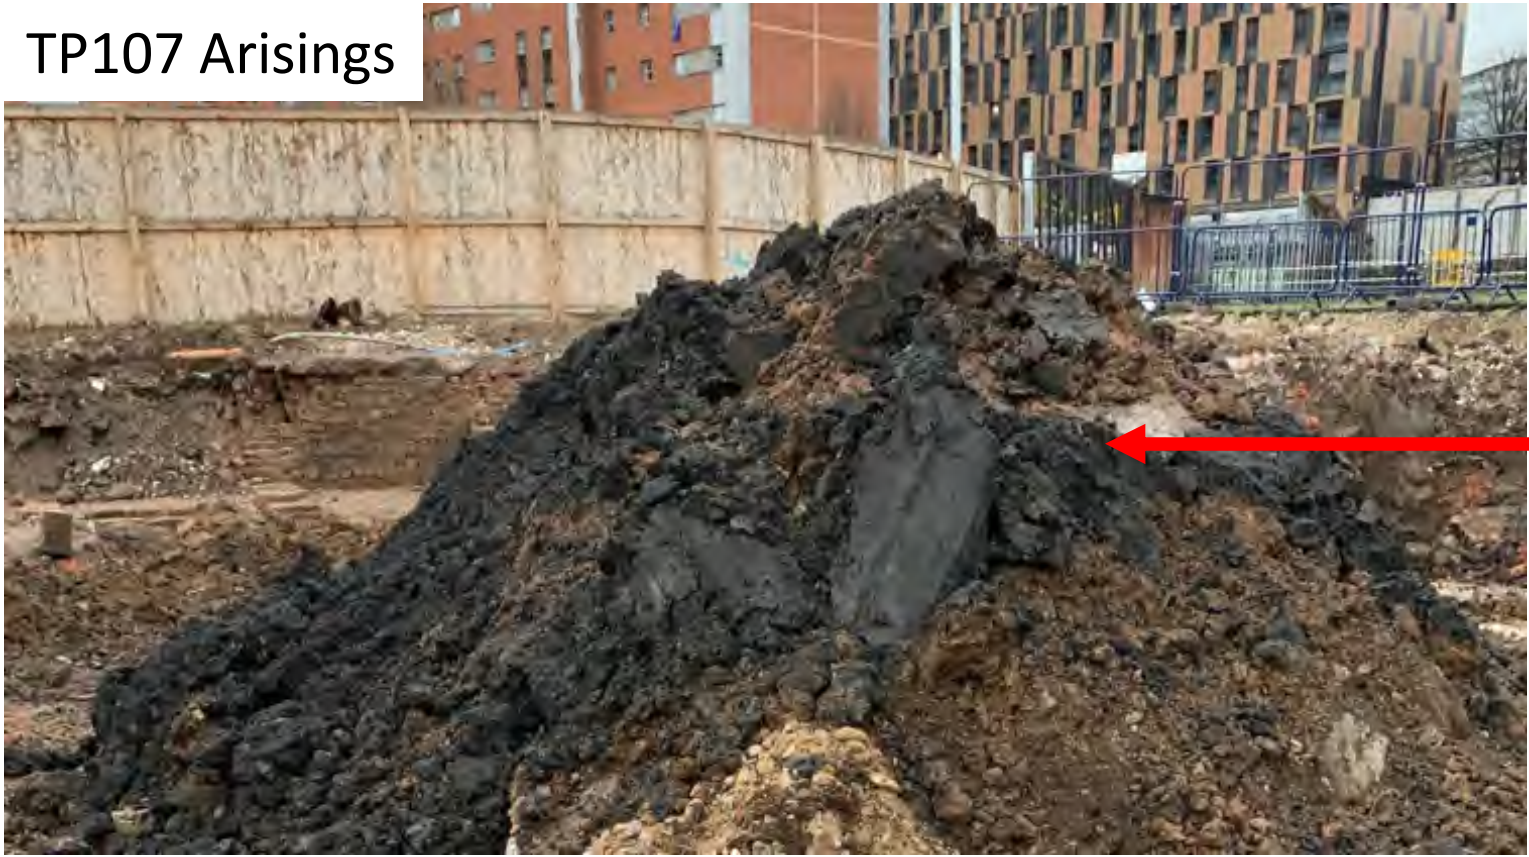
TP107 Arisings

Organic rich clay

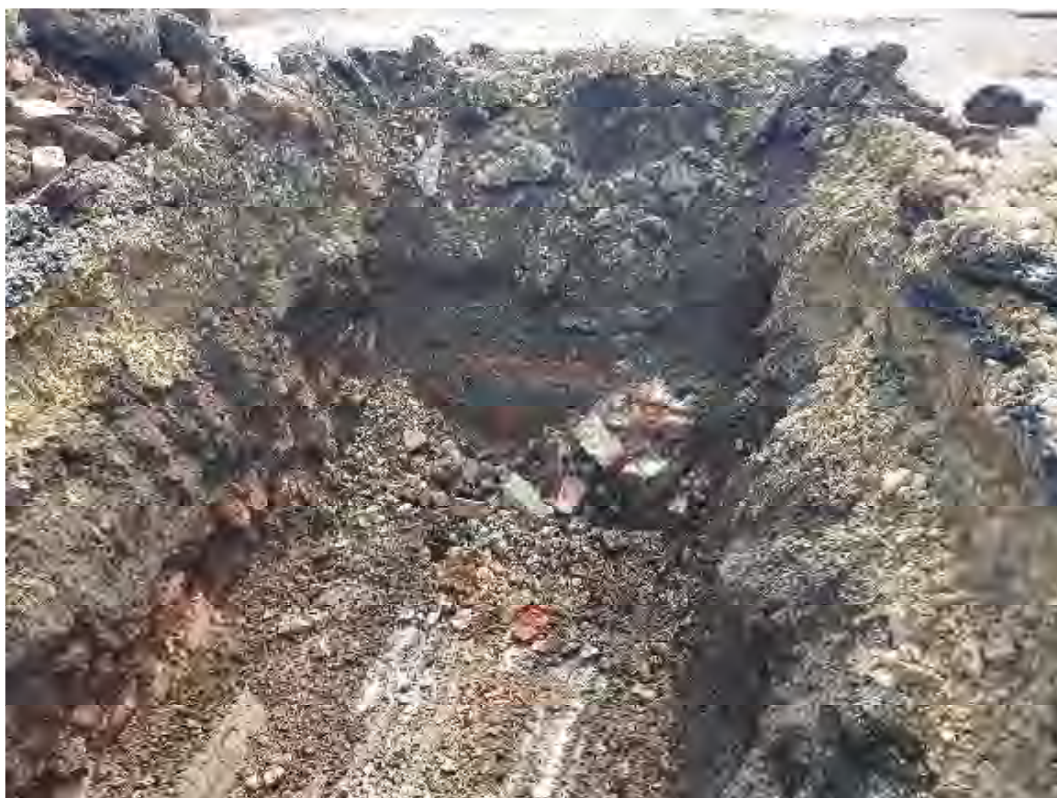
Photo No. 15: TT02

- 6.2.1 Within TT02 at 1.50m a bitumen odour was noted upon exposing a concrete obstruction. No further olfactory evidence of contamination was noted. Suspected asbestos cement was noted within three locations (BH105, TT03 and TT01) within Made Ground deposits. Subsequent analysis confirms the material to be chrysotile cement.
- 6.2.2 Groundwater strikes were reported within two boreholes. Groundwater strikes were observed in BH108 at 6.00m rising to 5.50mbgl (29.2mAOD) and in BH109A at 6.00m rising to 5.40mbgl (30.05mAOD).
- 6.2.3 Resting groundwater monitoring results (as revealed from borehole standpipes) indicate a groundwater table within the Made Ground, superficial and sandstone bedrock deposits at depths ranging between 3.57m and 5.40m. Full details of monitoring results have been provided within Appendix E.
