# Echo Street, Manchester

## Remediation Strategy

Curtins Ref: 065374-CUR-00-XX-RP-GE-80004-P03

Client Name: iQ Student Accommodation

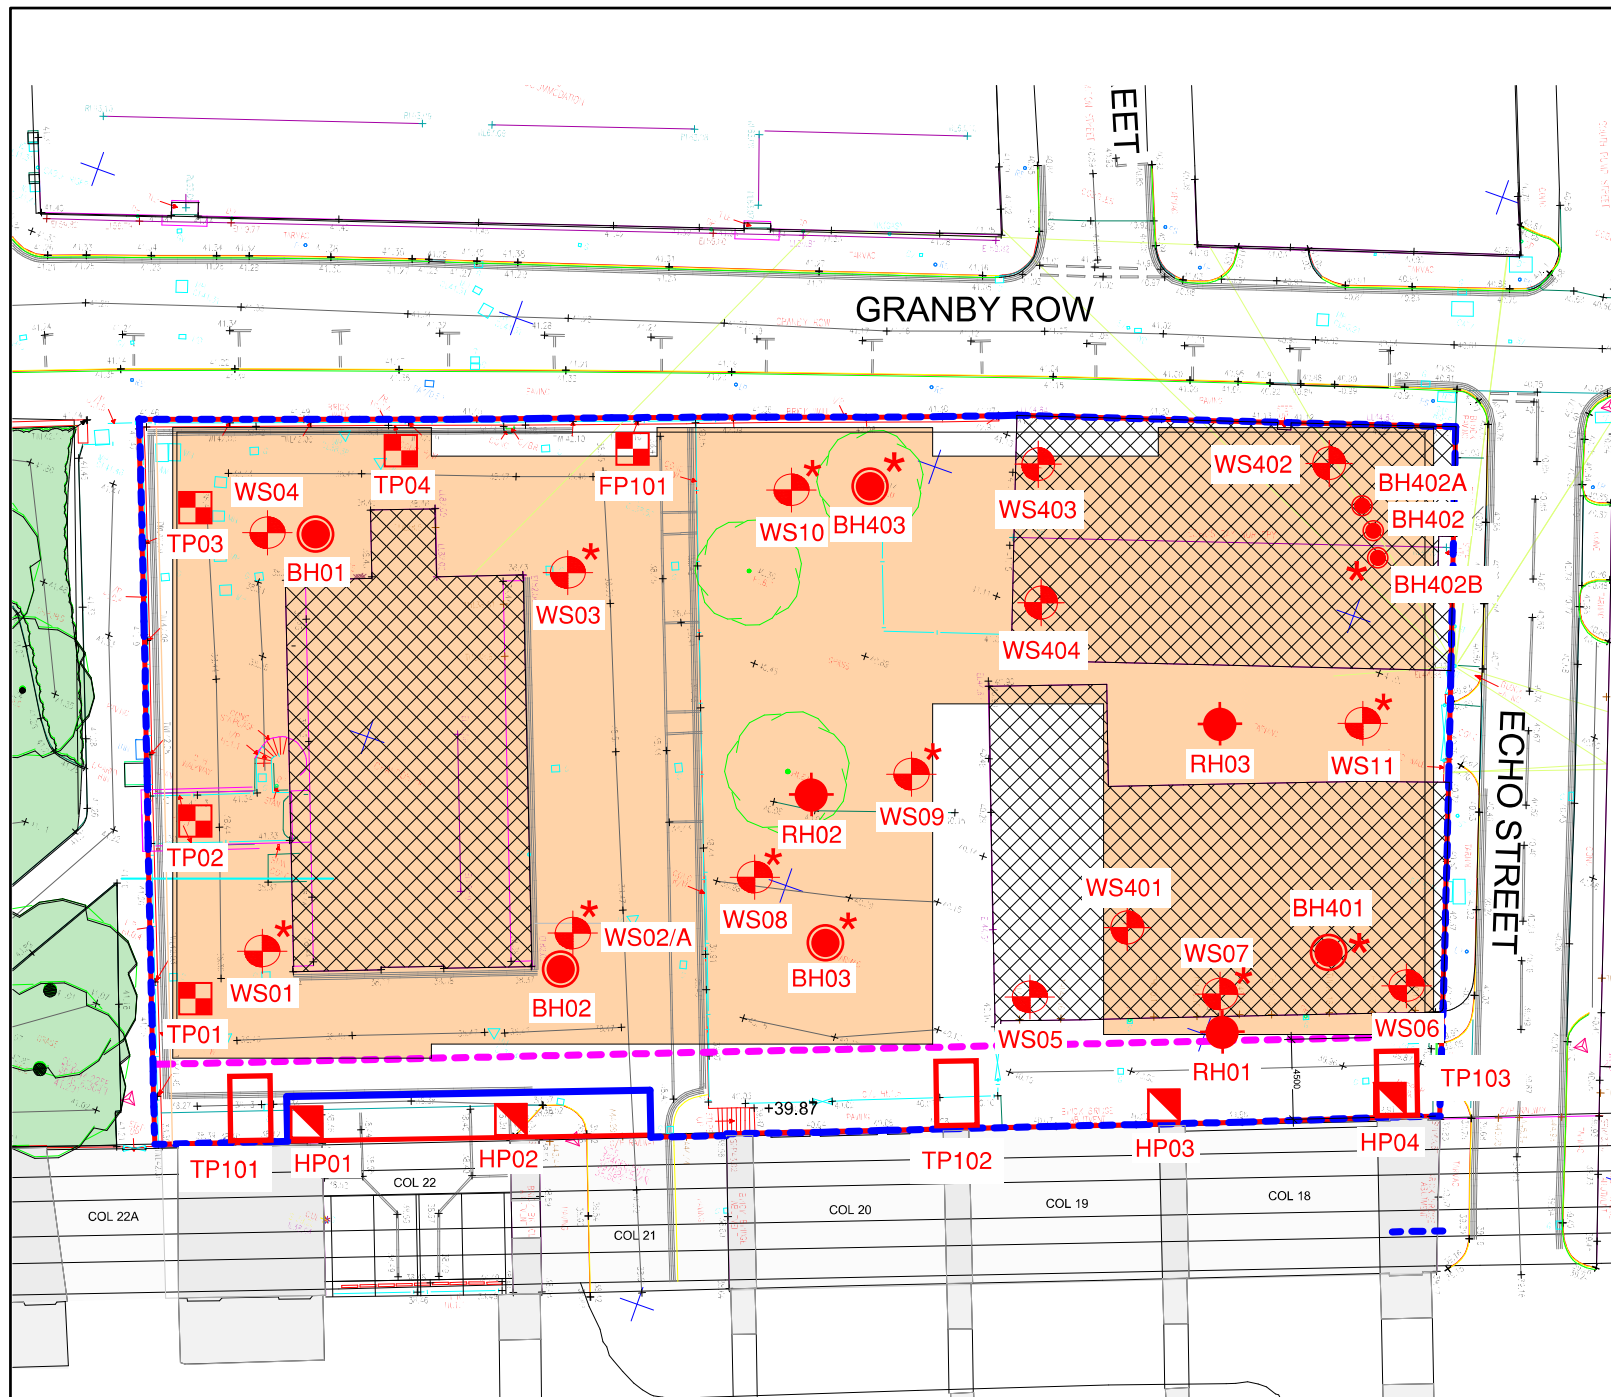
| Drg No: | Rev: |
|---|---|
| 065374-CUR-00-XX-DR-GE-005-V03 | / |

Borehole and trial pit locations are shown on the ref. 065374-CUR-00-XX-DR-GE-005-V03 and drawing ref. 065374-CUR-00-XX-DR-GE-006-V02 contained within *Appendix A*. The investigations generally revealed the following:
