# Phase 2 Site Investigation

## Parsonage Street Redevelopment

## Mawlawi Kurdish Cultural Centre

18 / 01 / 2023

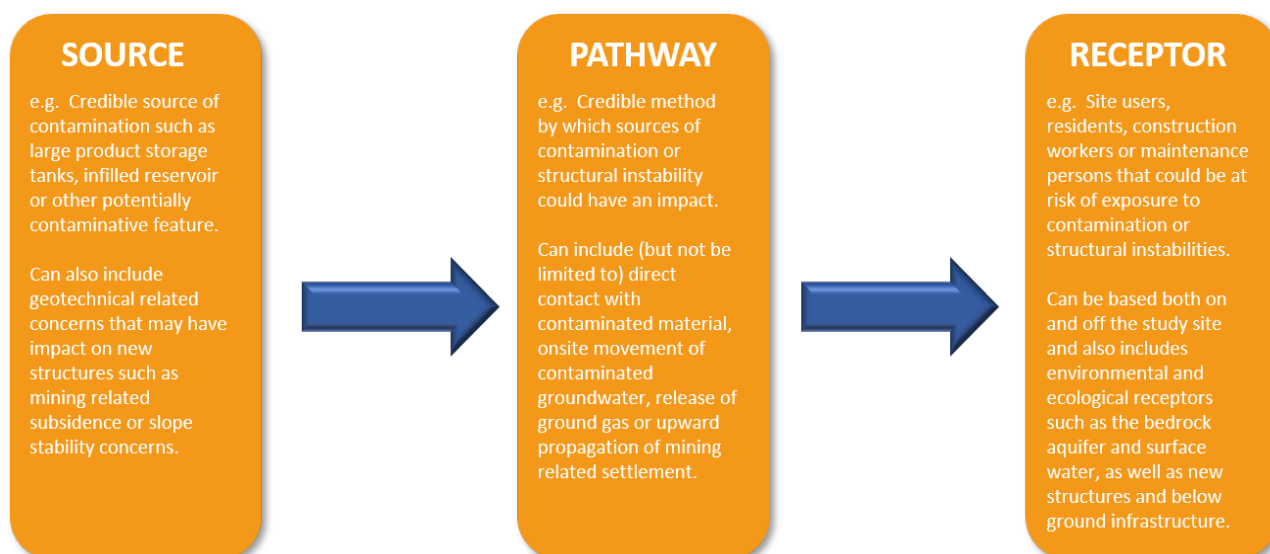
**Figure 8.0 Source Pathway Receptor Diagram**

- 8.0.3 In accordance with this method, a Refined Conceptual Model has been collated for the site based on the results of the desktop review. This model is based around the Source / Pathway / Receptor methodology as outlined in Fig 8.0.

- 8.0.4 Risk assessment is the process of collating known information on a hazard or set hazards in order to establish actual or potential risks to receptors. The receptor may be human health, controlled waters, a sensitive local ecosystem or even construction materials. Receptors can be connected with the hazard under consideration via one or several exposure pathways (e.g., the pathway of direct skin contact and oral exposure).

- 8.0.5 Risks are generally managed by isolating or removing the hazard, isolating the receptor, or by intercepting the exposure pathway. Without the three essential components of a source (hazard), pathway and receptor, there is deemed to be no risk. In other words, the mere presence of a hazard at a site does not mean that there will necessarily be risks.
