# Echo Street, Manchester

## Phase 2 Site Investigation

Curtins Ref: 065374-CUR-00-XX-RP-GE-80002-P03 Echo Street

Client Name: iQ Student Accommodation

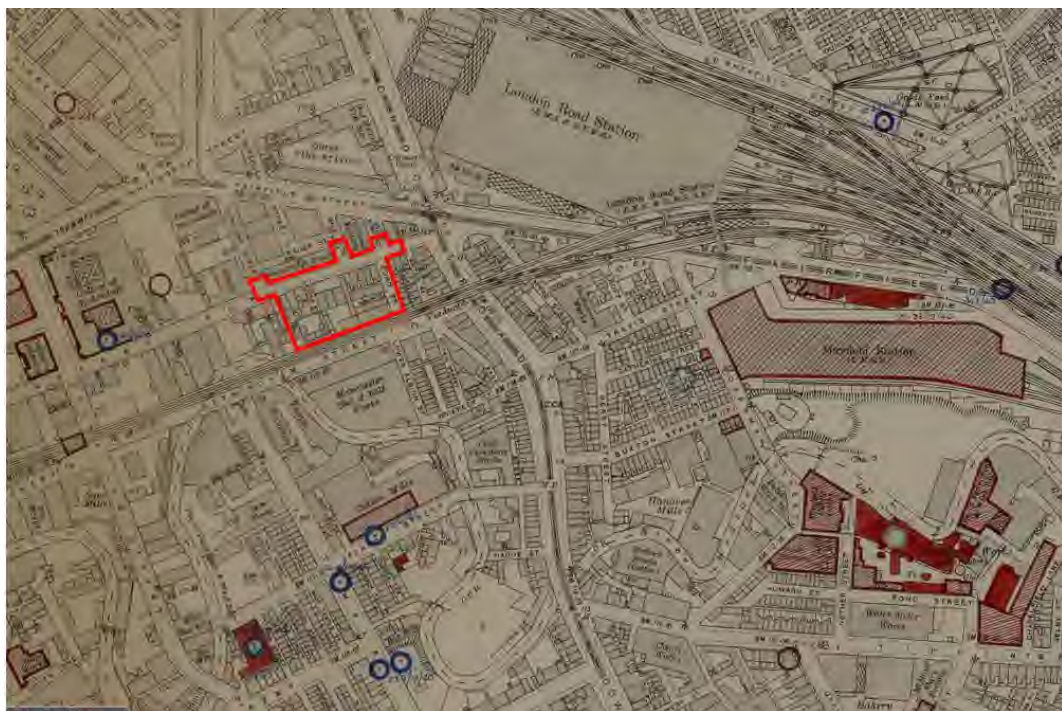
**Figure 2.6a** Map of bomb damage in Manchester from WWII. Site boundary identified in red.

Historical mapping shows a wharf 110m and 200m northwest of the site. A review of available Manchester Bomb Damage mapping was also undertaken indicating bombing ruins (red shading), several fire bombs (red circles), high explosives (blue circles) ruins and damaged buildings (dashed shading) in the immediate surroundings of the site.

- An area of clearance is noted in the northeast corner of the site. It is thought possible that this was because of a bomb strike/fire damage. If rubble and debris was present in this area, there is a risk that evidence of UXO could easily have been overlooked. UXBs falling into 'bomb sites' was one of the most common scenarios for this going unnoticed and unrecorded.
- The rest of the site appears to have survived the war intact.

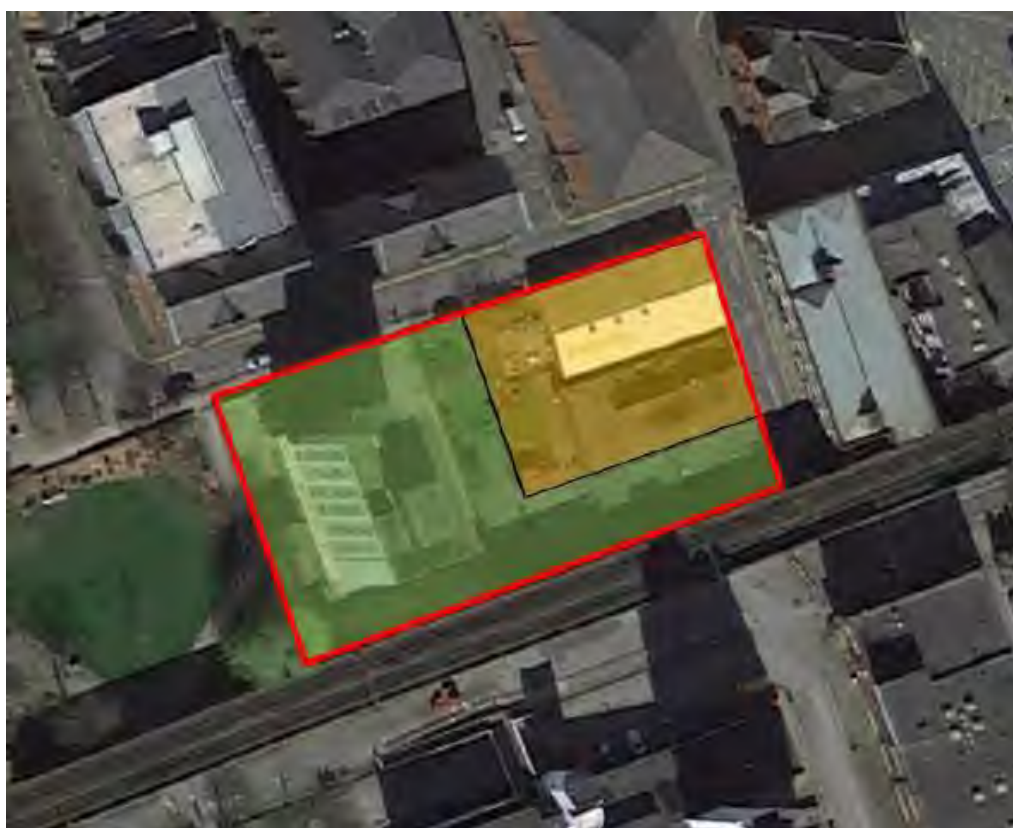
**Figure 2.6b** Zoned UXO Risk Map. Medium risk areas = orange. Low risk areas = green.

Given that most of the site appears to have survived the war, shows no signs of damage and was likely accessed frequently, this part of the site has been given a **Low** Risk. The area within the northeast of the site is shown as cleared on post-war aerial photography. Given the poor quality of the record set for Manchester, it has not proved possible to prove that this clearance was not due to bombing. Thus, this area, with a small buffer to account for the 'J-curve' effect, has been given a **Medium** Risk. The zoned risk areas are shown in *Figure 2.6b* below.

As such the following risk mitigation measures were recommended to support the proposed investigation works at the Echo Street site:

1. **All Works** – Site Specific Unexploded Ordnance Awareness Briefings to all personnel conducting intrusive works.
2. **Medium Risk Areas:**
  - a. *Open Intrusive Works (trial pits, service pits, open excavations, shallow foundations etc.)* – UXO Specialist On-site Support and Site Specific Unexploded Ordnance Awareness Briefings to all personnel conducting intrusive works.
  - b. *Boreholes and Piled Foundations* - Intrusive Magnetometer Survey of all borehole and pile locations/clusters down to maximum bomb penetration depth.

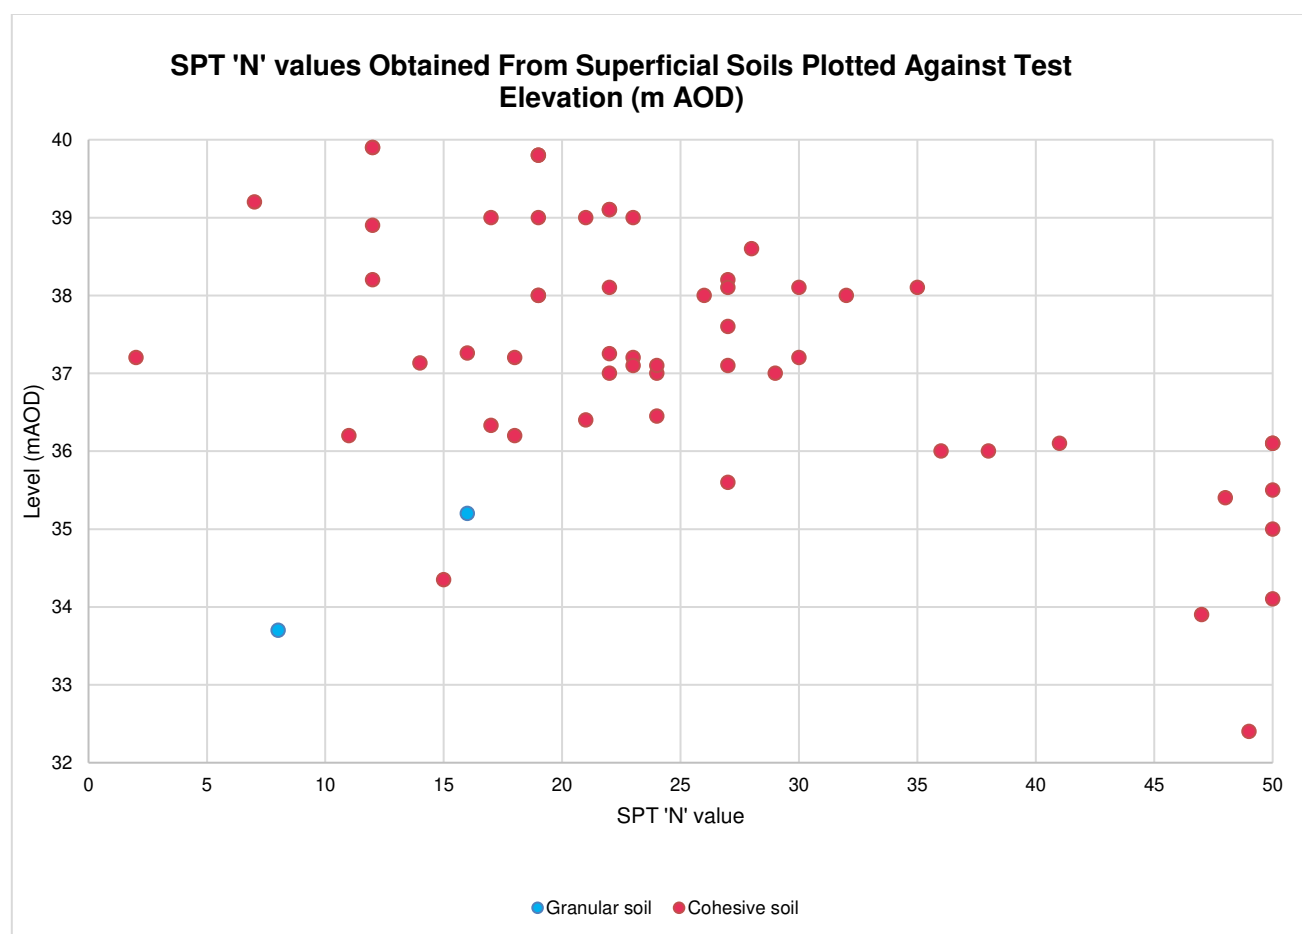
**Figure 5.3 – SPT 'N' Values vs Depth (values of >50 were recorded as 50).**

SPT 'N' Values in cohesive superficial soils generally increase with depth, though are generally variable, illustrated in *Figure 5.3*.

It should be noted that, as the SPT data is uncorrected, there may be some variation between the SPTs undertaken in the window sample boreholes compared to those undertaken in the cable percussive boreholes due to the different equipment used. Therefore, the characteristic 'N' values could equate to the lowest values recorded in each stratum; a characteristic SPT 'N' of 11 could be adopted for the cohesive and 26 for the granular superficial deposits, respectively. A review of  $N_{60}$  values confirm the lowest N values of 11 and 26 respectively, discounting locally soft deposits.

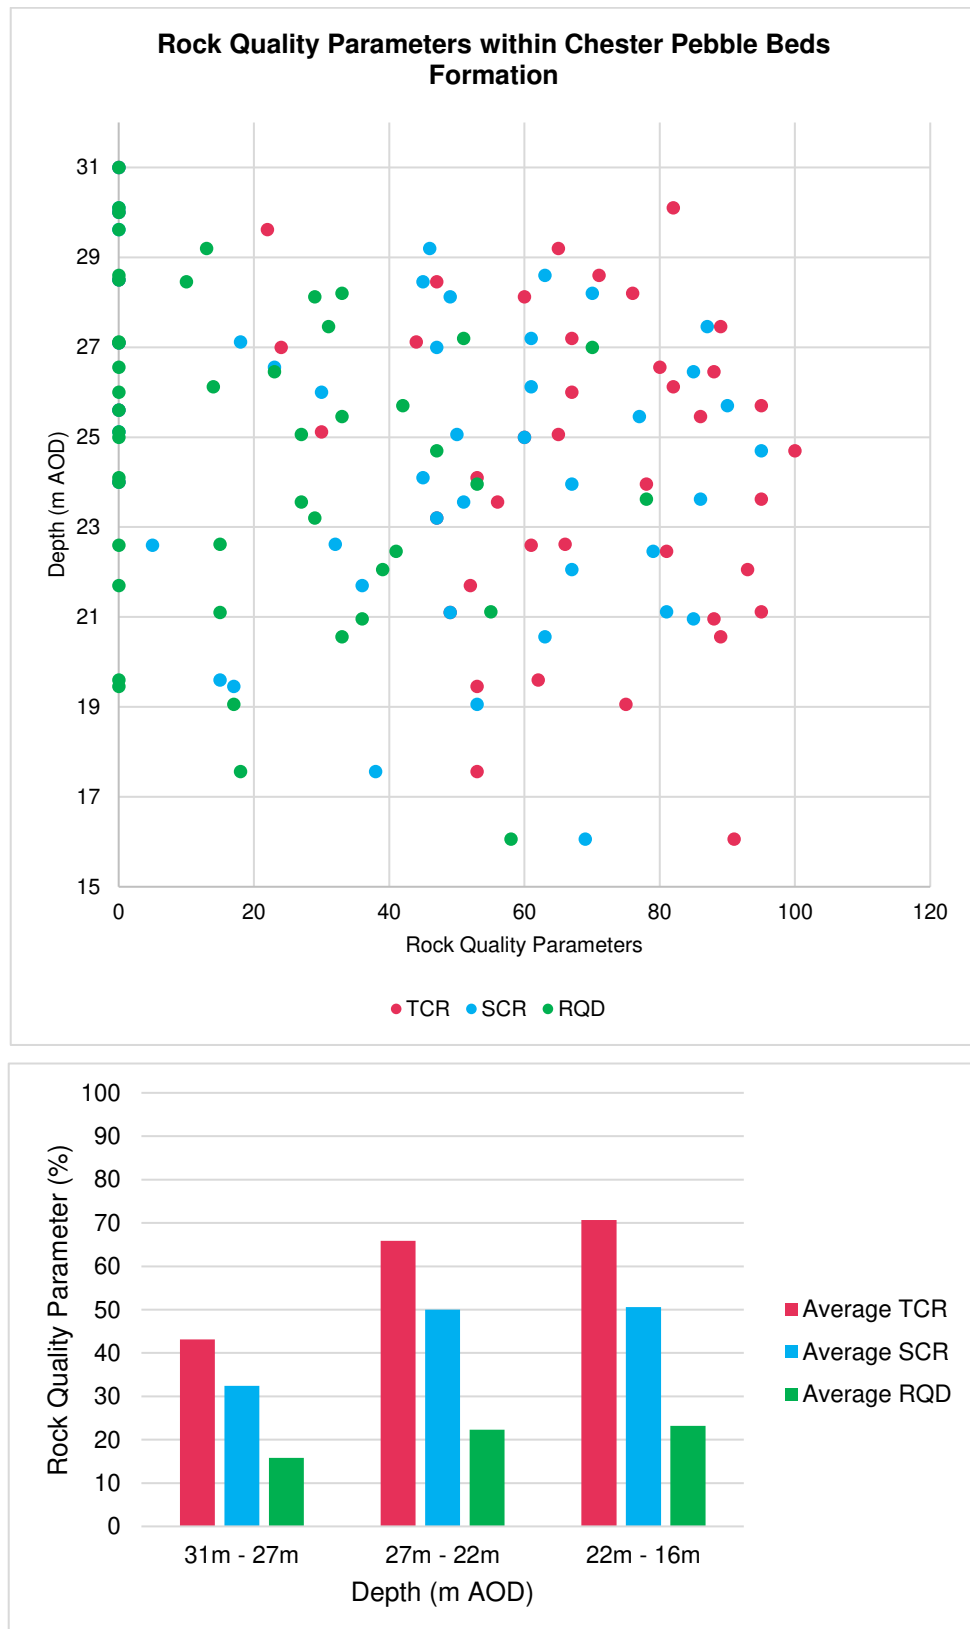
**Figure 5.5a – Summary of Rock Quality Parameters within Sandstone bedrock**

Rock Quality Designation (RQD) recorded in the exploratory hole logs ranged from 0% to 78%, averaging 19% in the bedrock formation. This classifies the rock as being of very poor to poor rock mass quality. The RQD varies significantly between core runs. The total core recovery (TCR) ranged between 0% - 100% and the solid core recovery (SCR) ranged between 0% - 95%. The variability in the quality of the rock core samples recovered during this investigation is illustrated in *Figure 5.5a*.

The base of the sandstone was not proven during this investigation. The boreholes were terminated at a maximum depth of 25.50m bgl (BH03).

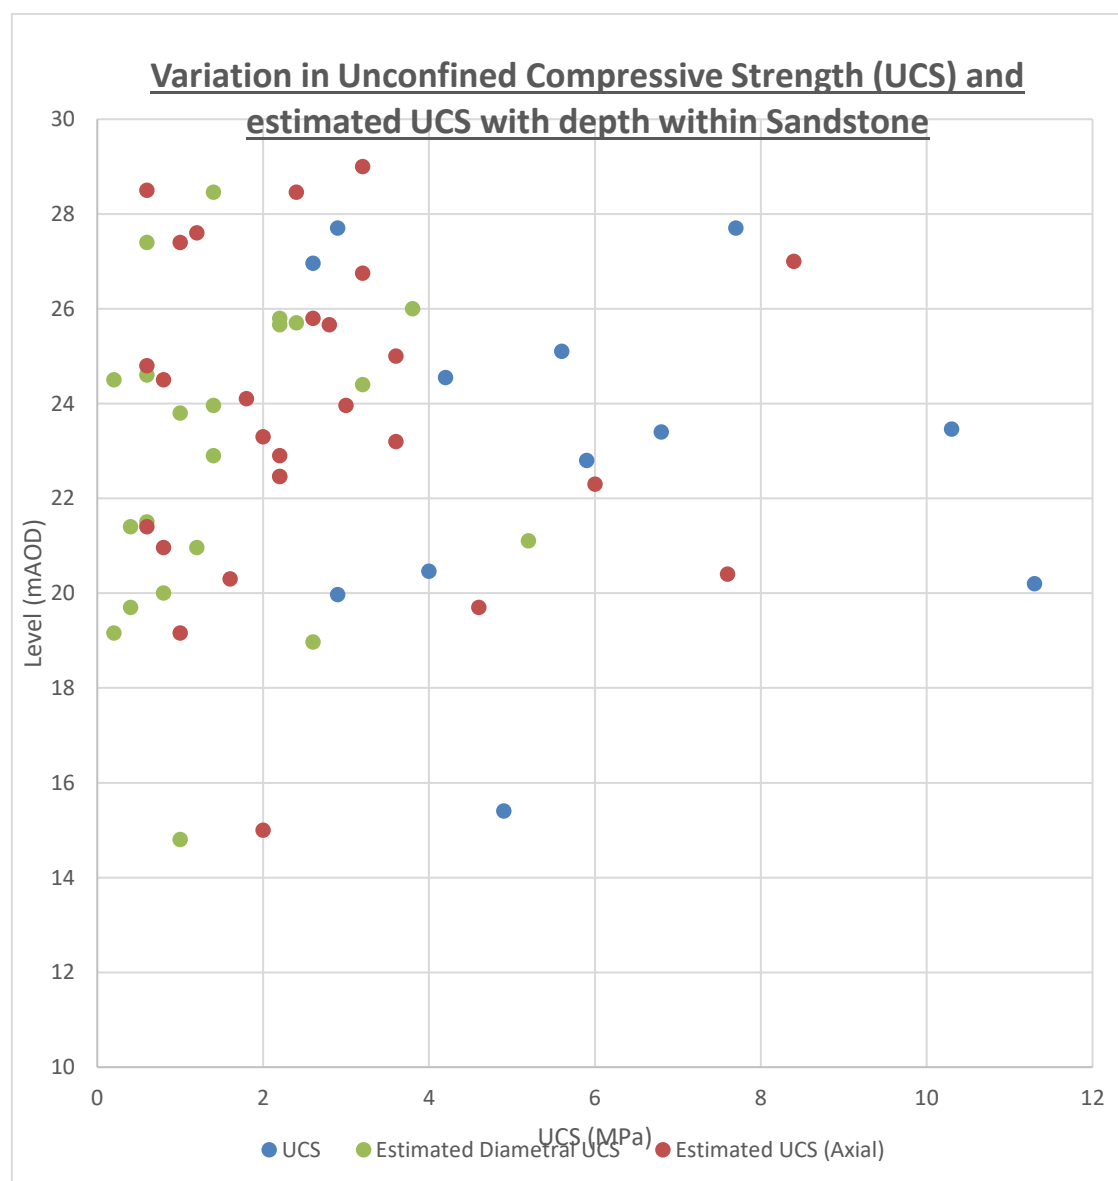
**Figure 5.5b – UCS and estimated UCS vs Depth within Sandstone.**

*Figure 5.5b*, summarises the UCS, estimated axial UCS and estimated diametral UCS test results against depth.

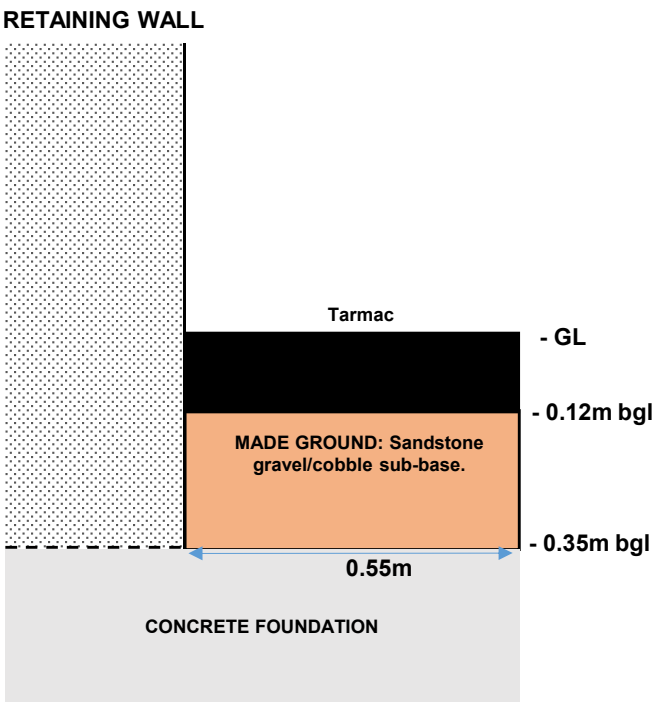
TP01- Identified Dimensions

Comments: Not to scale.  
Concrete foundation encountered but thickness not identified. Reference should be given to corresponding trial pit log for further strata details.

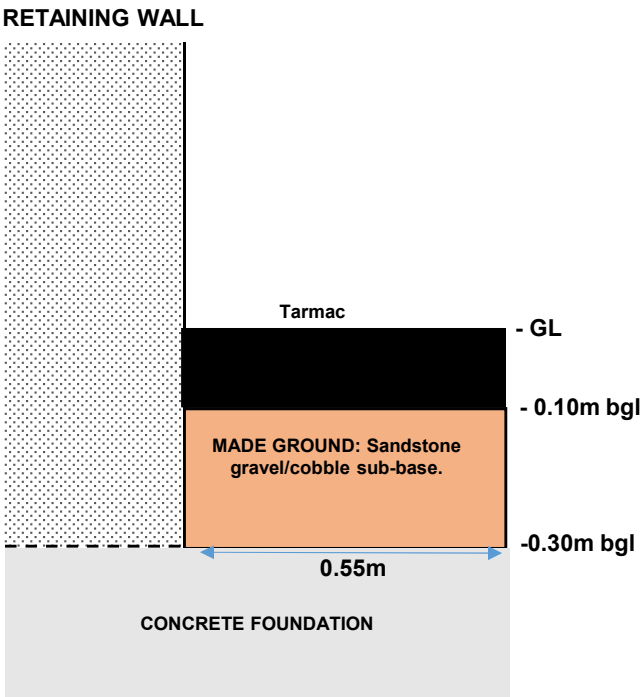
TP02- Identified Dimensions

Comments: Not to scale.  
Concrete foundation encountered but thickness not identified. Reference should be given to corresponding trial pit log for further strata details.

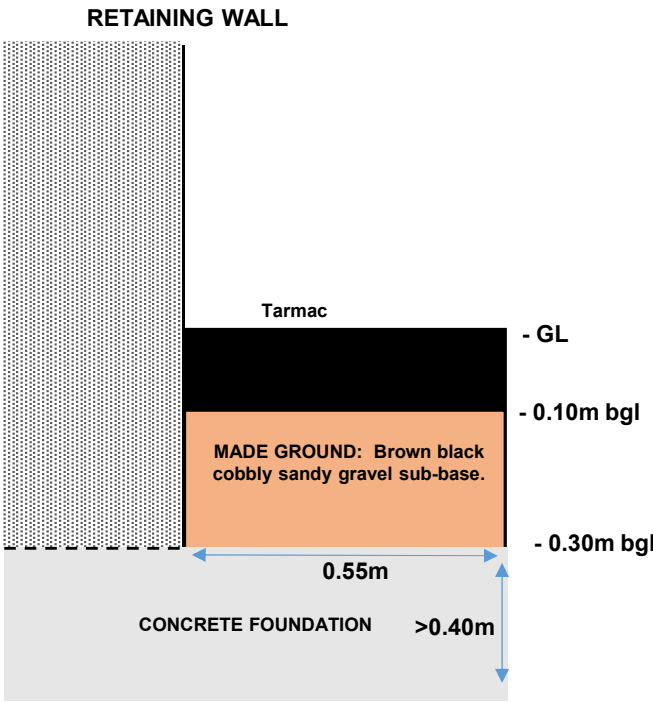
TP03- Identified Dimensions

Comments: Not to scale.  
Concrete foundation encountered but base not identified. Reference should be given to corresponding trial pit log for further strata details.

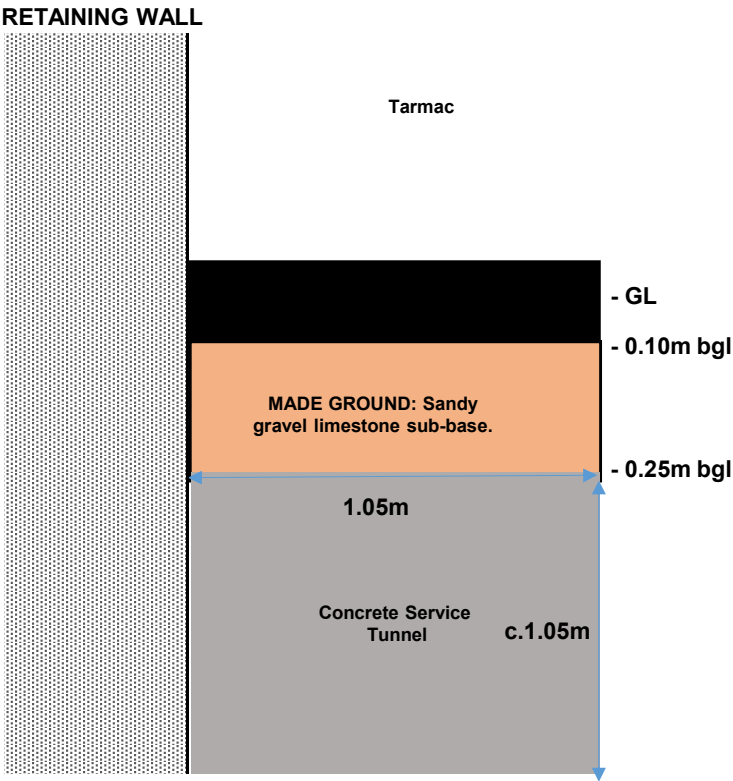
TP04- Identified Dimensions

Comments: Not to scale. Concrete service tunnel encountered, wall foundation not identified. Reference should be given to corresponding trial pit log for further strata details.

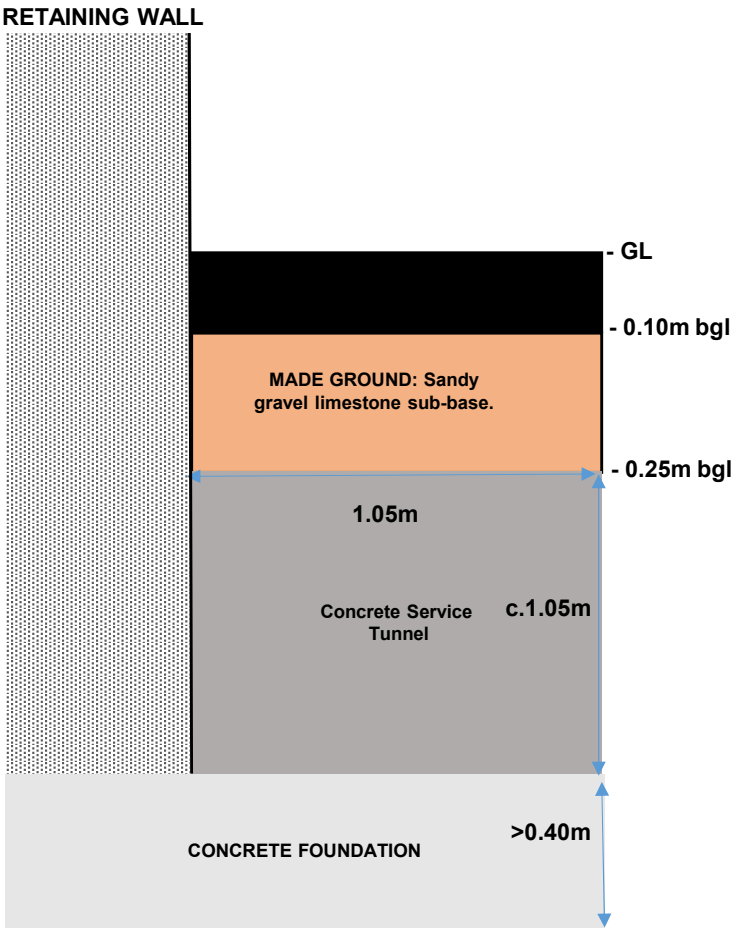
TP04- Estimated Potential Extent of Foundation

Comments: Not to scale. Drawing shows estimated potential extent of foundation based on available information, indicative only, foundation not proven during investigation.

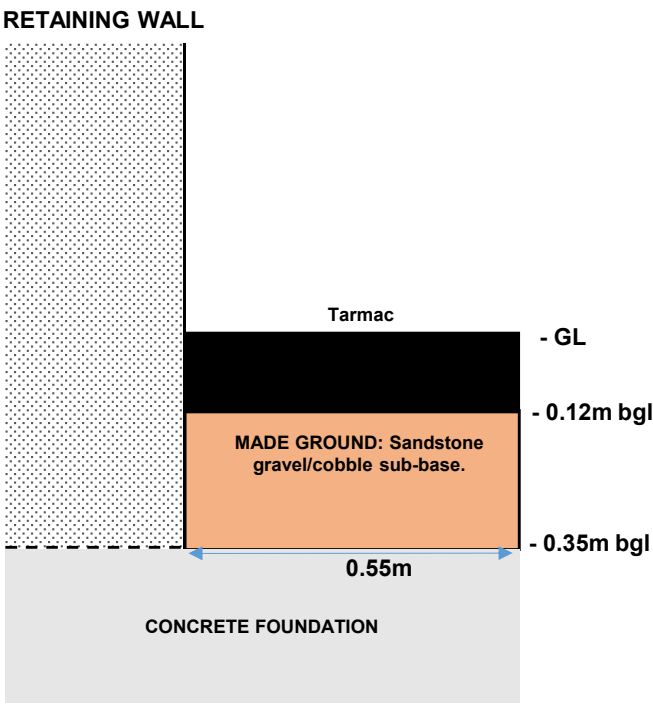
TP01- Identified Dimensions

Comments: Not to scale.  
Concrete foundation encountered but thickness not identified. Reference should be given to corresponding trial pit log for further strata details.

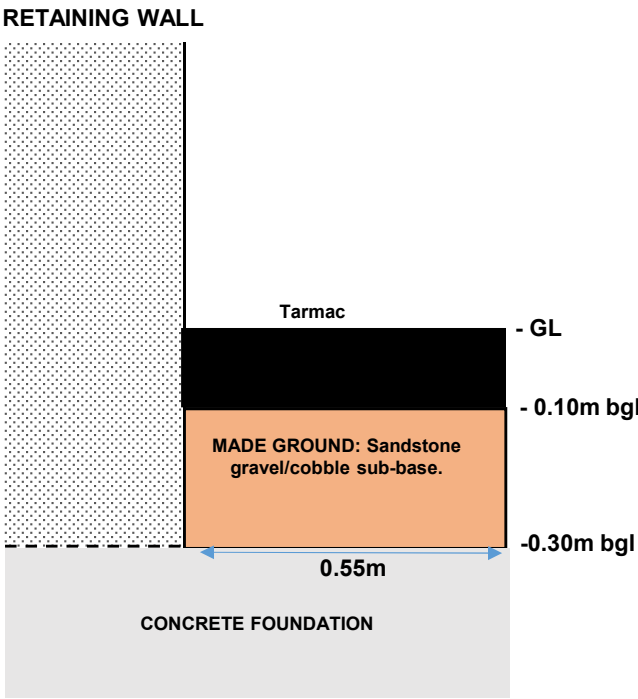
TP02- Identified Dimensions

Comments: Not to scale.  
Concrete foundation encountered but thickness not identified. Reference should be given to corresponding trial pit log for further strata details.

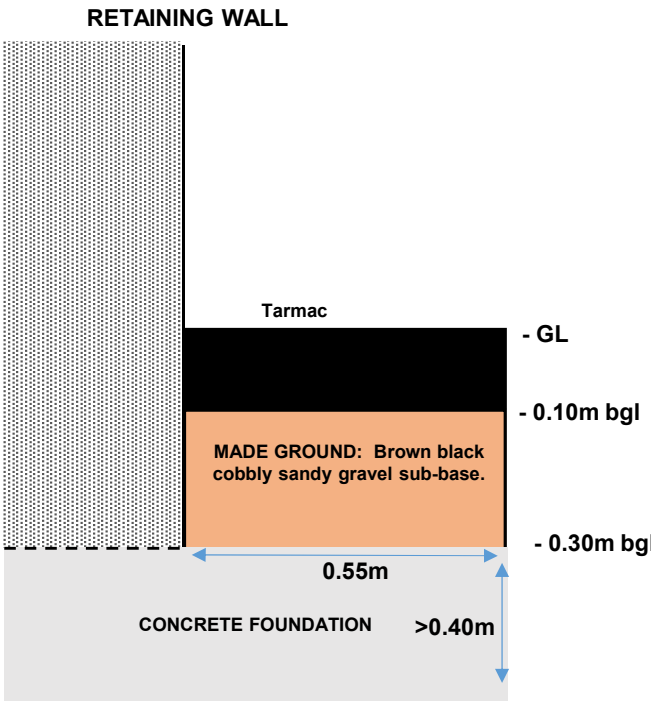
TP03- Identified Dimensions

Comments: Not to scale.  
Concrete foundation encountered but base not identified. Reference should be given to corresponding trial pit log for further strata details.

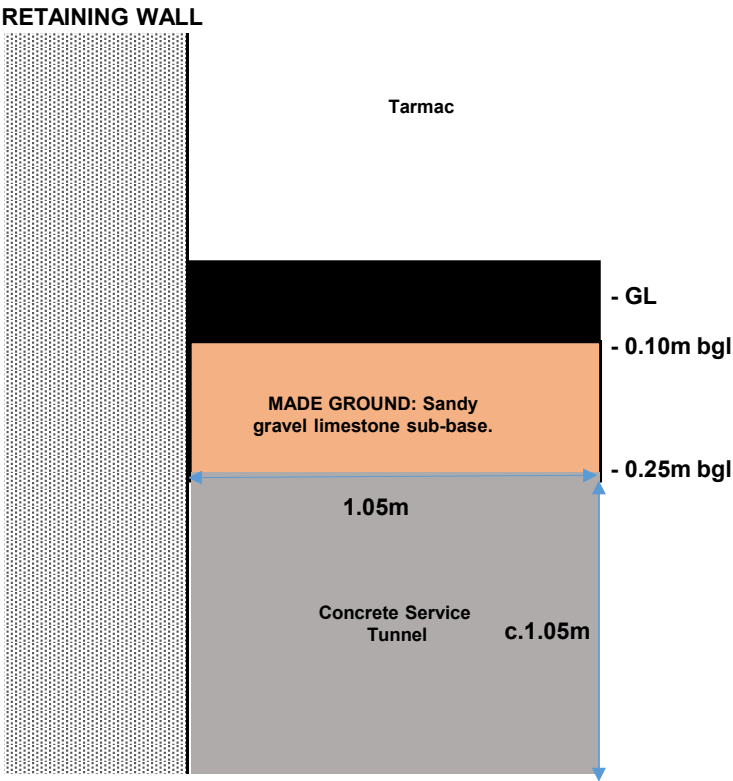
TP04- Identified Dimensions

Comments: Not to scale. Concrete service tunnel encountered, wall foundation not identified. Reference should be given to corresponding trial pit log for further strata details.

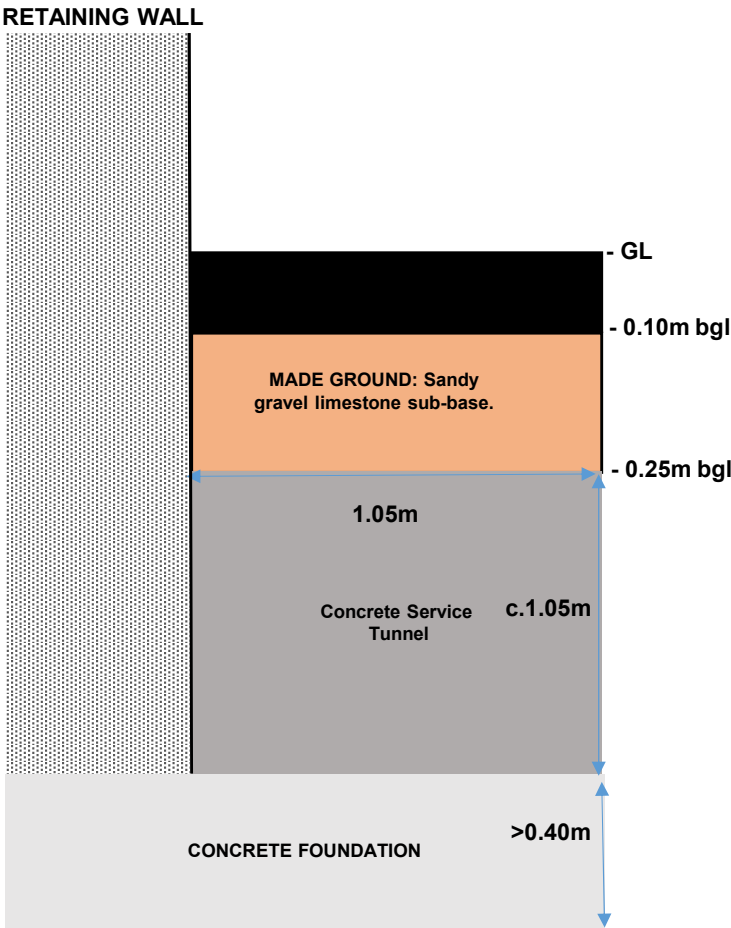
TP04- Estimated Potential Extent of Foundation

Comments: Not to scale. Drawing shows estimated potential extent of foundation based on available information, indicative only, foundation not proven during investigation.

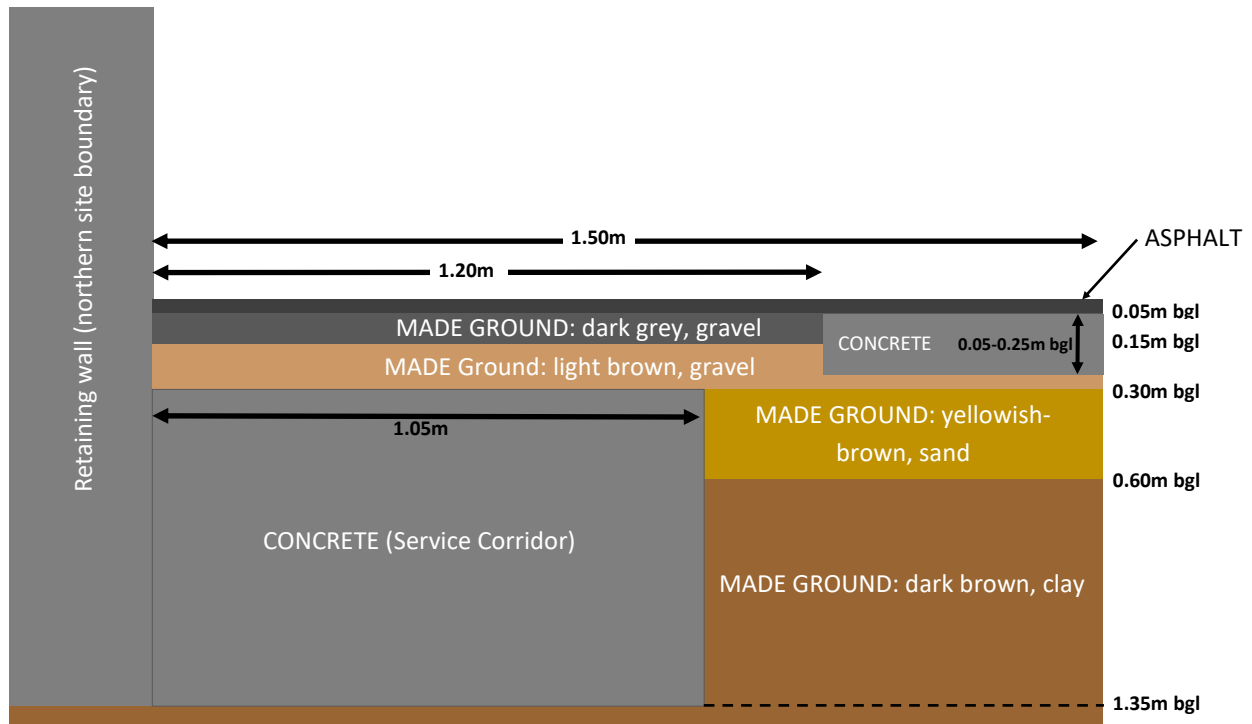
**FP101**

**Comments:** Not to scale. Reference should be given to corresponding trial pit log for further strata details. Trial pit edge stable.

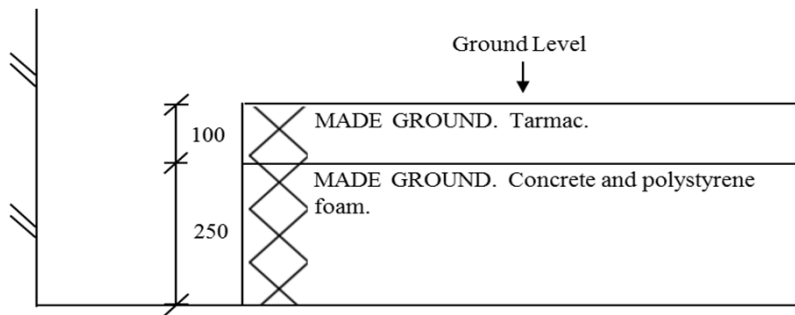
| <b>Trial Pit No: HP3</b> | | | |

HP3 terminated at 0.35m due to being unable to break through concrete.

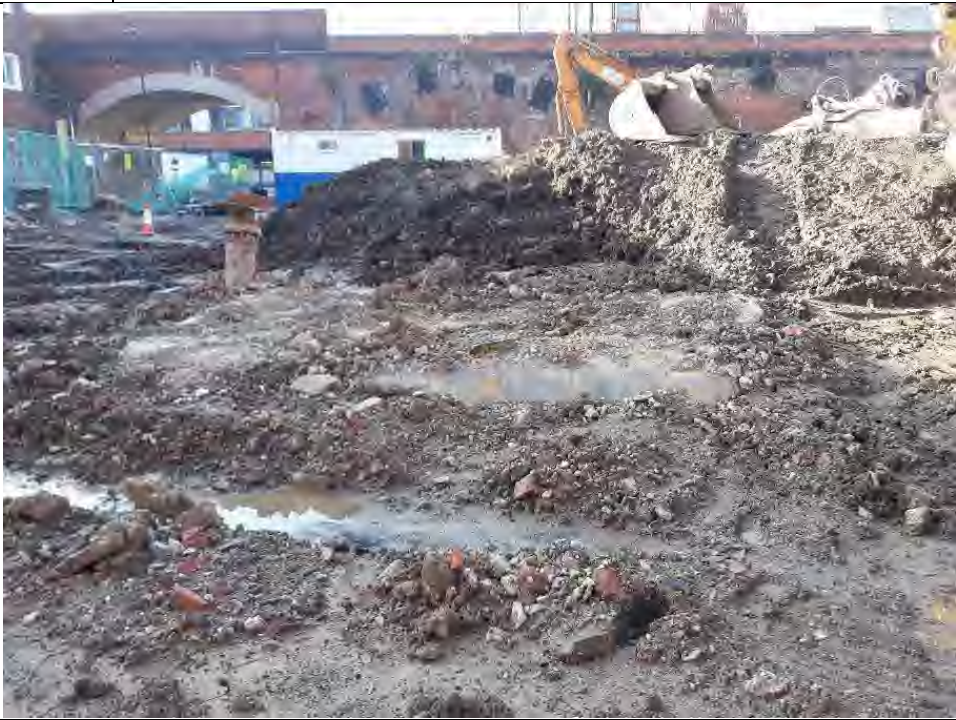
| <b>Photo No: 1</b> | <b>Description:</b> Tanks In-Situ |

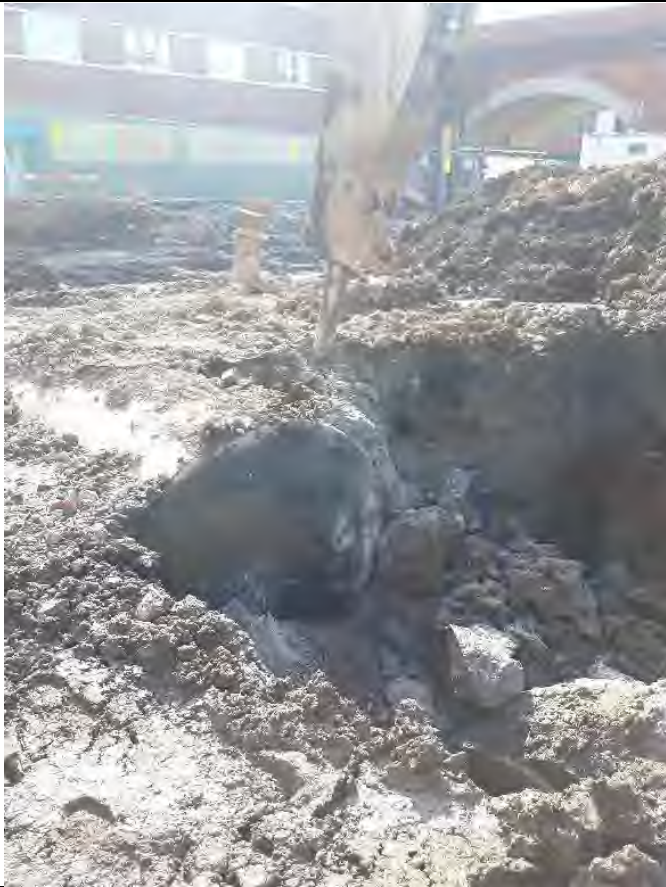
| <b>Photo No: 4</b> | <b>Description:</b> Removal of concrete bund to the side of the two tanks |

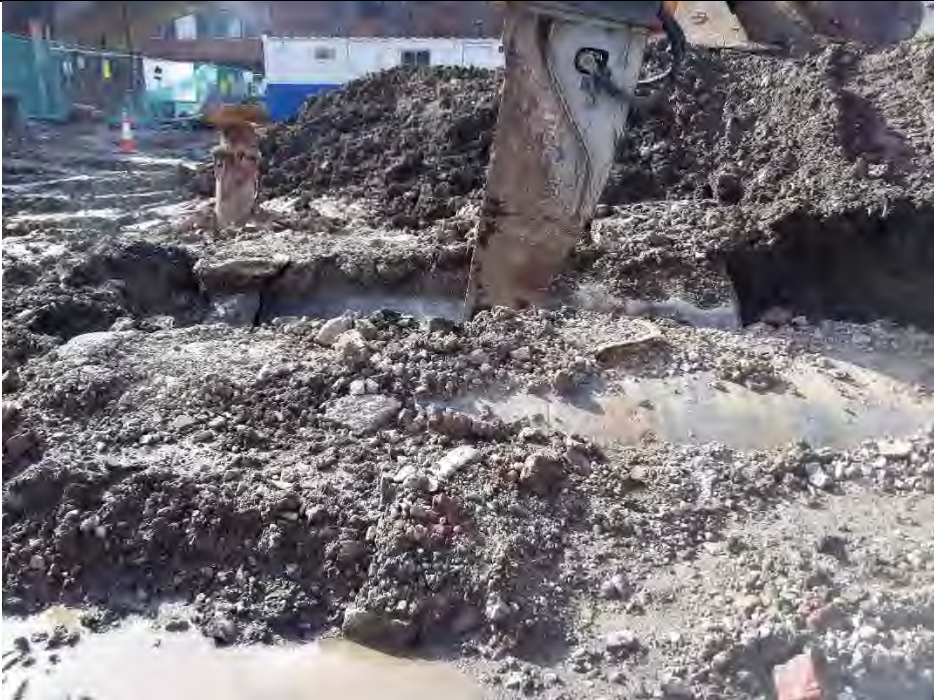
| <b>Photo No: 5</b> | <b>Description:</b> Removal of concrete bund to the side of the two tanks |

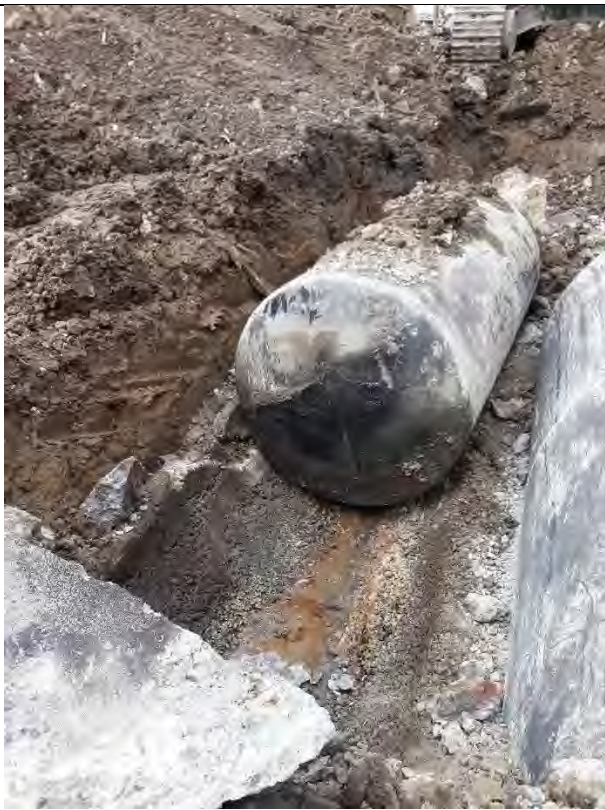
| <b>Photo No: 6</b> | <b>Description:</b> Slight sheen observed in water observed beneath Tank 1 |

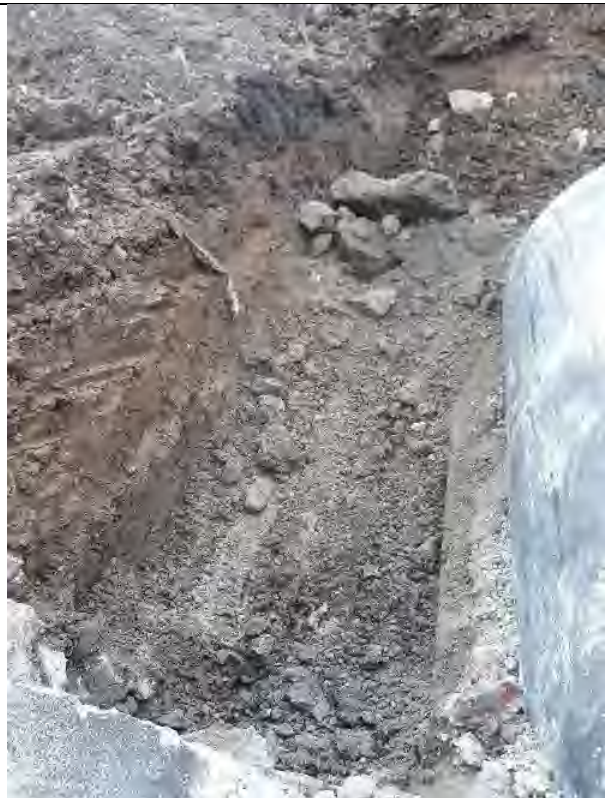
| <b>Photo No: 7</b> | <b>Description:</b> Ground beneath the tank after the use of a spill kit |

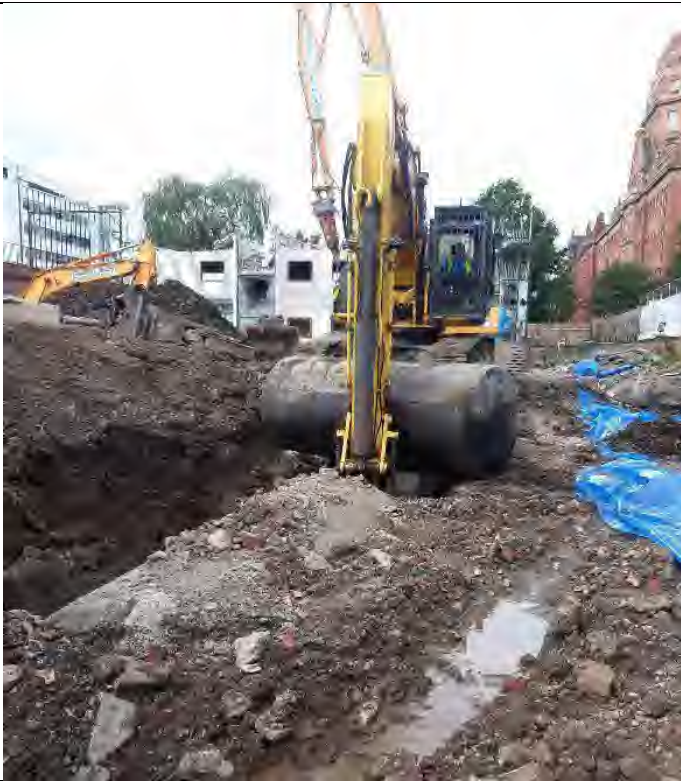
| <b>Photo No: 8</b> | <b>Description:</b> Removal of Tank 1 |

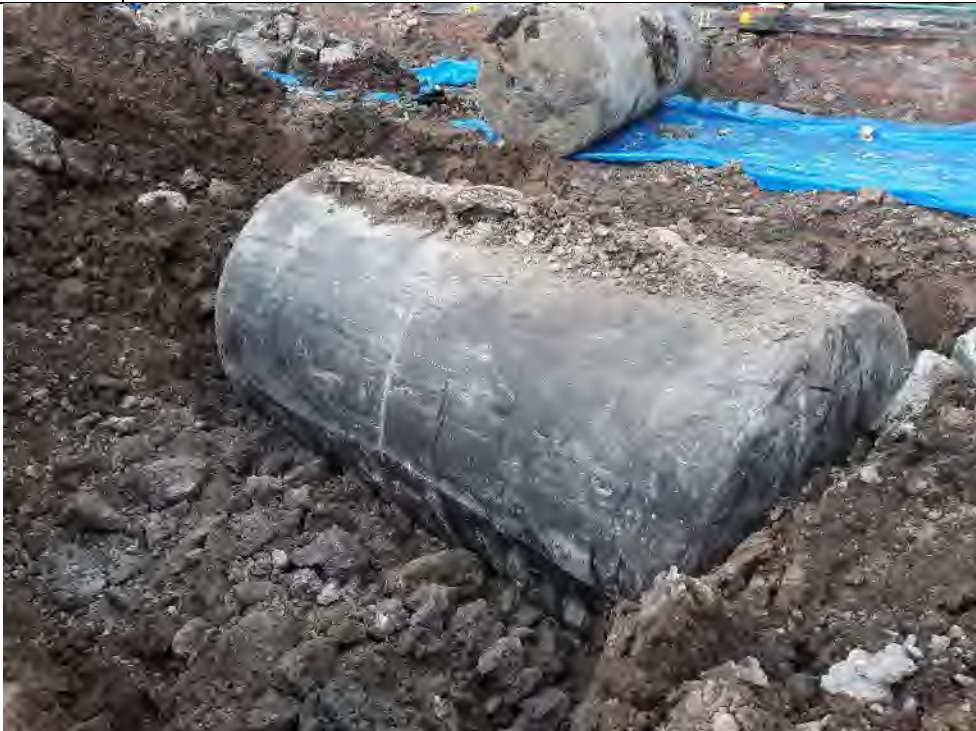
| <b>Photo No: 10</b> | <b>Description:</b> Tank 2 in-situ |

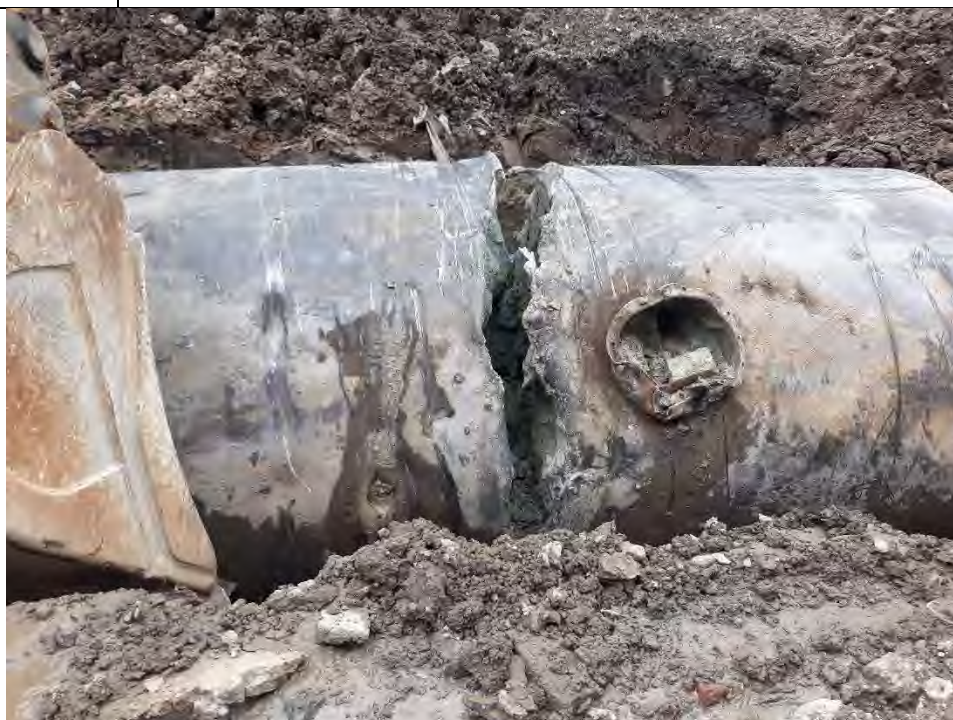
**Photo No: 12**

**Description:** Tank 2 broken in half exposing concrete used for decommissioning

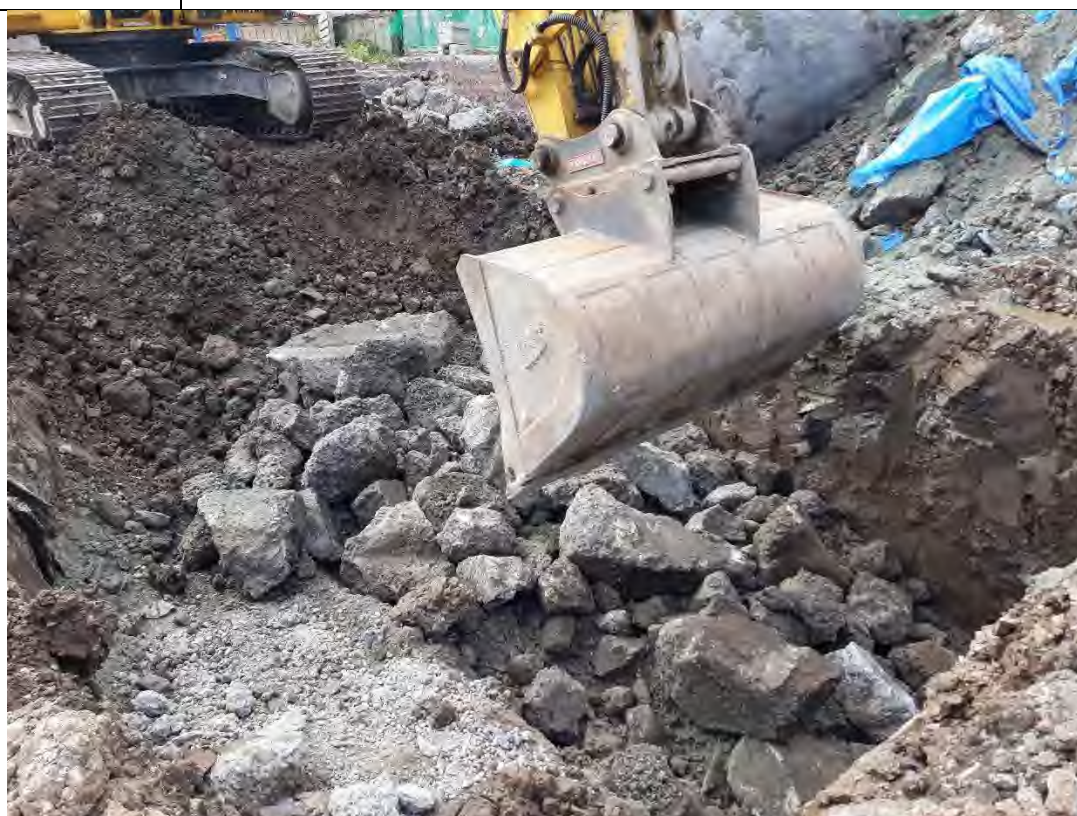
**Photo No: 13**

**Description:** Concrete base removed

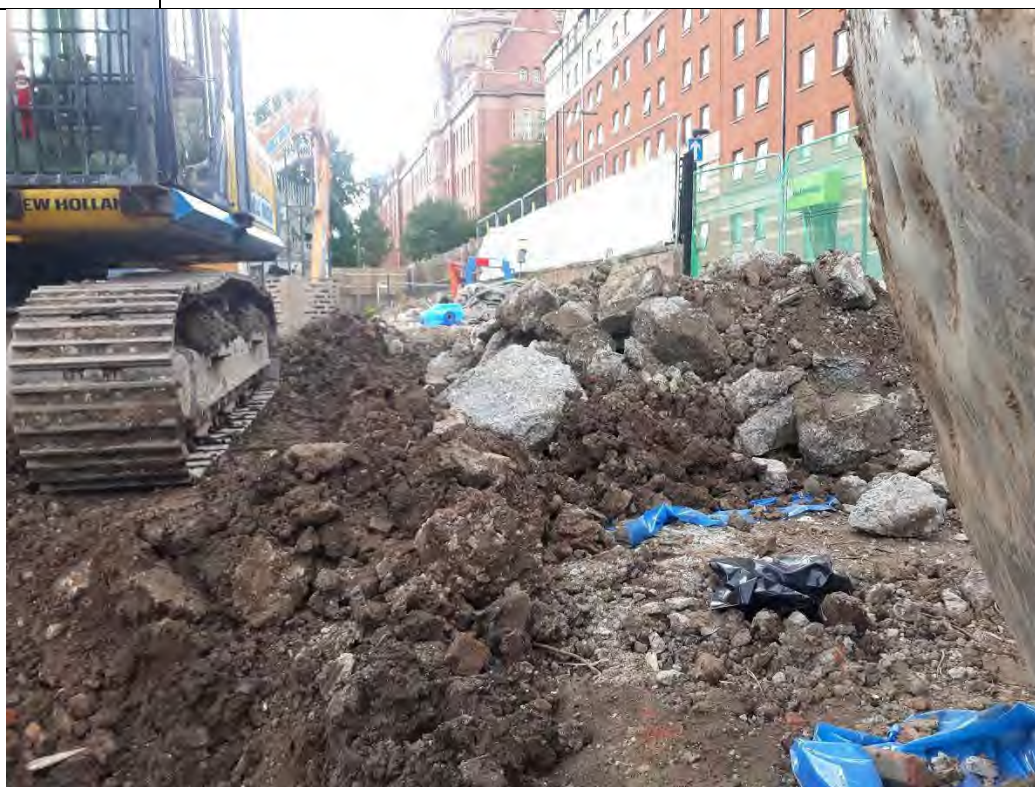
**Photo No: 15**

**Description:** Stockpiled material removed from around the tank (SP01)

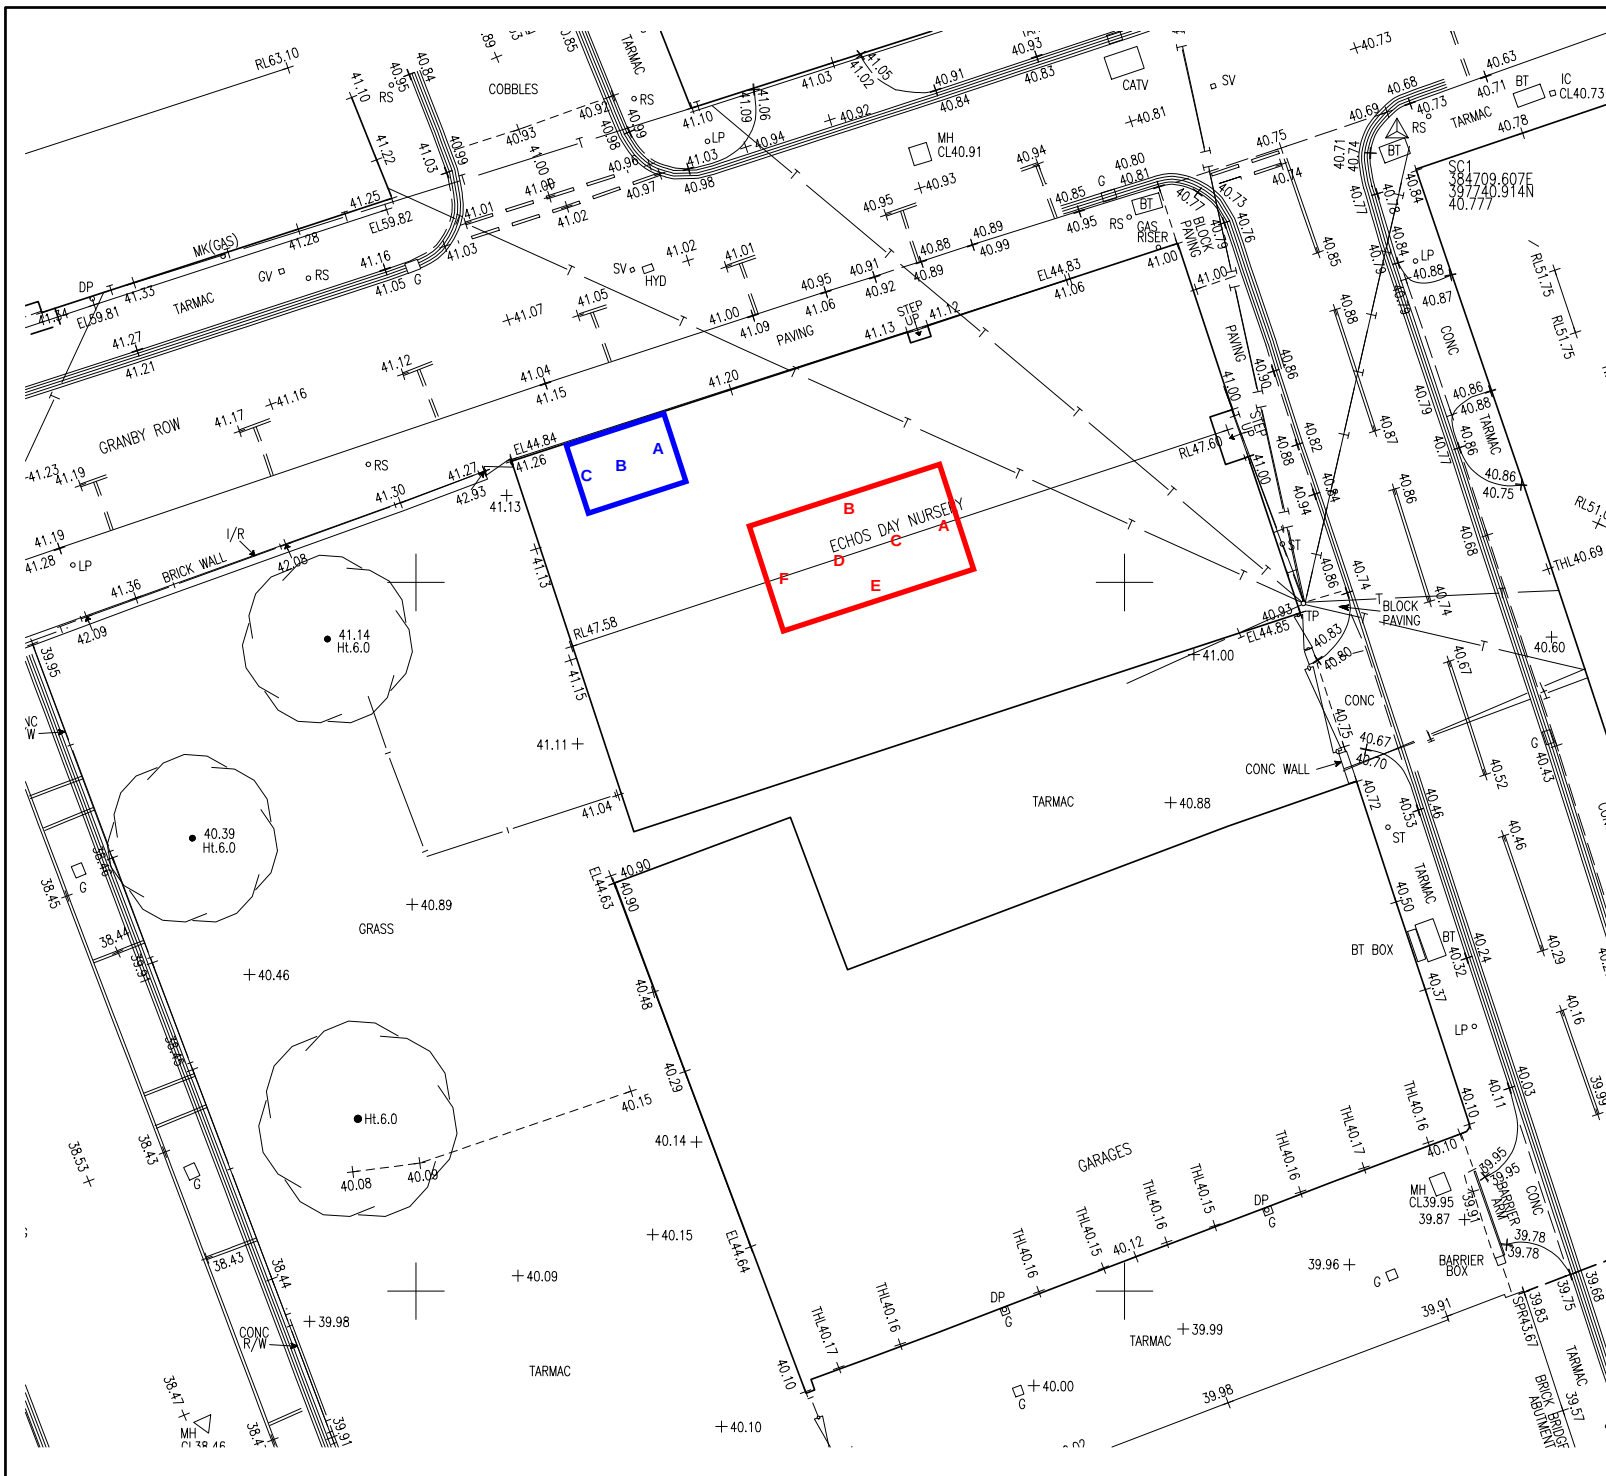
- APPROXIMATE TANK EXCAVATION (TP601)
- APPROXIMATE STOCKPILE LOCATION (SP01) (TANK EXCAVATION)
- A APPROXIMATE SOIL SAMPLE LOCATION
