## **Archaeological Excavation Report**

Mayfield,  
Manchester

**Report No:**  
SA/2021/56

**Project:** Mayfield, Manchester: Archaeological Excavation

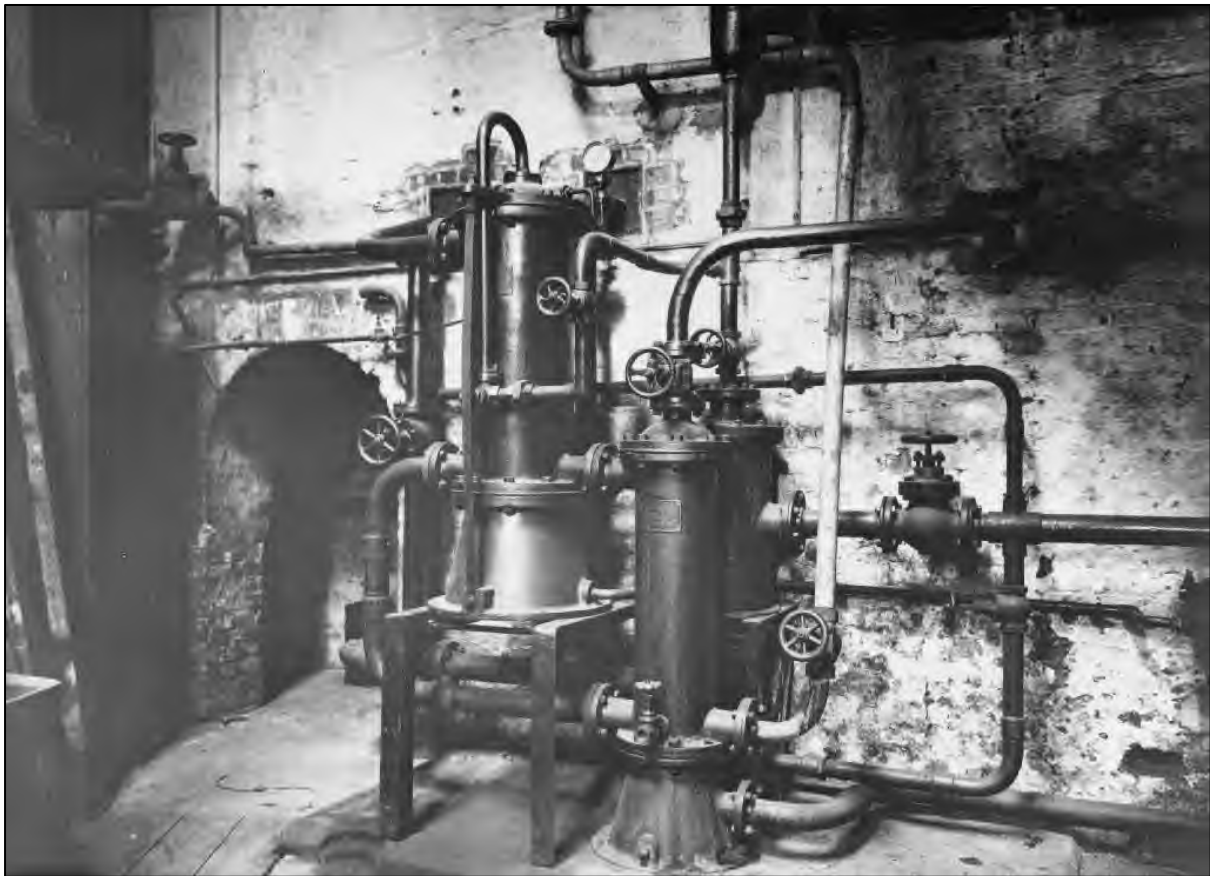
*Plate 14: The Royle Calorifier at Mayfield Baths, 1902.*

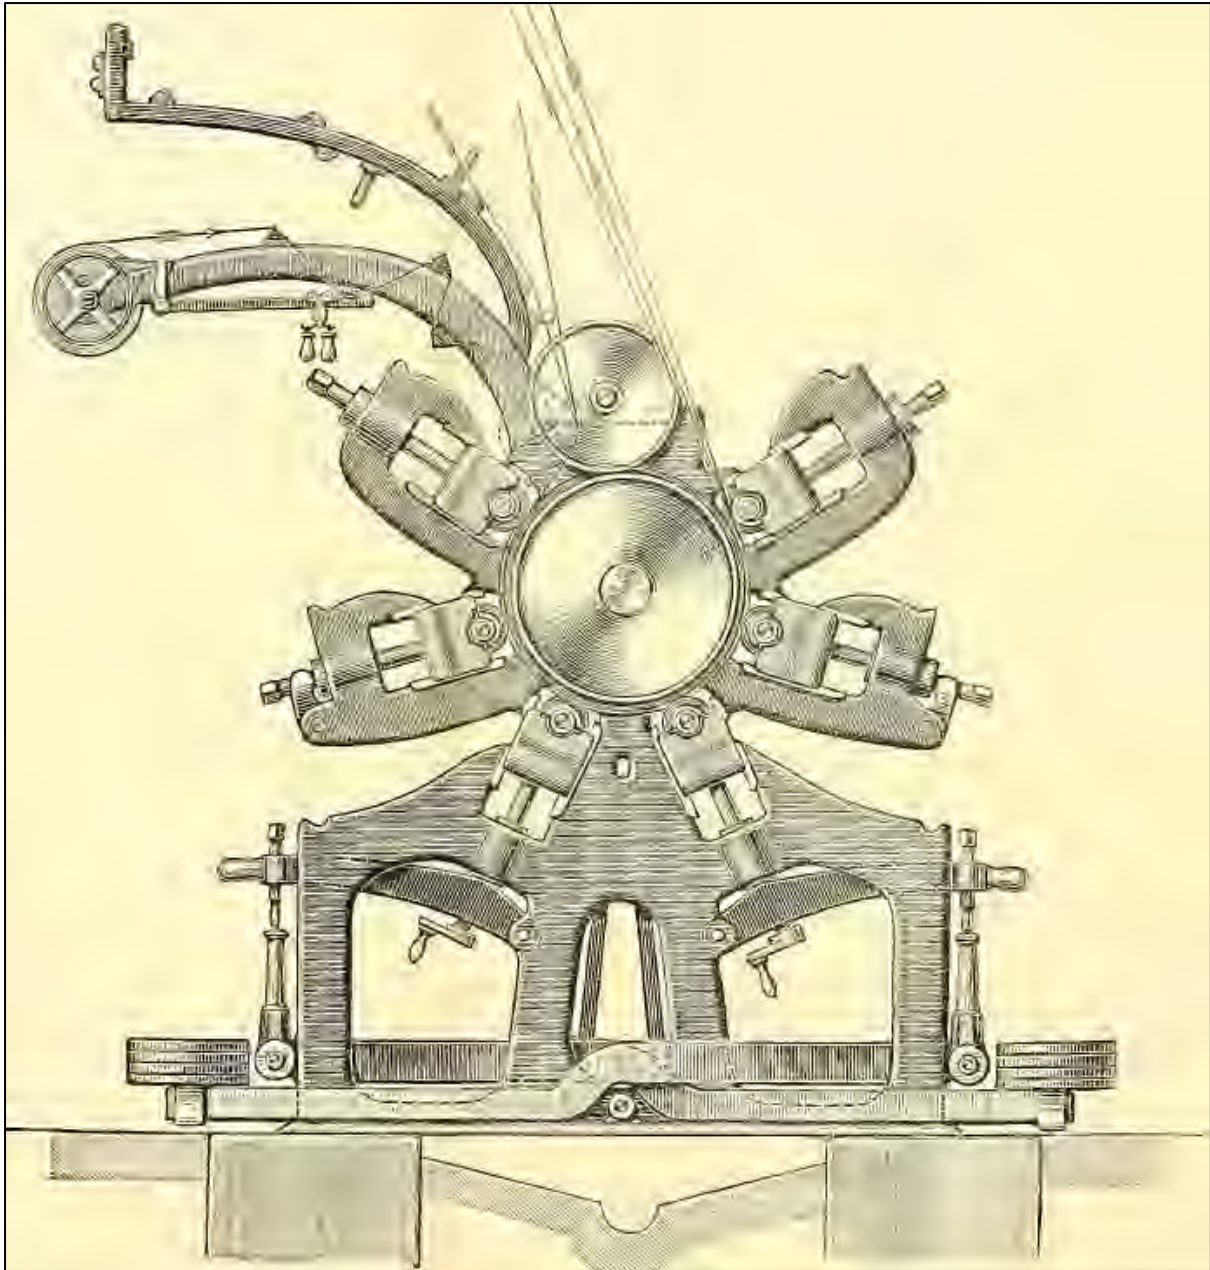
*Plate 17: A six colour printing machine depicted in 'The Printing of Cotton Fabrics' (Sansone 1887) similar to those mentioned in the 1897 auction*

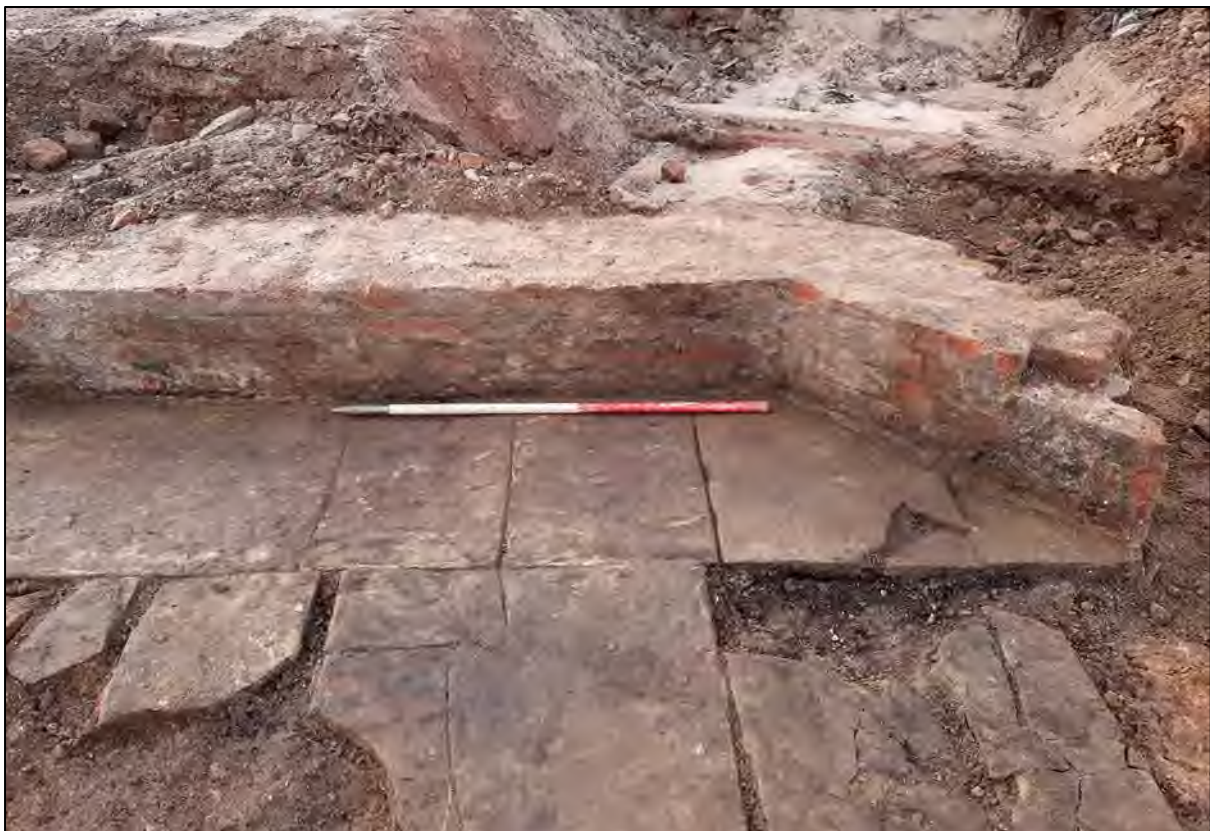
Plate 41: Wall 114, looking south (1m scale)

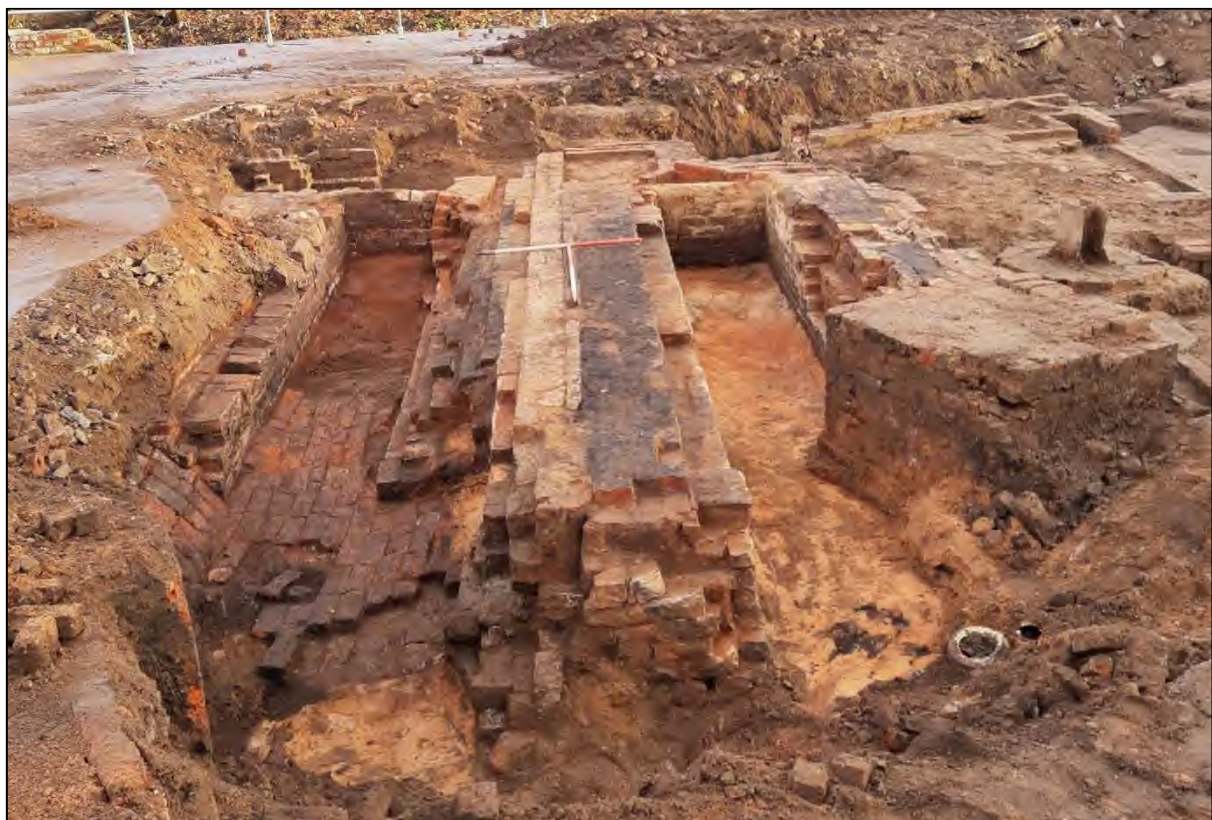
*Plate 43: Boiler beds 111 and 112, looking north (2 x 1m scales)*

The two boiler-beds, **111** and **112** were located to the southwest of the chimney at the west of the excavation area (Plate 43). Both boilers were truncated by later activity. This included a further brick stanchion, **109**, which truncated the southeast of boiler-bed **111** and measured 1.2 x 1.1m.

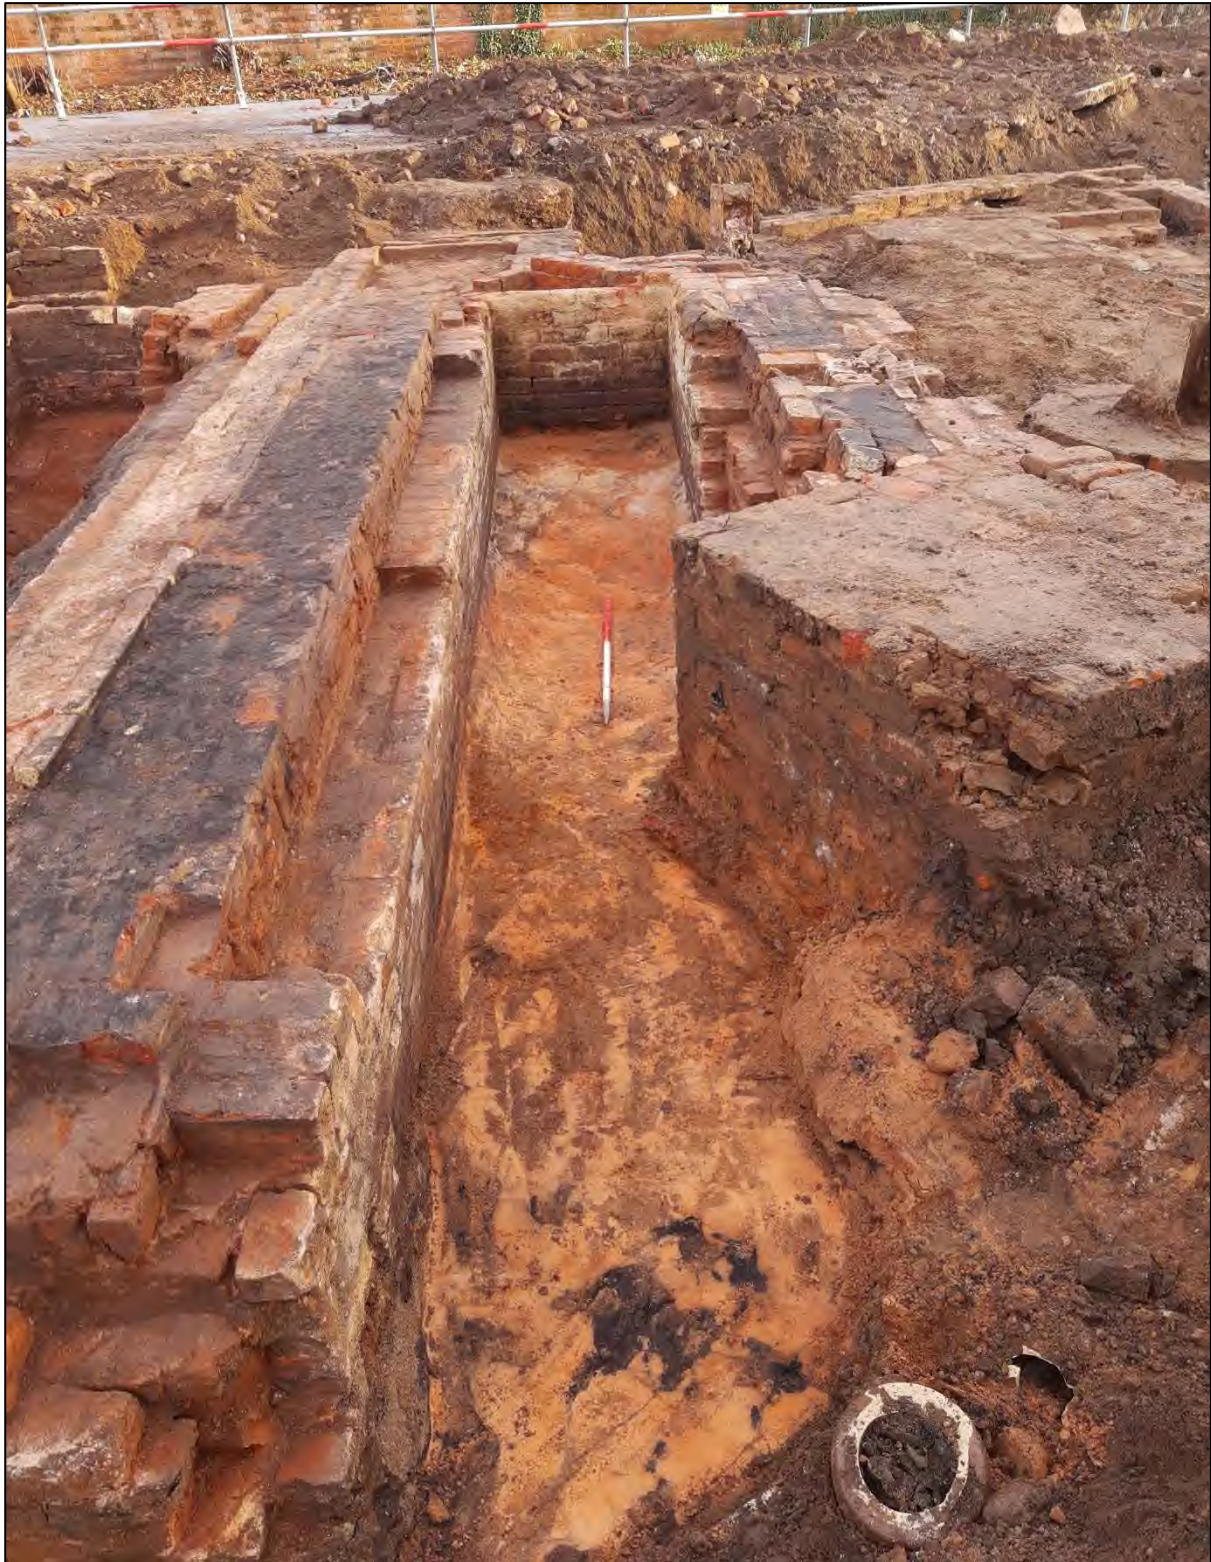
*Plate 44: Boiler 111, looking north (1m scale)*

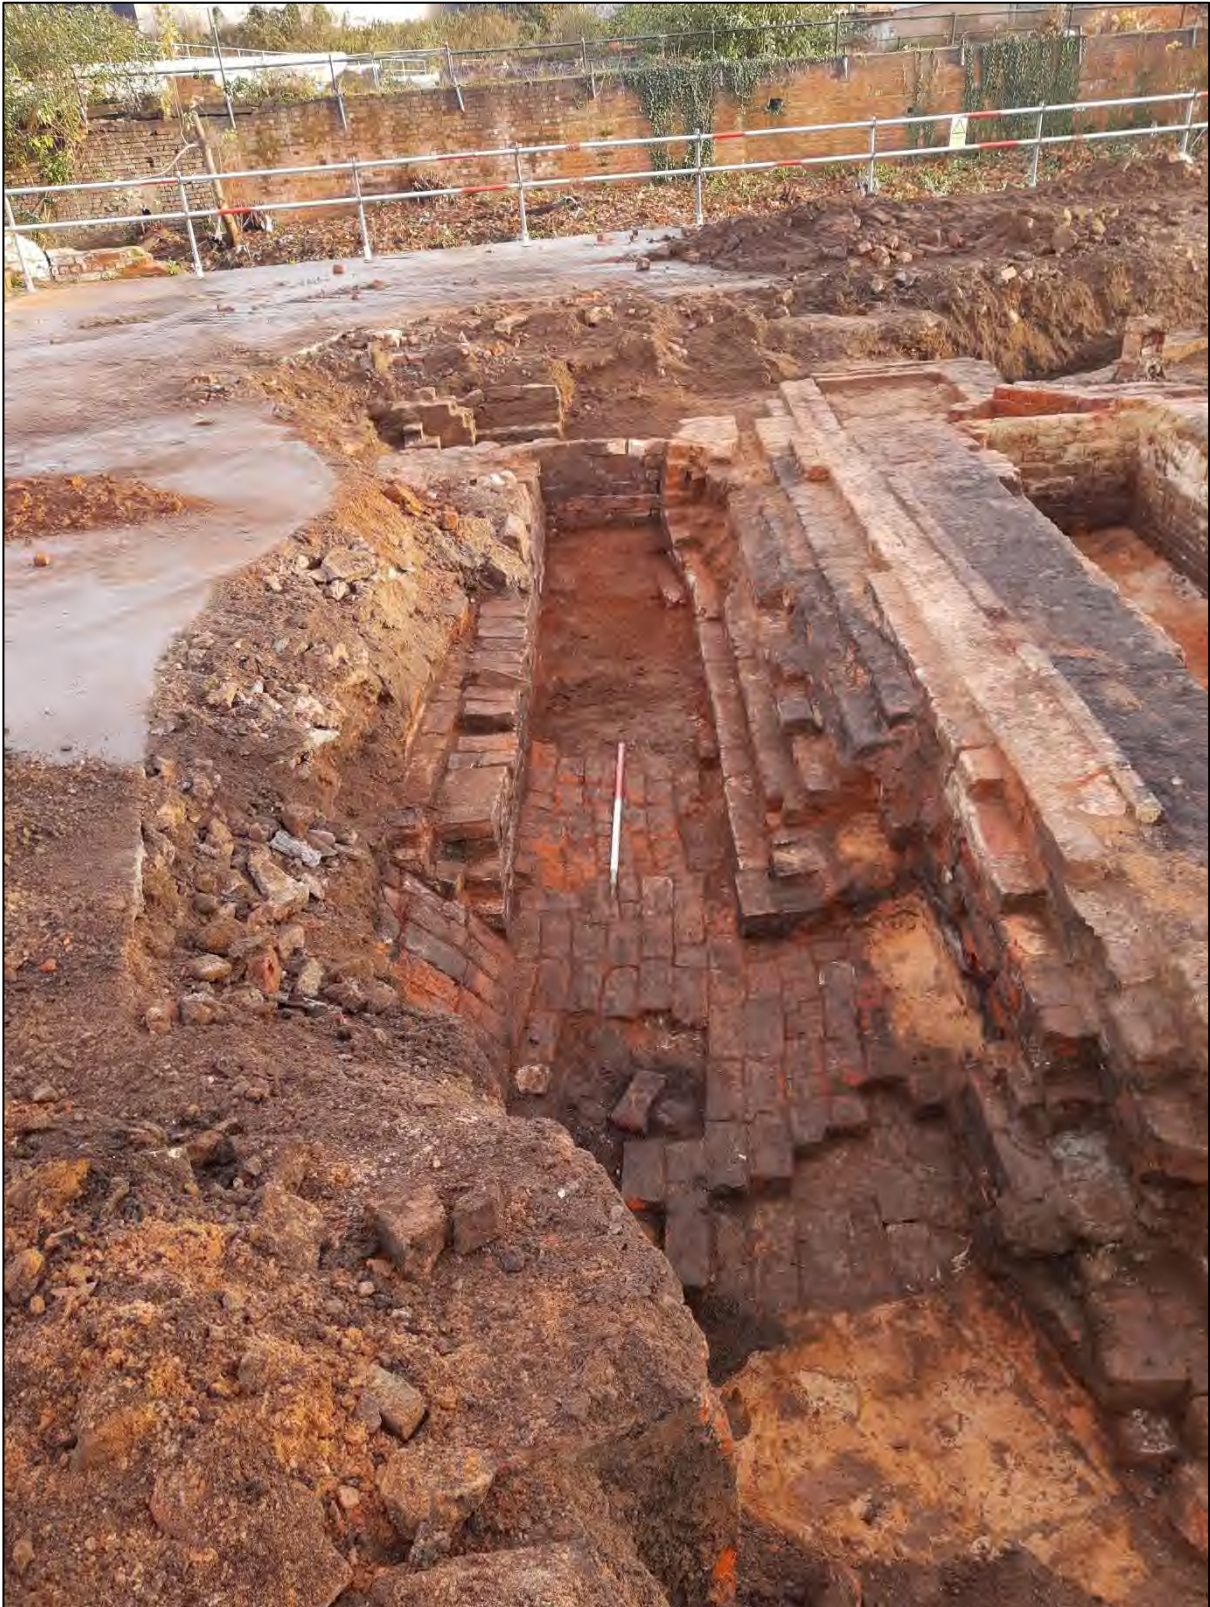
*Plate 45: Boiler 112, looking north (1m scale)*

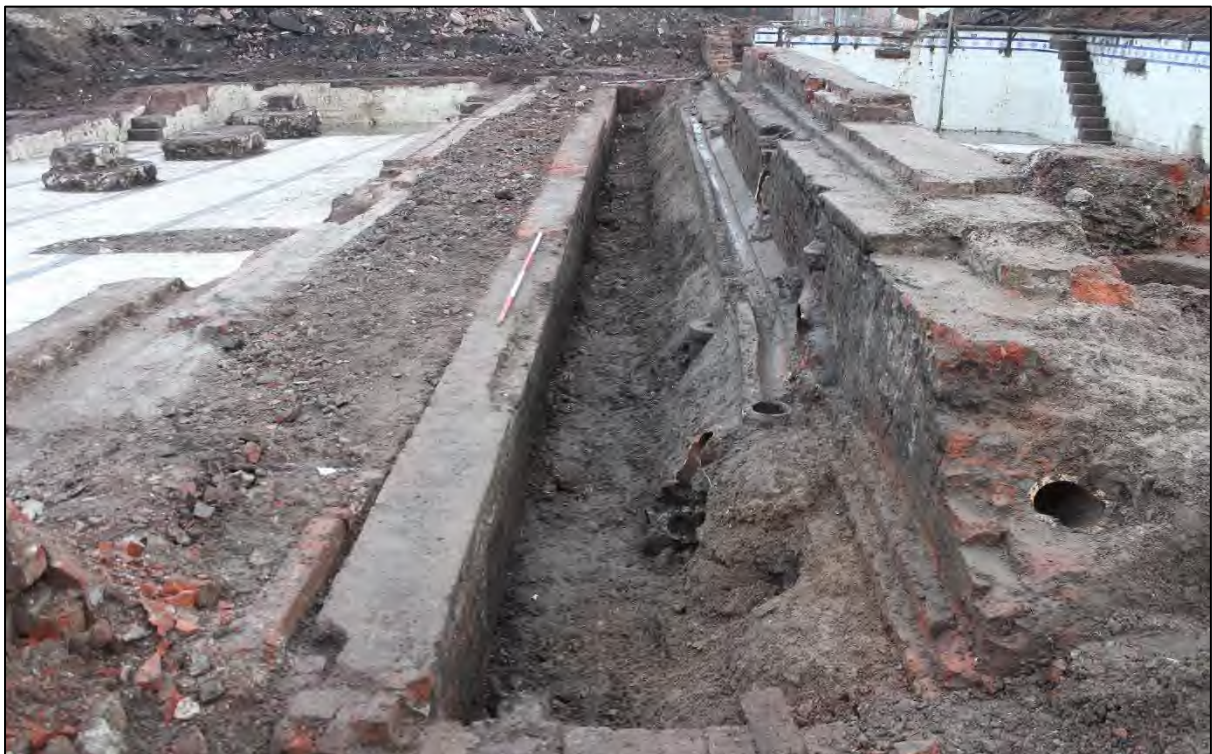
*Plate 48: Wall 227 looking east*

elements of the bathhouse design. The plan shows the water from the pools fed into a chamber situated between the pools (Plate 48) and flowed westwards towards Baring Street, where it emptied into a sewer.

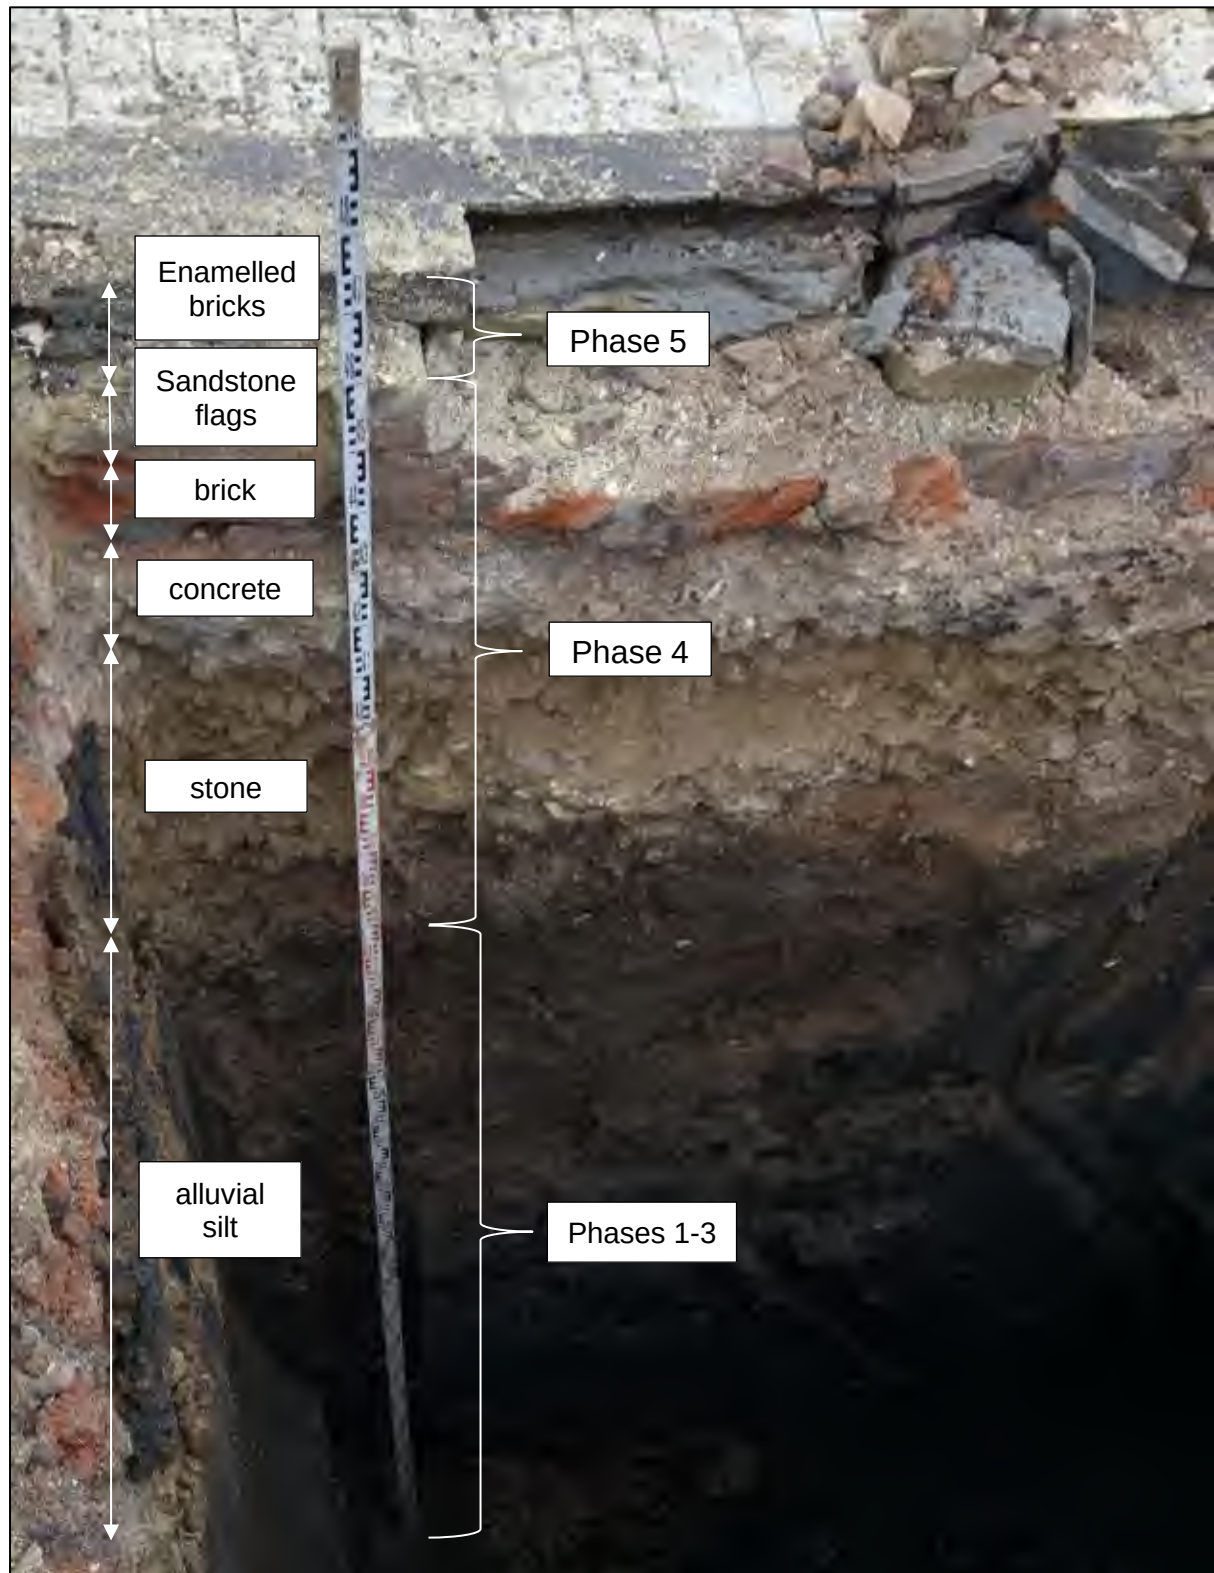
Plate 49: Sondage through the base of Pool 226 showing the composition of the foundations above earlier layers of alluvial silt

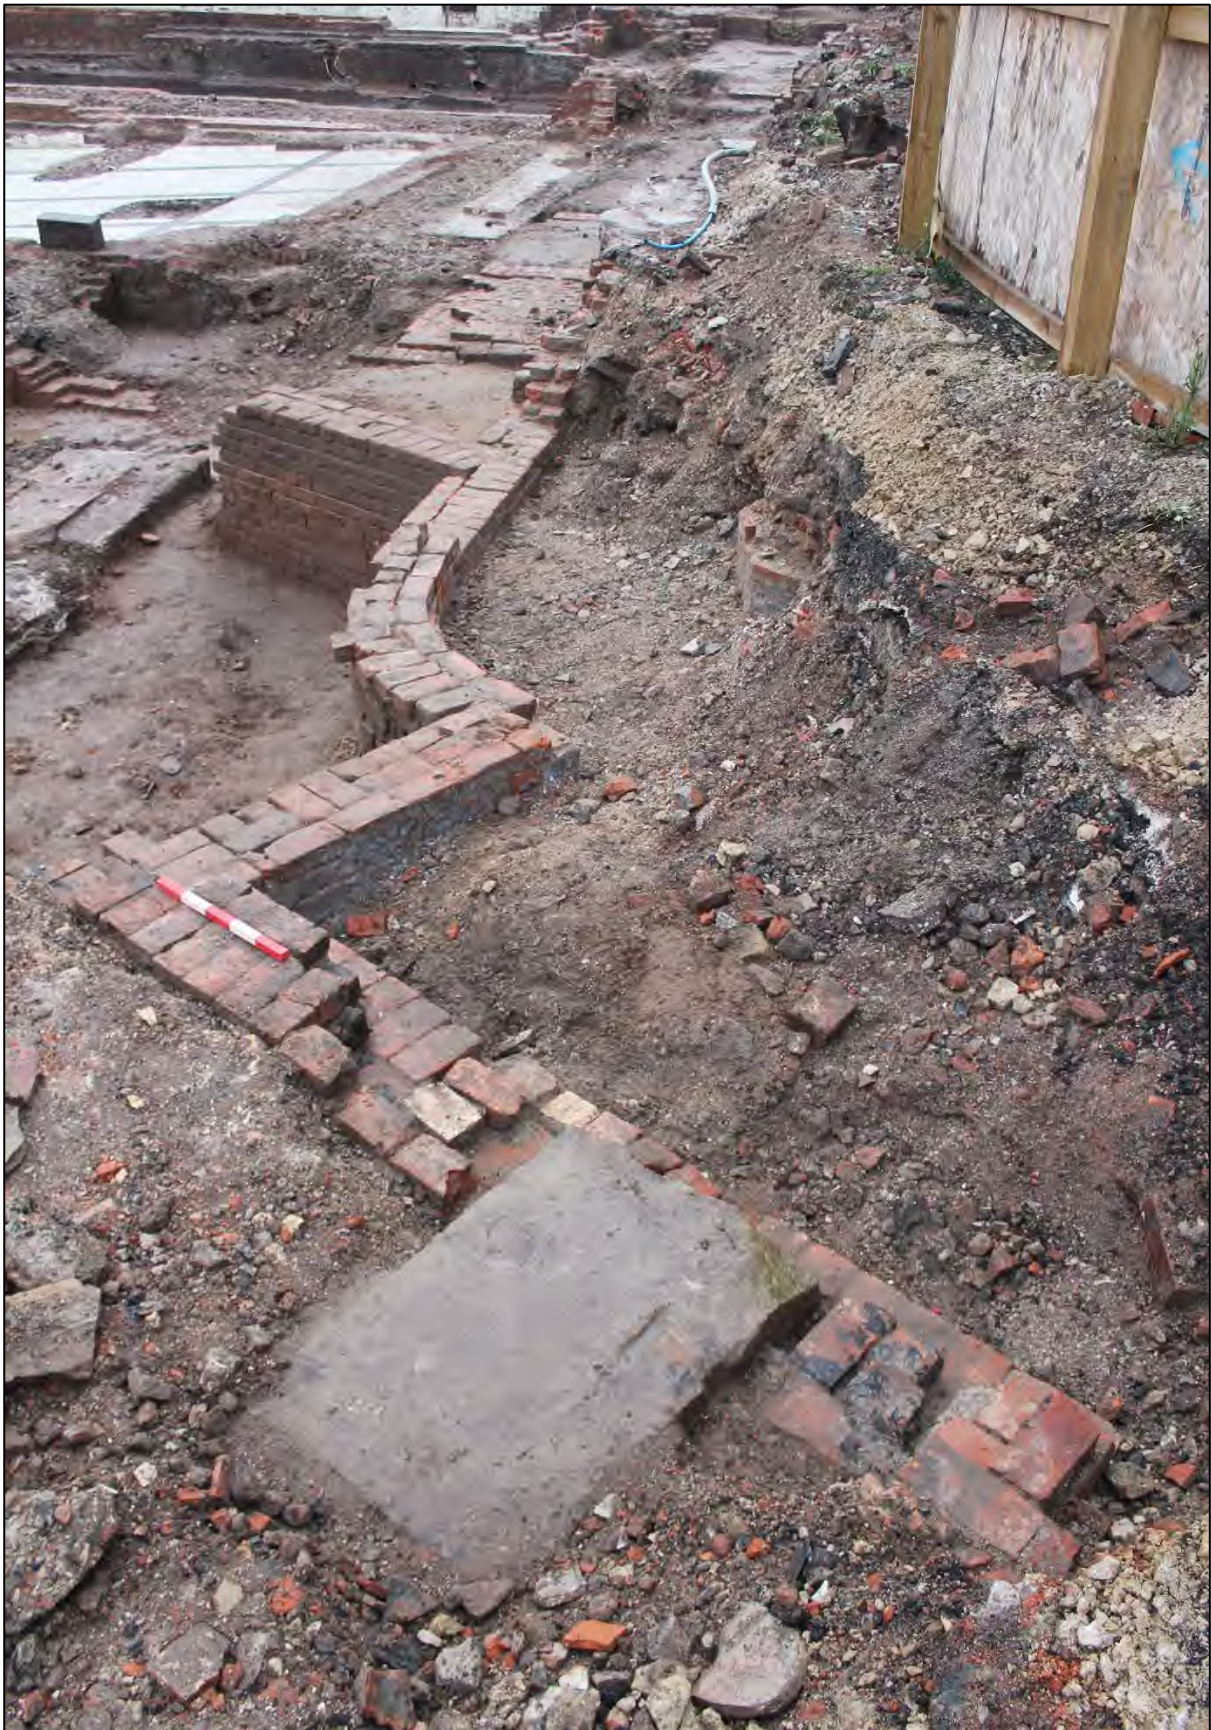
*Plate 50: Walls 204, 200 and 201 looking south, 0.50m scale*

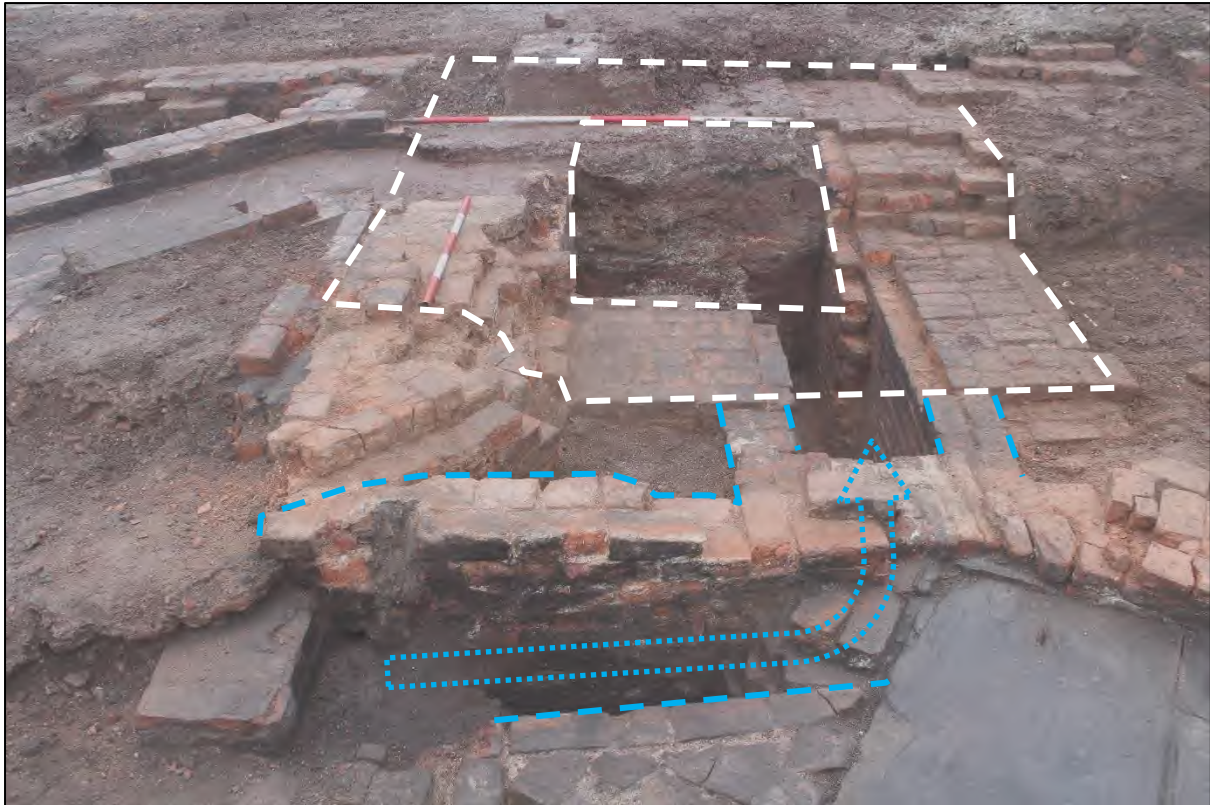
Plate 53: The remains of chimney 219 (white) and flue 218 (blue)

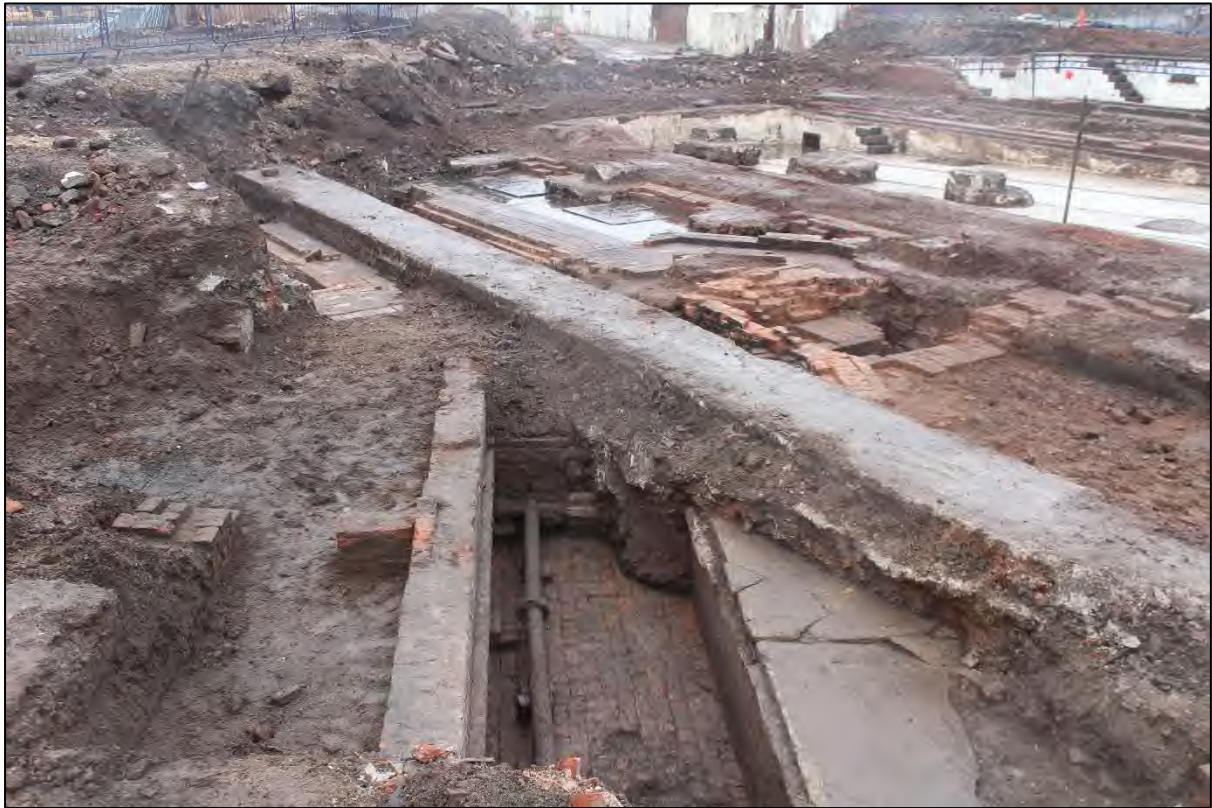
*Plate 55: The brick conduit formed by walls 204, 206 and 205 looking south-east*

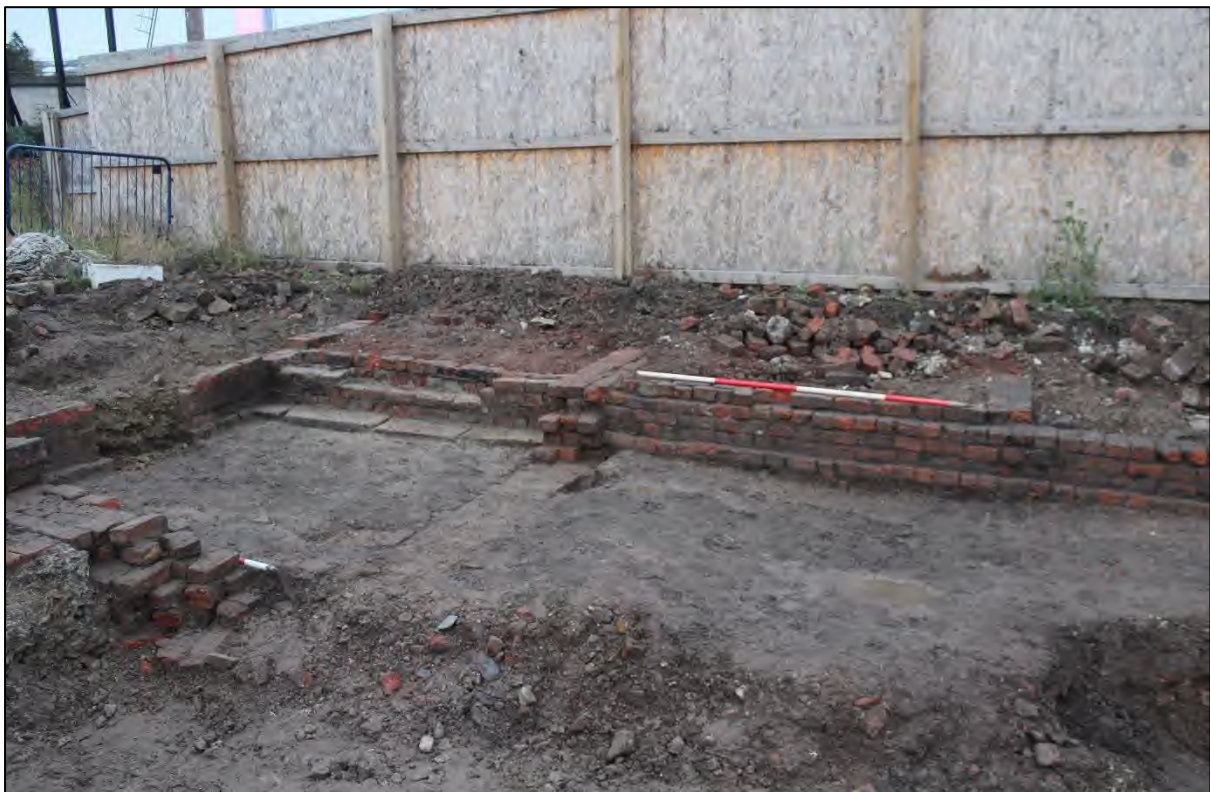
Plate 56: Wall 223 looking west (2m scale)

Wall **223** was located at the southwest of the excavation area (Plate 56). It was aligned north / south and measured 7.1 x 0.36m. It may have been a rebuild or repair of the *Phase 4* wall 200 but in plan it appeared as a continuation. It abutted the junction of the walls 200-212 and the east / west wall, 213. The foundations of the wall were shallower than those of Wall 200. The wall consisted of stepped bricks built upon a flagstone foundation and stood at a maximum height of 0.6m. A wall stub was visible on the western side of wall 223 between walls 212 and 213, indicating that this area had been further divided into small rooms: the southern room had a length of 2.17m and the northern room, a length of 2.2m. Both continued beyond the limit of excavation to the west.

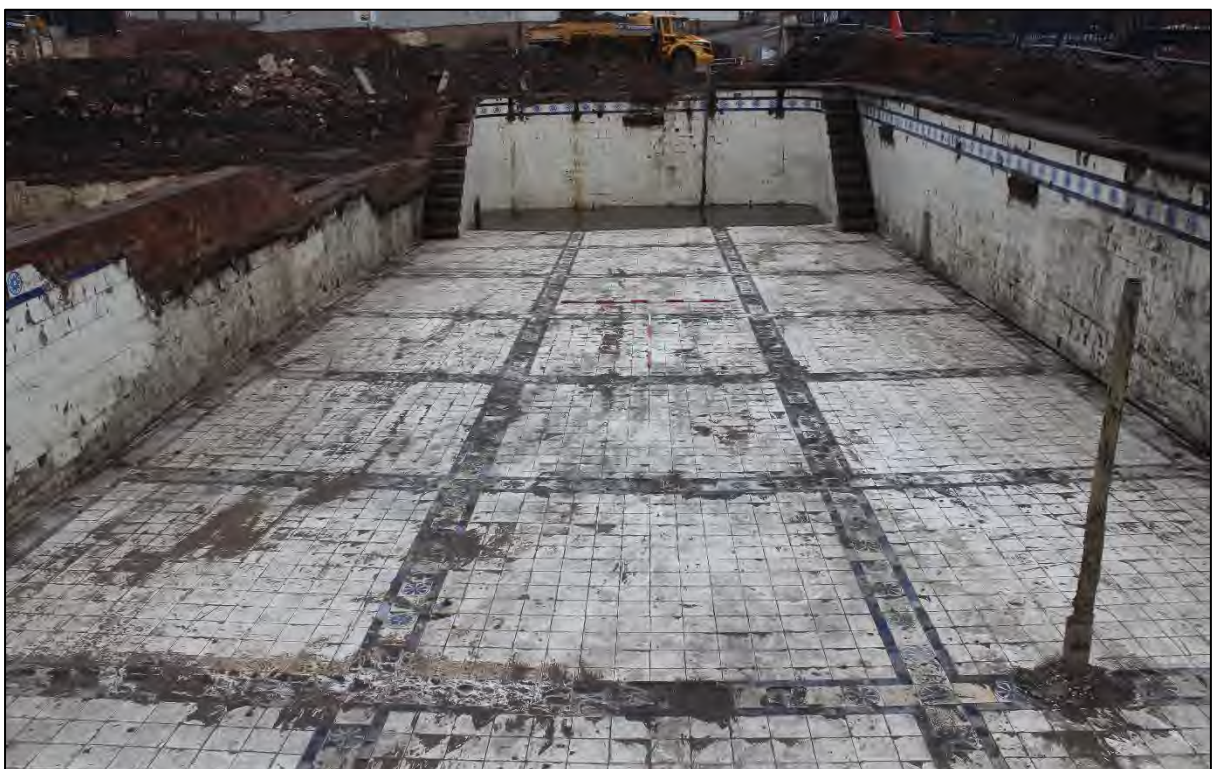
*Plate 57: Pool 225, Men's first-class, looking east (2 x 2m scales)*

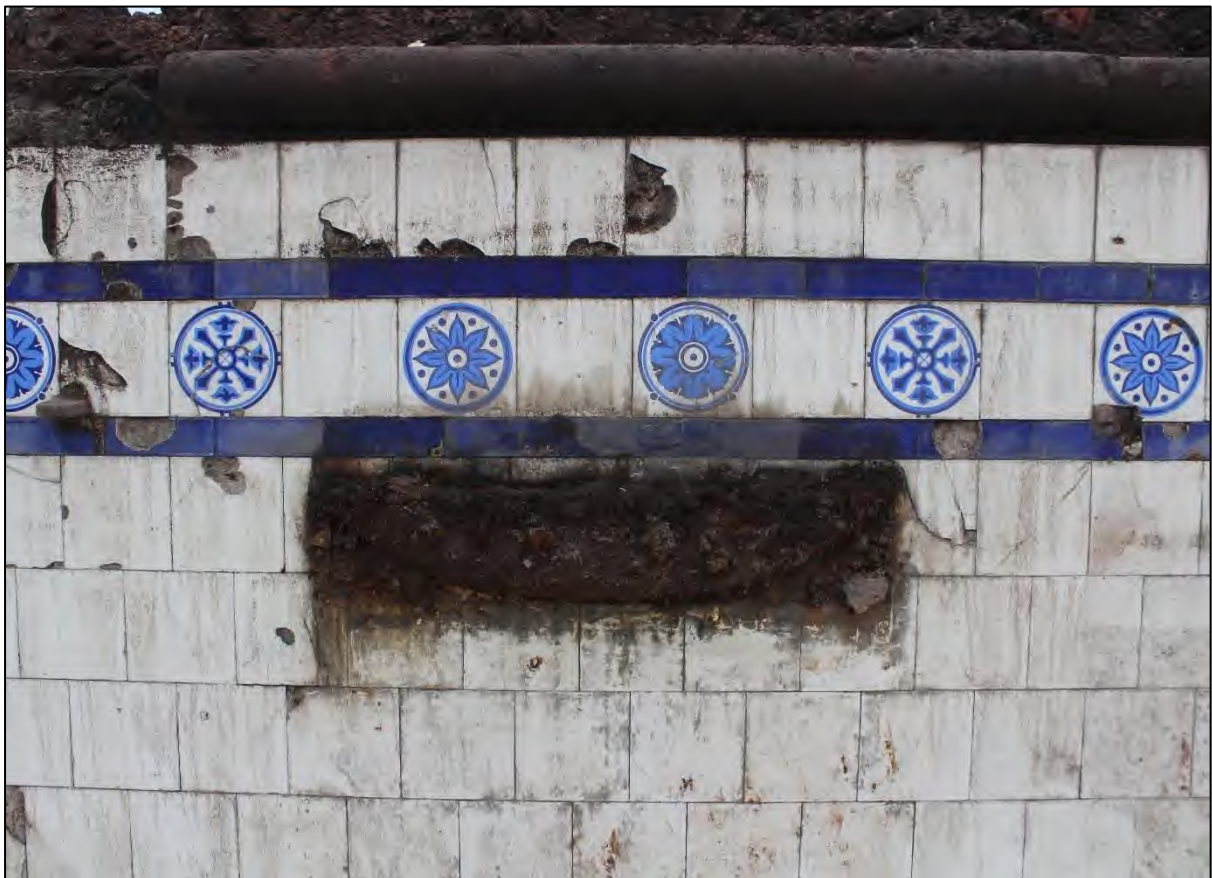
*Plate 60: The poolside of 225, showing the spit trough and floral tiles, looking east.*

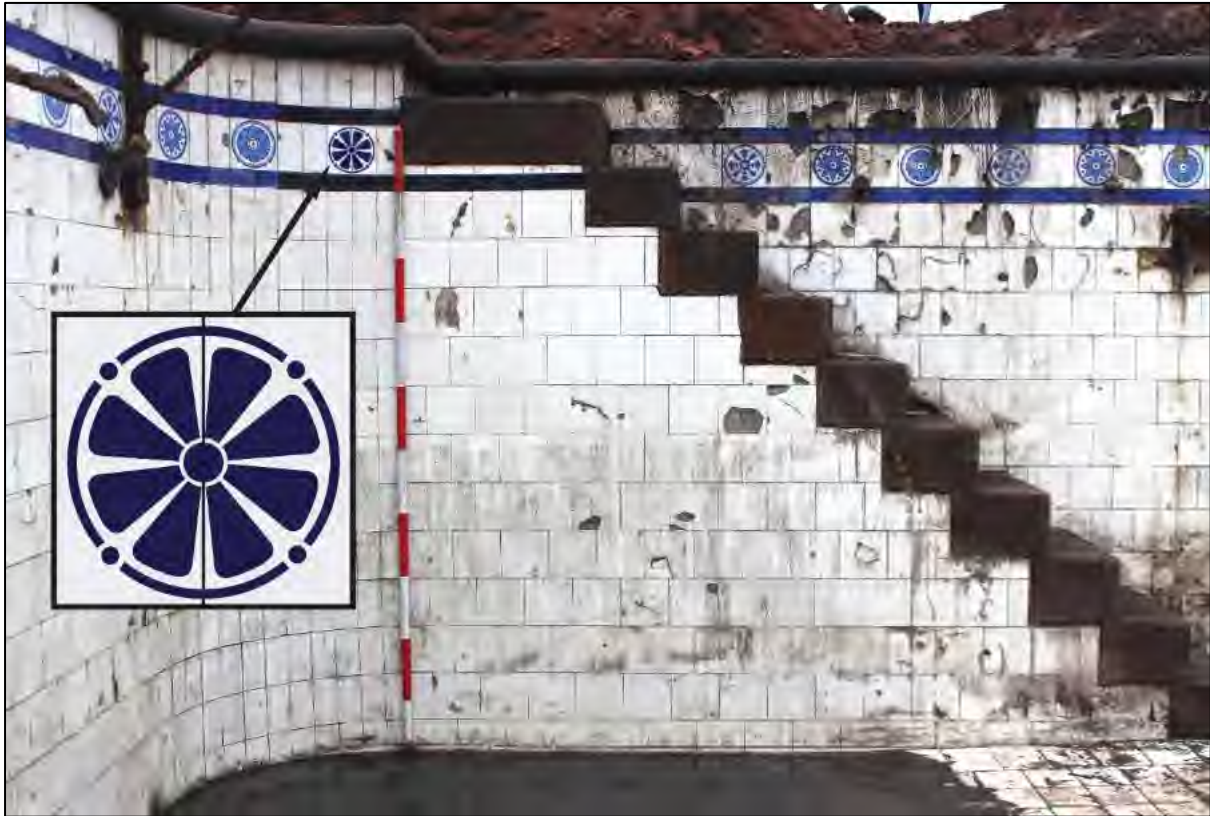
*Plate 61: Pool 225 showing the later steps and replacement tiles (2m scale)*

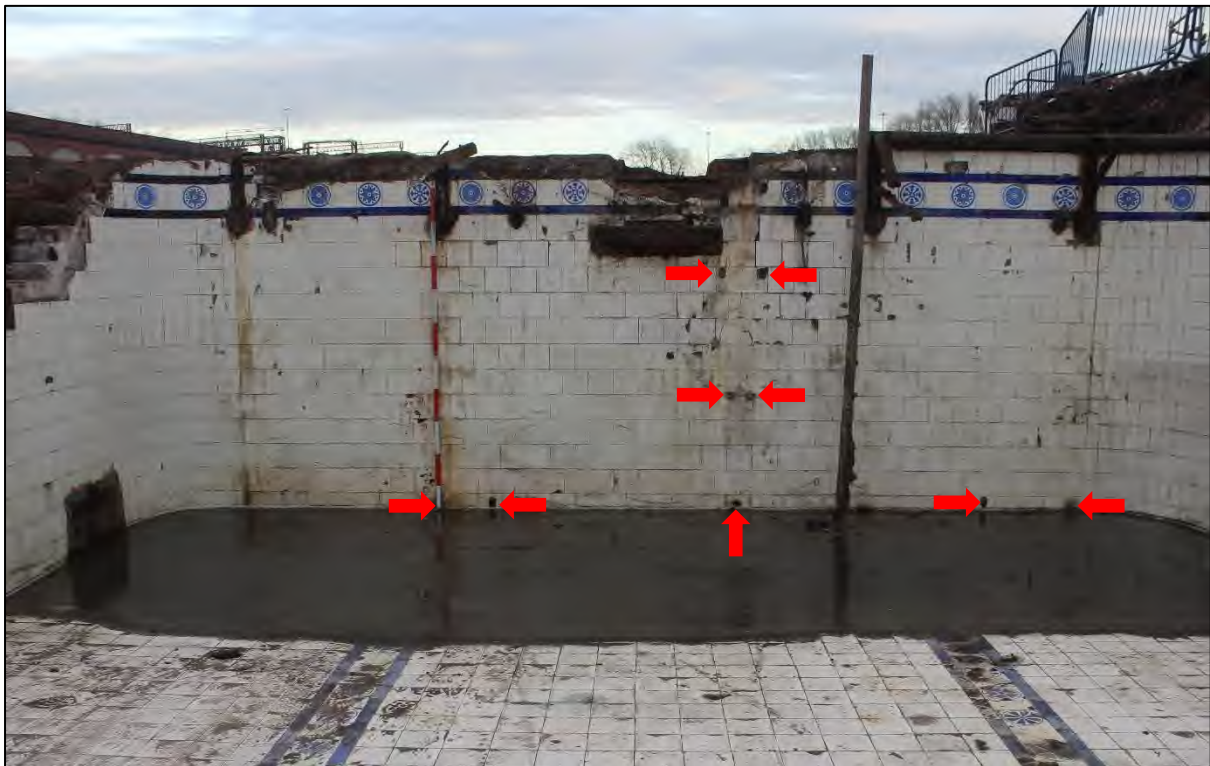
Plate 62: The eastern end of Pool 225 showing the position of the fixings for the steam injection pipe (removed) and L-shaped brackets visible above the waterline (2m scale)

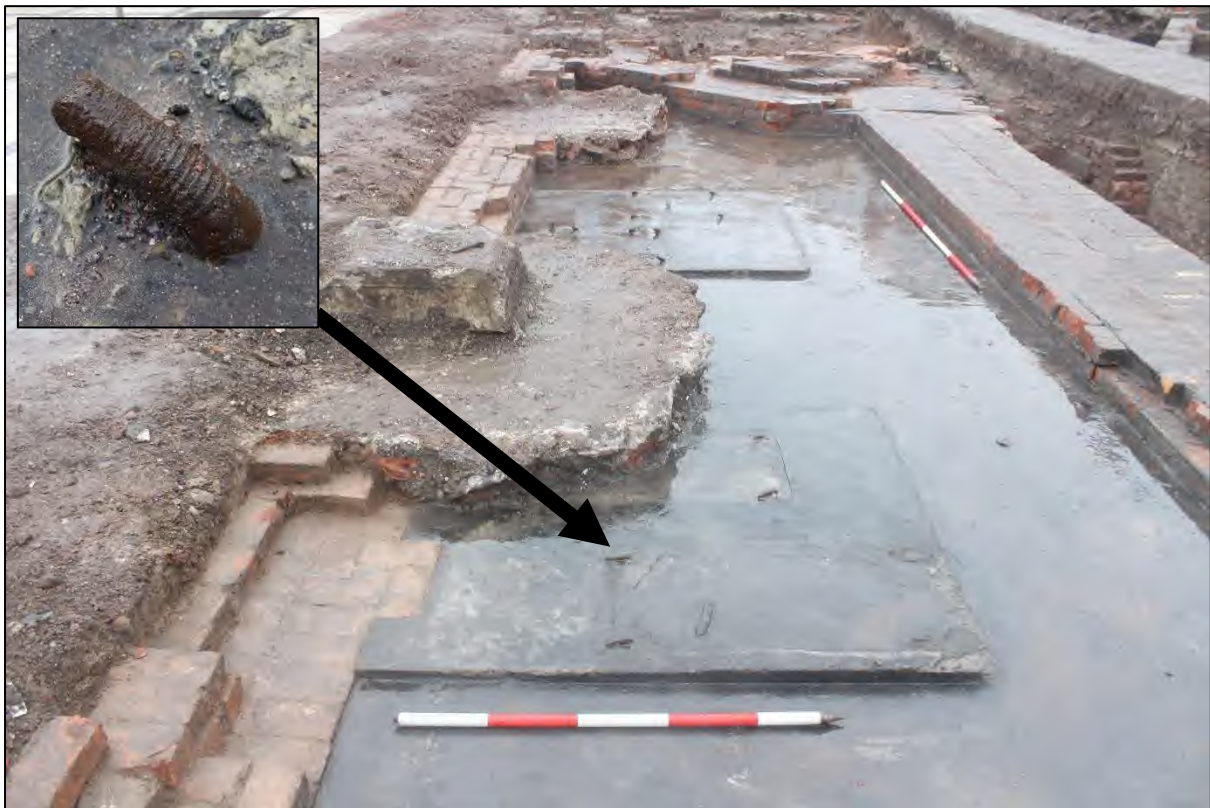
*Plate 66: Anteroom to the boiler showing stone machine beds 216a (foreground) and 216b in the rear of the shot (1m and 2m scales) Inset: showing threaded bolt*
