## **Archaeological Excavation Report**

Mayfield,  
Manchester

**Report No:**  
SA/2021/56

**Project:** Mayfield, Manchester: Archaeological Excavation

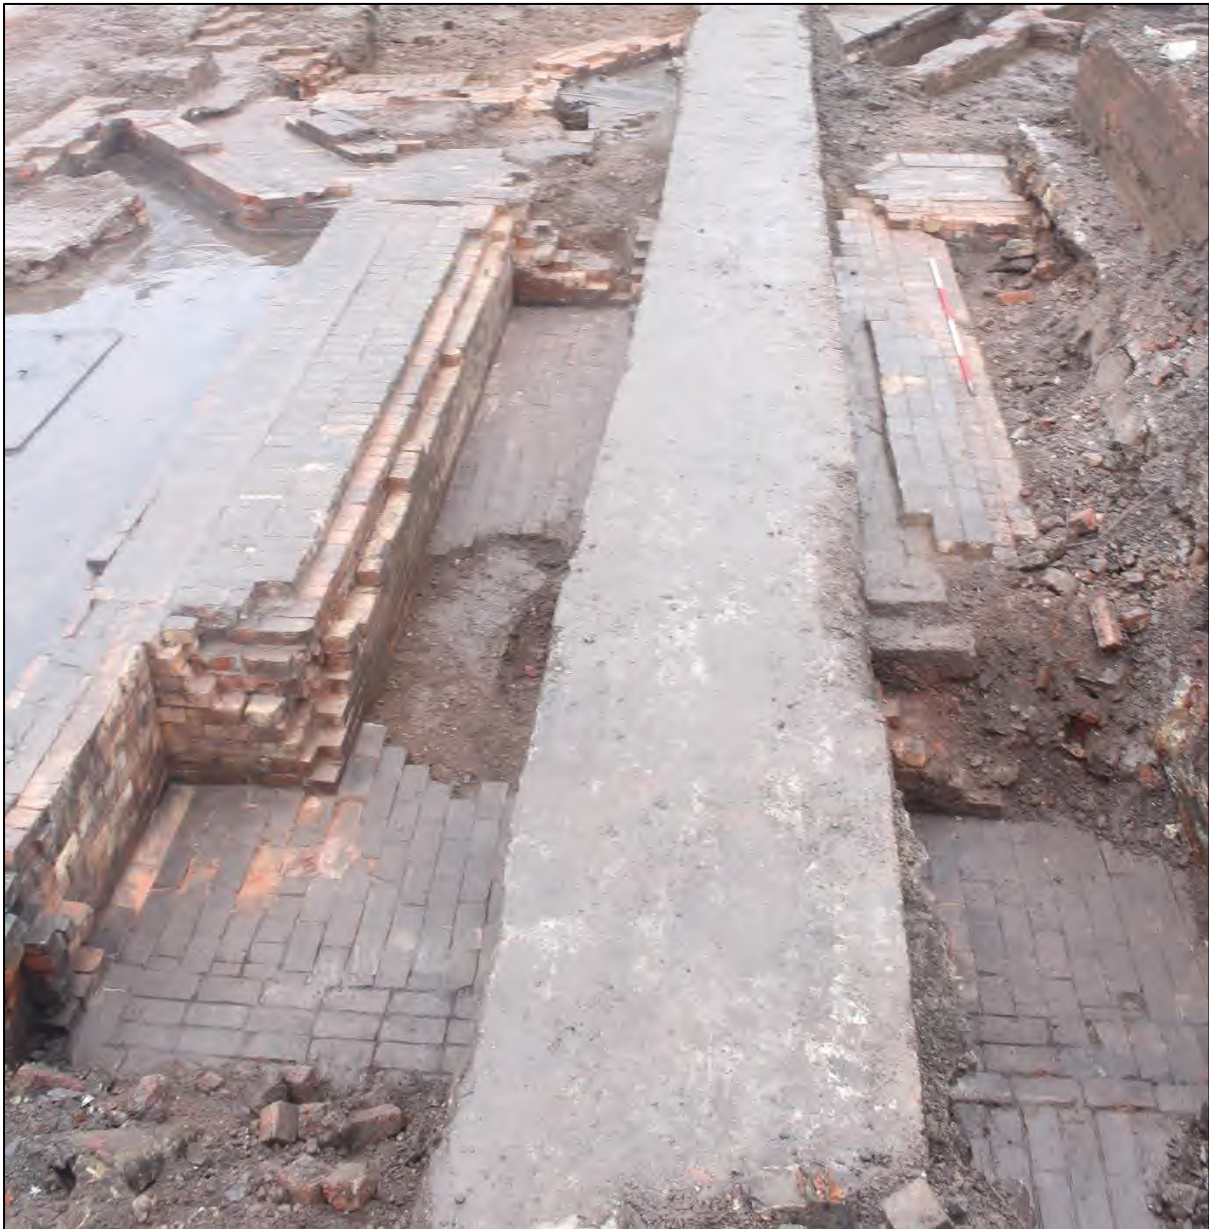
*Plate 69: View of the boilers 221 and 222 and flue 217 looking west (2m scale)*

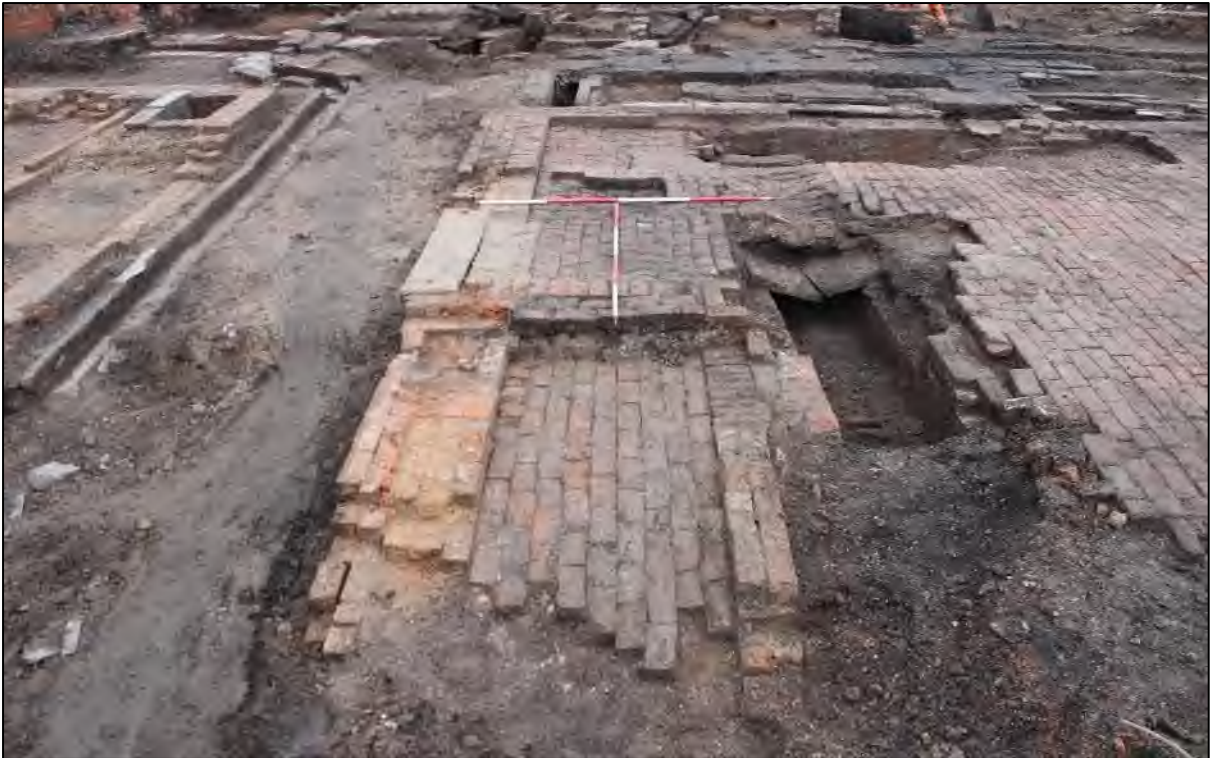
Plate 73: Walls 3011 and 3057 forming the northern wall of Building B. Note the yellowish-brown mortar and handmade brick forming the original one-and-a-half brick wall. Looking north-east (2 x 2m scales)

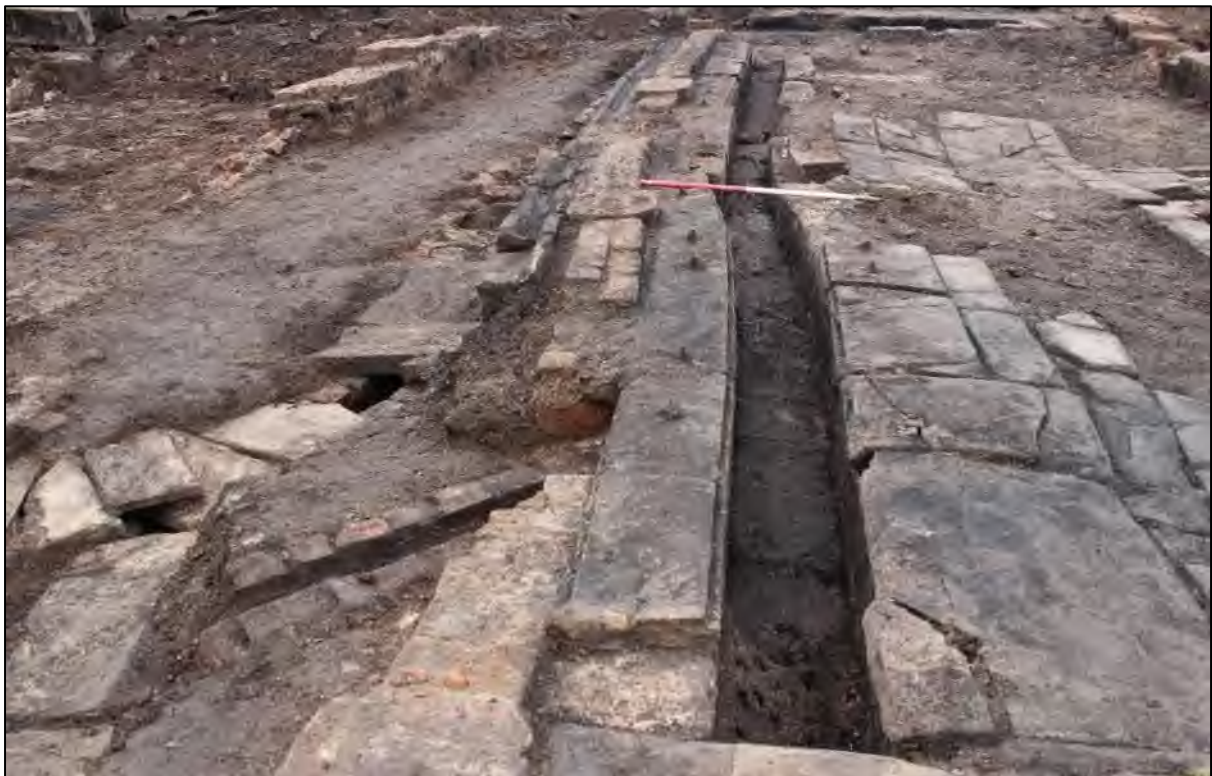
*Plate 78: View of drain 3038 constructed alongside wall 3027 looking south-west (1m scale)*

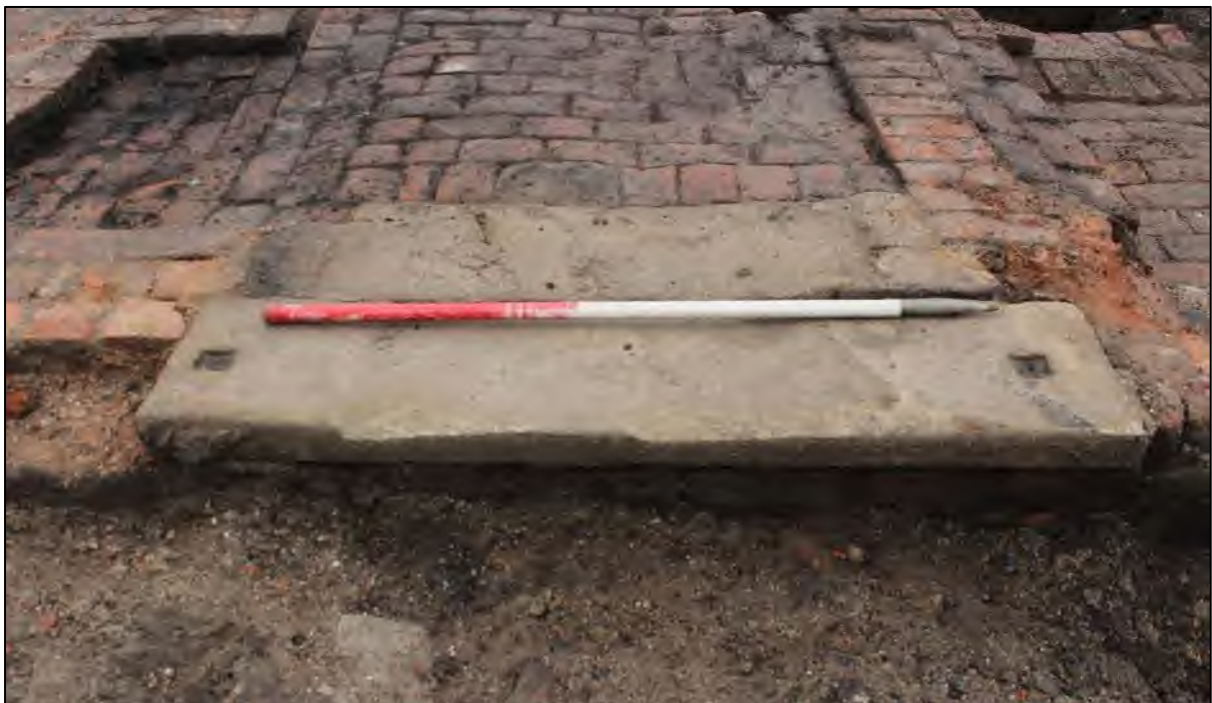
*Plate 83: Wall 3010 featuring a later threshold with rectangular sockets for the door jambs. The earlier wall and threshold are visible to the rear. Both exhibit traces of significant wear. (1m scale)*

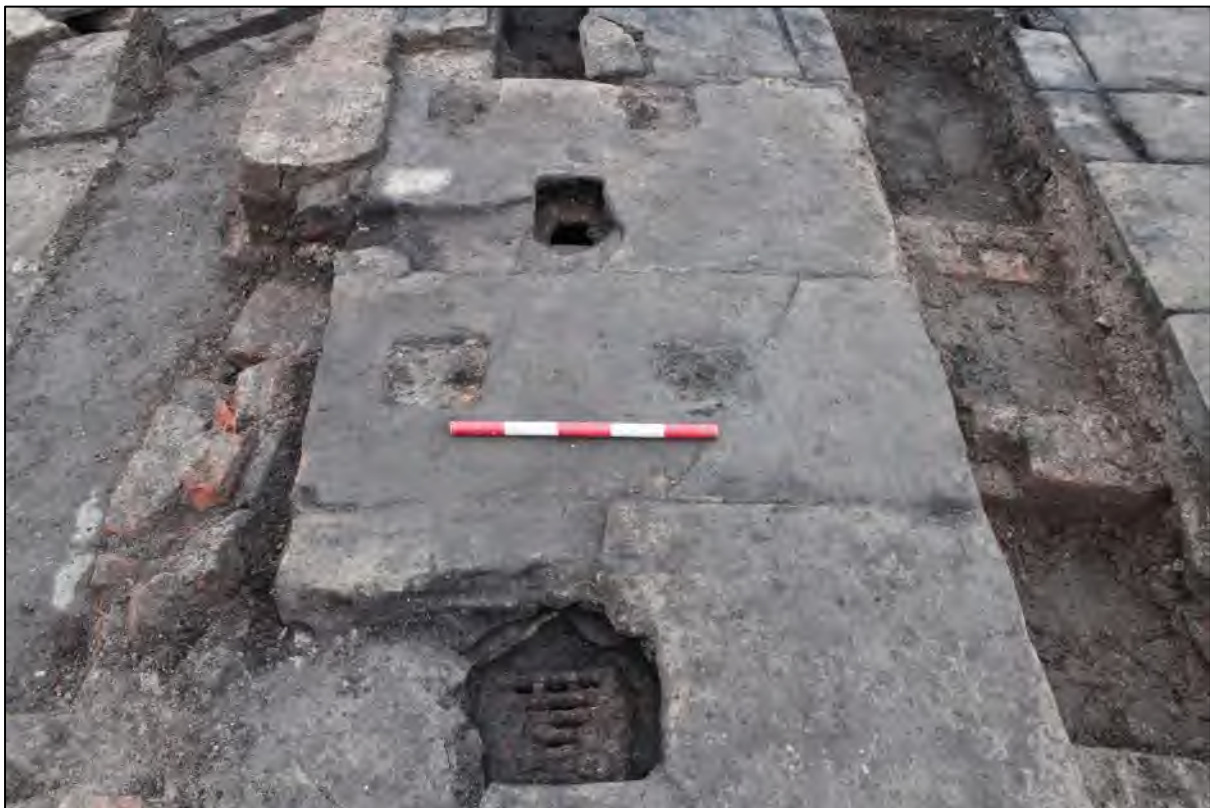
Plate 84: The fittings and drains set into the flags capping the extension of drain 3038 (0.50m scale)

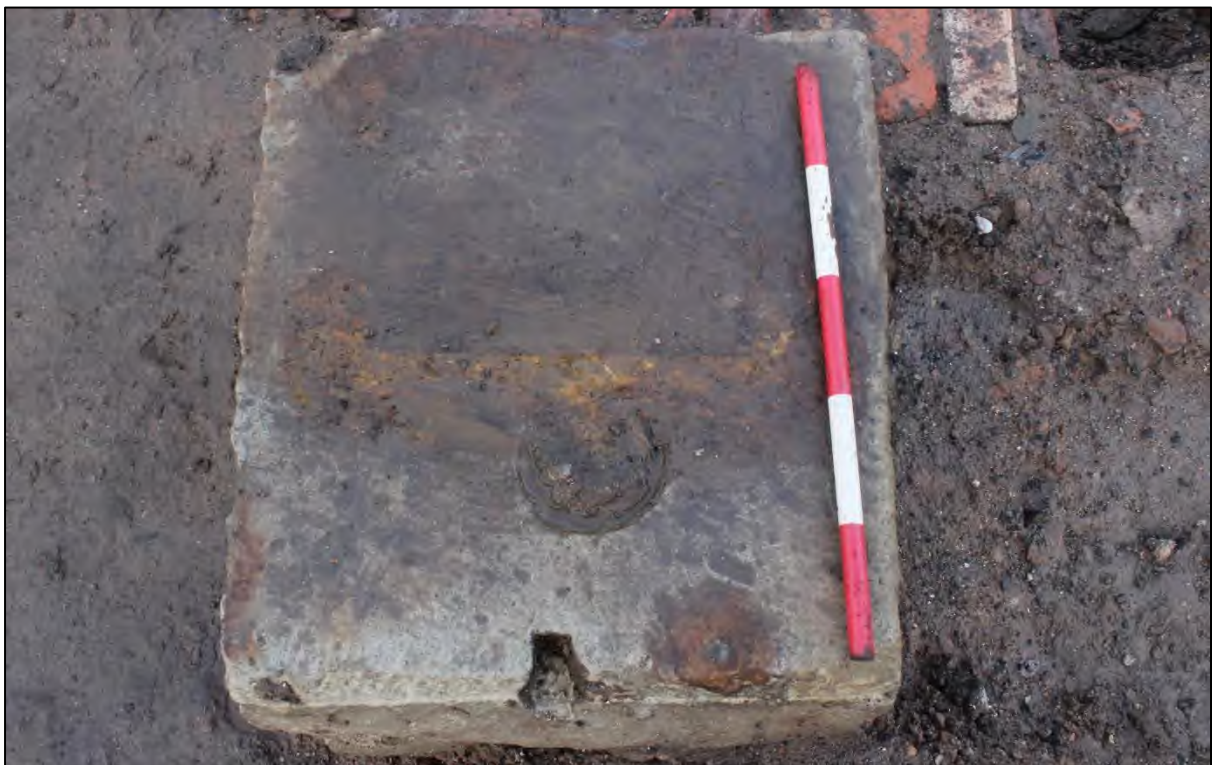
*Plate 115: Column base 3148 looking north. Note the shadow left behind by the cast iron column base as well as holes left by other potential fittings (0.50m scale)*

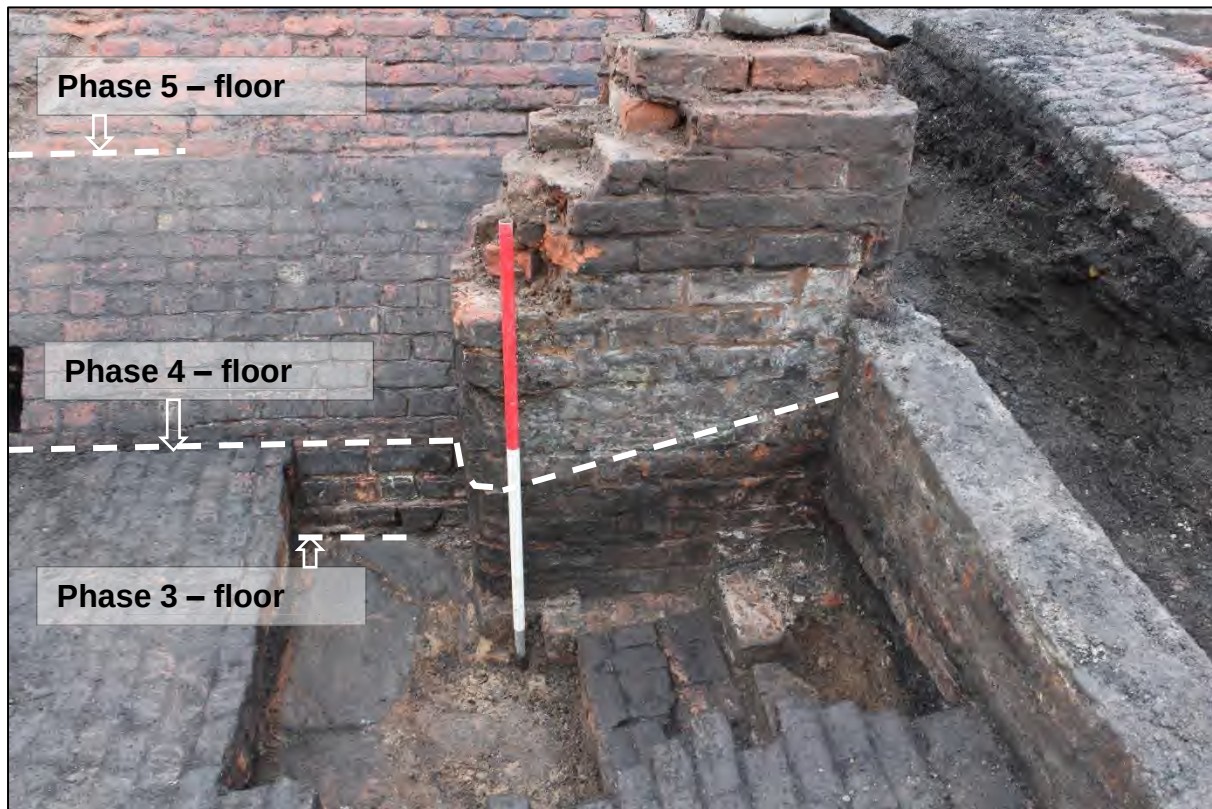
*Plate 131: The three successive charging floors revealed within the southern half of the boiler house: 3172 (Phase 3); 3065 (Phase 4) and 3174 (Phase 5). Photographed looking south (1m scale)*

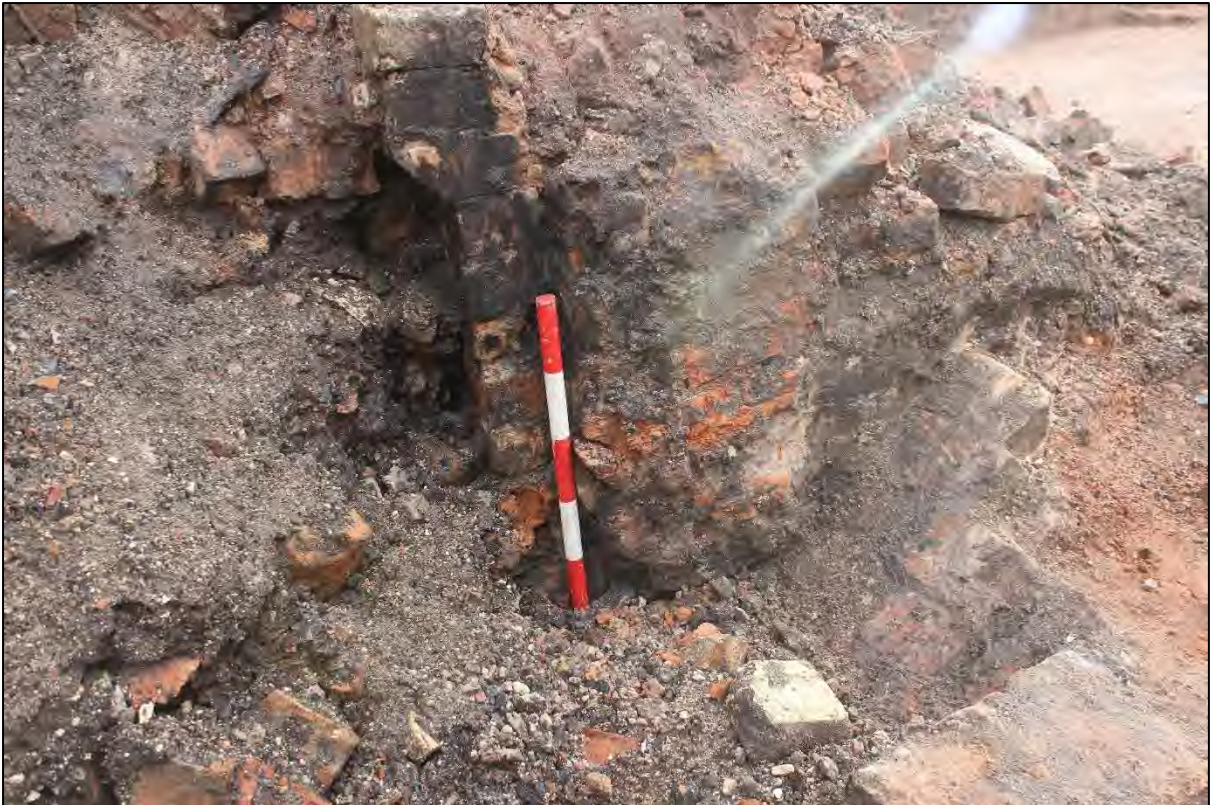
*Plate 132: Remnant of the vaulted flue to the rear of the boilers, looking east. Note the rebated brick wall and adjacent flue sloping down from below the boiler. This would have been the location of a damper to regulate draught (0.50m scale)*

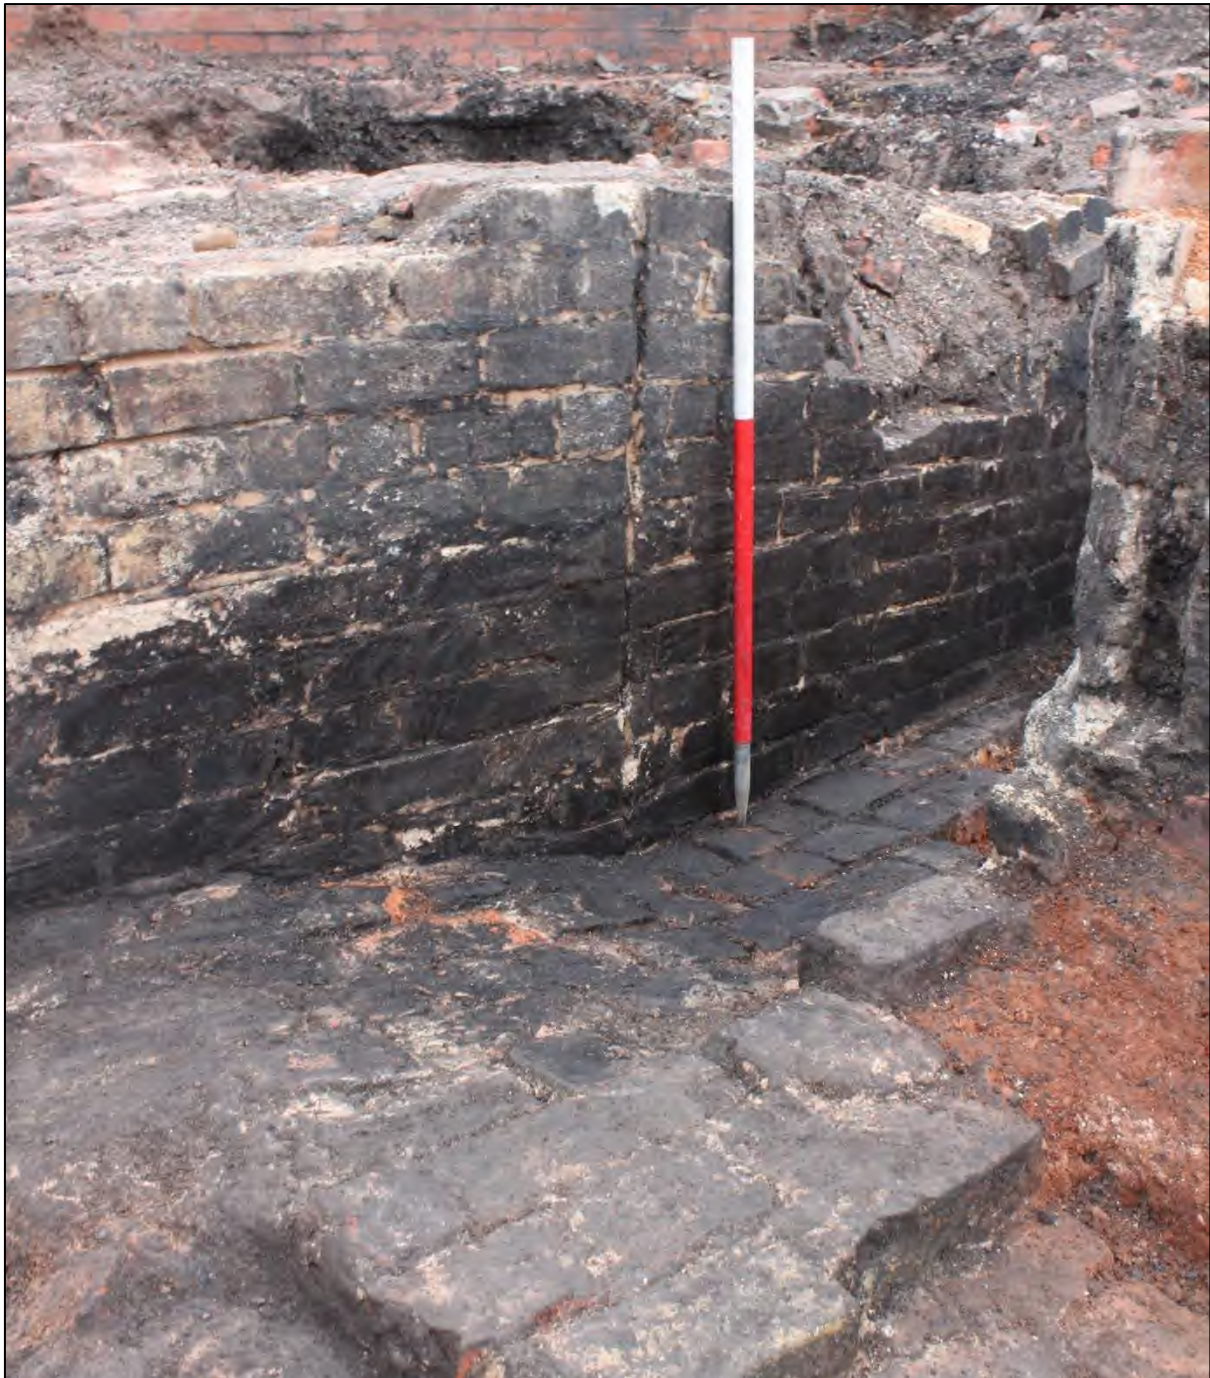
*Plate 144: Vertical phase break within the northern wall of flue 3064/3189 indicating its point of extension (1m scale). Note the upward sloping floor within the flue.*

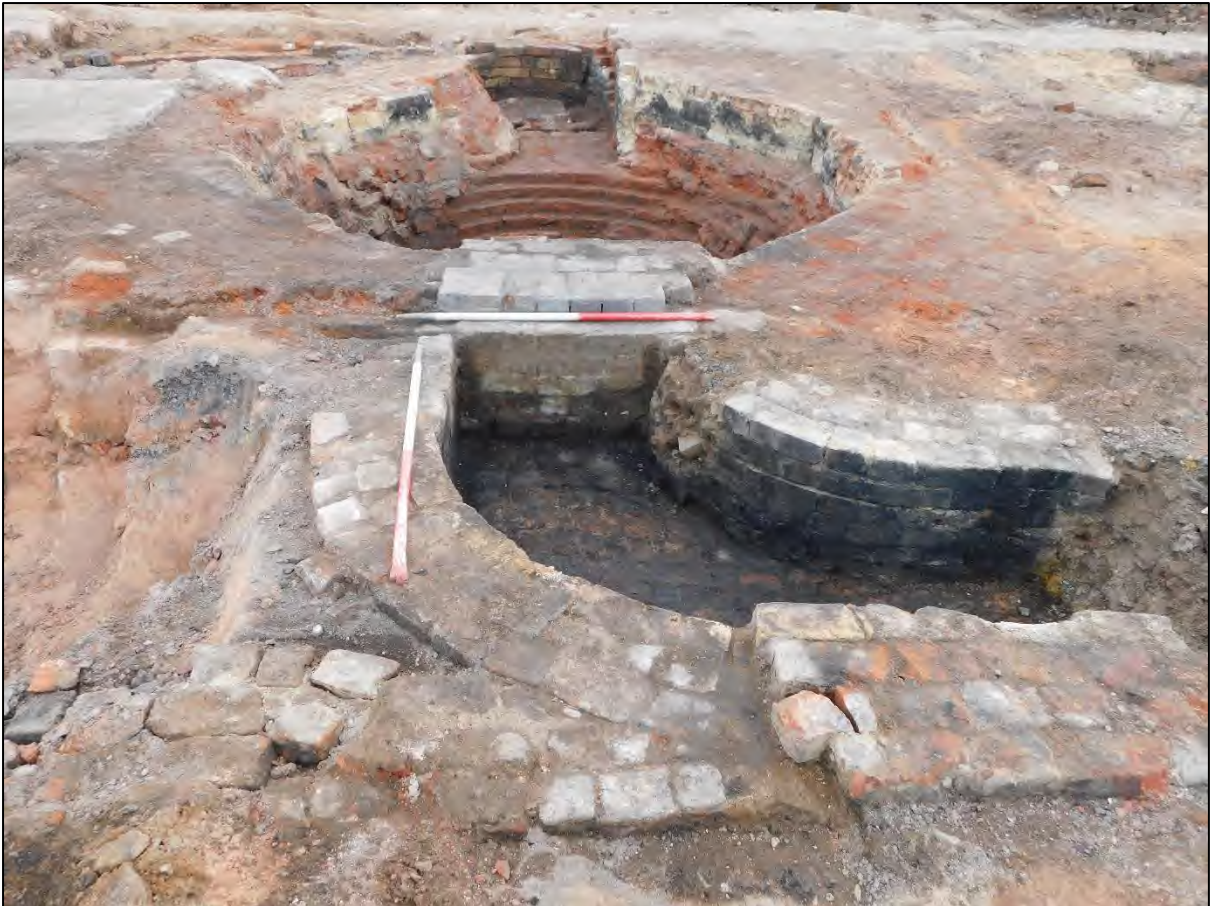
*Plate 163: Flue 422 feeding into chimney 424 blocked by later brick wall 423, facing north (2 x 1m scales)*

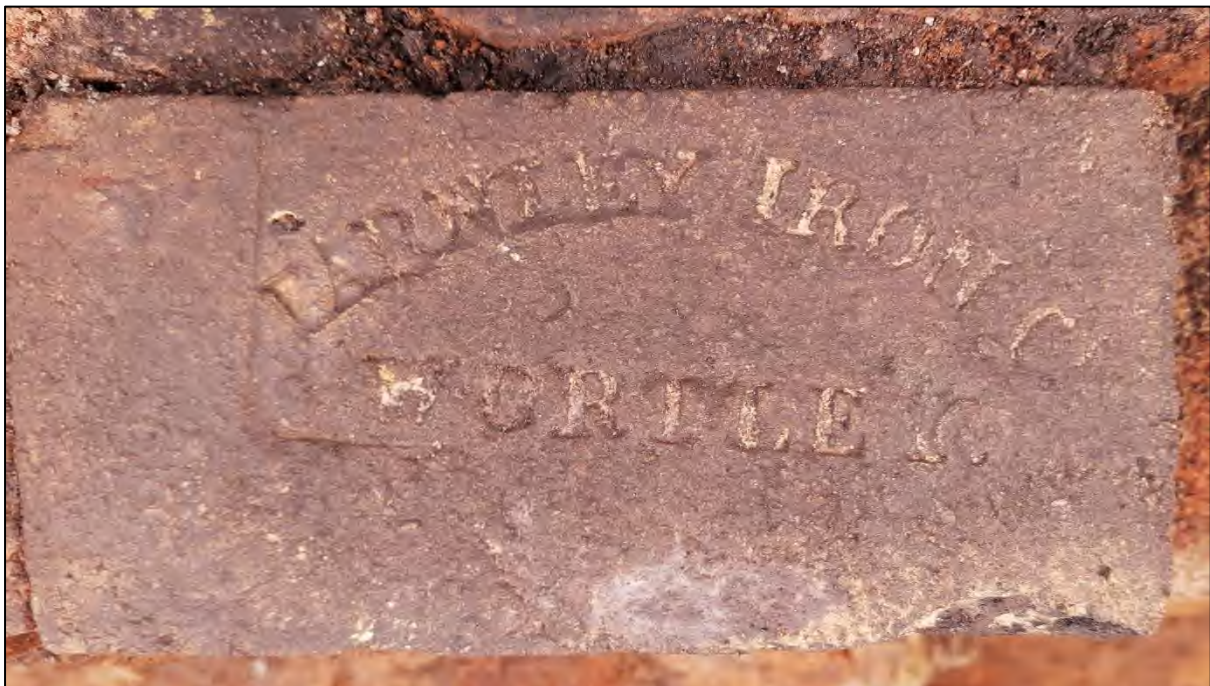
*Plate 179: Firebrick bearing the stamp Farnley Iron Co. Wortley' utilised in Boiler 111*

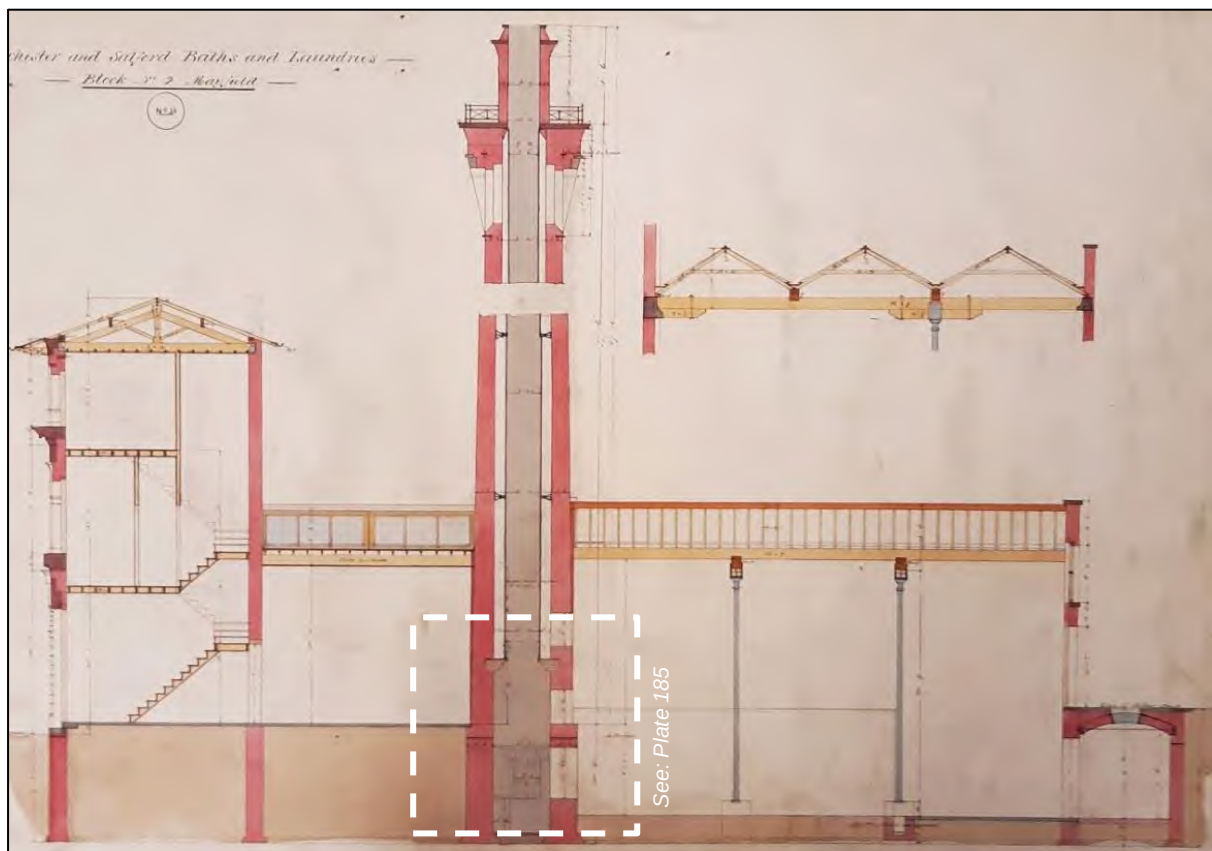
Plate 184: Cross-section through the northern part of Mayfield Baths with detail of chimney foundation

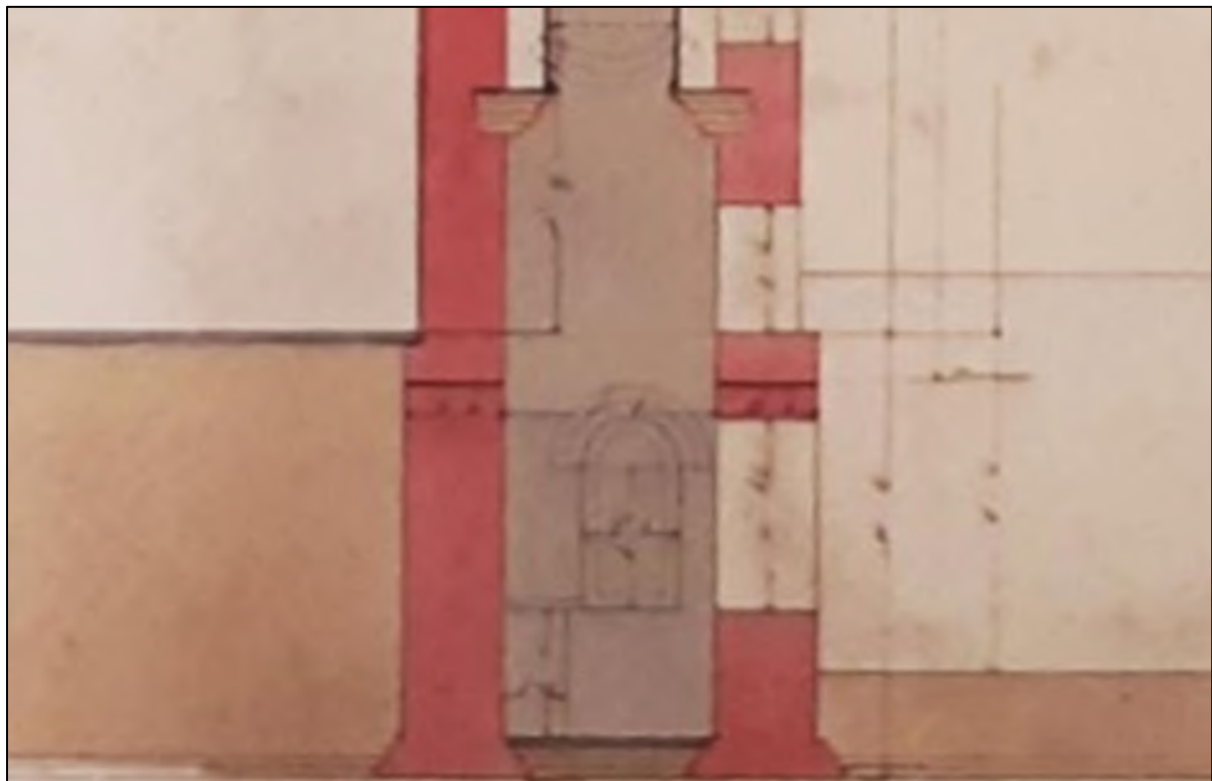
Plate 185: Detail of chimney foundation illustrating the position of the flues

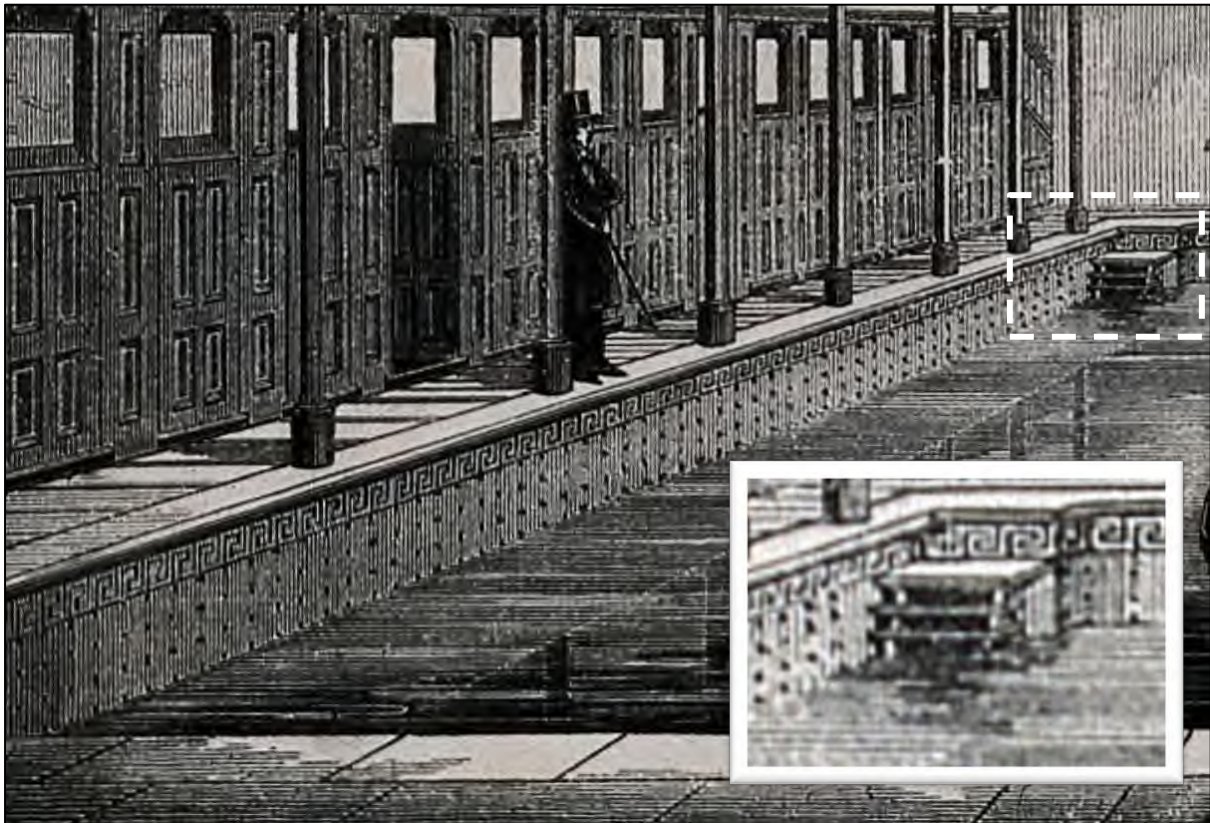
Plate 187: Extract from *The Builder* 1858 showing the original tiles and steps installed in the plunge pool of the first-class men's pool at Mayfield Baths (see inset for close-up)
