# Phase 1 Environmental Risk Assessment

**50 Red Bank, Manchester, M4 4HF**

**Presented to Lesing Eastbrook Limited c/o Praxis IFM**

Delta-Simons Project No. 18-1472.01

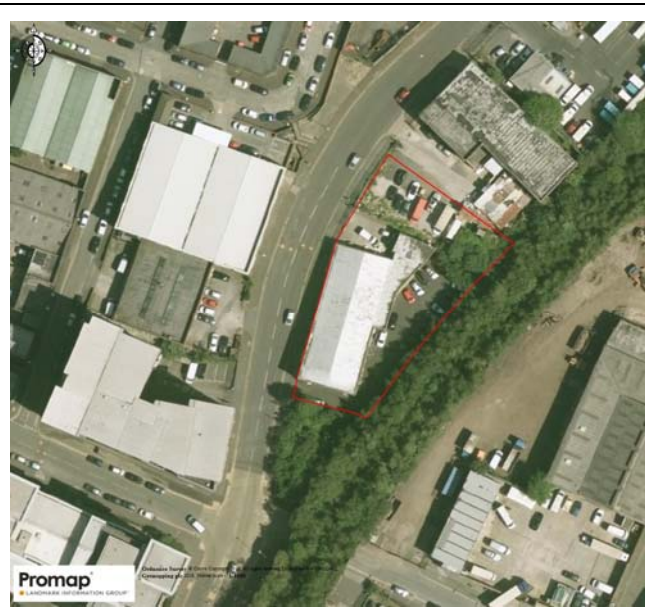
| <p>Contains OS data ©, Crown Copyright and Database Right (2018)</p> <p>Contains Data from, © 2018 Landmark Information Group Ltd</p> | | <p>Contains Data from, © 2018 Landmark Information Group Ltd</p> | |
|---|---|---|---|
| Current Site Use | <p>The Site is currently occupied by empty offices, show rooms and store rooms and was most recently Boardmans, which is a fashion design company. The building is considered to be a typical brick built commercial building with pitched roof from around the 1960/70s.</p> <p>External areas comprise associated hard standing for parking and unloading. Shrubs/trees are evident in the central area of hard standing between 50 Red Bank and 54 Red Bank to the north.</p> | | |

| | <ul style="list-style-type: none"> <li>▲ Surfacing in external areas of the Site is hardstanding and asphalt with some vegetation evident;</li> <li>▲ The building comprises show rooms, loading bays and carpeted office space. Suspected asbestos containing materials (ACMs) are evident within the building;</li> <li>▲ There was no evidence of any above ground storage tanks (ASTs) or below ground storage tanks (UST's);</li> <li>▲ There was no evidence of any spillages or leaks; and</li> <li>▲ There was evidence of suspected Japanese Knotweed in land in the north of the Site and adjacent to the viaduct in the east both within the premises and on adjacent land.</li> </ul> <p><i>There were no significant contamination concerns/sources observed during the Site walkover. It would be prudent to confirm the presence of the invasive plant species at the Site by an invasive weed specialist. Also, an initial structural stability assessment of the retaining wall/slope on the eastern boundary would be prudent.</i></p> | |
