# Archaeological Excavation Report

Mayfield,  
Manchester

**Report No:**  
SA/2021/56

**Project:** Mayfield, Manchester: Archaeological Excavation

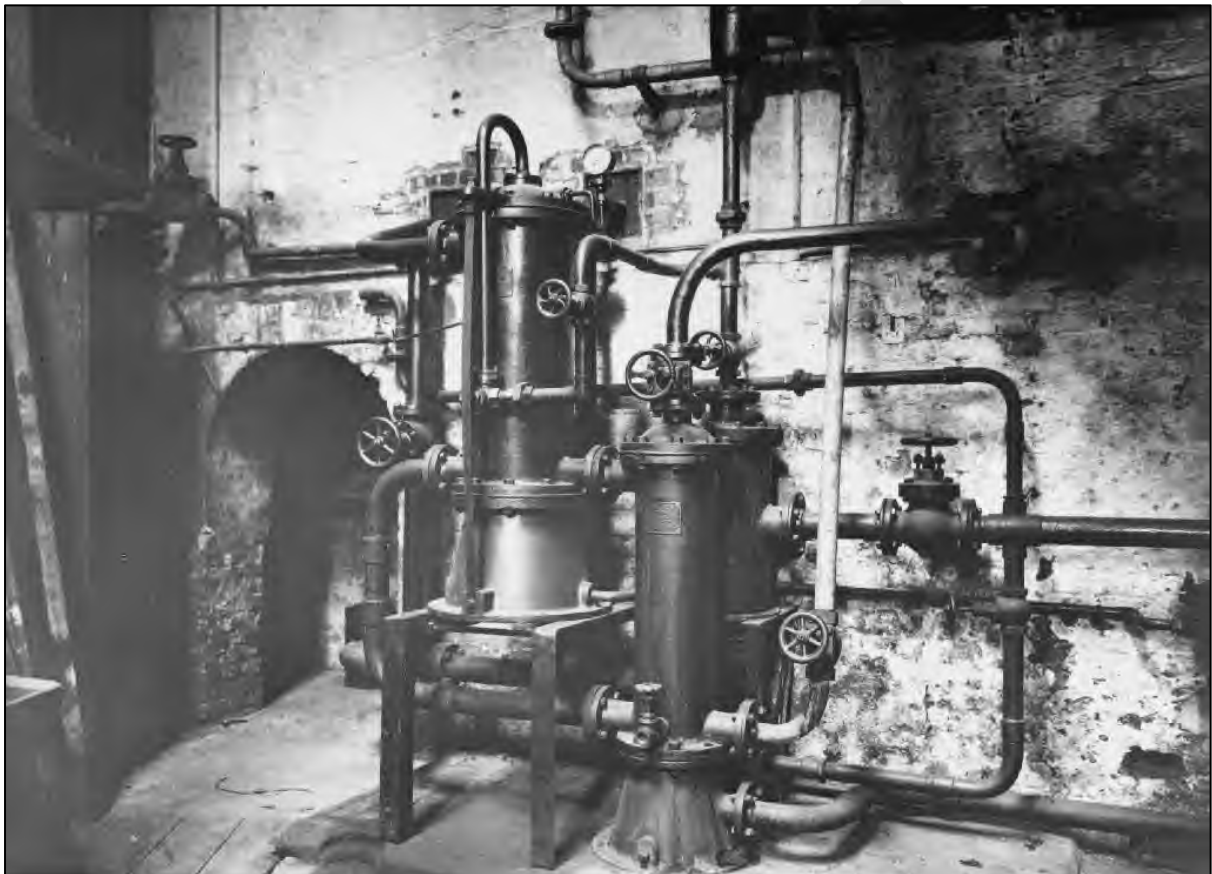
*Plate xx: The Royle Calorifier at Mayfield Baths, 1902.*

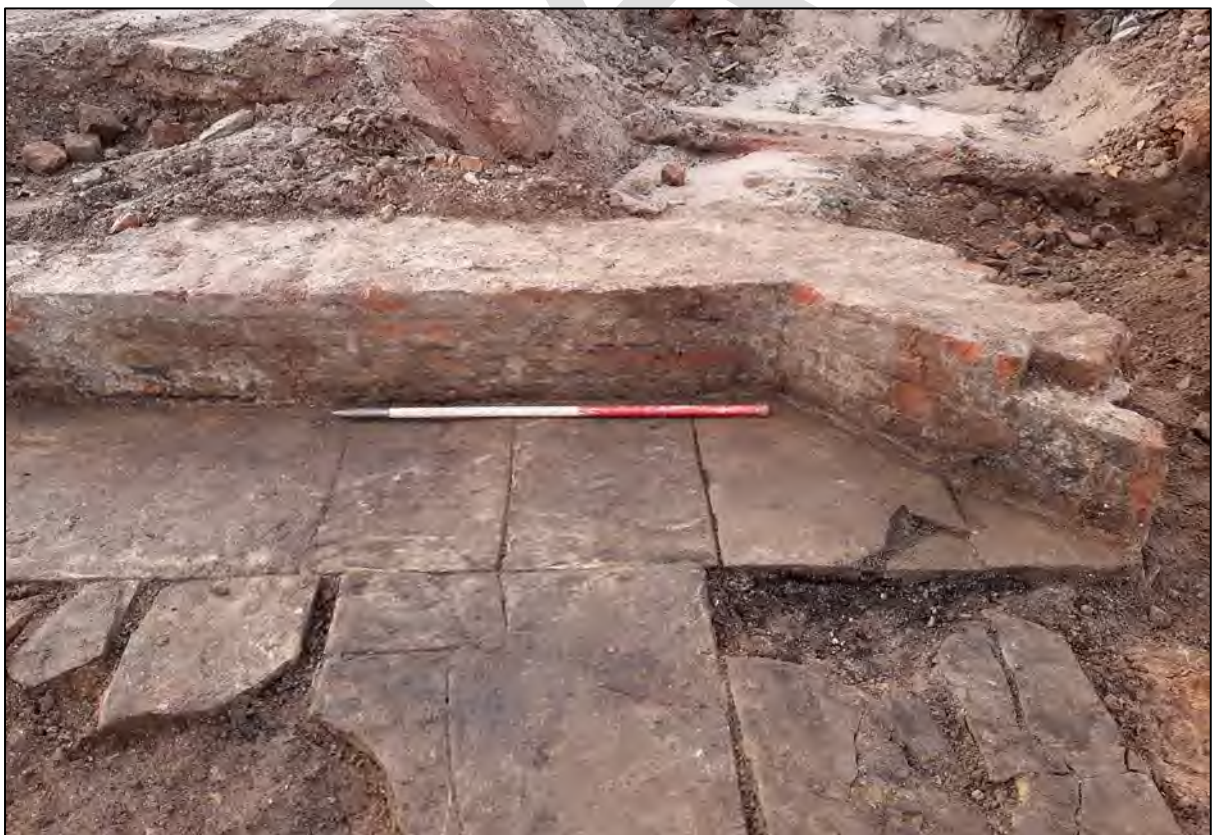
Plate xx: Wall 114, looking south.

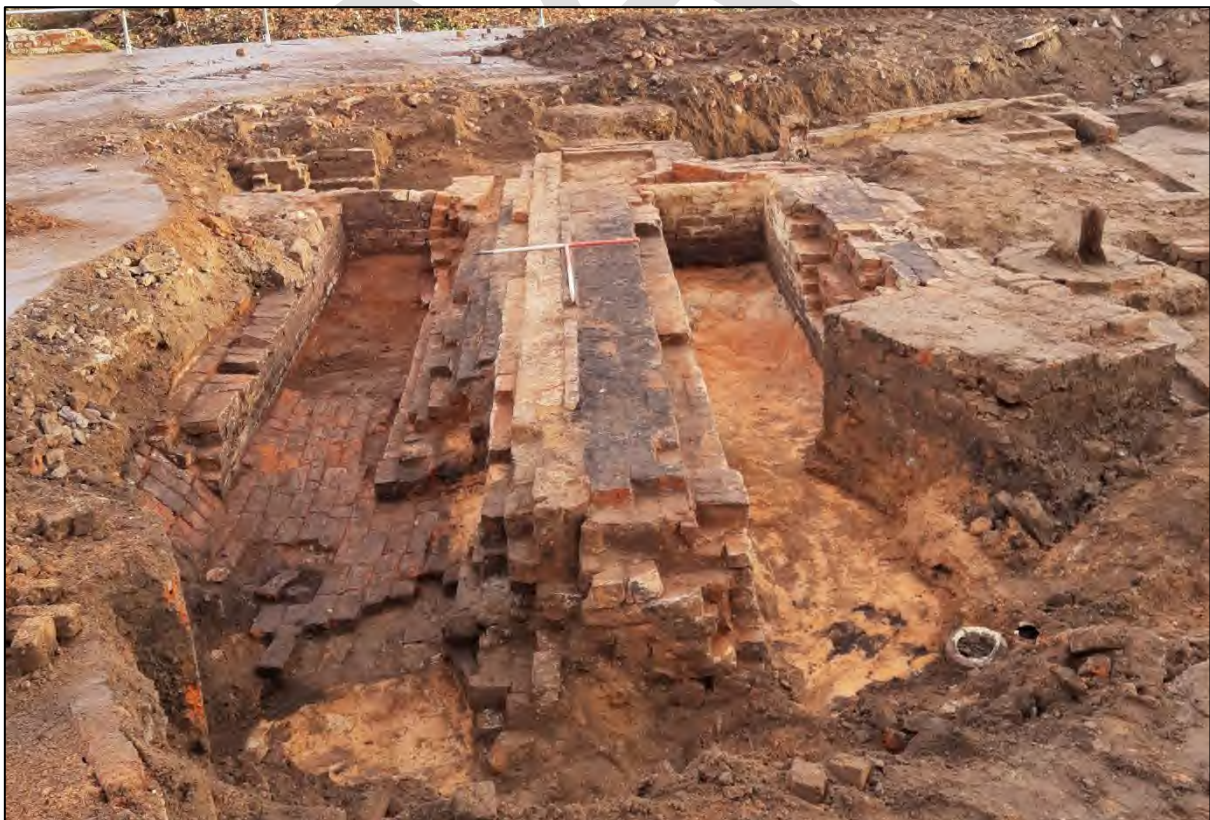
*Plate xx: Boiler beds 111 and 112, looking north*

The two boiler-beds, **111** and **112** were located to the southwest of the chimney at the west of the excavation area. Both boilers were truncated by later activity. This included a further brick stanchion, **109**, which truncated the southeast of boiler-bed **111** and measured 1.2 x 1.1m.

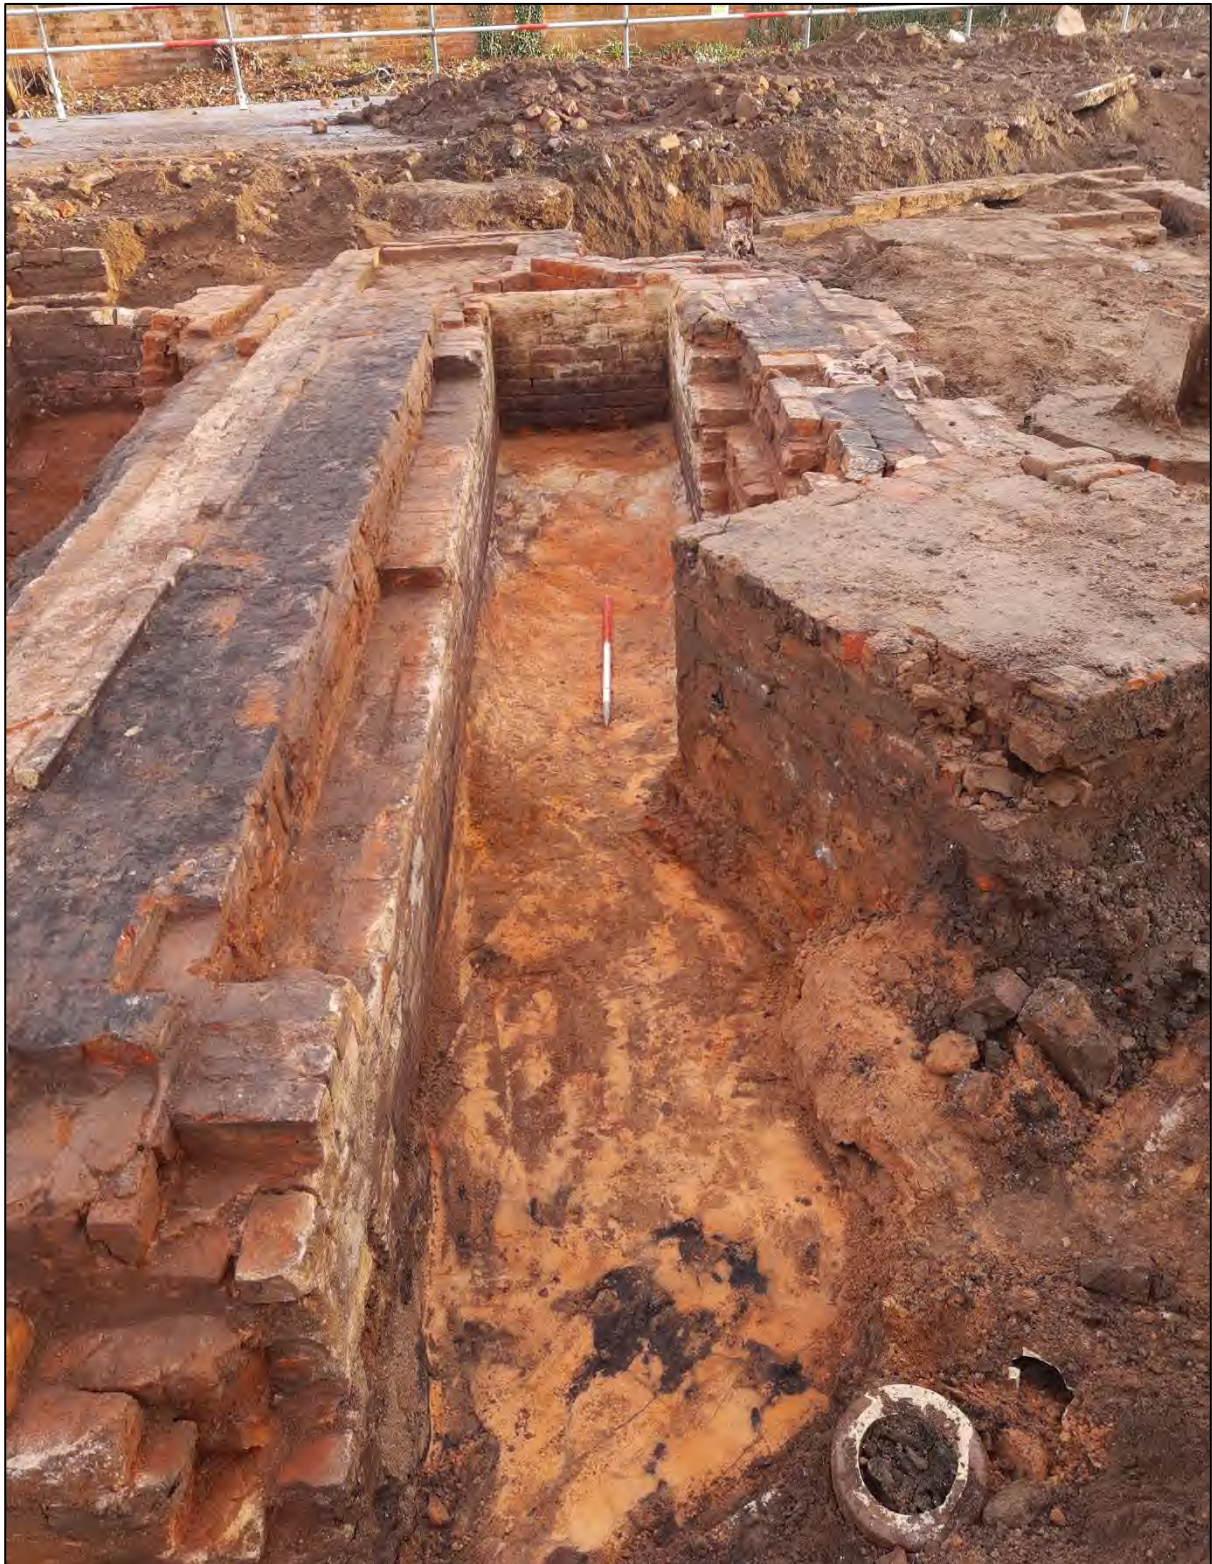
*Plate xx: Boiler 111, looking north*

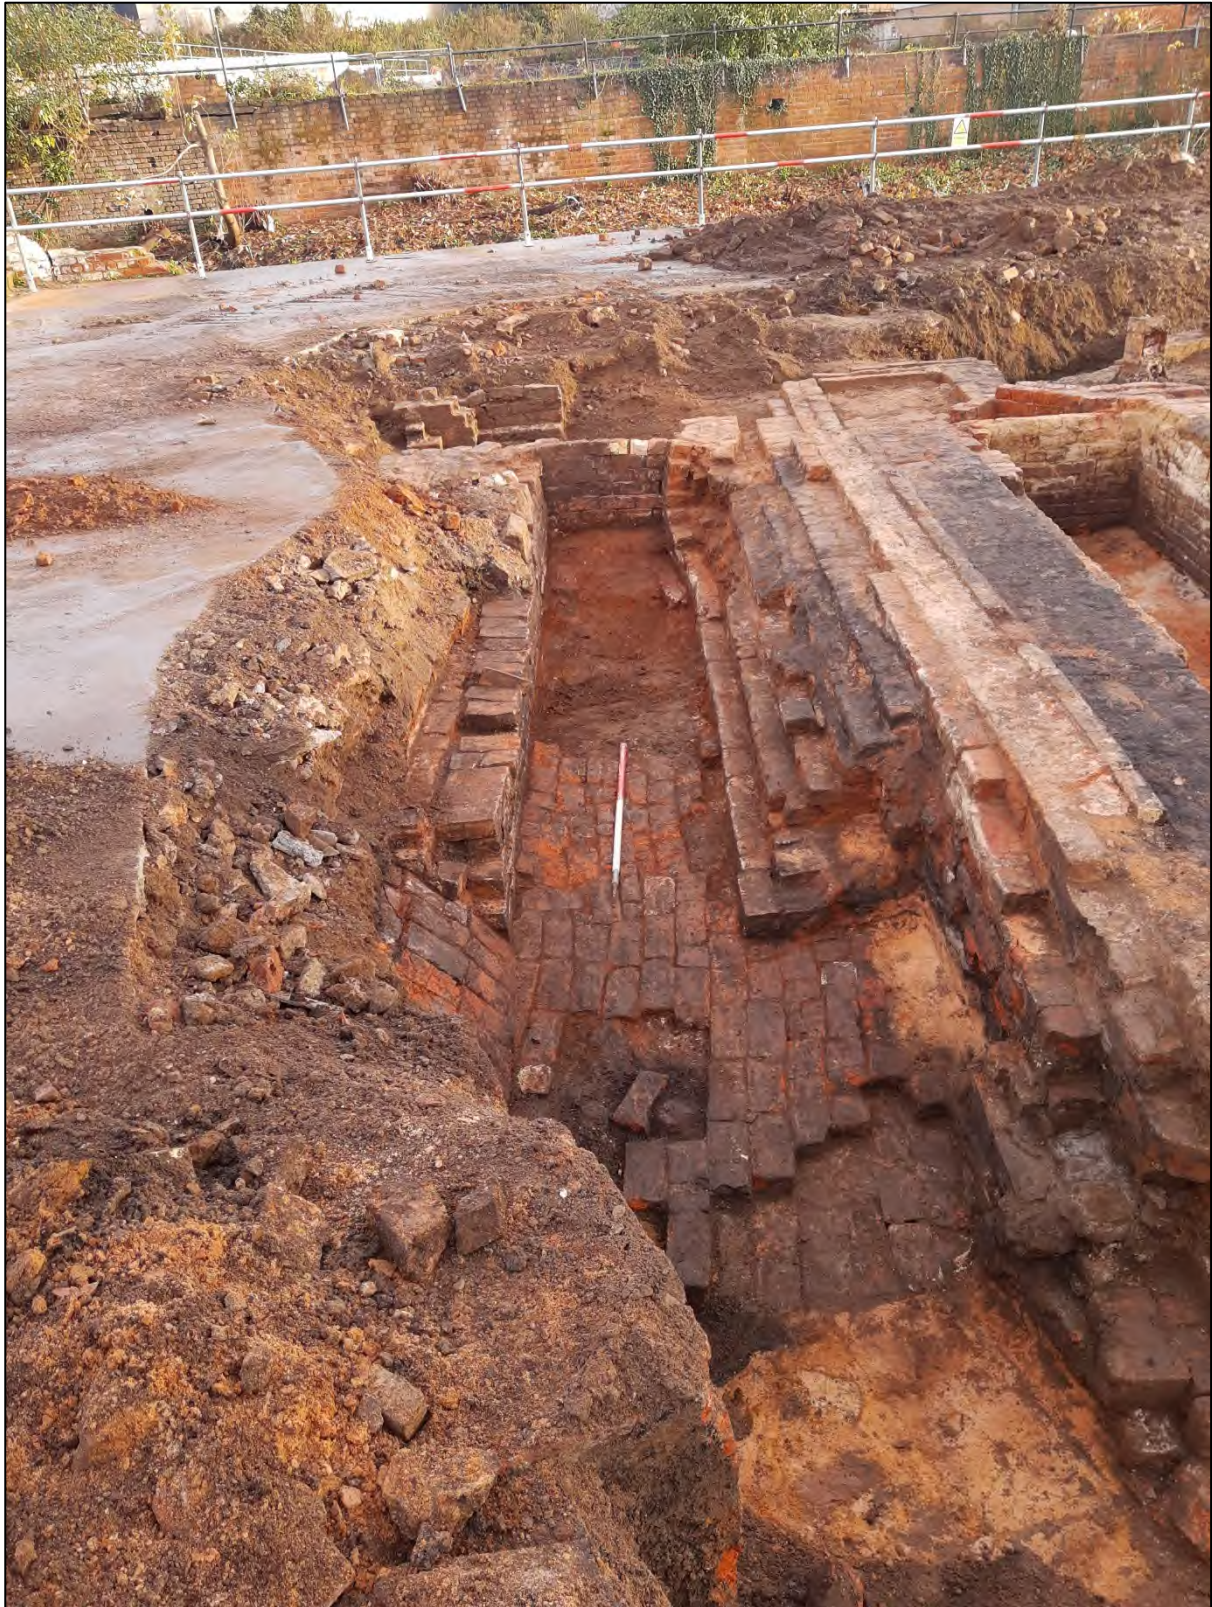
*Plate xx: Boiler 112, looking north*

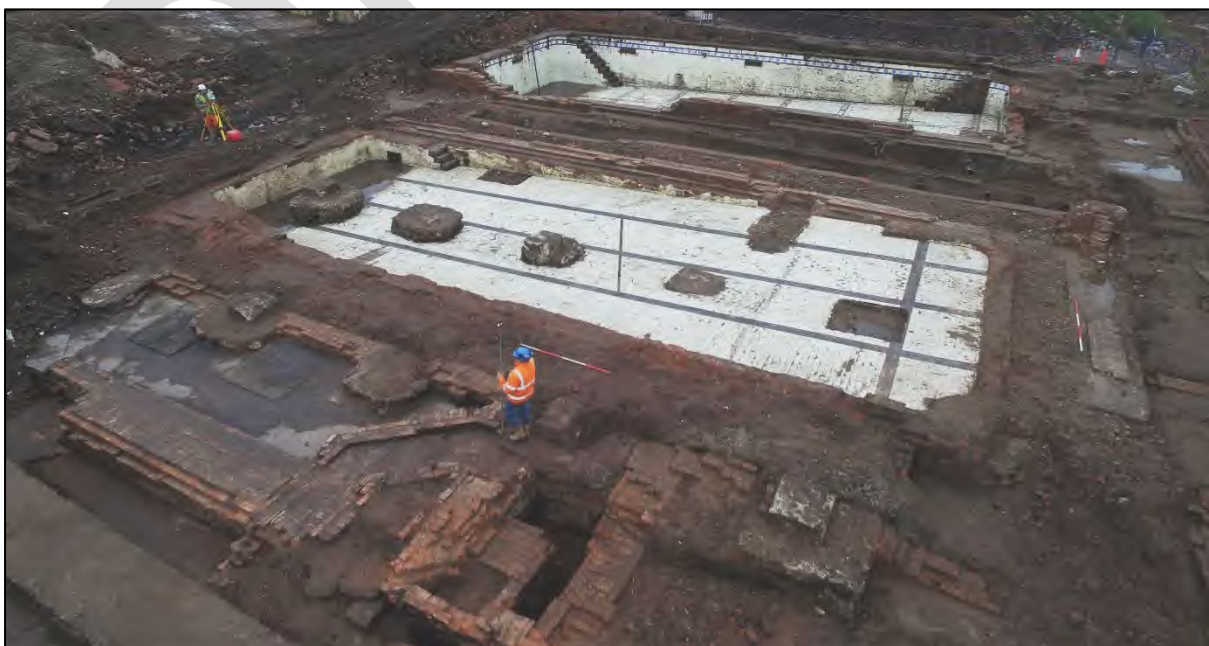
*Plate xx: The excavated remains of Mayfield Baths looking south-east*

This phase of construction was represented archaeologically by the remains of two plunge pools, an adjoining boiler house and foundation walls of the rooms, presumably the foyers and offices, which fronted onto Baring Street.

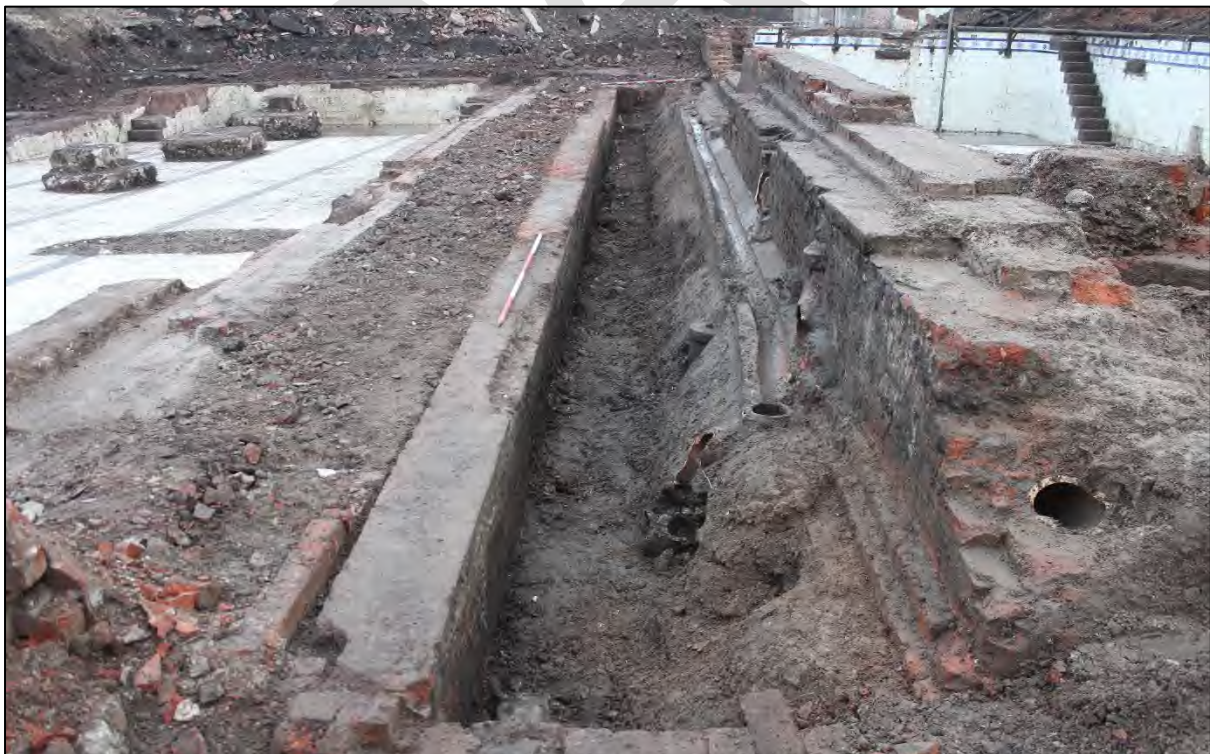
*Plate xx: Wall 227 looking east*

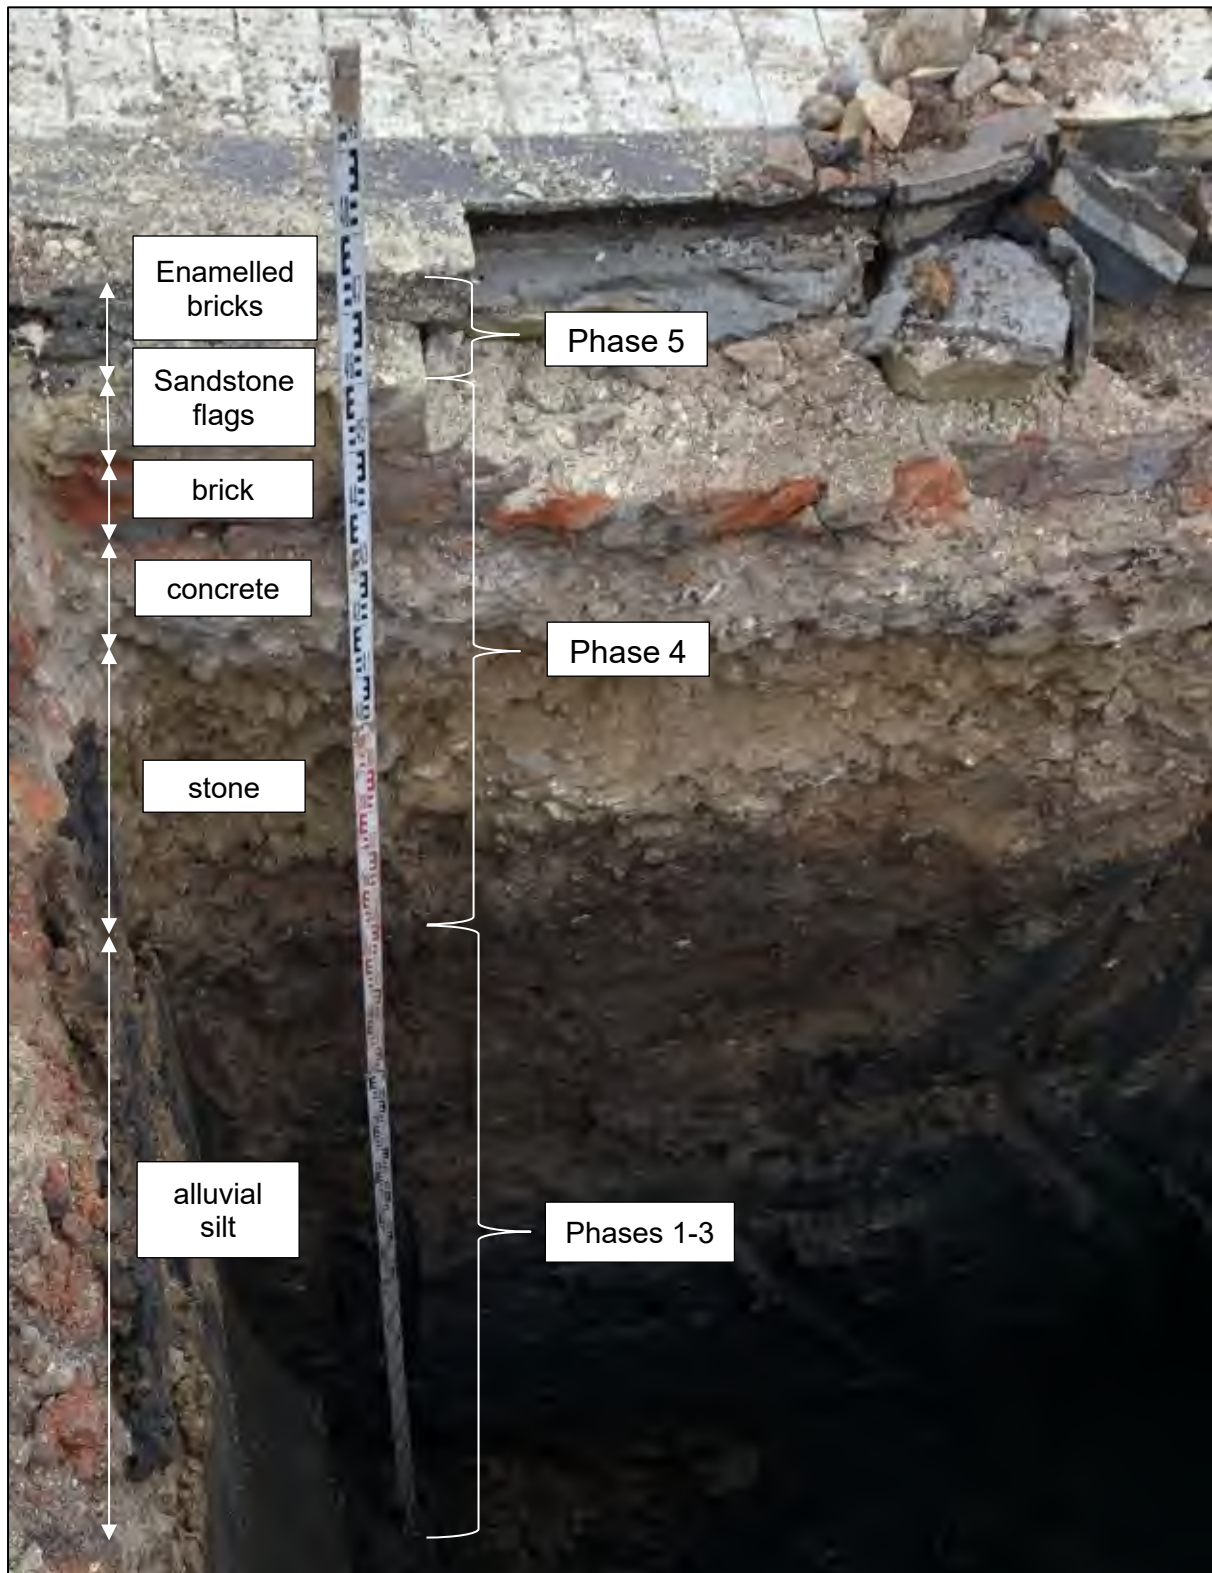
*Plate\_ : Sondage through the base of Pool 226 showing the composition of the foundations above earlier layers of alluvial silt*

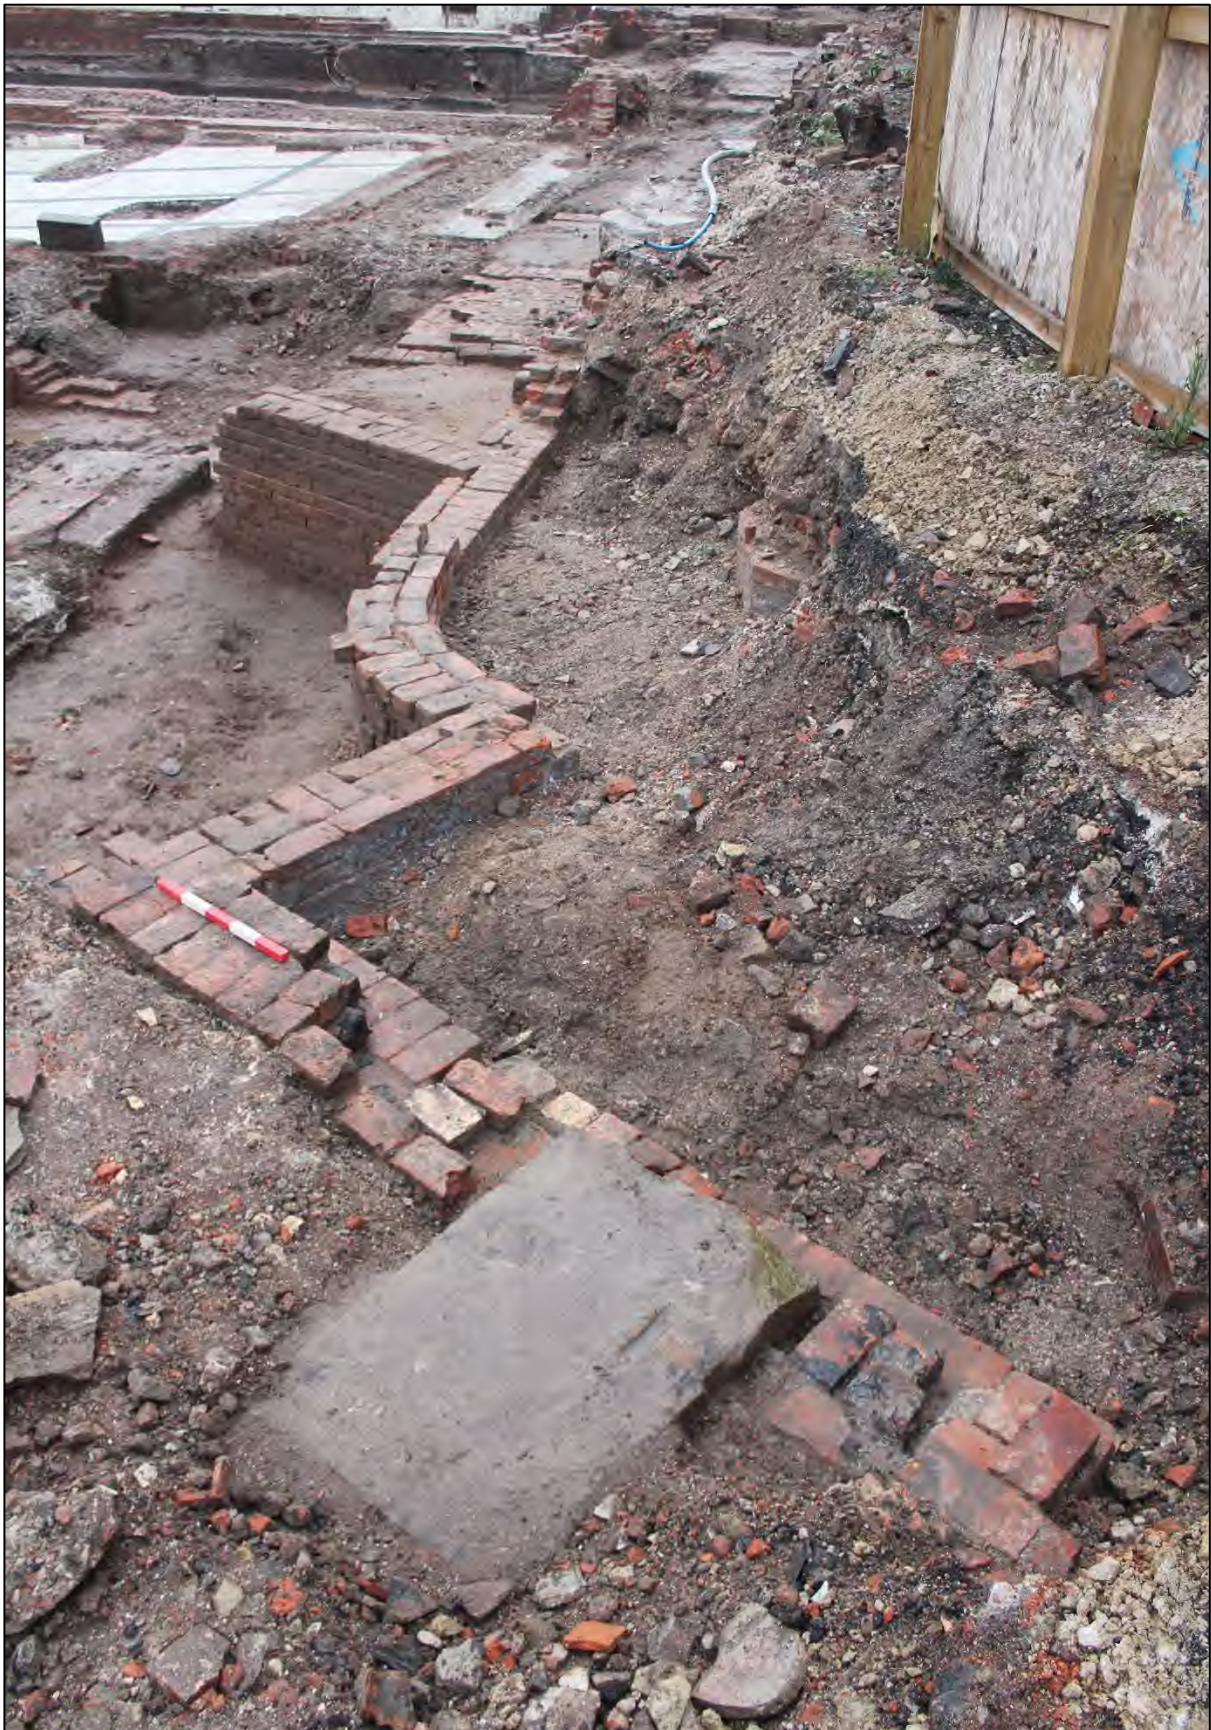
*Plate xx: Walls 204, 200 and 201 looking south, 0.50m scale*

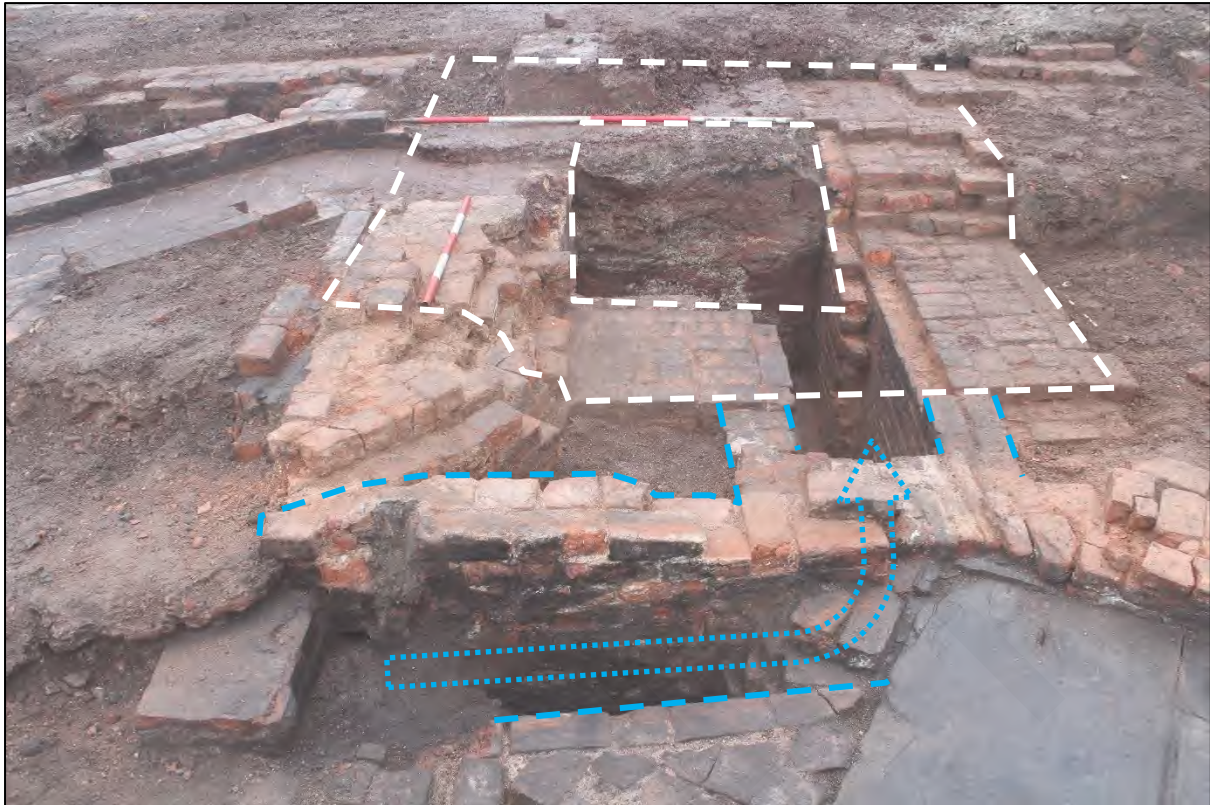
Plate xx: The remains of chimney 219 (white) and flue 218 (blue)

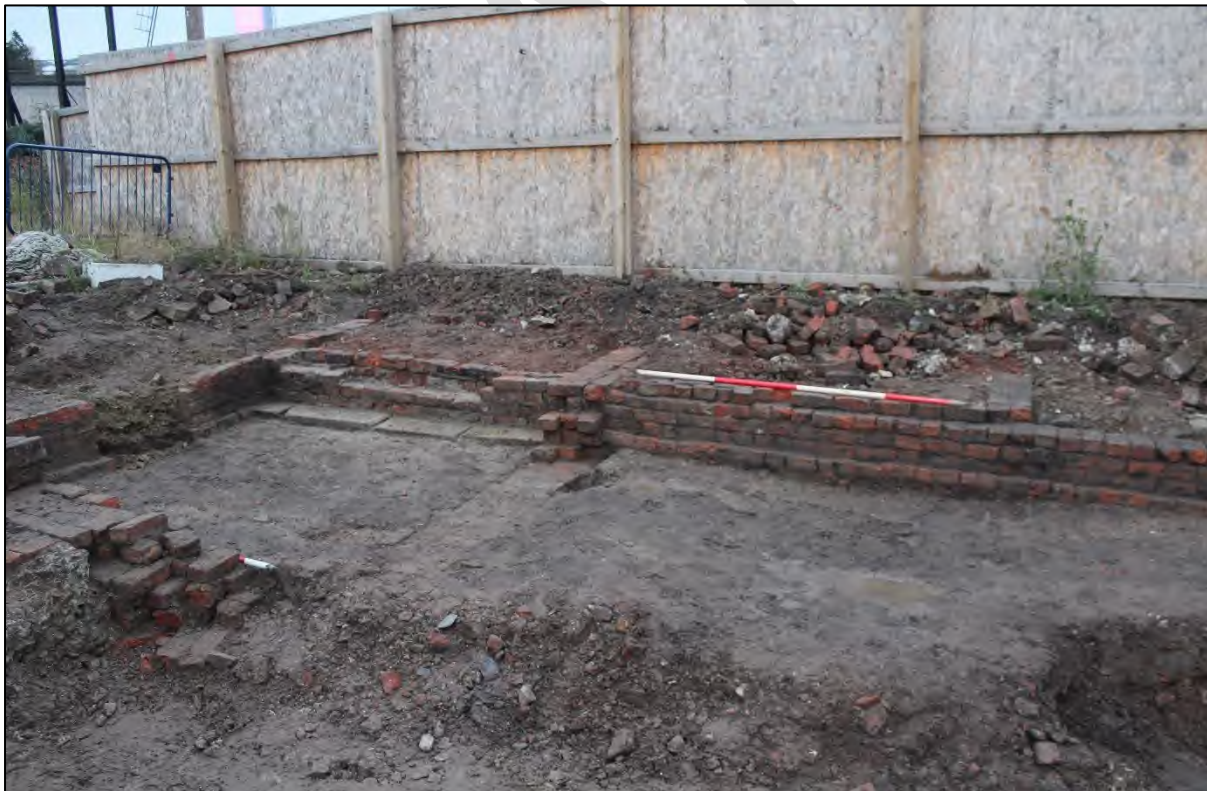
Plate xx: Wall 223 looking west (2m scale)

4.5m to the south of wall **212** was wall **213**, which was also aligned east / west. It measured 2.05 x 0.36m and was abutted by wall **223**. It continued beyond the limit of excavation towards the west. The relationship to wall **203** had been truncated by later concrete remains.

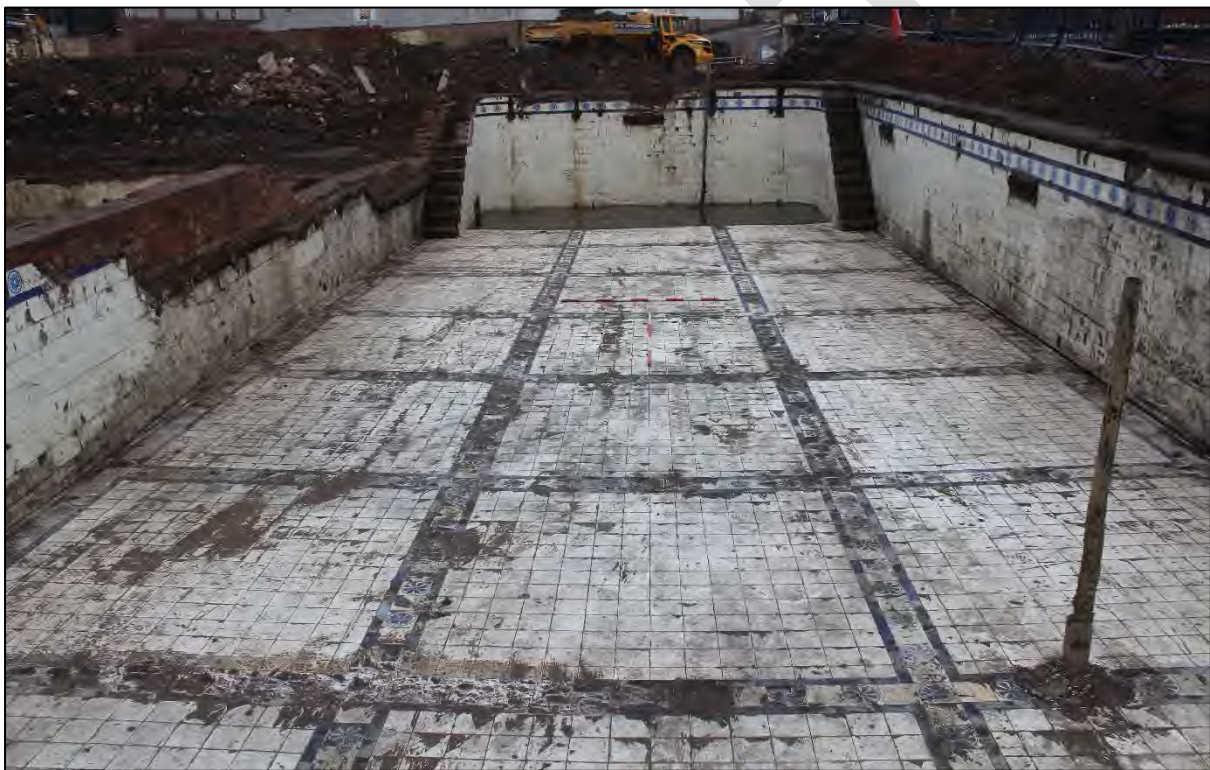
*Plate xx: Pool 225, Men's first-class, looking east (2 x 2m scales)*

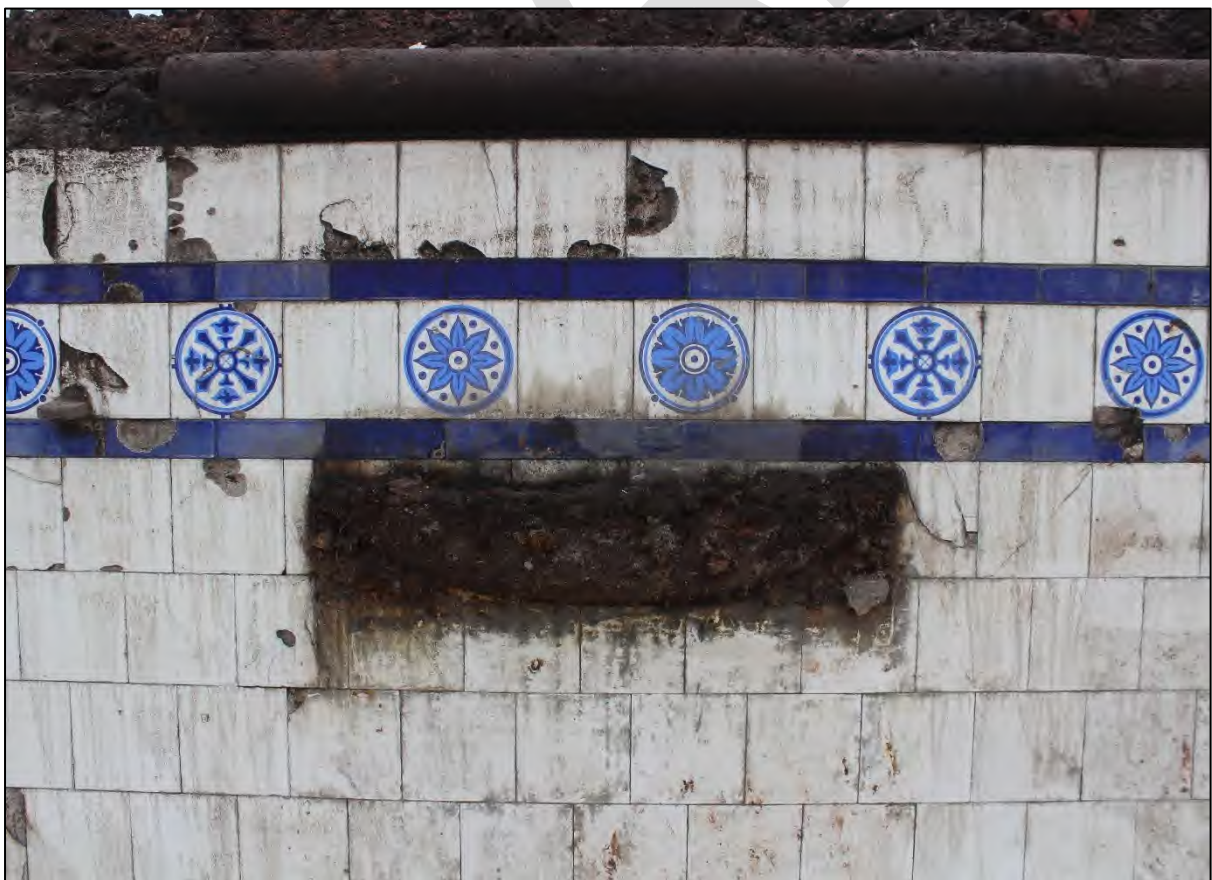
*Plate xx: The poolside of 225, showing the spit trough and floral tiles, looking east.*

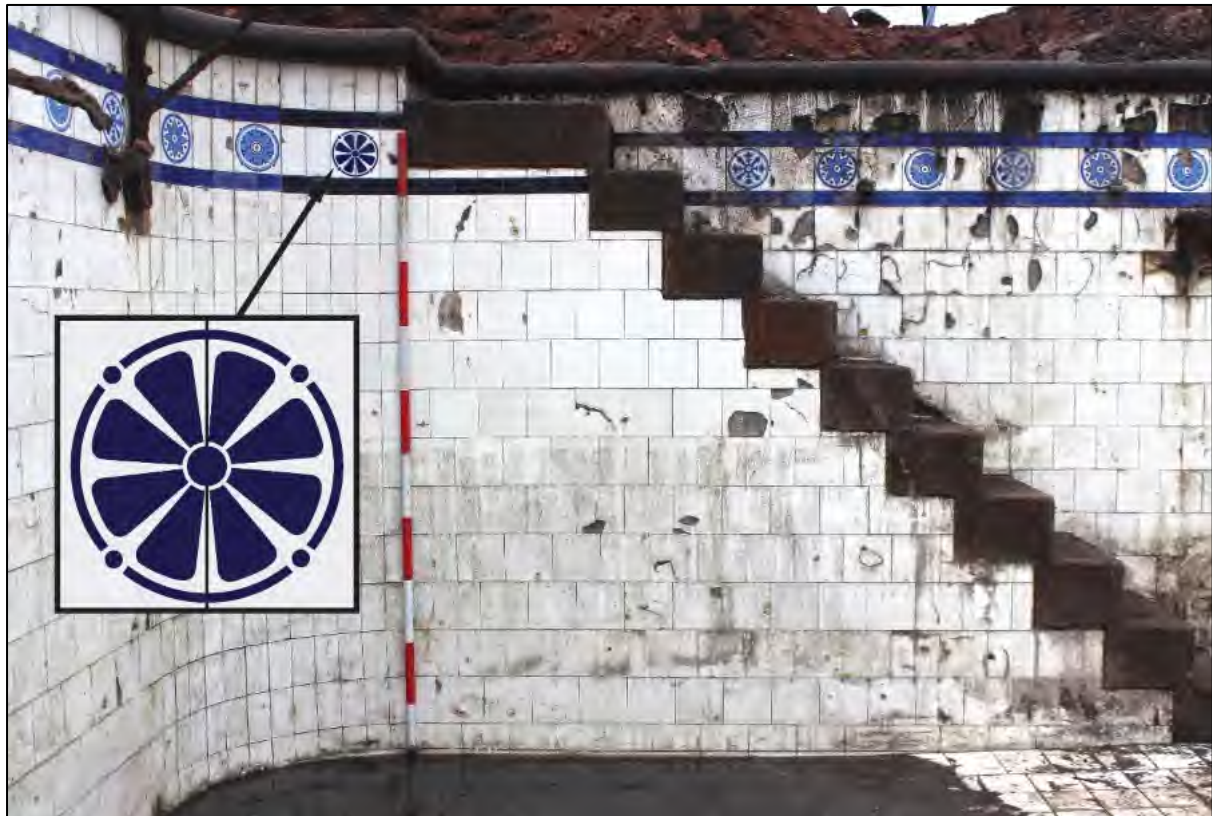
*Plate xx: Pool 225 showing the later steps and replacement tiles (2m scale)*

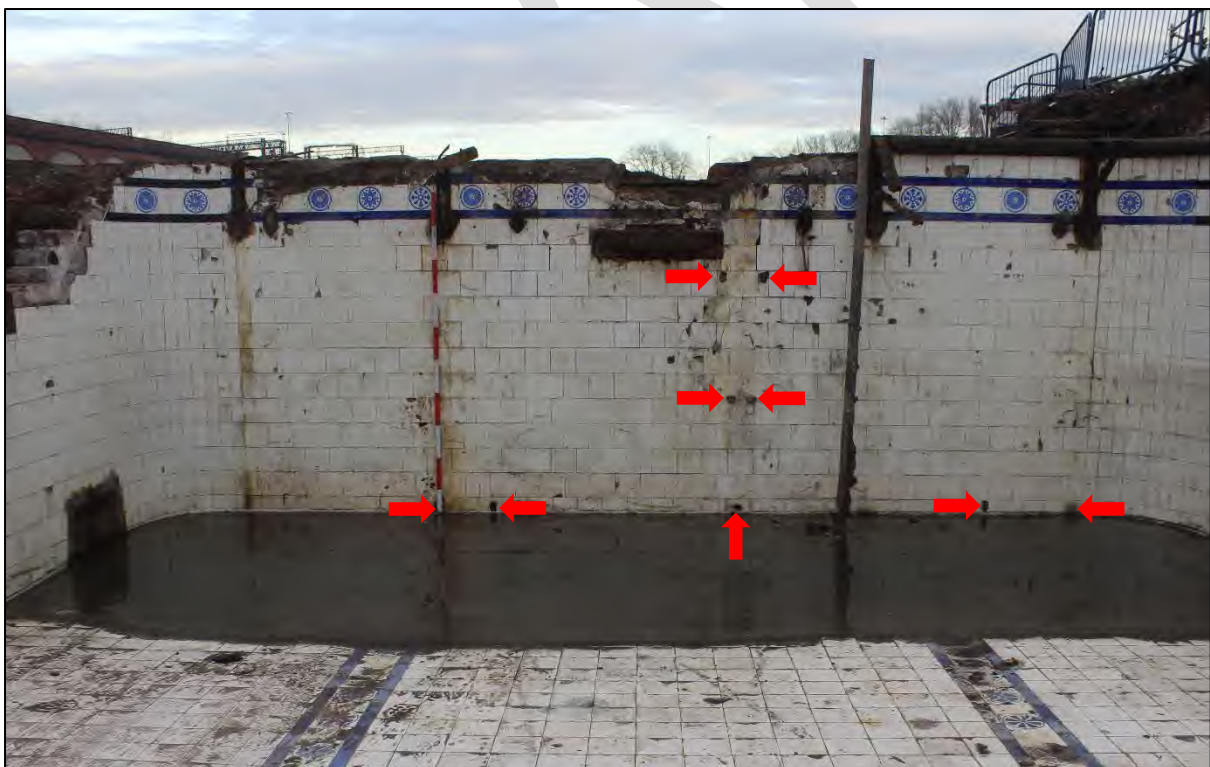
Plate xx: The eastern end of Pool 225 showing the position of the fixings for the steam injection pipe (removed) and L-shaped brackets visible above the waterline (2m scale)

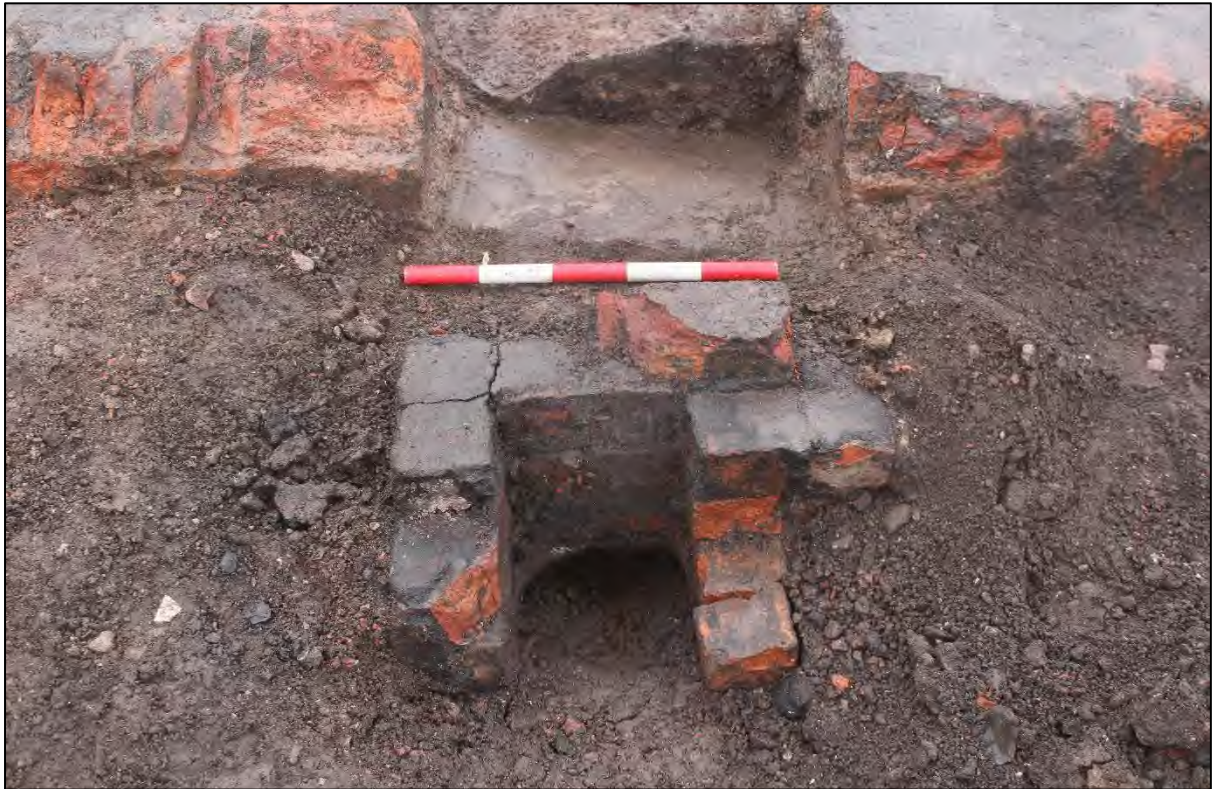
*Plate\_ : Phase 5-6 brick structure to the east of pool 225 (0.50m scale)*

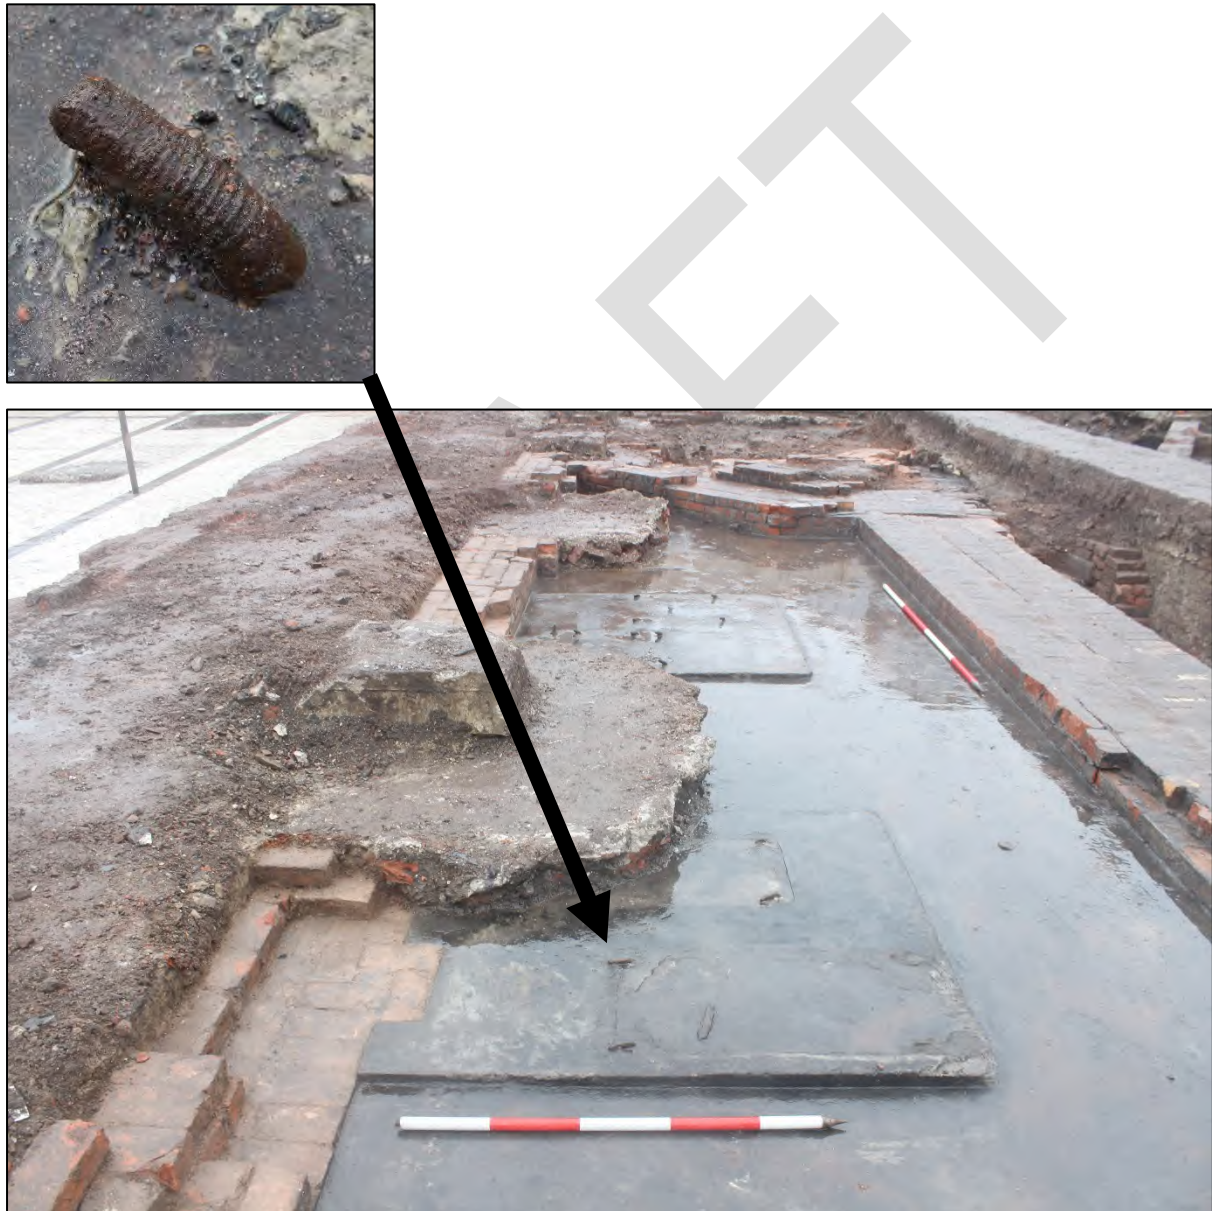
*Plate: Anteroom to the boiler showing stone machine beds 216a (foreground) and 216b in the rear of the shot (1m and 2m scales) Inset: showing threaded bolt*

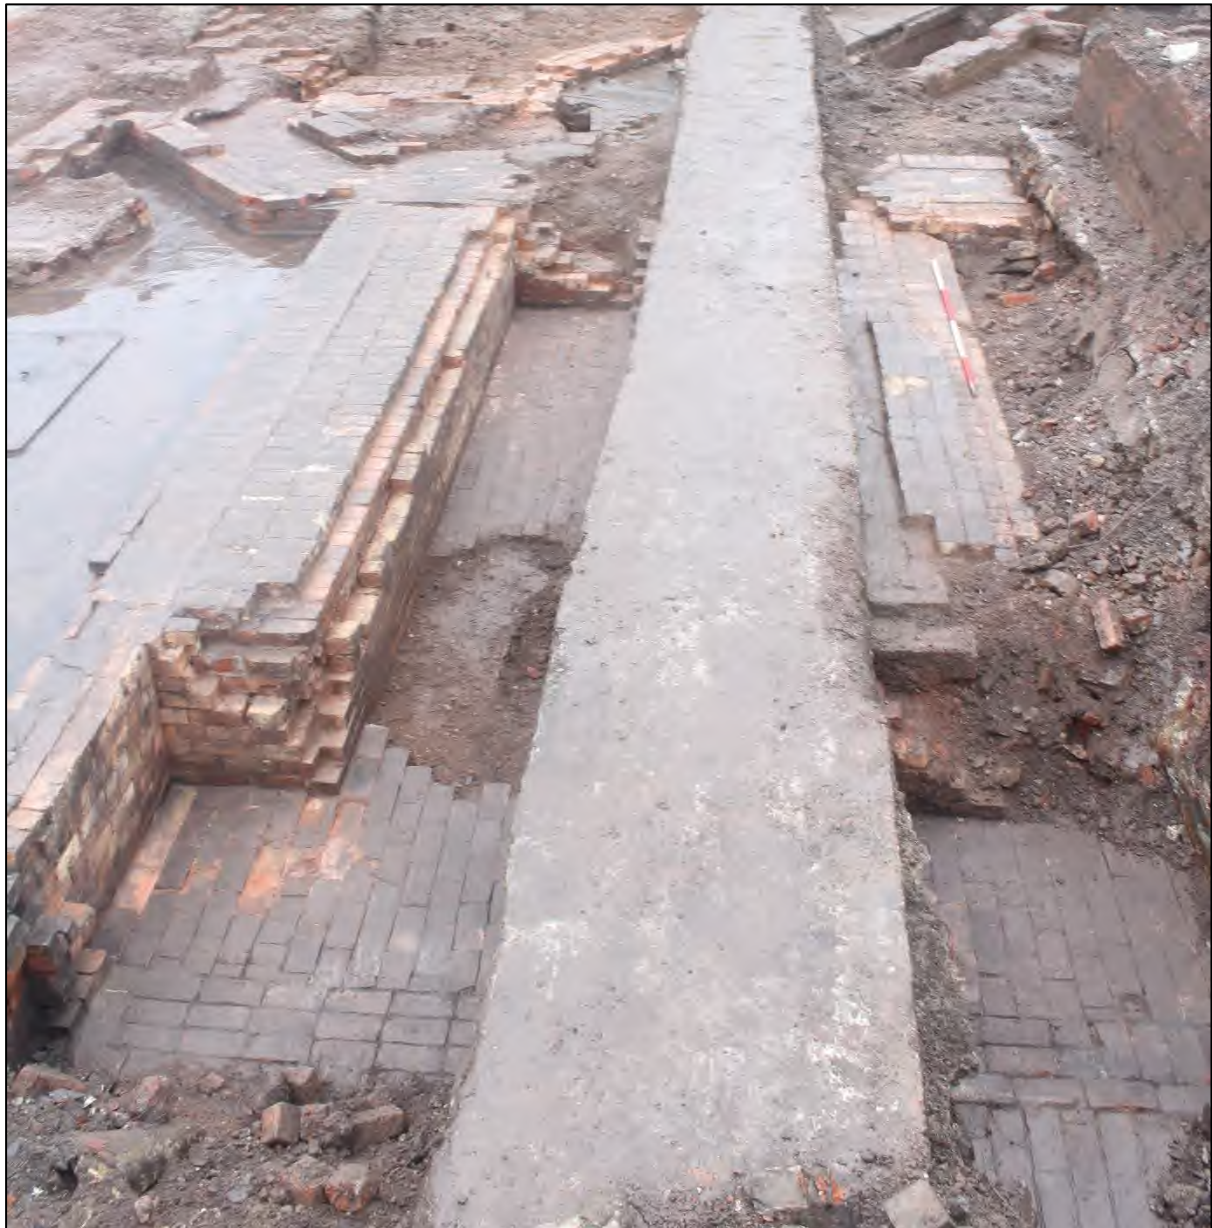
*Plate xx: View of the boilers 221 and 222 and flue 217 looking west (2m scale)*
