# Archaeological Excavation Report

Mayfield,  
Manchester

**Report No:**  
SA/2021/56

**Project:** Mayfield, Manchester: Archaeological Excavation

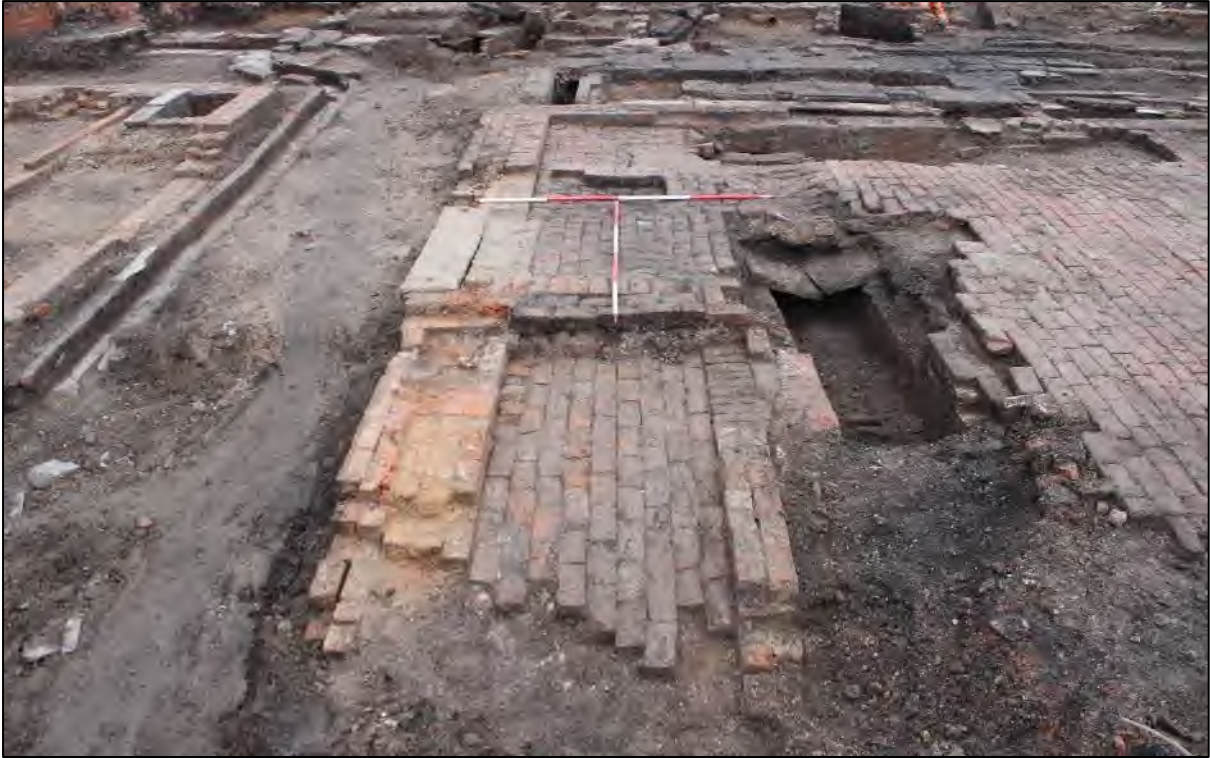
*Plate \_: Walls 3011 and 3057 forming the northern wall of Building B. Note the yellowish-brown mortar and handmade brick forming the original one-and-a-half brick wall. Looking north-east (2 x 2m scales)*

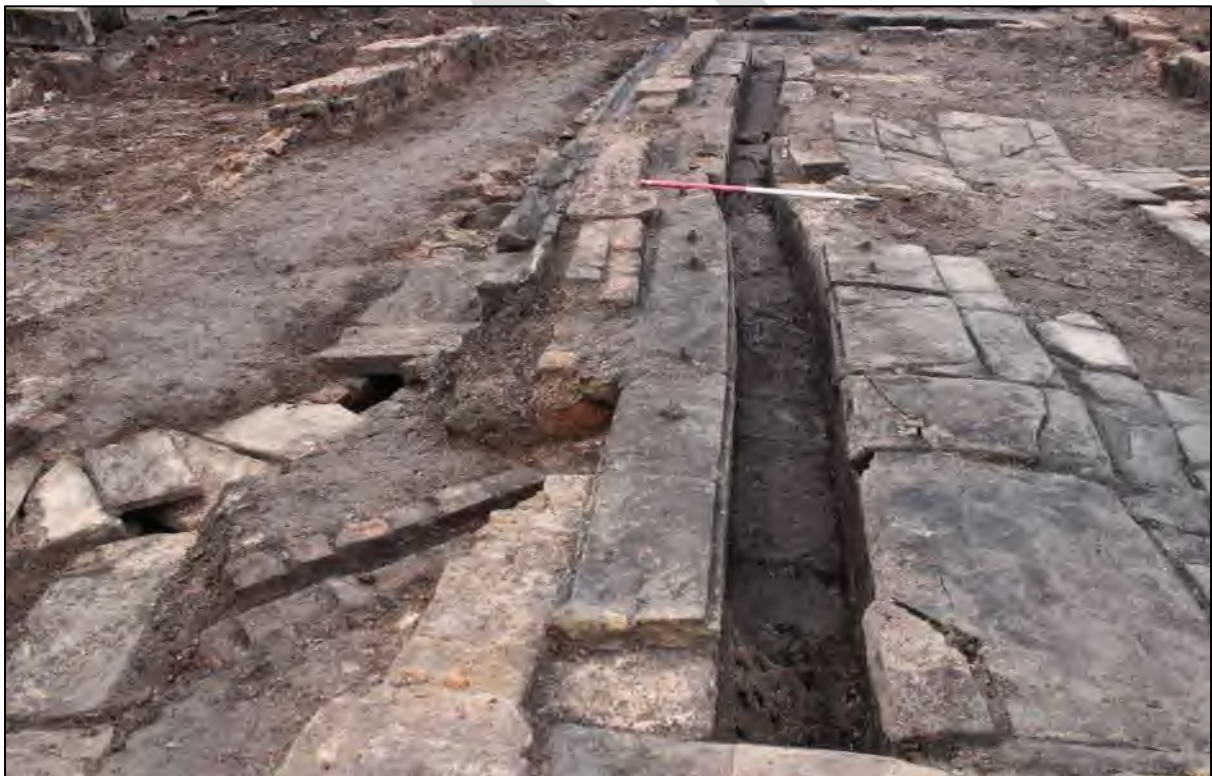
Plate \_\_: View of drain 3038 constructed alongside wall 3027 looking south-west (1m scale)

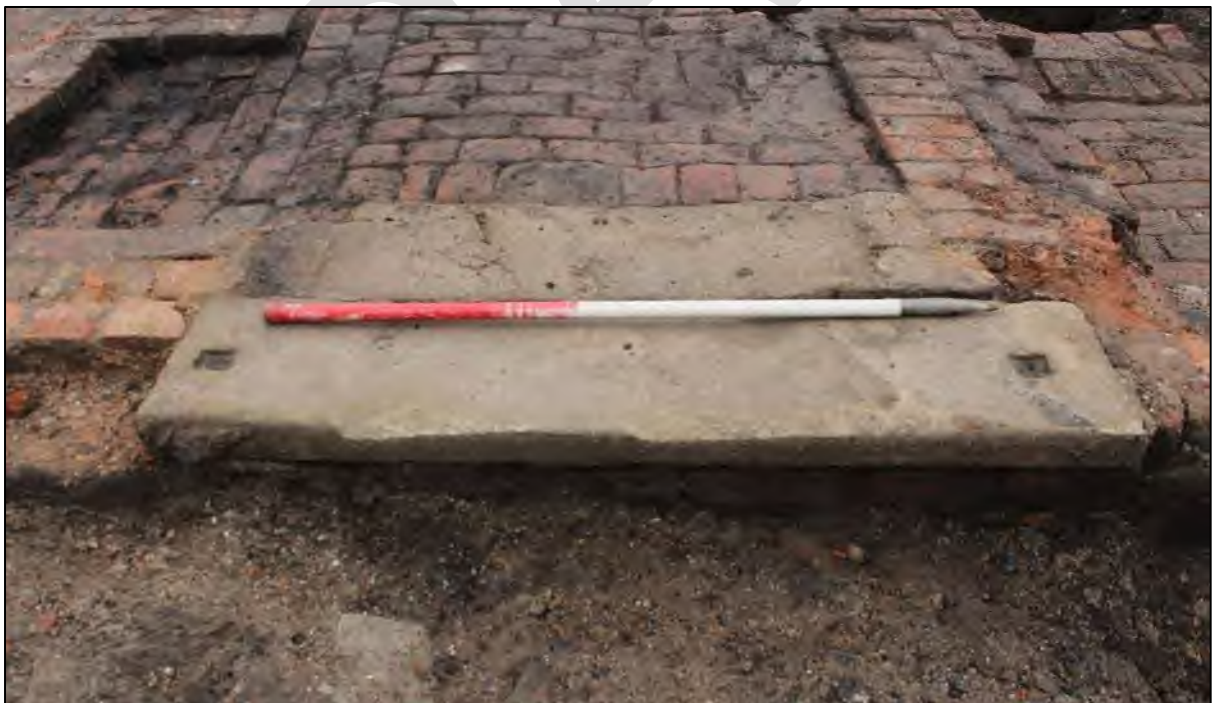
Plate\_: Wall 3010 featuring a later threshold with rectangular sockets for the door jambs. The earlier wall and threshold are visible to the rear. Both exhibit traces of significant wear. (1m scale)

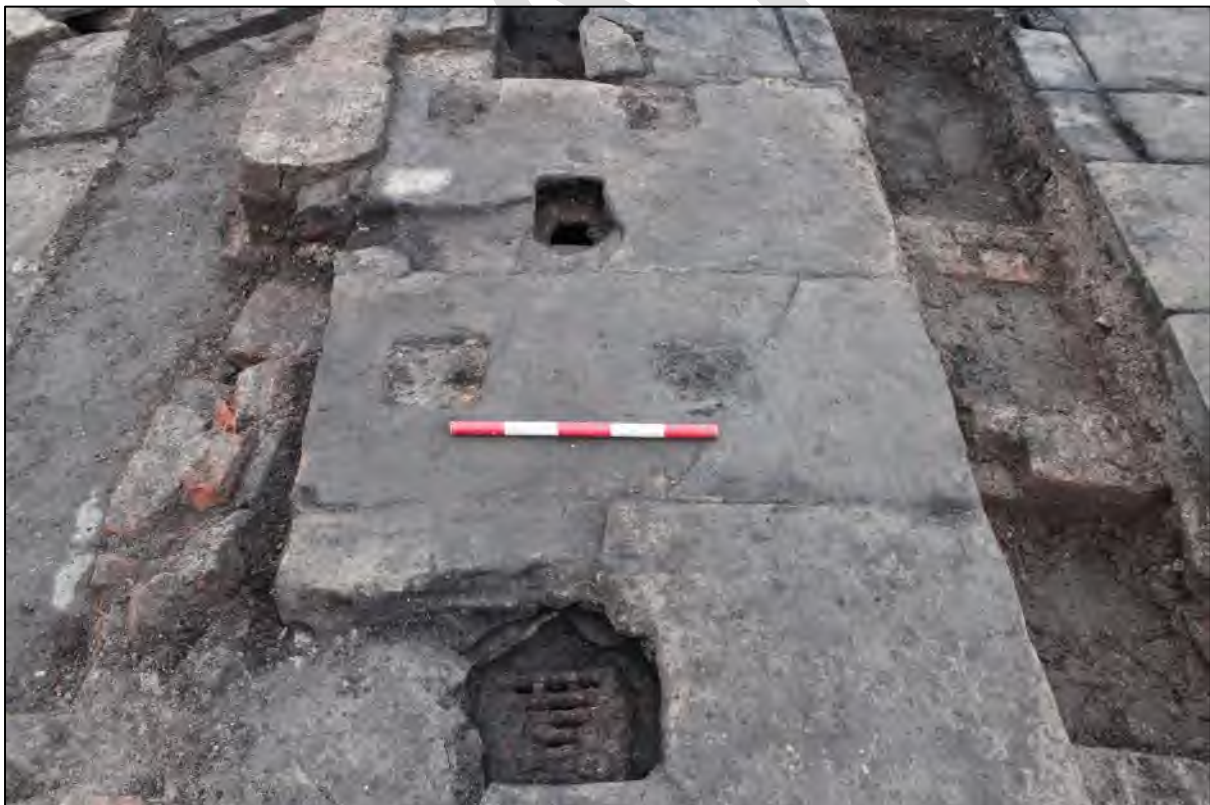
*Plate\_:* The fittings and drains set into the flags capping the extension of drain 3038 (0.50m scale)

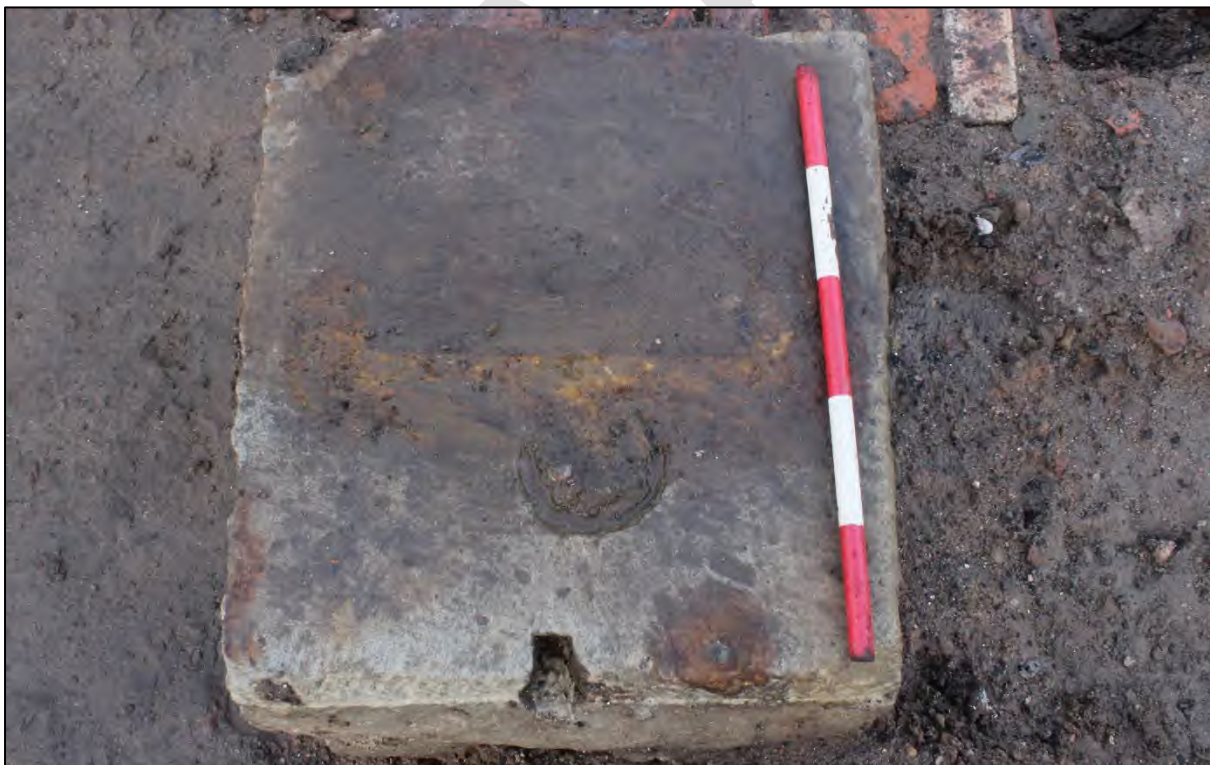
*Plate\_*: Column base 3148 looking north. Note the shadow left behind by the cast iron column base as well as holes left by other potential fittings (0.50m scale)

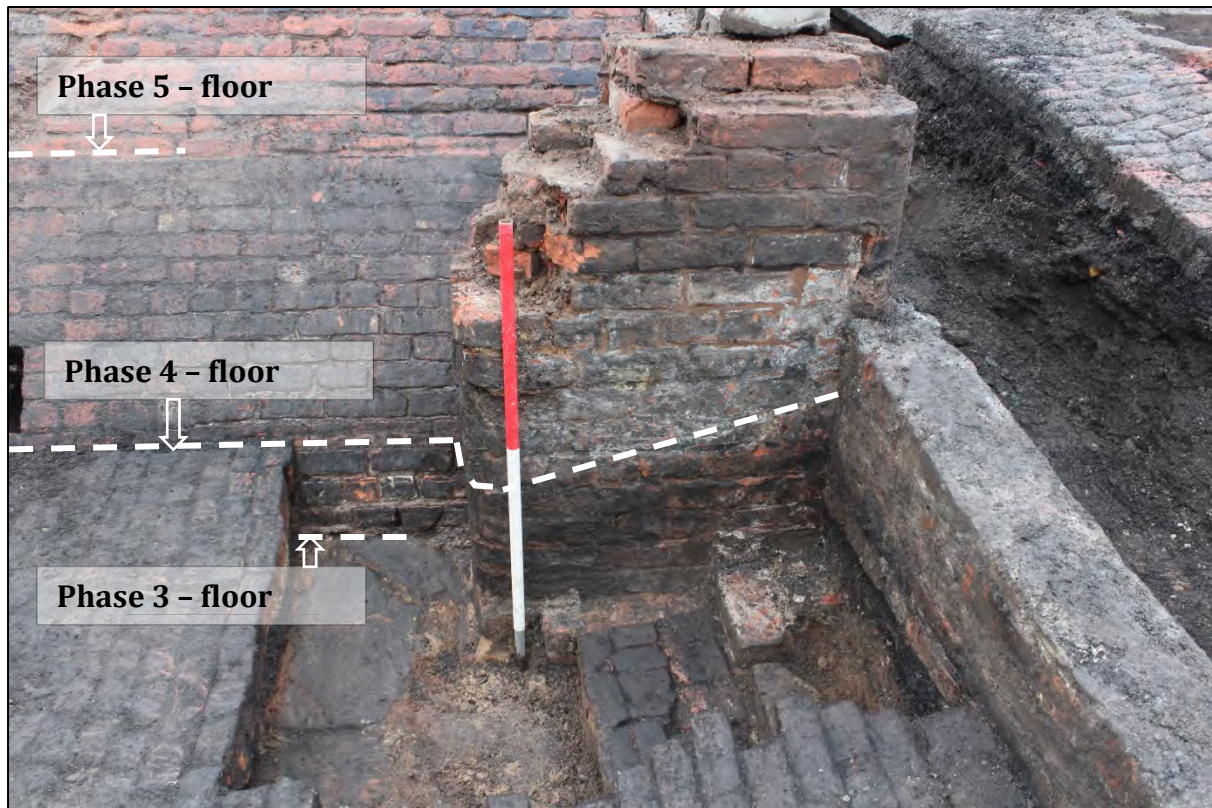
*Plate\_ : The three successive charging floors revealed within the southern half of the boiler house: 3172 (*Phase 3*); 3065 (*Phase 4*) and 3174 (*Phase 5*). Photographed looking south (1m scale)*

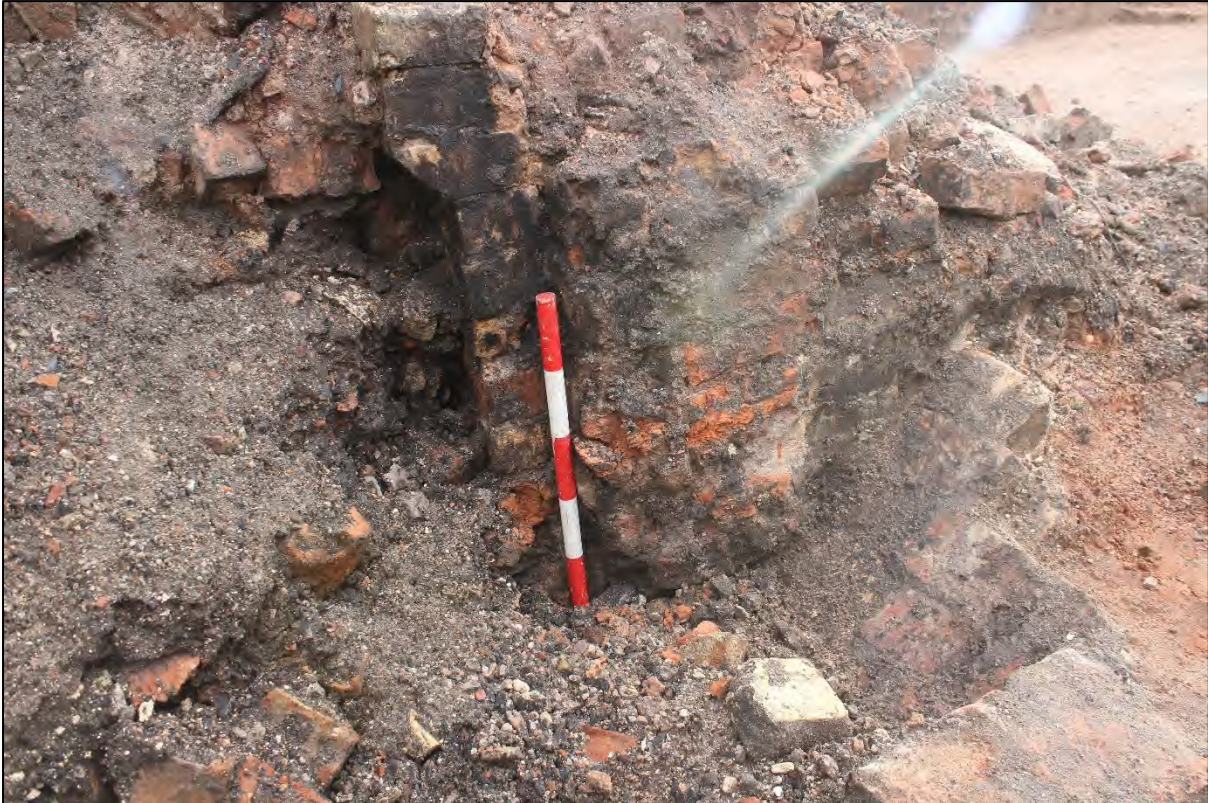
*Plate\_ : Remnant of the vaulted flue to the rear of the boilers, looking east. Note the rebated brick wall and adjacent flue sloping down from below the boiler. This would have been the location of a damper to regulate draught (0.50m scale)*

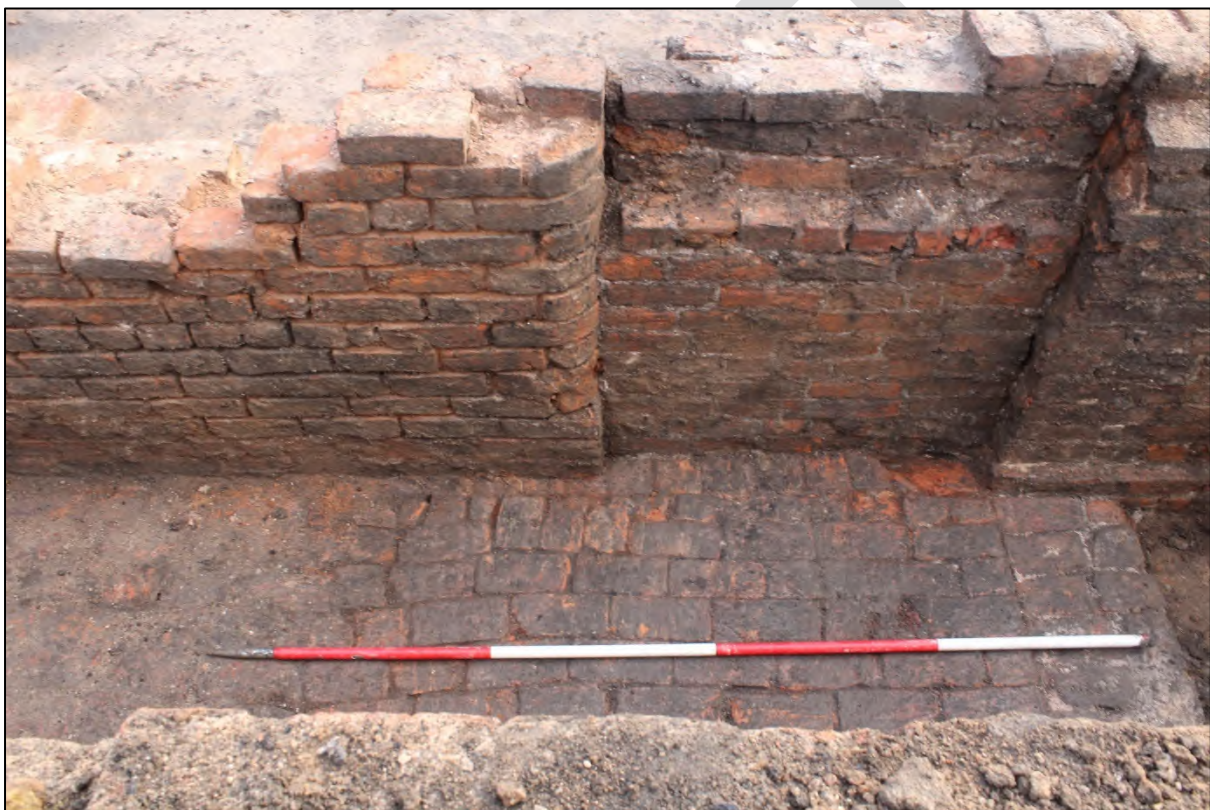
*Plate\_ : Southern end of the excavated walkway 3069, showing the blocked doorway 3177 (2m scale)*

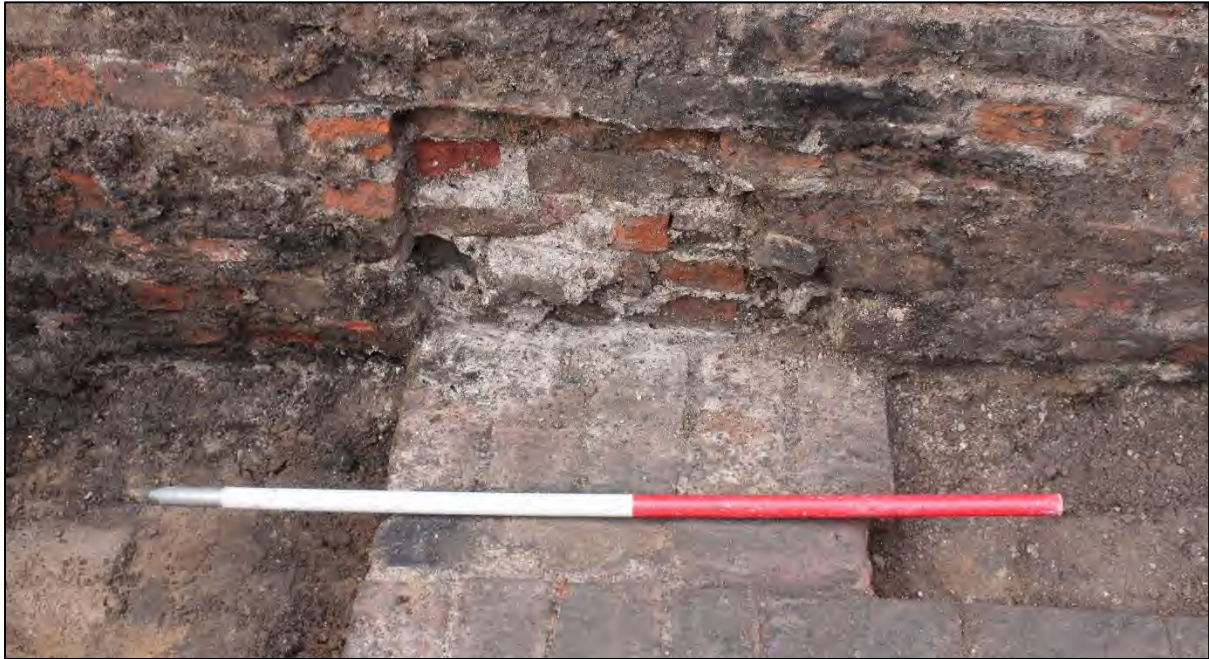
Plate \_\_: Denuded remains of the southern wall of walkway 3069, built over by wall 3178 (1m scale)

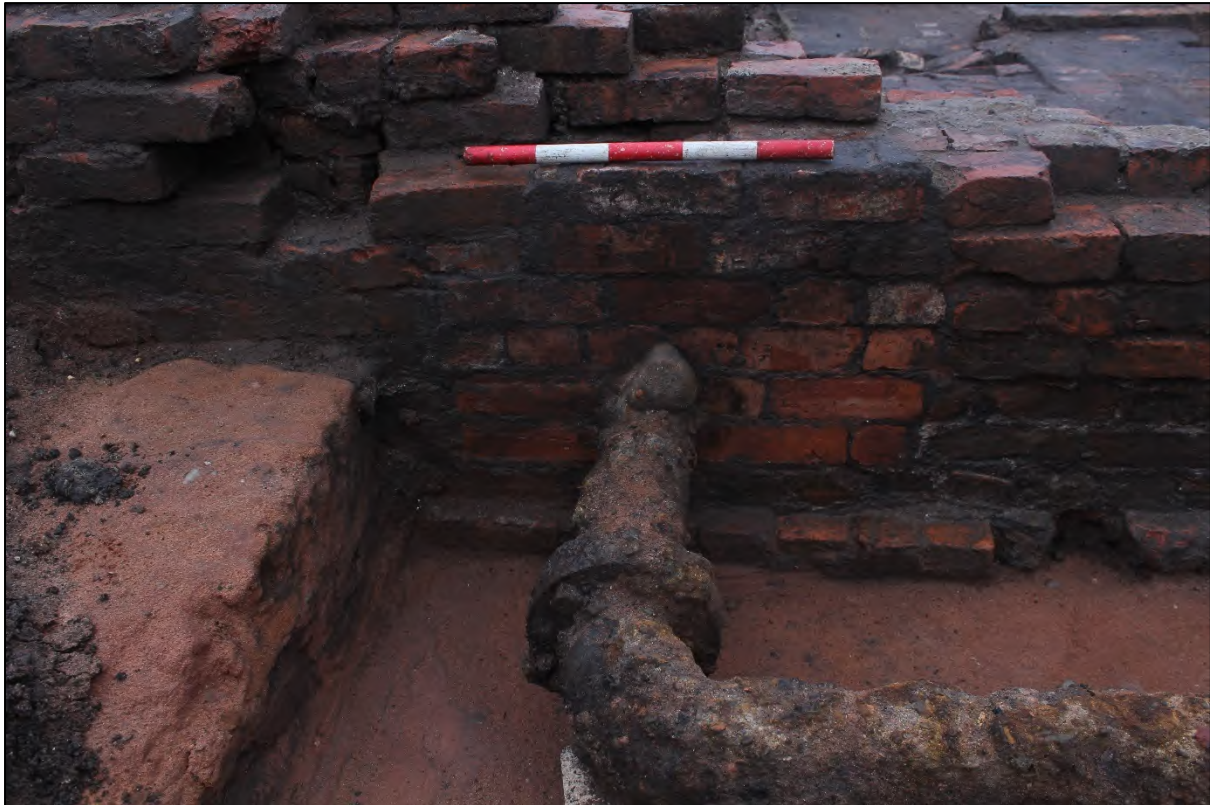
*Plate\_:* The cast iron pipe and Phase 5 repair to the southern extent of wall 3070, note the use of a black mortar

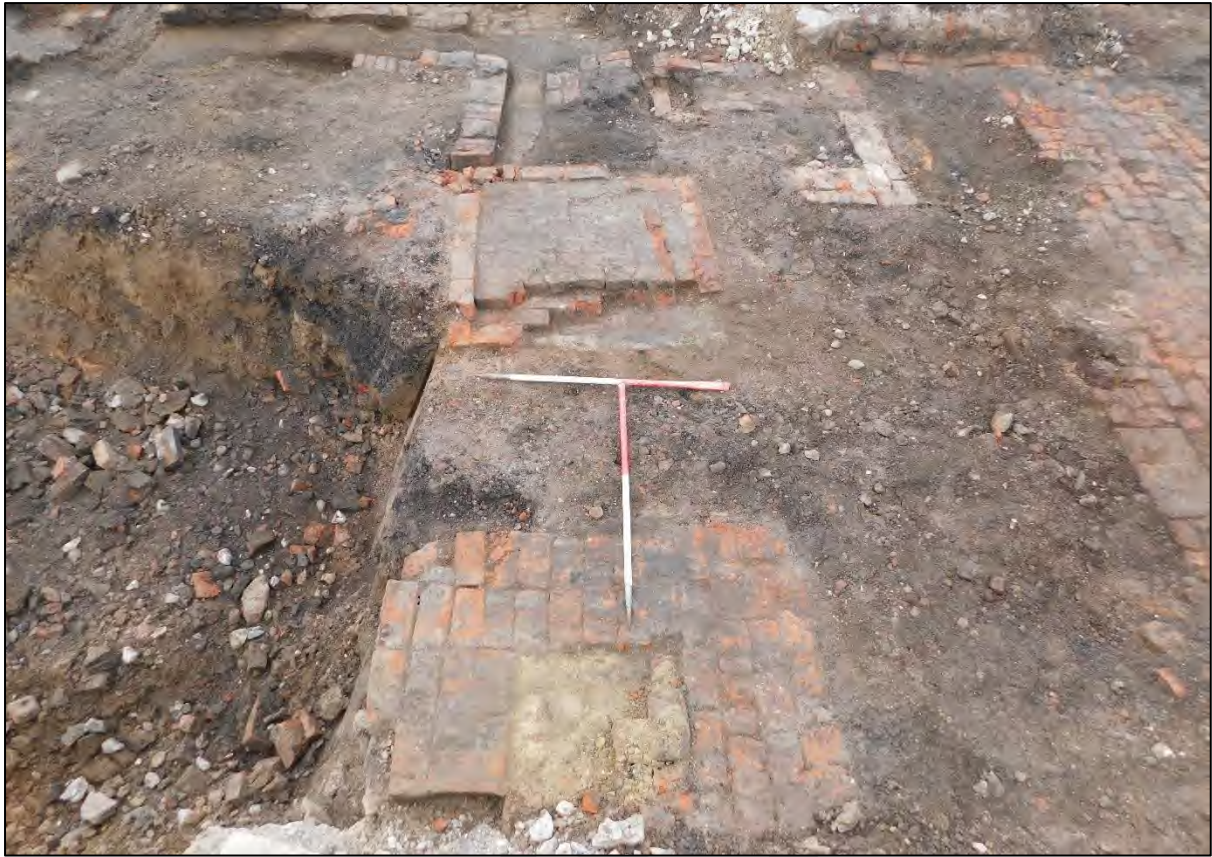
*Plate XX: Column bases 419 and 420 showing later 20<sup>th</sup> century truncation, facing south west*

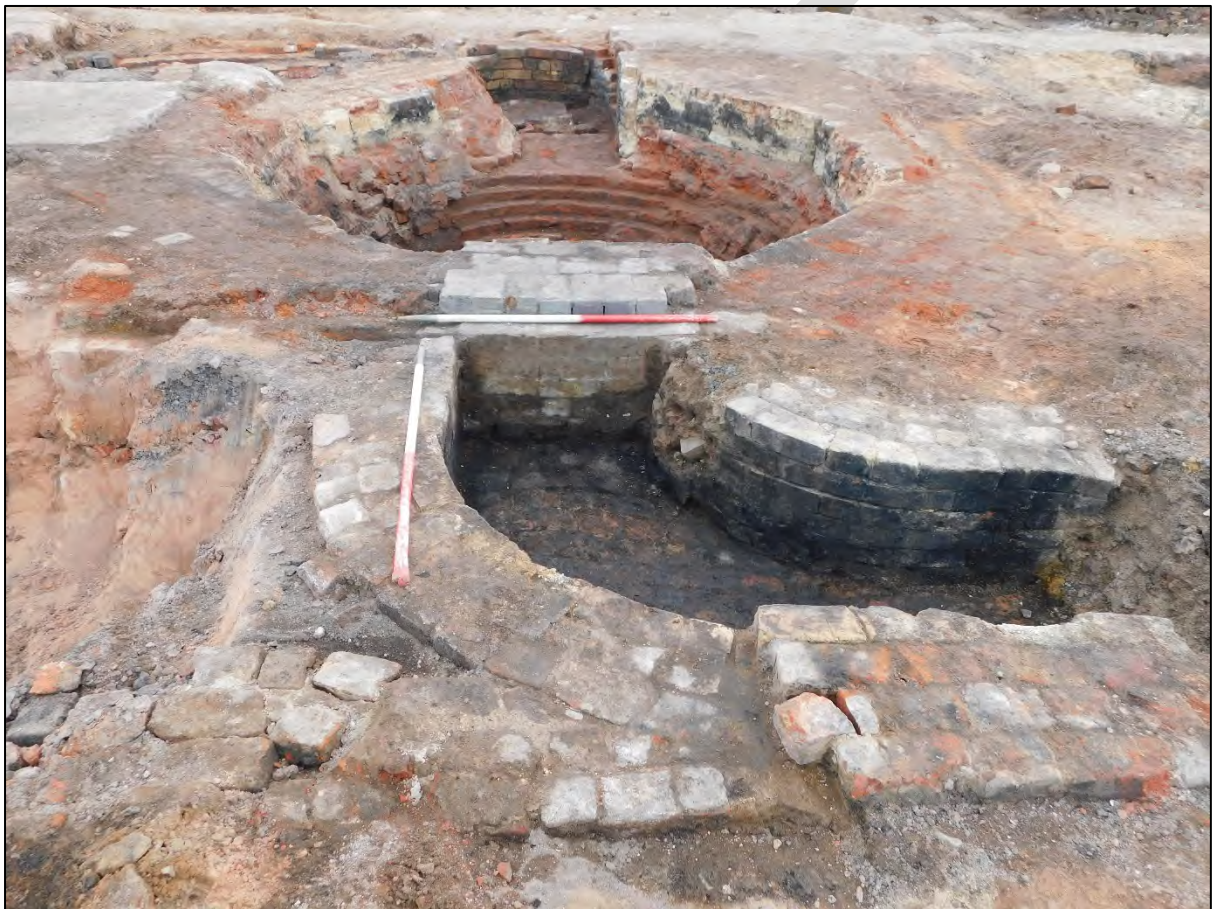
*Plate XX: Flue 422 feeding into chimney 424 blocked by later brick wall 423, facing north*

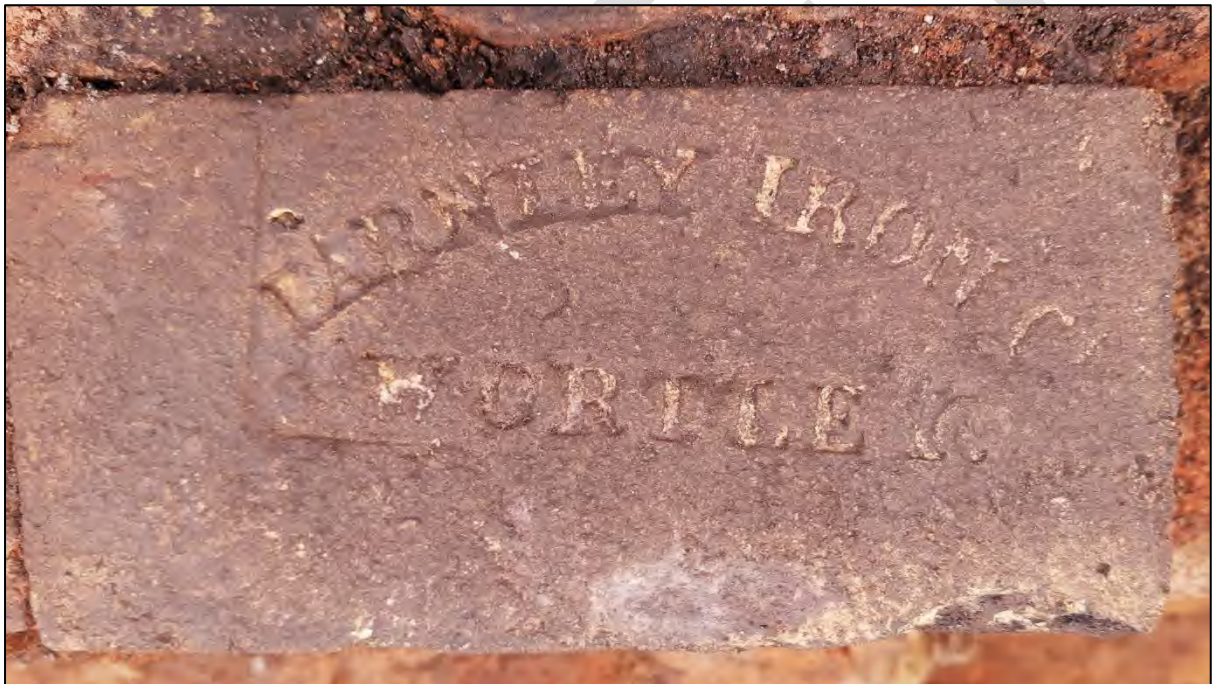
*Plate xx: Firebrick bearing the stamp Farnley Iron Co. Wortley' utilised in Boiler 111*

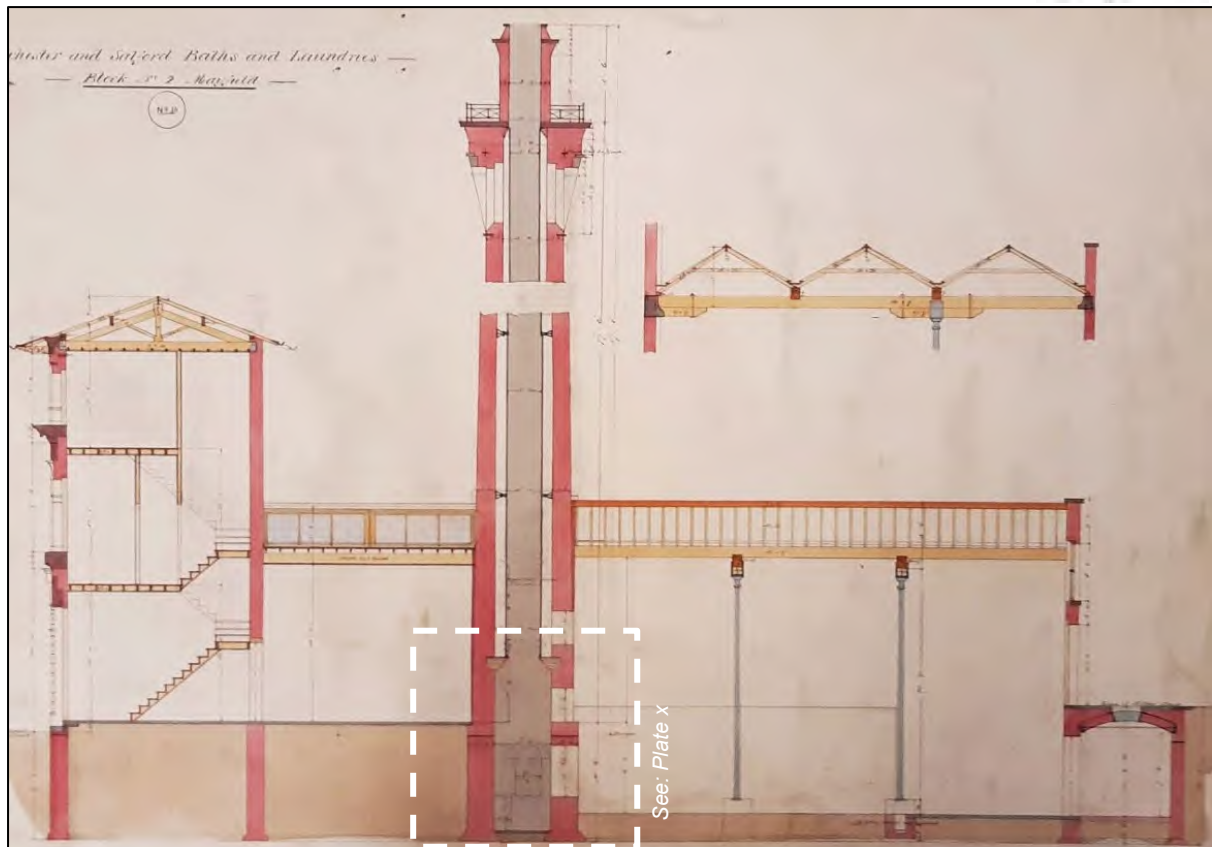
Plate xx: Cross-section through the northern part of Mayfield Baths with detail of chimney foundation

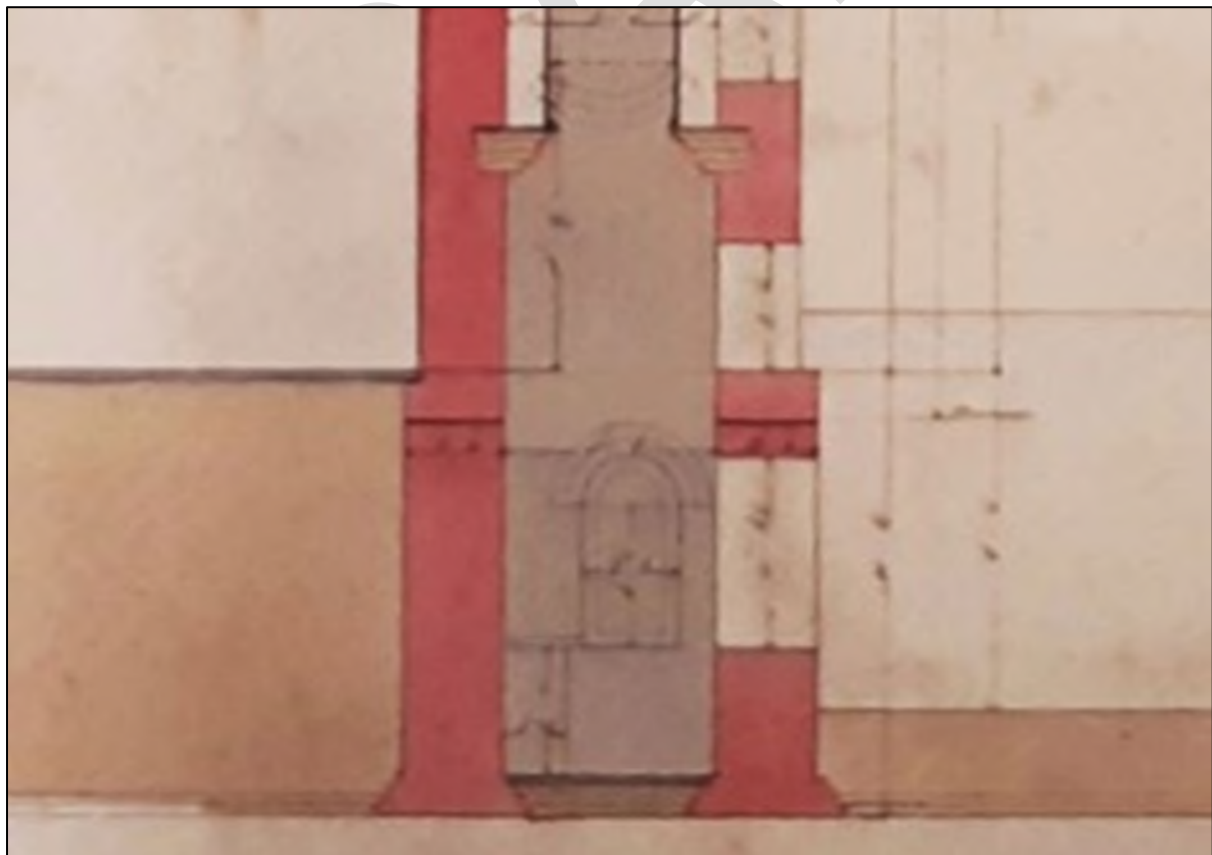
Plate x: Detail of chimney foundation illustrating the position of the flues

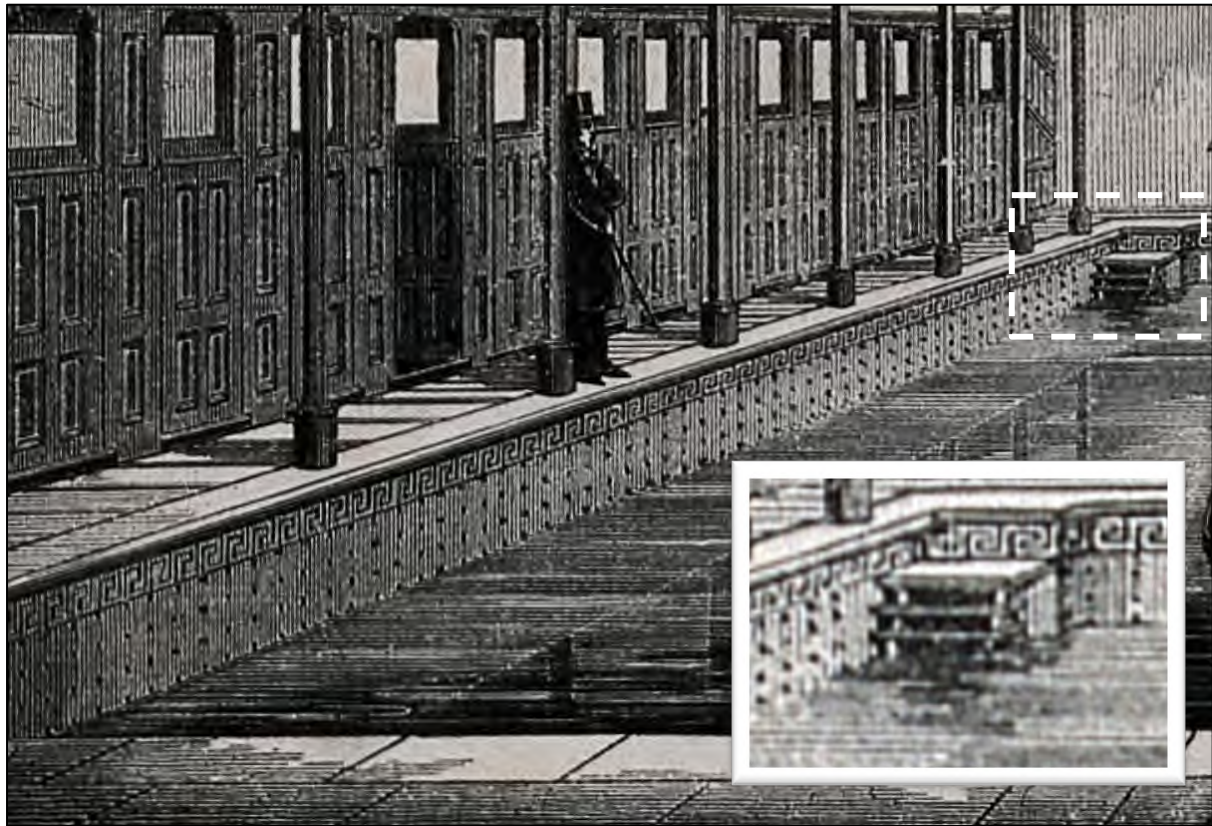
Plate x: Extract from *The Builder* 1858 showing the original tiles and steps installed in the plunge pool of the first-class men's pool at Mayfield Baths (see inset for close-up)

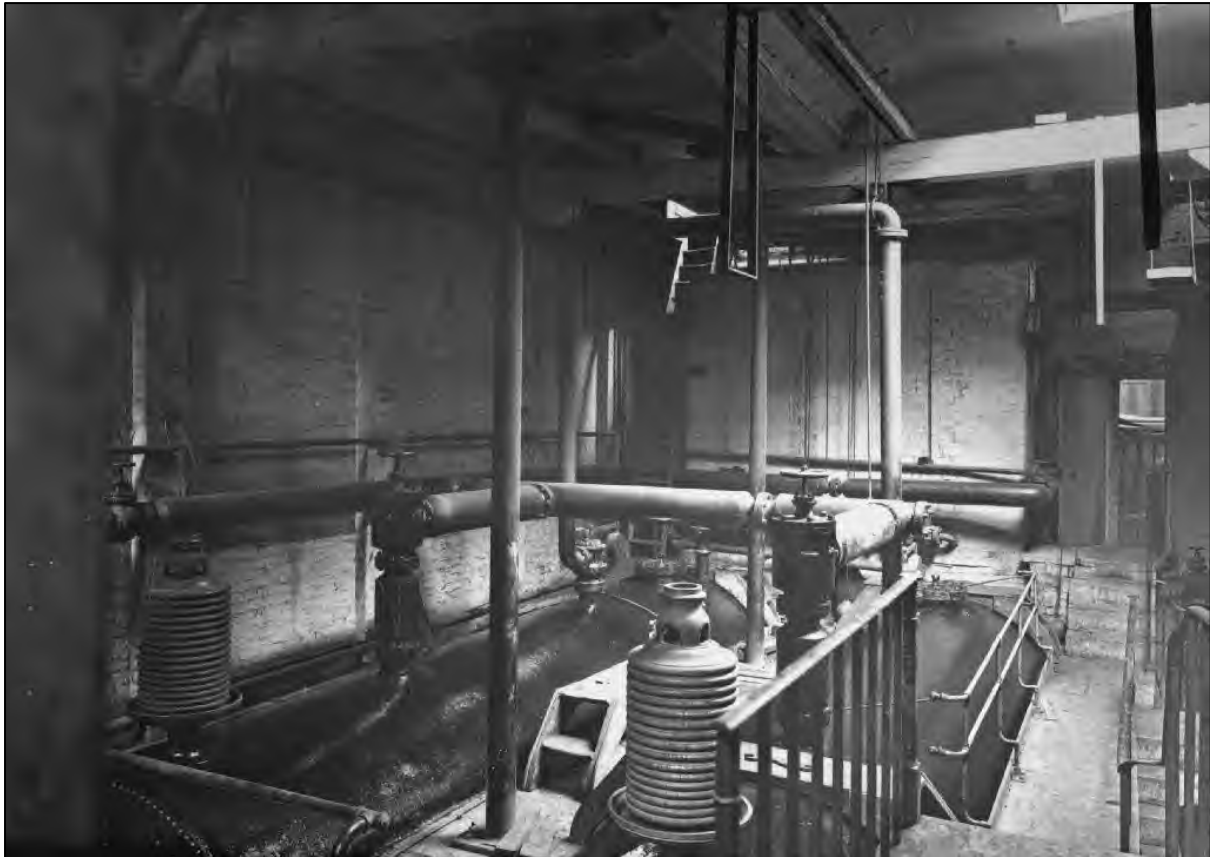
*Plate x: Photograph showing the two steam boilers at Mayfield Baths*
