Phase II Geoenvironmental Site Assessment  
Goulden Street, Manchester

## PHASE II GEOENVIRONMENTAL SITE ASSESSMENT

Goulden Street  
Manchester  
M4 5EH

**Report Ref: 12-728-R2-2**  
**Date Issued: 5<sup>th</sup> February 2021**

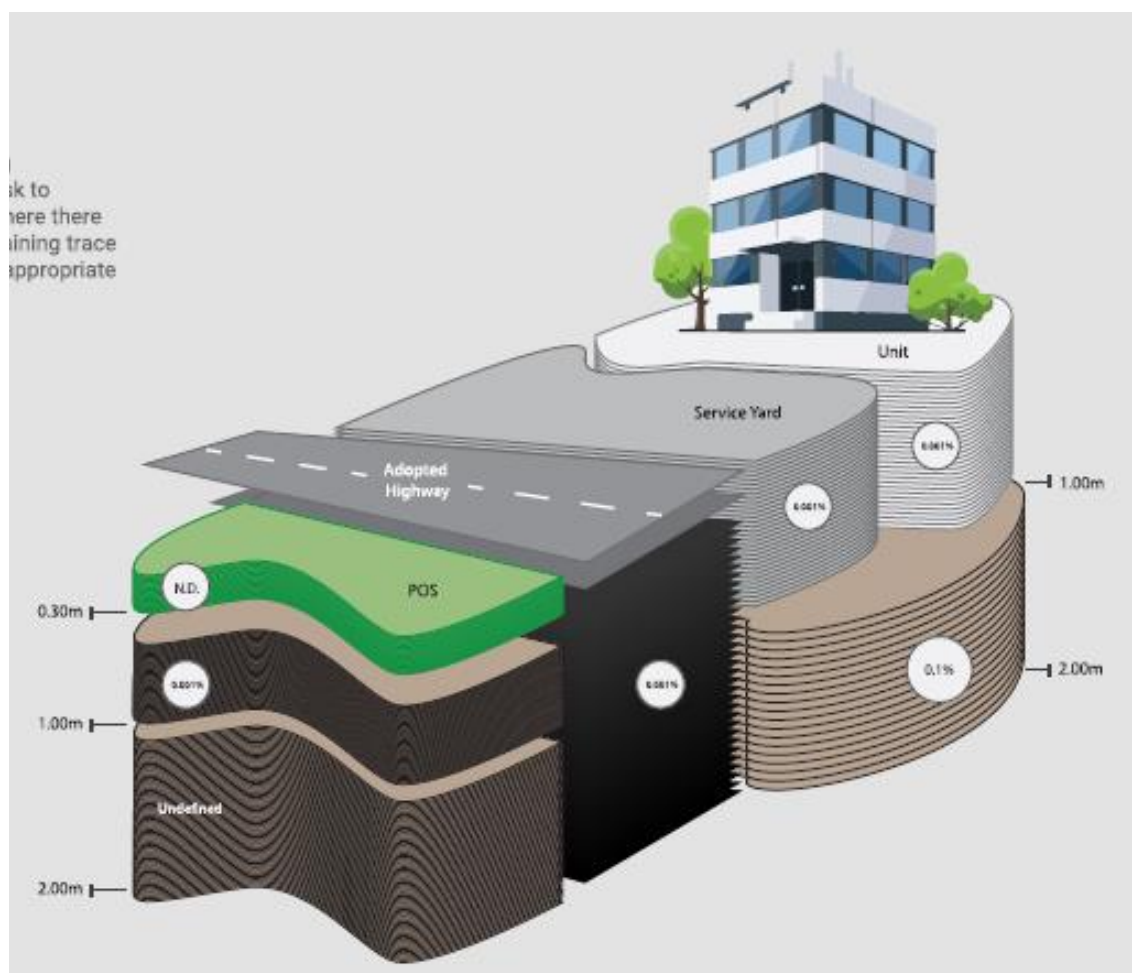
FIGURE 4.1 ASBESTOS RISK MITIGATION CONCEPTUAL SITE MODEL

Asbestos in the form of loose chrysotile fibres has been identified in the Made Ground in TT102C and WS103 at <0.001%.

| POLLUTANT LINKAGE | CONTAMINANT (SOURCE) | PATHWAY | RECEPTOR | PROBABILITY | CURRENT RISK | RESIDUAL RISK AFTER MITIGATION |
|---|---|---|---|---|---|---|
| <b>Recommendation:</b><br>Cover system to landscaped areas and placement of the soils in accordance the asbestos CSM will prevent exposure to future site users. Construction works completed with PPE and provision of welfare. | | | | | | |

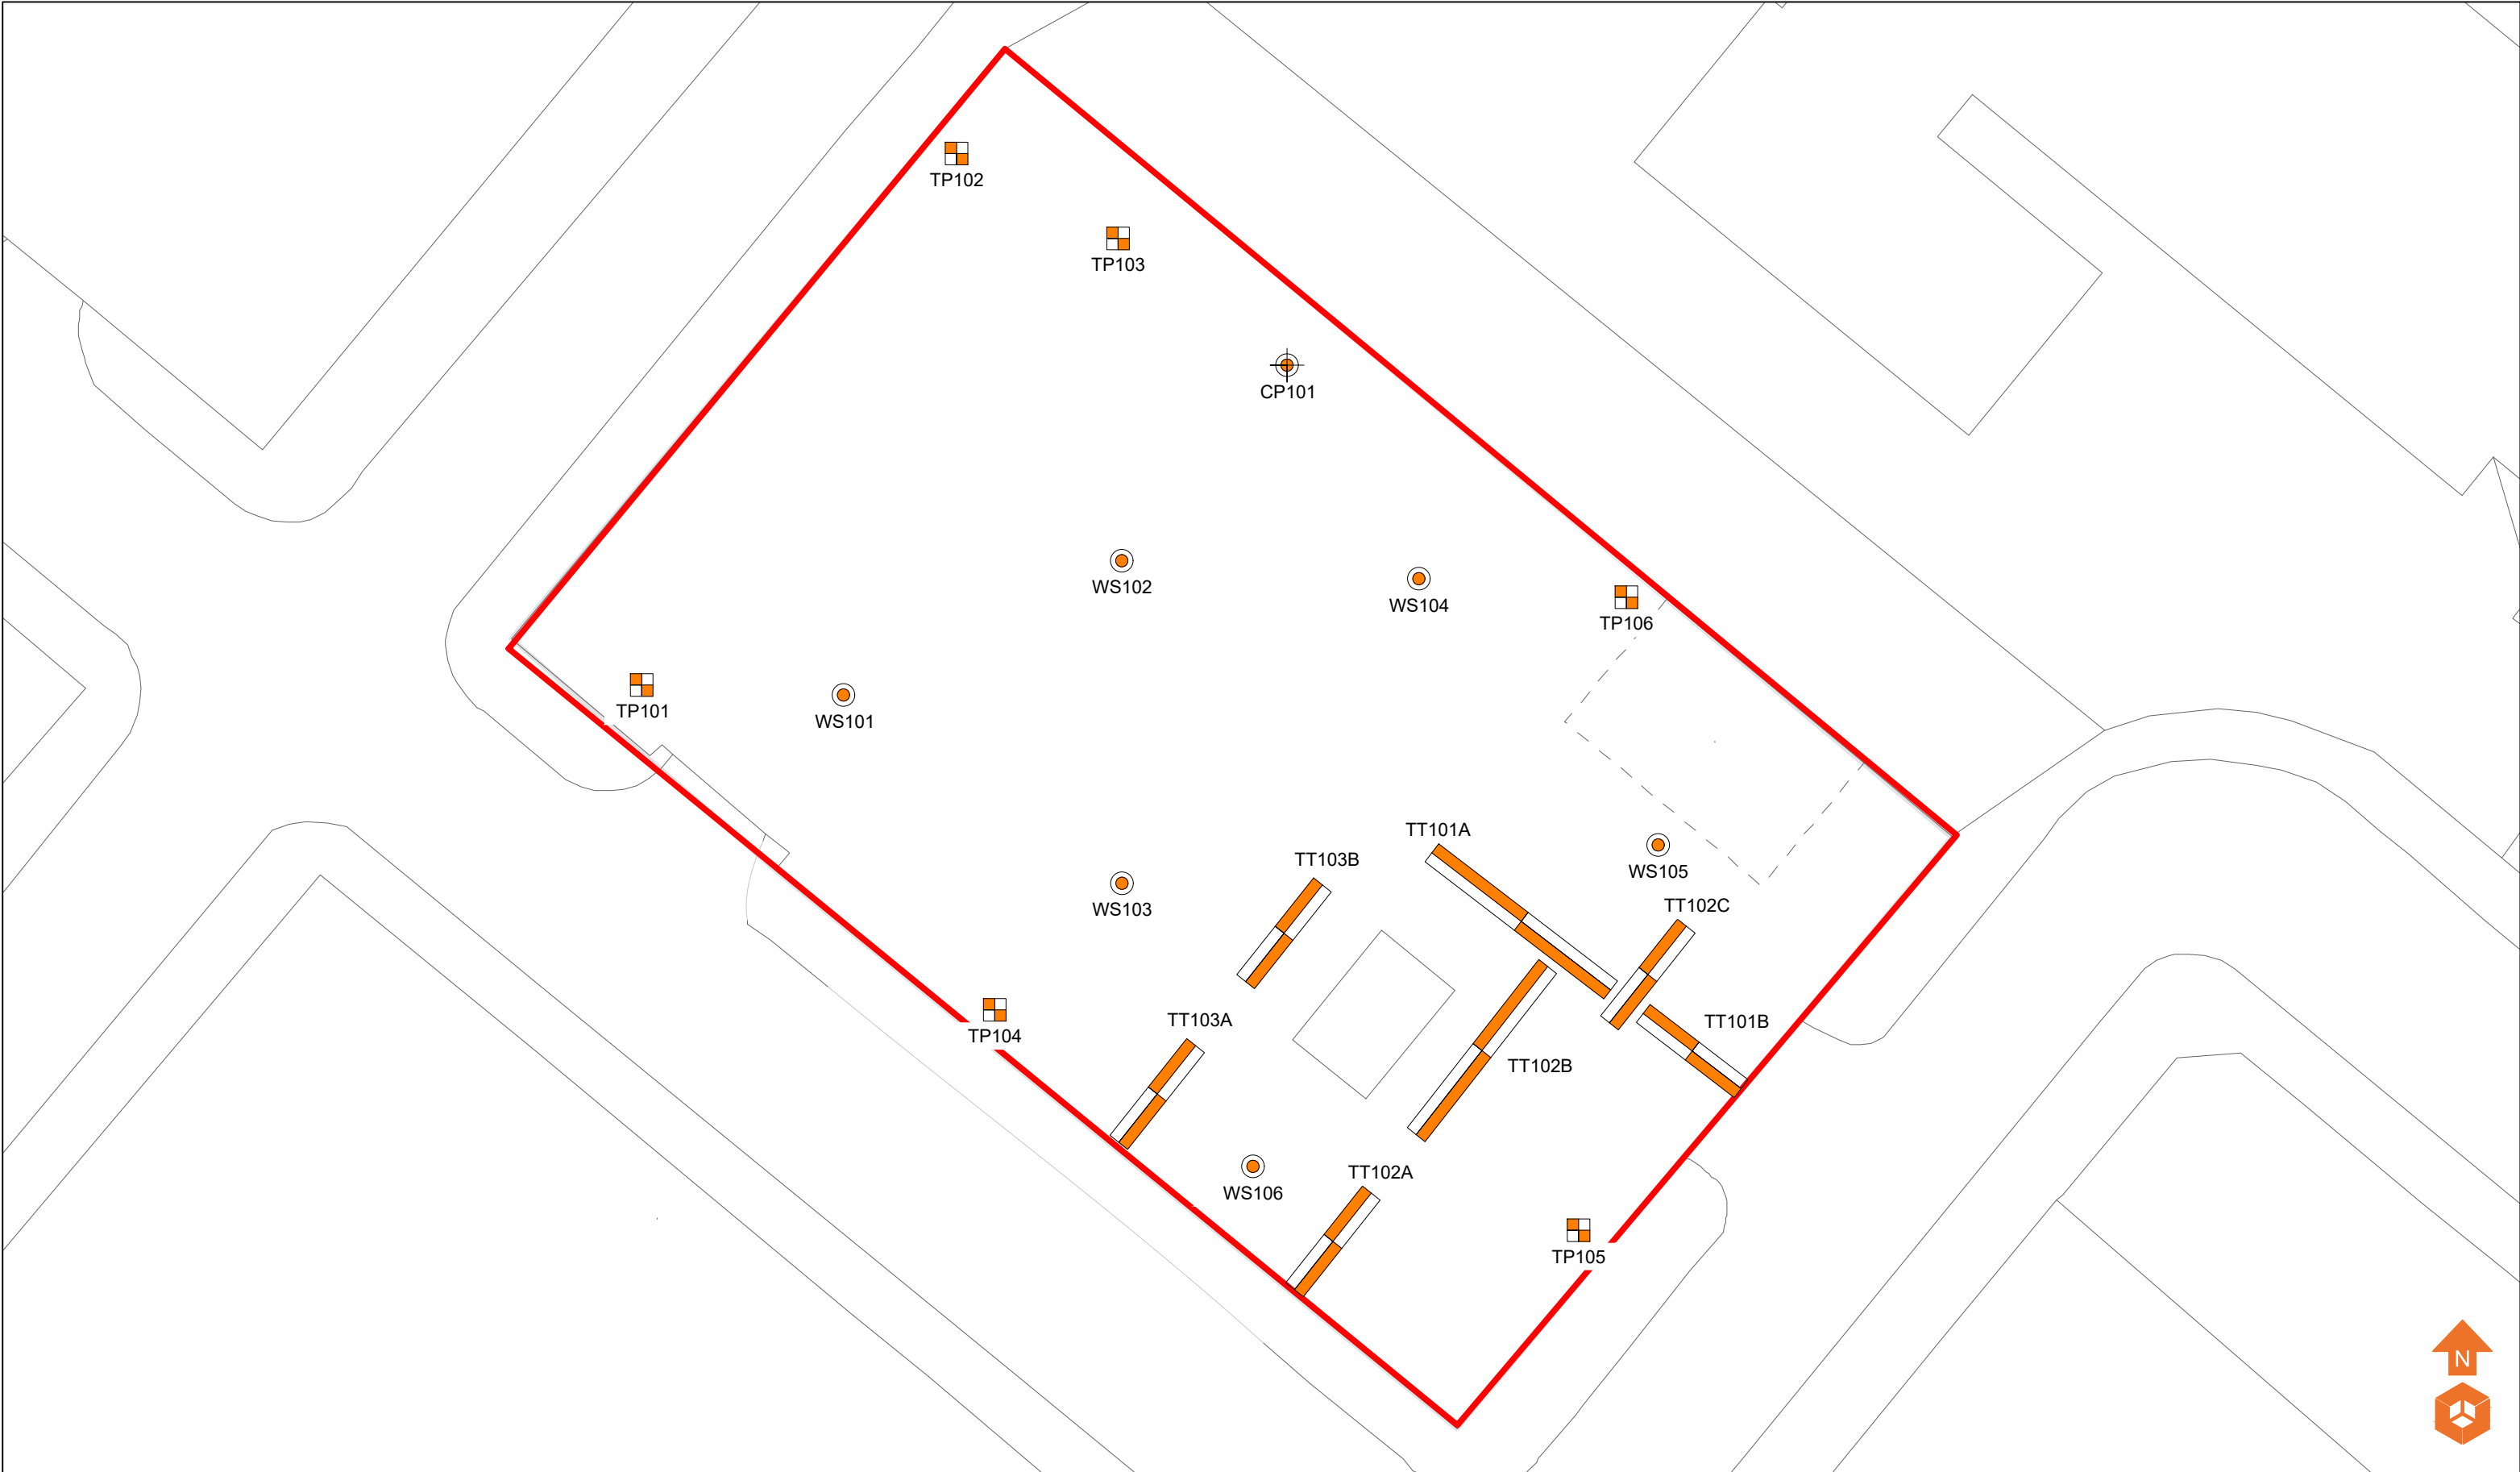
**Location Symbols**

- Approximate Window Sample Probehole Location
- Approximate Trial Pit Location
- Approximate Cable Percussive Borehole Location

The sampling locations are illustrated in Drawing 12-728-005 (Appendix III). The ground conditions encountered are indicated on the logs, which are provided in Appendix V.

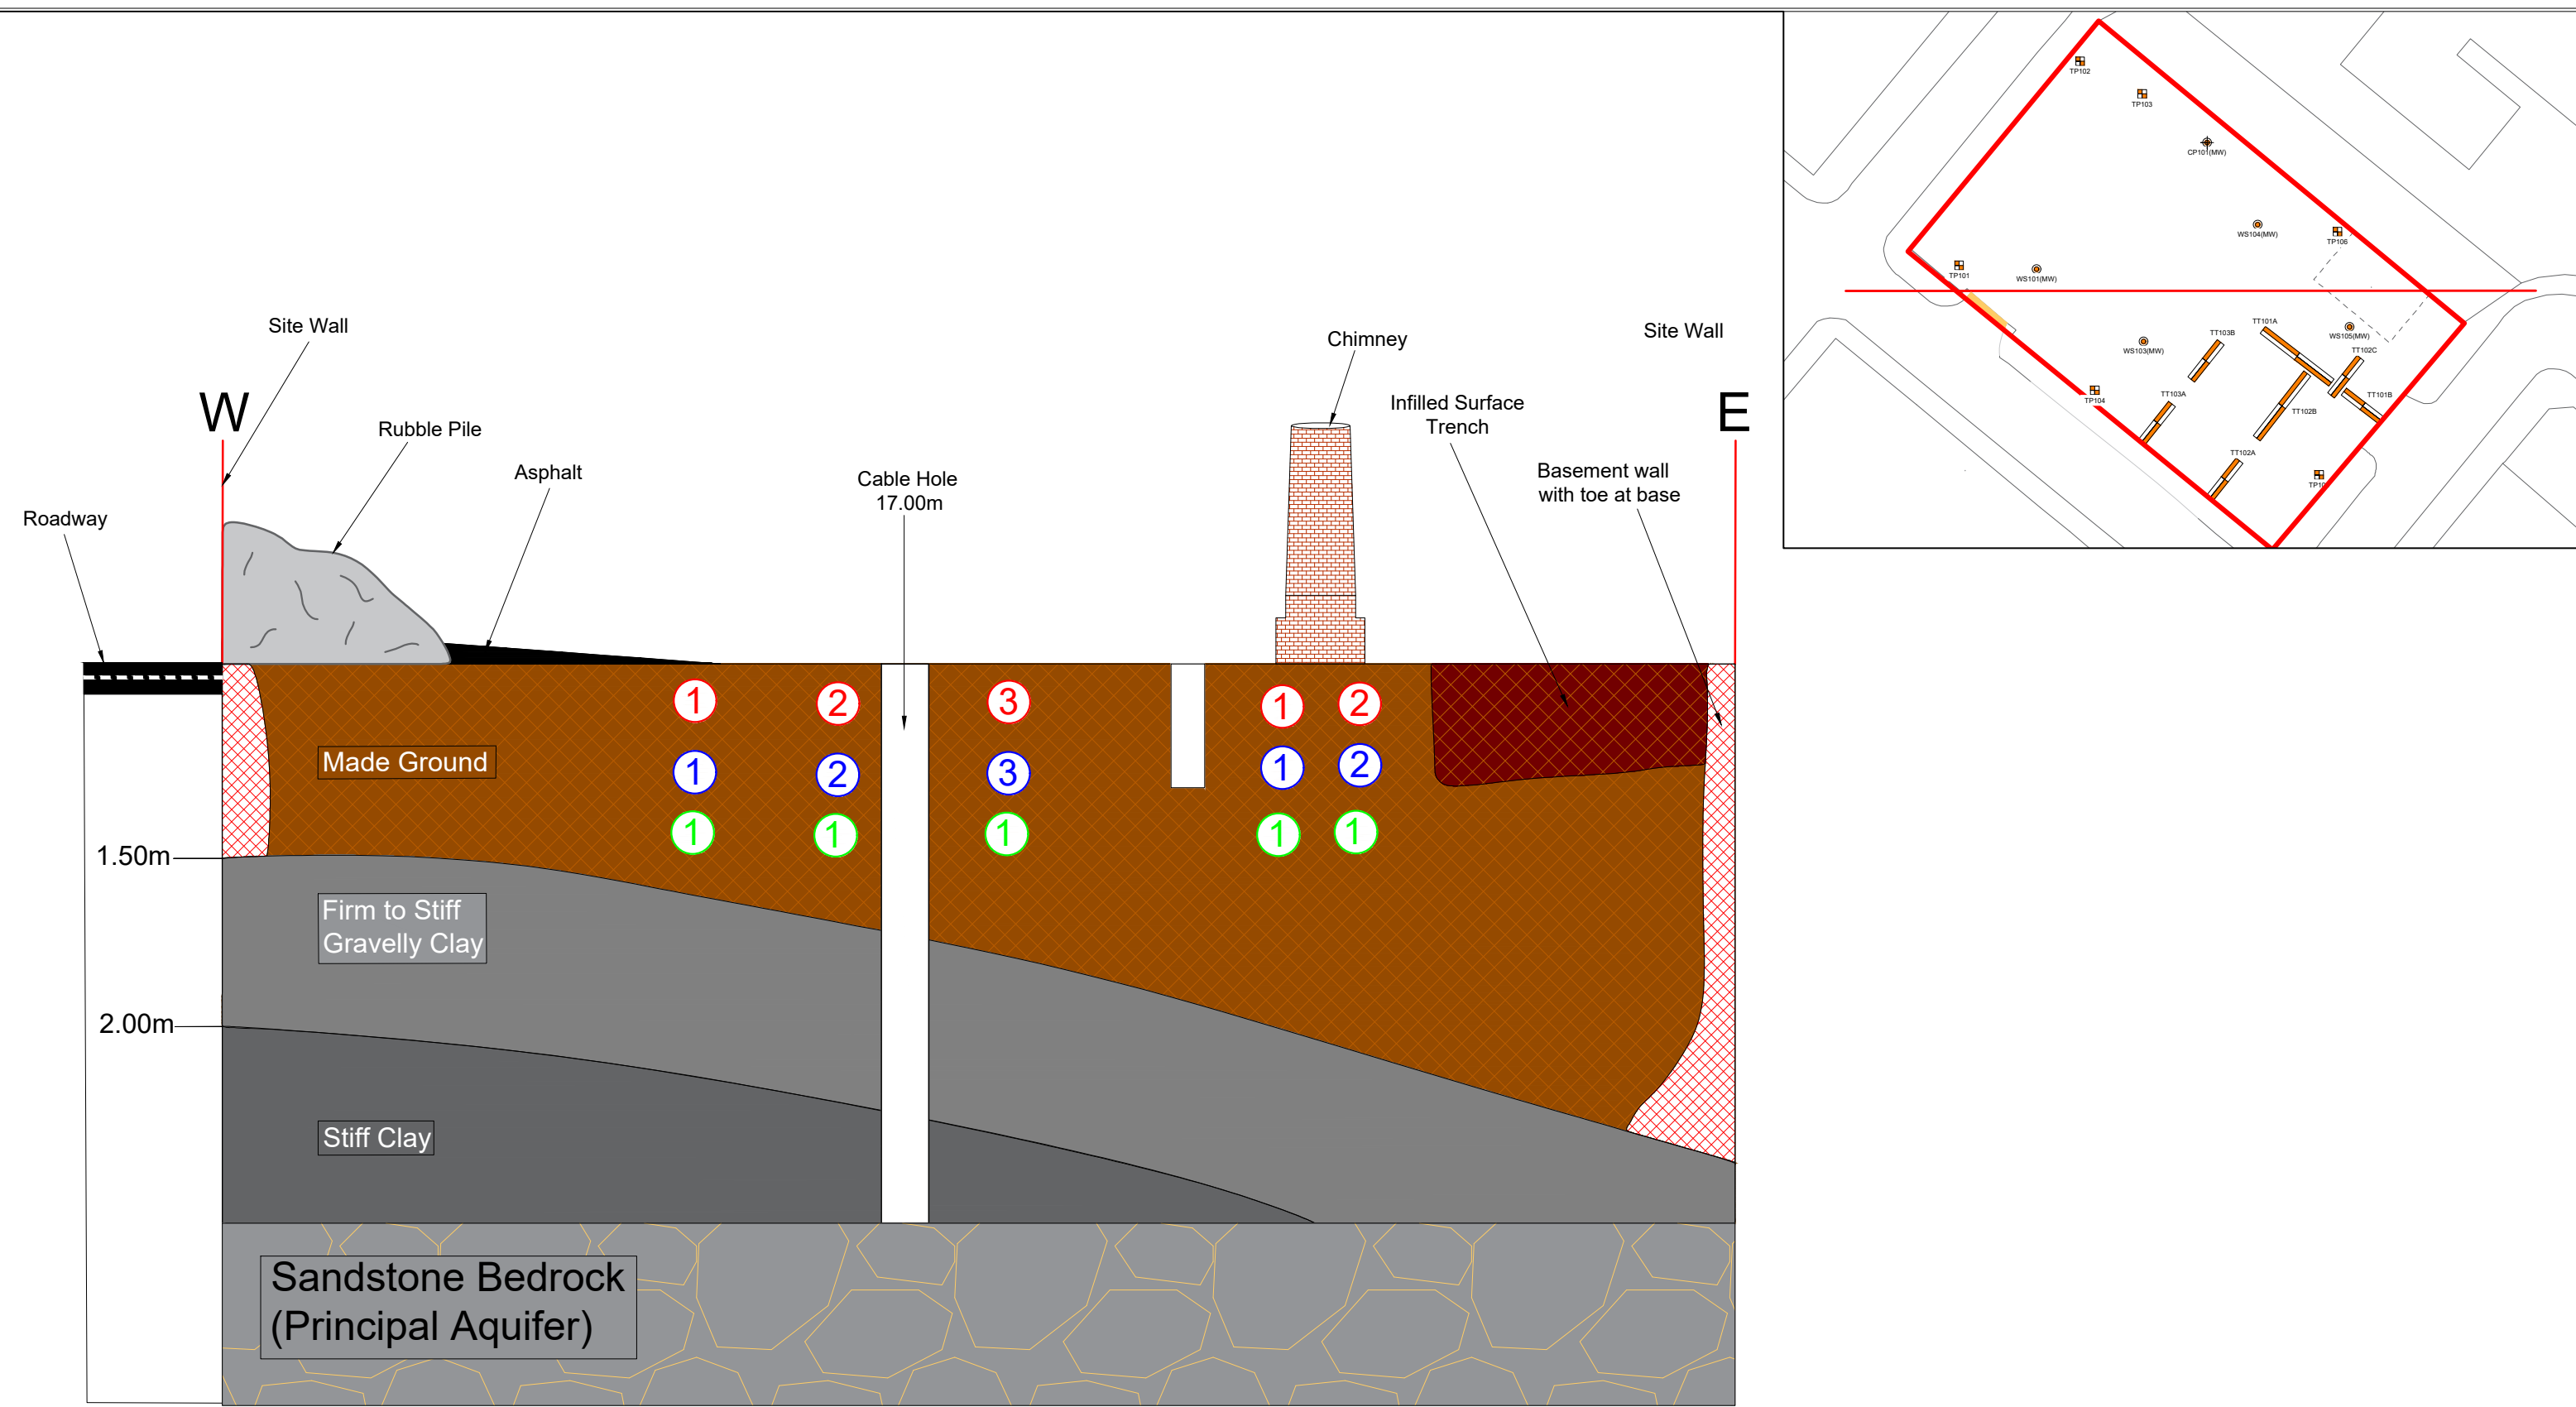
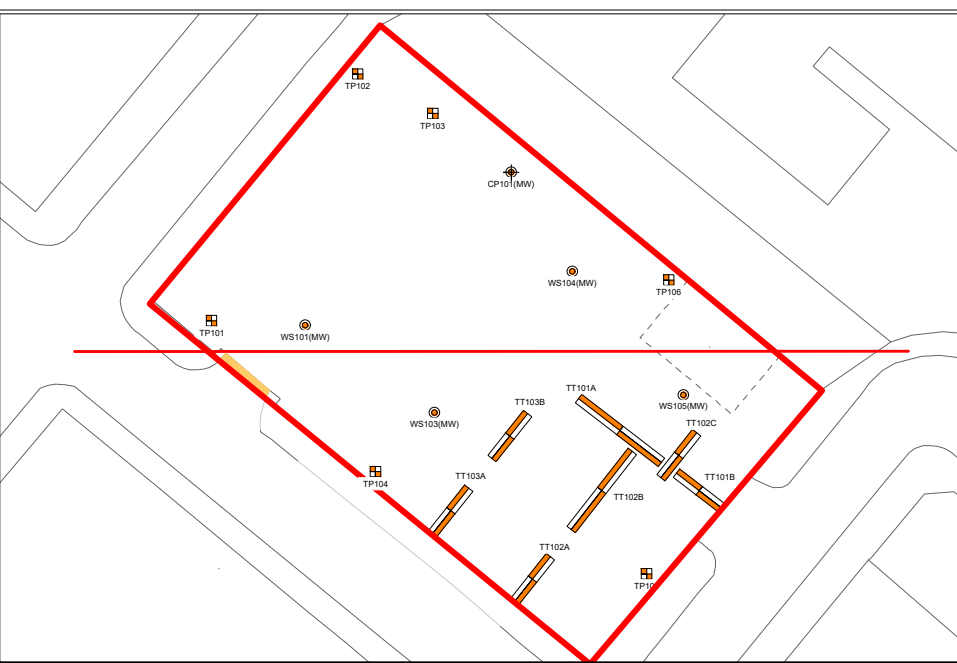
**Geology Key**

- Made Ground
- Firm to Stiff Gravelly Clay
- Stiff Clay
- Infilled Surface Trench
- Rubble Pile
- Asphalt
- Roadways
- Cable Holes
- Basement
- Sandstone Bedrock

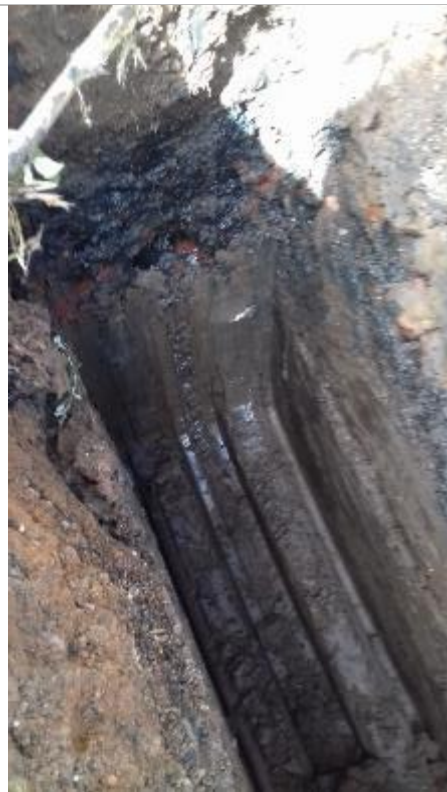
PLATE 2      TP102 EXCAVATION

| Contaminant Group | PE-threshold (mg/kg) | Concentrations at <u>Current</u> pipeline depth (mg/kg) |
|---|---|---|
| Is free product present in soil and groundwater? | A hydrocarbon sheen was noted in TP102. | |

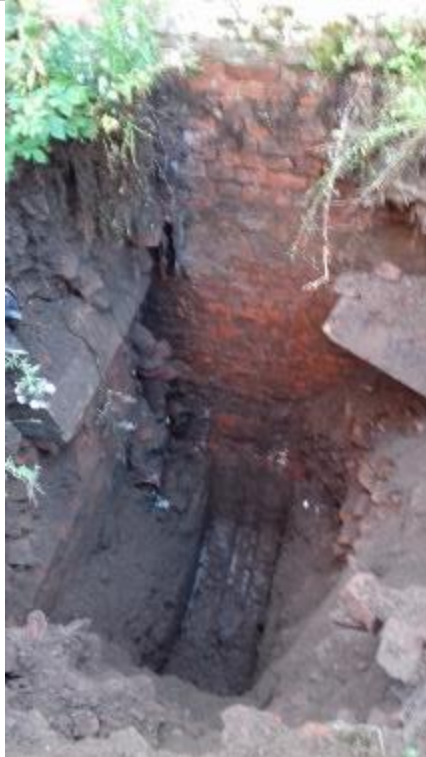
PLATE 3      TP105 EXCAVATION

The proctor compaction tests have indicated that the materials on site are variable with the material in TP105 being wet of the optimum. It should be noted that if this material is excavated for use in a cut/fill operation careful consideration should be taken in the stabilisation of this material.

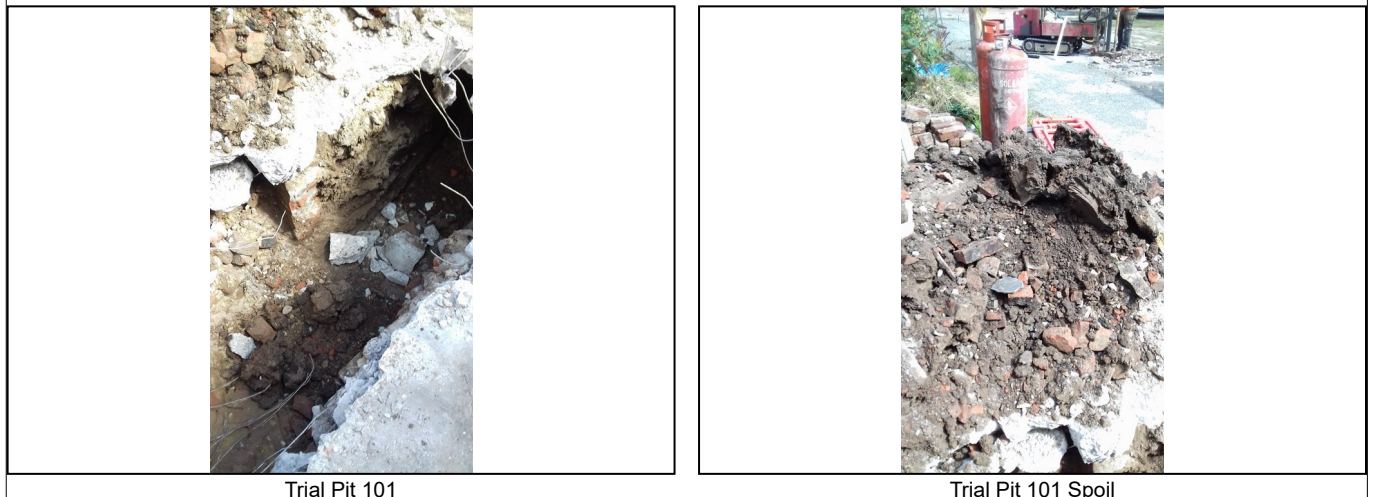
Remarks: Complete.

Stability: Unstable with sides collapsing.

The sides of the exploratory trial pit excavations were generally unstable due to loosely compacted Made Ground with frequent brick and concrete cobbles.

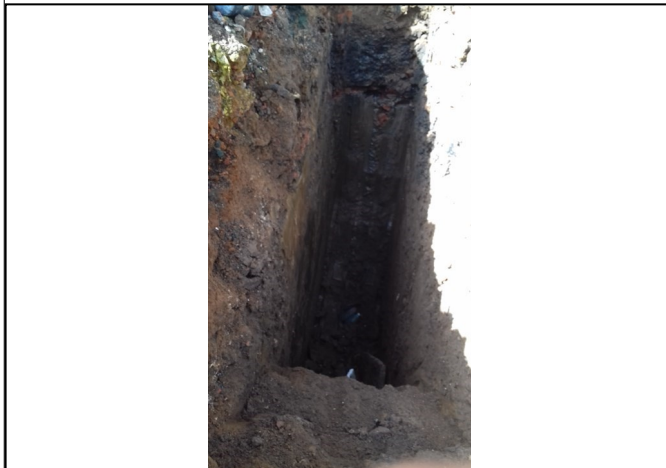
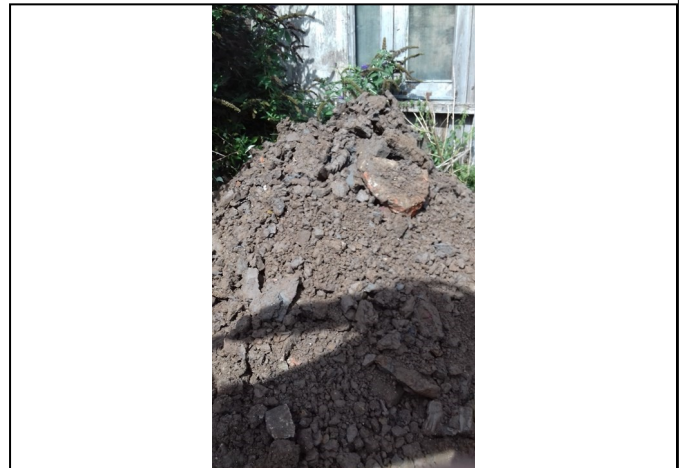
Trial Pit 102

Remarks: 1. Complete. 2. No HSV as couldn't get representative sample. 3. Water strike at 0.60m bgl.

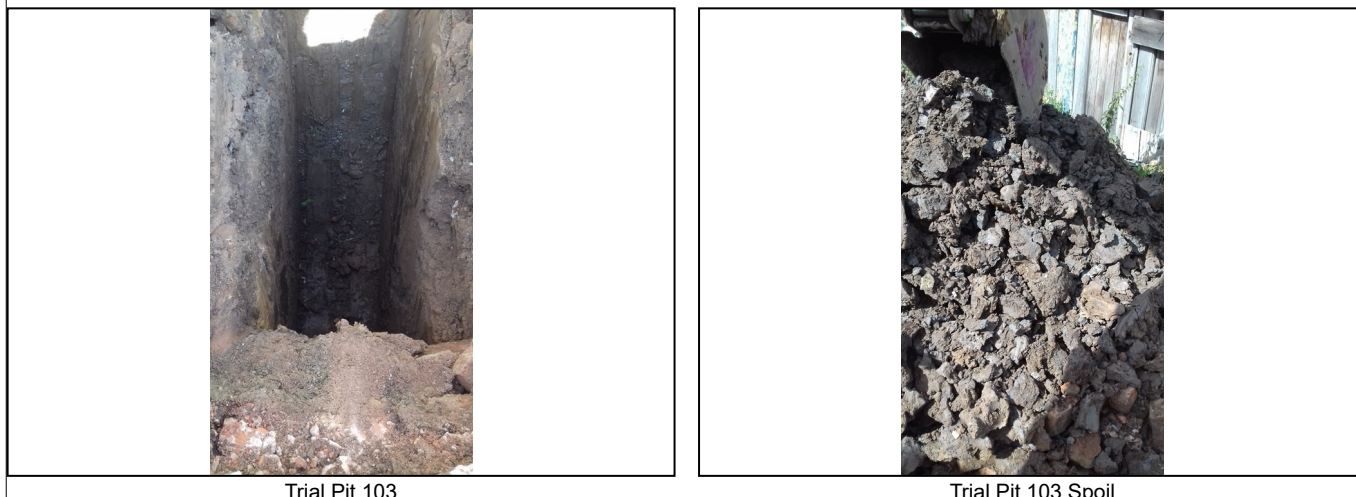
Trial Pit 103 Spoil

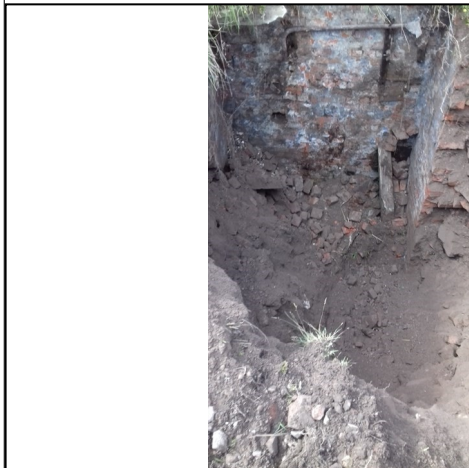
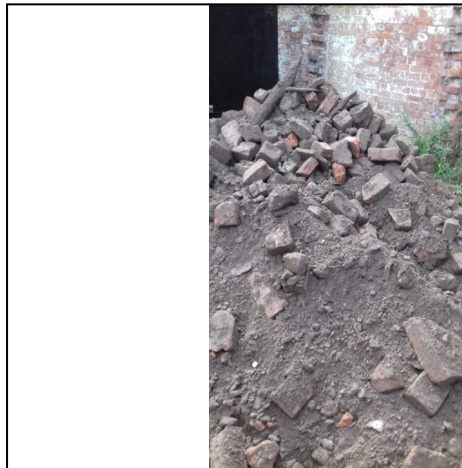
Trial Pit 104

Remarks: 1. Complete. 2. No HSV as couldn't get representative sample. 3. Lots of rubble from existing structure.

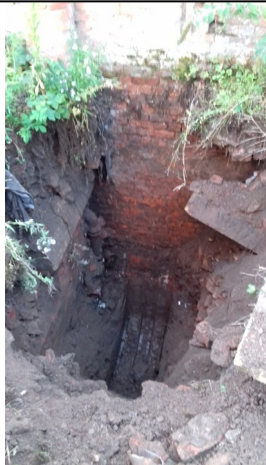
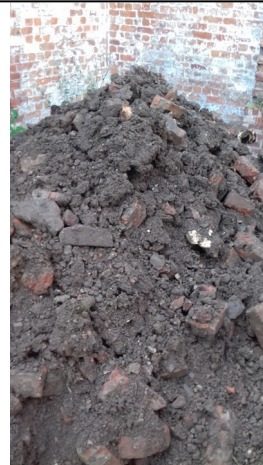
Trial Pit 105

Remarks: 1. Complete. 2. No HSV as couldn't get representative sample. 3. Lots of rubble from existing structure and pipework on walls of building.

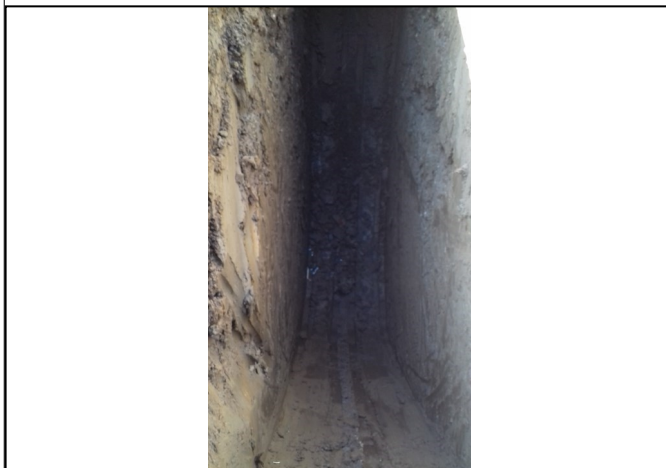
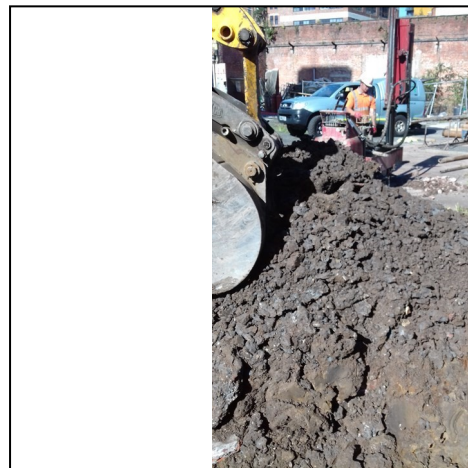
Trial Pit 106

Remarks: 1. Complete. 2. No HSV as couldn't get representative sample. 3. Water strike at 3.50m bgl. 4. Lots of rubble from existing structure.

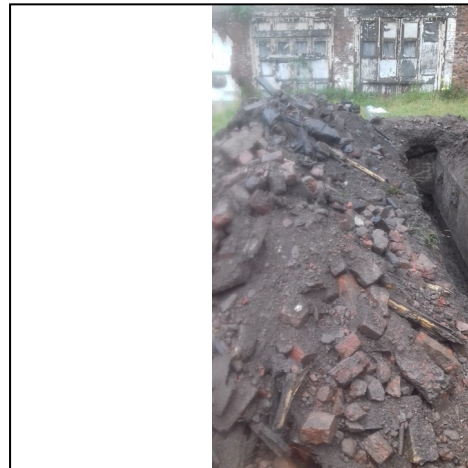
Trial Trench 101A Spoil

Remarks: Complete

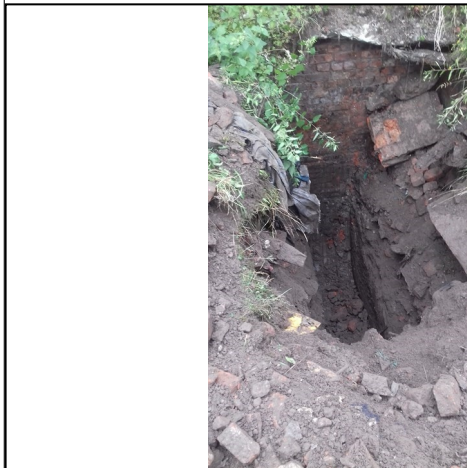
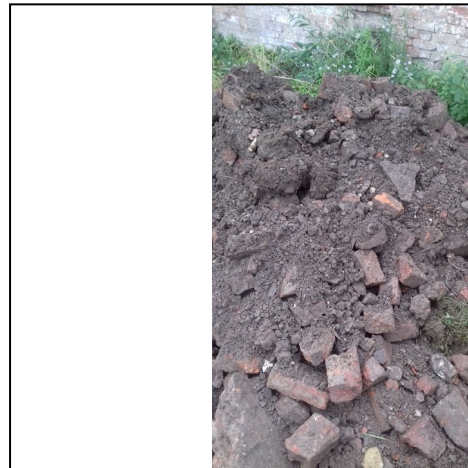
Trial Trench 102A

Remarks: 1. Complete. 2. No HSV as couldn't get representative sample

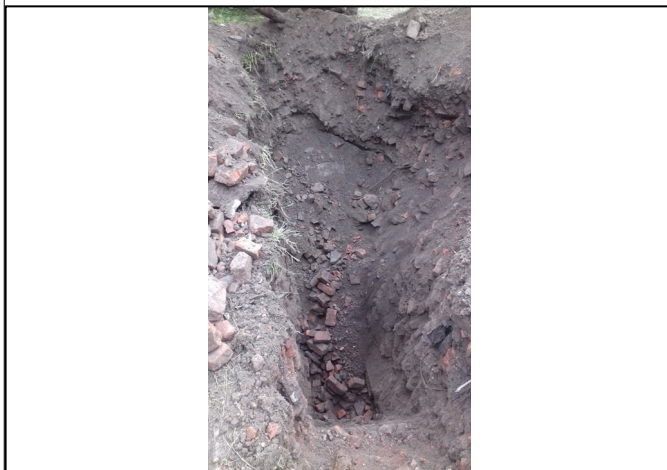
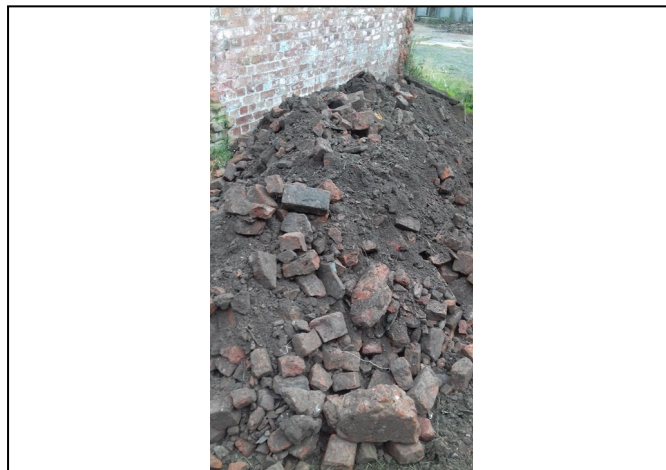
Trial Trench 102B

Remarks: 1. Complete. 2. Brick layer at 2.80m which is historic basement floor.

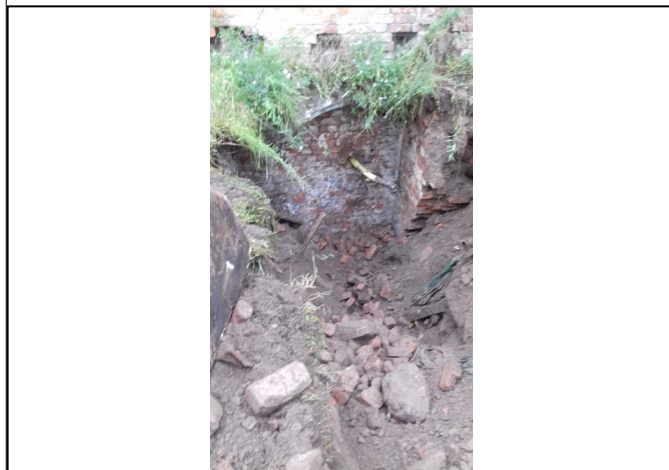
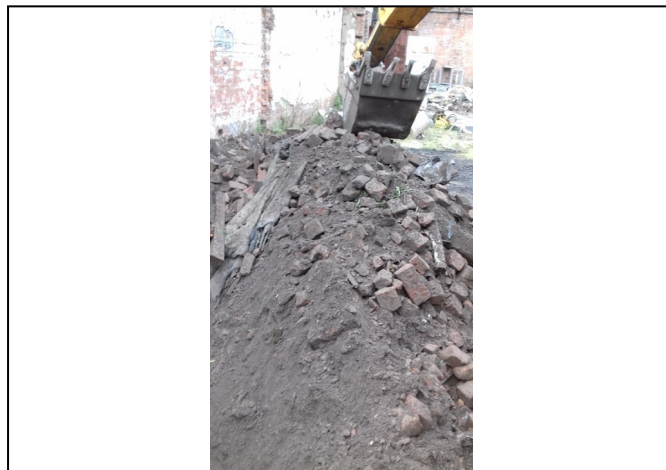
Trial Trench 103A

Remarks: 1. Complete. 2. No HSV as couldn't get representative sample. 3. Historical electric input into the building at 0.5m.

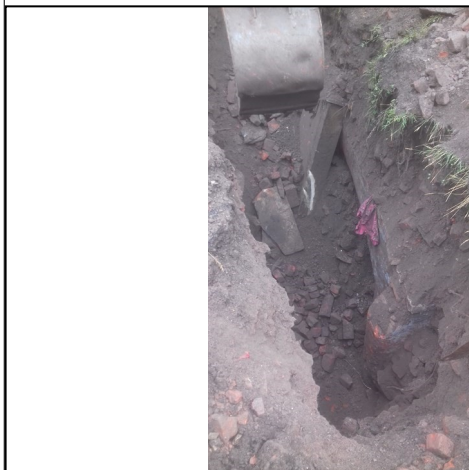
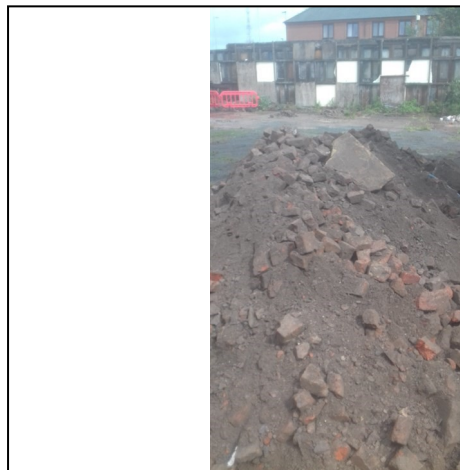
Trial Trench 103B

Remarks: 1. Complete. 2. No HSV as couldn't get representative sample. 3. Historic arch way structure that formed the basement.

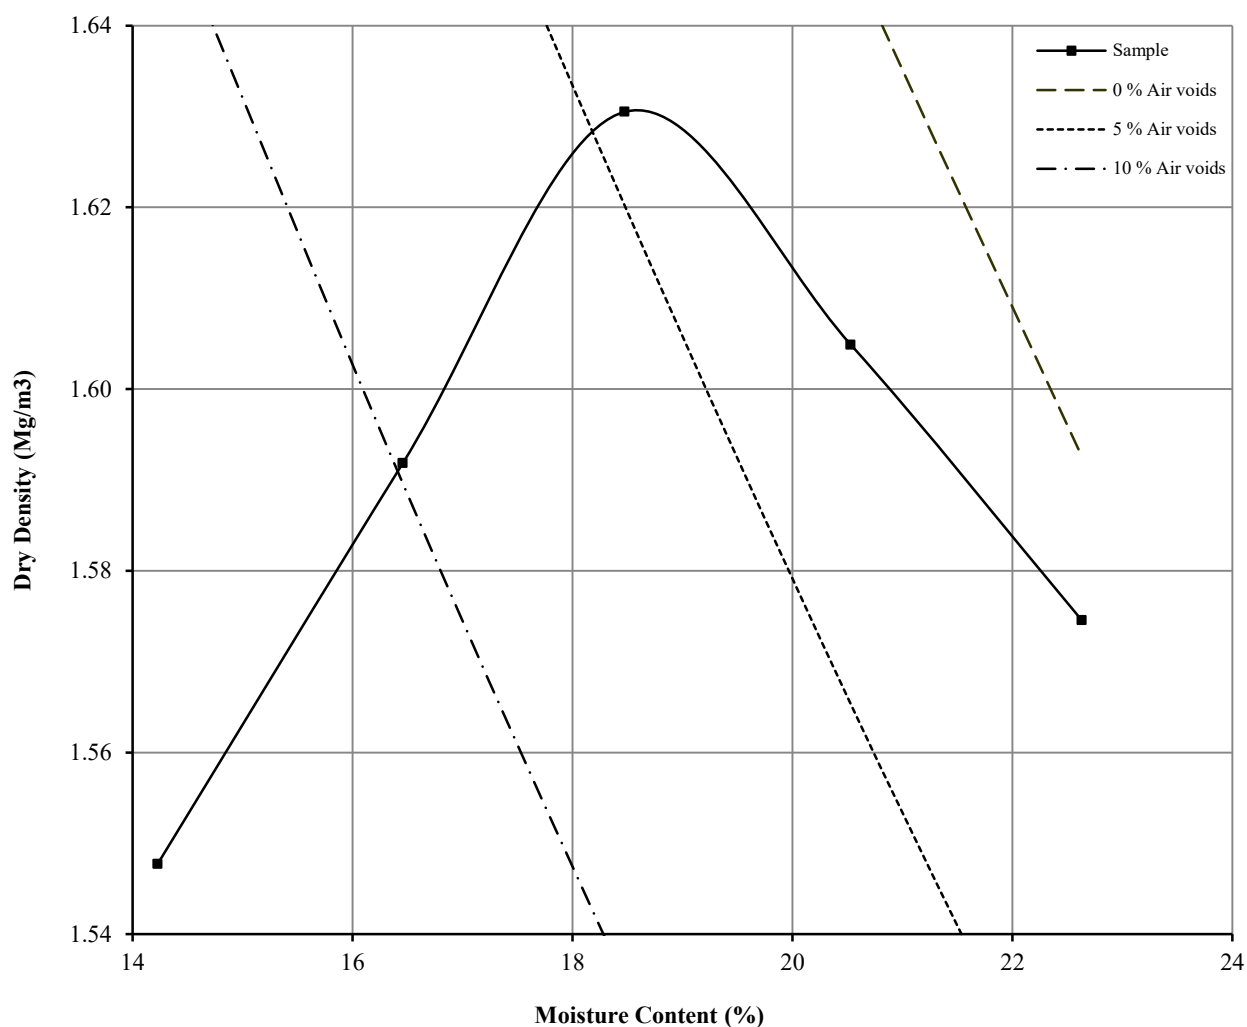
| Initial Moisture Content: | 18 | Method of Compaction: | 2.5kg | Separate Samples |
| Particle Density (Mg/m <sup>3</sup> ): | 2.49 | Assumed | Material Retained on 37.5 mm Test Sieve (%): | 4 |
