**REPORT ON ADDITIONAL TRIAL PITS AND CONTAMINATION ASSESSMENT**

**( SUPPLEMENTARY SITE INVESTIGATION )**

Report 1406B: Rev 0

**NEW MOSTON PRIMARY SCHOOL, MOSTON LANE EAST  
MANCHESTER M40 3QJ**

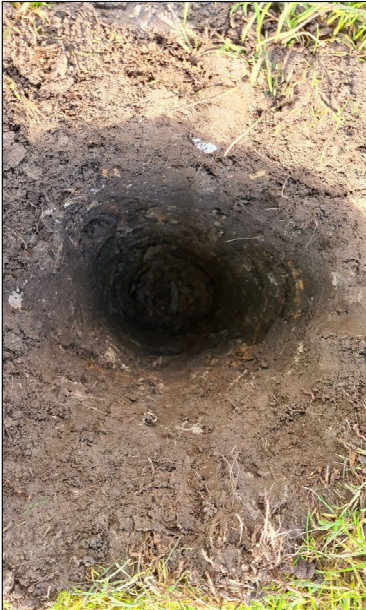
Beneath the topsoil, TPA encountered medium strength orange brown and blue grey gravelly silty clay, which was partially reworked near the upper surface as occasional brick fragments were noted. The gravel comprises fine to coarse subangular to subrounded sandstone and siltstone.

<div>Trial Pit TPA at 0.75m depth</div></div><div>

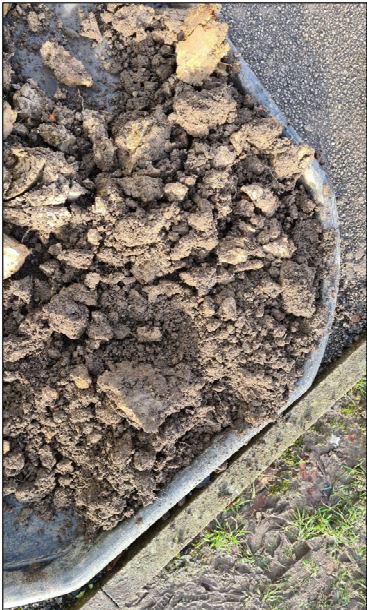
TPA was located on the playing field adjacent to the footpath, where the proposed car parking will extend onto the edge of the existing field. TPA encountered grass over dark brown grey clayey silty topsoil with occasional gravel size fragments of brick, sandstone and limestone to 0.40m depth BGL.

<div>Trial Pit TPA Arisings<br/>( brown grey clayey silty TOPSOIL )</div></div><div>

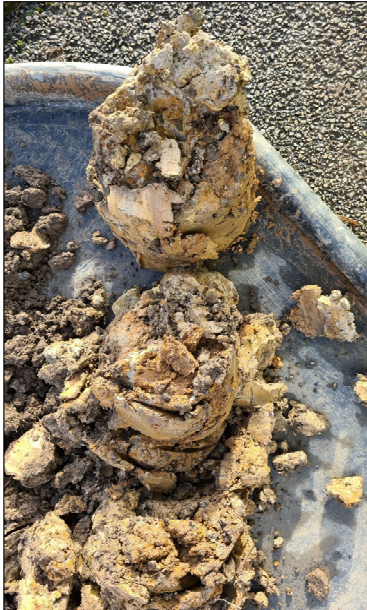
<div>Trial Pit TPA Arisings<br/>( partially reworked gravelly silty CLAY )</div></div></div>                                                                                                                                                                                                                                                                                                                                                                                                                                                                     |      |                                                                                                                                                                                                                            |                            |                                                                                                                                           |        |              |  |                            |                            |  |  |      |    |  |       |      |        |      |      |                                                                                                                          |      |       |  |  |  |  |      |     |       |      |      |                                                                                                                                                                                                                            |      |       |  |  |  |  |      |   |  |  |  |  |      |     |       |

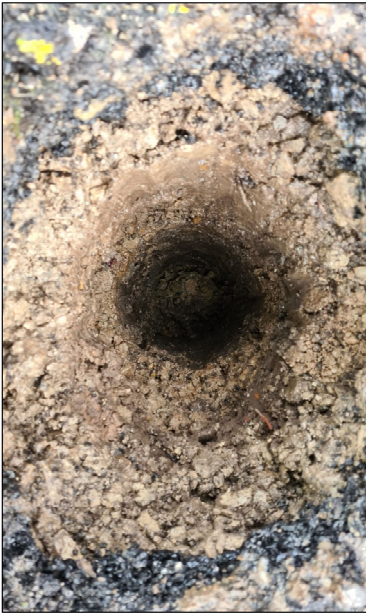
TPB was located on the tarmac surfaced footpath in the area of proposed soft landscaping. Beneath the tarmac surfacing, TPB encountered Made Ground comprising light brown silty sandy gravel of sandstone, limestone, mudstone and occasional macadam to 0.40m depth. This was underlain by further Made Ground comprising low strength grey brown and light brown gravelly silty clay. The gravel comprised fine to coarse angular to subrounded sandstone, mudstone, brick and clinker. There was less brick and clinker with increasing depth, but possibly still partially reworked soils.

In TPB, the clinker and brick fragments reduced in frequency with increasing depth, and the base of the trial pit may have been approaching the surface of the natural Devensian Till at 0.85m depth.

Trial Pit TPB at 0.85m depth

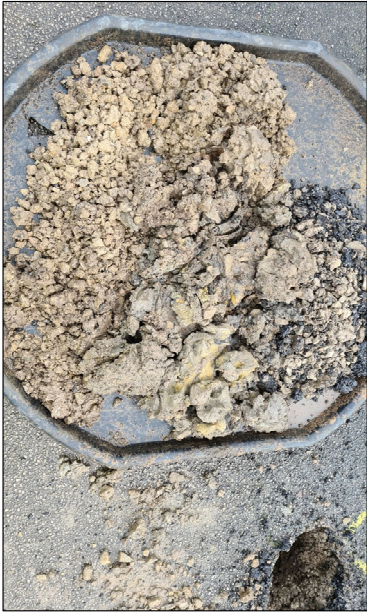
Manmade fragments of tarmac, clinker and brick were noted within the Made Ground but otherwise obvious olfactory or visual signs of soil contamination were not encountered.

Trial Pit TPB Arisings

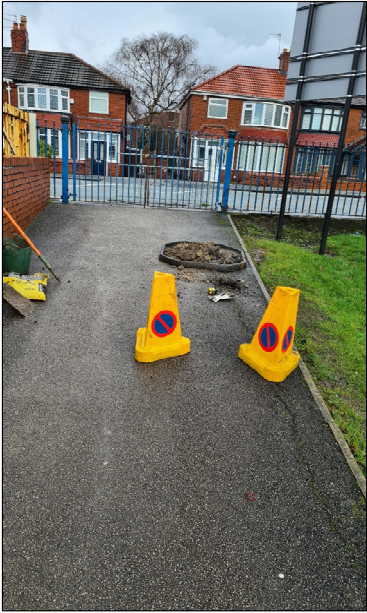
Trial Pit TPB Location

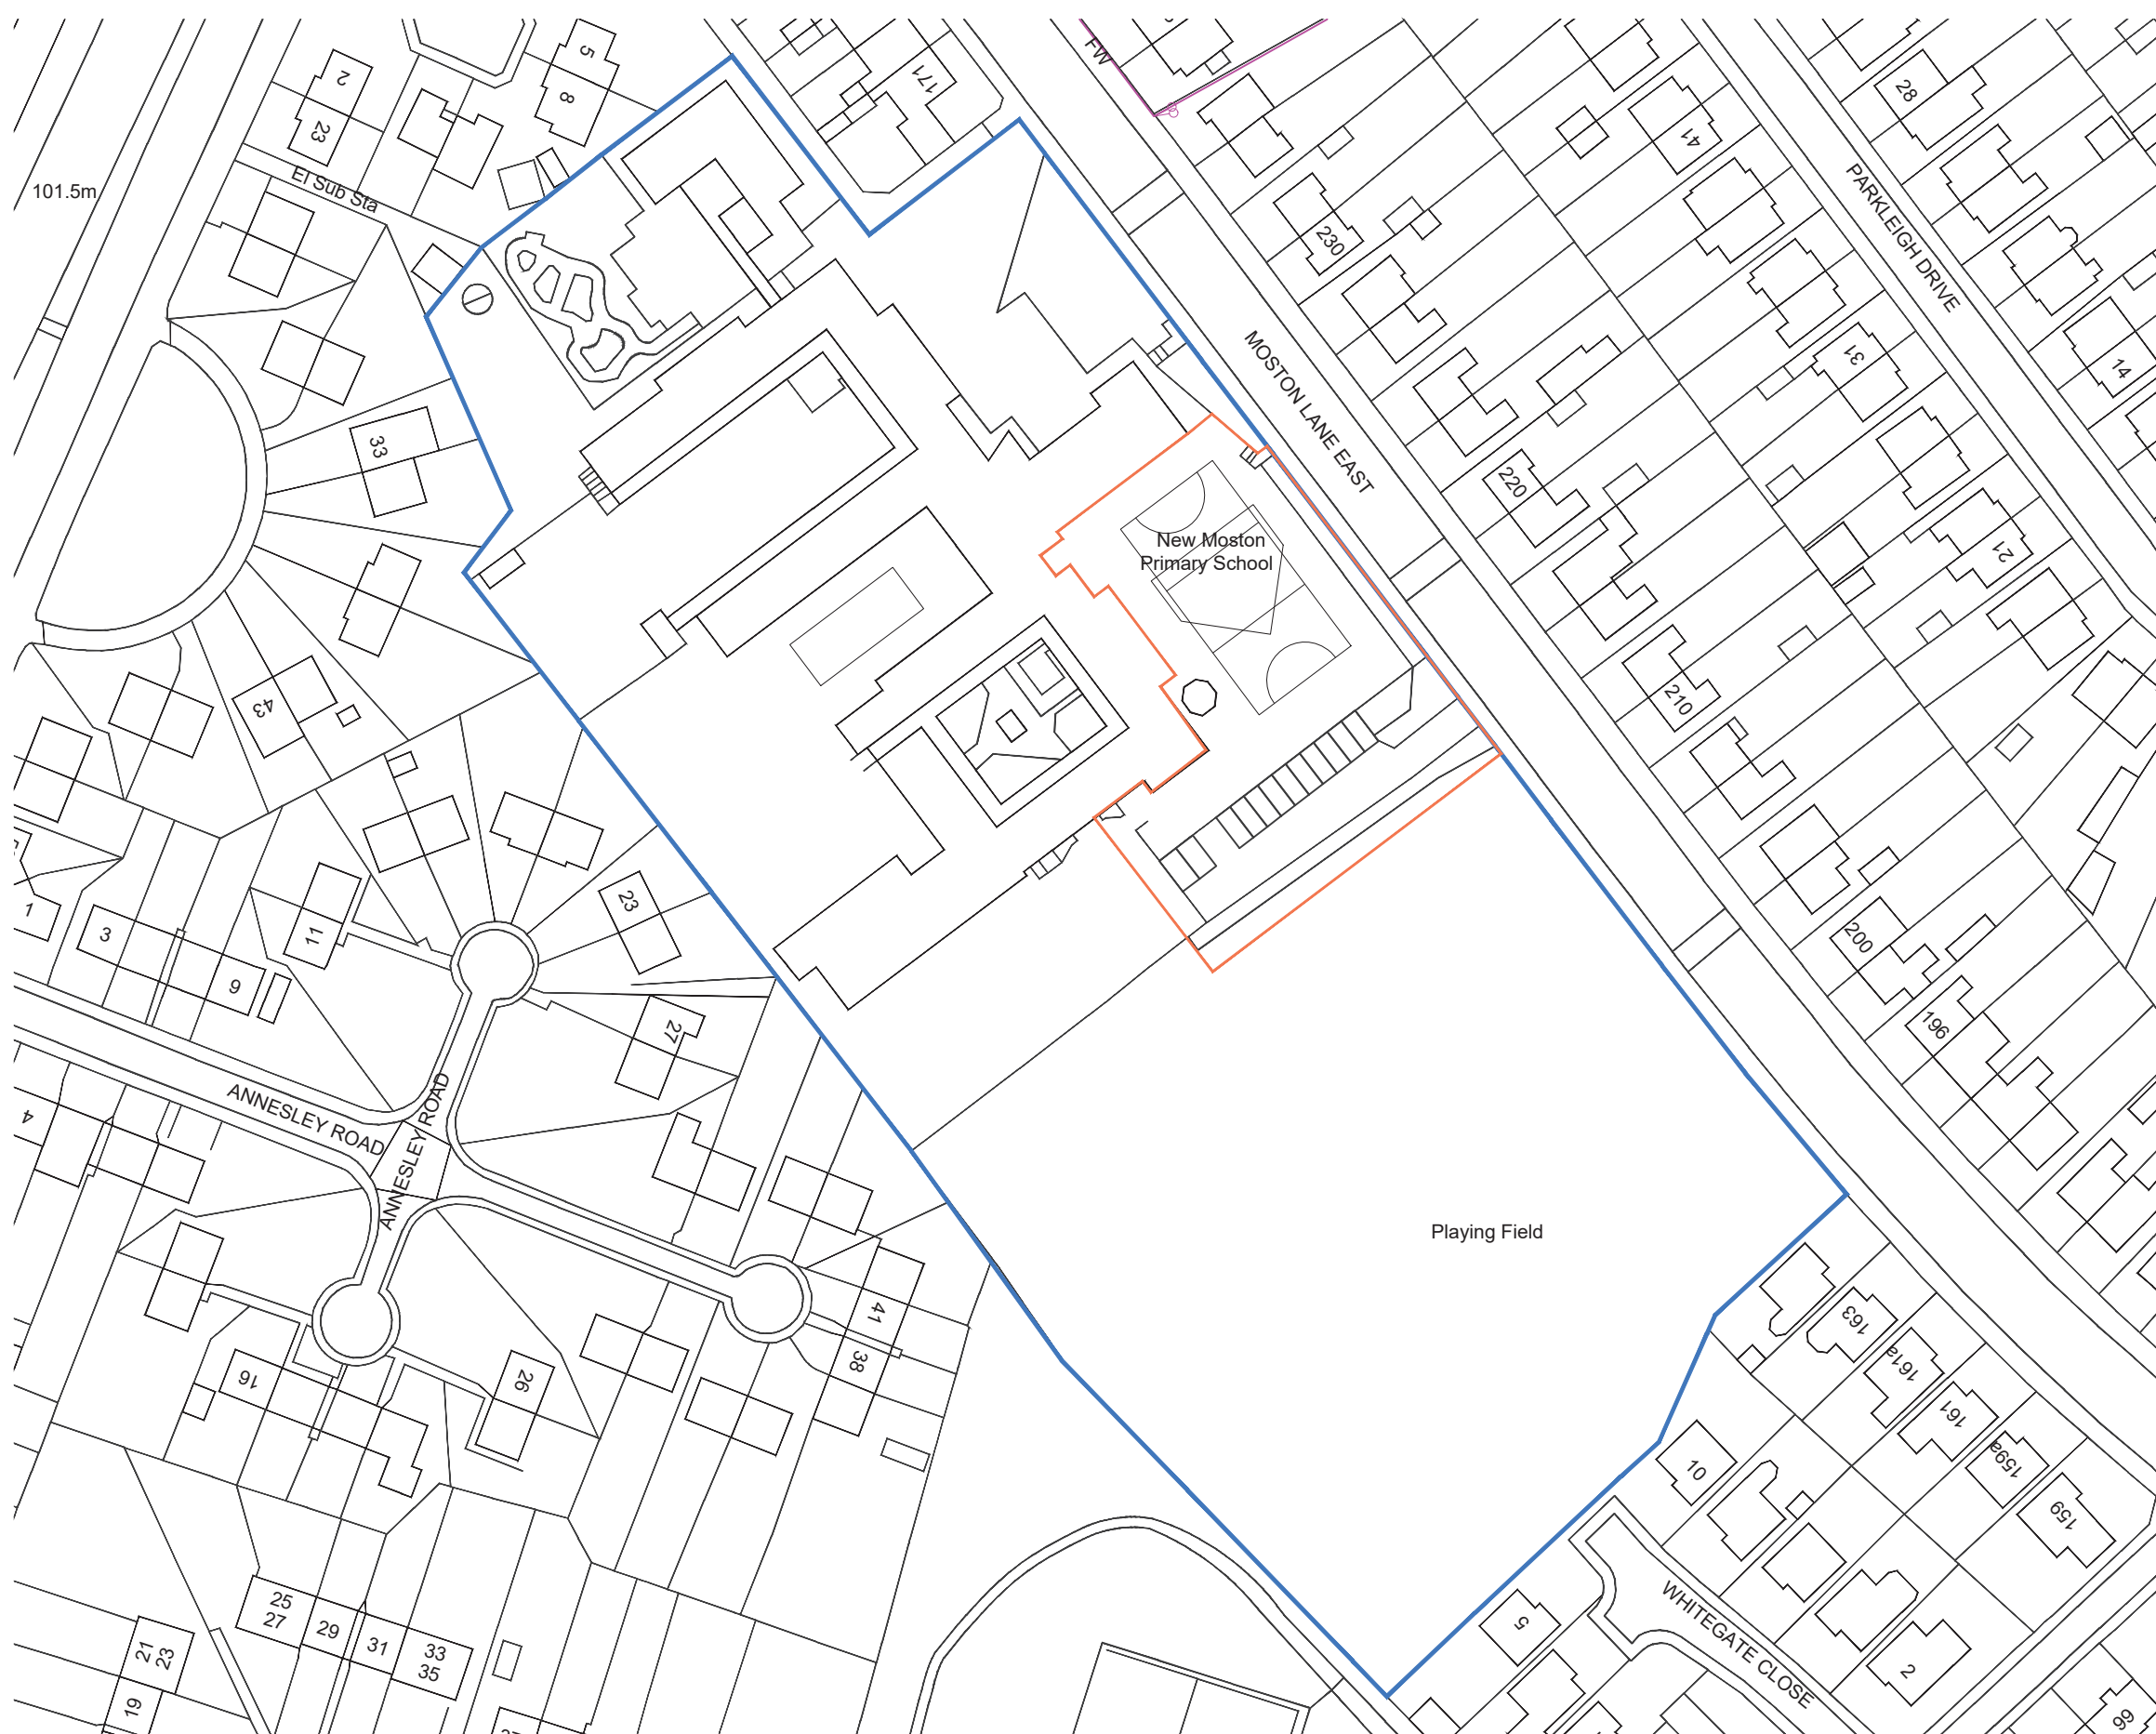
| Drawing Title<br><b>Proposed Site Plan</b> | | | |

Buried service avoidance &  
Intrusive fieldwork 12th Jan 2023
