**Louisa Street Works, Louisa Street, Openshaw, Manchester M11 1AD**

## **BAT ACTIVITY SURVEYS & MITIGATION STRATEGY**

**May 2023**

**ERAP (Consultant Ecologists) Ltd ref: 2023-107**

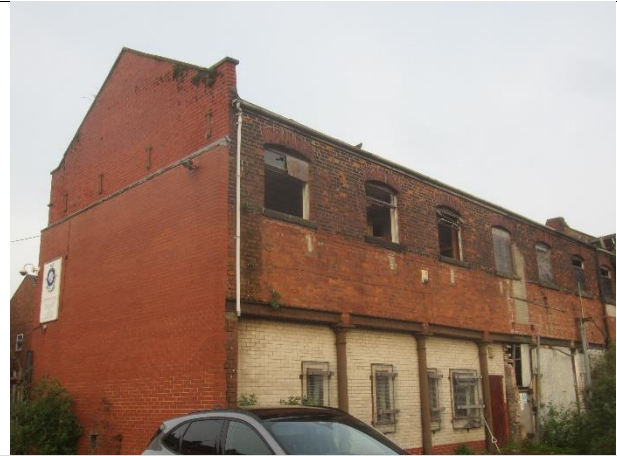
**Photo 2:** Northern and western elevations of B1

3.1.2 Refer to **Photos 1 to 7**. B1 is a dilapidated two story brick building with a pitched bitumen felt covered roof. Brick parapet walls with stone / concrete copings are present at the gable ends. A perpendicular section of pitched roof at the front (east facing) roof pitch is slate covered. The brick chimney stacks have lead flashing at the base and a timber fascia is present at the roofline on the western elevation.

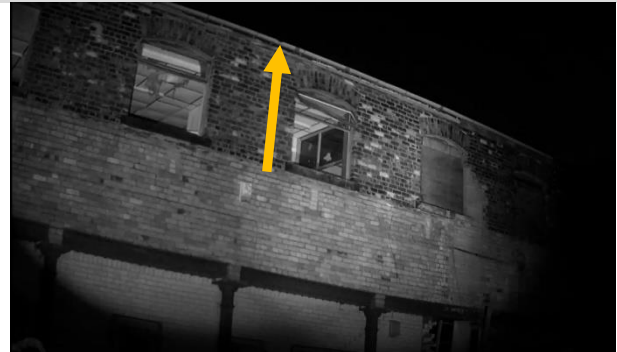
- 3.2.2 One common pipistrelle was observed emerging from behind the timber fascia at the western elevation (northern end) of B1 at 20:55 (14 minutes after sunset) (refer to **Photo 6**). The bat flew southwards towards the off-site park to the south. During the dusk emergence survey on 3<sup>rd</sup> May 2023 two common pipistrelle bats were recorded flying along the western elevation of B1 to the south at 20:55. The bats were not observed entering the site from the wider area and it is advised that these two bats are likely to have emerged from behind the timber fascia. The gap behind the fascia at B1 is identified as 'Roost 1: Common pipistrelle day roost' and is annotated on **Figure 2**.

**Photo 6:** Location of Roost 1 behind timber fascia at western elevation of B1 (common pipistrelle day roost) (NVA footage capture)

- 5.2.3 Prior to the commencement of works to ensure there is no net loss of roost opportunity at the site and to ensure a suitable feature is present at the site to receive any bats found during the works, one bat box will be installed on one of the trees along the western site boundary (within 110 metres of Roost 1 and within land of the same ownership), refer to **Figure 3**.

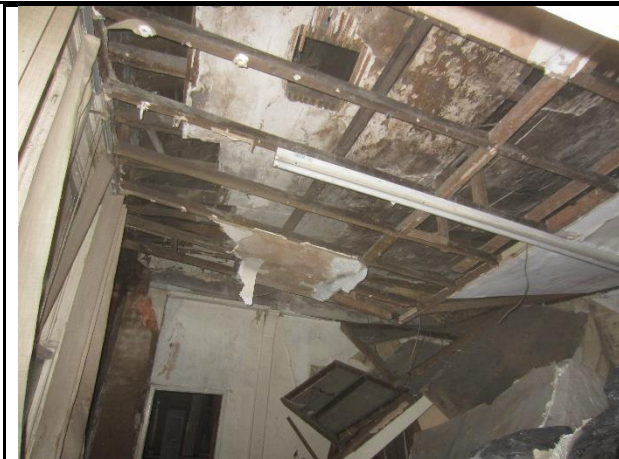
3.1.4 The interior of the building is damaged as a result of exposure to the elements and vandalism. The roof void was not accessed, although views beyond the suspended ceiling tiles on the first floor confirmed that the roof void is unlined and uninsulated.

**Photo 7:** Damage of ceiling at first floor of B1

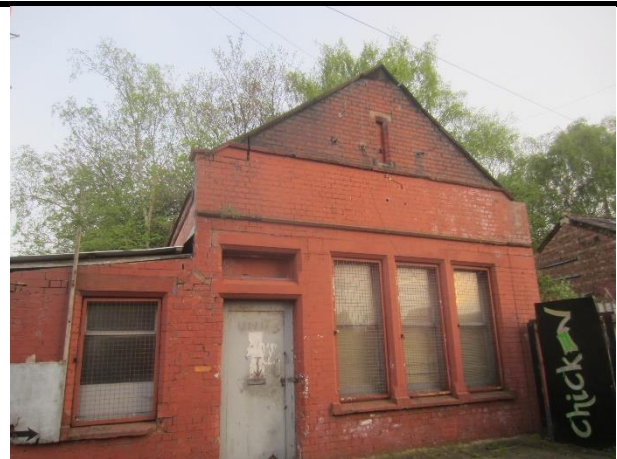
**Photo 8:** Norther elevation of B2

3.1.7 Refer to **Photos 8 to 11**. B2 is a single storey brick gatehouse building with a pitched slate covered roof with brick parapet walls at the gable ends. All slates and ridge copings appear to be tightly sealed; no missing, lifted or slipped slates were observed.

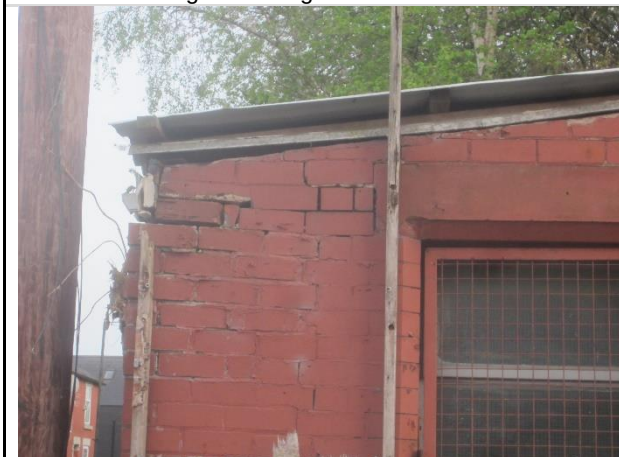
3.1.8 Gaps with suitability for access by individual bats were detected at the roof verge and in holes / gaps between the bricks, particularly on the northern elevation. A timber fascia is present at the eastern (Louisa Street) elevation.

**Photo 9:** Gaps in brickwork and roof verge at northern elevation of B2

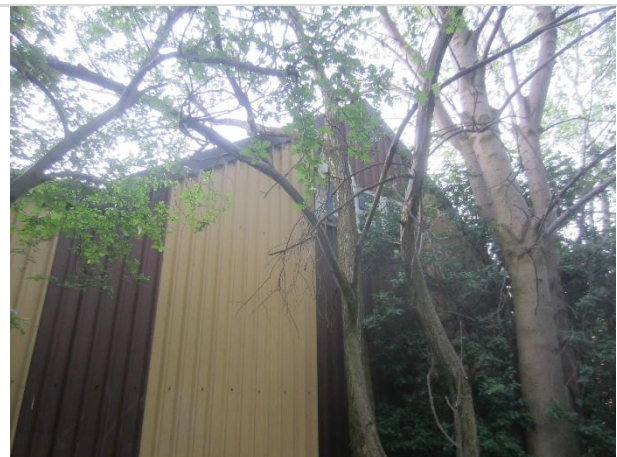
3.1.9 Although the southern elevation of the building faces the off-site park to the south this elevation is clad with a corrugated metal sheet and is obscured by the dense trees and shrubs to the south which limit the accessibility for bat access.

**Photo 10:** Southern elevation of B2 showing metal cladding and tree / shrub cover

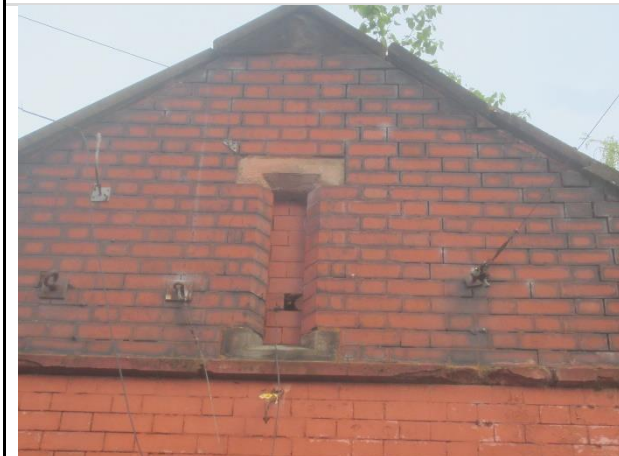
**Photo 11:** Gaps in the brickwork at the northern elevation of B2

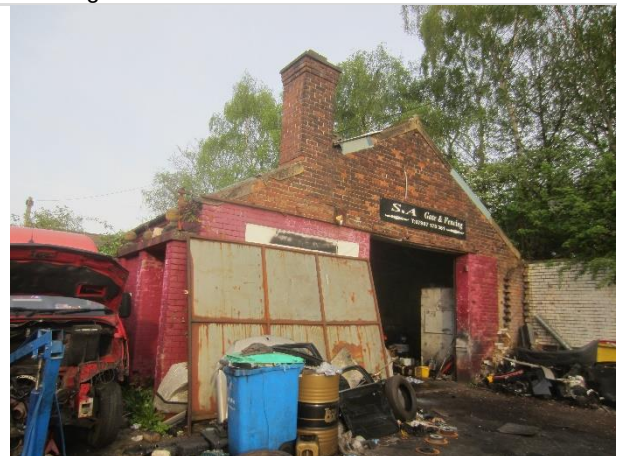
**Photo 12:** Western elevation of B3

3.1.11 Refer to **Photos 12 to 19**. B3 is a workshop building in operational use. The building is a single storey brick building with a pitched sheet covered roof that meets brick parapet walls. A small, single storey extension is present off the northern elevation. The extension is constructed in brickwork walls with a pitched, corrugated metal roof. Large gaps are present between the roof and walls as well as at the gable ends of the roof. A large loading entrance with metal shutter is present off the western elevation and small gaps were identified between the shutter and brickwork walls. The windows are single-glazed and sit within metal frames with metal mesh grills present.

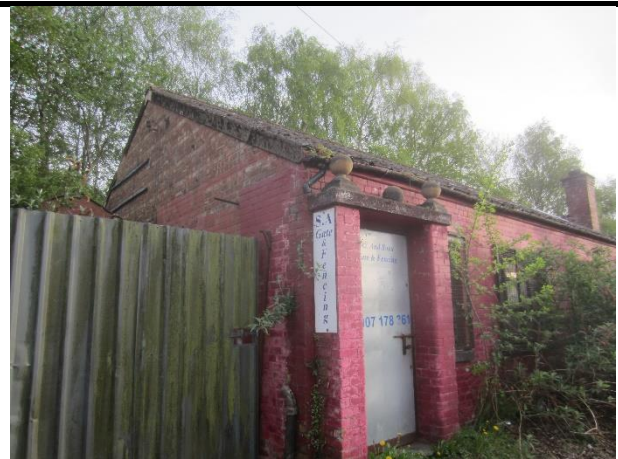
- 3.1.12 Opportunities for bat access around the exterior are present at gaps behind the fascia at the eastern and western gable ends and at gaps in the external brickwork.
- 3.1.13 As reported at B2, the southern elevation is clad with a metal corrugated sheet and is obscured to bat access by the presence of the dense trees and shrubs in the off-site parkland to the south.
- 3.1.14 The underside of the sheet covered roof is unlined and uninsulated. No gaps suitable for bat access were found on the internal side of the brick walls / at the wall tops.
- 3.1.15 No bats or evidence of use of B3 by roosting bats was detected.

**Photo 14:** Eastern and southern elevations of B3 showing overlapping fascia at gable end

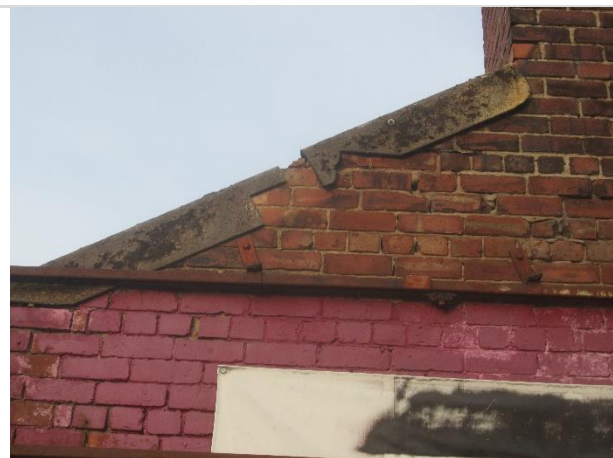
**Photo 15:** Gaps behind overlapping sheeting / fascia at western elevation of B3

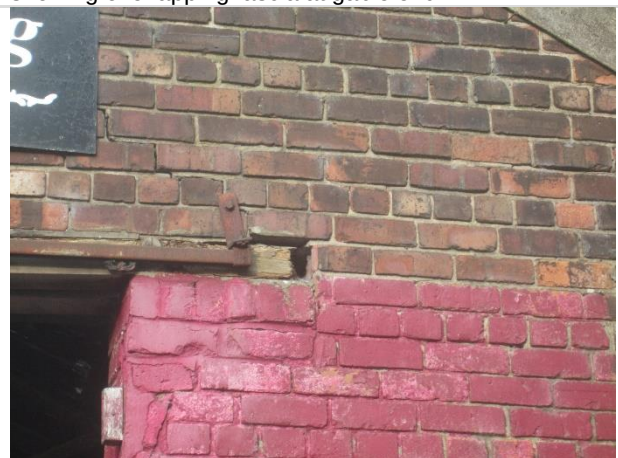
**Photo 16:** Holes in brickwork at B3 (western elevation)

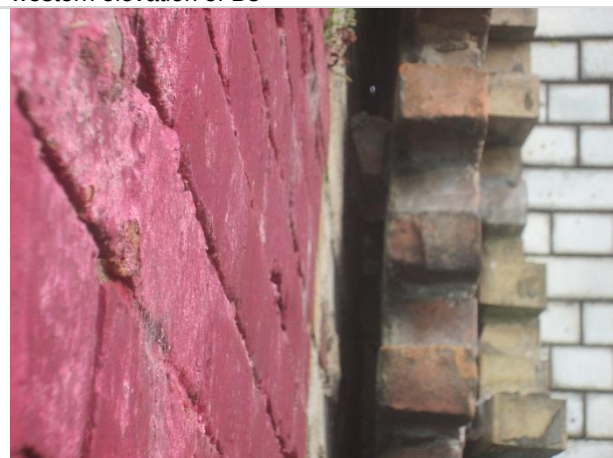
**Photo 17:** Gaps between brick layers at western elevation of B3

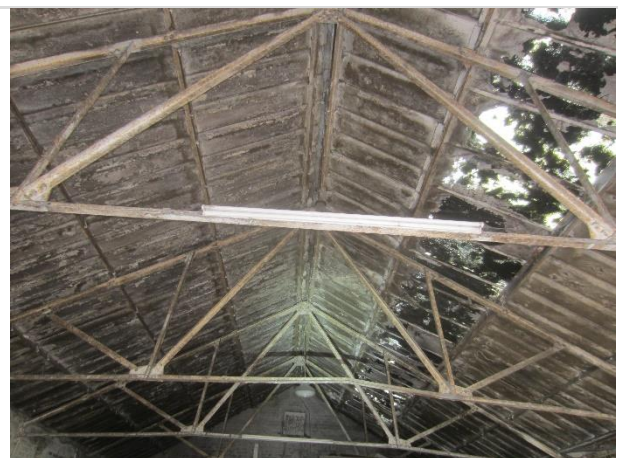
**Photo 18:** Interior of B3 showing uninsulated and unlined roof covering

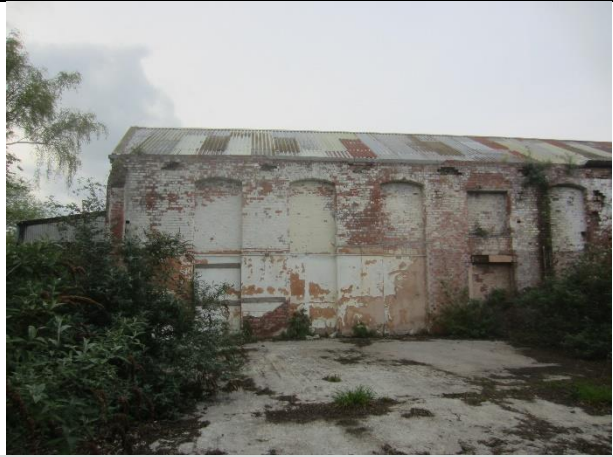
**Photo 20:** Southern elevation and roof of B4

- 3.1.16 Refer to **Photos 20 to 30**. B4 is a long narrow two storey brick building with a pitched corrugated sheets and felt covered roof. A dilapidated timber framed feature is located along the ridge.

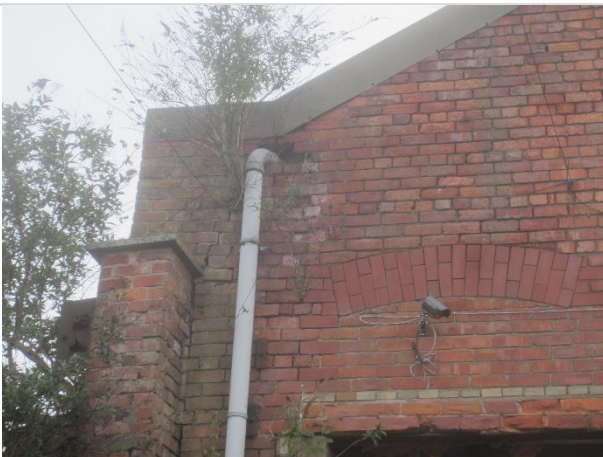
- 3.1.17 Features around the exterior with suitability for use by low numbers of bats were detected at the brick walls, particularly at the eastern elevation. Large loading entrances with metal shutters are present off the western and eastern elevations and small gaps were identified between the shutter and brickwork walls.

**Photo 23:** Cracks and gaps in brickwork at eastern elevation of B4

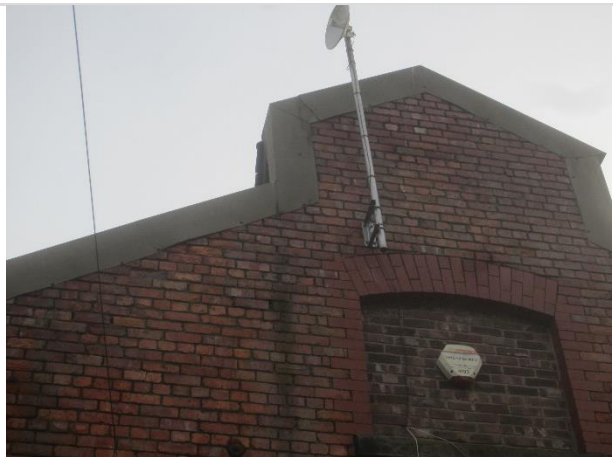
**Photo 24:** Gaps behind overlapping sheet cover at eastern elevation of B4

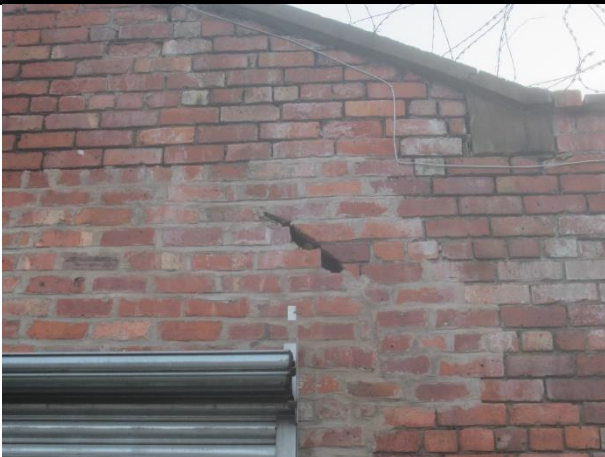
**Photo 25:** Holes in brickwork at eastern elevation of B4

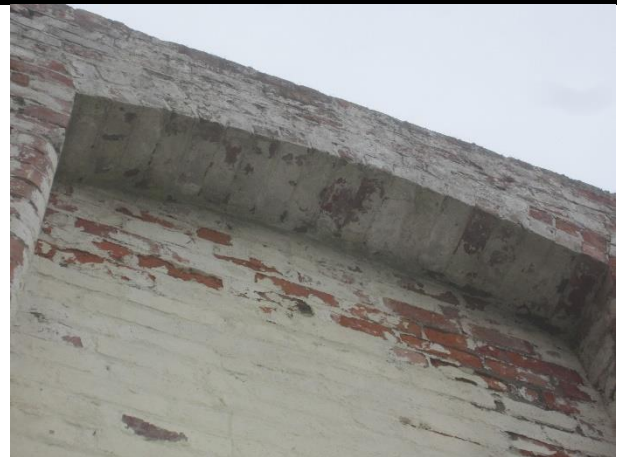
- 3.1.18 Examination of the underarch of the bricked up former window apertures at the southern elevation confirmed these features are sealed, however.

**Photo 26:** no gaps at bricked up window apertures / underrach at B4

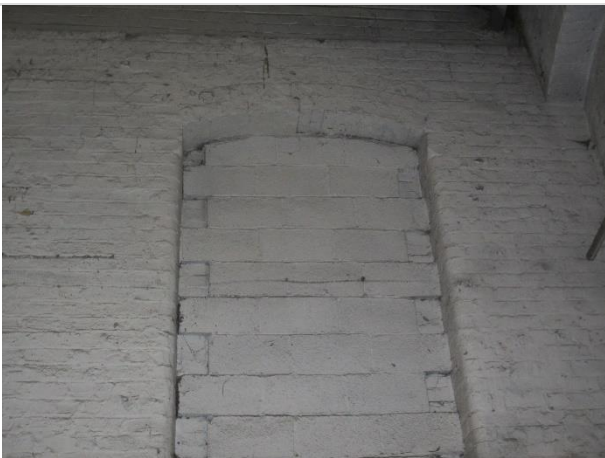
**Photo 27:** No bats or suitable gaps for bat access found around the blocked up doorway apertures

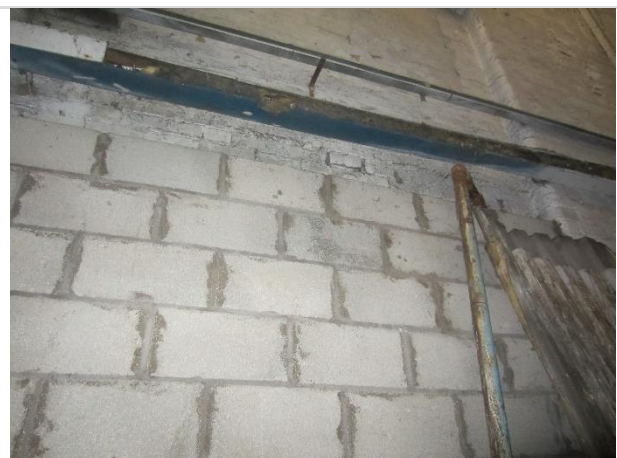
- 3.1.19 Sections of the interior of B4 are light inside due to the presence of skylights. The internal side of the walls are typically well mortared and where internal doorway apertures have been blocked with concrete blocks the walls have been well-mortared and no gaps are present at the top (which can provide a honeycomb of gaps which has been recorded to be use by roosting bats at other sites). No other gaps or features with suitability for bat access were detected.

**Photo 30:** Well-pointed walls in interior of B4

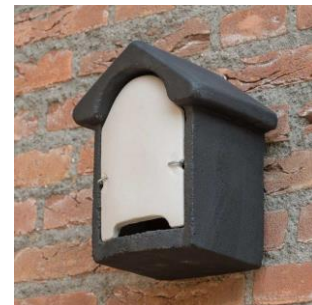
**Supplier:** Available from www.NHBS.com

**Installation:** To be installed beneath the eaves of the properties, as annotated (boxes on fences to be moved to buildings)

- 5.2.8 To ensure provisions for roosting bats are accommodated at the redeveloped site bat access panels will be installed at the new properties.
- 5.2.9 The specifications and detail of the above is provided at **Figure 3**, appended.
