## GeoEnvironmental Site Investigation

Kingsley Road

Northenden

**Report Ref: A3939/22**

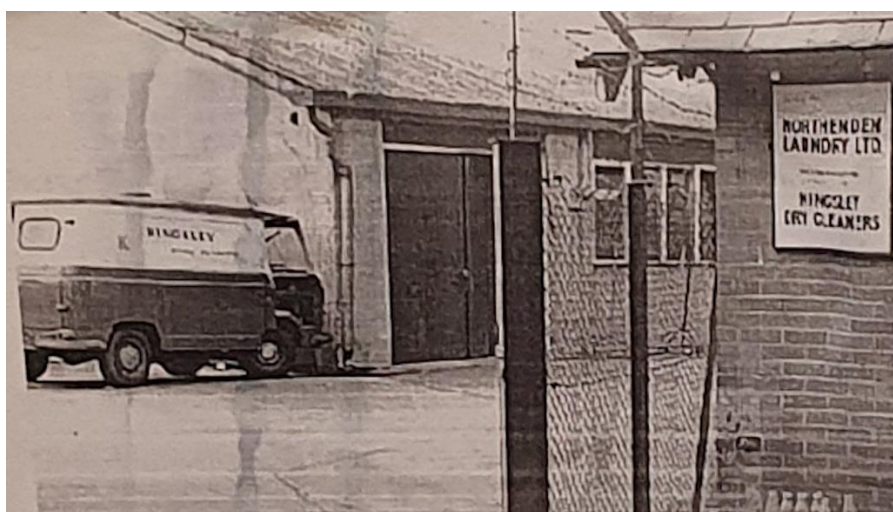
**Figure 1: Historical Photograph of Laundry**

Figure 1 shows a historical photograph of part of the former laundry.

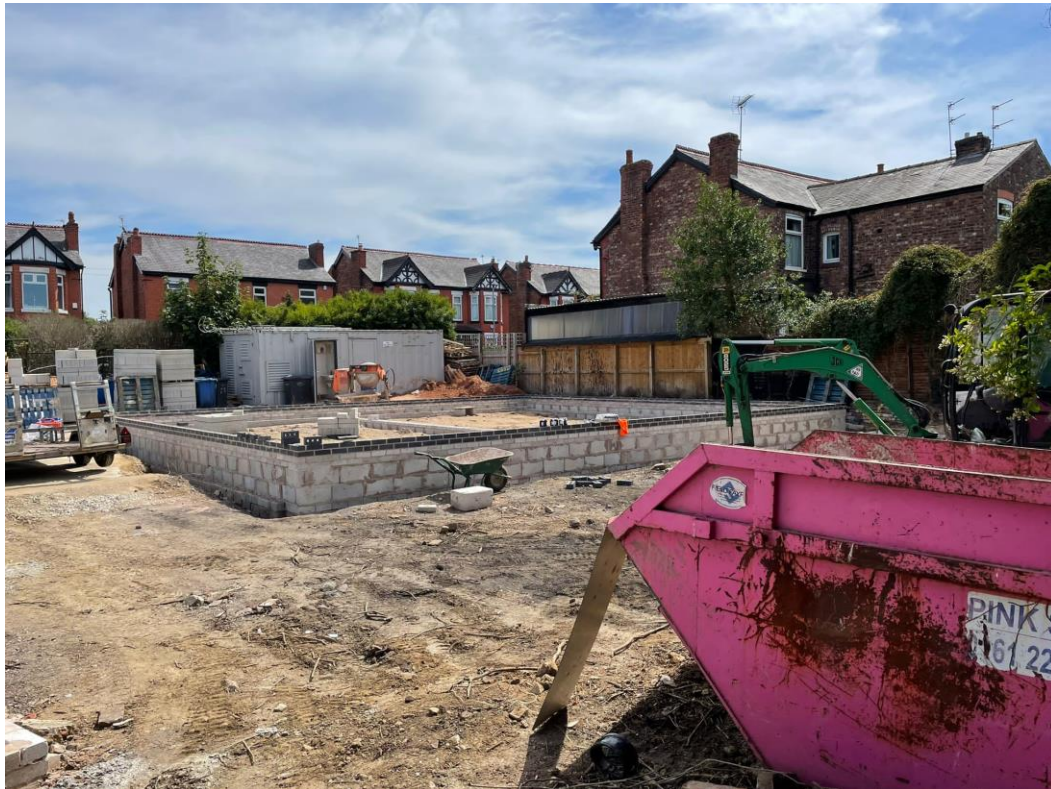
View facing southeast showing the site cabin and skip

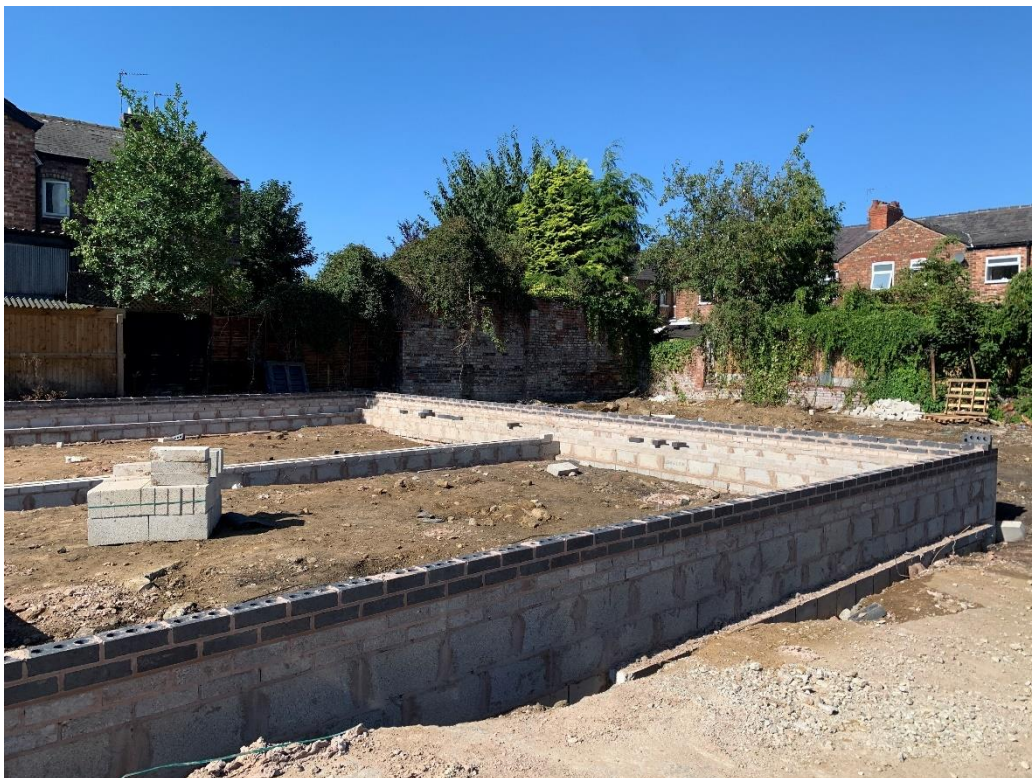
View facing southwest showing the new foundations and partially built walls

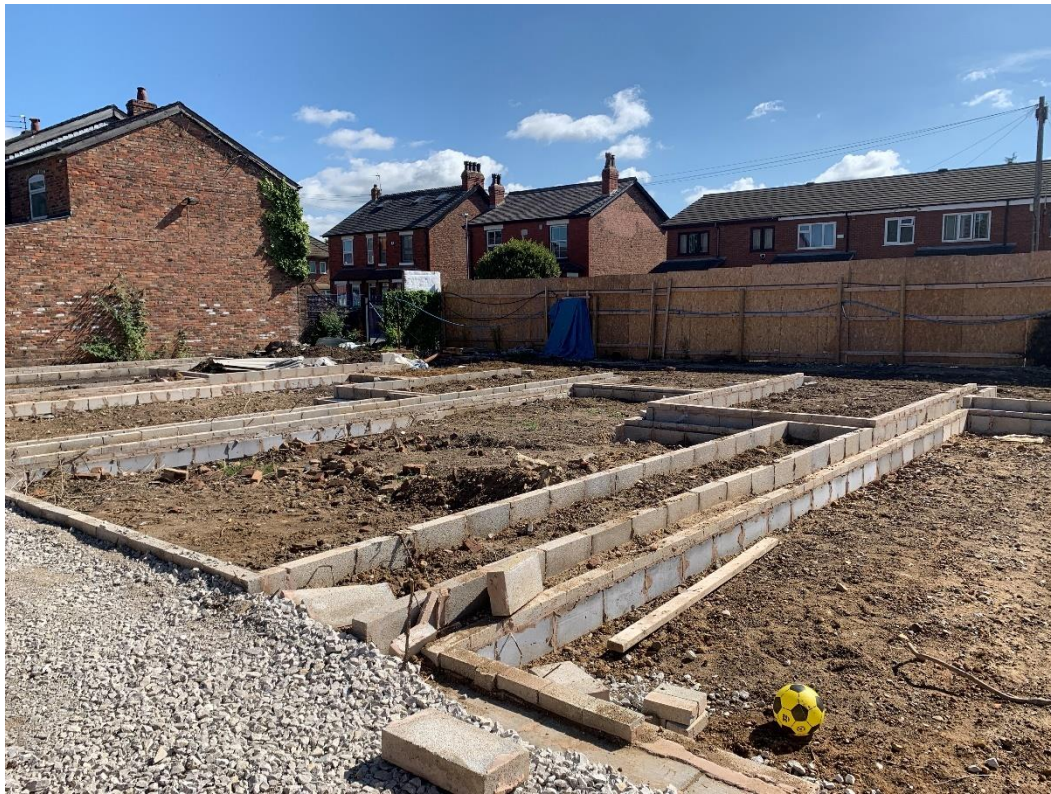
View facing northeast showing the hardcore and partially built buildings

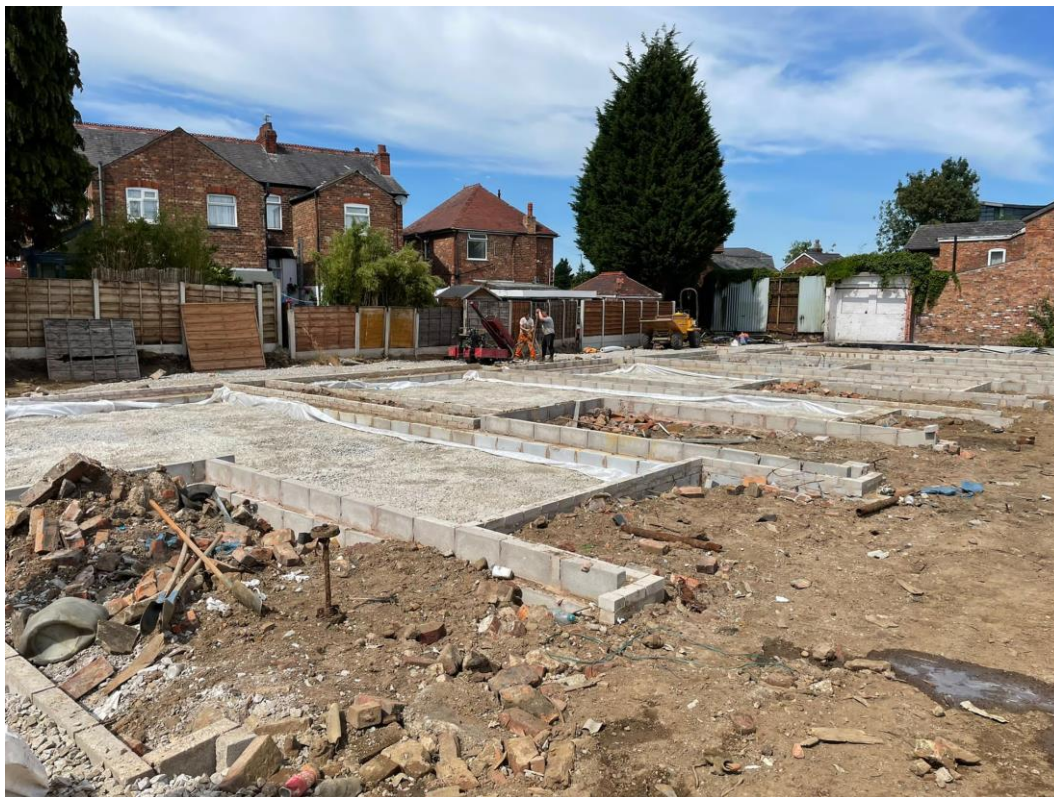
View facing northwest showing the partially built buildings and rubble

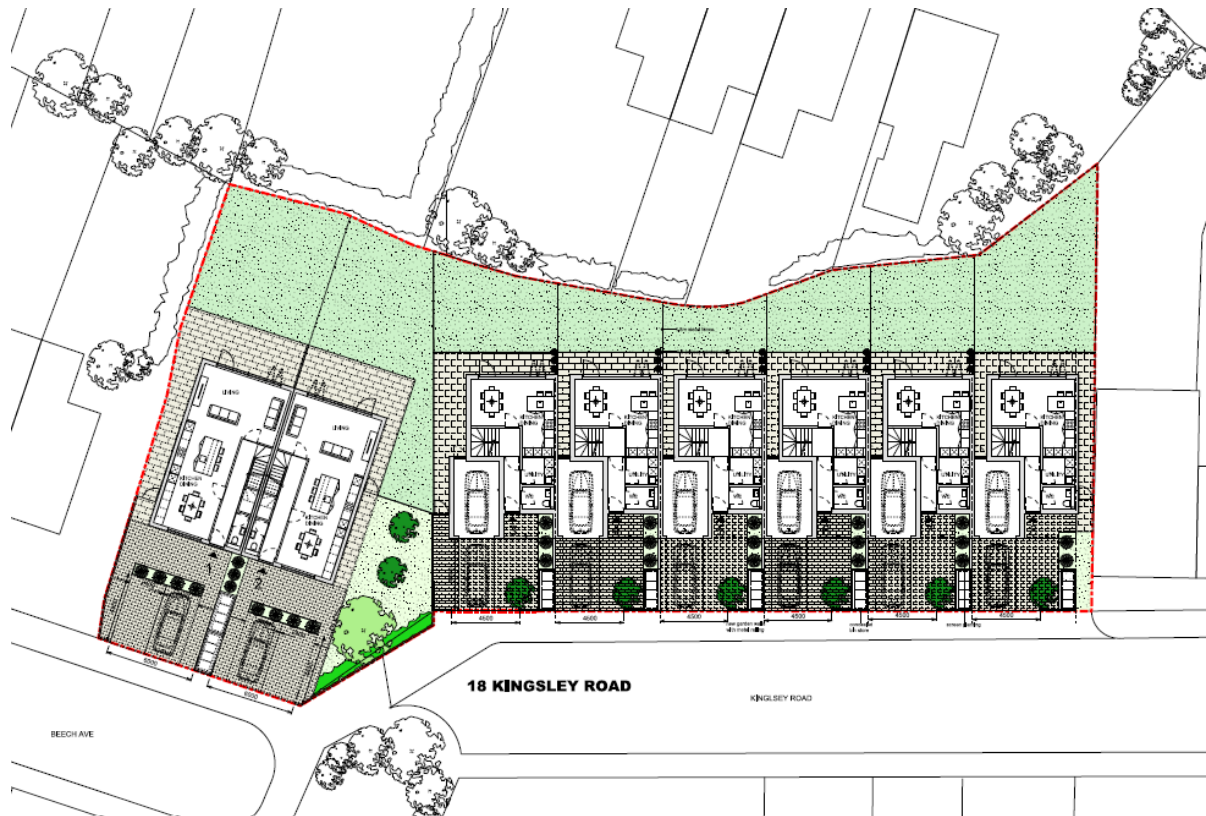
**Figure 4: Proposed Development Plan**

It is understood that the Client intends to build eight residential properties on site with associated soft landscaping and parking. Access will be provided via Kingsley Road and Beech Avenue.
