**FW: Great Ducie Street conditions - drainage- (application: CDN/22/0849)**

Please find attached a response in relation to the comments received in respect of the information submitted to discharge condition 23 (drainage) of the consent at Great Ducie Street ([application reference CDN/22/0849](#)).

Project  
**ONE VICTORIA MANCHESTER**

Great Ducie Street, Manchester,  
M3 1PJ

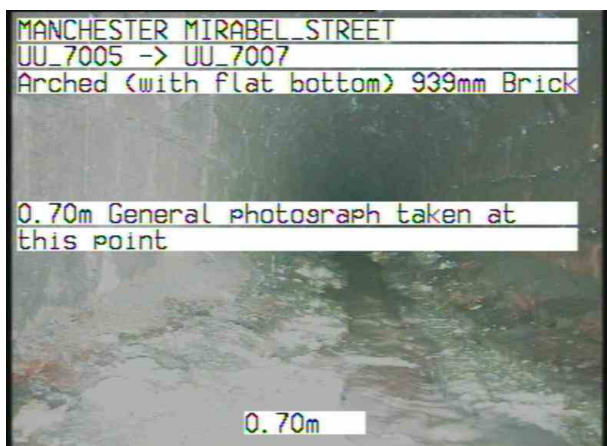
UU\_7005X\_7585bf66-69b0-4321-93a6-397dd534e942\_20220914\_100718\_603.jpg, 00:00:25, 0.70 m  
General photograph taken at this point

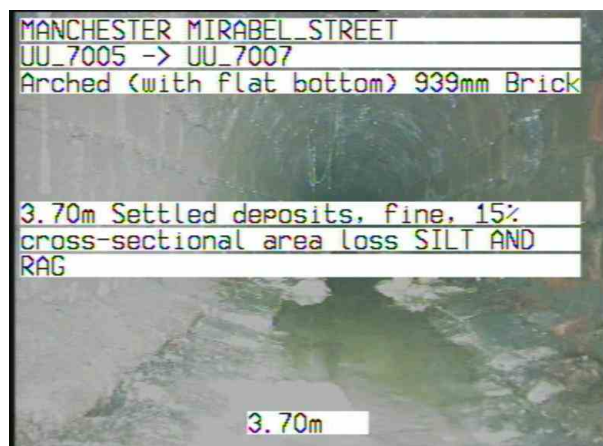
UU\_7005X\_5a572f83-b0e1-4d16-8fd0-bffd17460e10\_20220914\_100801\_731.jpg, 00:00:56, 3.70 m  
Settled deposits, fine, 15% cross-sectional area loss, SILT AND RAG

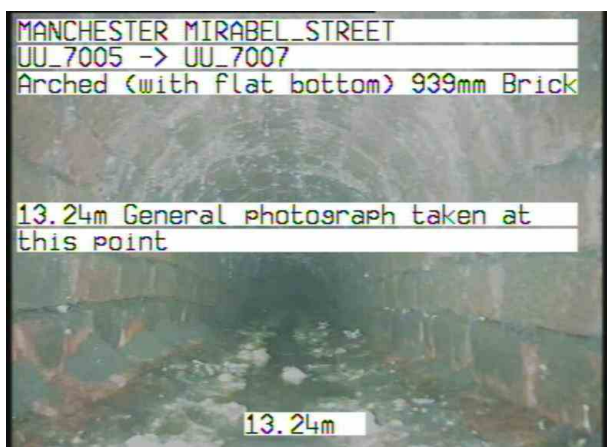
UU\_7005X\_abea3733-9ef6-459e-b6e6-561245bf003c\_20220914\_100930\_697.jpg, 00:02:23, 13.24 m  
General photograph taken at this point

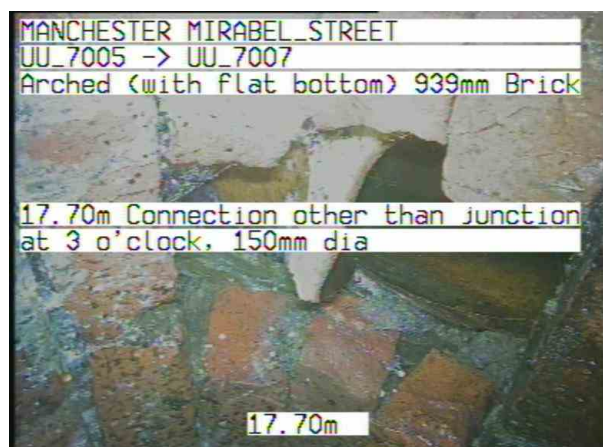
UU\_7005X\_4716ee5e-008a-40ef-99b1-78fa0c5b3197\_20220914\_101024\_287.jpg, 00:03:03, 17.70 m  
Connection other than junction at 3 o'clock, 150mm dia

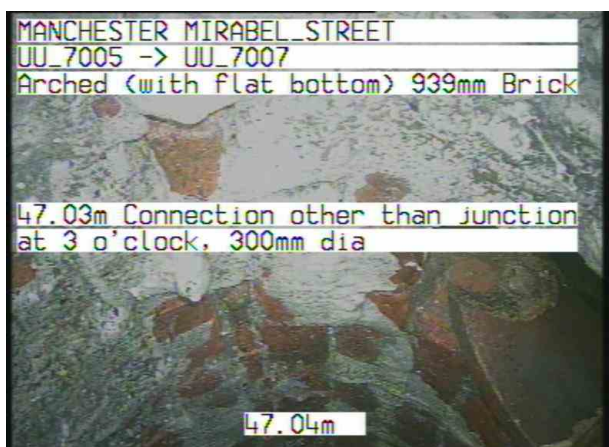
UU\_7005X\_37ba41dc-8feb-4ca2-810f-908c66b61ced\_20220914\_103110\_290.jpg, 00:07:25, 47.03 m  
Connection other than junction at 3 o'clock, 300mm dia

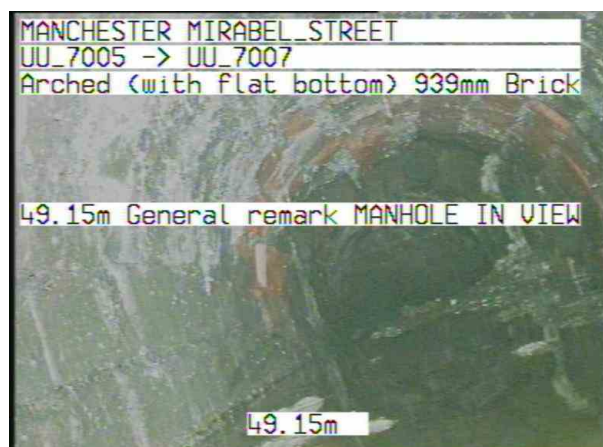
UU\_7005X\_b2acda02-03ab-403f-9812-f903a72371f7\_20220914\_103157\_784.jpg, 00:08:03, 49.15 m  
General remark, MANHOLE IN VIEW

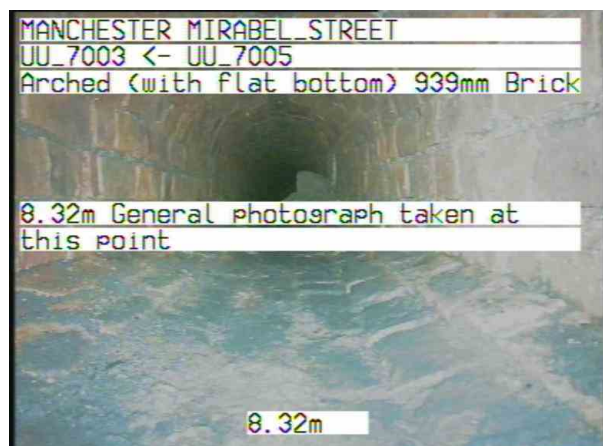
UU\_7003X\_4a89acd2-31d0-4228-878b-4576d76e746e\_20220914\_104958\_559.jpg, 00:01:42, 8.32 m  
General photograph taken at this point

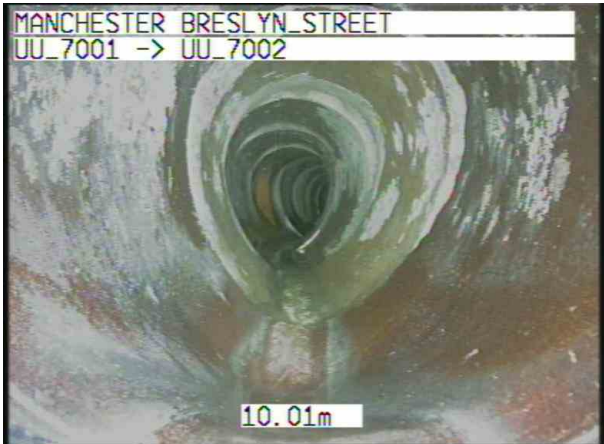
UU\_7001X\_204cf936-b952-4a7a-ba41-949c8656d6f7\_20220914\_112307\_282.jpg, 00:01:30, 10.01 m  
Shape changes to egg-shaped, new size(s), 300mm high, 150mm wide

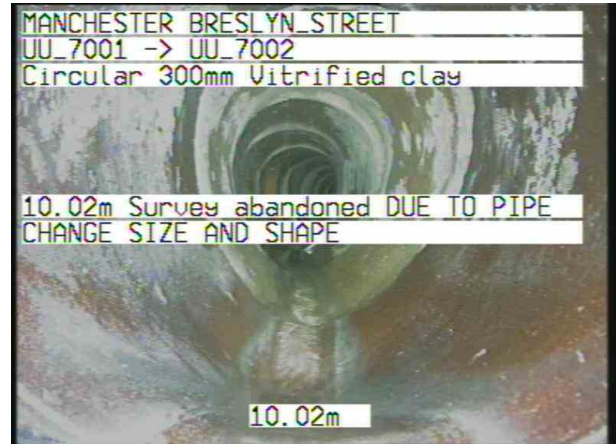
UU\_7001X\_f4b55c27-c717-4821-b113-a1d981659c8d\_20220914\_112323\_193.jpg, 00:01:37, 10.01 m  
Survey abandoned, DUE TO PIPE CHANGE SIZE AND SHAPE

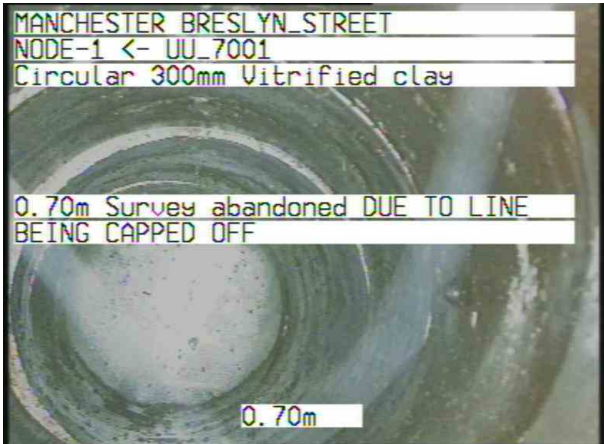
NODE-1X\_97b57d75-f901-41d1-b873-5ff2f4315293\_20220914\_112719\_075.jpg, 00:00:36, 0.70 m  
Survey abandoned, DUE TO LINE BEING CAPPED OFF
