Phase II Geoenvironmental Site Assessment  
Renaissance, Manchester

Reference: 14-261-R2-1  
Date: 21<sup>st</sup> May 2021

Renaissance  
Deansgate  
Manchester  
M3 2FE

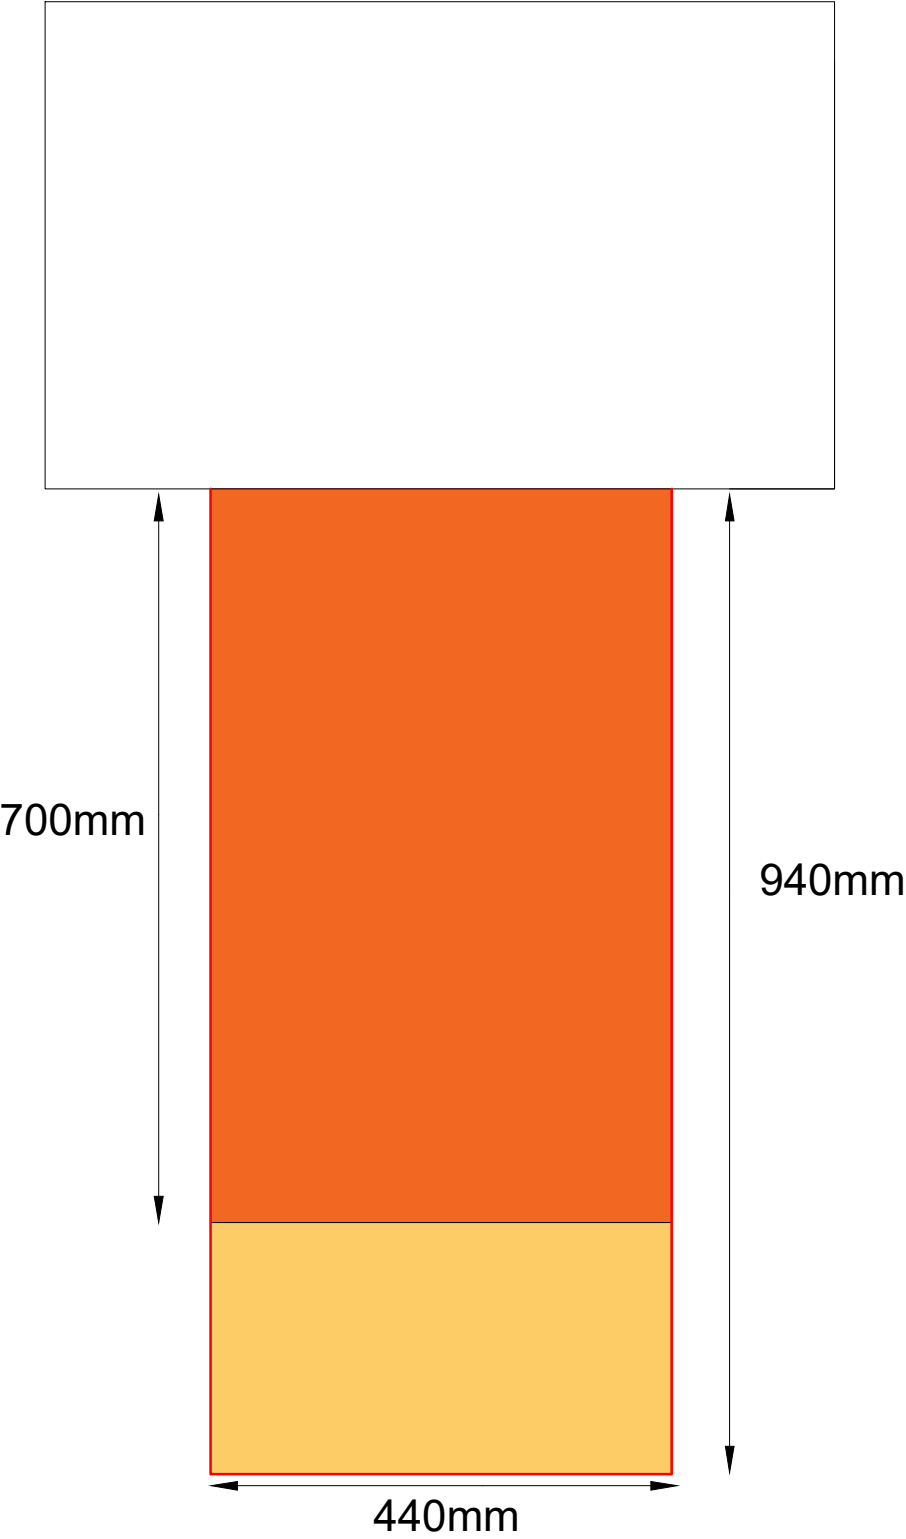
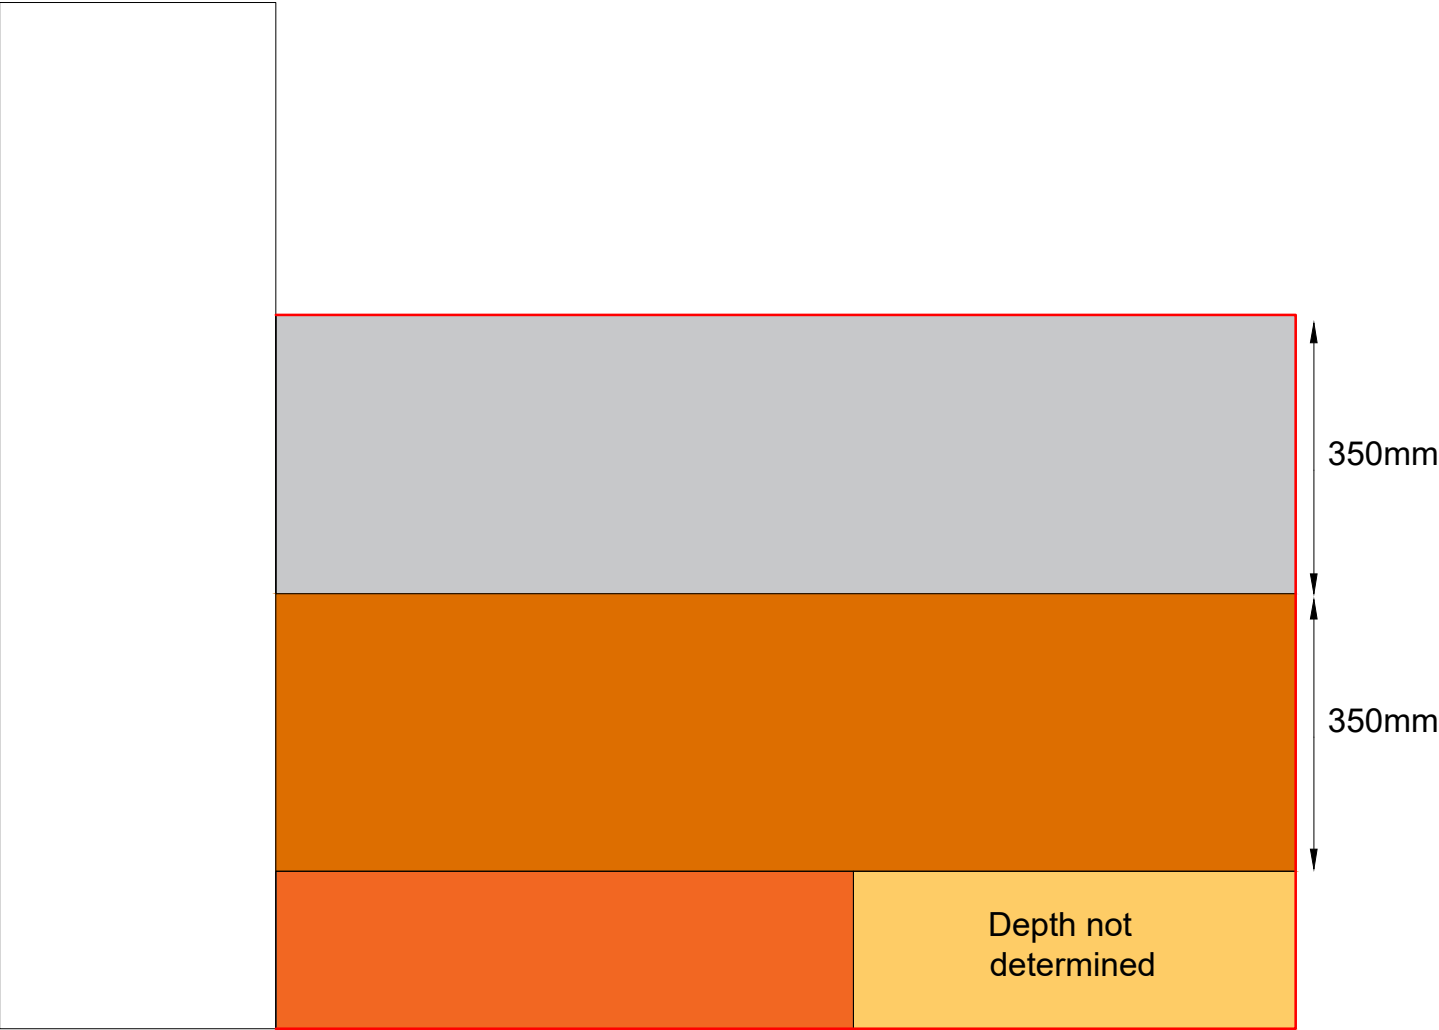
Foundation Pit Details

- Concrete Pillar
- Foundation Slab
- Concrete
- Sandstone
- Made Ground - Brown Gravelly Sand.  
Site won natural backfill
- Rubber Membrane
- Trial Pit

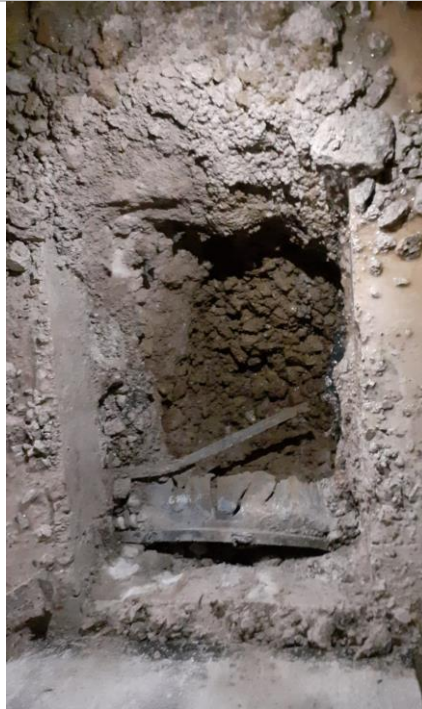
PLATE 1 TP103 EXCAVATION

TP101, TP103 and TP104 identified the foundation slab within the SANDSTONE from 700 mm, the full depth was not determined.

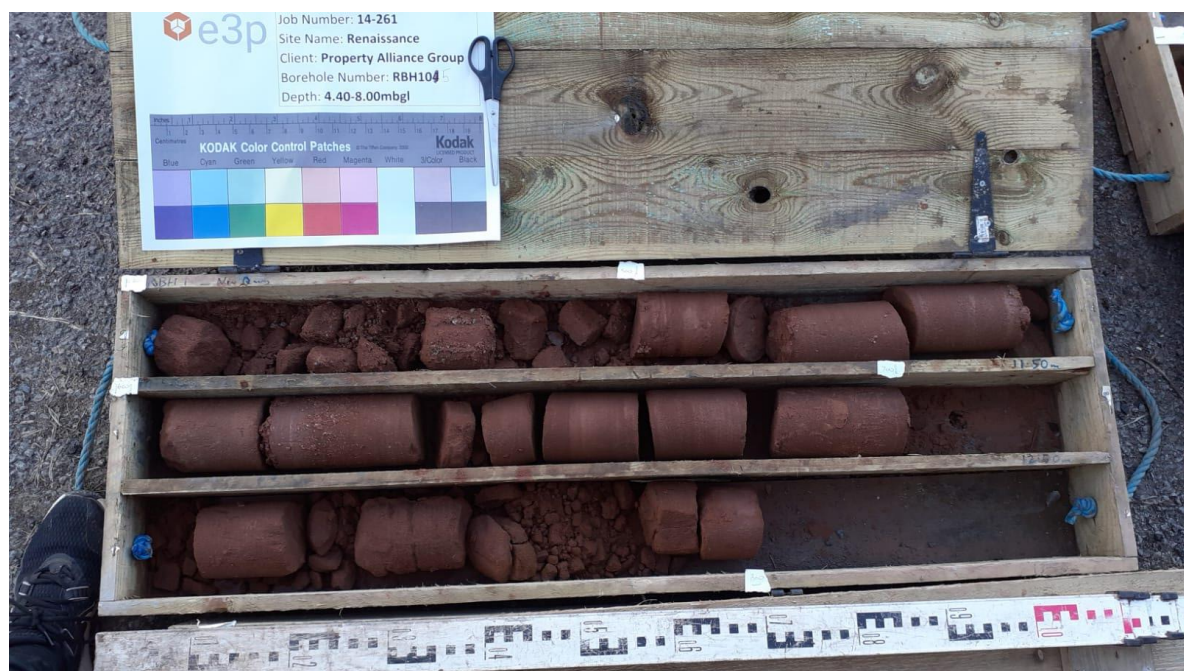
PLATE 6 RBH106 ROCK CORE (4.40 – 8.00 m bgl)

Due to the highly fractured nature of the bedrock, only one Unconfined Compressive Strength (UCS) test could be undertaken from the core recovered. The results indicate that at a depth of between 6.63–6.98 m bgl the sandstone recorded a strength of 3.3 (MPa) which equates to 3300 kN/m<sup>2</sup>.

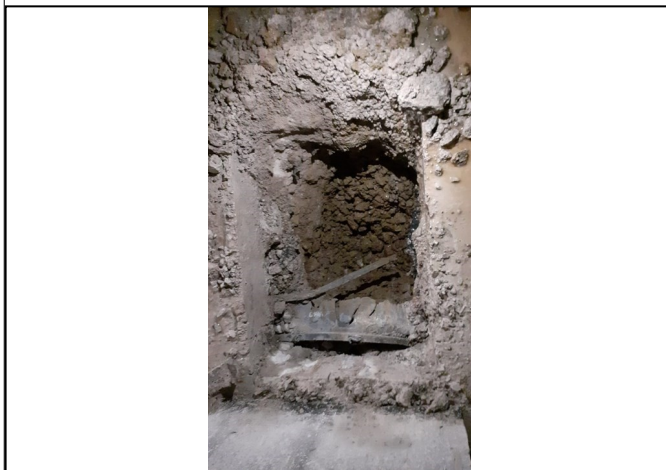
TP103

Remarks: 1. Foundation pad observed at 0.70m bgl 2. Foundation pad 0.70m in length from supporting pillar 3. Depth of pad could not be determined
