VALLEY GUTTER: EXISTING TYPICAL DETAIL OVER VALLEY BEAM 1:5 @ A1 / 1:10 @ A3

| BASED ON MEASURED SURVEY BY "SITECH SURVEYING SERVICES" | | | | |
|---|---|---|---|---|
| JOB TITLE<br>Essential Repairs, 1830 Warehouse<br>Science & Industry museum M3 4FP | JOB NO.<br>275 | DRWG. TITLE<br>Valley Gutter: Existing typical<br>detail over Valley Beam | STATUS<br>Planning | |
| | | DRWG. NO.<br>275 / PD / 121<br>(A1 ORIGINAL FORMAT) | REV: | SCALE:<br>1:5@A1<br>1:10@A3 |

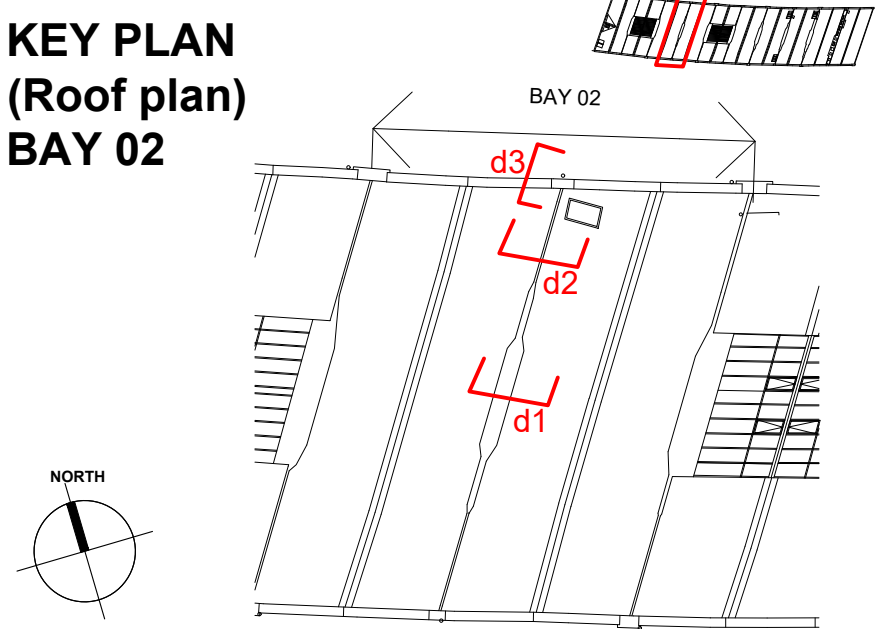
MC to survey existing roof and to carefully remove and salvage for re-use existing slate tiles and to remove existing leadwork and substrate to enable new valley gutter installation as per SDA Drwg Nos. 275/PD/320-322
