# Manchester Art Gallery

Heritage Impact Assessment  
February 2023

Project name: Manchester Art Gallery  
Project number: 9518  
Client: Manchester City Council

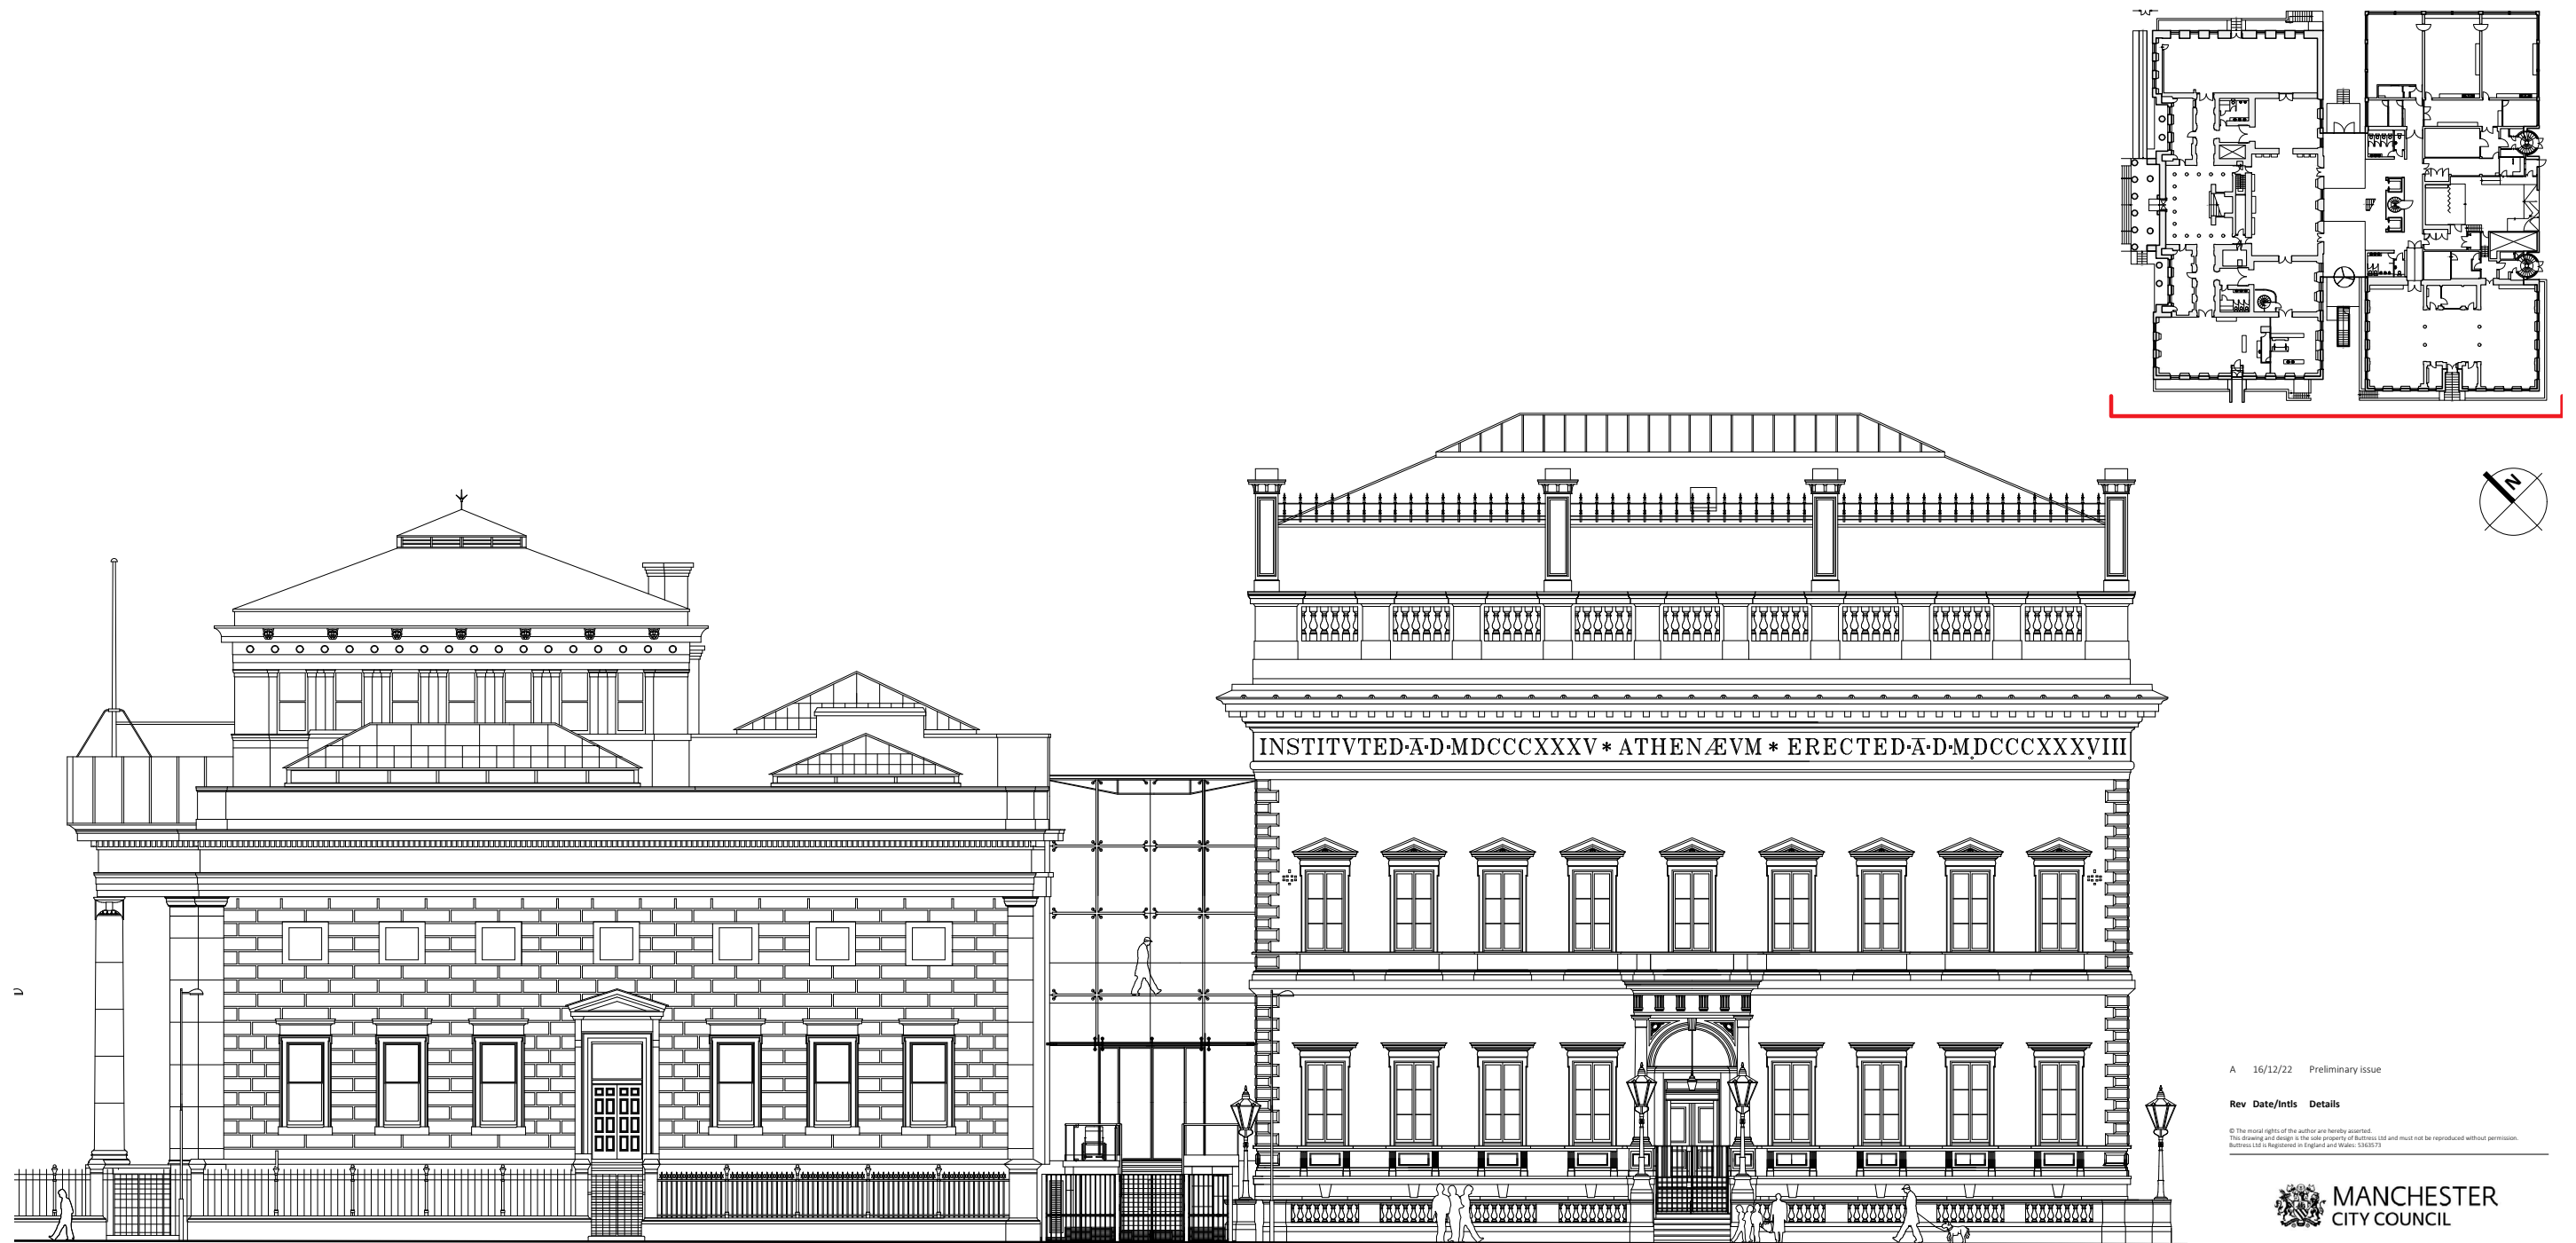
Figure 2 Princess Street Elevation

**Drawing Title** Existing Elevations  
Princess Street Elevation
