**REMEDIATION METHOD STATEMENT  
ANCOATS MOBILITY HUB  
POLAND STREET, ANCOATS  
BOWMER AND KIRKLAND  
RMS-20376-22-276REVB  
MAY 2023**

REMEDICATION METHOD STATEMENT  
ANCOATS MOBILITY HUB  
POLAND STREET, ANCOATS  
BOWMER AND KIRKLAND  
RMS-20376-22-276REVB  
MAY 2023

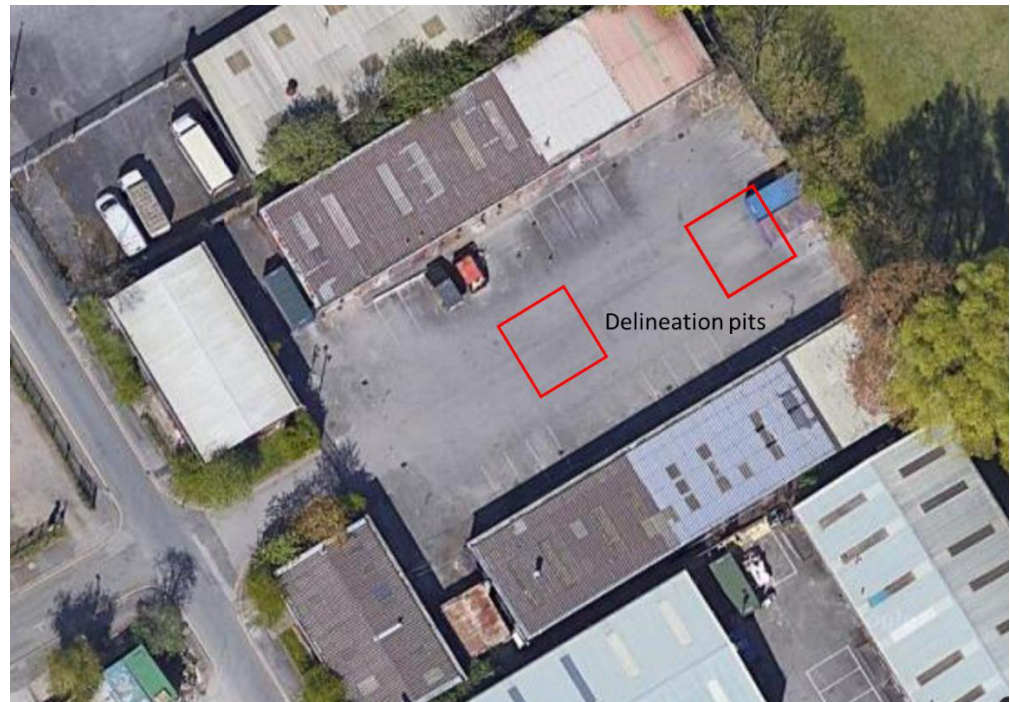
- 2.5 **CONTAMINATION HOTSPOT DELINEATION AND EXCAVATION APRIL 2023**
- 2.5.1 On 11 April 2023, an IDOM engineer revisited the site to supervise the excavation of the "hotspot" areas for the removal of contaminated materials. The areas of these hotspots were marked out by an engineer prior to excavation. The excavation process involved digging a pit in a 4 m by 4 m square at each location to a depth of 0.5 m bgl, ensuring the removal of all contaminated material. The locations of the delineation pits excavated are illustrated in the figure below.

- 2.5.2 Samples of the made ground were collected from the contaminated areas and from four surrounding points and submitted for laboratory analysis.

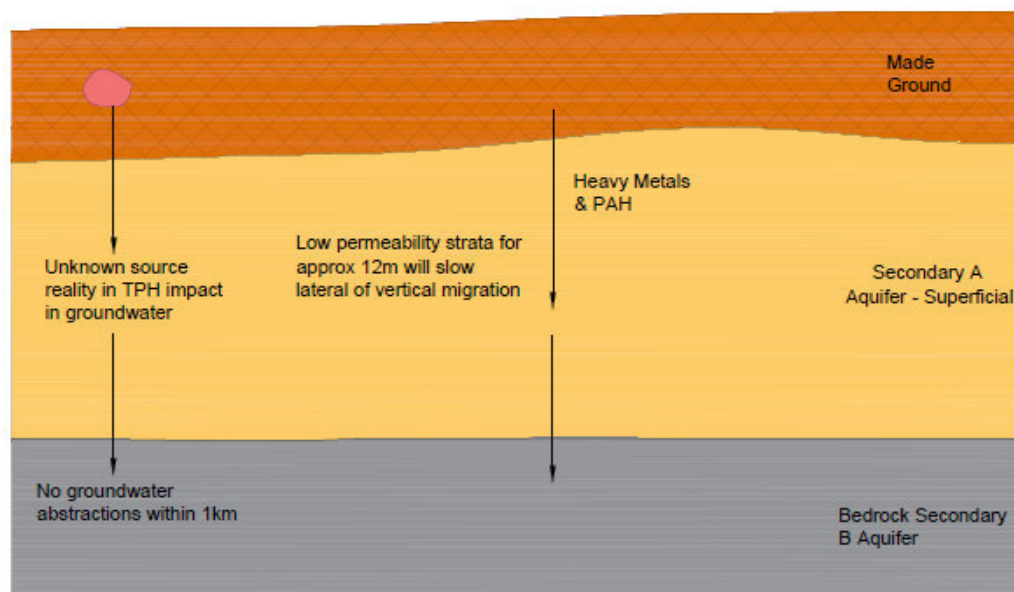
FIGURE 4.1 DIAGRAMMATIC CONCEPTUAL SITE MODEL (CONTROLLED WATERS)

To ensure a robust appraisal of the identified risk to controlled waters, E3P has identified the sources of potential contamination that represent a risk to controlled waters from the initial CSM, we have then assessed the availability of ground investigation data in the form of analysis of the solid phase (soil) and dissolved phase within the perched groundwater or aquifer. The results of this assessment are presented in Table 4.3.

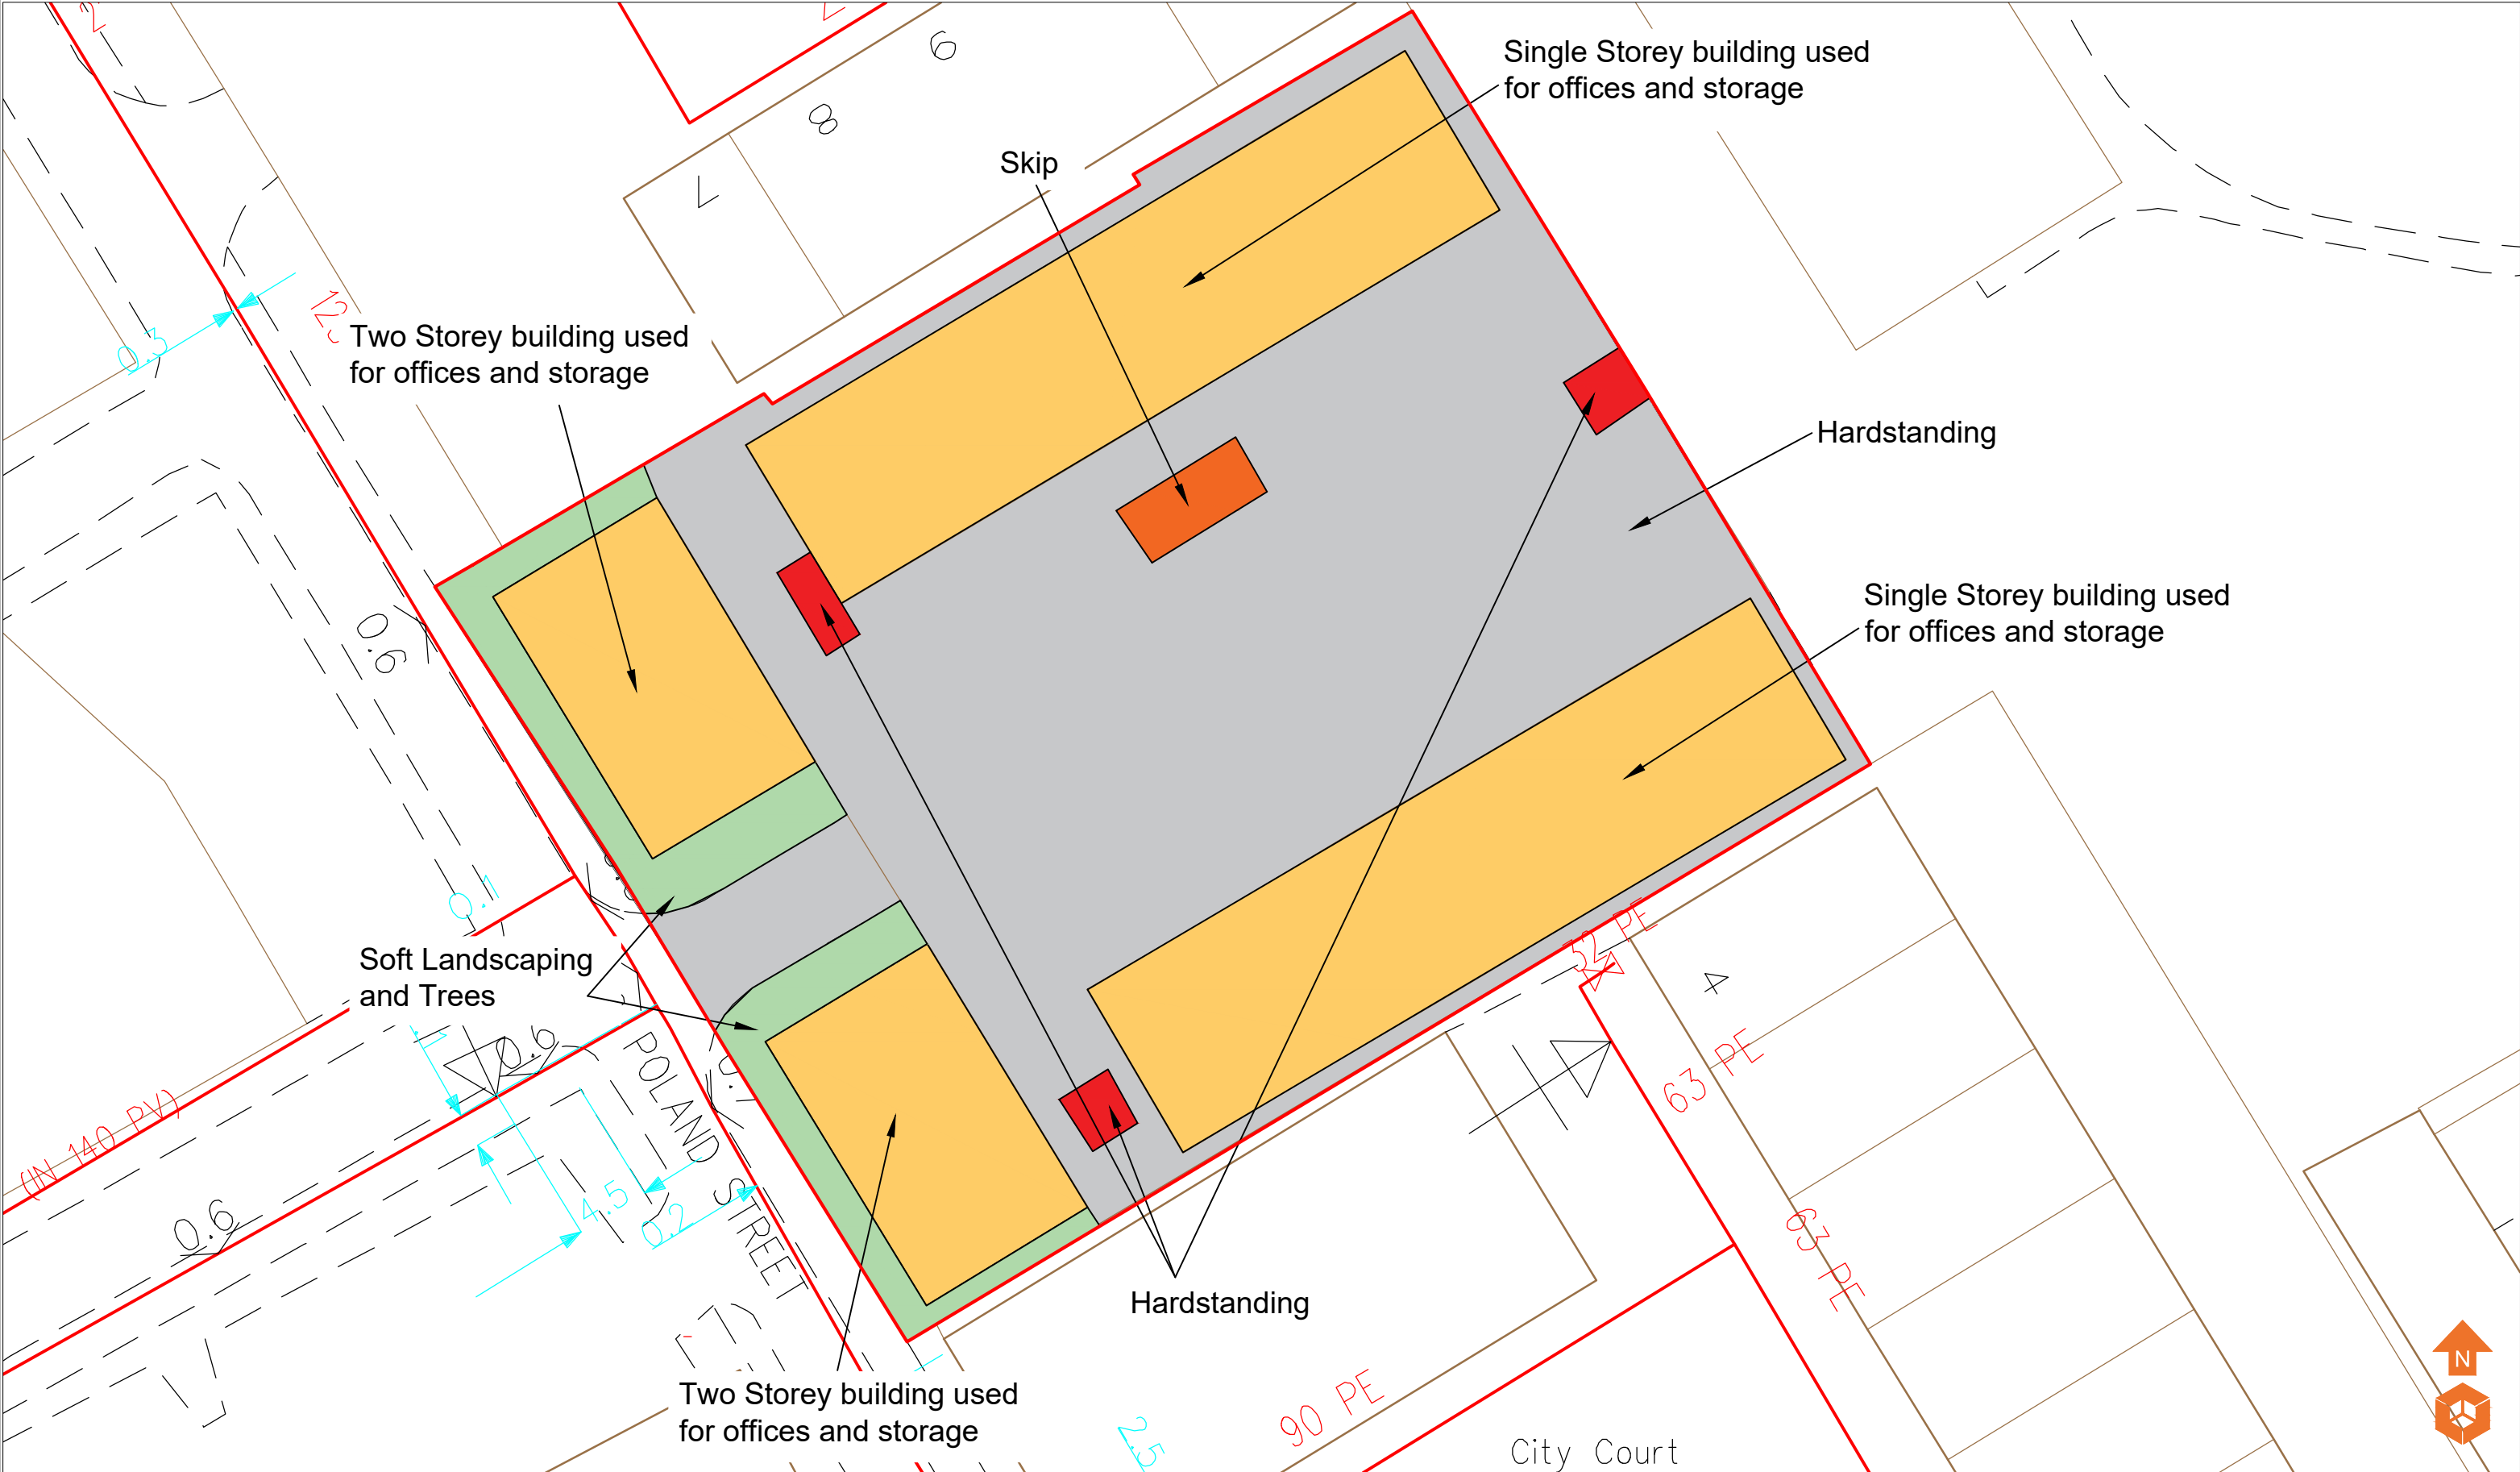
| | <div><div><div>P1</div><div>REVA</div><div>08.04.2021</div><div>LM</div><div>SE</div></div><div><div>Phase</div><div>Issue</div><div>Date</div><div>Drawn</div><div>Checked</div></div></div> | | | | | <div>Job Title:</div> <div>Ancoats MSCP</div> | | <div>Drawing Title:</div> <div>Site Features Plan</div> | | |

- 2.1.3 The site is a rectangular shaped parcel of land currently occupied by twelve, two-storey brick and metal clad structures surrounding a central hardstanding carpark. Three storage containers and two skips are also noted to be present on site.

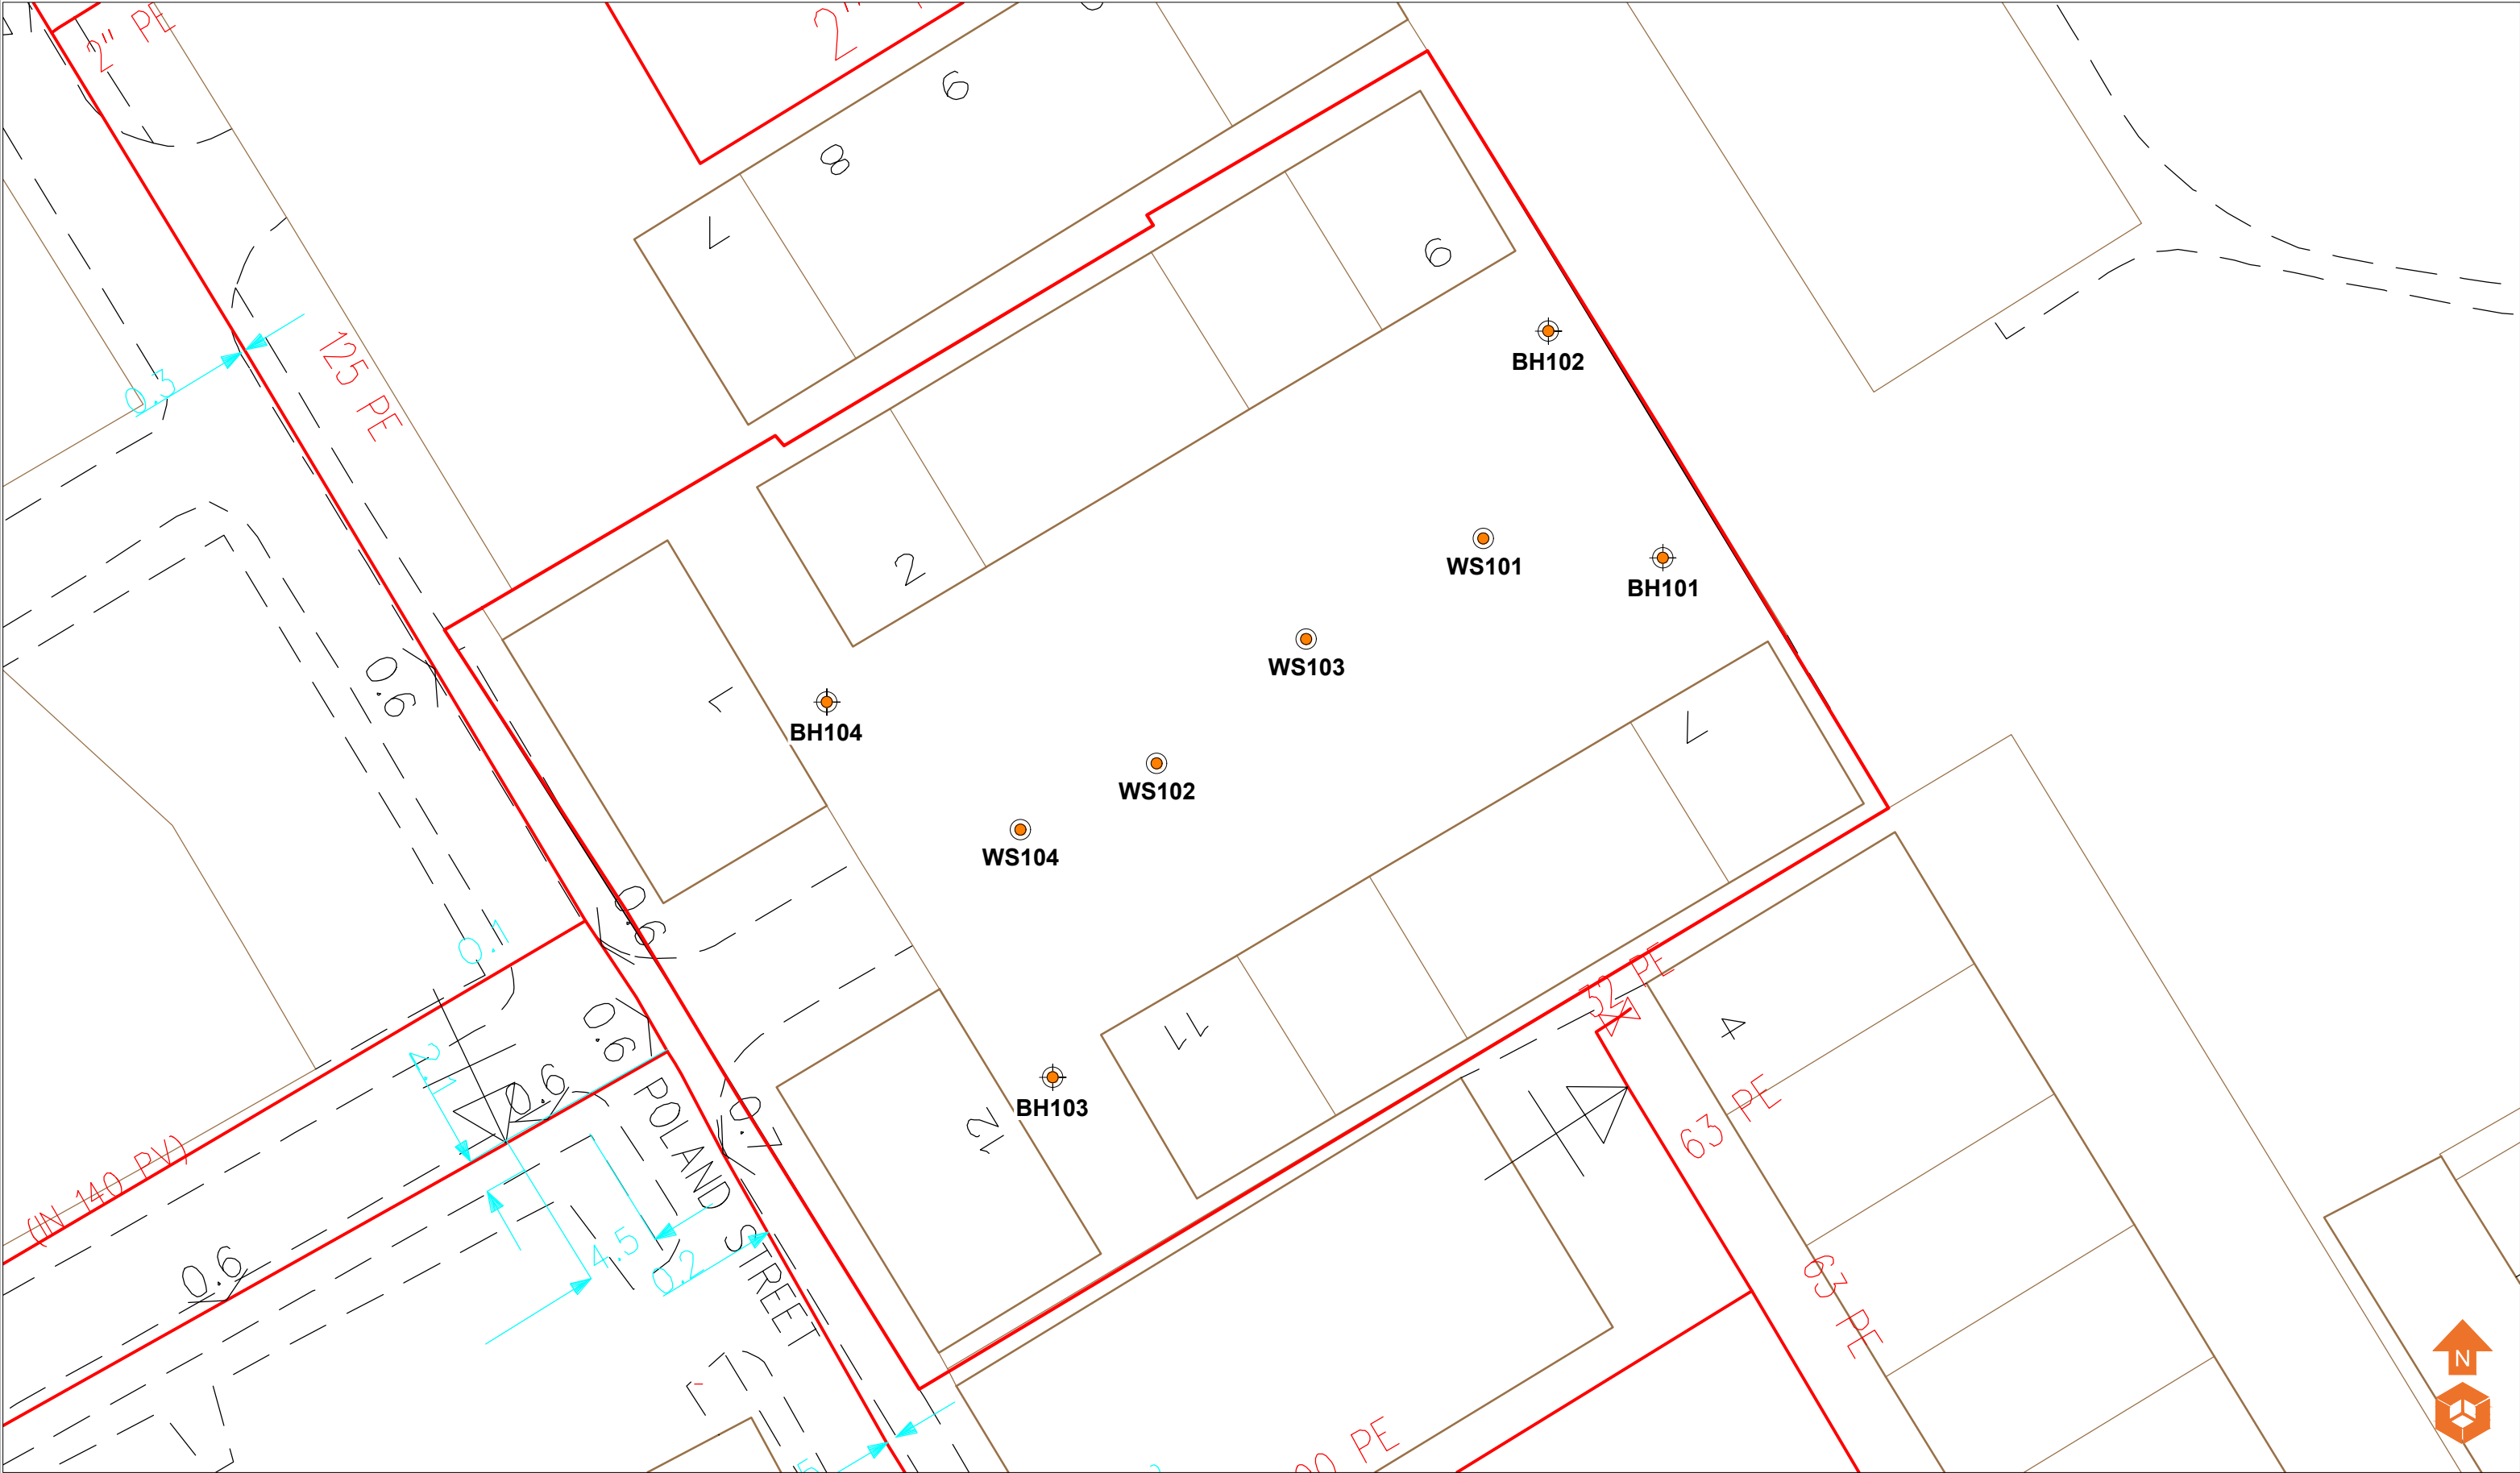
| | <div>P1</div> <div>Phase</div> | <div>REVA</div> <div>Issue</div> | <div>13.07.2021</div> <div>Date</div> | <div>LM</div> <div>Drawn</div> | <div>SE</div> <div>Checked</div> | <div>Drawing Title:</div> <div>Exploratory Hole Location Plan</div> | <div>The client must not amend any drawing, design or other intellectual property produced by E3P Ltd without permission in writing from E3P Ltd in advance of any amendments being made. In the event that such written permission is not obtained in advance of the amendments being made, E3P Ltd shall not be liable for any damage and/or losses occurring as a result of the amended drawing, design or intellectual property.</div> | | |

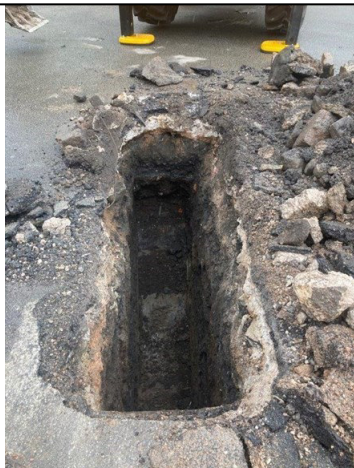
TP101

Remarks: 1. Complete. 2. Slight hydrocarbon odour between 0.40-1.30m bgl. 3. Breaking hard standing out, 10 mins.

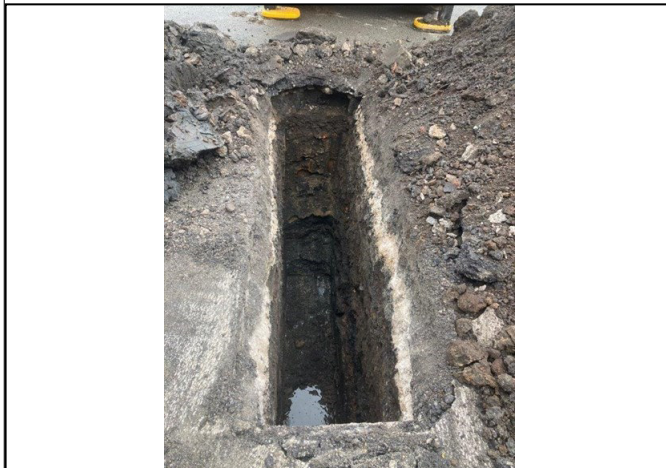
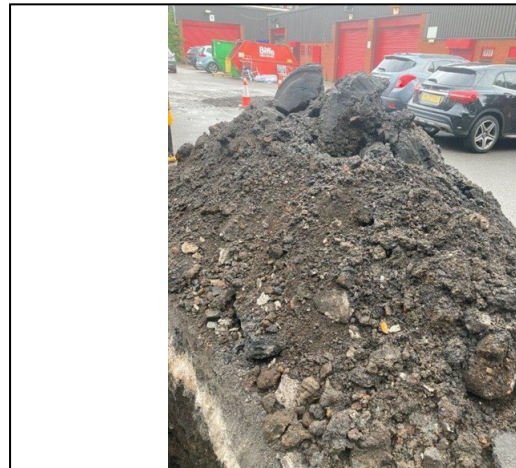
TP102

Remarks: 1. Complete. 2. Slight hydrocarbon odour between 0.45-1.90m bgl. 3. Water strike encountered at 2.00m bgl on the clay with a slow ingress. 3. Breaking hard standing out, 10 mins.

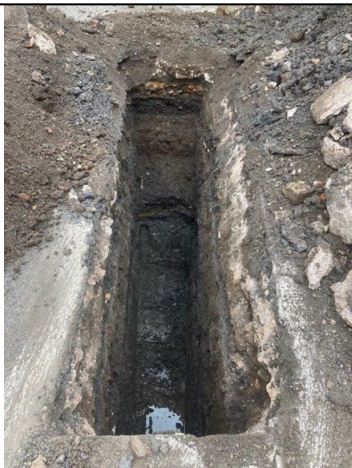
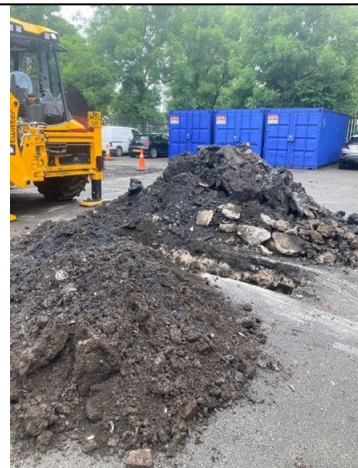
TP103

Remarks: 1. Complete. 2. Breaking hard standing out, 10 mins.

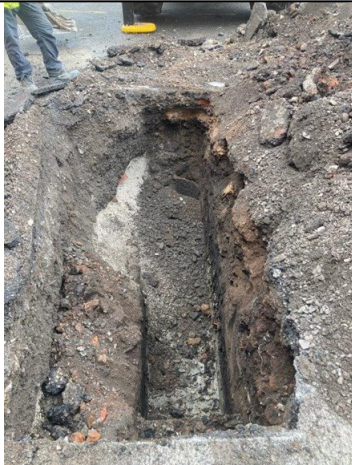
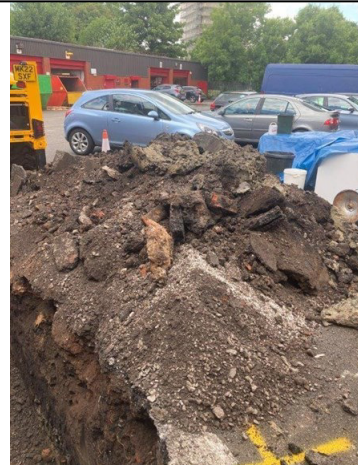
TP104

Remarks: 1. Terminated due to instability. 2. Gravel indicative of service identified at 0.65m bgl, trial pit moved 0.50m away to continue dig. 3. Breaking hard standing out, 10 mins.

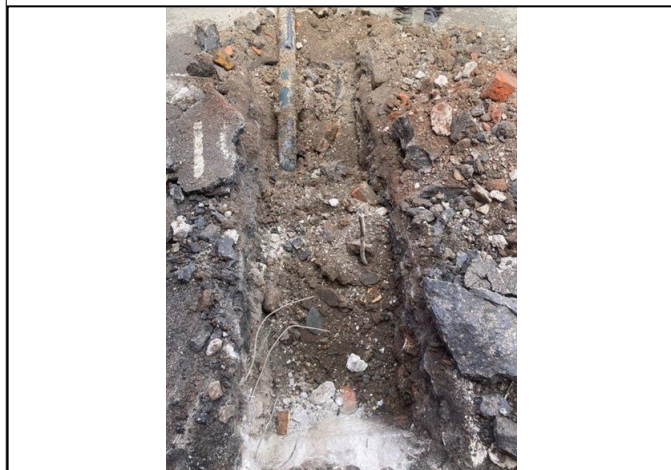
TP105

Remarks: 1. Terminated due to redundant services at 0.65m bgl. 2. Possible water pipe 1.30m long and 10cm diameter. 3. Breaking hard standing out, 10 mins.
