# Phase 2 Site Investigation Report New Music Block, Martin Harris Centre for Music and Drama, University of Manchester

## Prepared for University of Manchester

**10/2084/002 Rev. 00**

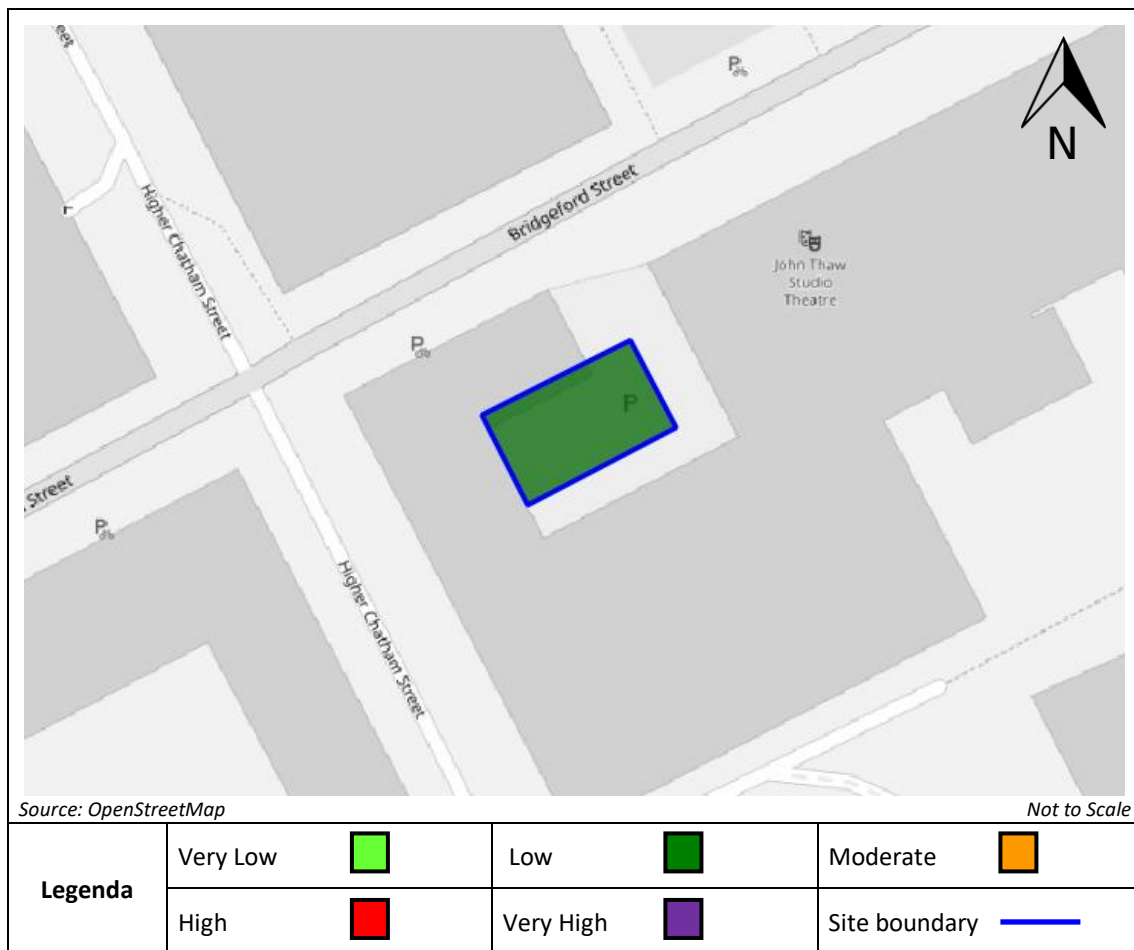
### UXO hazard zone plan of the Site

The UXO hazard zone plan of the Site is also given in the accompanying P11803-22-R1-MAP01-A.

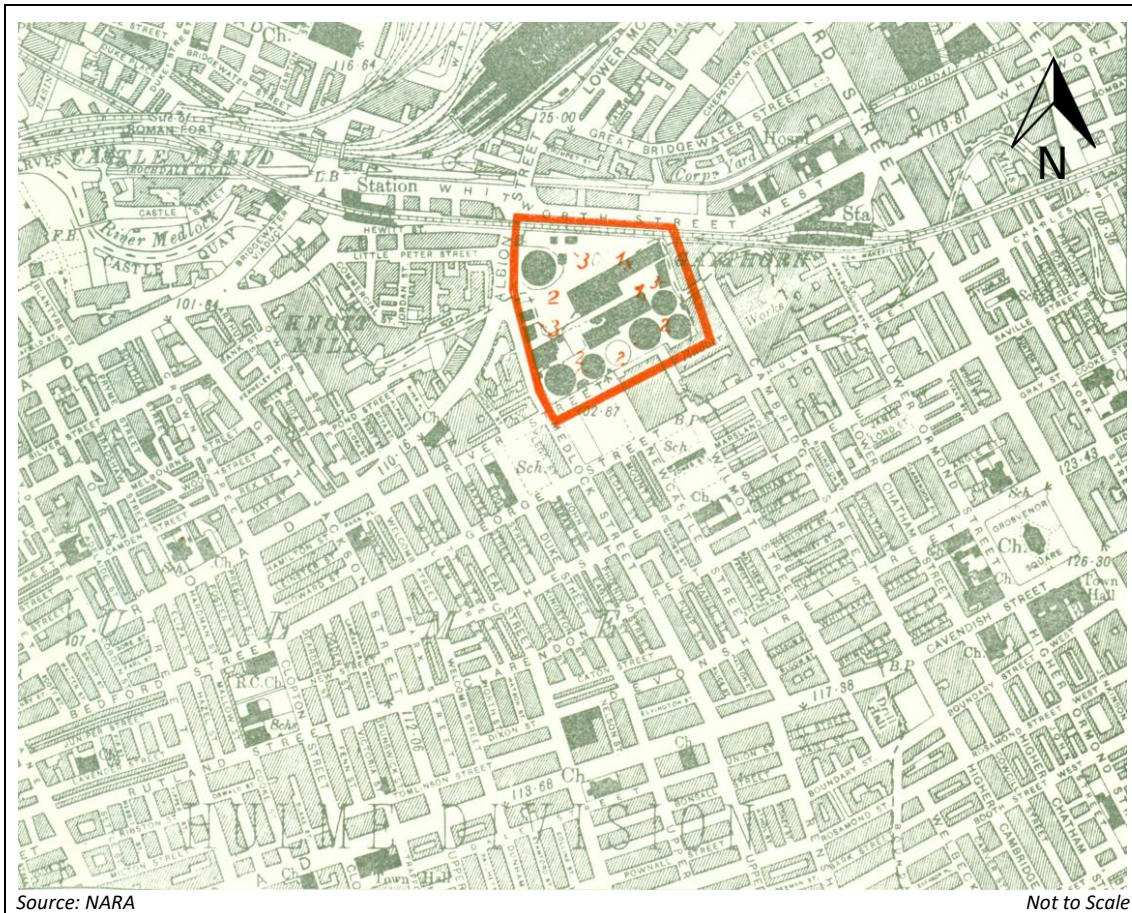
**Figure 2 Luftwaffe target plan of Manchester Gasworks, 1939**

Figure 2 is a Luftwaffe target plan of Manchester Gasworks, approximately 1km northwest of the Site, dating from October 1939. It identifies the gasworks, coke furnaces (1), gasholders (2), and office buildings (3).

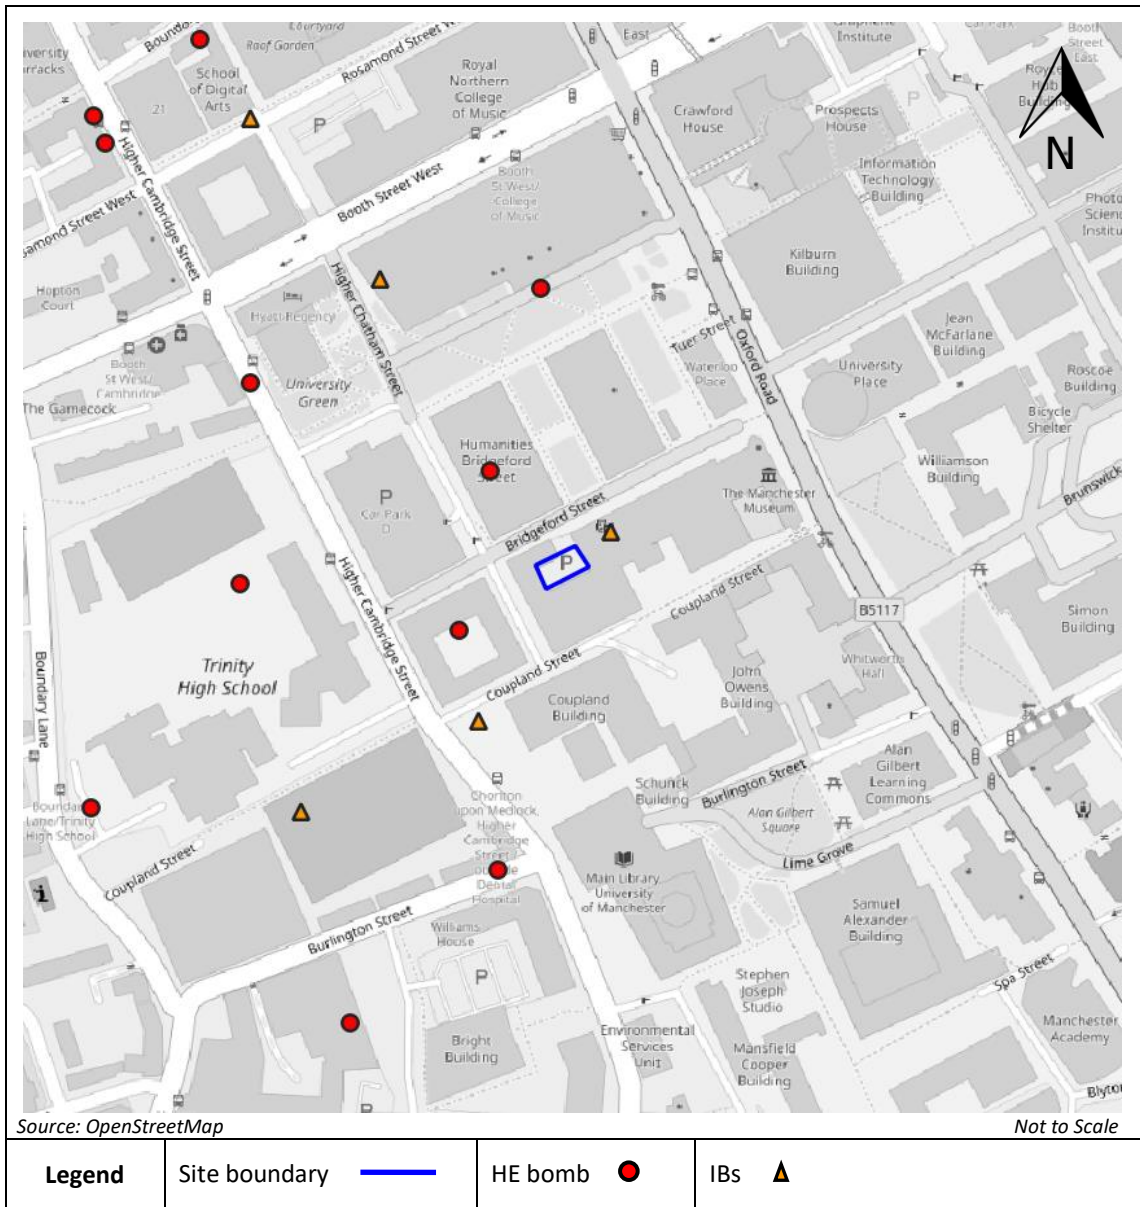
Figure 3 Compiled bomb impact map for the vicinity of the Site

The bomb map is also given in the accompanying P11803-22-R1-MAP01-A.

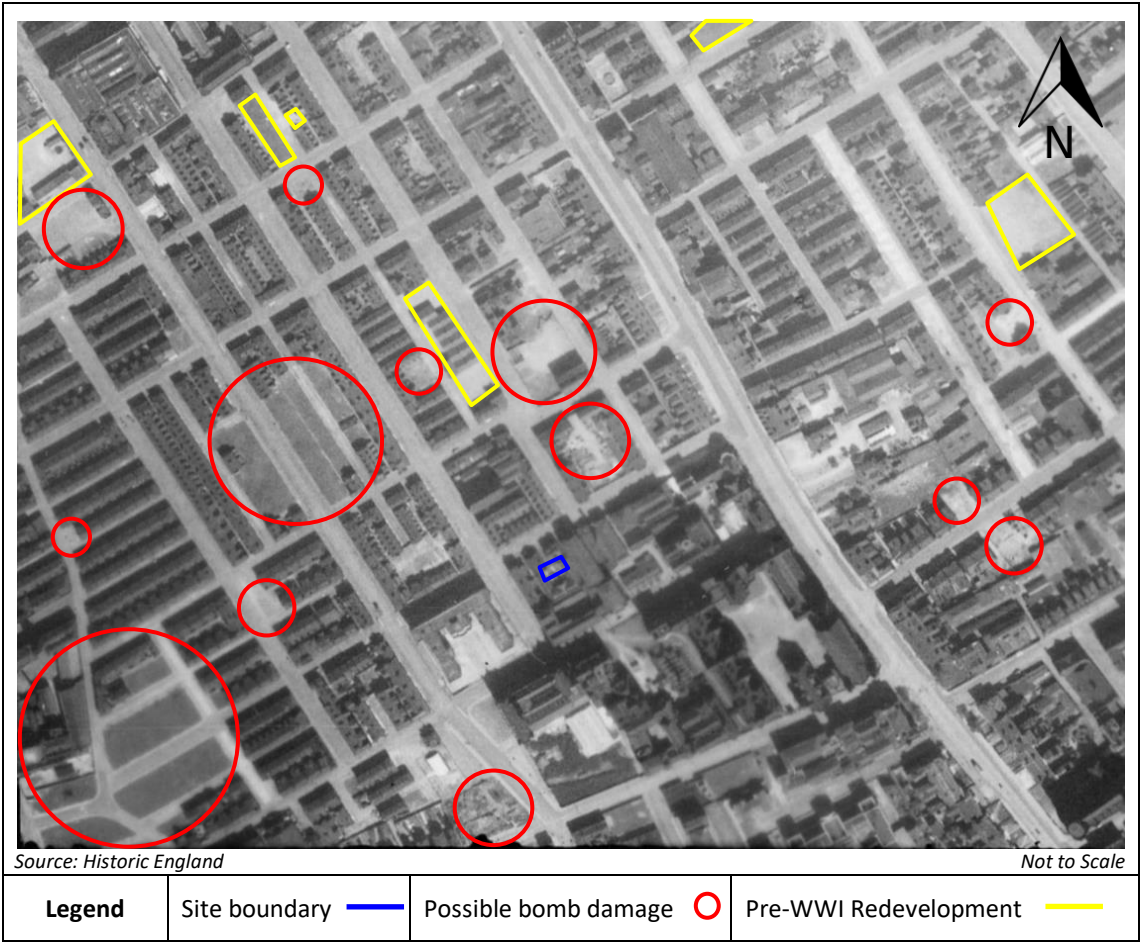
Plate 2 Aerial photograph, 16<sup>th</sup> May 1948

Plate 2 is an aerial photograph dated the 16<sup>th</sup> May 1948. No bomb damage has been identified on the Site.

Some areas of bomb damage have been identified in the vicinity of the Site. Some of these are likely the result of pre-WWII slum clearance.

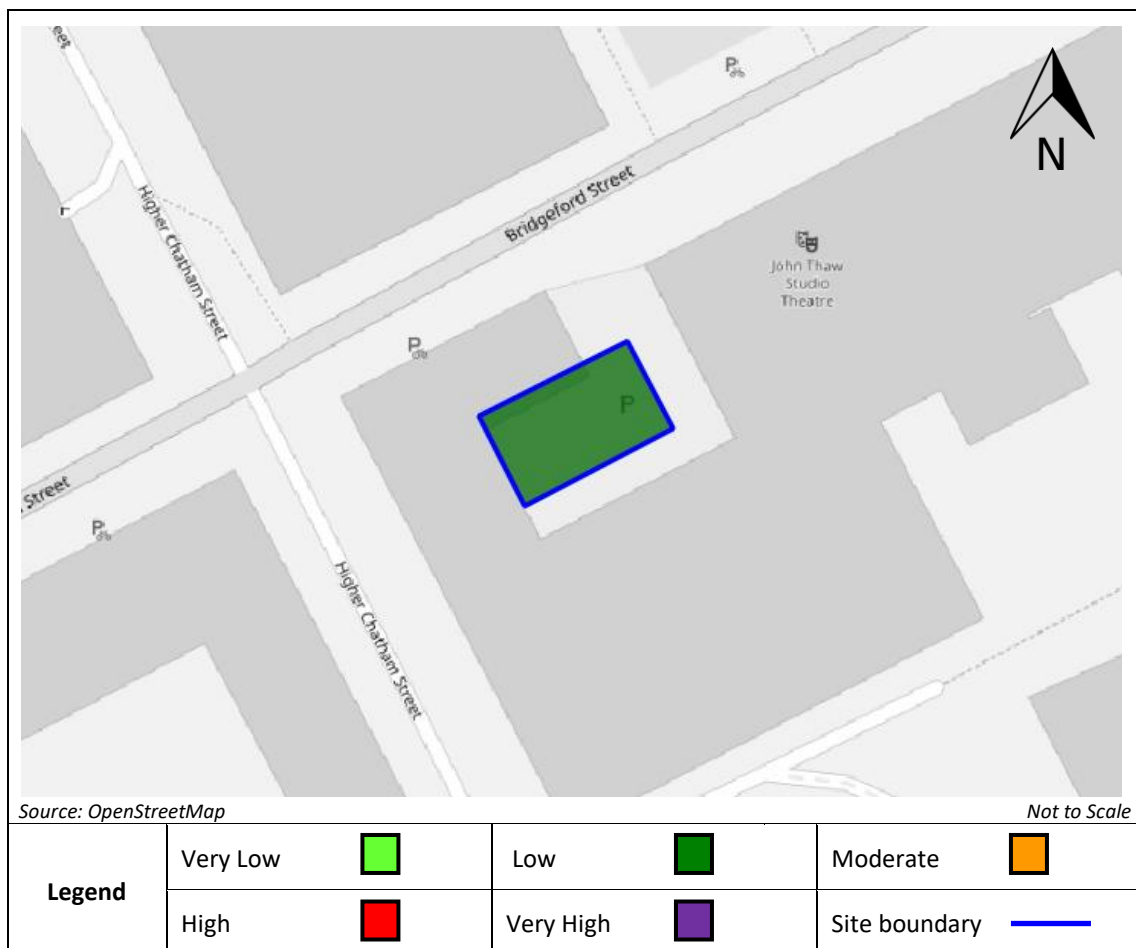
**Figure 4 UXO hazard zone plan of the Site**

The UXO hazard zone plan of the Site is also given in the accompanying P11803-22-R1-MAP01-A.

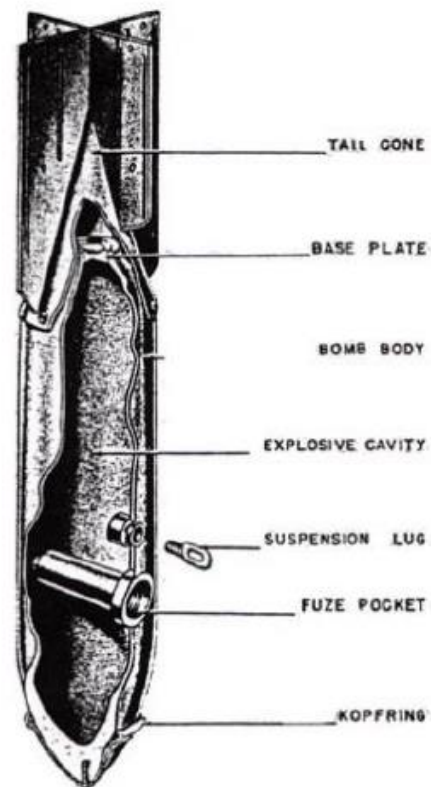
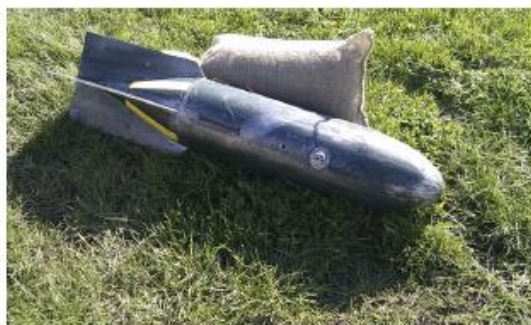
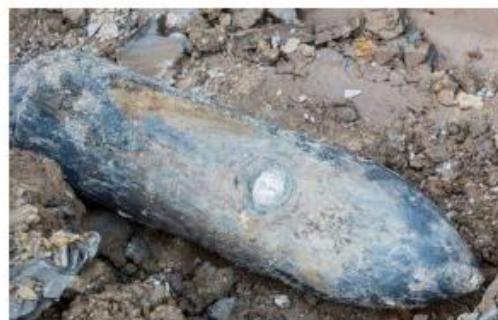
**Description** Thick nose welded to a steel body. Nose may be attached to Kopfring (a triangular section steel ring) or spike. Suspension bolt in eye/body and sheet metal tail attached to body with rivets/screws. Originally painted green-grey with a yellow stripe on the tail. Cast TNT, Amatol or Trialen filling.

**Function** Designed to maximise shock waves through air, water and earth and for general demolition. Used against easily damageable targets, including roads, aircraft hangars, rolling stock and small buildings. Spike bombs/ 'Stabo' (SC 50 with spikes attached to nose) were used against rail lines and country roads, with Kopfring used against naval targets.

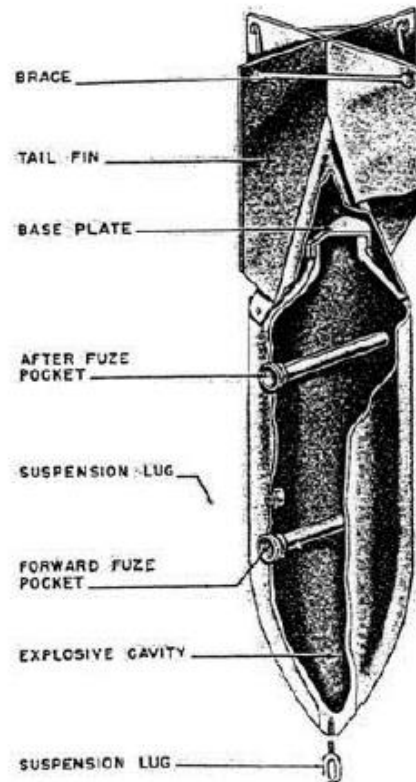
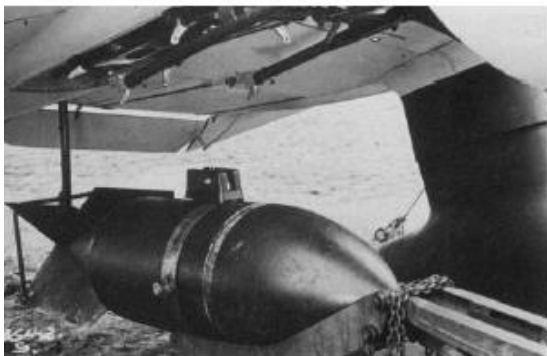
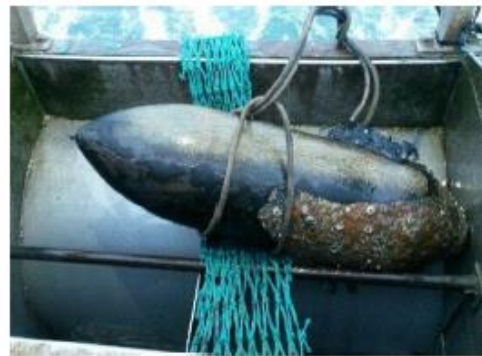
**Description** Thick nose welded to steel body. Nose may be attached to Kopfring (triangular section steel ring) or spike. Sheet metal tail attached to body with rivets/ screws. Suspension eye bolt in the nose/body. Originally painted green-grey with a yellow stripe on the tail. TNT; amatol; TNT and aluminium powder, naphthalene, ammonium nitrate and wax/ wood meal filling.

**Function** Designed to maximise shock waves through air, water and earth and general demolition. Used against railway installations, large buildings, ammunition depots and below-ground installations (to 8m). Spike bombs/ 'Stabo' (SC 50 with spikes attached to nose) used against rail lines and country roads.

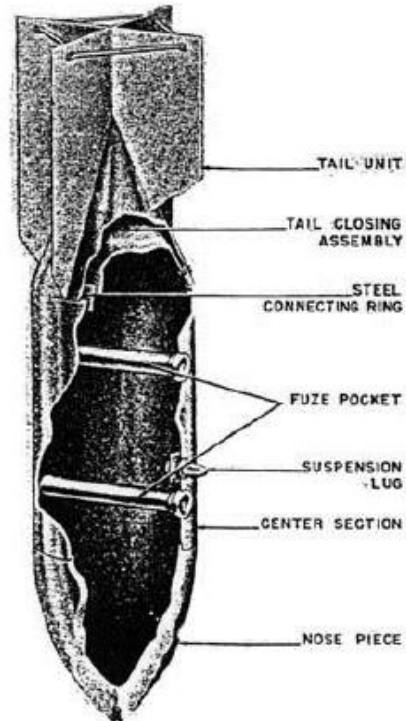
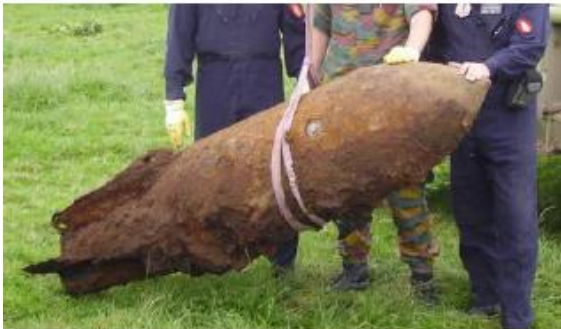
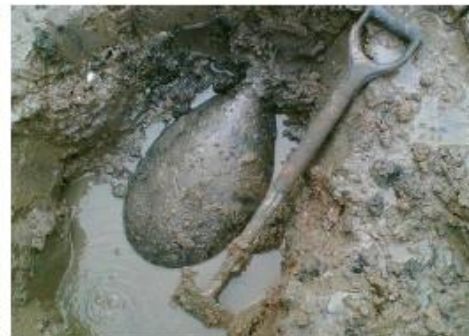
**Description** Thick nose welded to steel body. Nose may be attached to Kopfring (triangular section steel ring). Tail either steel sheet or drum-shaped. Suspension band. Originally painted green-grey/ buff (some later versions sky blue) with yellow stripe on tail. Filled with amatol, TNT or trialen.

**Function** Designed to maximise shock waves through air, water and earth and for general demolition. Used against railway property, large buildings, shipping and below-ground installations.

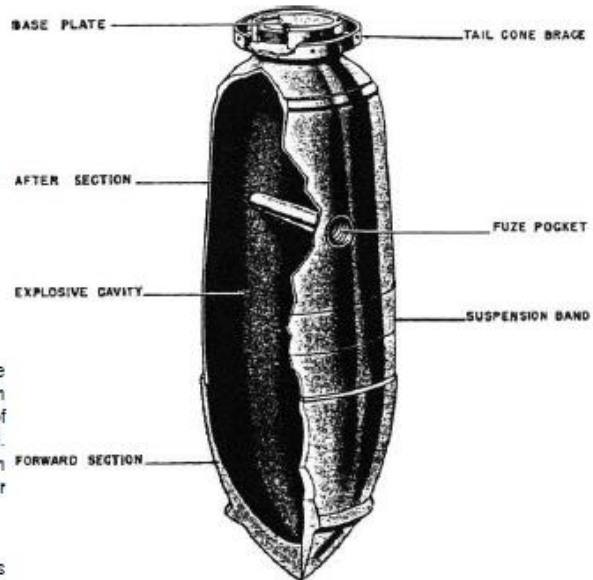
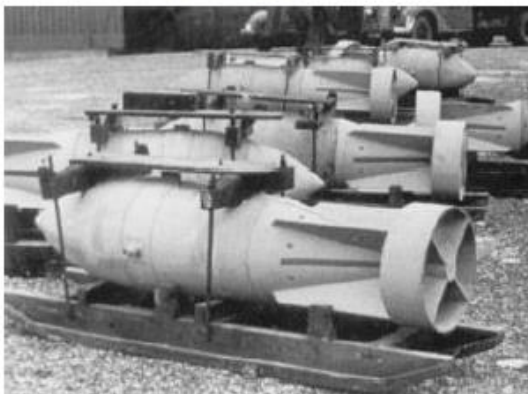
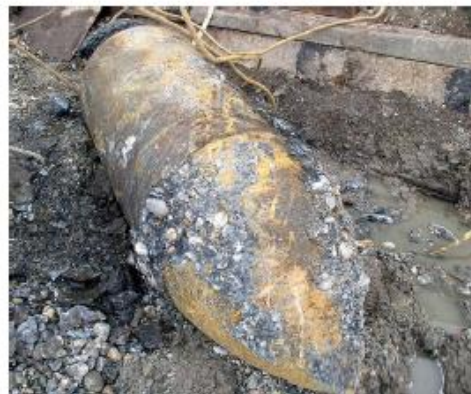
**Description** Thick nose welded to steel body. Nose attached to Kopfring (triangular section steel ring). Drum-shaped tail made of magnesium alloy. Suspension band. Originally painted sky-blue. Filled with amatol, TNT/aluminium/wood meal or trialen.

**Function** Designed to maximise shock waves through air, water and earth and for general demolition.

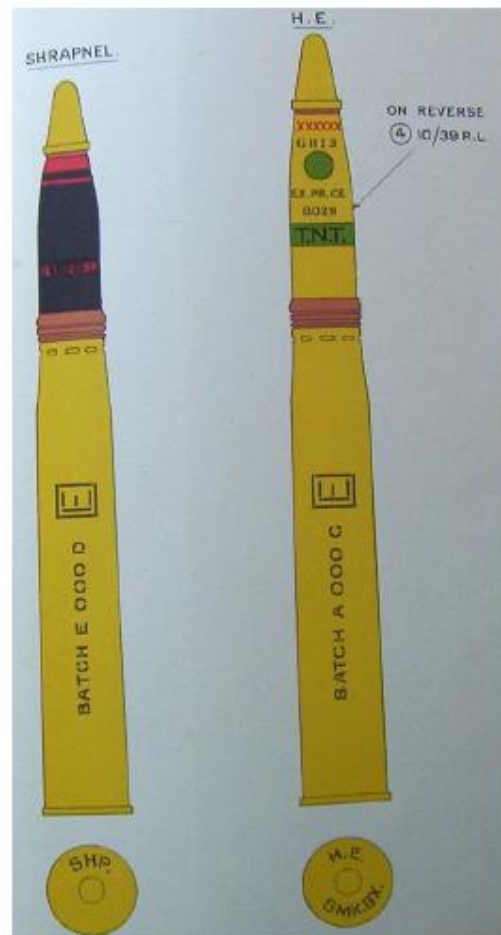
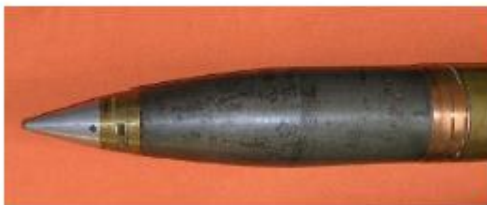
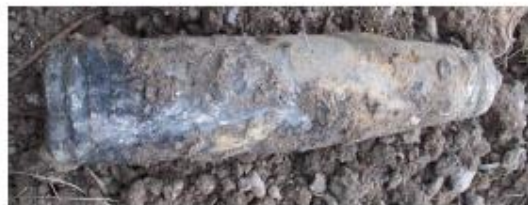
**Description** Brass cartridge case. Square-based shell with tapered nose, filled with Amatol, TNT or RDX/TNT. MK6 had forward centring bands and a wider driving band.

**Function** Used as a defence against enemy aircraft, fired from fixed batteries and mobile mountings. Could fire approximately 20 rounds per minute with a maximum ceiling of 41,000ft and horizontal range of 20,600 yards.

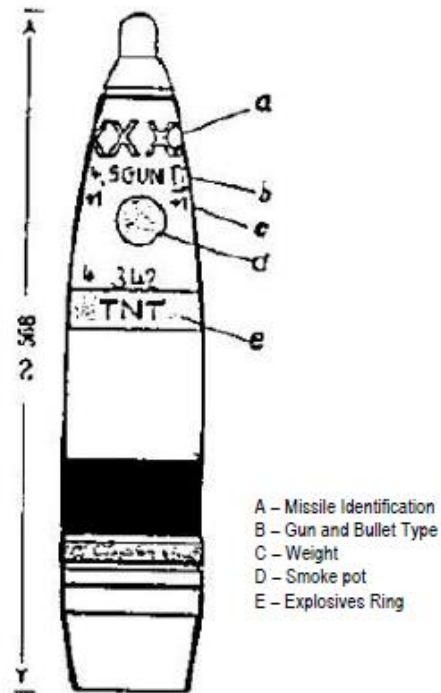
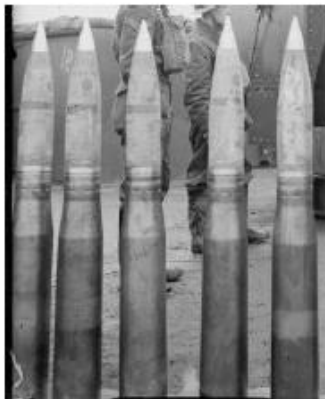
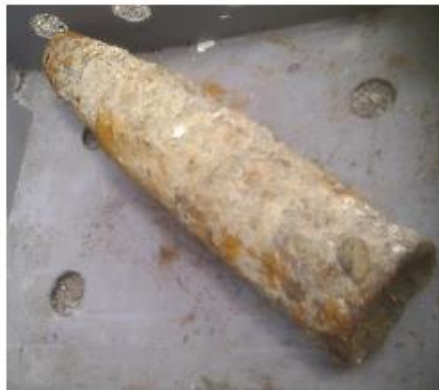
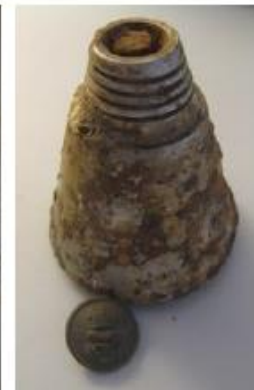
**Description** Square-based, tapered-nosed shell filled with TNT or Amatol. Steel casing, rotating band of either copper or gilding metal located 3.5" in front of the base end with single groove.

**Function** Used as field artillery and adapted for use in anti-aircraft defence from fixed batteries. Rate of fire of 8 rounds per minute, maximum ceiling of 44,000ft and horizontal range of 22,800 yards.

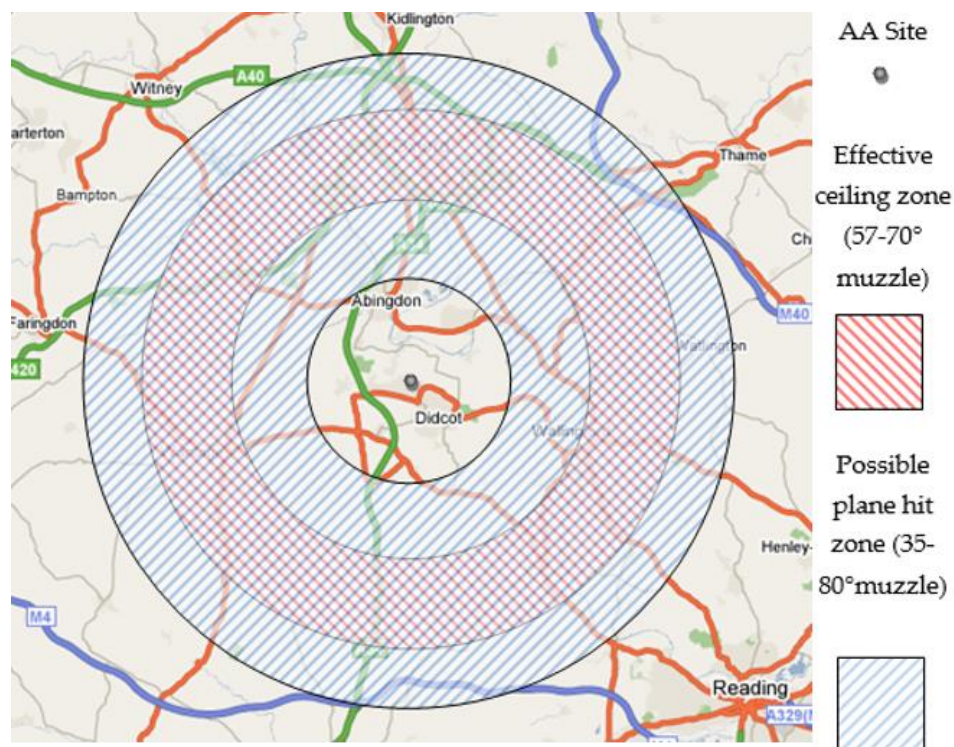
Unexploded AA (UXAA) shells were a common occurrence during WWII. As the figure below demonstrates, shells were unlikely to fall in the immediate vicinity of a gun battery but in the surrounding area. This would be dependent upon the angle of fire and the flight height of the attacking aircraft.

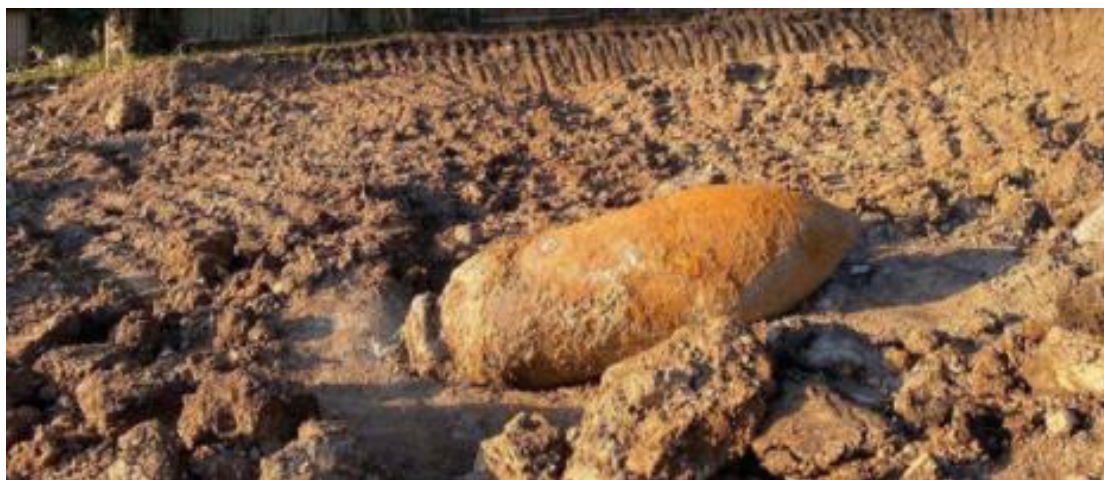
On the 26<sup>th</sup> February 2021, a 1,000kg German “Hermann” UXB was discovered by builders at Exeter University campus (see plate below). It was investigated and detonated in-situ following the evacuation of nearby properties and University halls of residence.
