Phase II Geoenvironmental Site Assessment  
Ancoats Mobility Hub

Reference: 15-849-R1-2  
Date: September 2022

Ancoats Mobility Hub  
Poland Street  
Manchester  
M4 6AZ

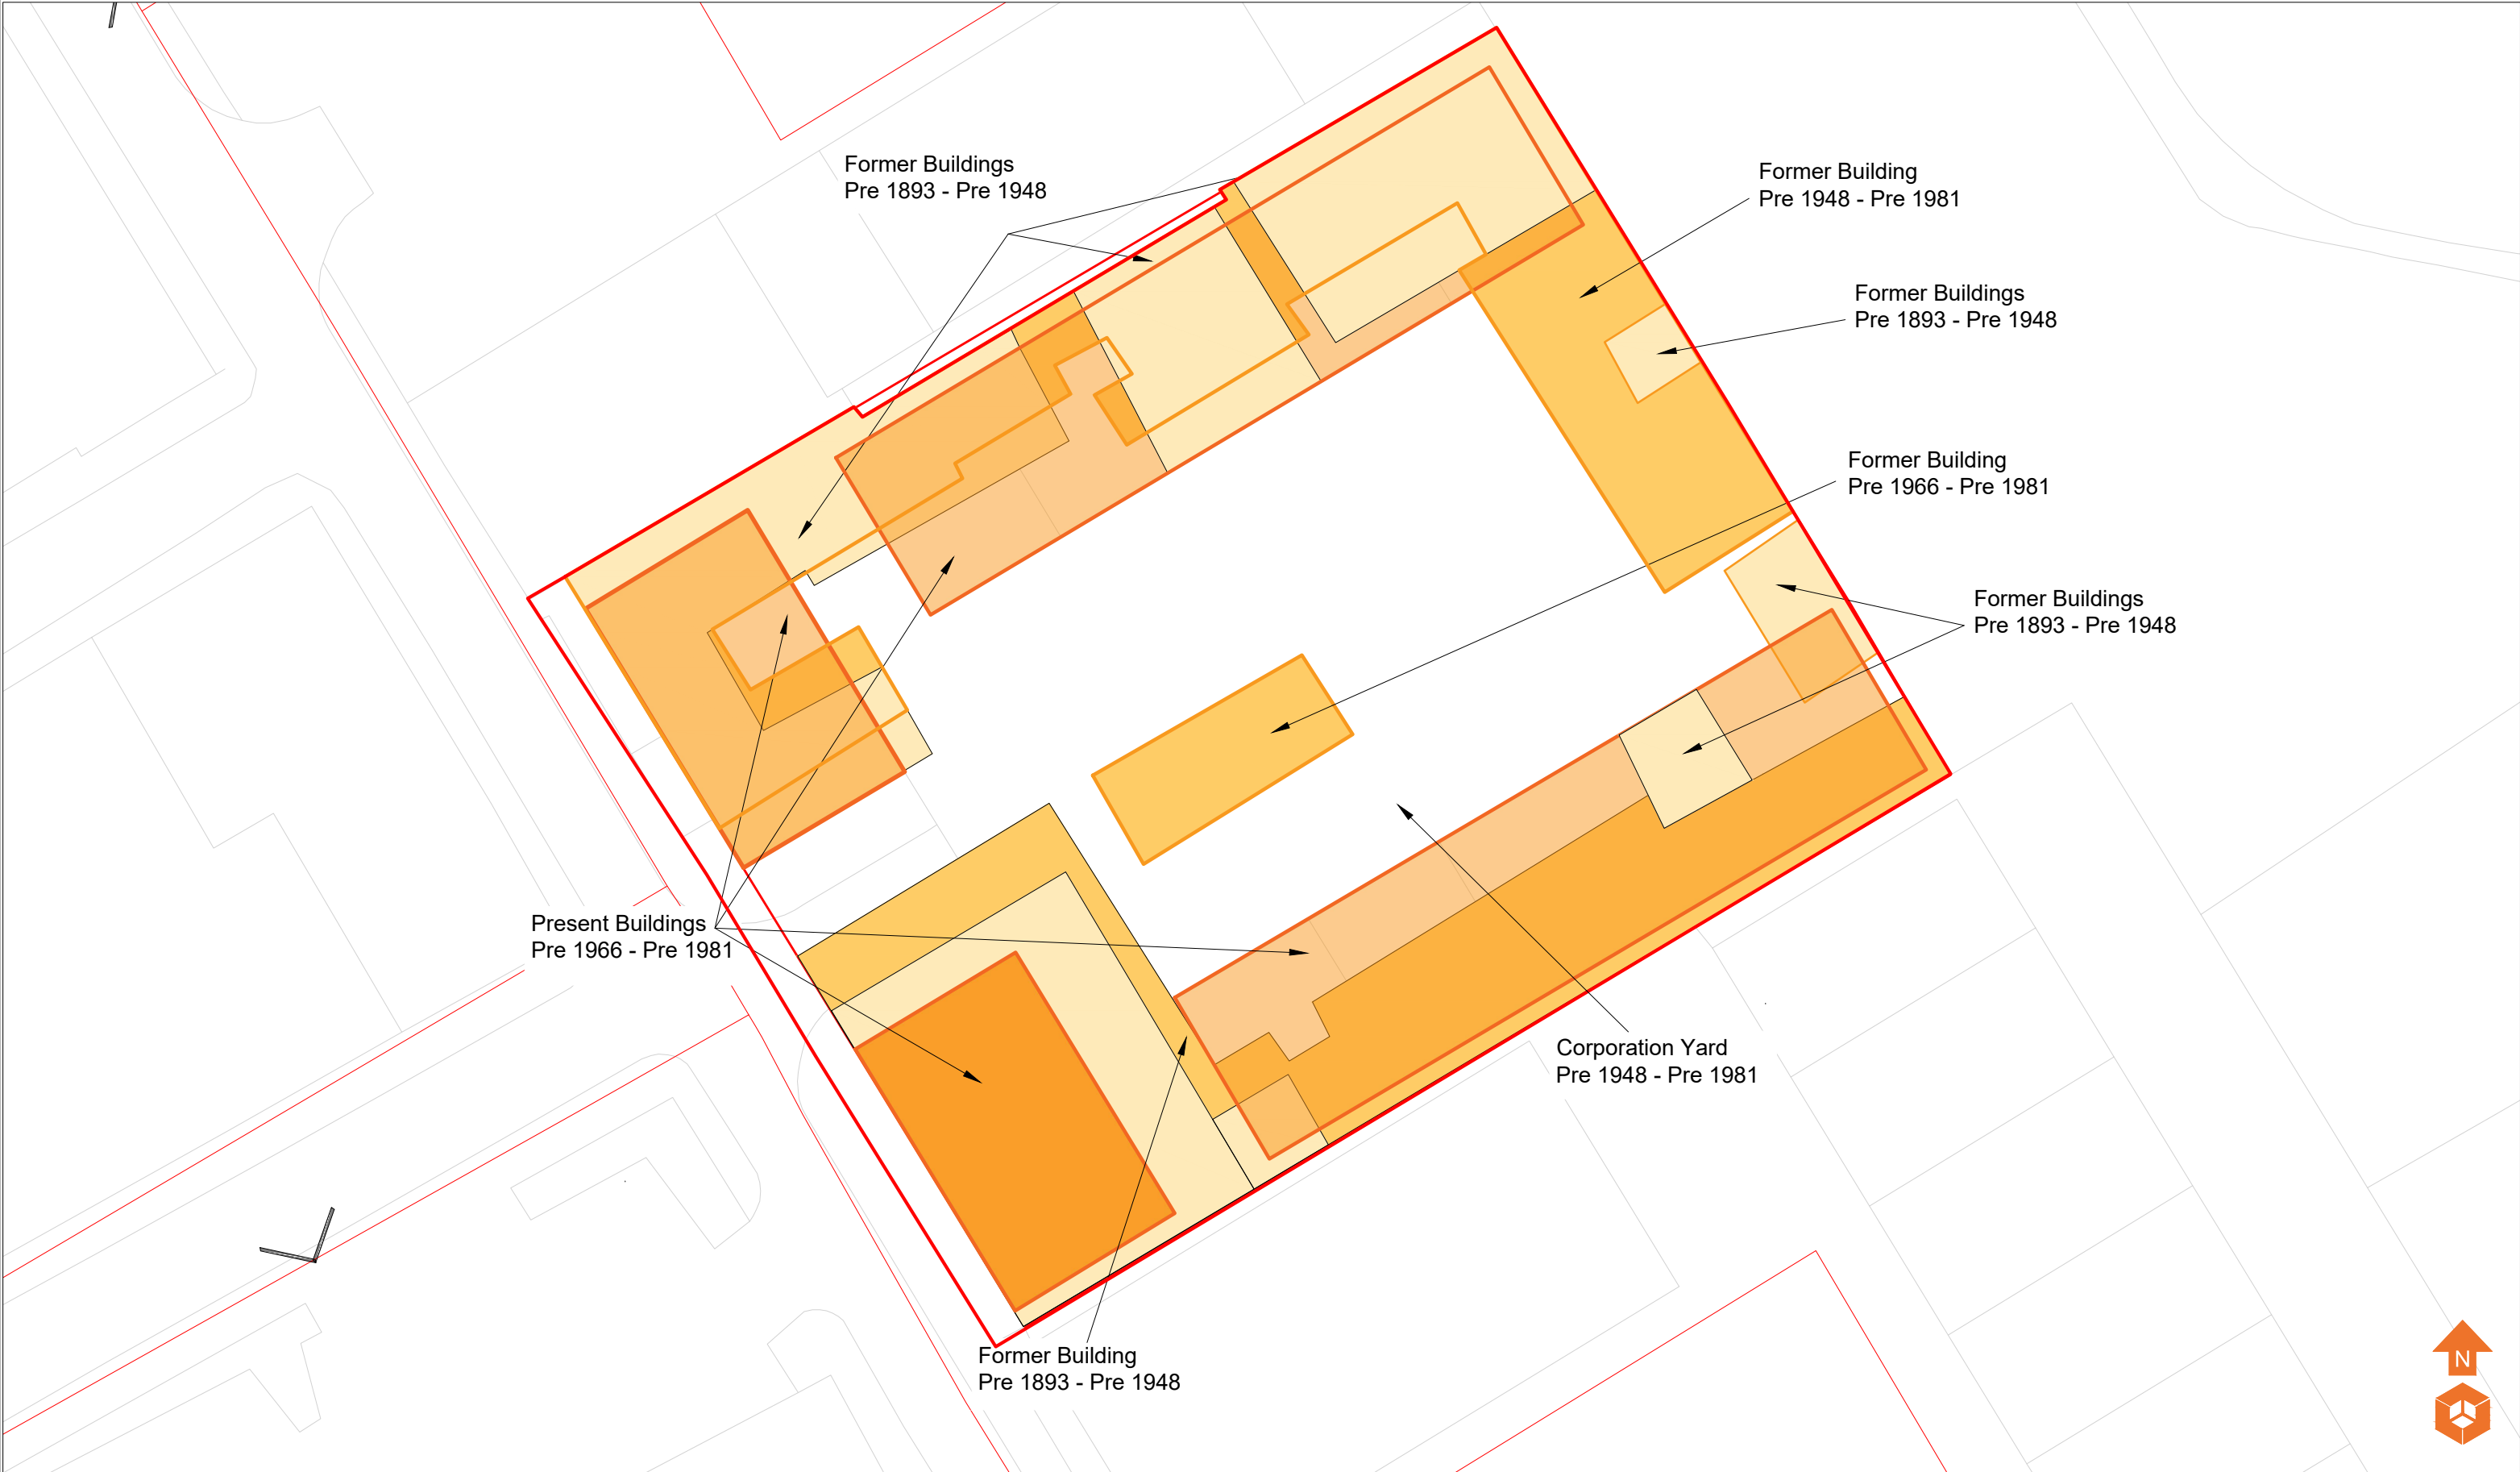
| <div>Historical Features</div> <div><div></div>Former Buildings</div> <div><div></div>Former Buildings</div> <div><div></div>Current Buildings</div> <div><div></div>Corporation Yard</div> | <div>Notes:</div> <div></div> | <div>Client:</div> <div>Bowmer and Kirkland</div> | <div>Job No:</div> <div>15-849</div> | <div>Date:</div> <div>31.08.2022</div> | <div><div><div></div>e3p</div><div>Environmental Engineering Partnership Ltd<br/>Taylor Road, Trafford Park<br/>Urmston, Manchester, M41 7JQ<br/>Tel: 0161 707 9612<br/>E-mail: <a href="mailto:info@e3p.co.uk">info@e3p.co.uk</a><br/>Website: <a href="http://www.e3p.co.uk">www.e3p.co.uk</a></div></div> |

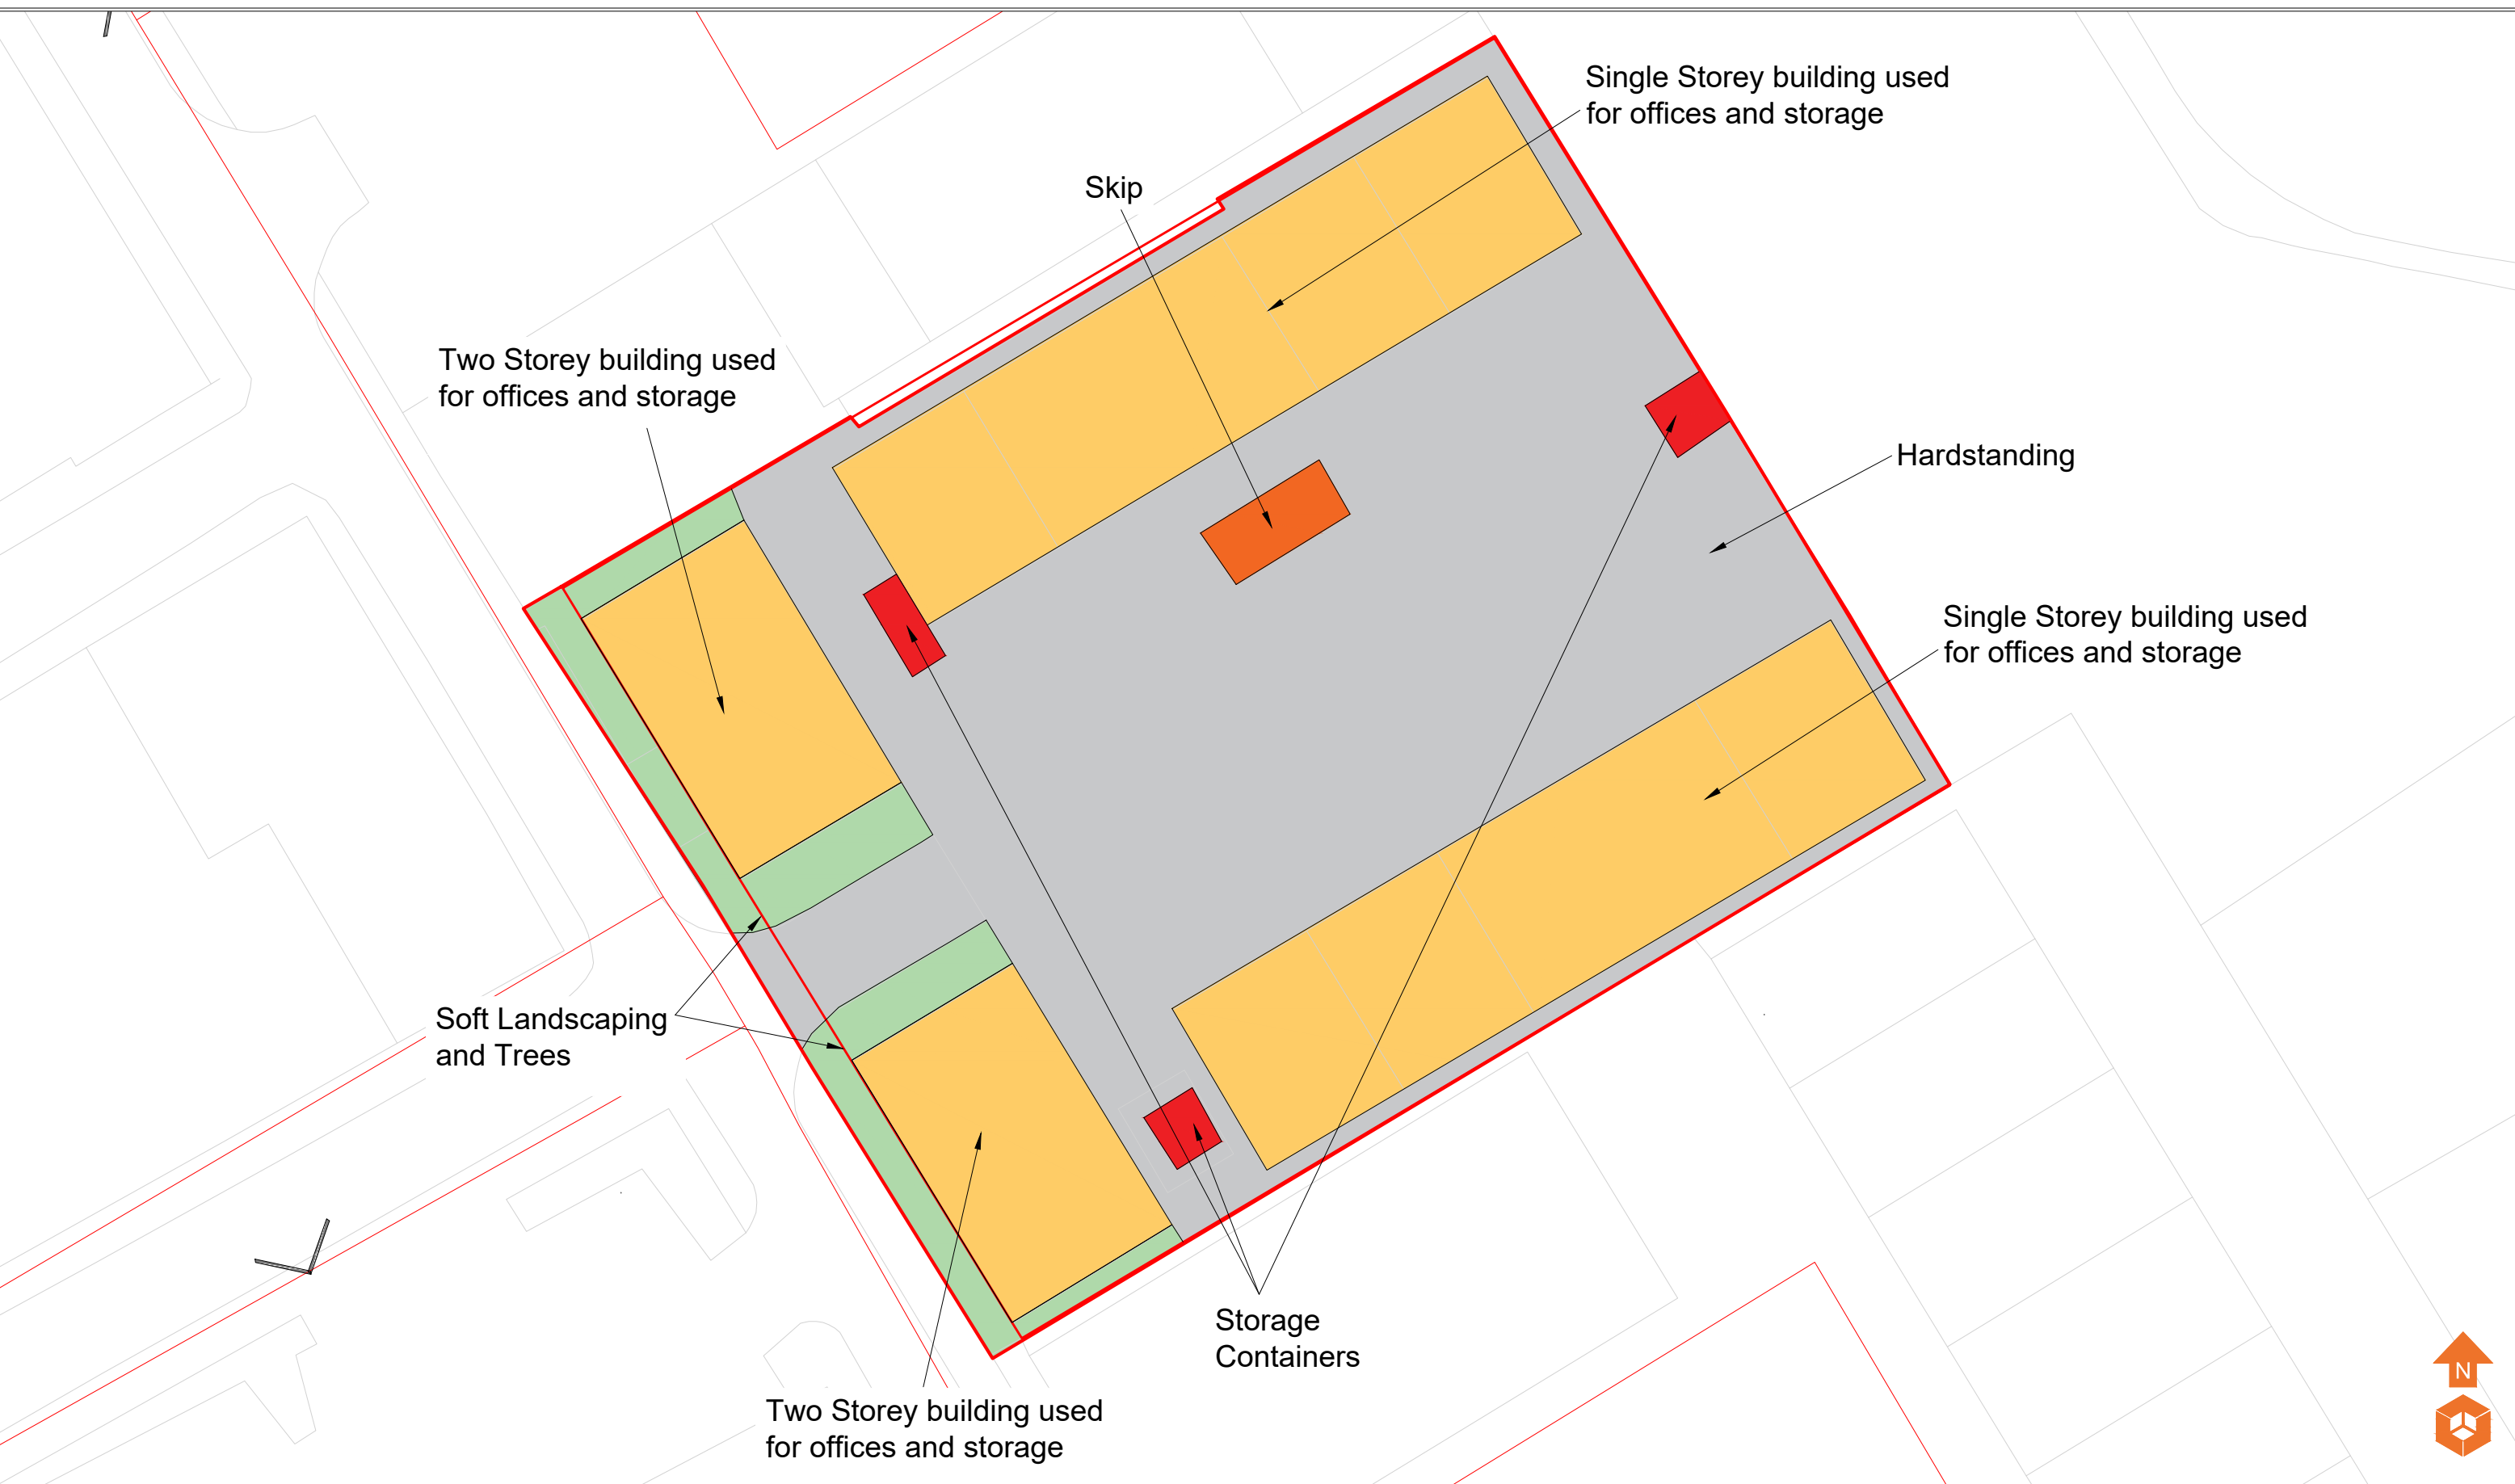
| <div>Site Features</div> <div><div></div>Buildings</div> <div><div></div>Soft Landscaping and trees</div> <div><div></div>Storage Containers</div> <div><div></div>Skip</div> <div><div></div>Hardstanding</div> |

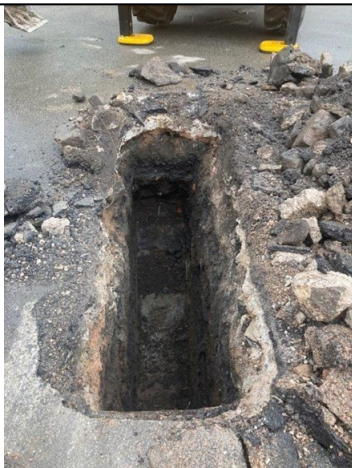
TP101

Remarks: 1. Complete. 2. Slight hydrocarbon odour between 0.40-1.30m bgl. 3. Breaking hard standing out, 10 mins.

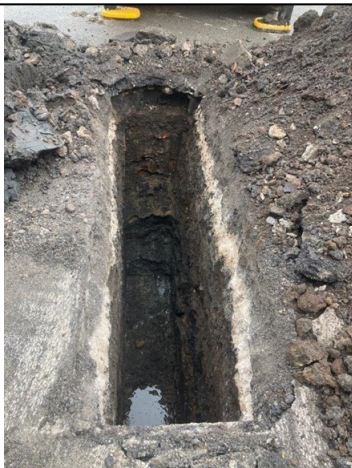
TP102

Remarks: 1. Complete. 2. Slight hydrocarbon odour between 0.45-1.90m bgl. 3. Water strike encountered at 2.00m bgl on the clay with a slow ingress. 3. Breaking hard standing out, 10 mins.

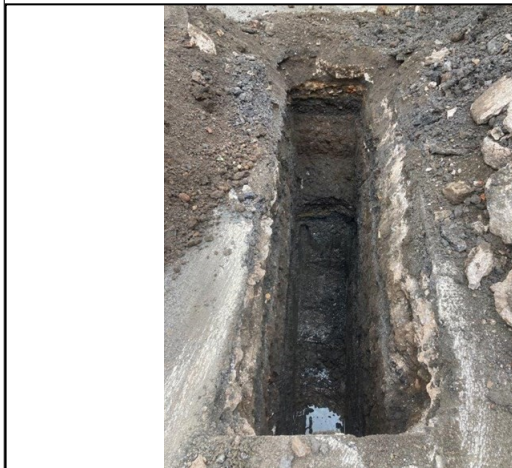
TP103

Remarks: 1. Complete. 2. Breaking hard standing out, 10 mins.

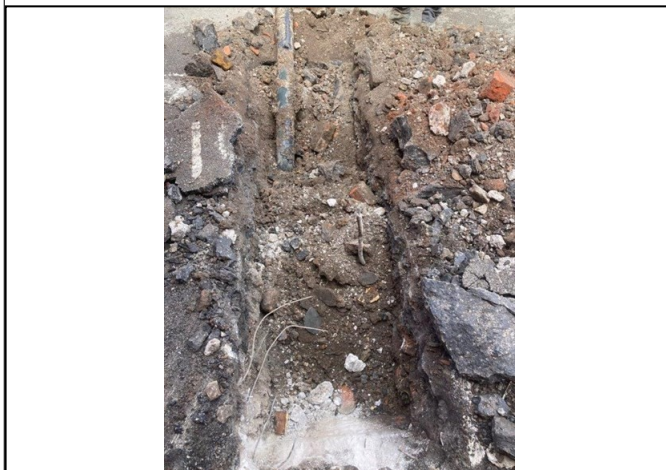
TP105

Remarks: 1. Terminated due to redundant services at 0.65m bgl. 2. Possible water pipe 1.30m long and 10cm diameter. 3. Breaking hard standing out, 10 mins.
