# **Generic Quantitative Risk Assessment**

Rochdale Road, Manchester

January 2023

**Client Name:** McGoff Construction Limited  
**Document Reference:** WIE19453-100-R-2.3.1-GQRA  
**Project Number:** WIE19453-100

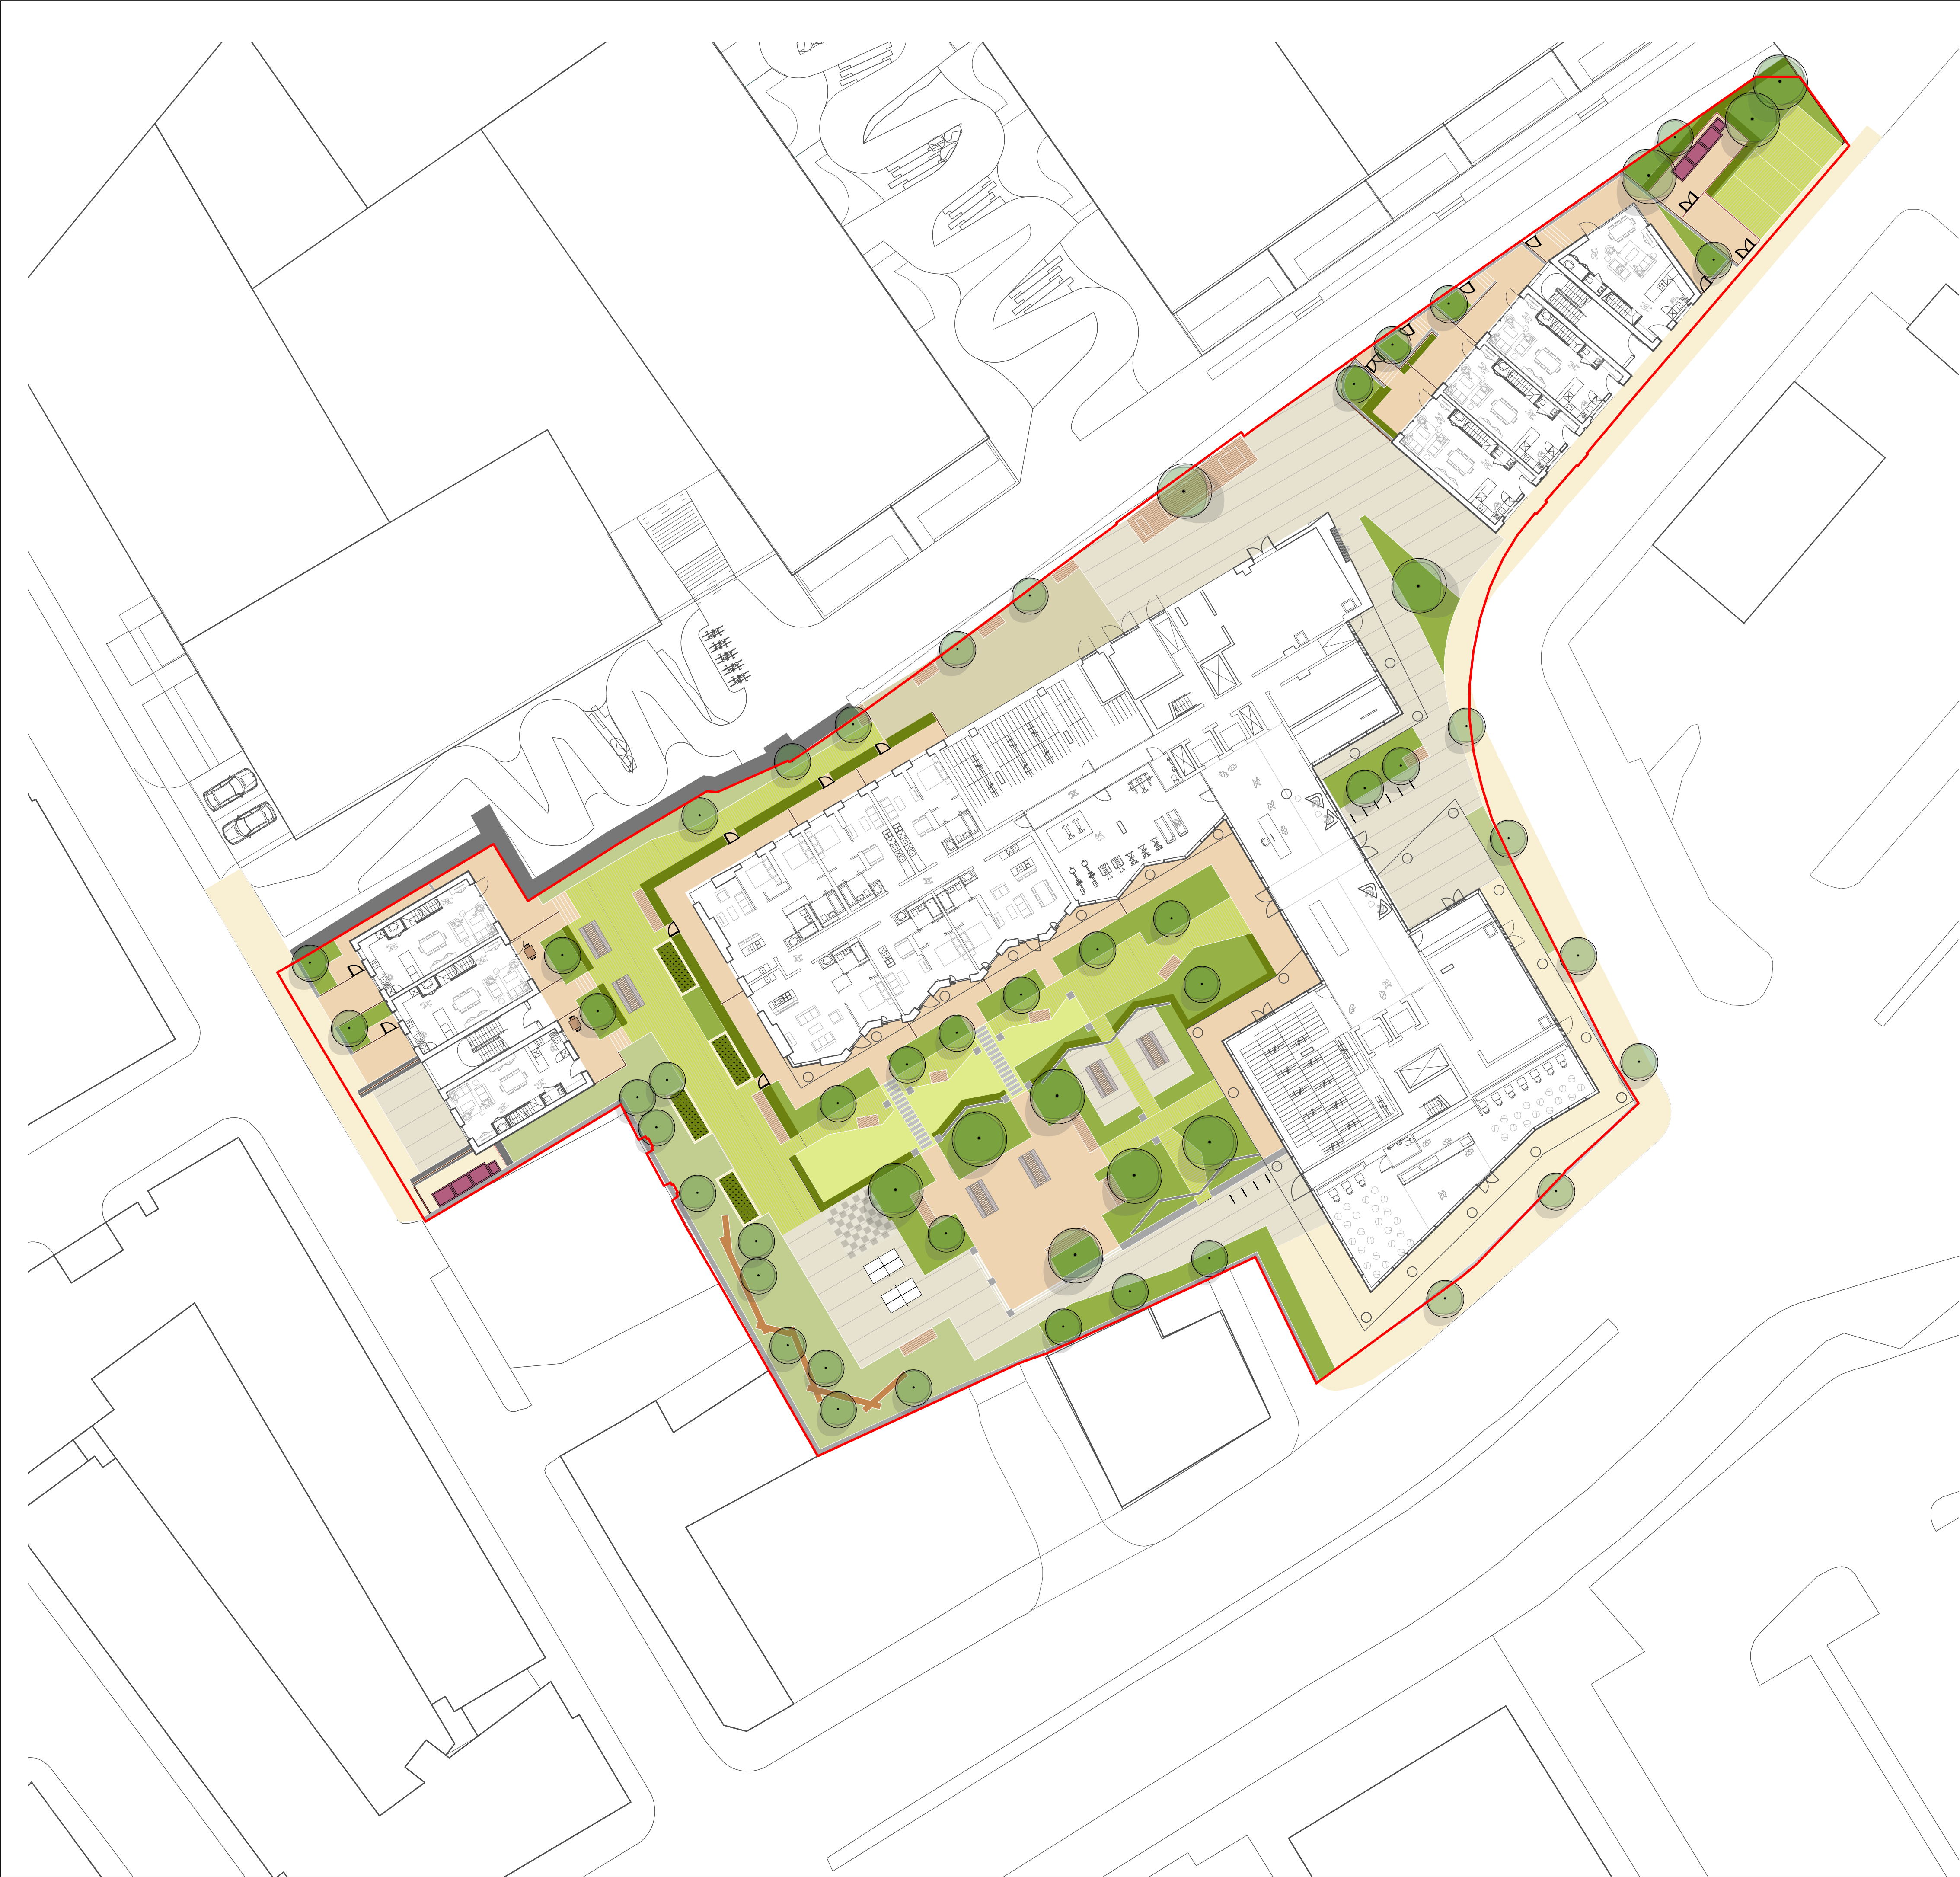
| 19453-100-WIE-ZZ-XX-DR-V-80-006 | | P01 | |

| Title | GROUNDWATER EXCEEDANCE PLAN |
