**PROPOSED SITE ACCESS ARRANGEMENTS,  
OLIVE SCHOOL, CHEETHAM HILL,  
MANCHESTER**

**STAGE 1 - ROAD SAFETY AUDIT  
JANUARY 2023**

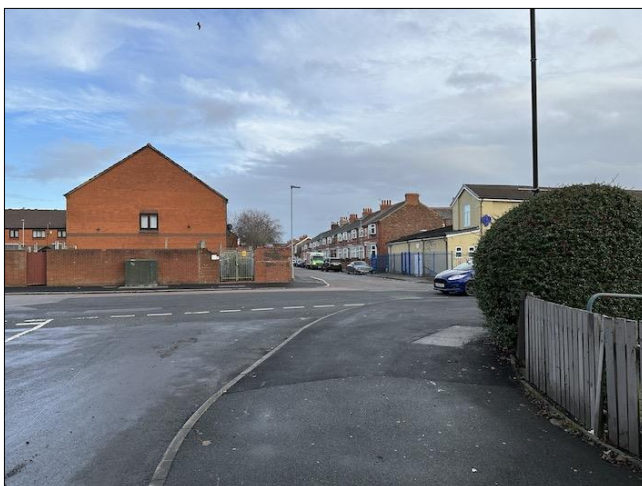
- 2.1 The location of the existing uncontrolled pedestrian crossing on Tamerton Drive is located away from the pedestrian desire line, potentially resulting in pedestrians crossing at more direct/convenient locations where there are full height kerbs, which could potentially increase the risk of pedestrian trip hazards. The intervisibility to/from the crossing point on the southern side of Tamerton Drive is also restricted by the adjacent boundary fence/hedge at the back of the footway (Ref: **Photograph 1**) which could increase the risk of pedestrian/vehicle collisions.

- 2.3 It is also noted that the upstands at the existing crossing are considered to be excessive and could increase the risk of pedestrian trip hazards.

**Photograph 1:** Restricted intervisibility to/from the southern crossing point.

- 2.4 It is recommended that the existing pedestrian crossing be relocated to correspond with the likely pedestrian desire line and improve the intervisibility to/from the southern crossing point.

Existing pedestrian crossing has been relocated east on the pedestrian desire line.

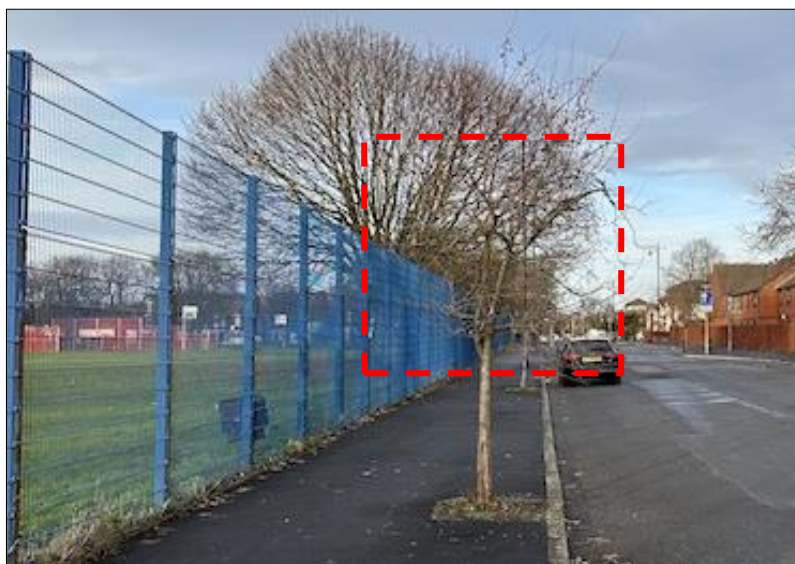
- 2.5 The audit team would note that there is vegetation overhanging the footway on the western side of Heywood Street (Ref: **Photograph 2**). Vegetation overhanging the footway could pose a hazard to pedestrians.

**Photograph 2:** Vegetation overhanging the footway.

- 2.6 It is recommended that the branches overhanging the footway be cut back.

Note added to plan detailing that vegetation overhanging the footway is to be cut back.

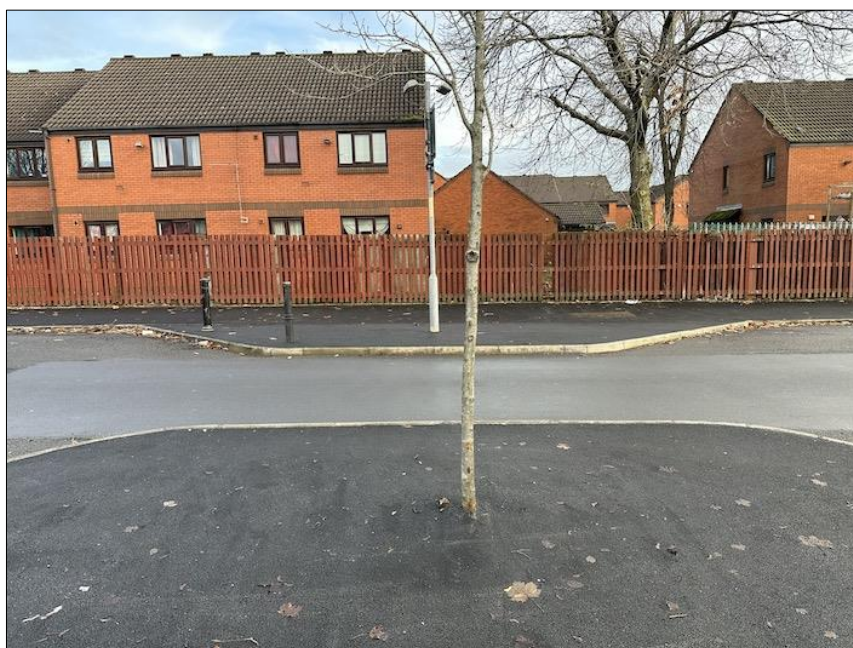
- 2.7 The audit team would note that there is a sign post and tree located where the proposed uncontrolled pedestrian crossing will be located (Ref: **Photograph 3**) that would be in the path of pedestrians using the crossing and could pose a collision hazard to pedestrians with visual impairments.

**Photograph 3:** Tree and sign post adjacent to proposed uncontrolled crossing.

- 2.8 It is recommended that the tree and sign post be relocated away from the crossing point or vice versa.

Noted added to plan that details the tree is to be removed and a compensatory tree proposed in a location to be agreed. The sign is to be moved south on the build out, exact location to be agreed at detailed design stage.
