Phase I Geoenvironmental Site Assessment  
Albany Road, Chorlton

Reference: 15-843-R1-2  
Date: March 2023

## PHASE I GEOENVIRONMENTAL SITE ASSESSMENT

Albany Road  
Chorlton  
Greater Manchester  
M21 0AZ

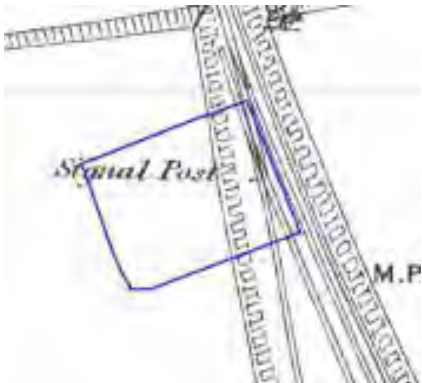
| MAP EDITION | HISTORICAL LAND USE | HISTORICAL MAP EXCERPT |
|---|---|---|
| <b>1881</b><br><b>1:2,500</b> | <p>The pond on the northern boundary has been infilled and is no longer recorded.</p> <p>The eastern sector of the site appears to have been cut forming an embankment with railway lines present on the eastern boundary of the site.</p> <p>A signal post is marked within the east of the site.</p> <p>The western sector of the site remains undeveloped.</p> | |

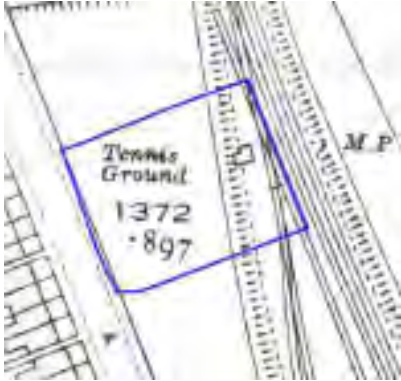
| <p><b>1922</b><br/><b>1:1,250</b></p> | <p>The western sector of the site is now mapped as forming part of a Tennis Ground.</p> <p>No further changes have been identified.</p> | |

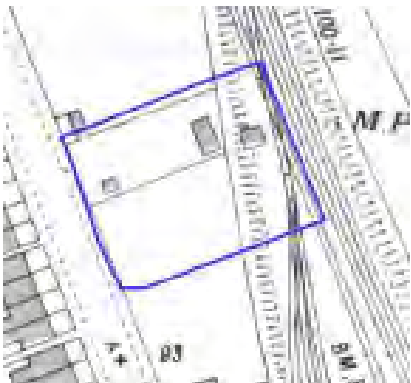
| <p><b>1933</b><br/><b>1:2,500</b></p> | <p>The tennis grounds are no longer marked and a boundary is present bisecting the site east to west.</p> <p>Two further structures have been added to the northern sector of the site.</p> <p>No further changes have been identified.</p> | |

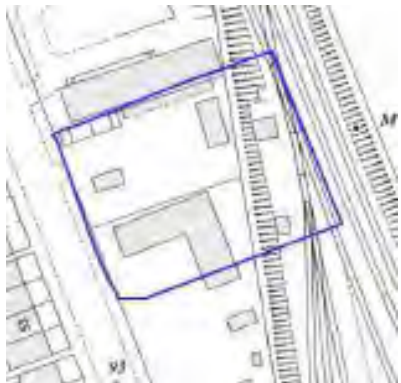
| <p><b>1950</b><br/><b>1:1,250</b></p> | <p>The structures in the north of the site have expanded with a series of structures present along the northern boundary. The former boundary bisecting the site has moved southwards.</p> <p>A large L shaped building has been constructed in the south of the site.</p> <p>An additional small structure has been erected in the south-east of the site.</p> | |

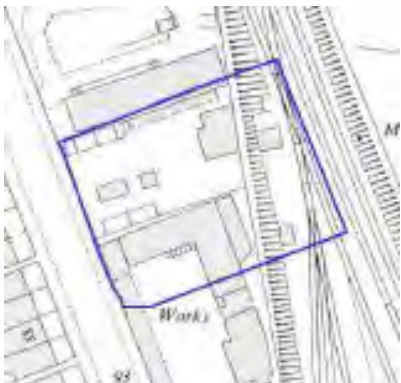
| <p><b>1959</b><br/><b>1:1,250</b></p> | <p>Several further structures have been constructed in the northern sector of the site. The L shaped building in the south has been extended and is named as a Works which is part of a wider development.</p> <p>No further changes have been identified.</p> | |

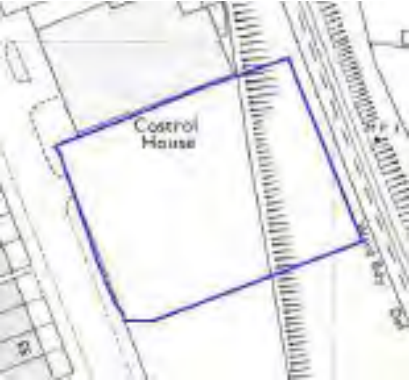
| <p><b>1981-1986</b><br/><b>1:1,250</b></p> | <p>All structures have been removed from the site, as well as the boundary in the centre of the site and the railway in the east of the site.</p> <p>The embankment is still present.</p> <p>No further changes have been identified.</p> | |

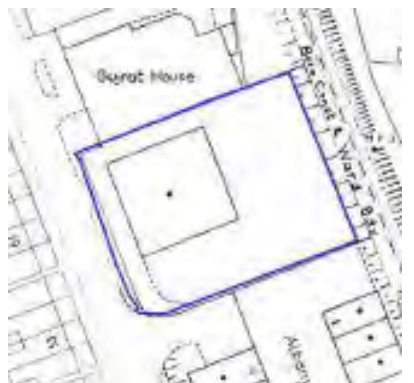
| <p><b>1985</b><br/><b>1:1,250</b></p> | <p>The eastern sector of the site appears to have been raised and the embankment no longer present.</p> <p>A large structure has been erected in the west of the site with what is assumed to be the embankment which is present on-site today.</p> <p>No further changes have been identified.</p> | |

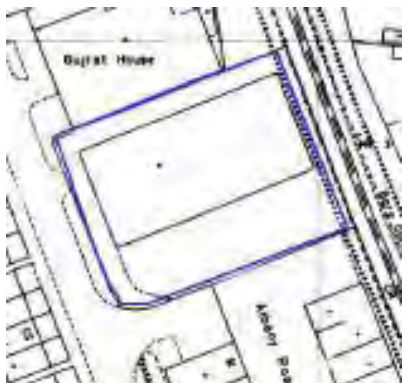
| <p><b>1992</b><br/><b>1:1,250</b></p> | <p>The building has been extended and now spans the whole of the northern sector of the site.</p> <p>No further changes have been identified.</p> | |

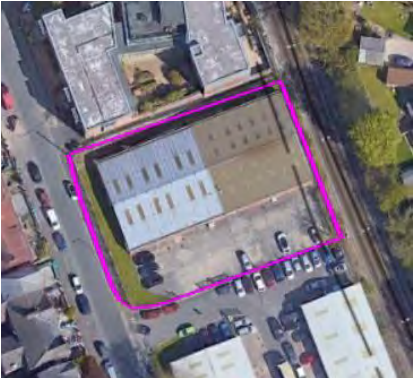
| <p><b>2021</b><br/><b>Google Earth</b></p> | <p>The site remains unchanged.</p> <p>Concrete hardstanding can be seen in the southern sector of the site acting as a carpark for the building in the north of the site.</p> <p>Limited landscaping can be seen along the western boundary.</p> | |

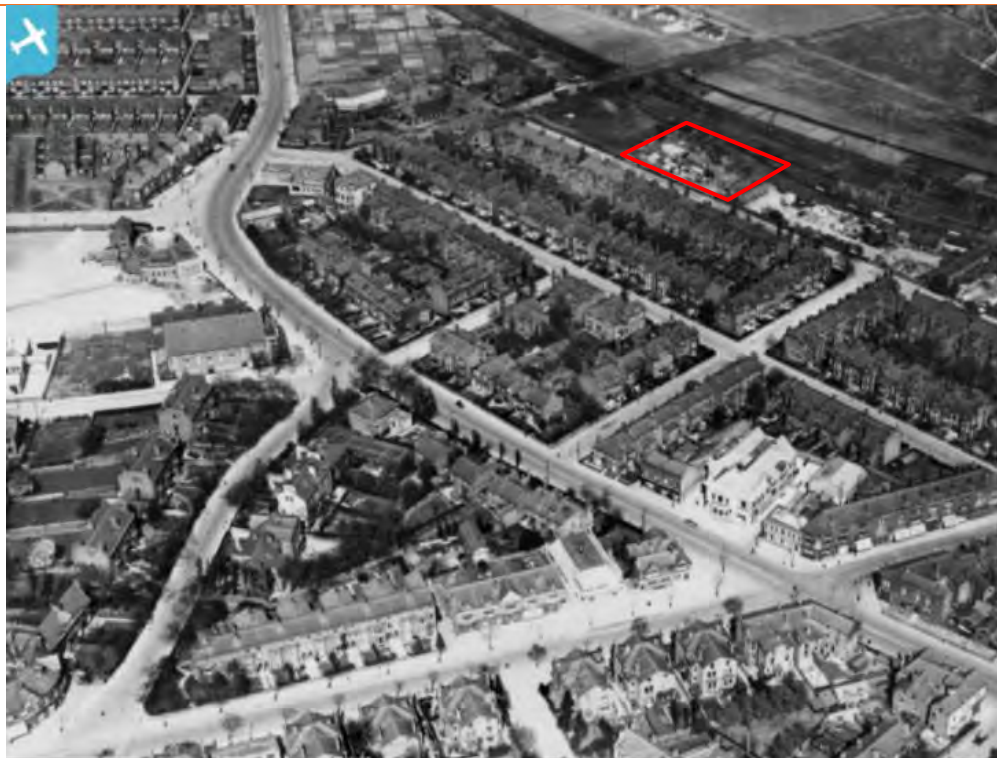
**PLATE 1 –  
BRITAIN  
FROM  
ABOVE  
1927**

The site can be seen in the rear of the 1927 aerial photograph of Chorlton-Cum-Hardy. The rail tracks that have been historically mapped in the eastern sector of the site can be seen as well as several structures across the site.

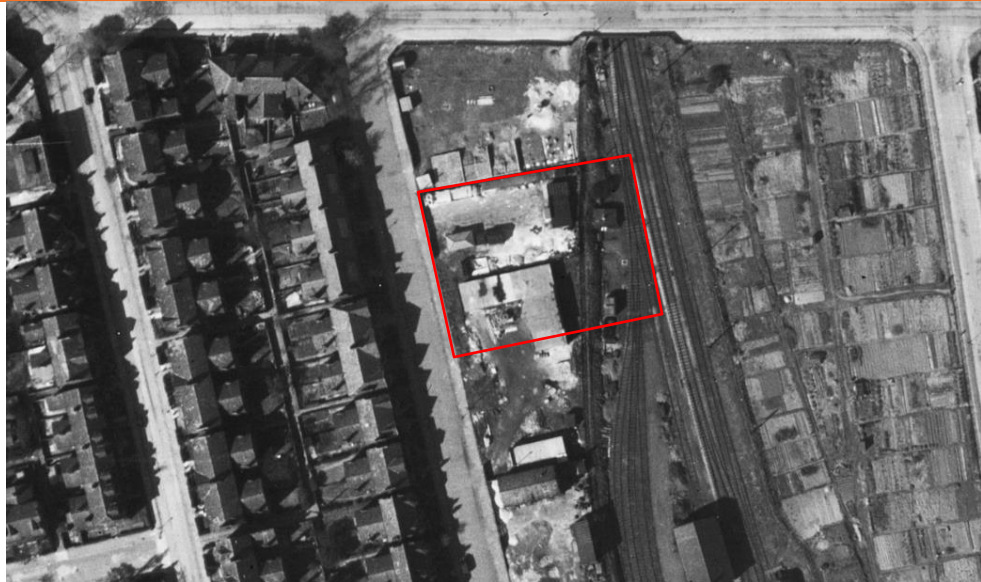
**PLATE 2 –  
HISTORIC  
ENGLAND  
1949**

The aerial imagery identified the series of buildings in the north and south of the site along with the railway and sidings in the east of the site.

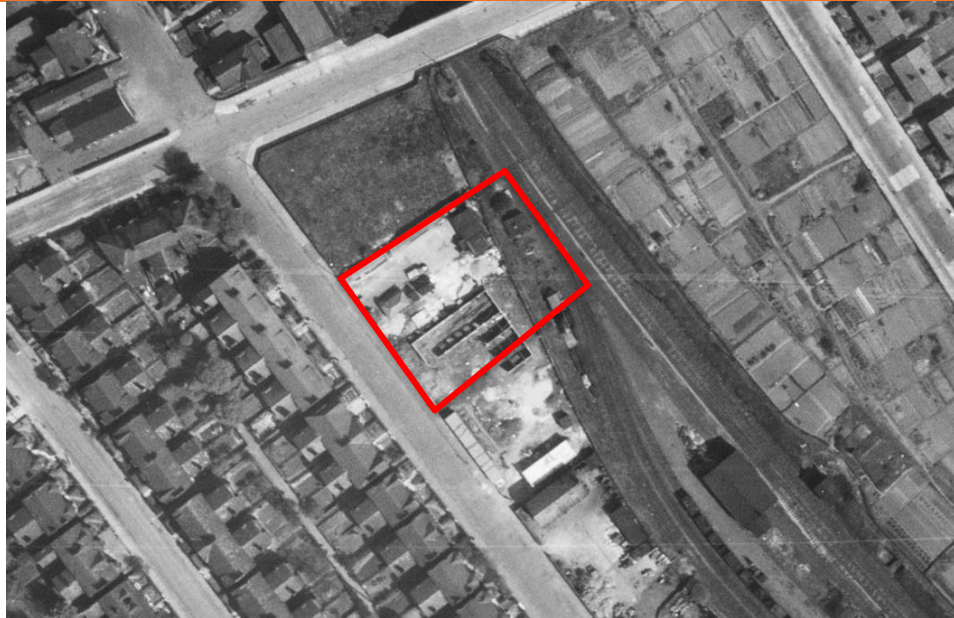
**PLATE 4 –  
HISTORIC  
ENGLAND  
1946**

The aerial imagery shows the construction of the building in the south of the site with various buildings to the north and the railway and sidings to the east.

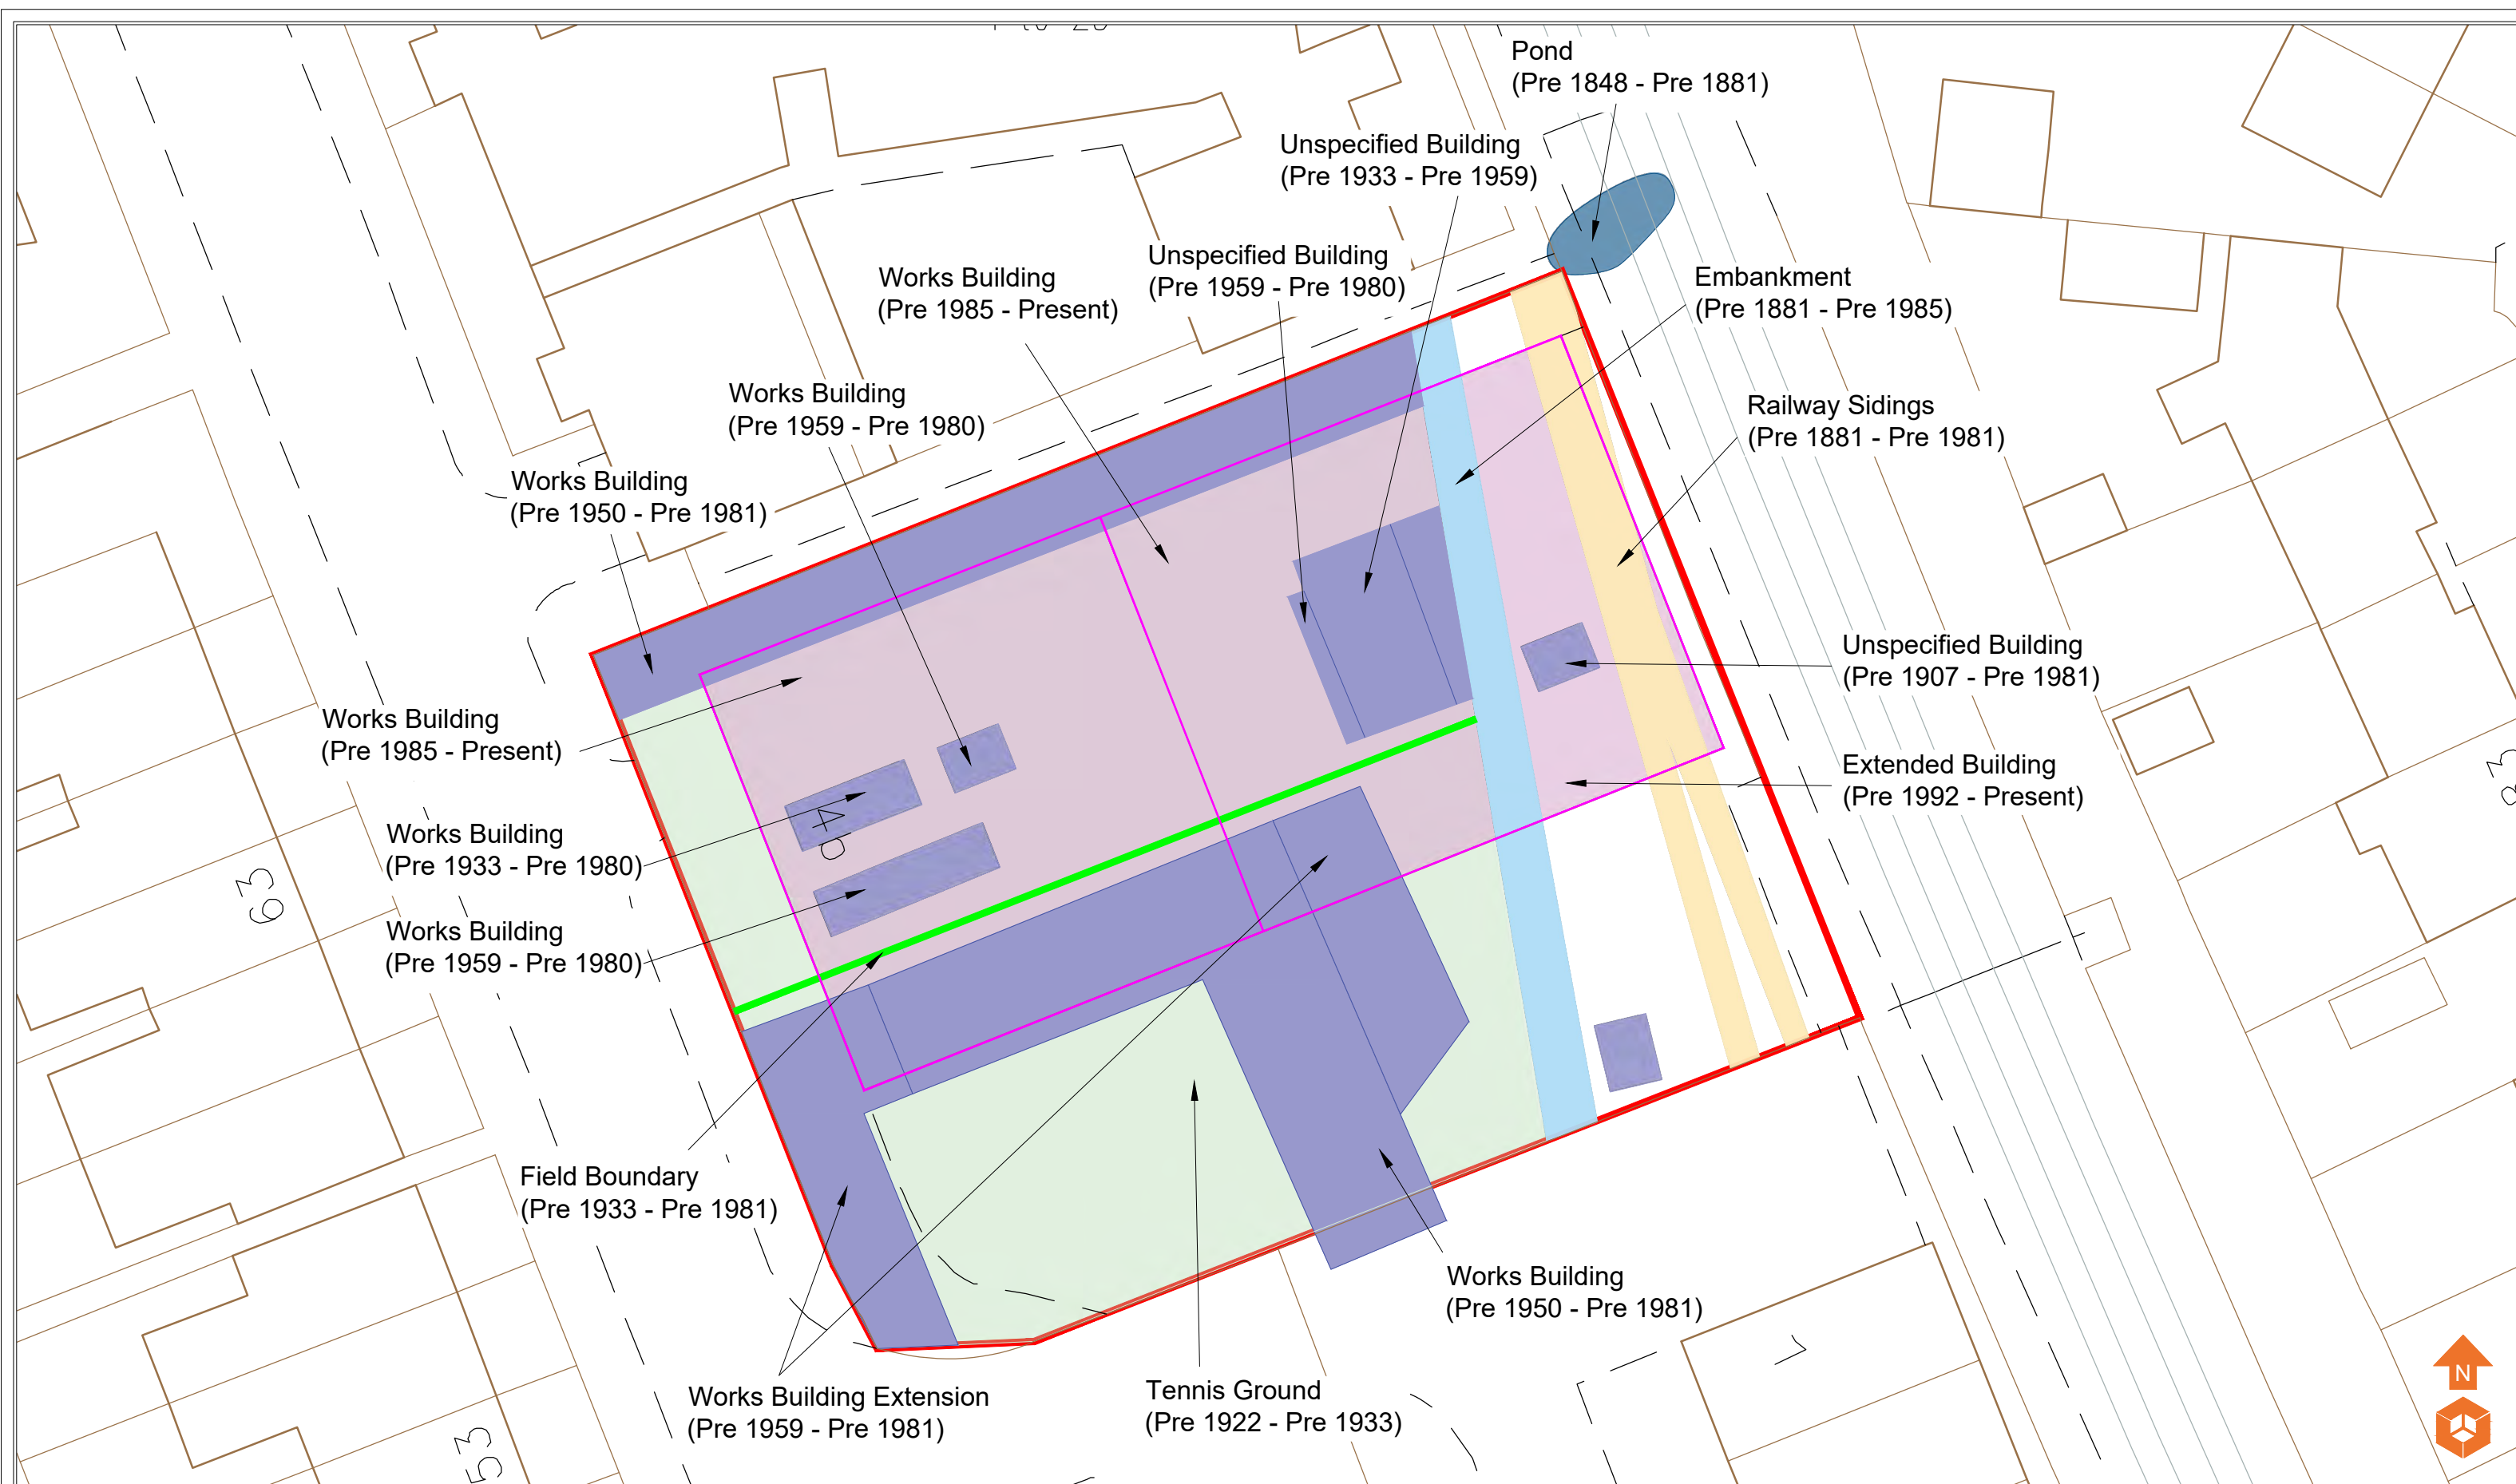
- Historical Features**
- Railway Sidings
  - Embankment
  - Tennis Ground
  - Field Boundary
  - Works Buildings/Unspecified Buildings
  - Works Buildings
  - Pond

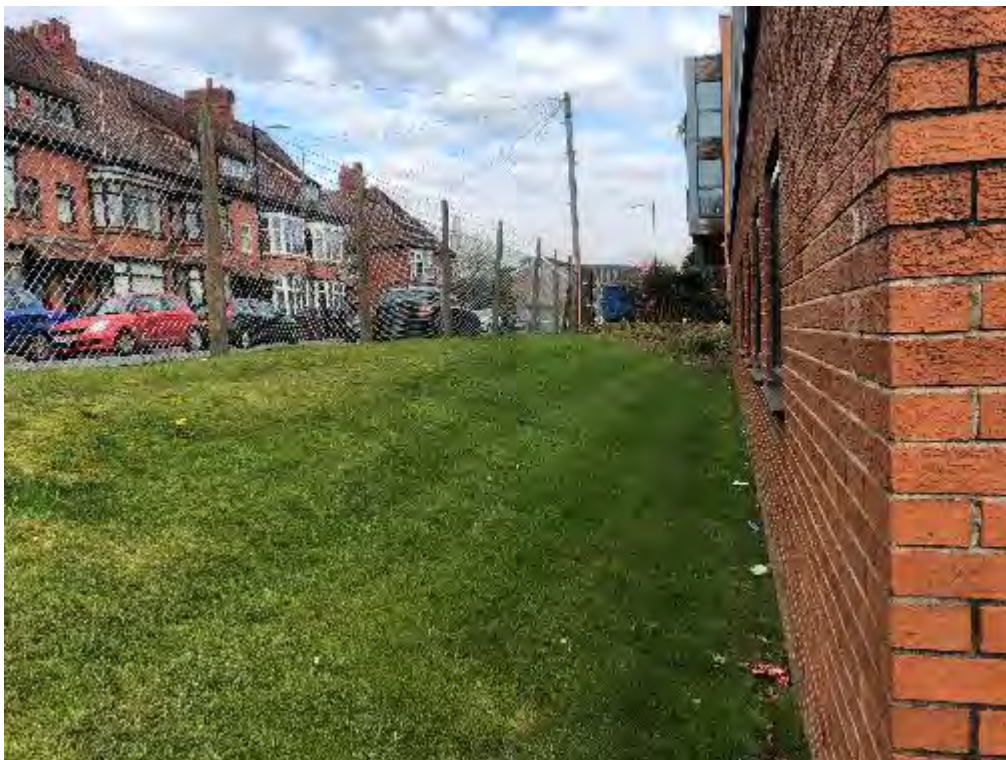
PLATE 4      EMBANKMENT ON WESTERN BOUNDARY

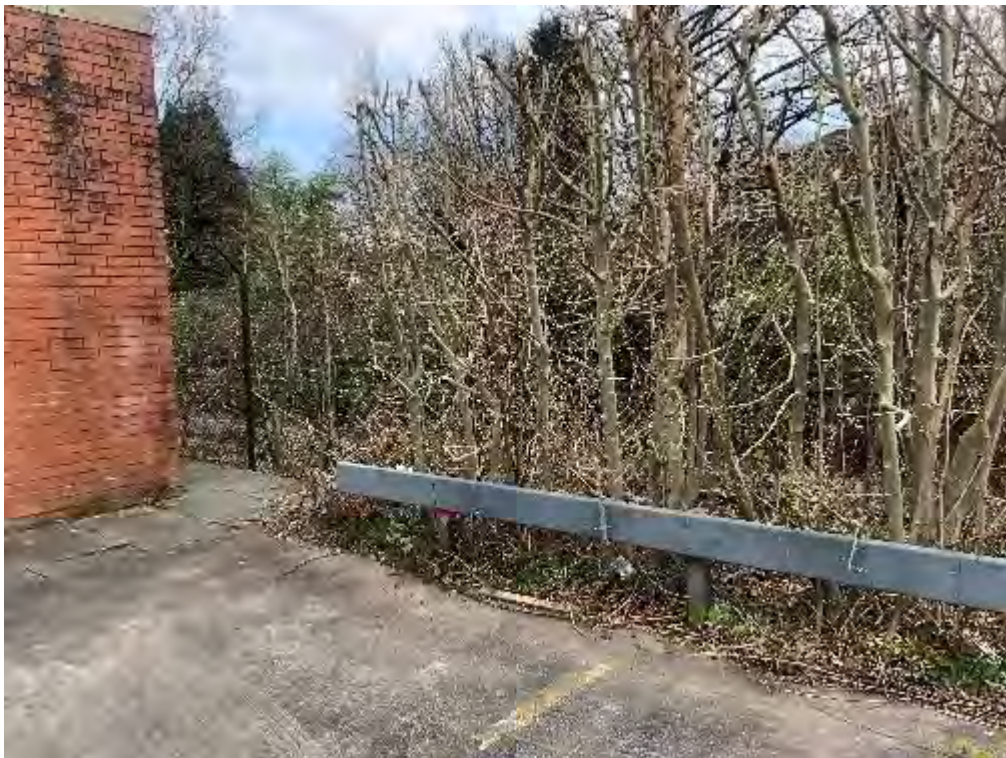
PLATE 6 EASTERN BOUNDARY AGAINST METROLINK

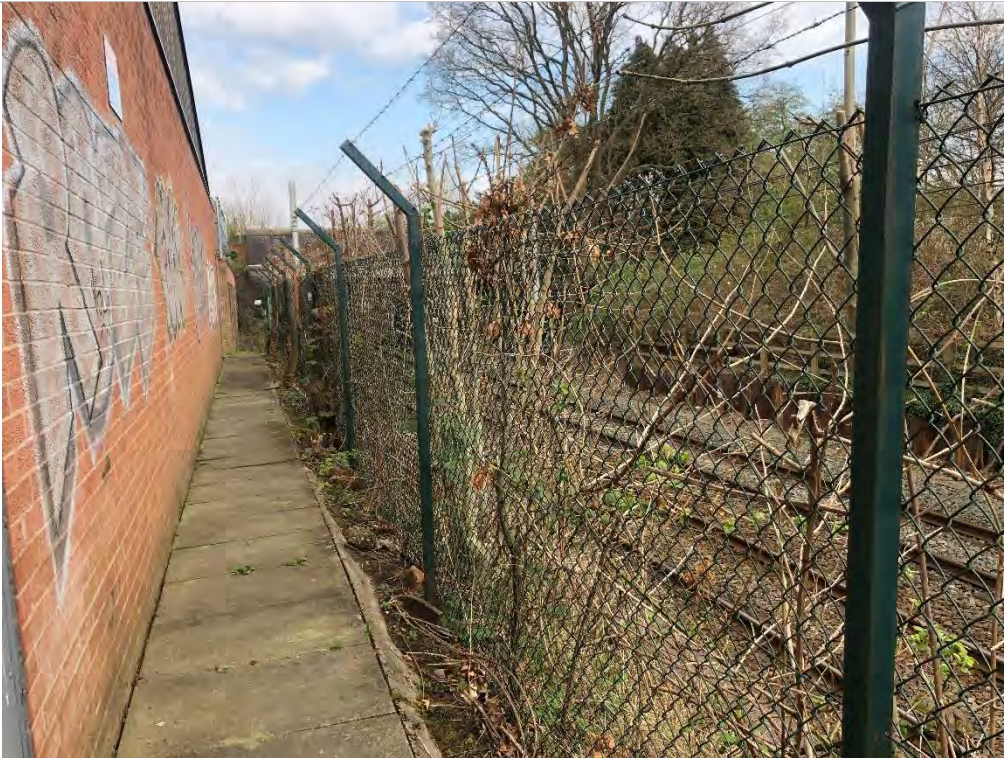
PLATE 7 EASTERN BOUNDARY AGAINST METROLINK

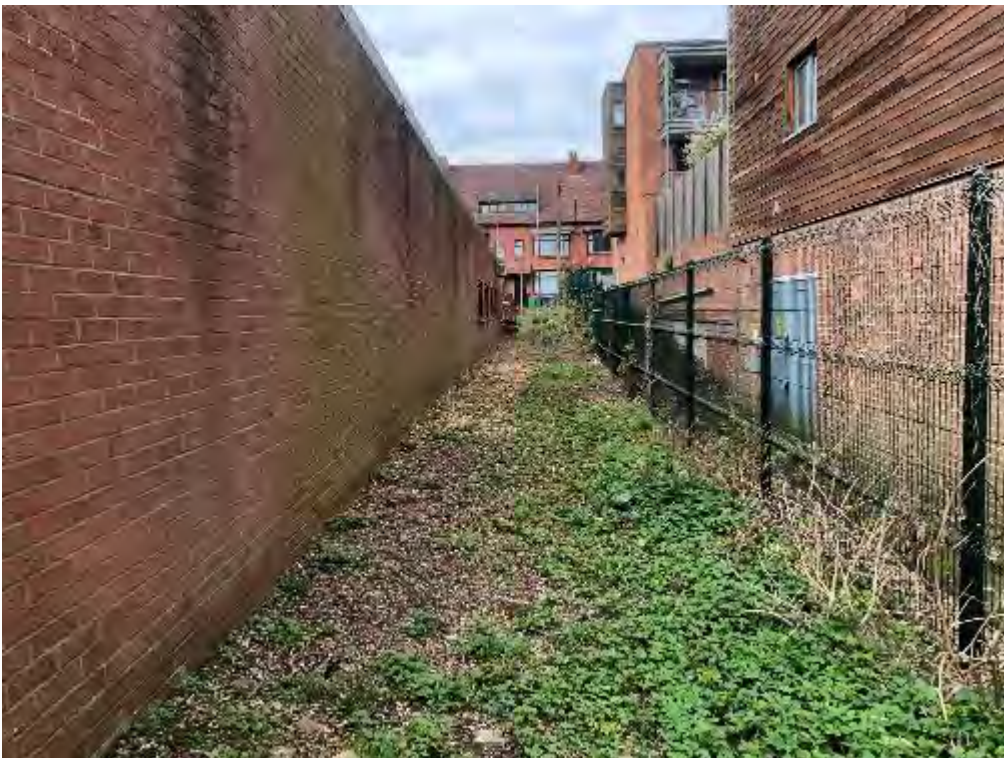
PLATE 8 NORTHERN BOUNDARY OF SITE
