# Phase 2 Site Investigation

## Parsonage Street Redevelopment

## Mawlawi Kurdish Cultural Centre

| TITLE | NAME | SIGNATURE | DATE |
|---|---|---|---|
| Report Reference | 4423-ROC-ZZ-XX-RP-ES-P2S1 | | |

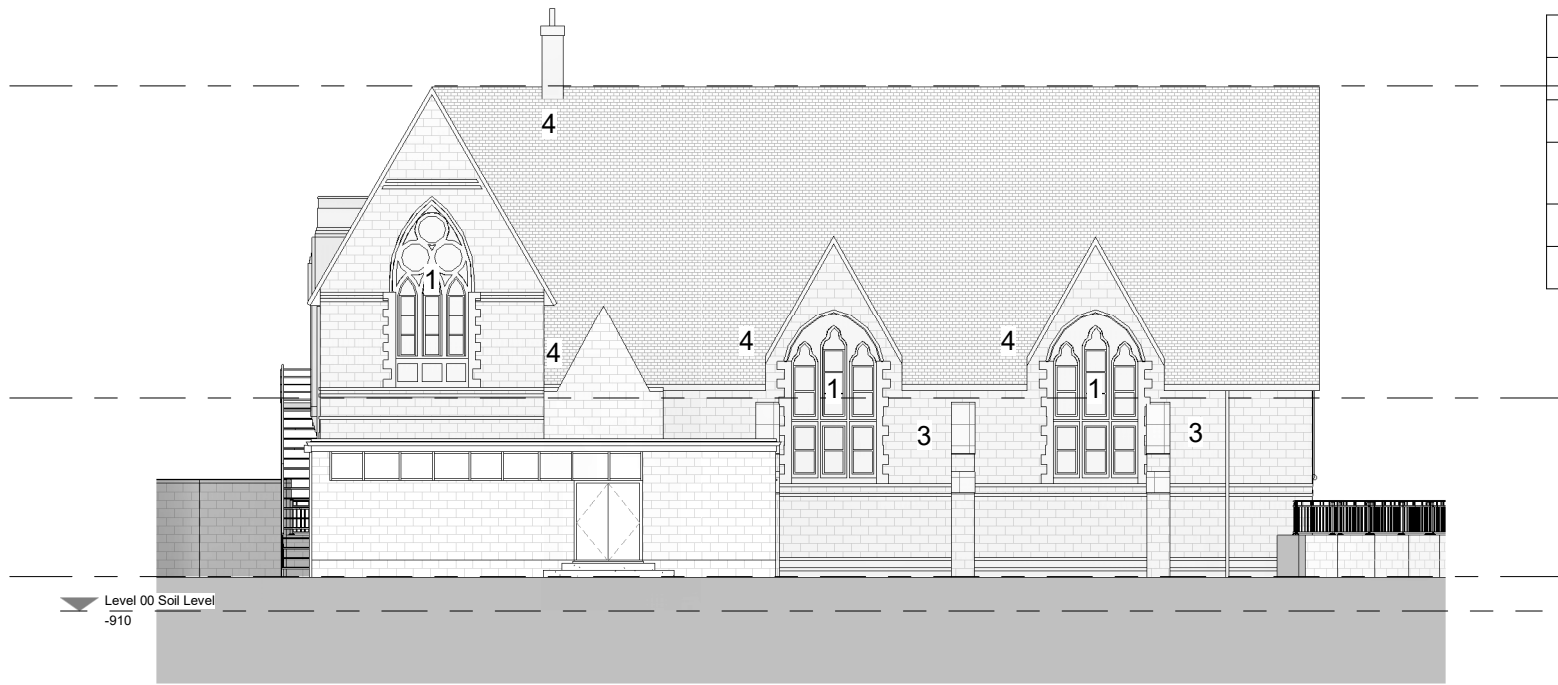
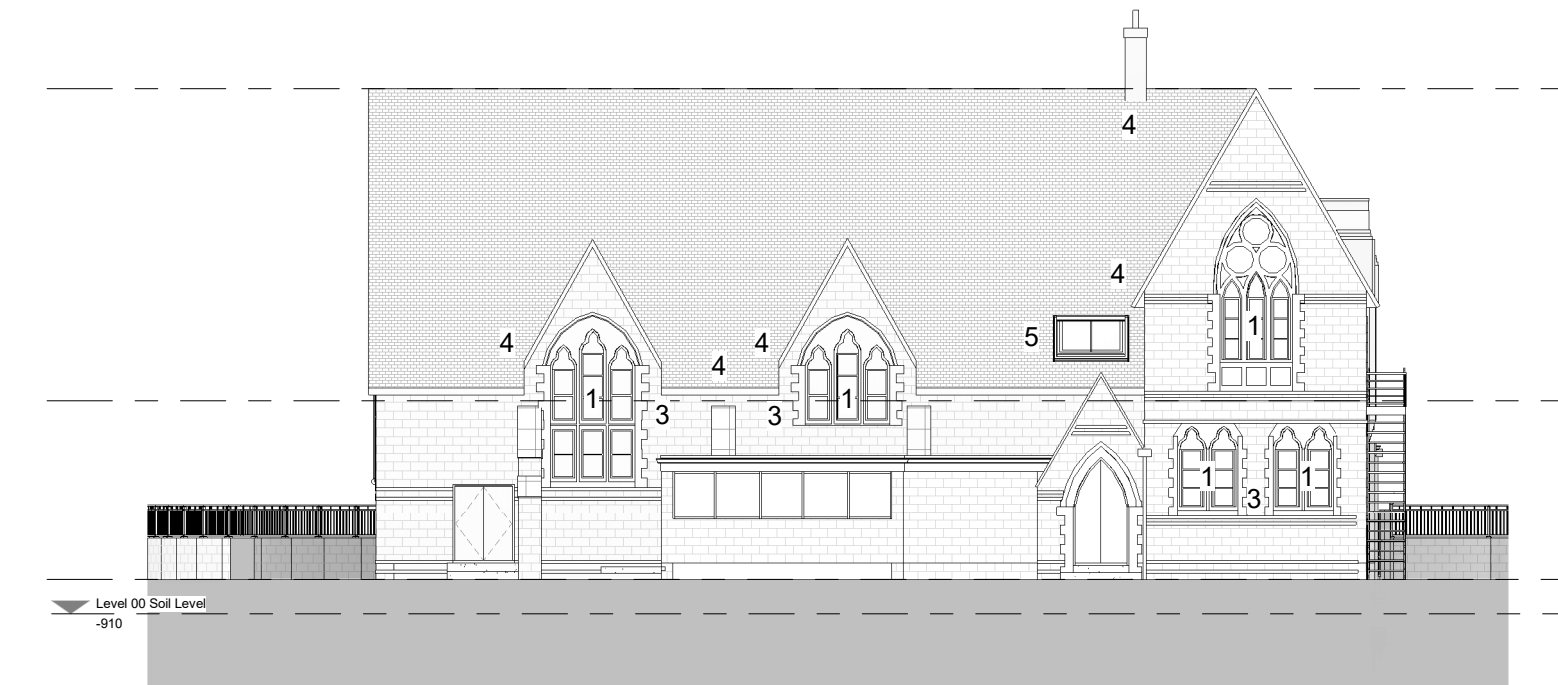
| Items in Need of Repair | |
| 1 | All Windows cleaned and repaired where required |
| 3 | Brickwork spalling and staining to be rectified |
| 5 | Damp by skylight to be rectified |
| 6 | Degradation at basement level. To be repaired |
