3951-01 / AS

John Southworth Ltd.  
10 Charles Street,  
Dukinfield,  
Cheshire,  
SK16 4SD

## REMEDIATION STRATEGY - LAND OFF VICTORIA AVENUE, HIGHER BLACKLEY

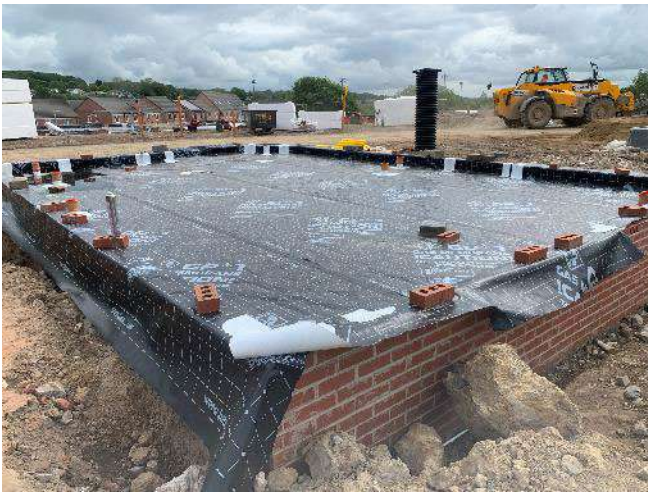
Figure 1 – Membrane neatly installed and in good condition.

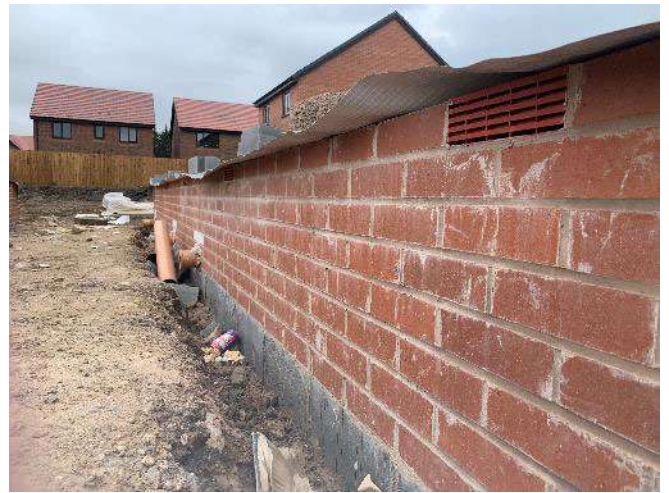
Figure 2 – Air bricks installed at 2m centres.

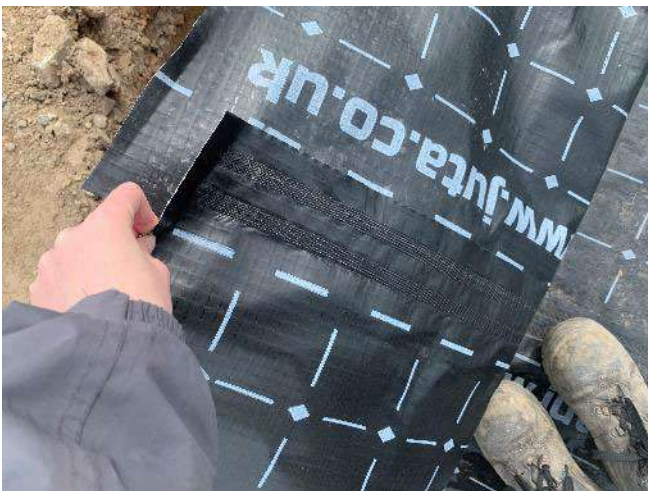
Figure 3 – Correct auto-welding.

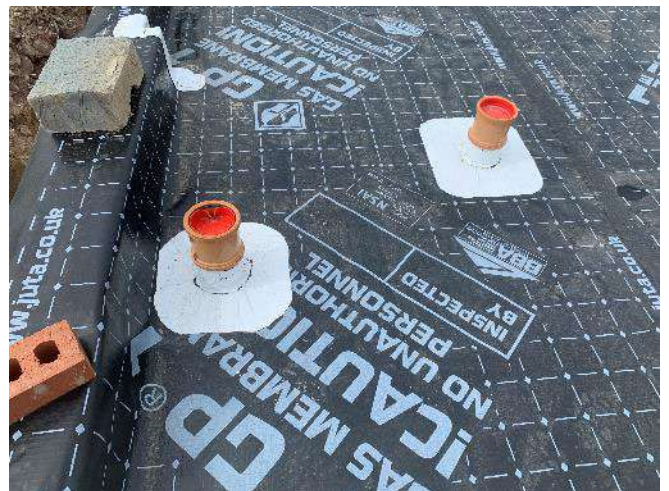
Figure 4 – Service penetrations sealed using detailing strip.

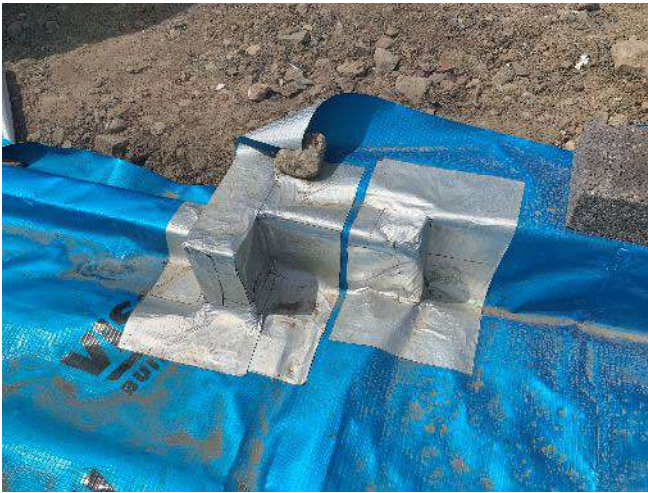
Figure 5 – Corners installed using detailing strip.

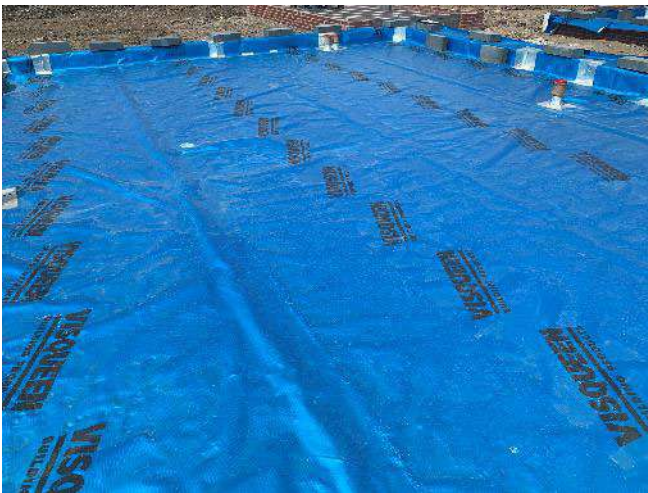
Figure 7 – Membrane kept free of stones, debris and equipment to ensure it stays intact. No holes, tears or punctures are present.

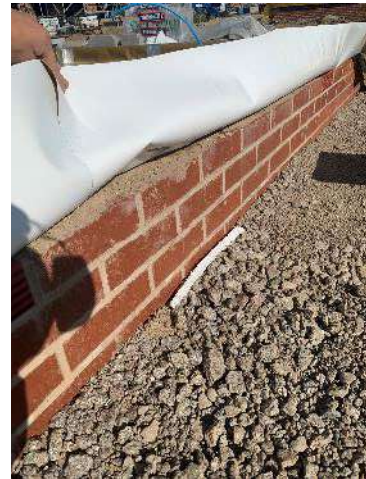
Figure 8 – Sufficient overlap of cavity.

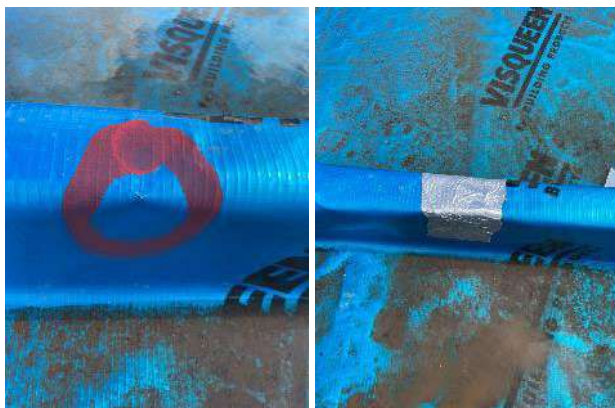
Figure 9 – Small hole noted and correctly patched using detailing strip.

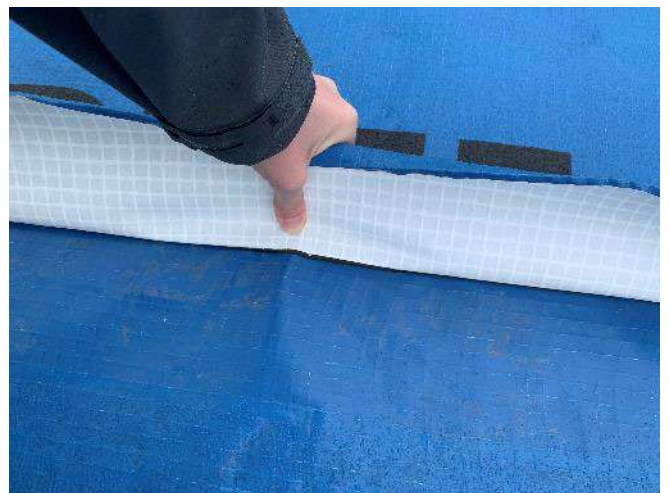
Figure 10 – Correct jointing with double sided tape.

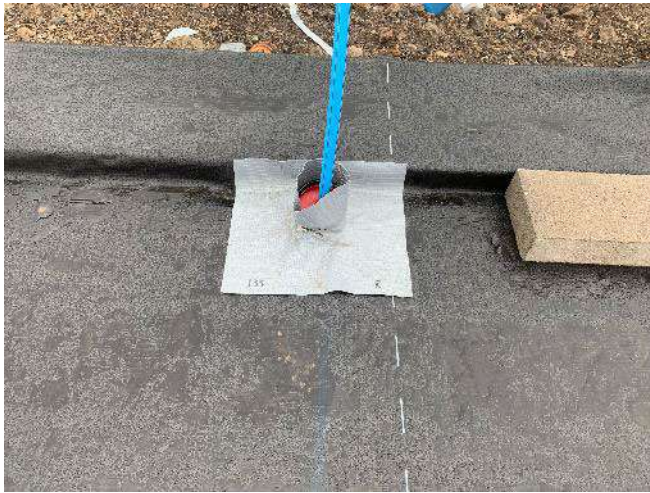
Figure 11 – Service penetration correctly sealed using a pre-formed top hat, double sided tape and jubilee clip.

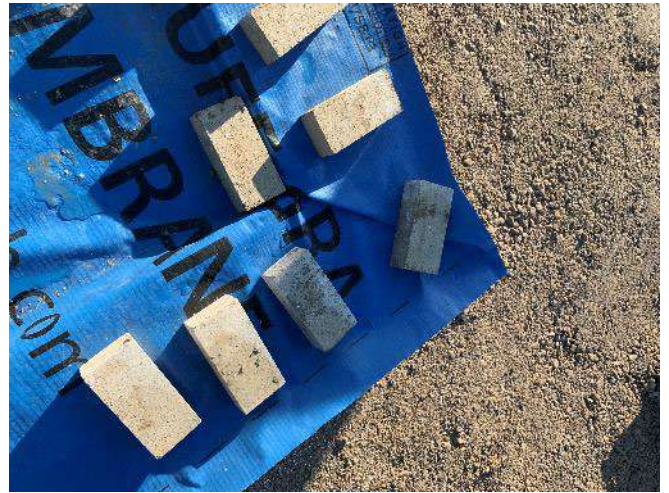
Figure 12 – Corner folded into place.

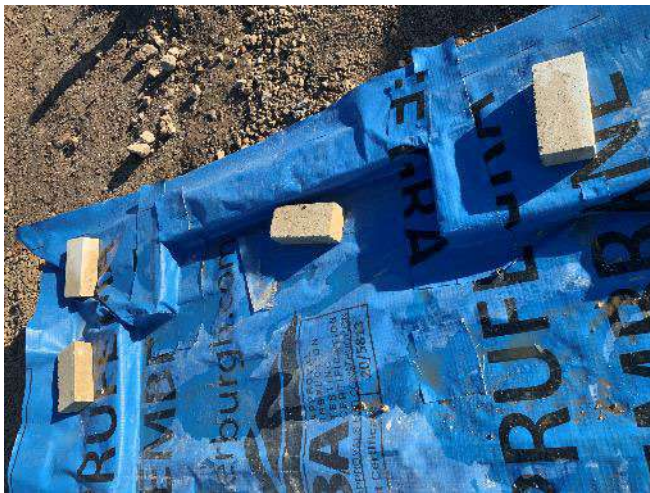
Figure 13 – Corners formed correctly using double sided tape.

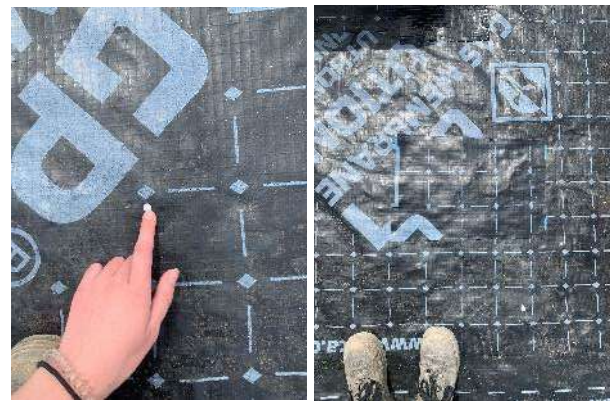
Figure 14 – Small hole noted and correctly patched using double sided tape.

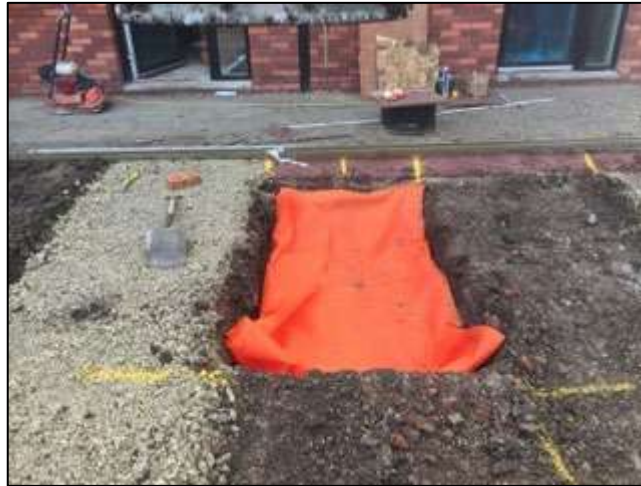
*Figure 1: First, the gardens are dug out to 600mm below FFL and lined with a hi-viz geotextile marker:*

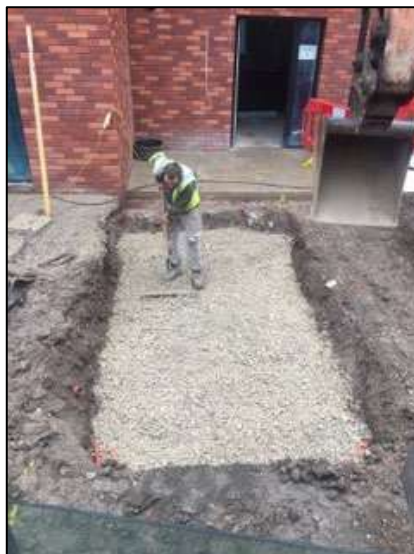
*Figure 2: The geotextile is overlain by a 150mm clean stone break layer.*

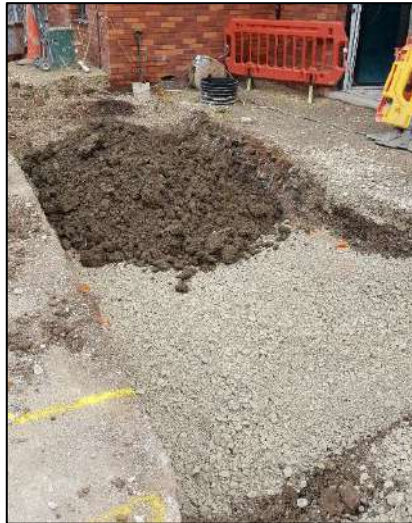
*Figure 3: The break layer is overlain by 300mm sub-soil, seen here before spreading across the garden:*

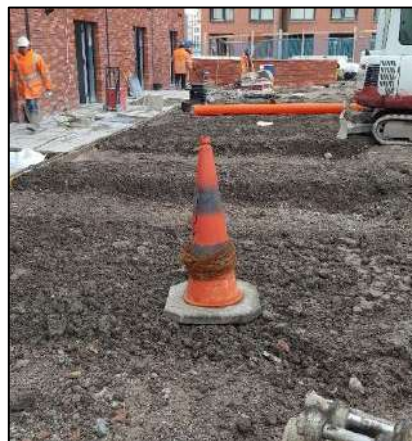
*Figure 4: The sub-soil is overlain by 150mm topsoil to FFL:*

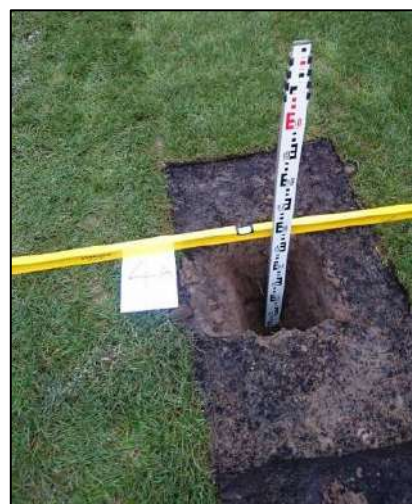
*Figure 5: The gardens are finished with turf. The overall cover system depth is 600mm:*

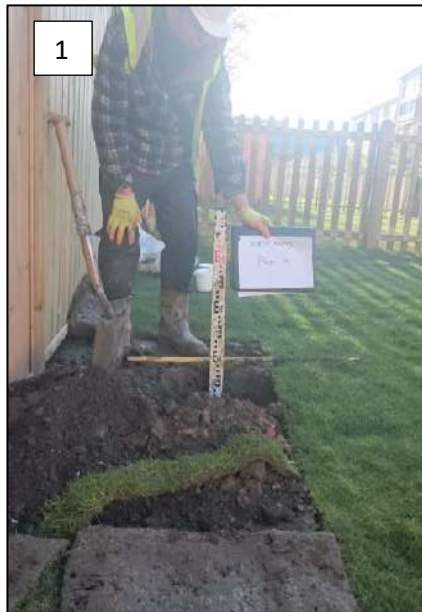
Photograph 1 – Identifies the plot number and shows the validation dig location in relation to the plot.

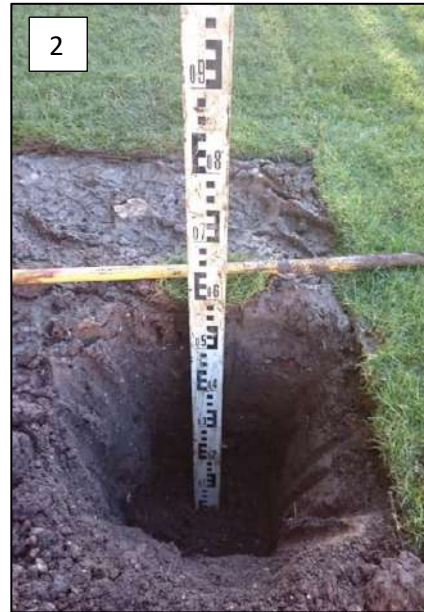
Photograph 2 – Shows the validation depth clearly, using a staff and a marker which crosses the hole. Shows the topsoil and subsoil, and the base of the hole.
