# Greenheys Development Demolition Management Plan

Document Reference: 00168434-002-MSPGH-XX-GD-Z-0004

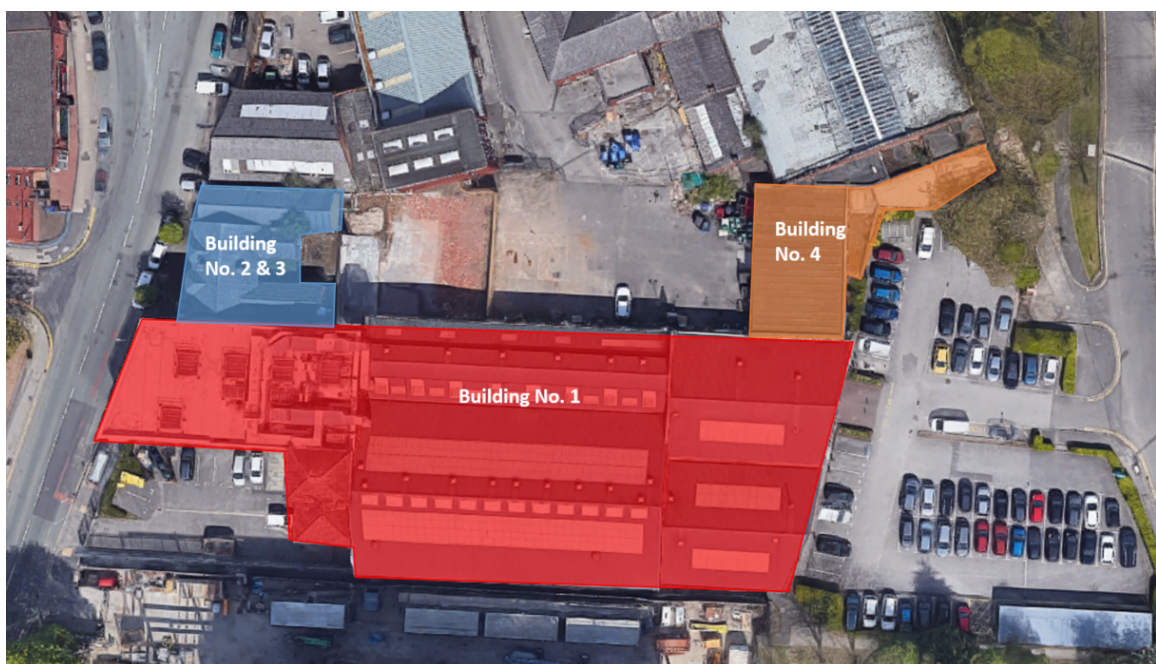
Fig5: Overview of buildings scheduled for demolition.

There are 4 buildings on site which will be demolished, identified as per Fig5 below. Building 1 is also referred to as the Greenheys Business Centre, Buildings 2 & 3 are also referred to as No.7 and No. 9 Greenheys Lane respectively and Building 4 is also referred to as the McDougall Centre Furniture Store.

Building No 1 is a two storey building for the most part with a small section being 3 stories. The make up of the building consists of a mixture of timber and steel pitched roof with corrugated roofing panels, double skin brick walls sat on a concrete base. Building No 2 and 3 are two storey terraced houses which consist of a timber pitched roof with concrete roof tiles, double skin brick walls sat on a concrete base. Building No 3 is connected via flashing to an adjoining property (an existing garage outside of the demolition site boundary and under separate ownership). Building No 4 is a single story brick building which has been extended from its eastern elevation since first construction; both the main building and extensions will be demolished.

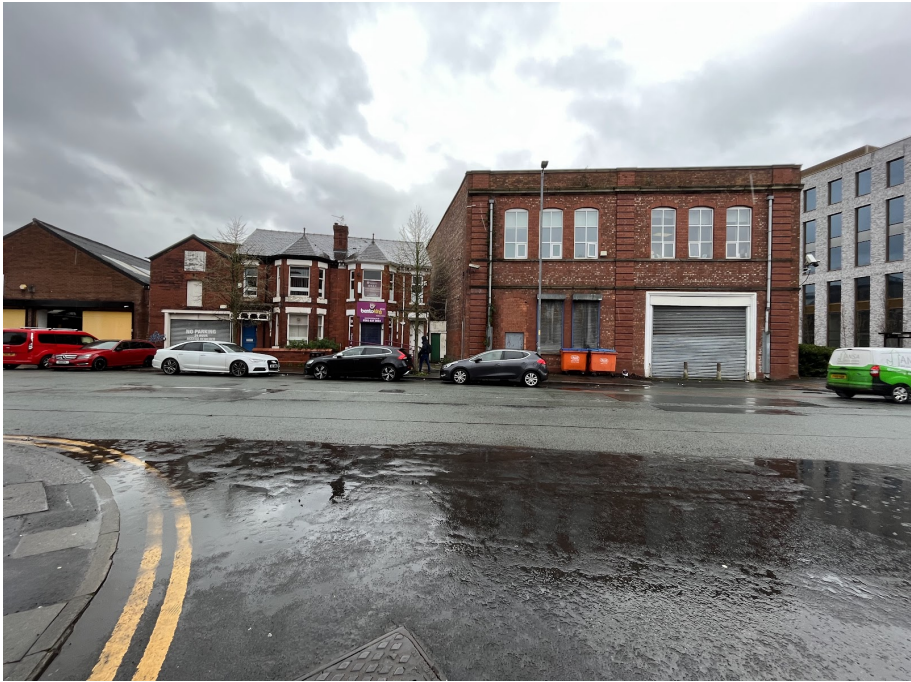
Image 1: West elevation of buildings 1, 2 & 3.

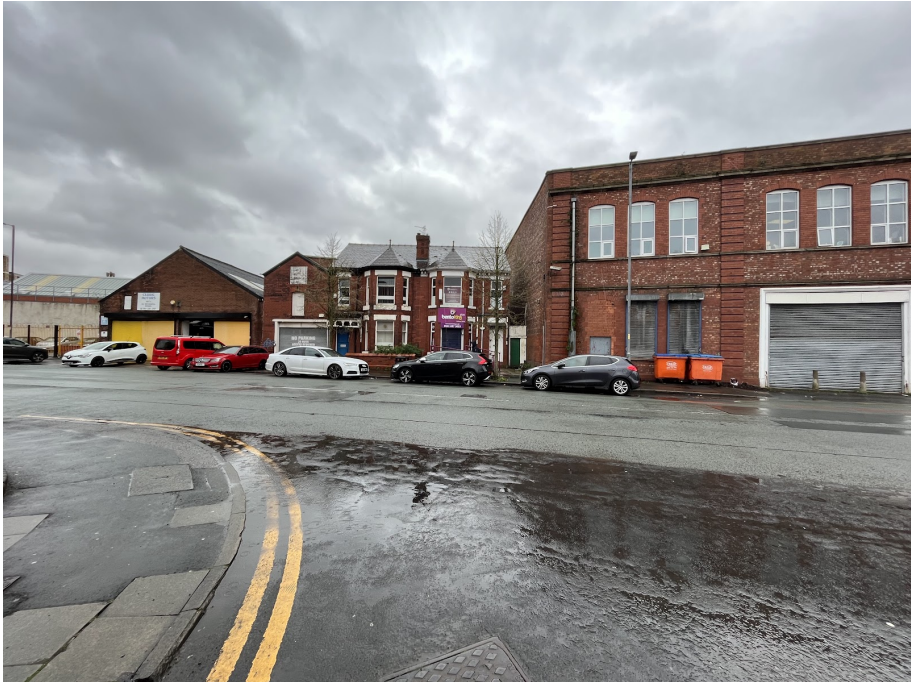
Image 2: West elevation of buildings 1, 2 & 3.

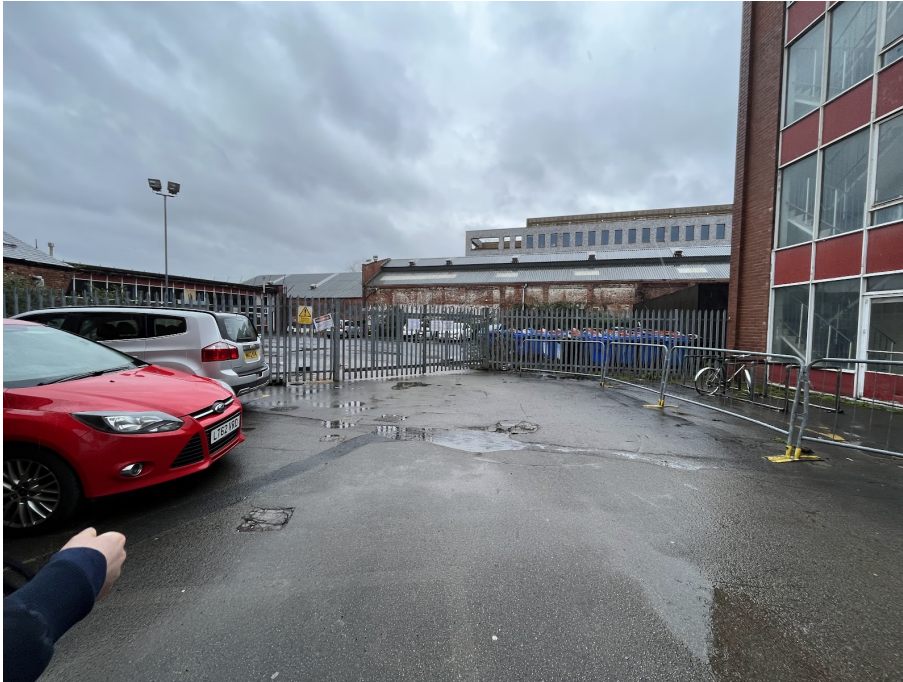
**Image 3:** North elevation of building 1 and west elevation of building 4 visible behind fencing.

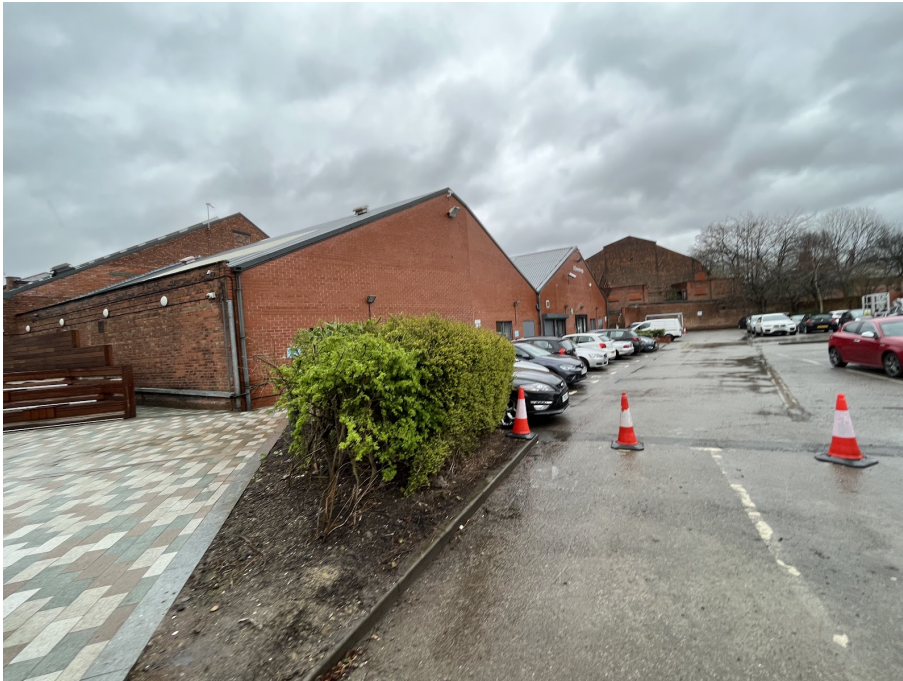
**Image 4:** South-east section of building 1 and adjacent car park (within demolition site).

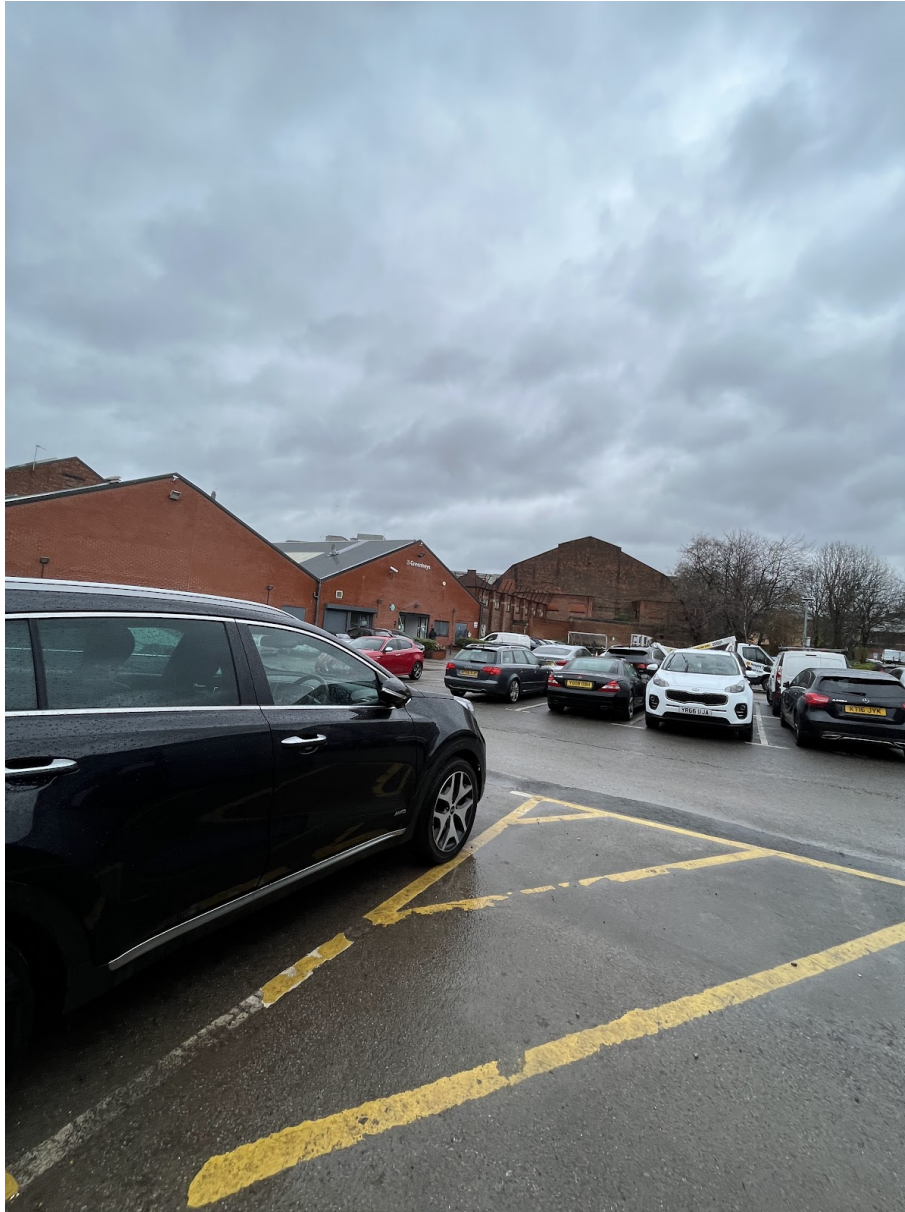
**Image 5:** East elevation of building 1. East elevation of building 4 visible in back ground.

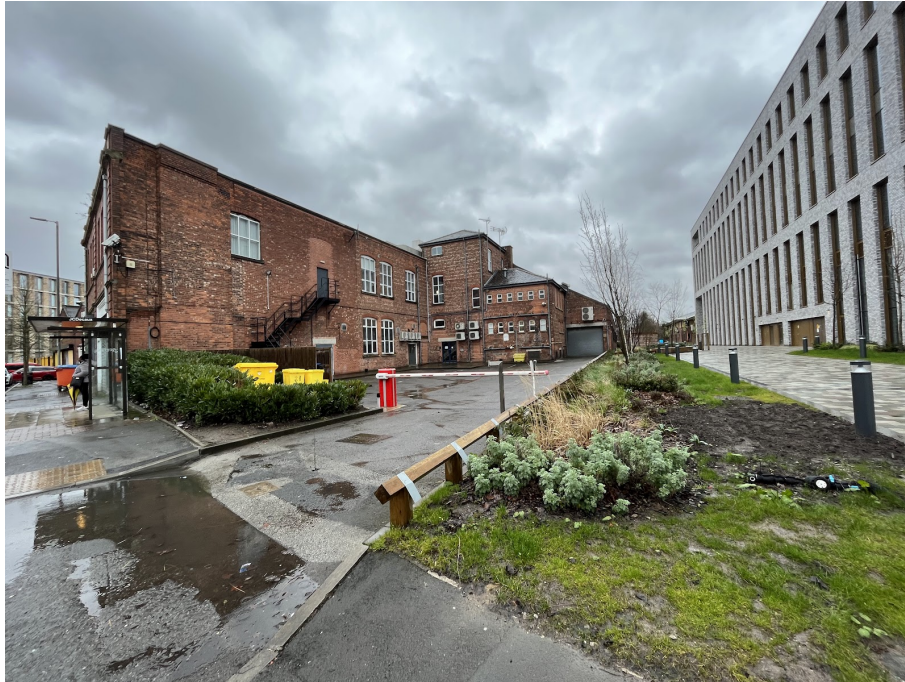
**Image 6:** Service yard in west section of building 1.

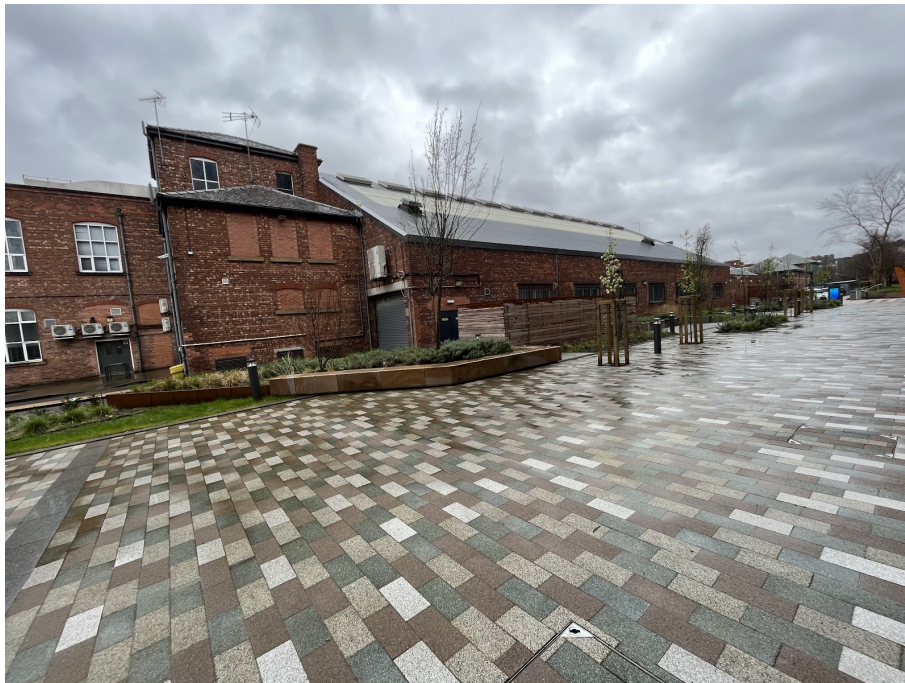
**Image 7:** South elevation of building 1.

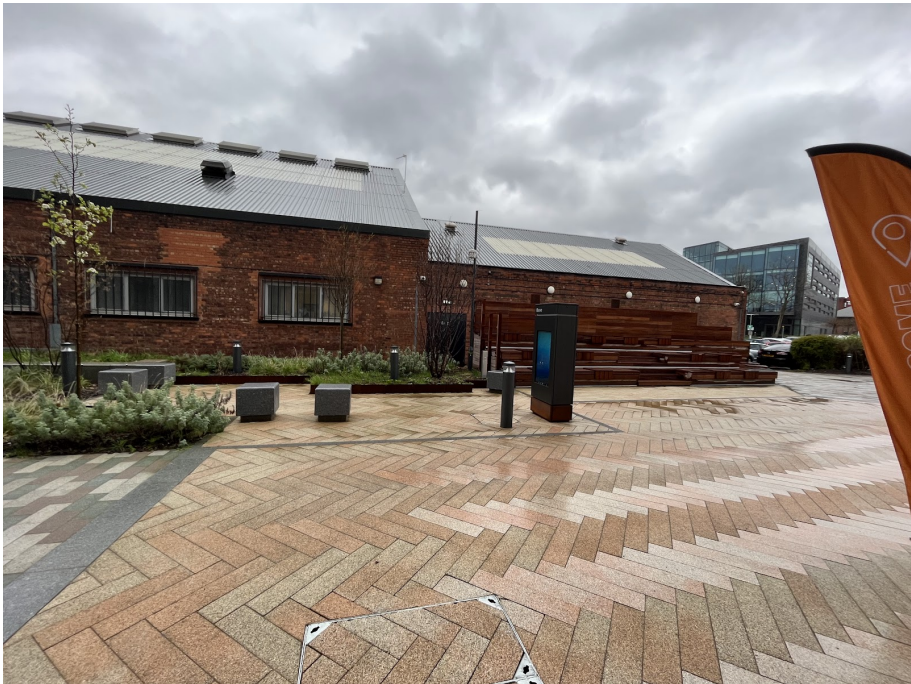
Image 8: South elevation (eastern portion) of building 1.

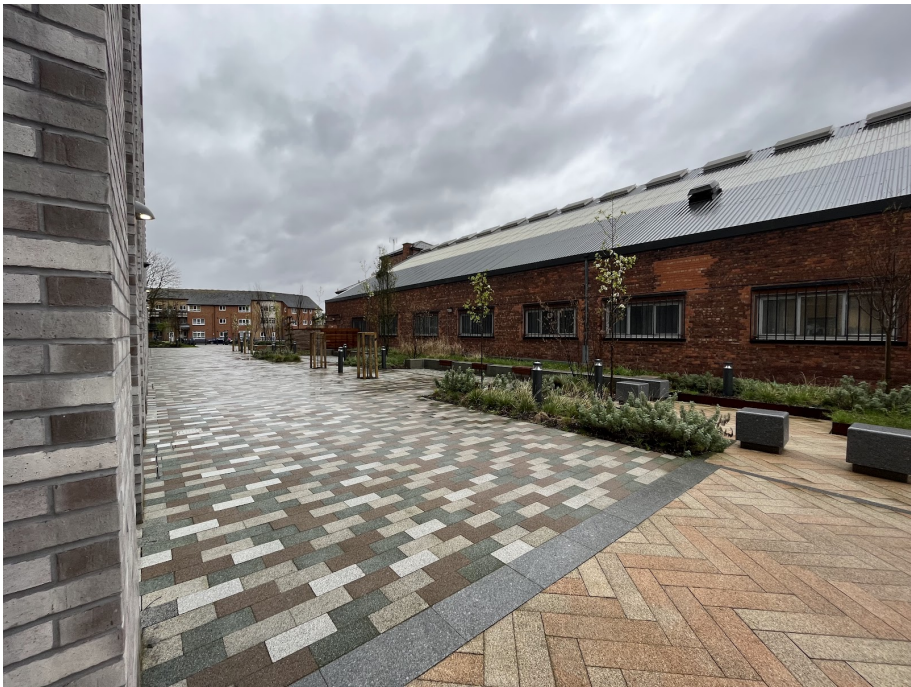
Image 9: South elevation (western portion) of building 1.

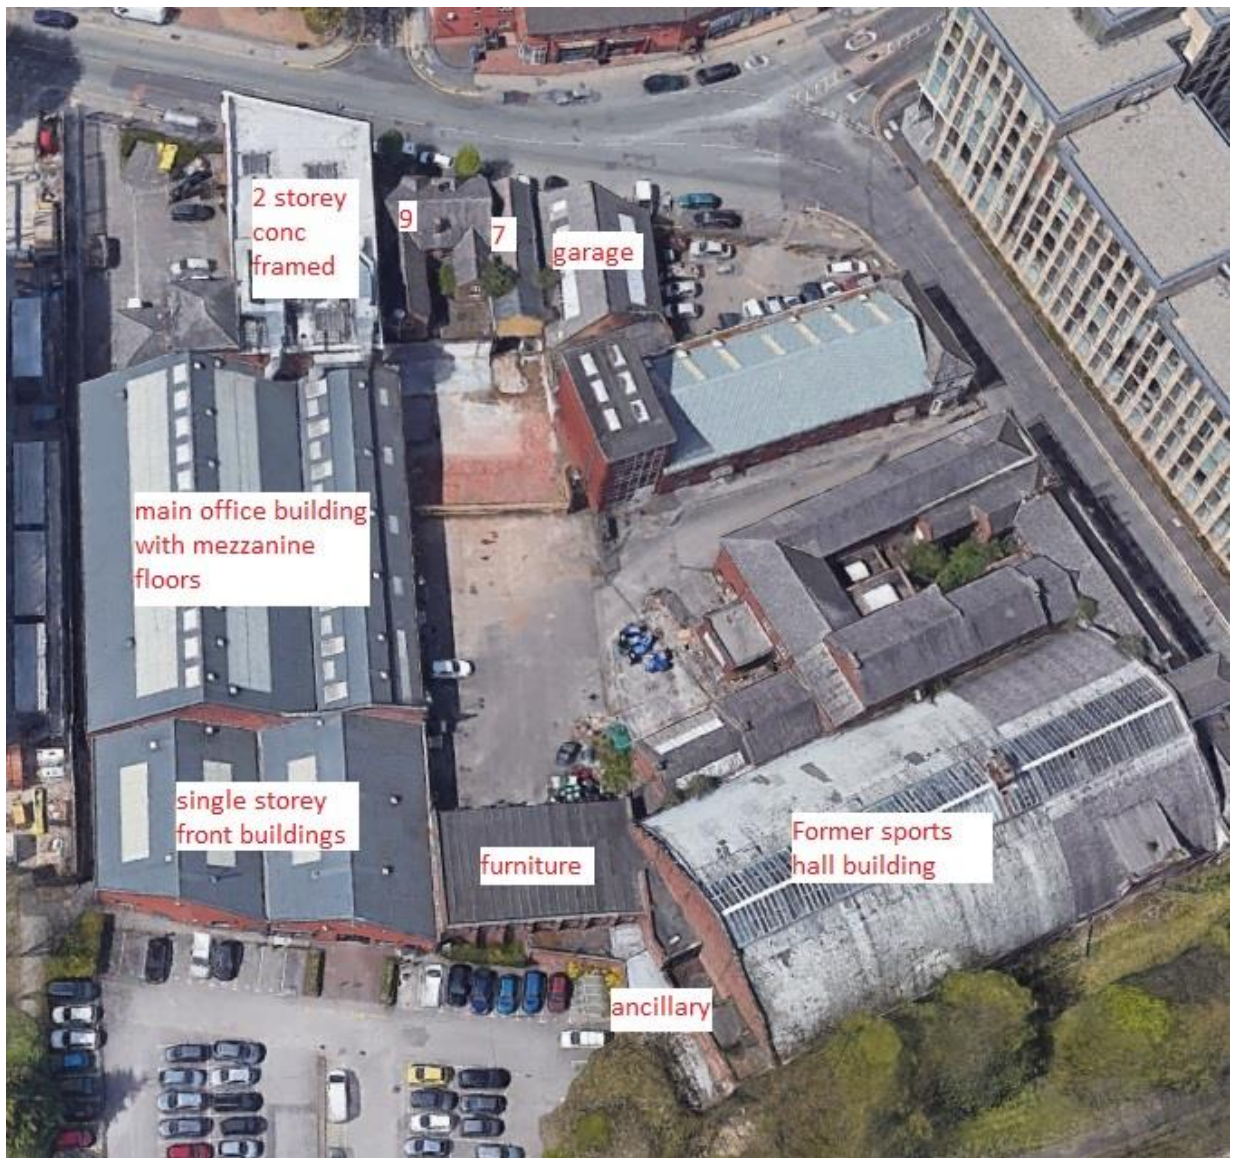
Aerial view from East indicating structures to be demolished and the Garage and Sports Hall buildings that are to remain occupied during the works

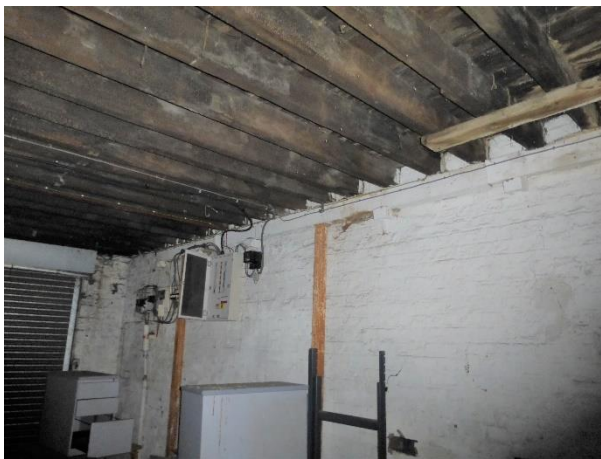
Underside of first floor joists

- Demolition of No 7 & 9 Greenheys Lane must fully consider the adjacent garage property, which will be operational during the demolition process.
- The 'link' between No 7 and the garage appears to be the infill of a former road access, constructed with suspended timber joists at first floor level and timber trusses at roof level. The floor joists and roof trusses are supported on the boundary wall to the garage and therefore this section must be propped and carefully dismantled to avoid ANY damage to the party wall. In addition, the garage roof must be protected to prevent any demolition materials falling through or damaging the roof coverings. It must also be noted that the first floor joists and floor are in very poor condition due to water ingress through the roof over many years.

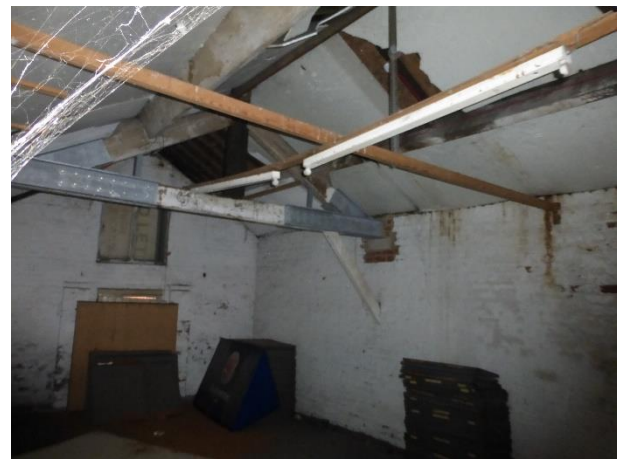
Roof trusses

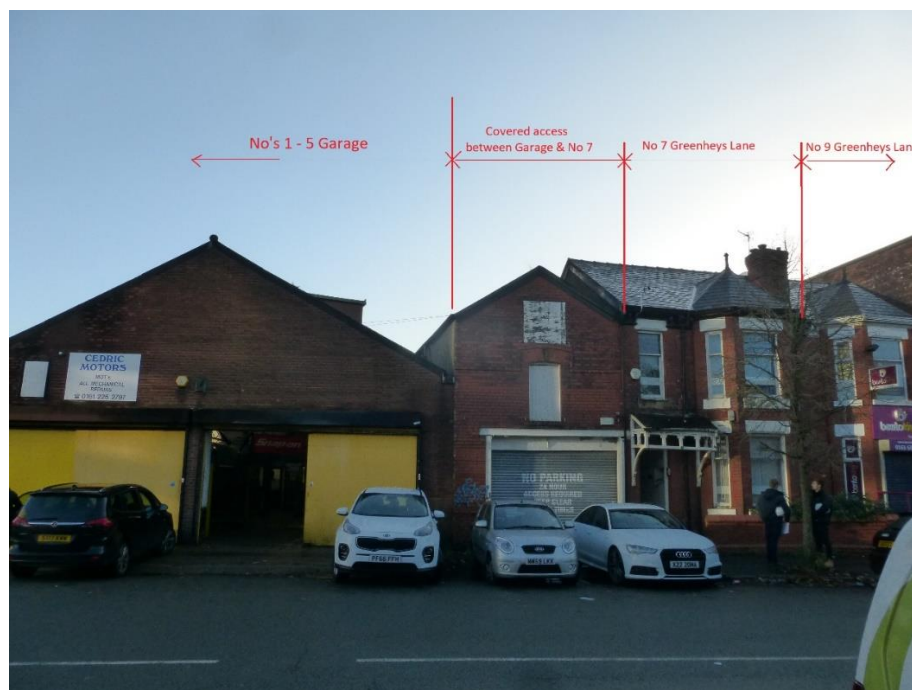
#### Street elevation.

Note the party wall between the garage (No 1-5) and No 7 Greenheys Lane extends above the garage roof level and therefore great care must be taken to ensure the safety of the occupiers of the garage and the garage building and roof.

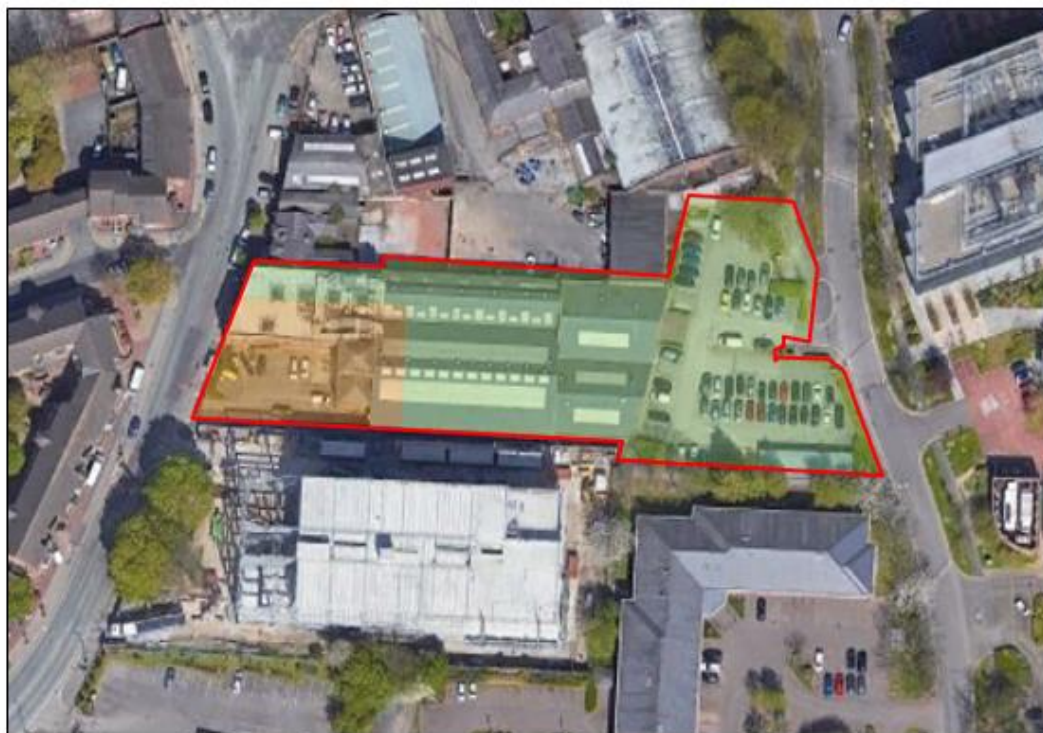
### German UXO Risk Map

For indicative purposes – not to scale.

Please note that this assessed risk map may not take into account all post-war redevelopment/excavations on site.
