# Echo Street Additional Ground Investigation, Manchester

## Phase 2 Additional Ground Investigation

Curtins Ref: 065374-CUR-00-XX-RP-GE-8003-P03

Site Address: Echo Street, Granby Row, Manchester, M1 3QJ

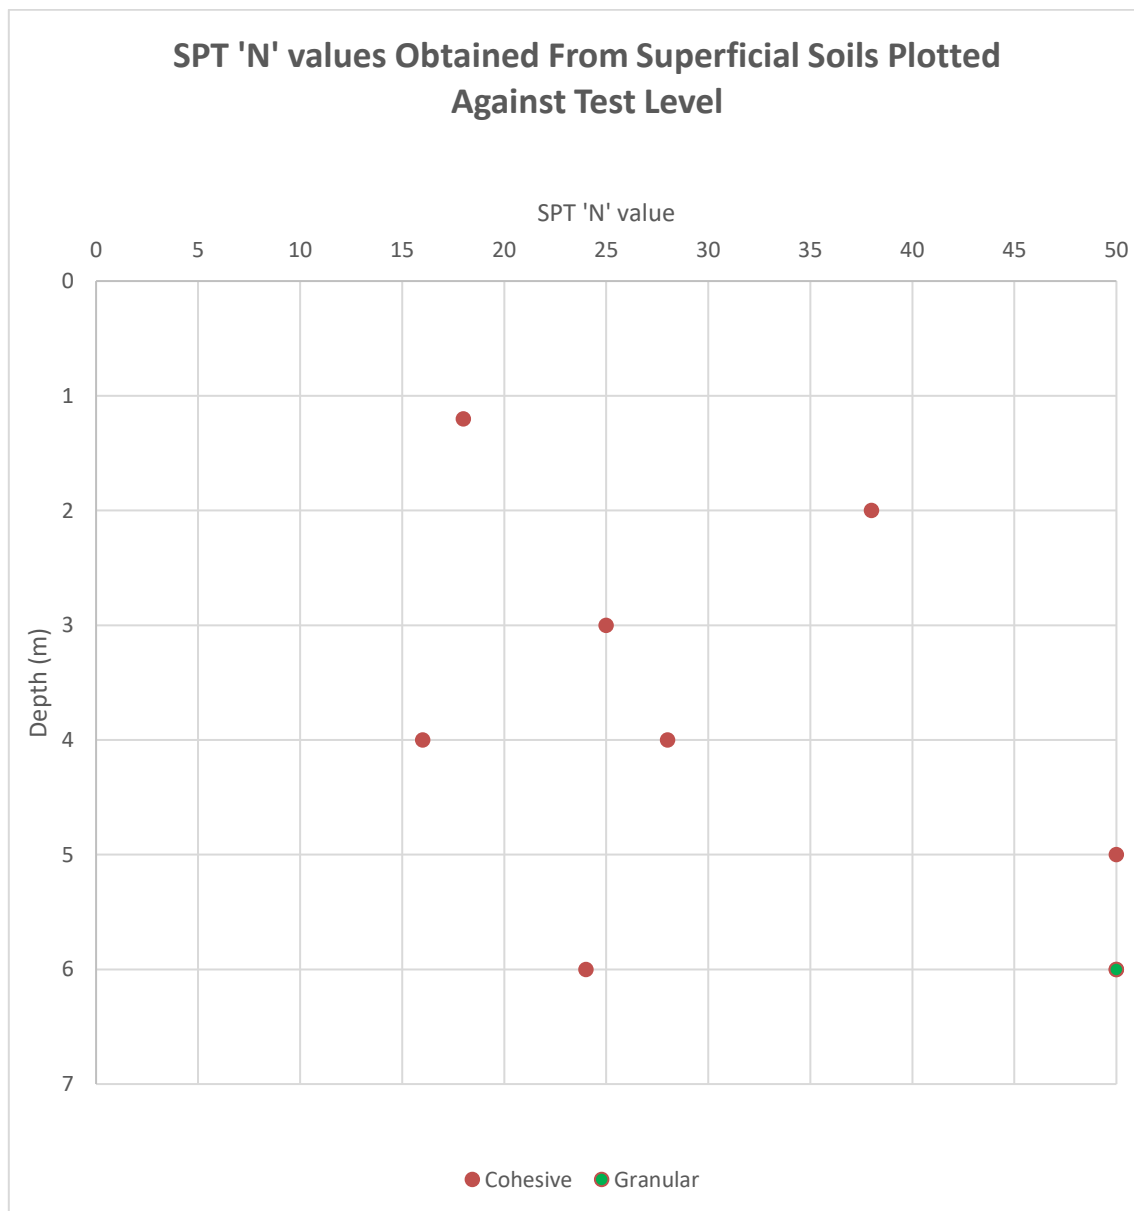
**Figure 4.3 – SPT 'N' Values vs Depth**

SPT 'N' Values in cohesive superficial soils generally increase with depth, though are generally variable, illustrated in *Figure 4.3*.

Refusals on Figure 4.3 shown as SPT N = 50 for demonstration.

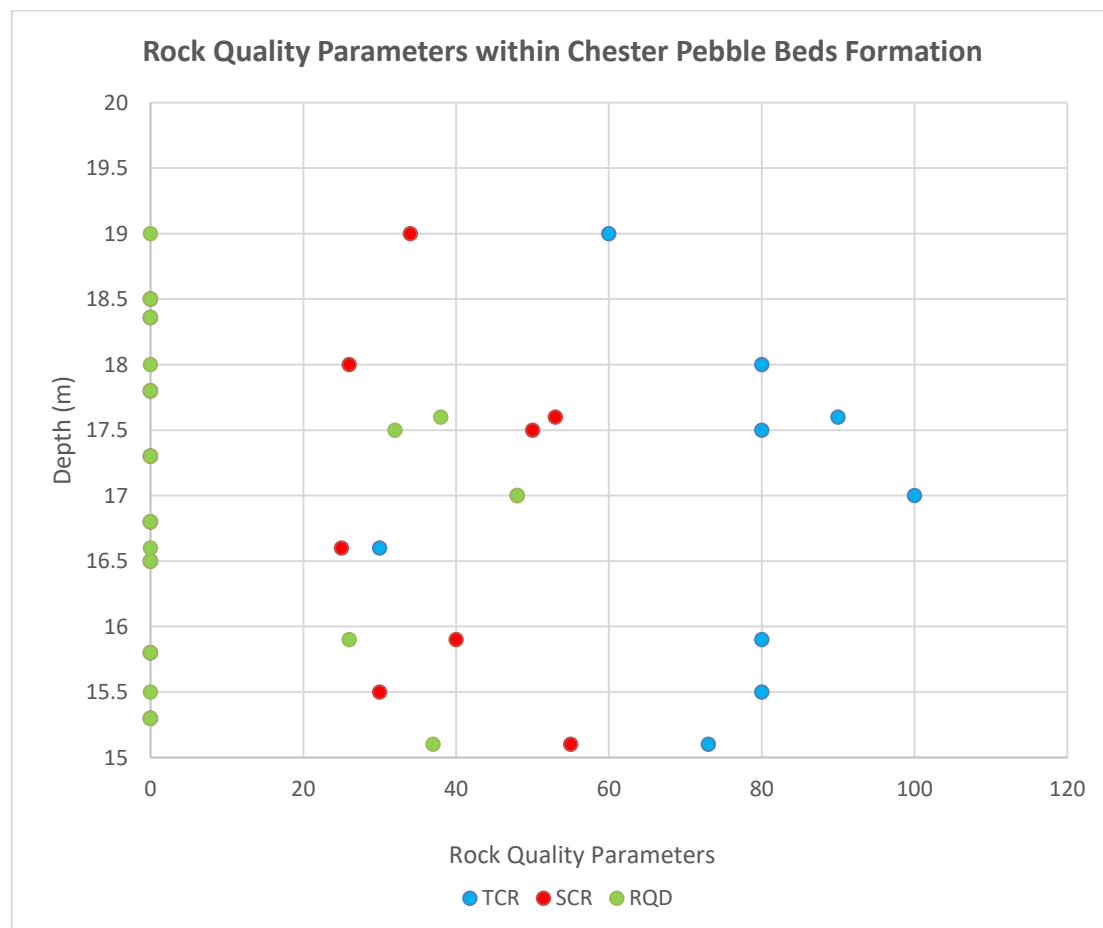
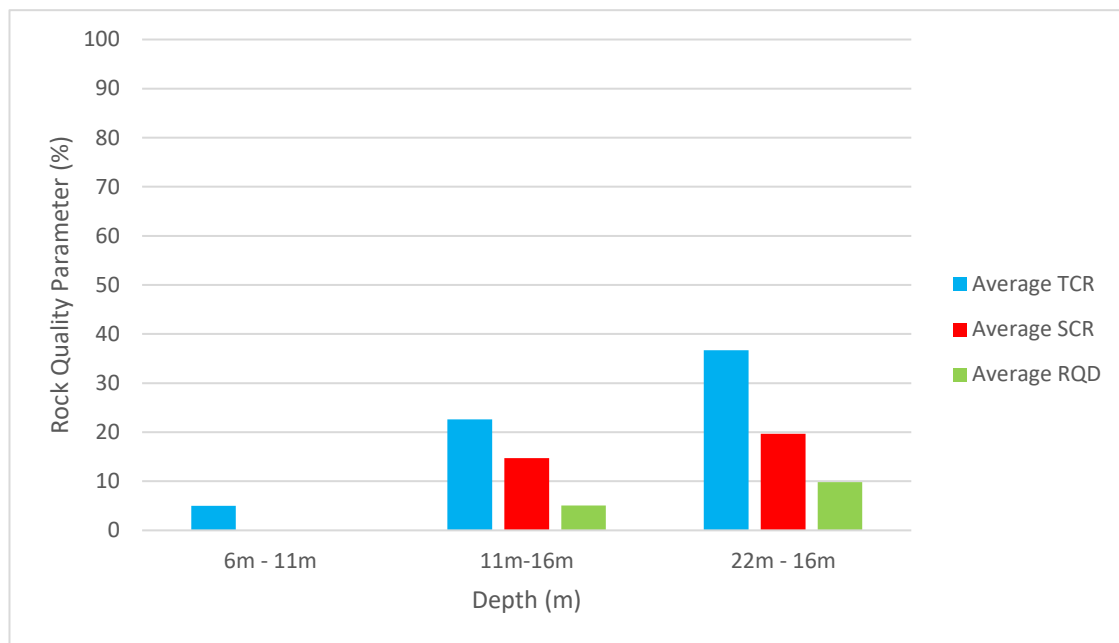
**Figure 4.5a – Summary of Rock Quality Parameters within Sandstone bedrock**

Rock Quality Designation (RQD) recorded in the cored samples ranged from 0% to 59%, averaging 5.2% across all of the rock core samples. This classifies the rock as being of very poor to fair rock mass quality. The RQD varies significantly between core runs. The total core recovery (TCR) ranged between 0% - 100% and the solid core recovery (SCR) ranged between 0% - 89%. The variability in the quality of the rock core samples recovered during this investigation is illustrated in *Figure 4.5a*.

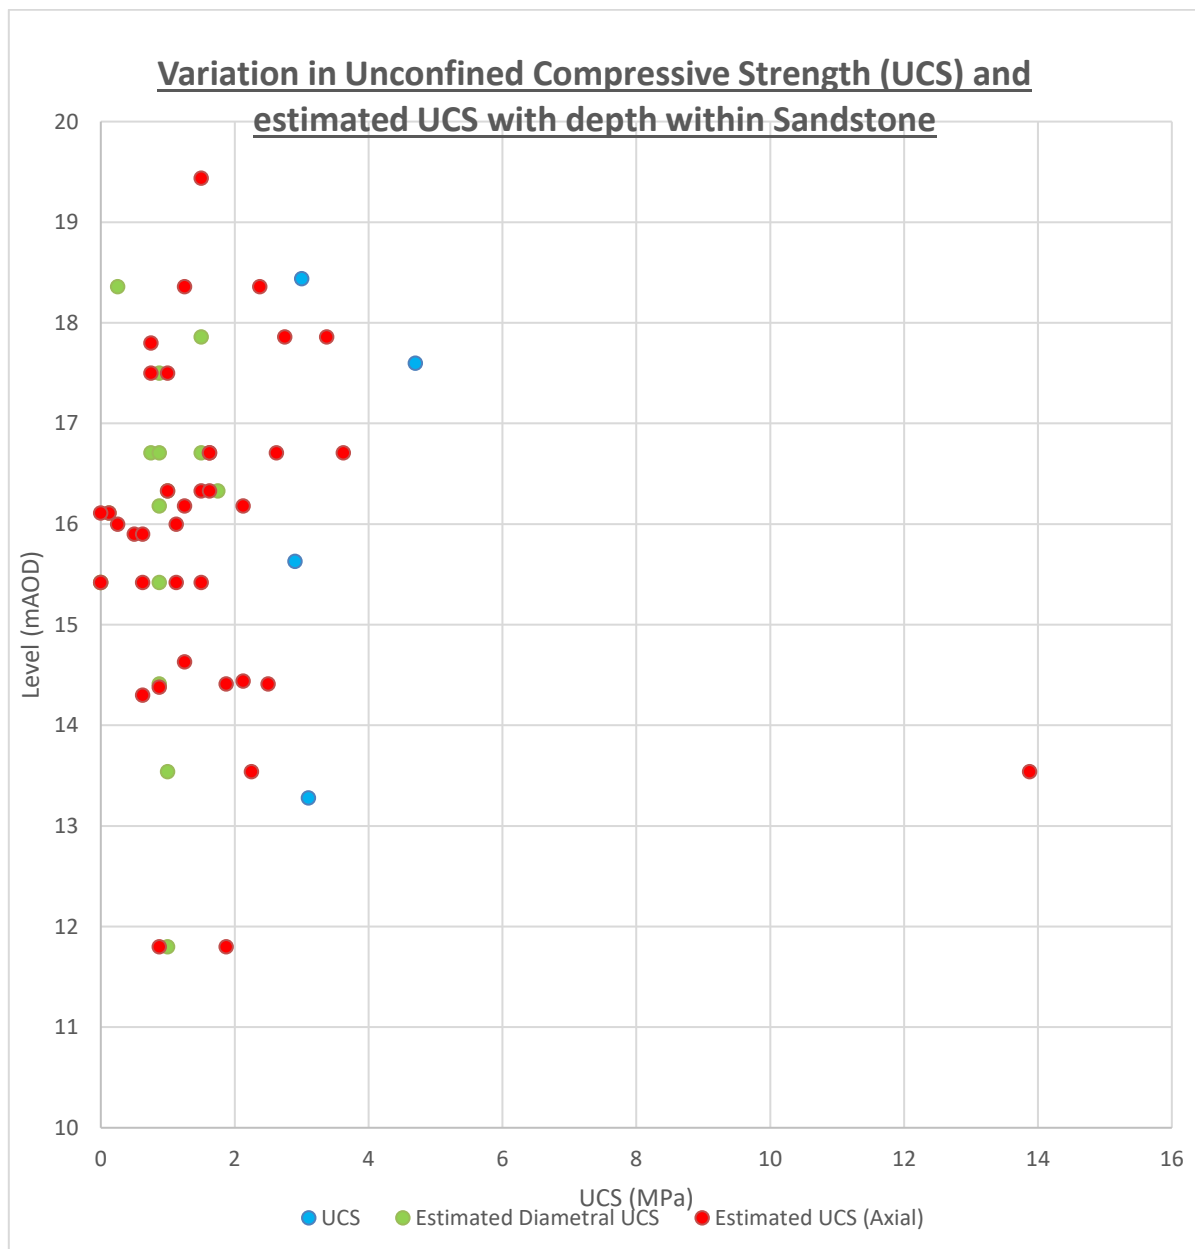
**Figure 4.5b** – UCS and estimated UCS vs Depth within Sandstone.

*Figure 4.5b*, summarises the UCS, estimated axial UCS and estimated diametral UCS test results against depth.

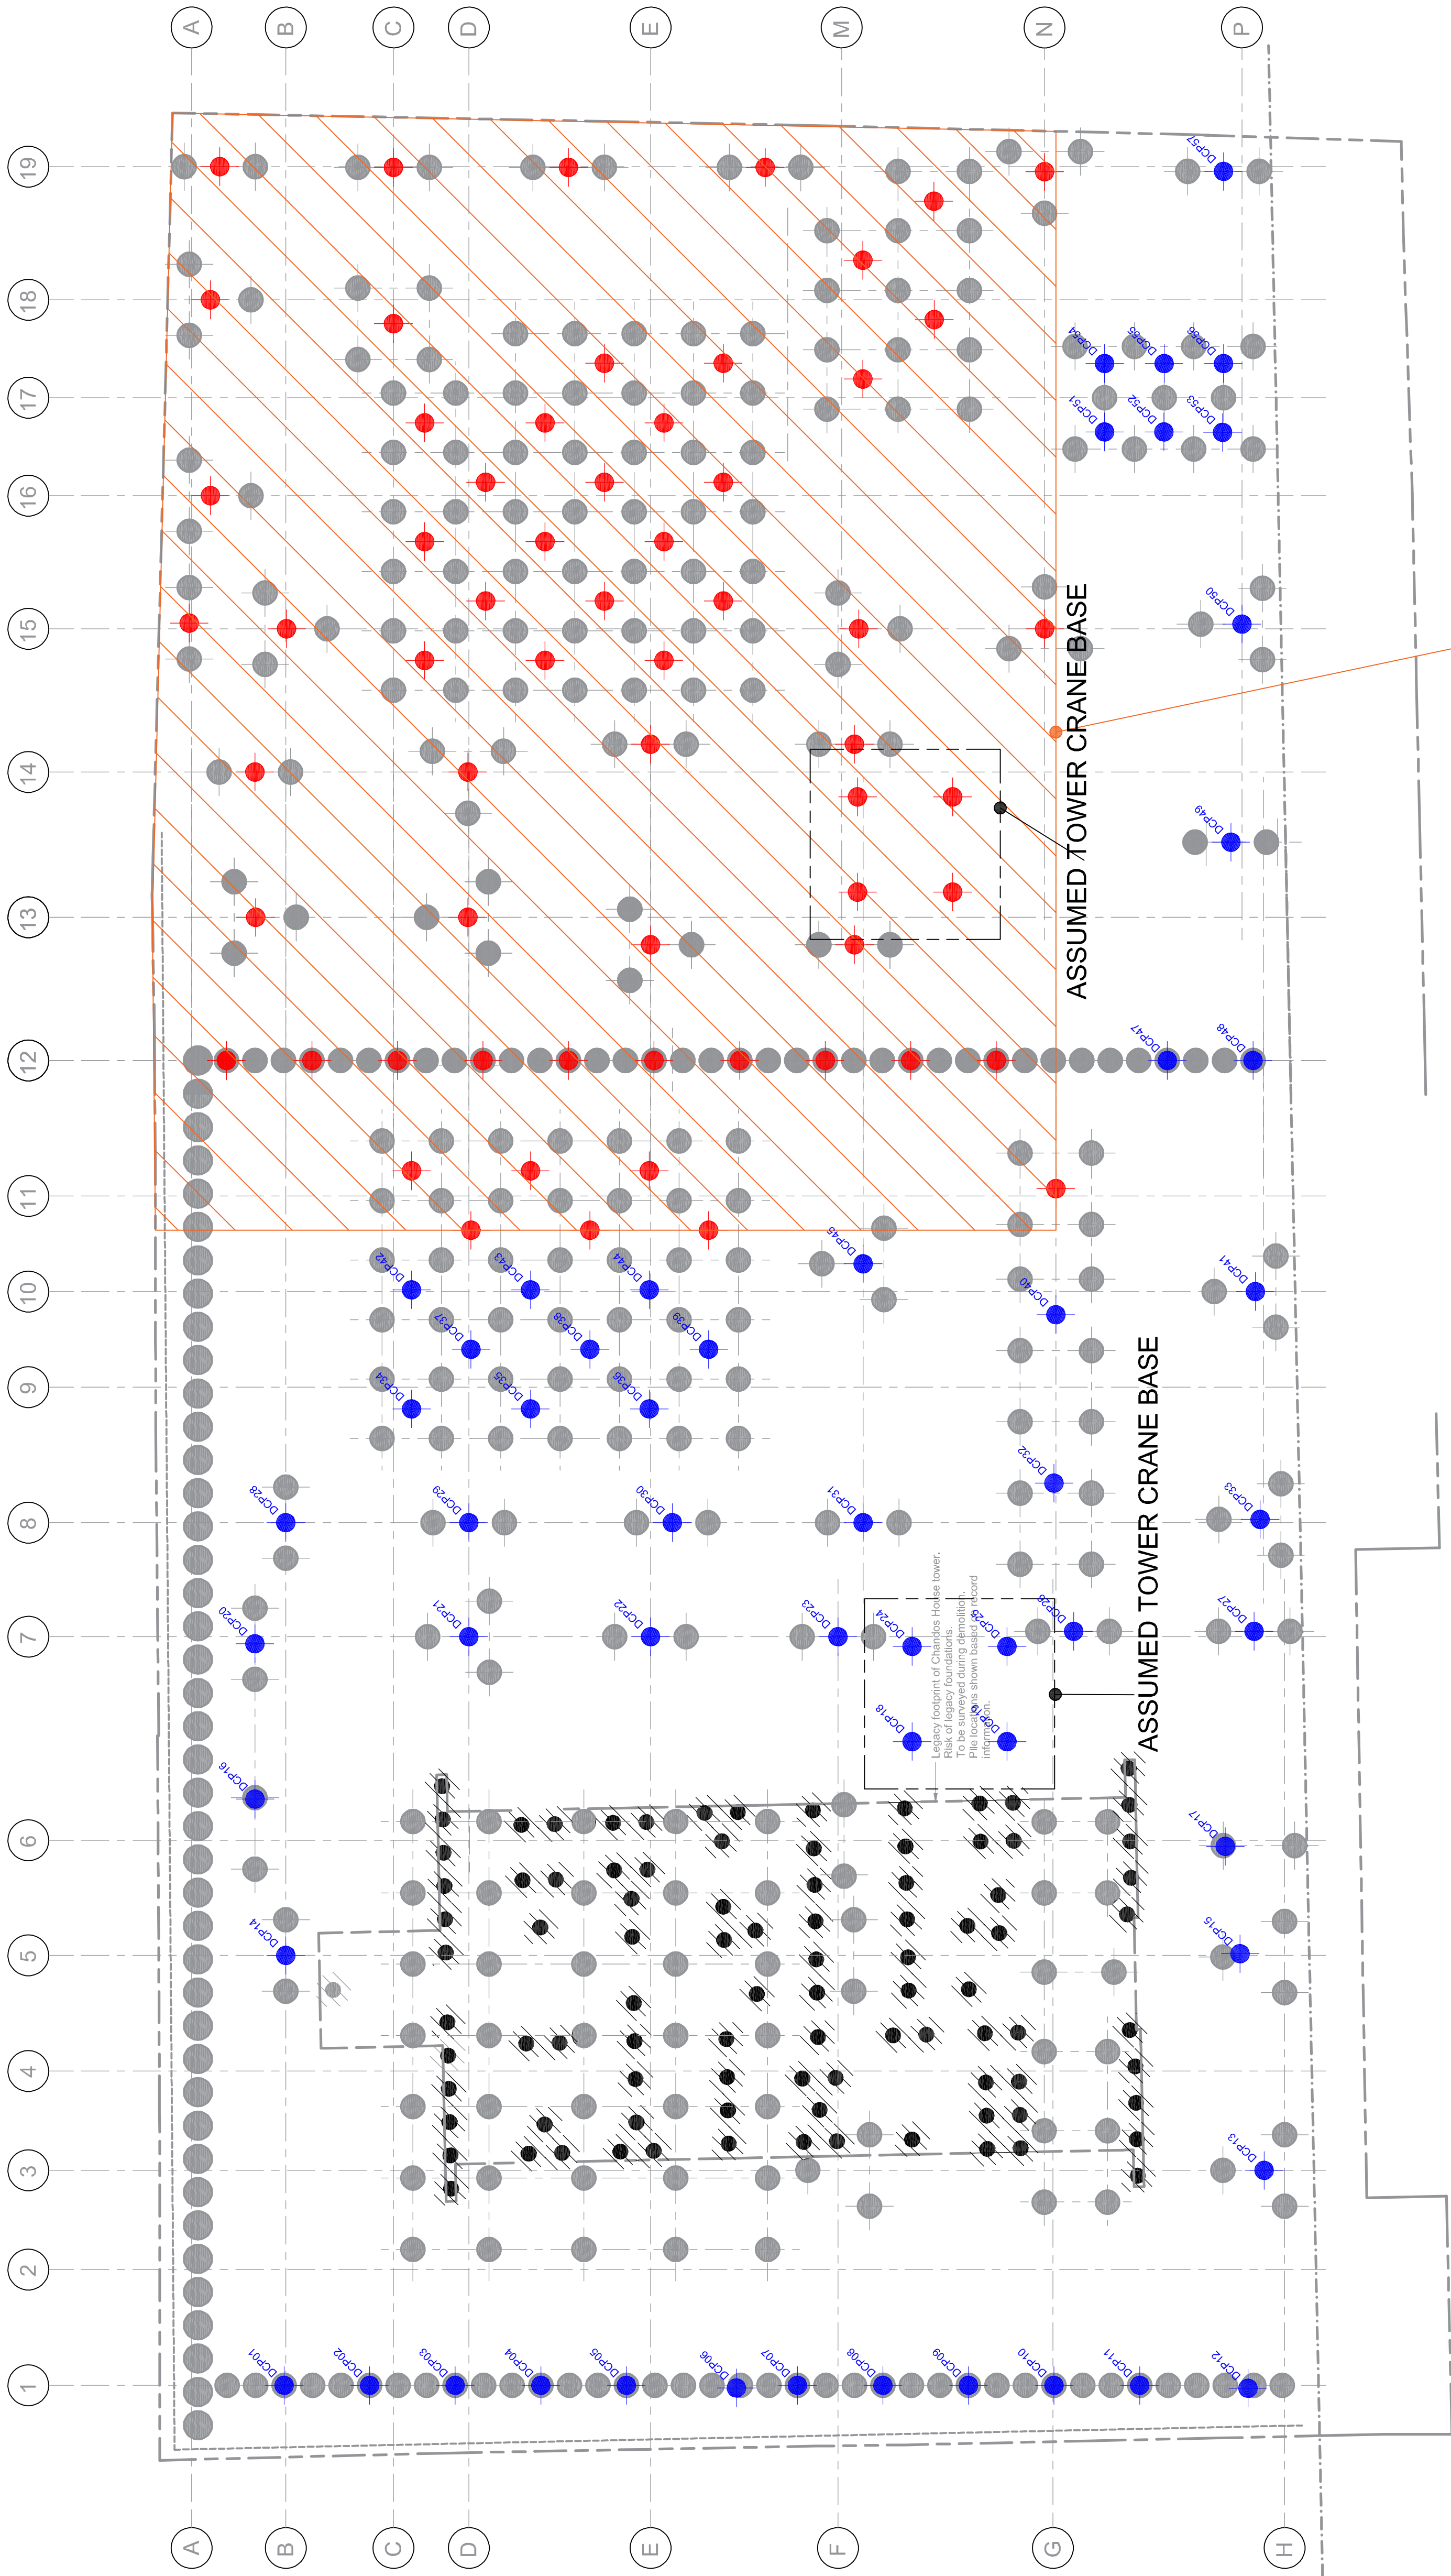
ASSUMED "**MEDIUM RISK**" UXO AREA, AS PER '1ST LINE DEFENCE REPORT'

| " <b>MEDIUM RISK</b> " UXO PROBE POSITIONS<br>(TO BE UNDERTAKEN BY OTHERS) | - 62 Nr |

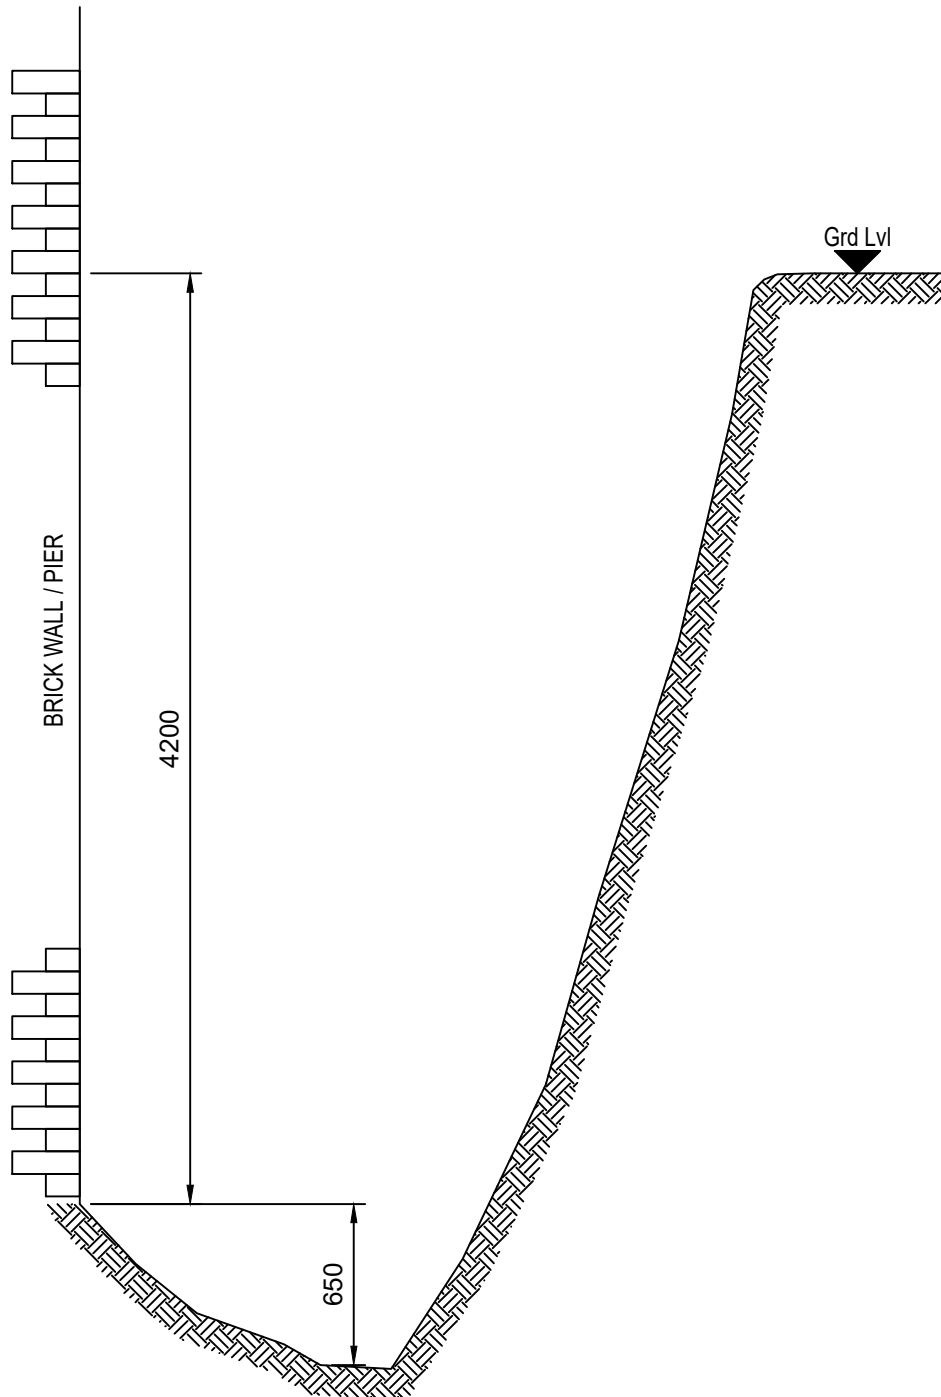
NO EVIDENCE OF FOUNDATIONS IDENTIFIED TO BASE OF HOLE.  
REFER TO CURTINS TRIAL PIT LOG FOR STRATA DETAILS.  
TRIAL PIT UNDERTAKEN AGAINST BRICK PIER.

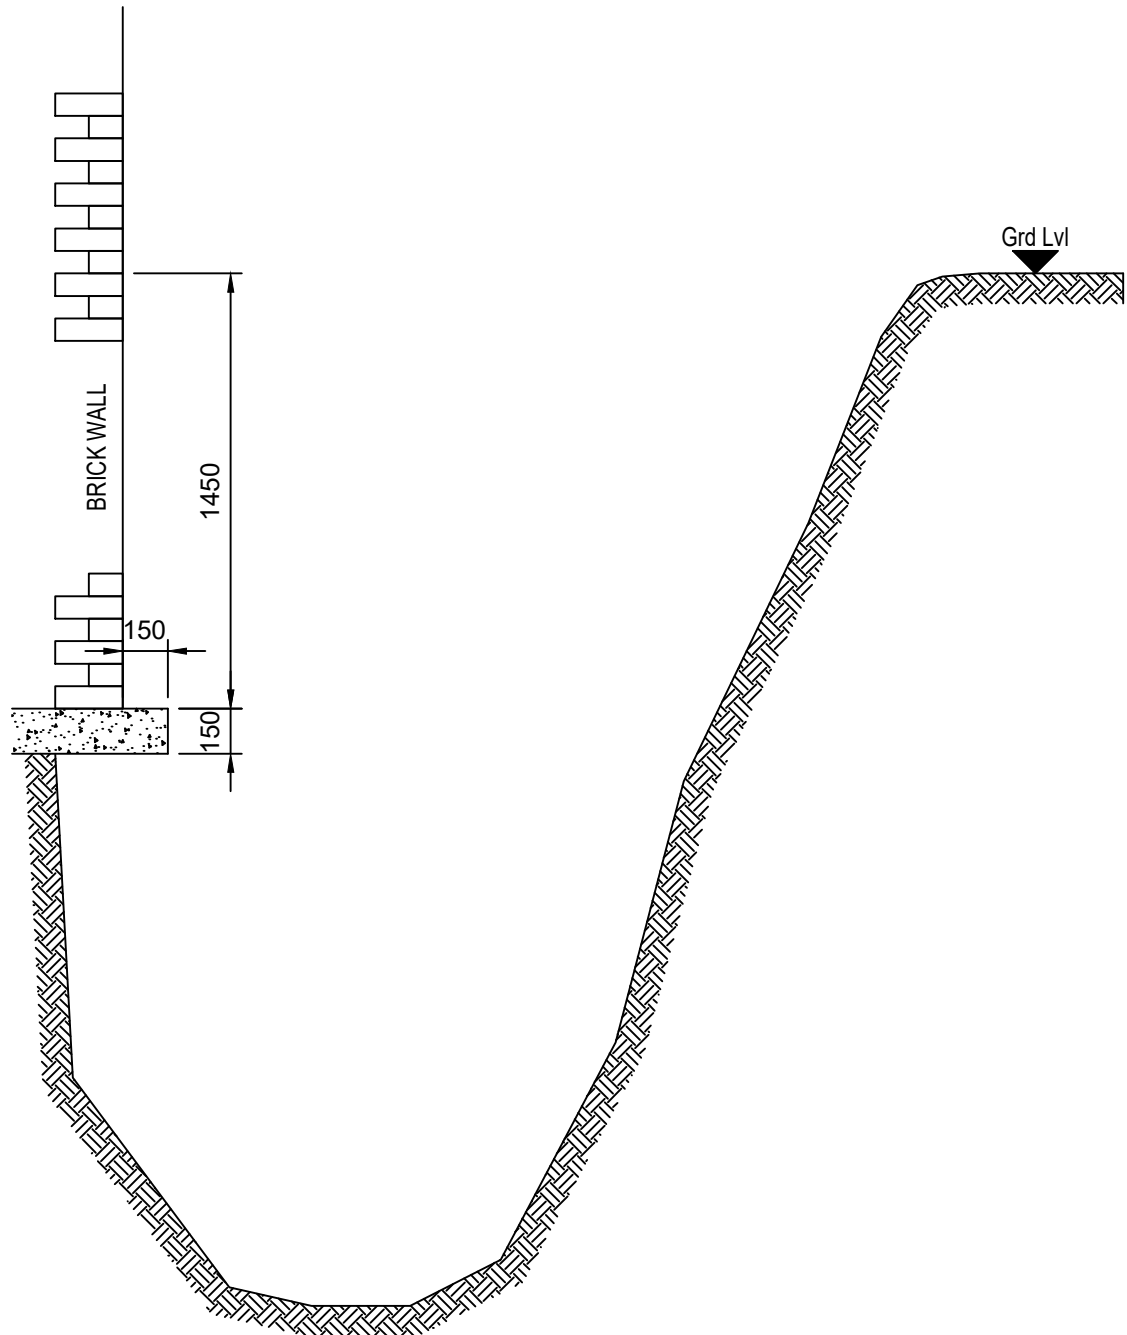
BASE OF FOUNDATION IDENTIFIED NATURAL GROUND BELOW.  
REFER TO CURTINS TRIAL PIT LOG FOR STRATA DETAILS.  
TRIAL PIT UNDERTAKEN PARTLY AGAINST BRICK PIER AND  
PARTLY AGAINST BRICK ARCH INFILL.

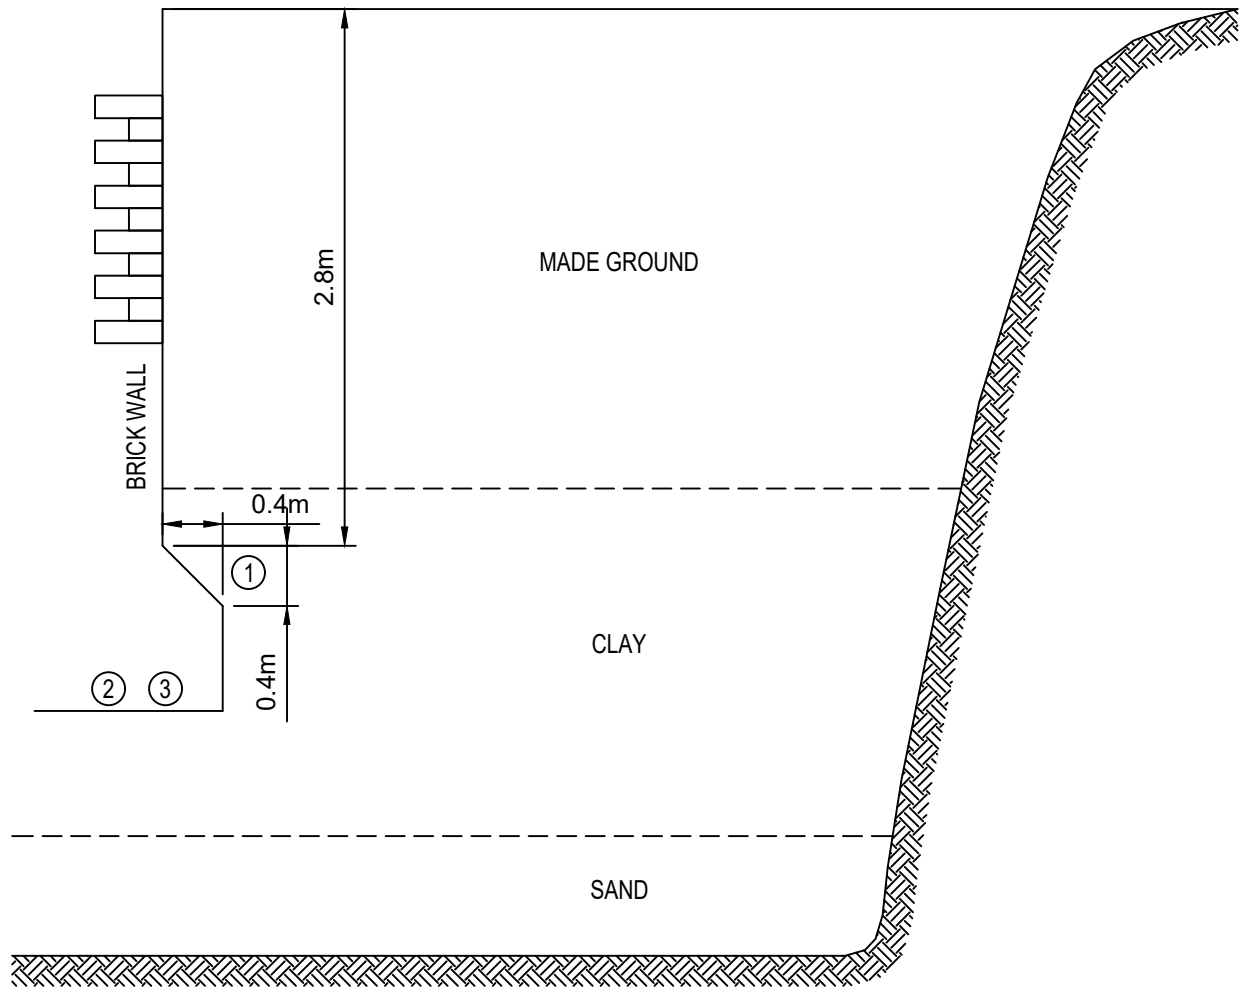
FACING WEST

1. BRICK WALL STEPS OUT 0.40m AT 2.80 bgl.
2. NO PROTRUDING FOUNDATION IDENTIFIED. BRICK WALL RESTS DIRECTLY ONTO UNDERLYING STIFF CLAY STRATA.
3. NO PROTRUDING FOUNDATION IDENTIFIED TO THE WEST. SEE SKETCH C FOR ADDITIONAL DETAILS.
4. REFER TO CURTINS TRIAL PIT LOG TP102A FOR STRATA DETAILS.
5. TRIAL PIT UNDERTAKEN PERPENDICULAR TO VIADUCT PIER.

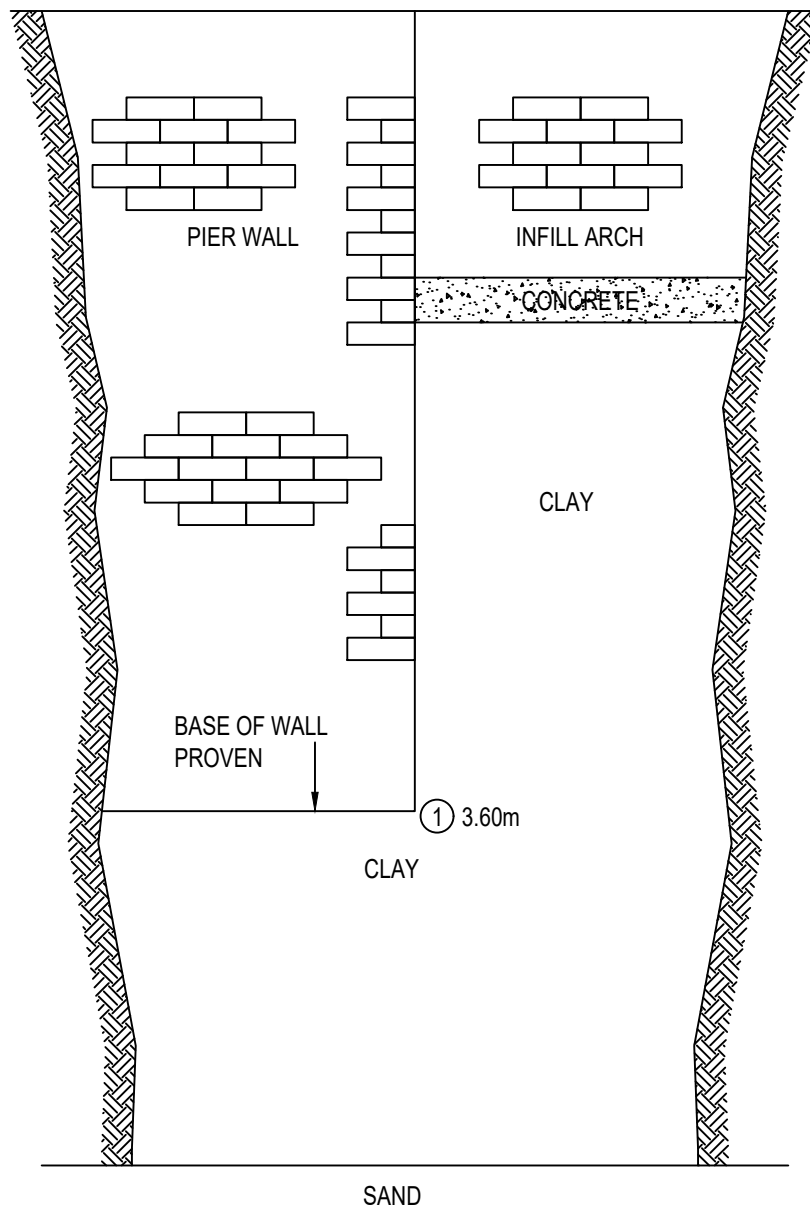
FACING SOUTH

1. NO FOUNDATIONS PROTRUDE WEST AT THE BASE OF THE VIADUCT PIER.
2. CONCRETE AT 1.45m bgl POTENTIALLY FOUNDATIONS OF BRICK INFILL. (ARCH).
3. REFER TO CURTINS TRIAL PIT LOG TP102A FOR STRATA DETAILS

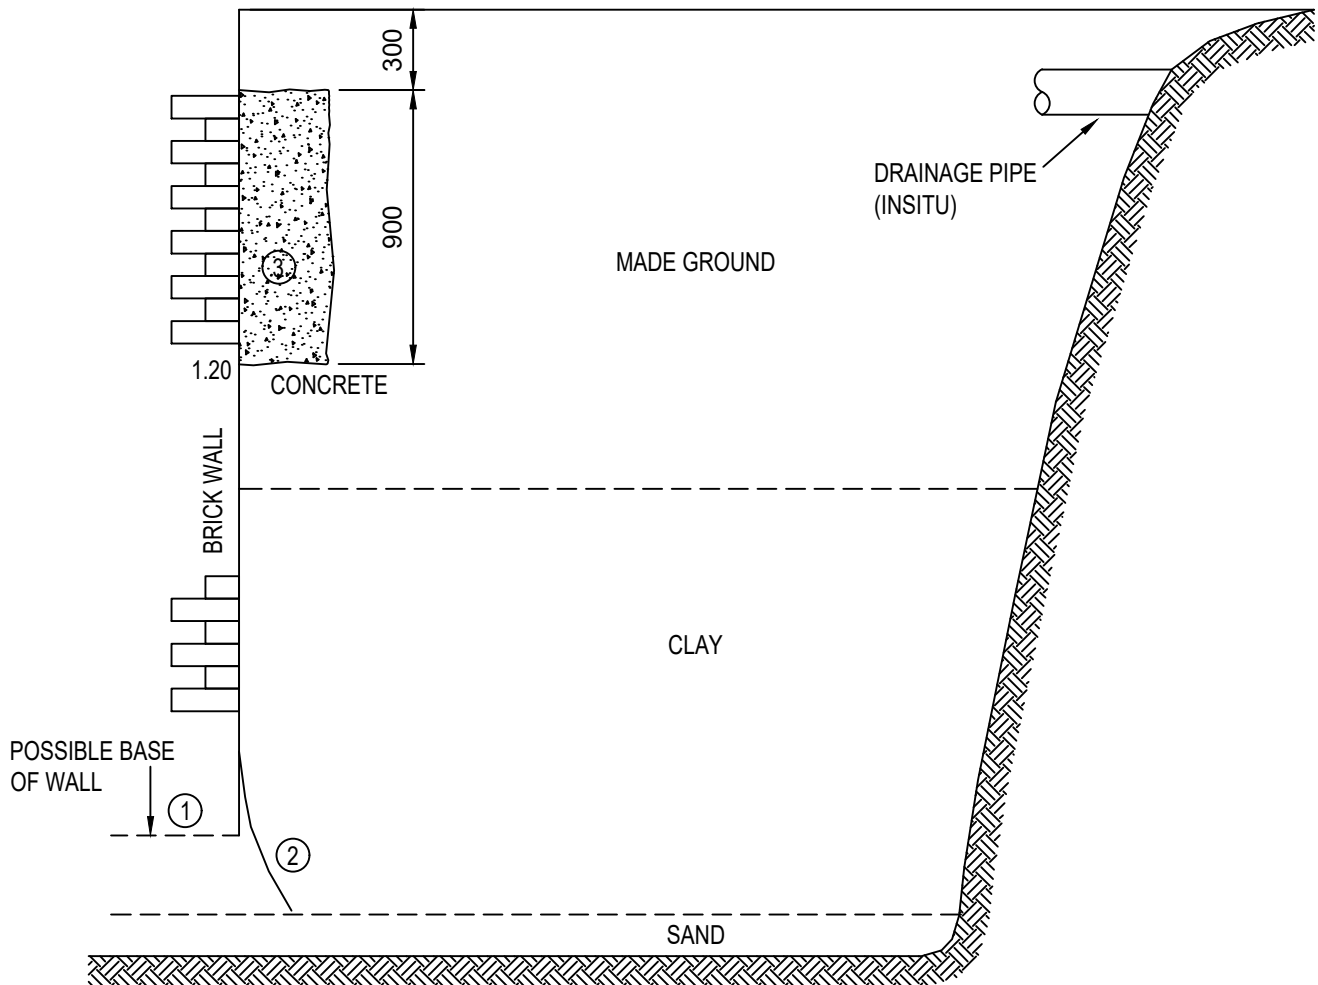
FACING WEST

1. BASE OF VIADUCT PIER NOT ENCOUNTERED IN THIS TRIAL PIT. STIFF CLAY ENCOUNTERED THROUGHOUT THE TRIAL PIT NOT PREVIOUSLY DISTURBED. INTERPRETTED THAT BASE OF WALL IS FOUND IN SIMILAR GROUND CONDITIONS AS TP102A, AND AS SUCH IS ASSUMED TO BEAR ONTO STIFF CLAY. NO EVIDENCE OF FOOTING PROTRUDING NORTH INTO TRIAL PIT TO 5.00 bgl.
2. DUE TO RESTRICTIONS ON SITE, IT WAS NOT POSSIBLE TO SAFELY EXCAVATE CLAY FROM BRICK WALL. THE EXCAVATOR COULD NOT BE MOVED BACK FROM THE PIT (NORTH) DUE TO ELEVATION CHANGE BEHIND IT.
3. SHALLOW CONCRETE NOT THOUGHT TO REPRESENT FOUNDATION. IT IS NOT CLEAR WHAT THE PURPOSE OF THE CONCRETE IS.
4. REFER TO CURTINS TRIAL PIT LOG TP103A FOR STRATA DETAILS.
5. TRIAL PIT UNDERTAKEN PERPENDICULAR TO BRICK PIER.
