**project**  
51-53 richmond st, manchester  
**job no.**  
7593  
**title**  
Warehouse Existing First Floor Finish Plan  
**scale**  
1:100 @ A3  
**drawing no.**  
**al(05)0082**

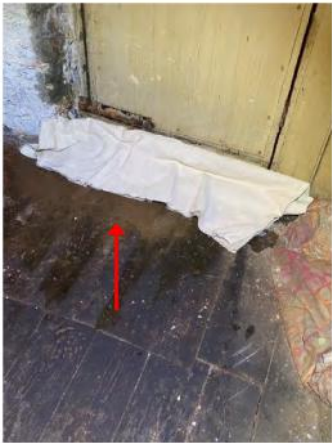
Photo 2

Floorboards were damp where rainwater from the leaking gutter was splashing off the emergency exit door threshold and penetrating the interior.

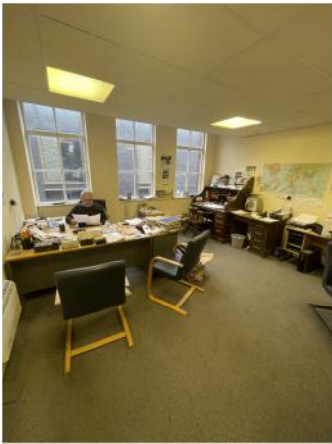
Photo 3

Most of the floor is occupied by an office enclosed by lightweight partitions. Non-original chipboard panels fixed to existing floor with contemporary carpet tiles in office space.

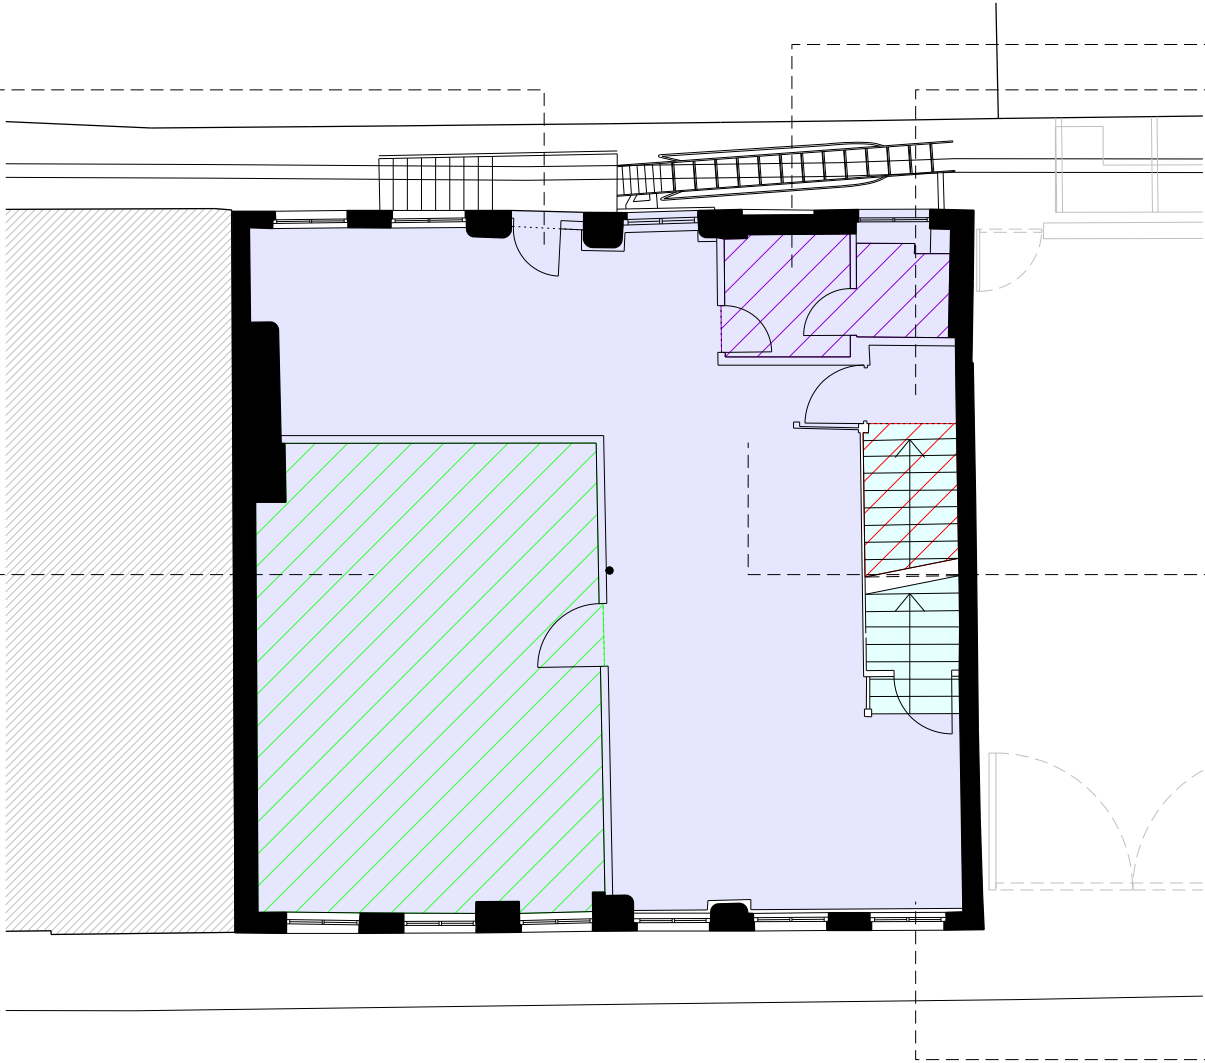
| | Existing non-original concrete slab dishes towards central low point and floor gully | | Original timber panel boxing out to lower ground floor entrance head room | | Solid timber planks fixed to existing floor boards. Assumed for strengthening floor below heavy machinery |
| | Existing brick and stone steps down to lower ground floor level | | Non-original chipboard panels fixed to existing floor along high traffic routes | | |
| | Existing non-original floorboards replaced following basement fire | | Non-original timber capping on top of original timber stair treads | | |
| | Existing original floorboards | | Non-original chipboard panels fixed to existing floor with contemporary carpet tiles | | |
| | Existing original timber staircase | | Non-original chipboard panels fixed to existing floor with timber effect linoleum | | |

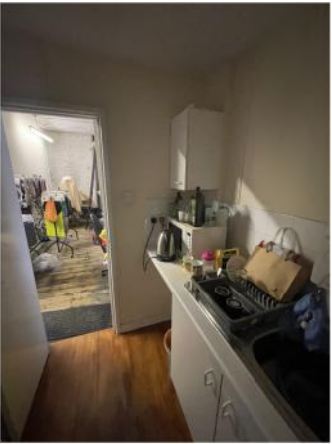
Photo 5

Timber effect linoleum floor finish shown in kitchen space with contemporary ceiling.

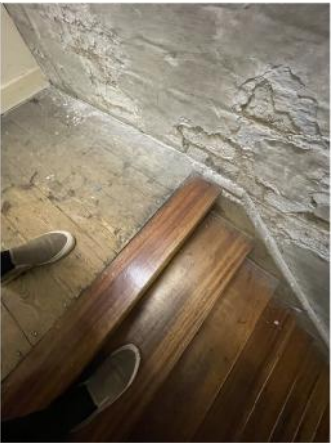
Photo 6

Existing floorboards meeting the non-original timber capping on top of the original timber staircase. Finish added to the original brick wall in poor state.

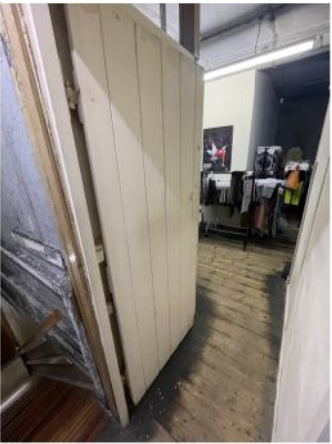
Photo 7

Lightwight partitions with timber doors.

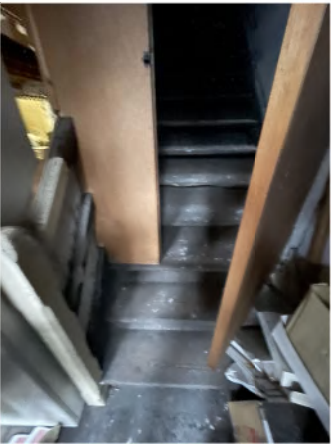
Photo 8

Lightwight partitlions with timber doors leading up to second floor.
