# REPORT

## **REPORT ON A GEO-ENVIRONMENTAL INVESTIGATION**

**29 BERRY BROW, MANCHESTER, M40 1GR.**

**Report No J3408/16/E**

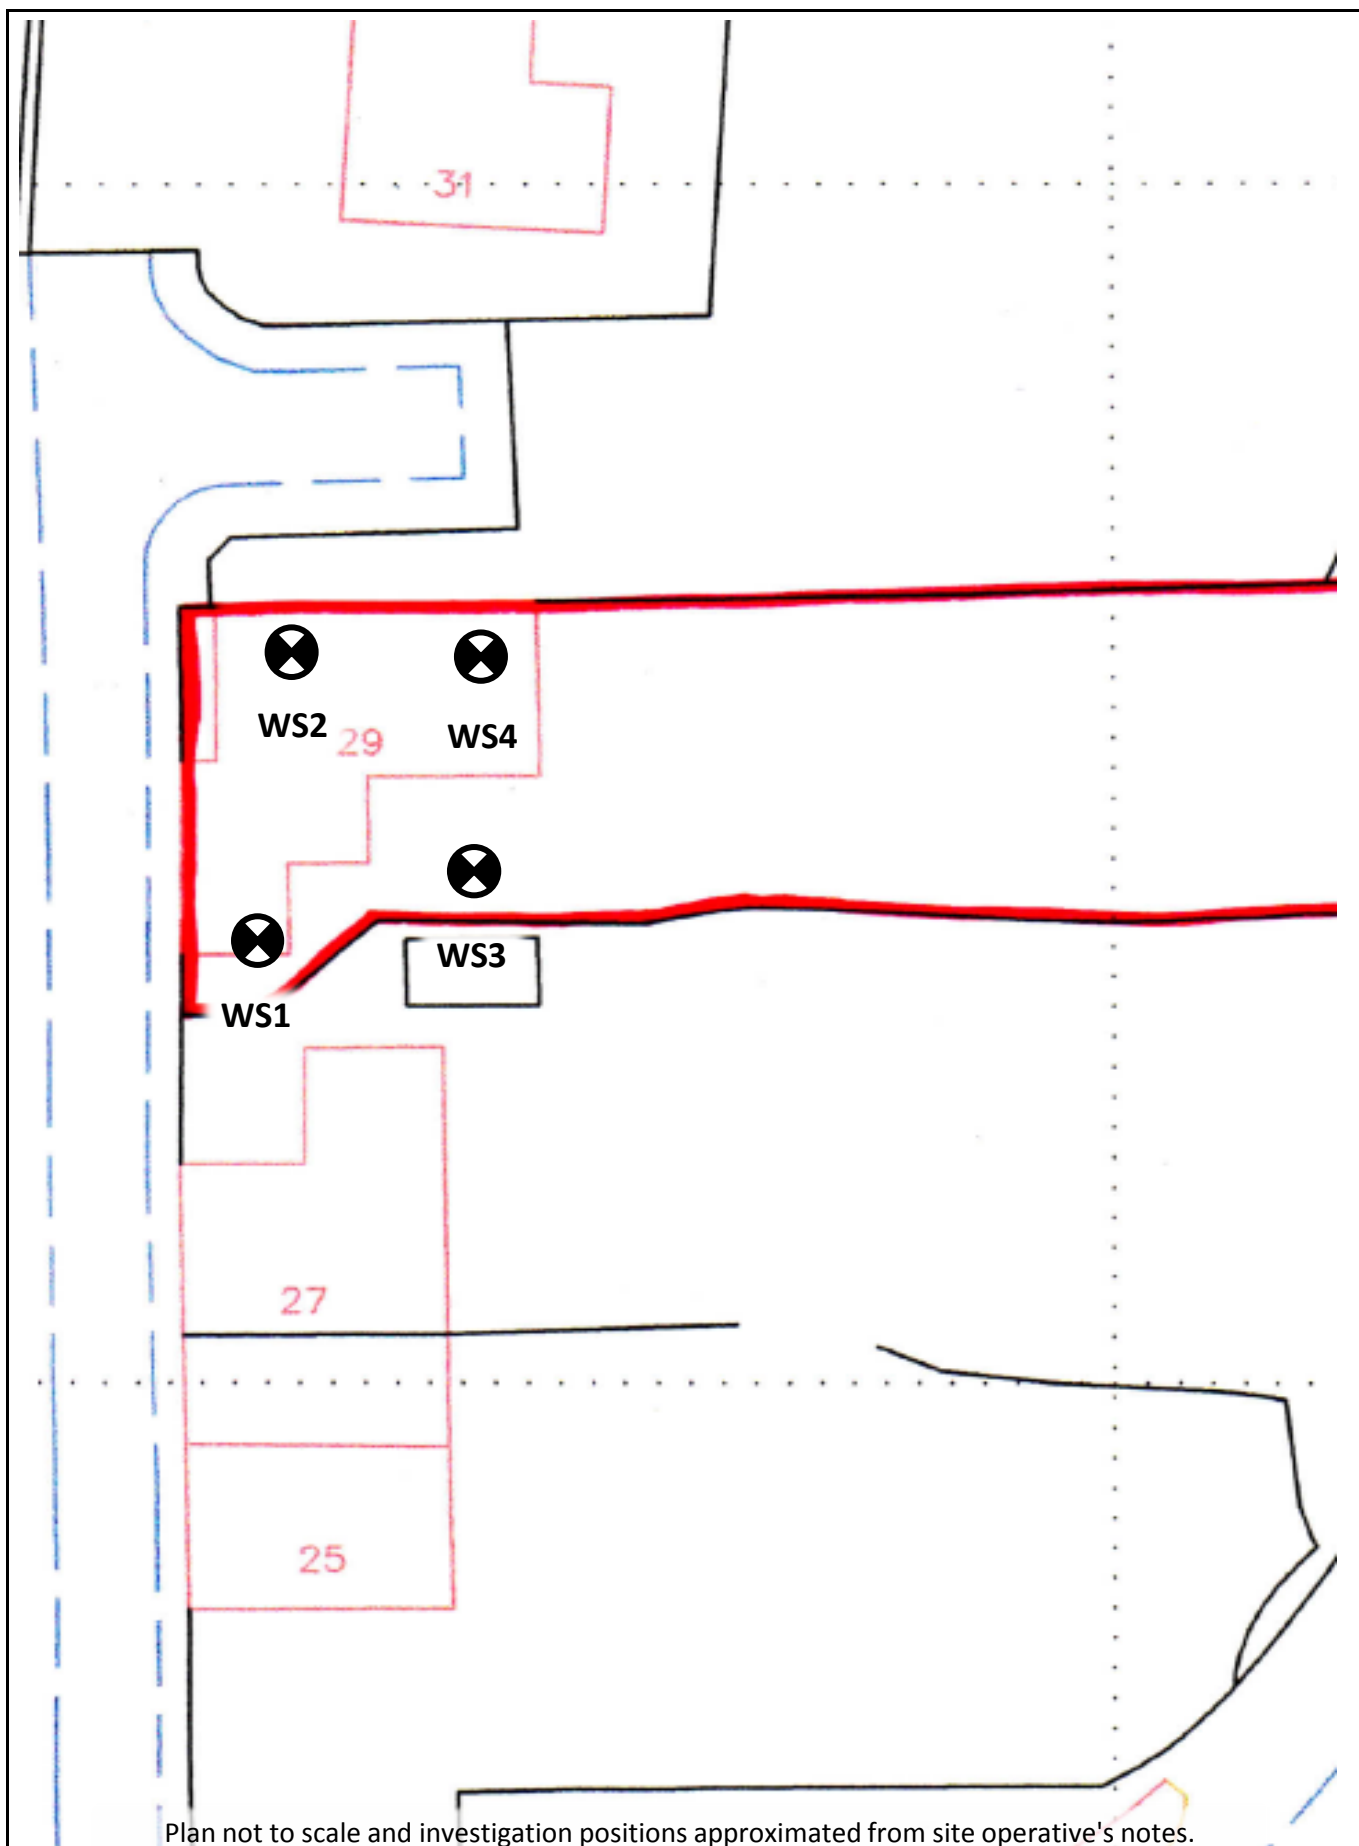
| Title: <b>Investigation Location Plan</b> | | |

The investigatory locations are shown on the site plan which is presented in Appendix 1 to this report.

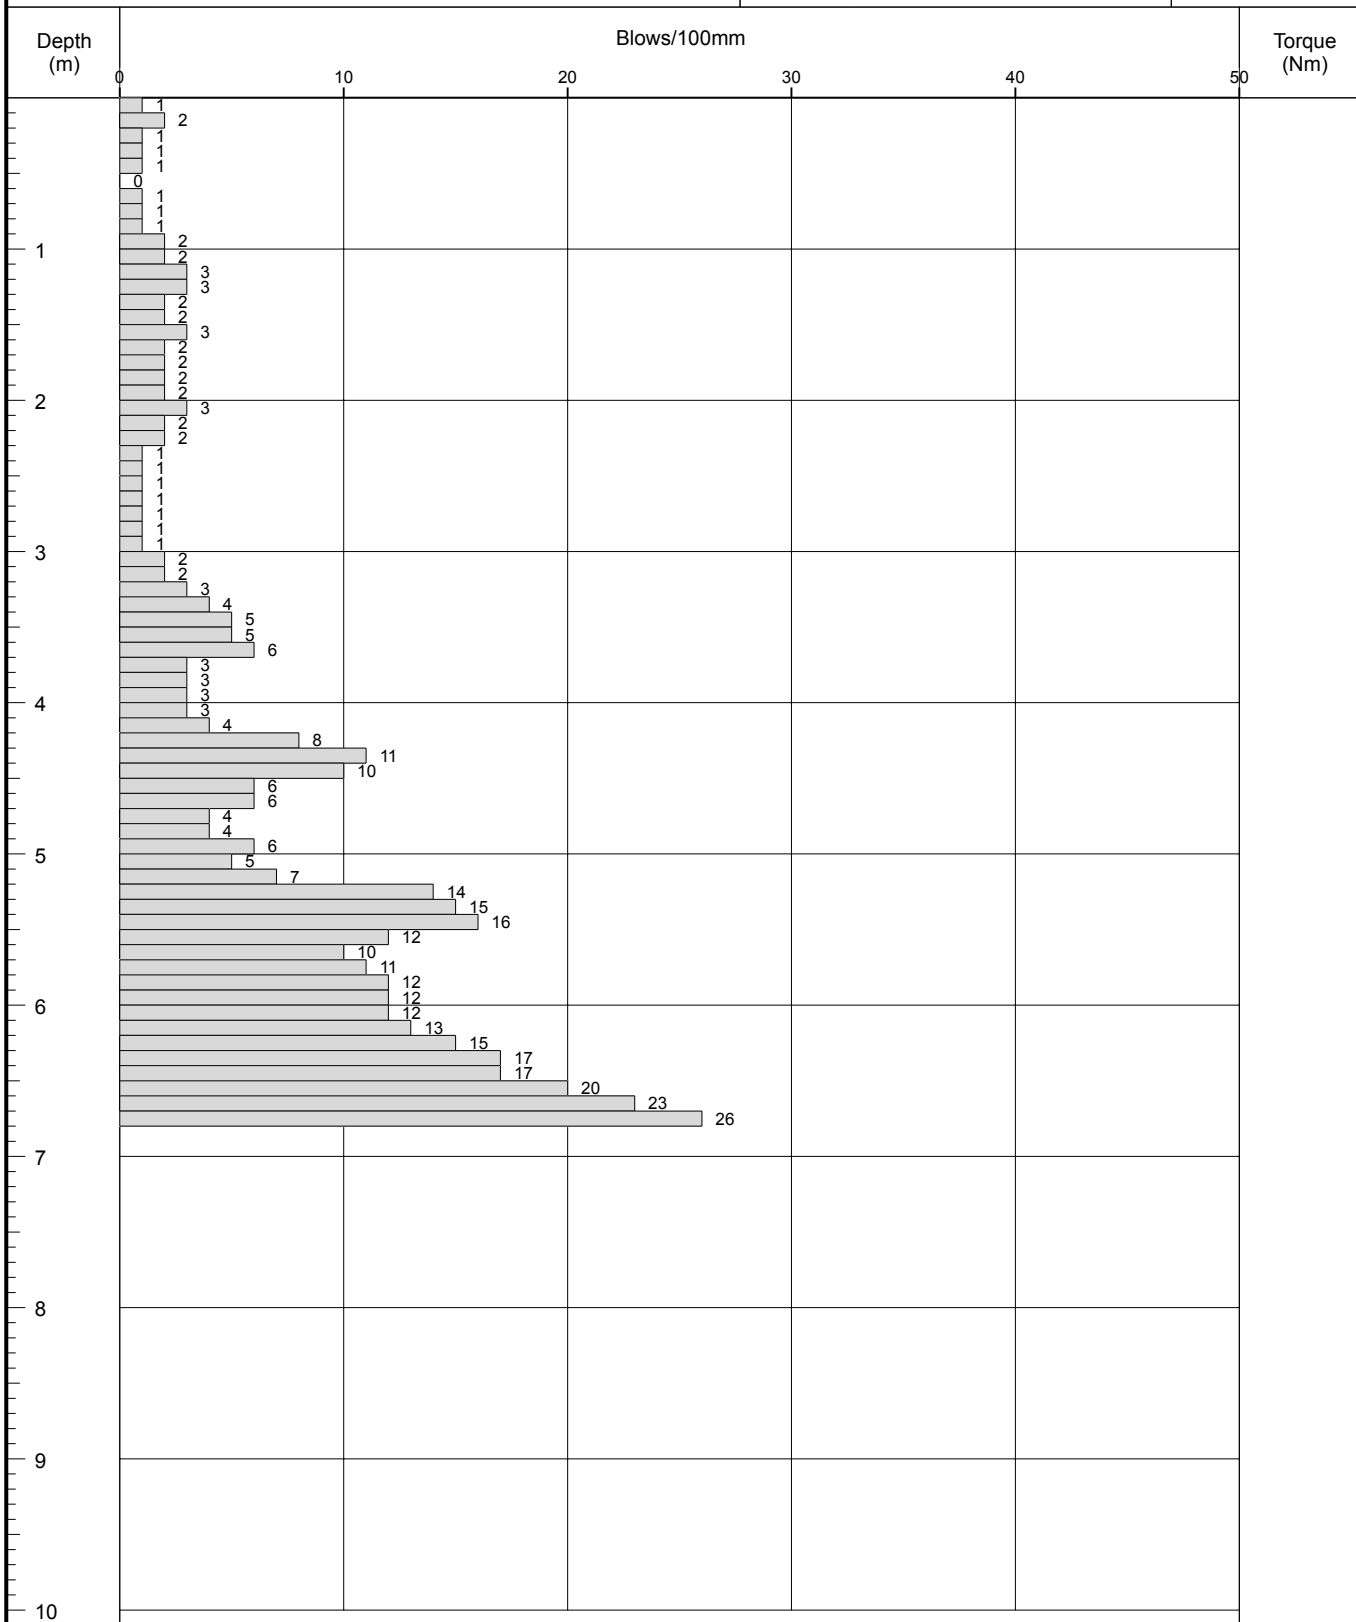
Remarks:  
Refused at 6.8m depth.

Fall Height 750mm

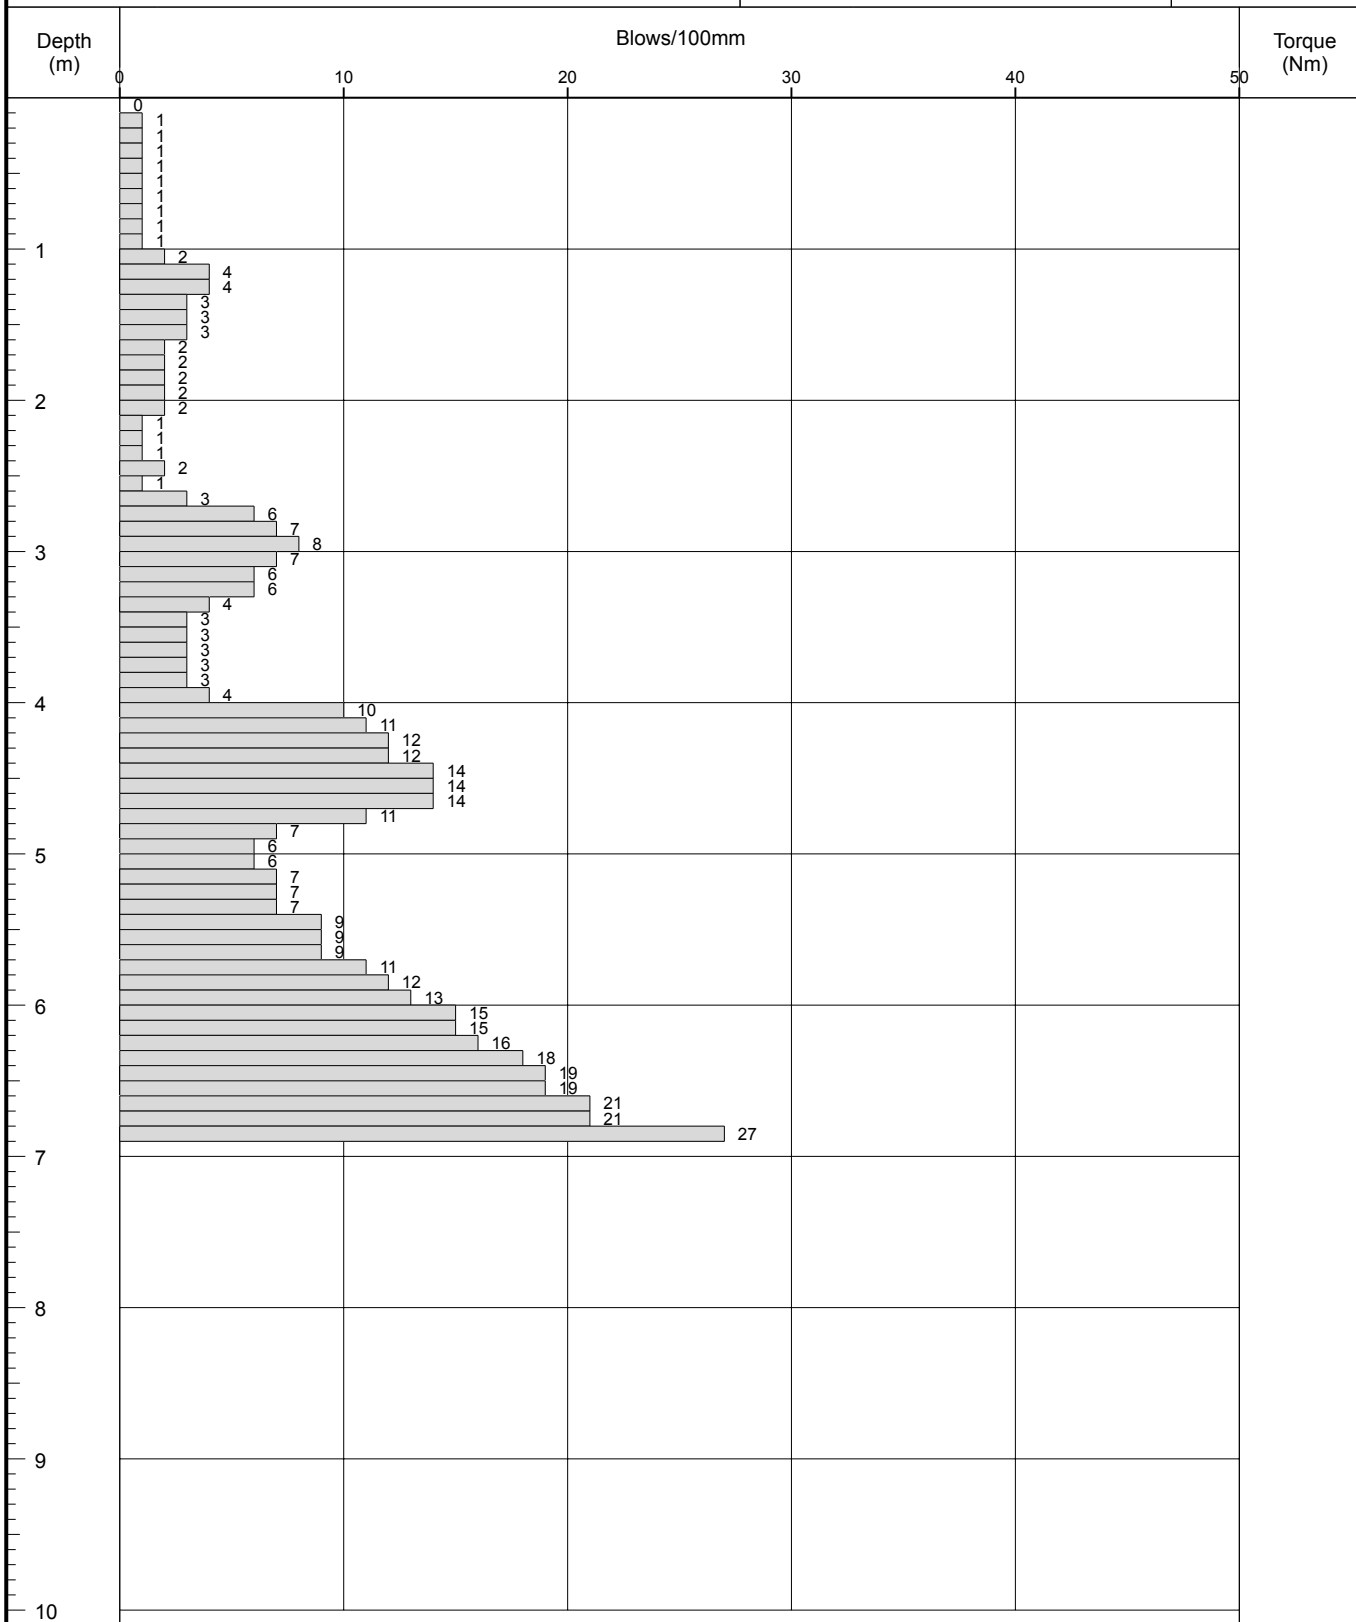
Remarks:  
Refused at 6.9m depth.

Fall Height 750mm

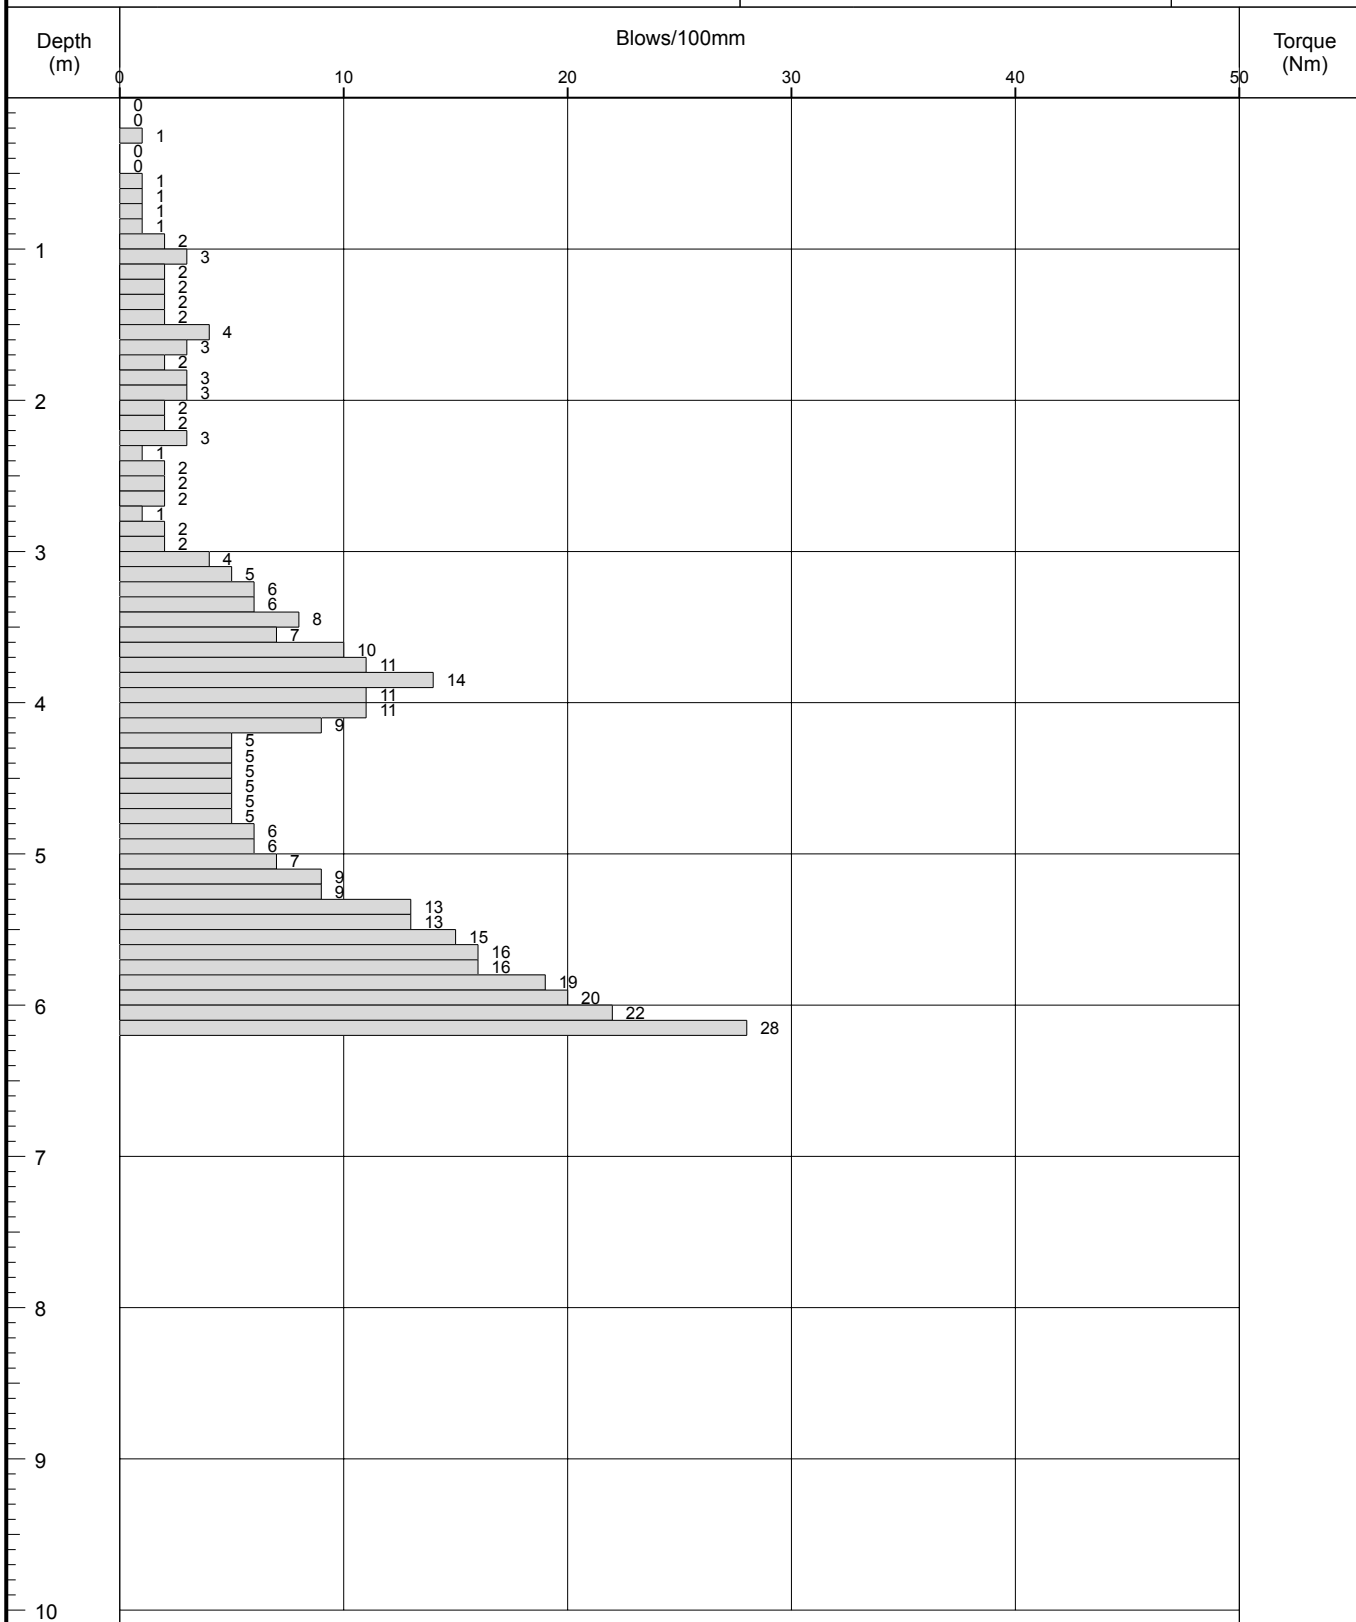
Remarks:  
Refused at 6.2m depth.

Fall Height 750mm

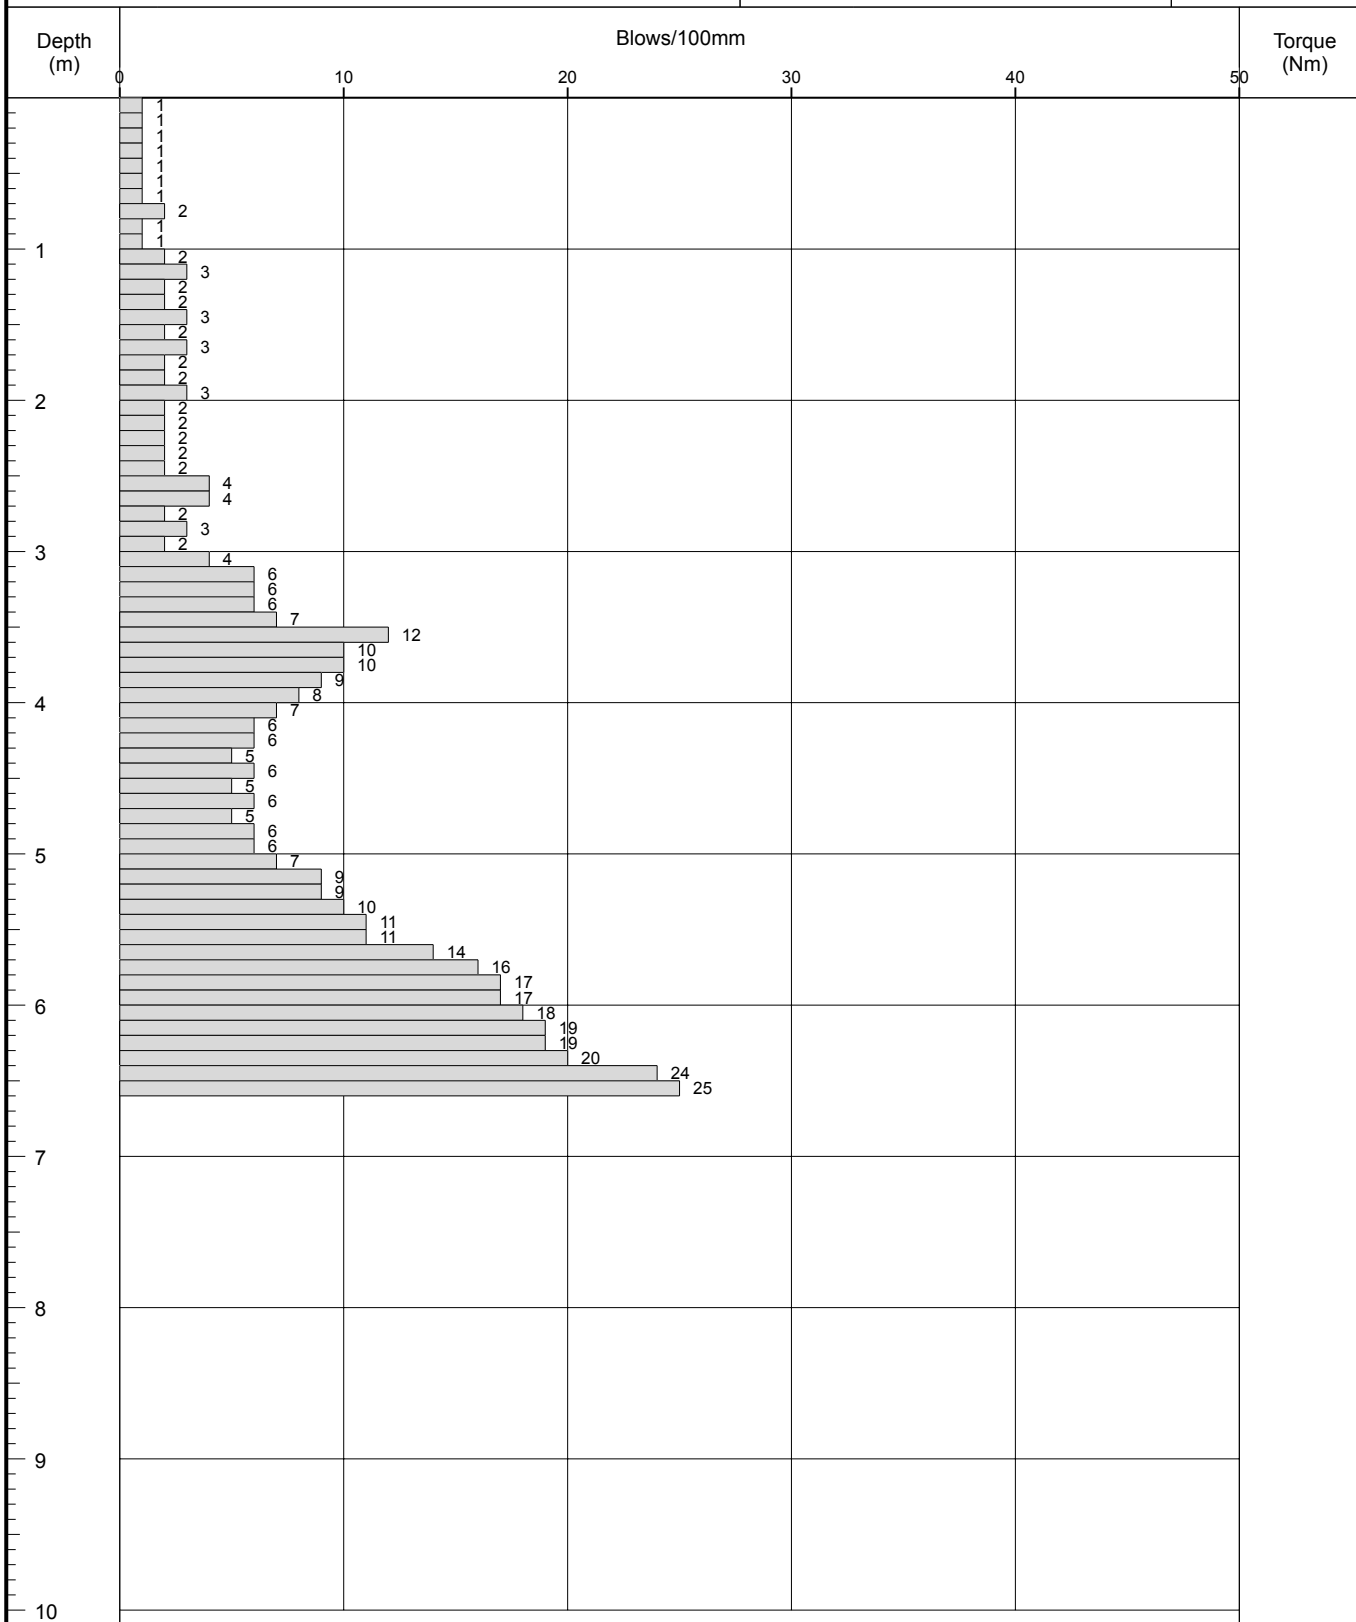
Remarks:

Refused at 6.6m depth.
