## **Proposed replacement of Broomcroft Conservatory**

Broomcroft Hall, Ford Lane, Didsbury,  
M20 2RU

November 2022

**Issue 1**

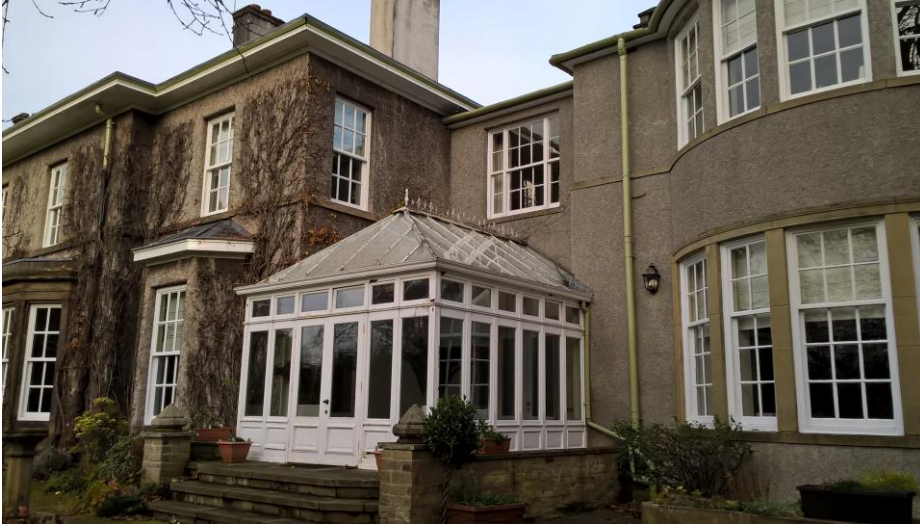
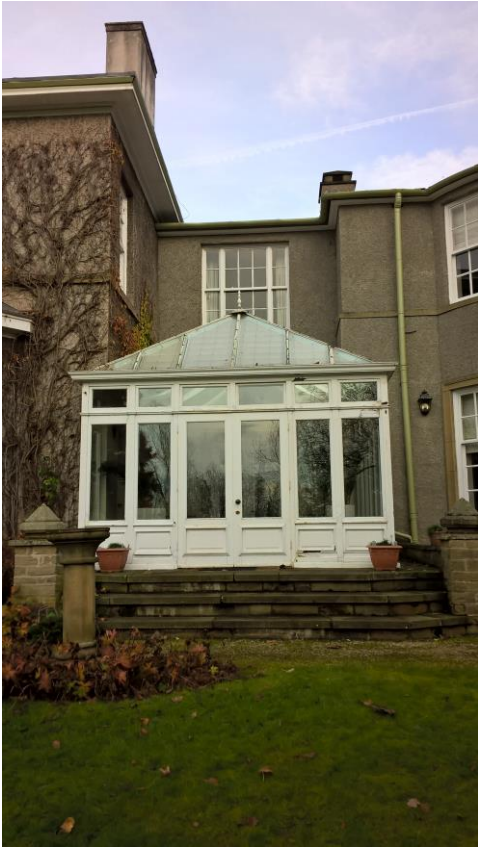
The images below show the existing conservatory:

After timber repairs were carried out to the conservatory in 2018, an inspection earlier this year by the University's Facilities Maintenance and Compliance unit found that there were numerous areas of rotten timber, in some areas extending right the way through the frame, strongly suggesting that the conservatory had reached the end of its useful life.

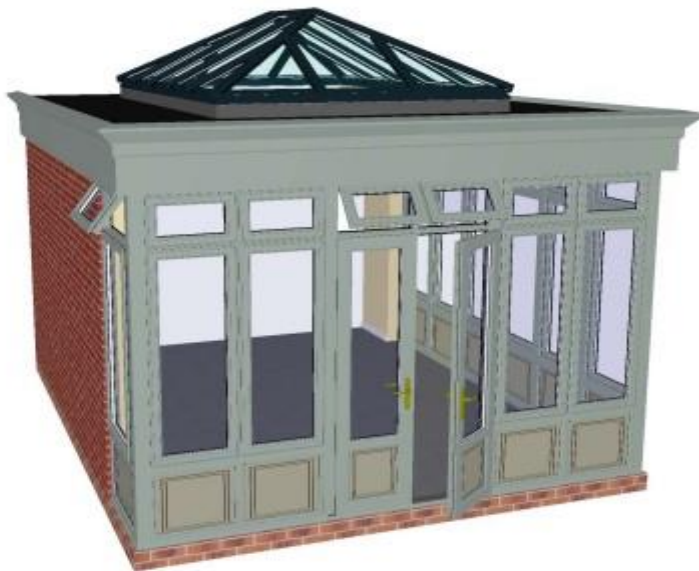
5. Proposed design of replacement conservatory – Accoya timber frame with a lantern roof

The proposed design is an Accoya timber frame conservatory with a lantern roof. The stable nature of Accoya timber and the factory finish means that the conservatory will not require regular redecoration, and is maintenance free aside from cleaning.

There is a ten year guarantee on the glazing units and the Accoya timber comes with a 50 year guarantee against decay. The U-value for the glazing is 1.0.

All joinery will be factory painted to a colour of our choice. The aluminium capping of the lantern roof can also be painted in a colour of our choice (it doesn't necessarily have to be black), but may not match the timber completely. The colour choice for the timber frame and aluminium cappings have not yet been confirmed but are likely to be white, grey or green to match the rainwater goods.

The lantern roof will allow access to the problematic side gutter, and the timber frame is in keeping with the historic character of Broomcroft Hall.

The footprint of the new conservatory will match the existing conservatory and the configuration of fixed lights, opening lights and entrance doors will also match.

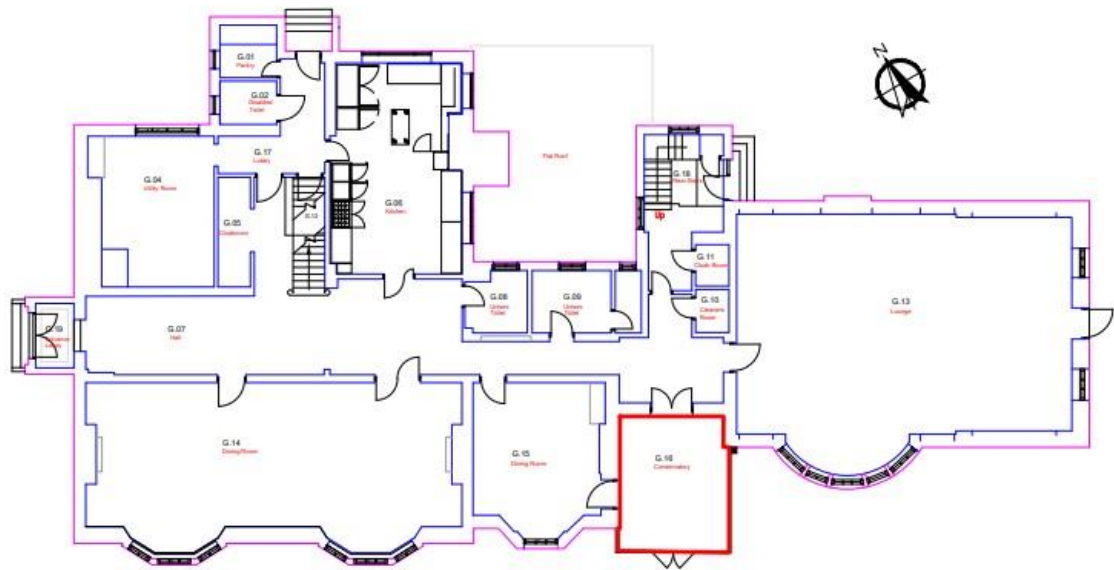
Ground floor plan of Broomcroft Hall is shown below with the conservatory outlined in red.

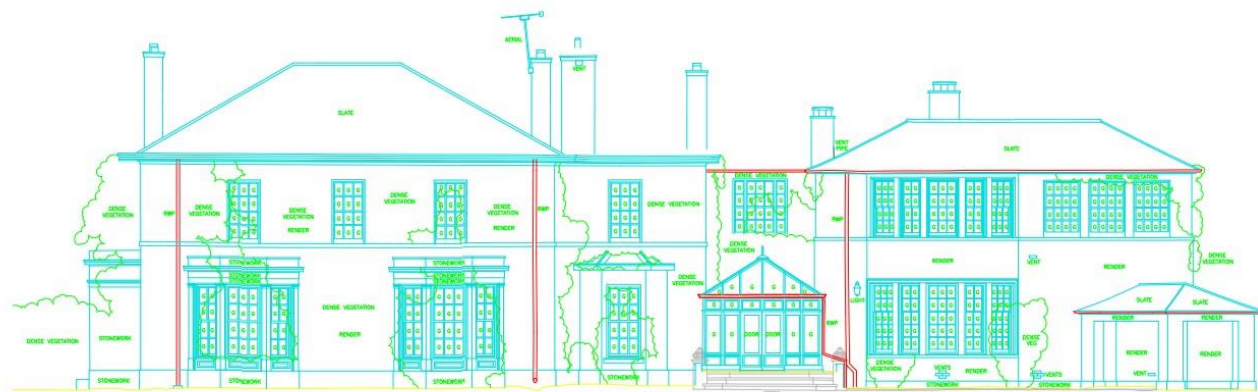
Existing

Elevation drawing showing existing conservatory
